CARR-1548

447 Crowl Road, Union Mills Vicinity

# Maryland Historical Trust State Historic Sites Inventory Form

historic Frock-Burgoon Farm

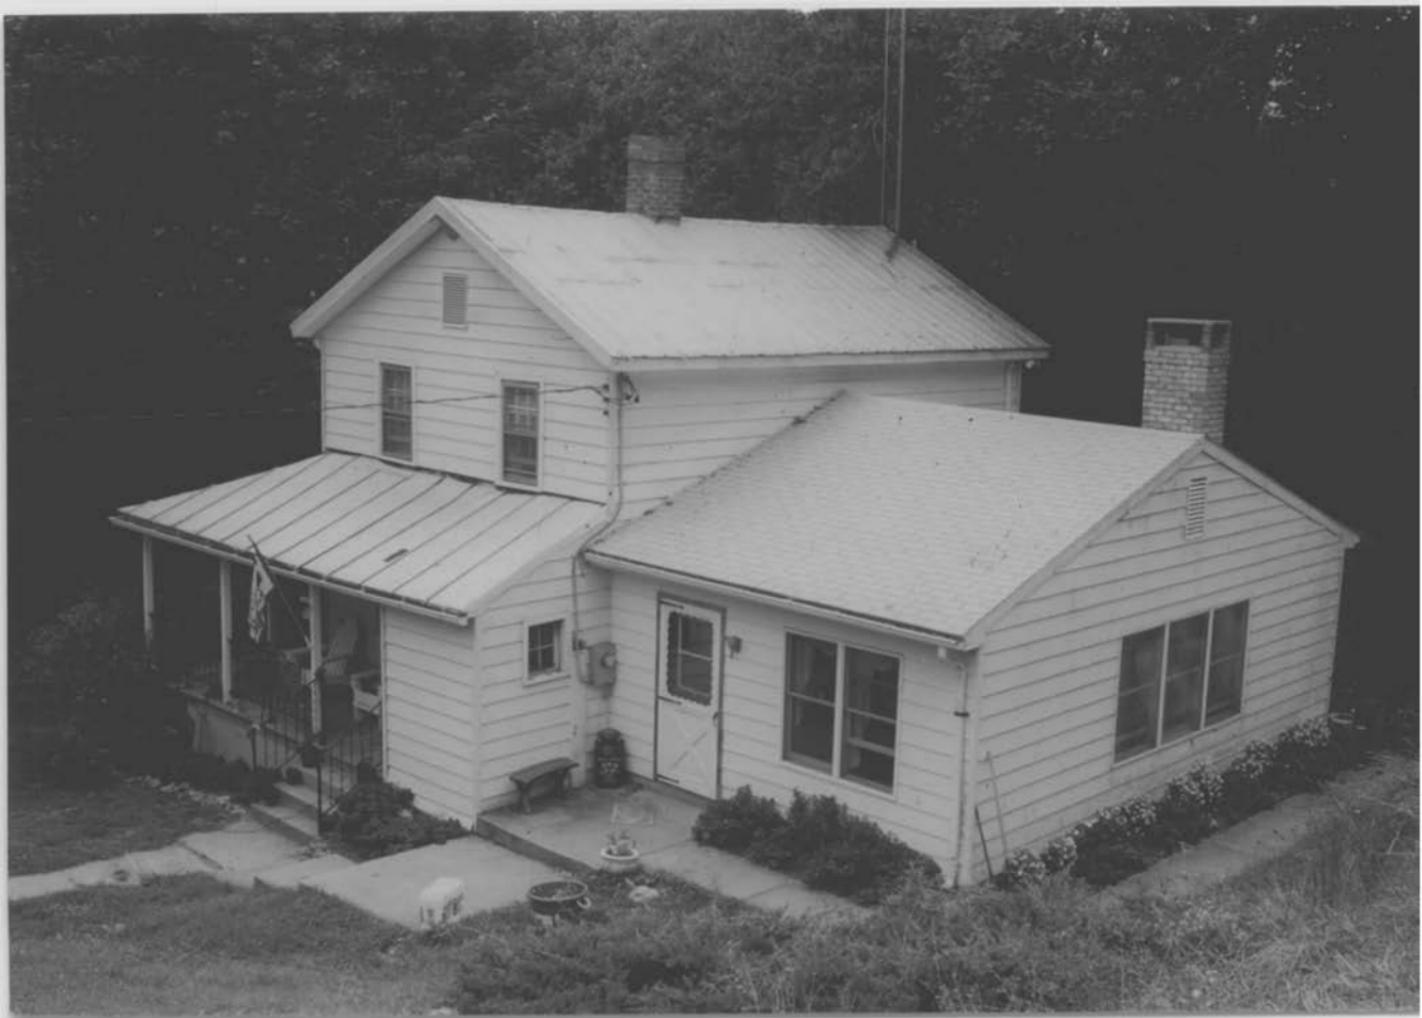
10F4

NEG. LOC: MARYLAND HISTORICAL TRUST  
HOUSE - EAST & NORTH ELEVATIONS

On the east elevation, the foundation area below the porch is enclosed and this wall is parged. The first story has a six-over-six sash in the south bay and a six-paneled door in the north bay. The top two panels are glazed. The northeast corner of the porch is enclosed and has a vertical-board door on the south elevation. The second story of the east elevation has two six-over-six sash, and the gable end has a vent that appears to be placed over top of a four-light sash. There is a one-story wing on the rear, or north, elevation that is a more recent addition. It is a two-bay by one-bay structure with a CMU foundation and a gable roof of asphalt shingles with a north-south ridge. There are no openings currently on the north elevation of the main block, above this wing. On the west elevation, the foundation has a six-over-six sash in the center with beaded-edge-and-center vertical-board shutters. The first and second stories each have two six-over-six sash and the gable end has a vent in the center.

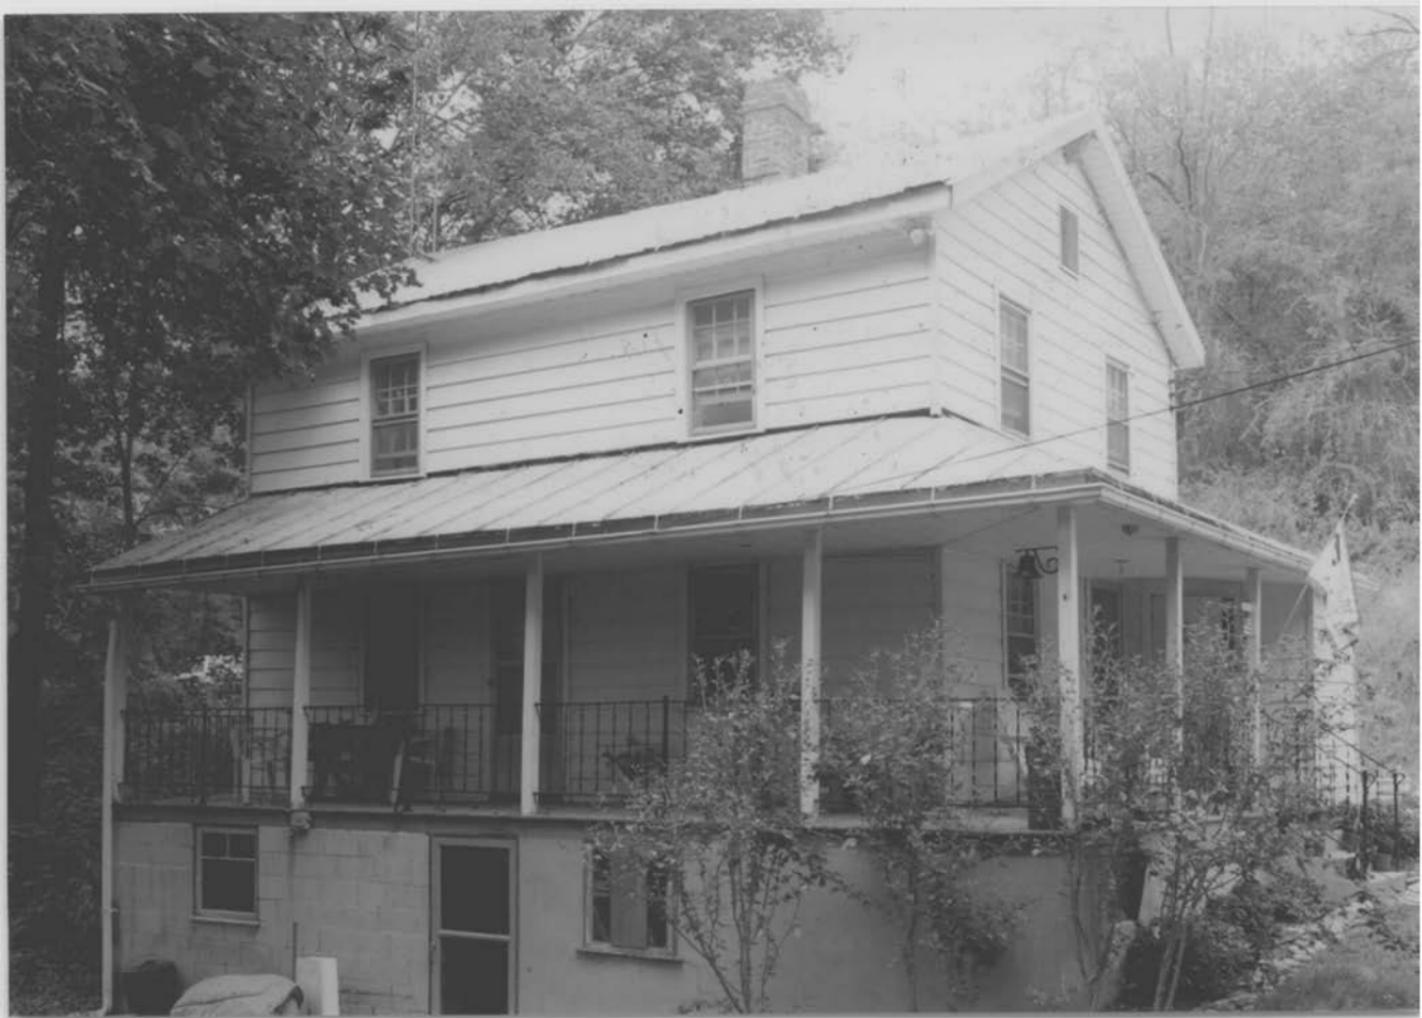
2 OF 4

NEG. LOC: MARYLAND HISTORICAL TRUST  
HOUSE - EAST & SOUTH ELEVATIONS

The house is banked on the north with an exposed foundation on the south elevation. It is a two-story, three-bay by two-bay log structure with a rubble stone foundation, aluminum siding, and a gable roof with inverted v-seam metal with an east-west ridge. On the south elevation, the porch is enclosed at the lower story. The west end has CMU's. The east-end wall is parged. On the first story, there is a center entrance with a four-paneled door and a six-over-six sash to either side. There is a one-story, three-bay porch that wraps around on the east. On the south, the porch is supported by five square wood posts and has a shed roof of standing-seam metal. The second story has a six-over-six sash in each end bay, with no opening in the center. There is a box cornice, and an interior brick chimney between the center and east bays.

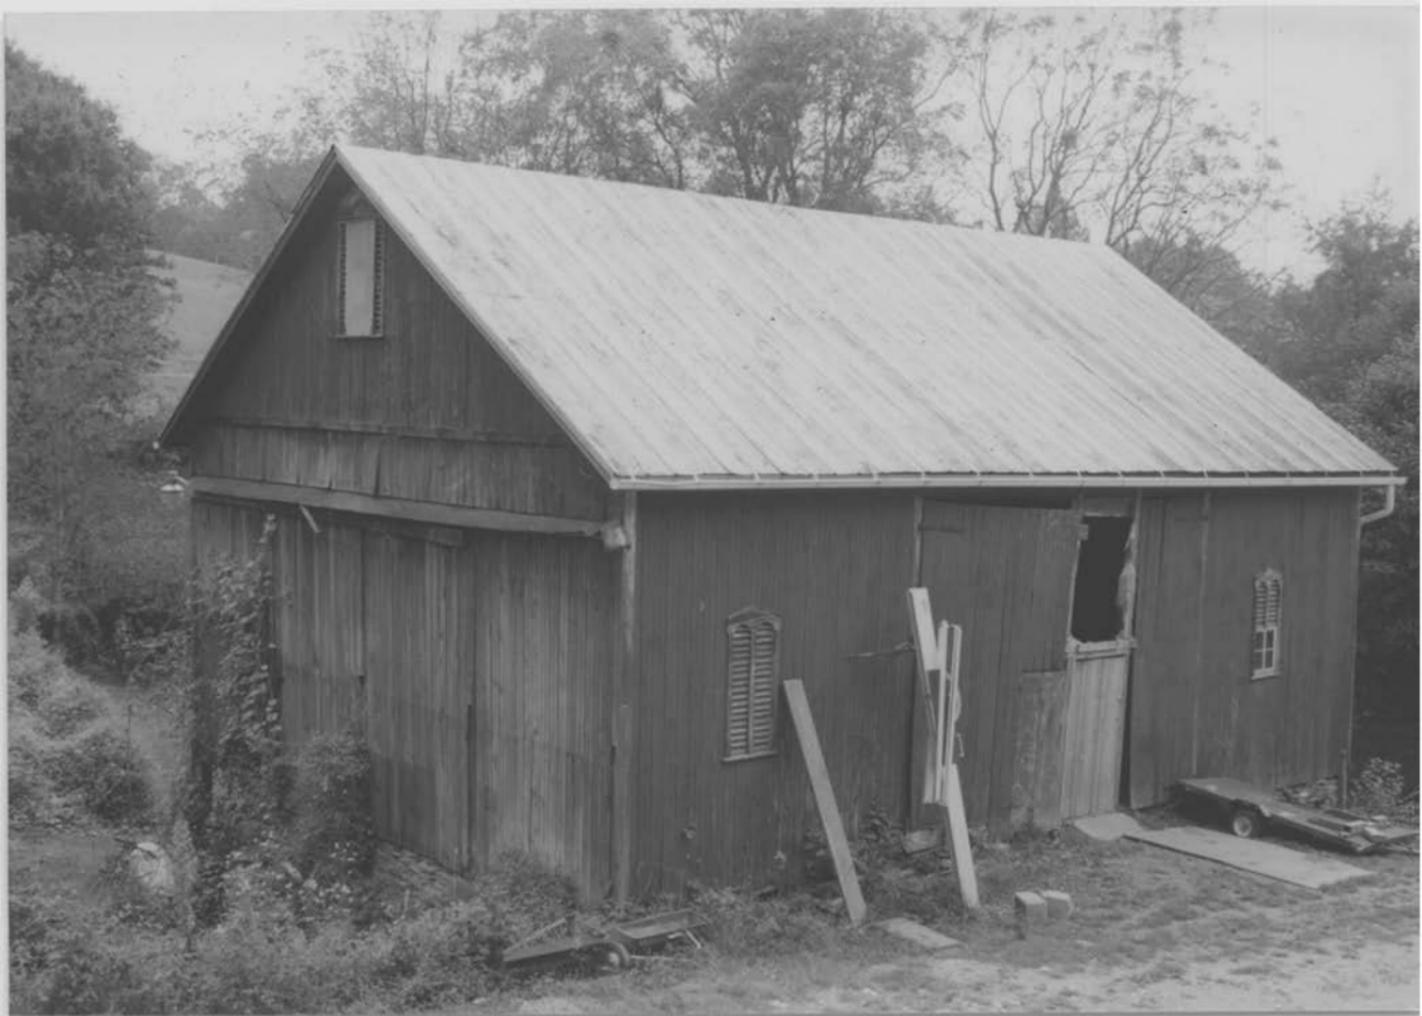
3 OF 4

NEG. LOC: MARYLAND HISTORICAL ~~AL~~ TRUST  
BARN - NORTHEAST  $\frac{1}{2}$  NORTHWEST ELEVATIONS

The northeast elevation of the barn is somewhat overgrown on the lower story, but appears to have one or two openings there. The upper story gable end has an opening, and the bottom sash survives. It has four lights, but the upper sash is now gone. There is a wood louver to each side of the sash and a pediment set above it. There are holes in the

siding and flashing near the eave suggesting some kind of shed was originally attached to this side. On the northwest elevation, the upper story has center double wagon doors on machine-made strap hinges. There is a wood vent to the north and a vent with a four-light sash at the bottom of it to the west. On the southwest elevation, the lower story has two four-over-four sash. The upper story has three bipartite wood-louvered vents and a door set at the west end. The gable end has a four-over-four sash with a wood louver to each side and a pediment above.

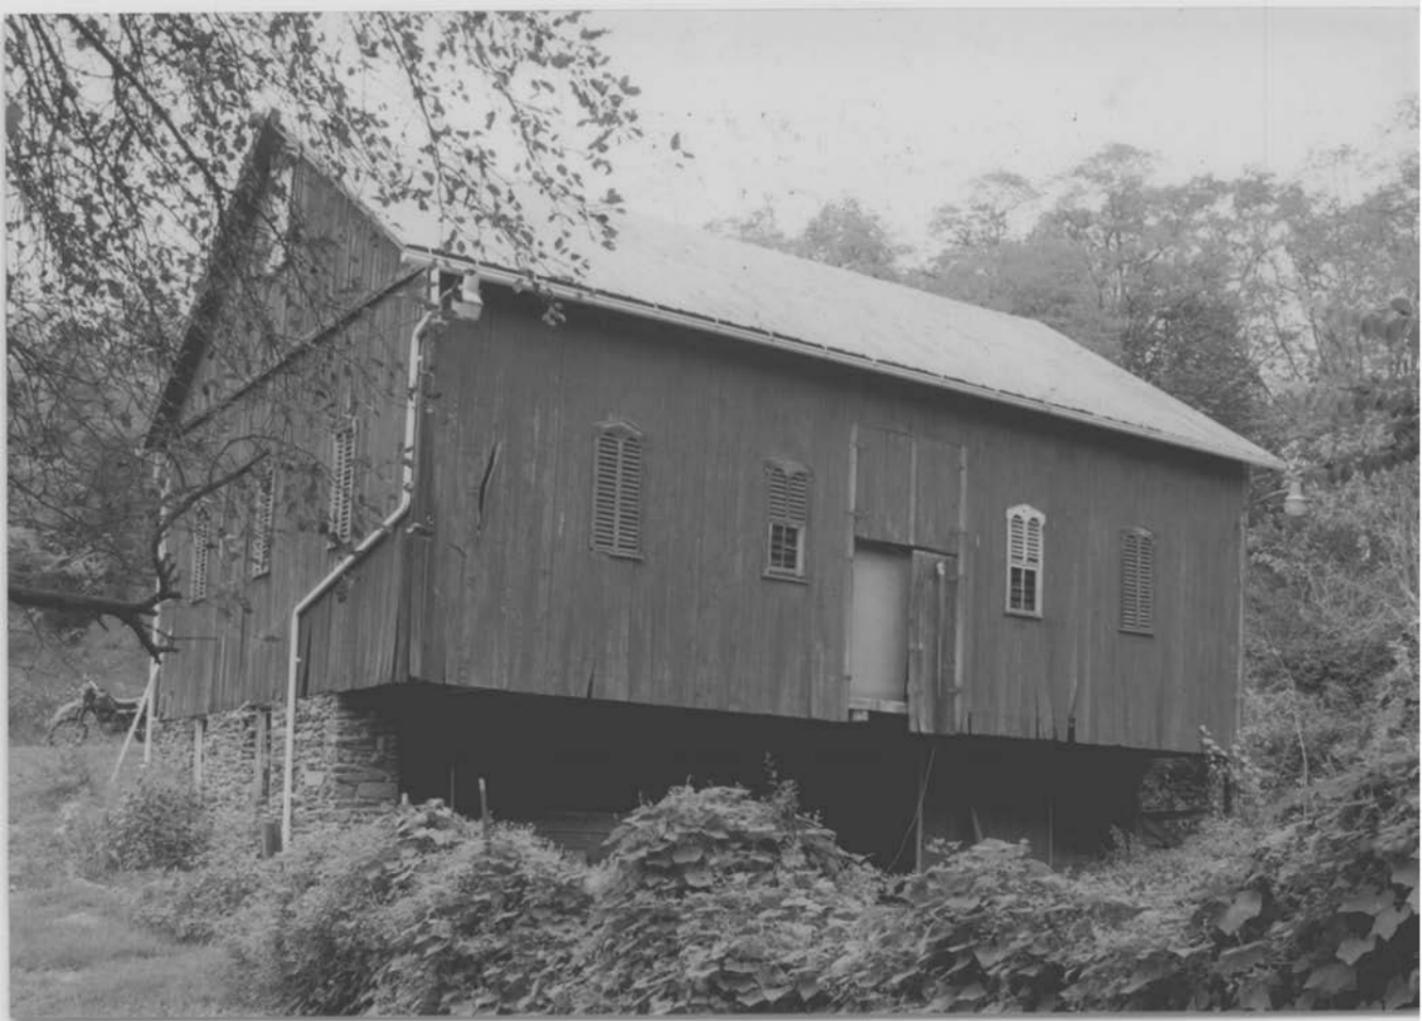
4 OF 4

(BARN): SOUTHWEST & SOUTHEAST ELEVATIONS

About one hundred feet east of the house is a bank barn with a forebay that faces southeast and a ramp on the northwest side. The barn has rubble stone on the lower story with new horizontal siding on the southeast elevation of the lower story. It also has beaded-edge-and-center vertical-board siding on the upper story and a gable roof of inverted-v-seam metal with a northeast-to-southwest ridge. On the southeast elevation, the lower story has a large centered door on rollers with an opening to each side. The upper story has center double doors set above another pair of double doors. There are two wood vents to each side. The south-center and east-center vents each have a four-light sash at the bottom.
