CARR-1551

524 Smith Rd., New Windsor Vicinity

**Maryland Historical Trust  
State Historic Sites Inventory Form**

historic Smith Family Farm

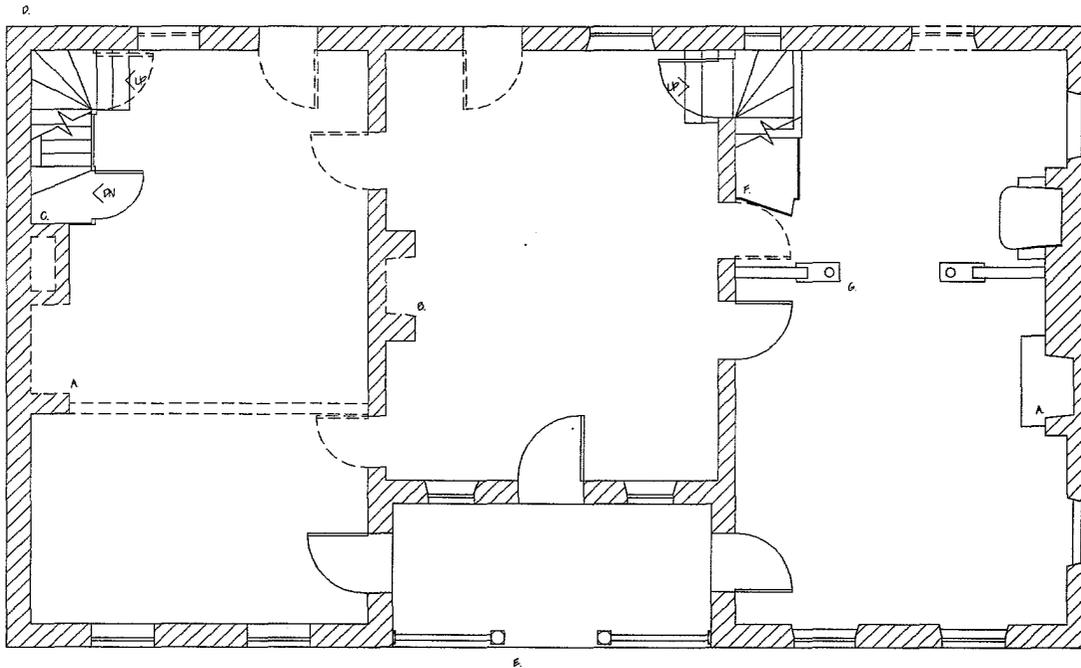
FIRST FLOOR PLAN

- A. FIREPLACE RESULT.
- B. NOT ACCESSIBLE TO MEASURE ACCURATELY.
- C. STAIRS RESULT.
- D. ROUGH ACCTION NOT SHOWN.
- E. PORCH DECK REPLACED WITH CONCRETE.
- F. NEW CONCRETE STEPS NOT SHOWN.
- G. CLOSET ADDED C. 1910.
- G. WALL OPENED UP C. 1919.

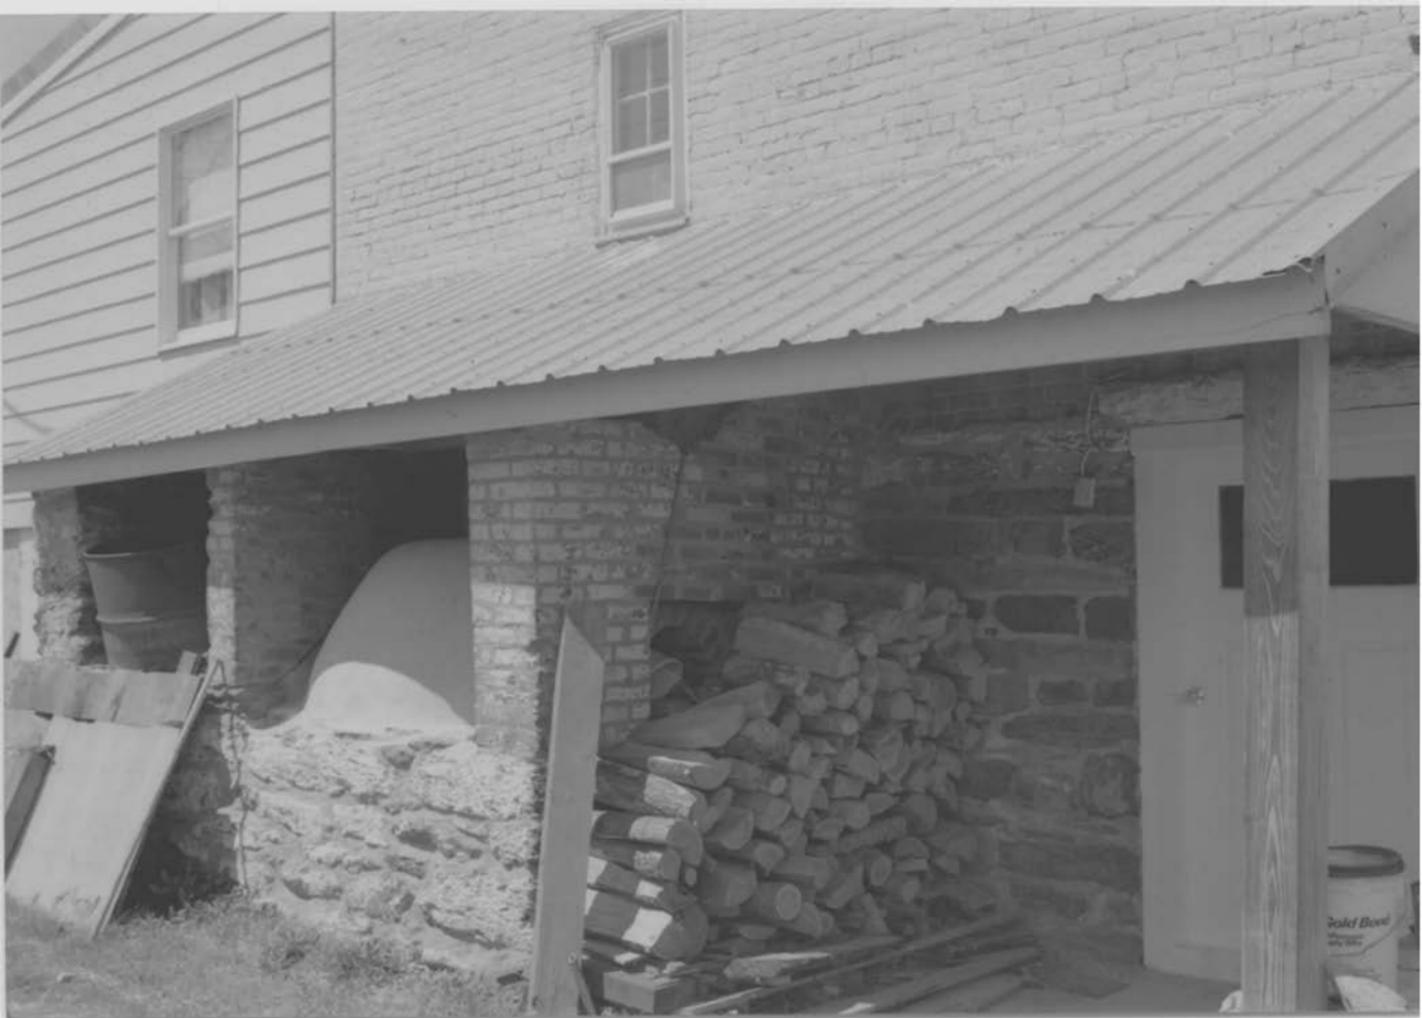
1 OF 17

House - S. Elev.

Bake oven & shed

The south elevation has an exposed foundation and a rebuilt pent roof on a stone and brick foundation that covers a beehive bake oven in the center. There is a covered opening to the west of the oven and a doorway on the east that leads to the basement. The door is new. The first story has a four-over-two sash on the west bay. The second story has no openings and the gable end has two six-light casements. There are tapered rake boards with beaded bottom edges.

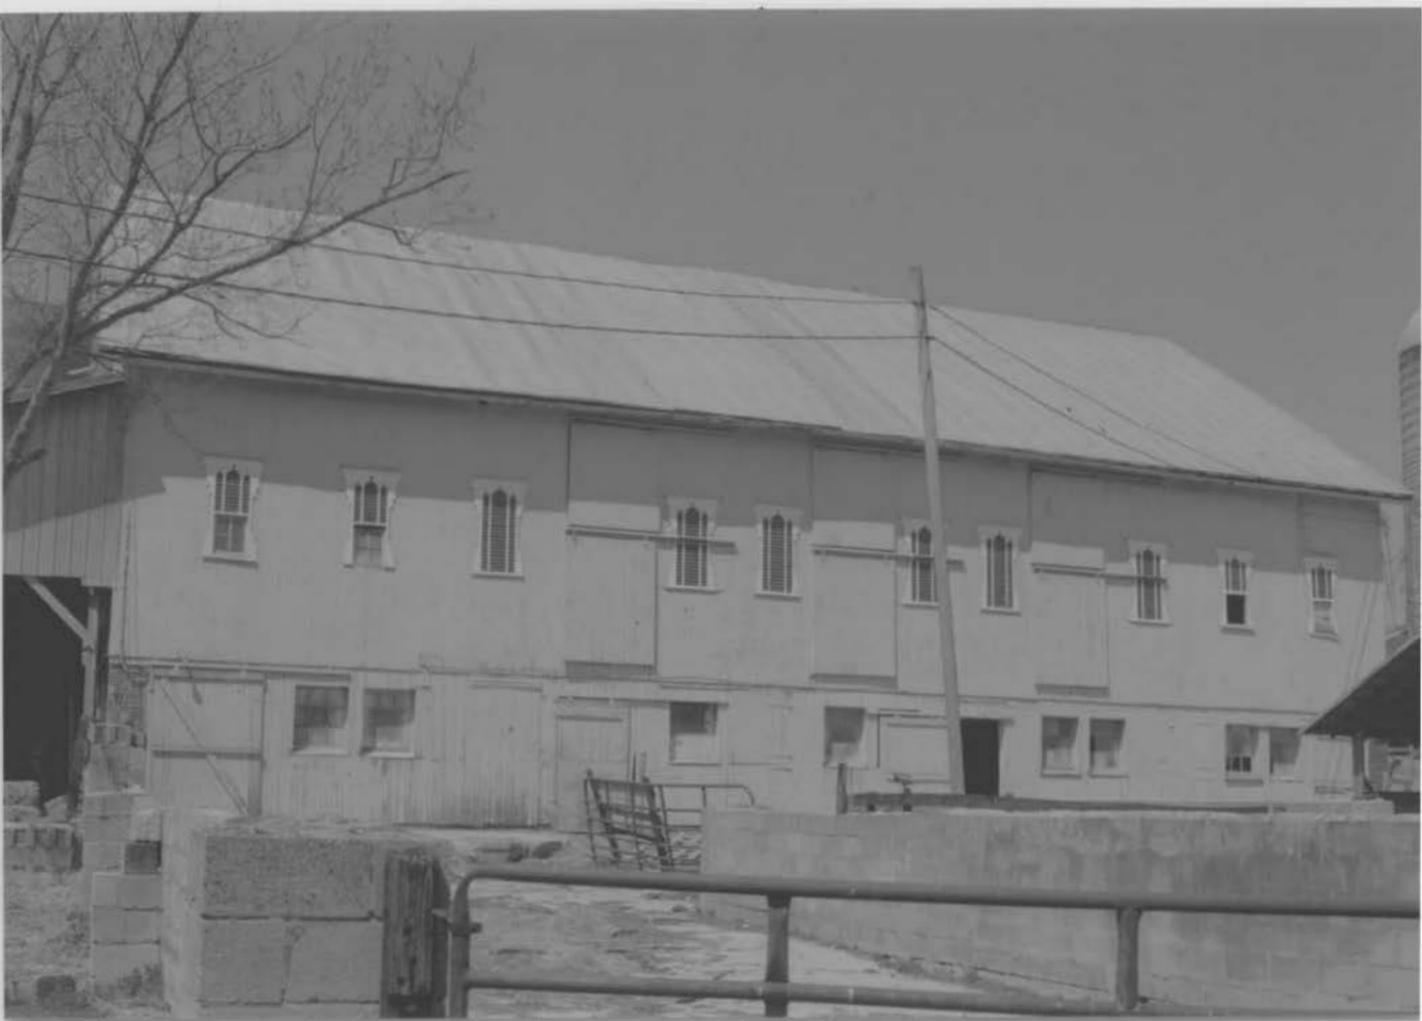
20F17

Barn - S. elev.

There is a bank barn located about 60 feet east of the wagon shed. It has a south-facing forebay, with a ramp on the north side. The lower story has a rubble stone foundation on the north, east, and west elevations, and there is beaded-edge-and-center vertical board siding on the south elevation and on the entire upper story. The barn has a gable roof of standing seam metal with an east-west ridge. The south elevation has brick piers on each end at the lower story. The lower story has, from west to east, a door on rollers, two nine-light sash, another door, a boarded-up window opening, a Dutch door on strap hinges, a nine-light sash, another door on rollers, two nine-light sash, a Dutch door on strap hinges, two nine-light sash, and a door on rollers. All of the doors match the siding. The upper story has two vents with four-light sash at the bottom at the west end, and to the east another vent, a door on rollers above another door on rollers, two vents, another door over top of a door (both of them on rollers), two more vents, another door over a door (both on rollers), another vent, and two vents that have four-light sash beneath them at the east end. The vents are tripartite and have jigsawn surrounds.

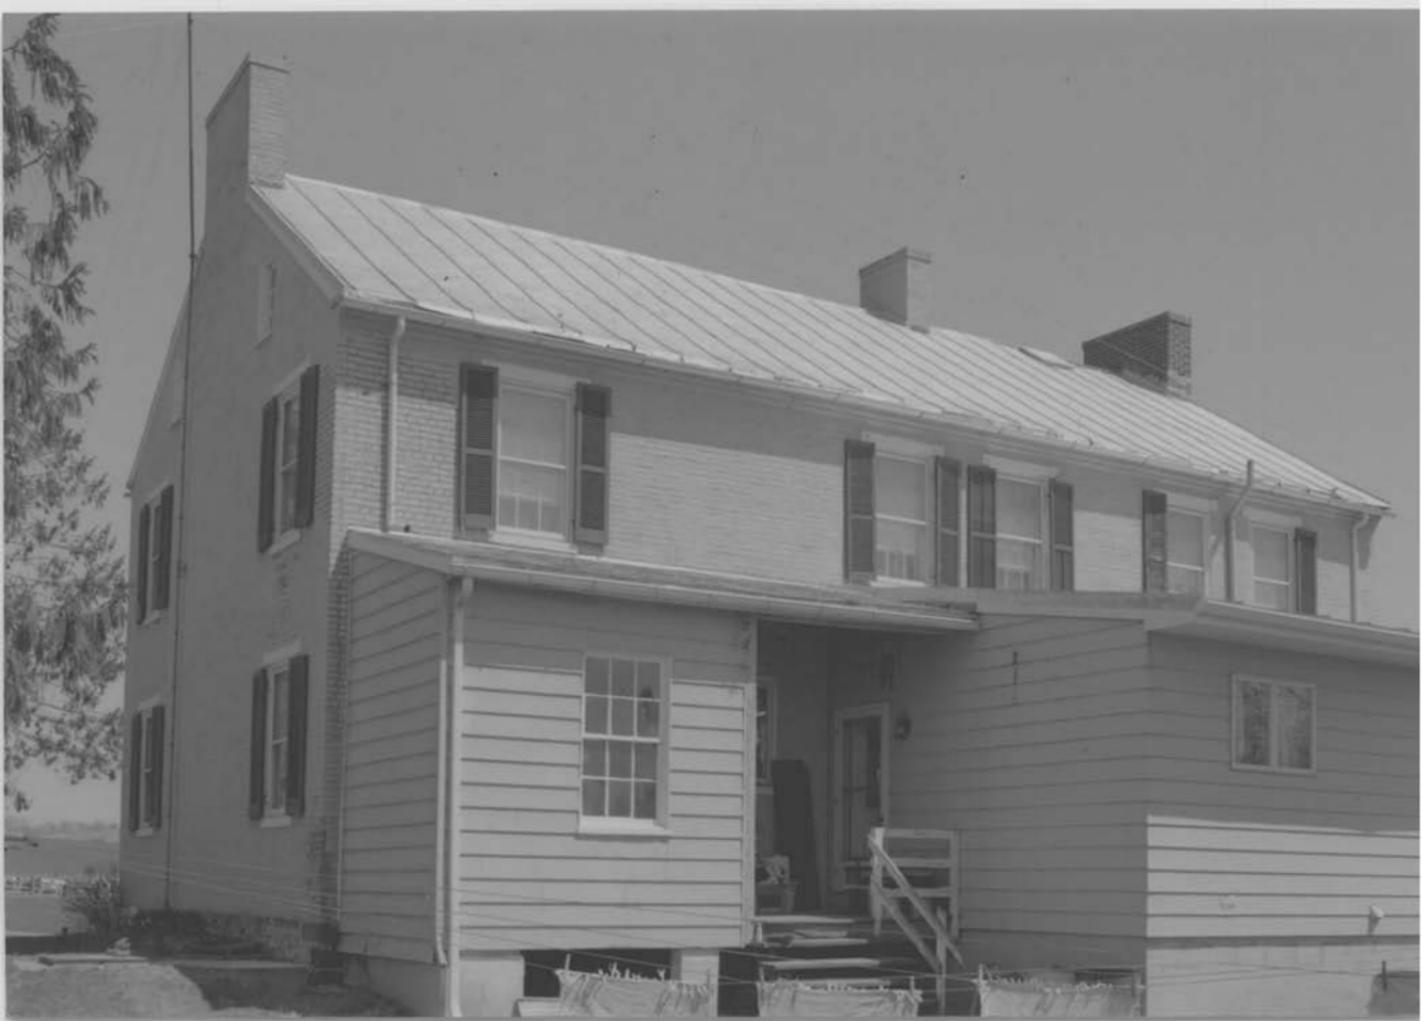
30F17

House - N & W Elevs

On the west elevation, the first story porch is now altered. It is set on CMU's and has a shed roof with asphalt shingles. The north bay of the porch is enclosed with aluminum siding and has a six-over-six sash. The south side of this enclosure has German siding and a six-panel door with the small panels set in the center. The north three bays of the porch were added later and are built of circular-sawn material. The original porch was on the south four bays and was taken down for a new one-story addition with aluminum siding and a shed roof. The north-center bay of the

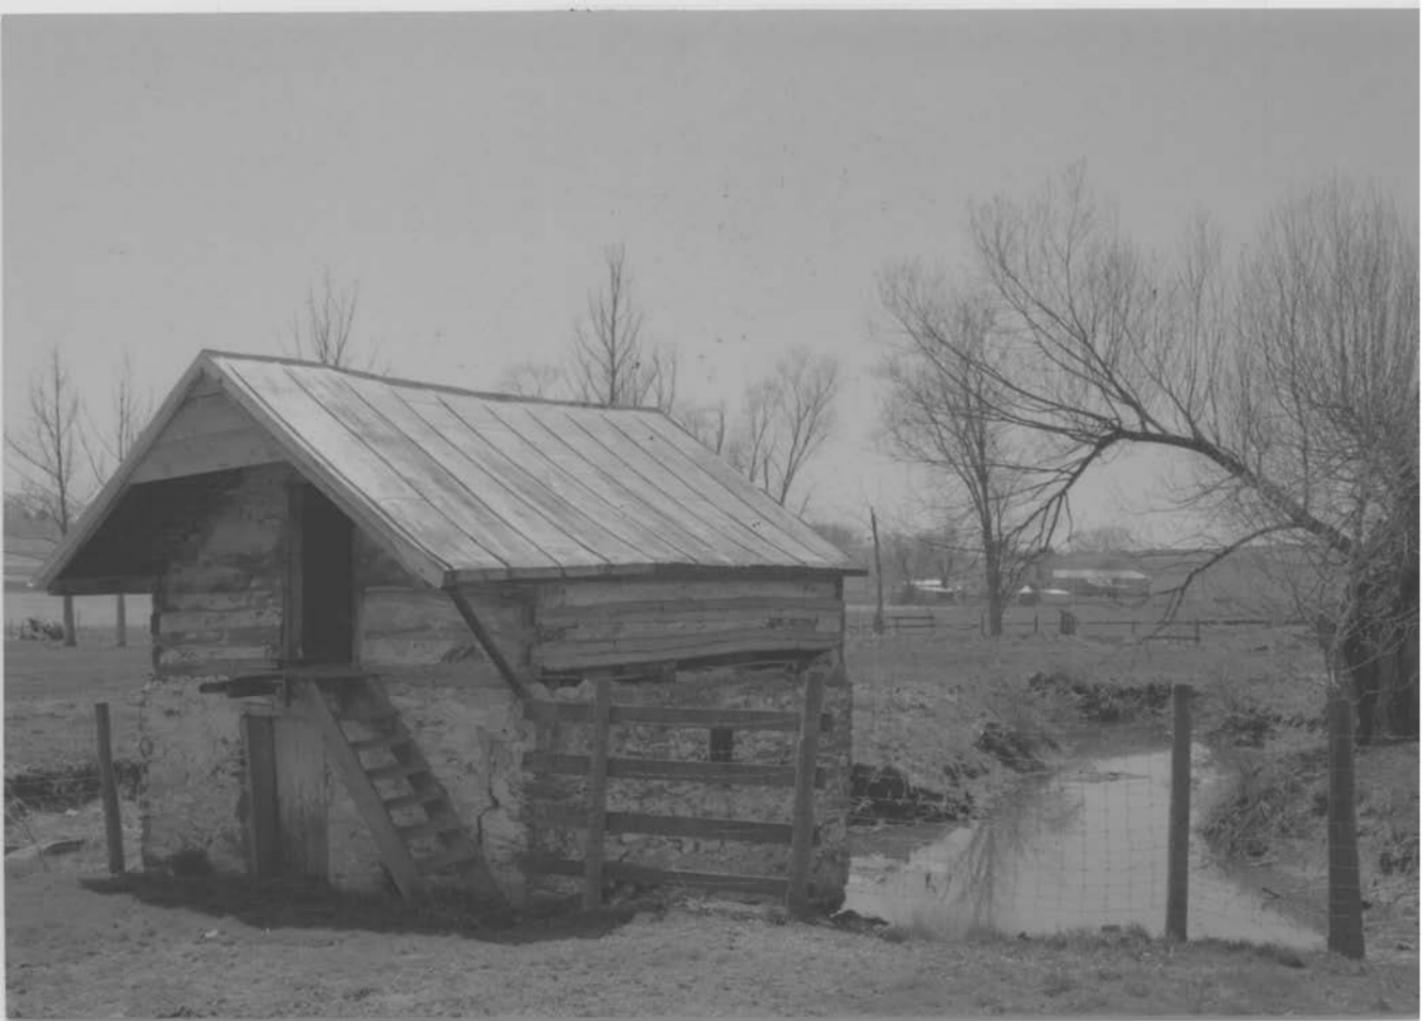
40F17

Spring house -

E. & N. Elev.

There is a spring house about 75 feet west of the house. It is a two-story, one-bay by one-bay structure. The lower story is of rubble stone and the upper story logs with v-notch corners and stone chinking. The gable end weatherboarding survives, it has grooves on both the top and bottom of each board. There is a gable roof with standing seam metal over top of wood shingles, some of which are circular sawn. The roof cantilevers on the east about 3' and the ridge runs east-west. On the east elevation the lower story has a vertical board door on interior strap hinges and a Norfolk latch with a cast iron handle. The upper story has three projecting beams that support boards and one end of a later circular-sawn wood stair that leads up to the doorway. The doorway above this landing has a frame that is pegged to the log ends. There is a vertical board door on interior strap hinges, with the same Norfolk latch as the first story. The gable end of the roof has several flush boards surviving. On the south elevation the lower story has a wood frame with a horizontal wood louver surviving. The upper story has no openings. The rafters are tapered and overhang the plate. It appears the plate is notched to hold them. On the west elevation the lower story has no openings and the gable end has an original opening. On the north

elevation the lower story has a closed-up opening and there is nothing in the upper story. The stone foundation is crumbling and the north wall is moving. As the west end of the building sits in a stream, some of the logs are very deteriorated. The lower story is one step down to a concrete floor with a trough along the south and west sides. The water comes in through a pipe on the south side, at the east end, and goes out a hole in the foundation on the west side, to the north. The walls are parged. The joists are hewn and several have been replaced with circular-sawn, reused timbers. The upper story has exposed rafters with collar beams that are half-lapped and spiked, and it is not possible to get inside for closer examination.

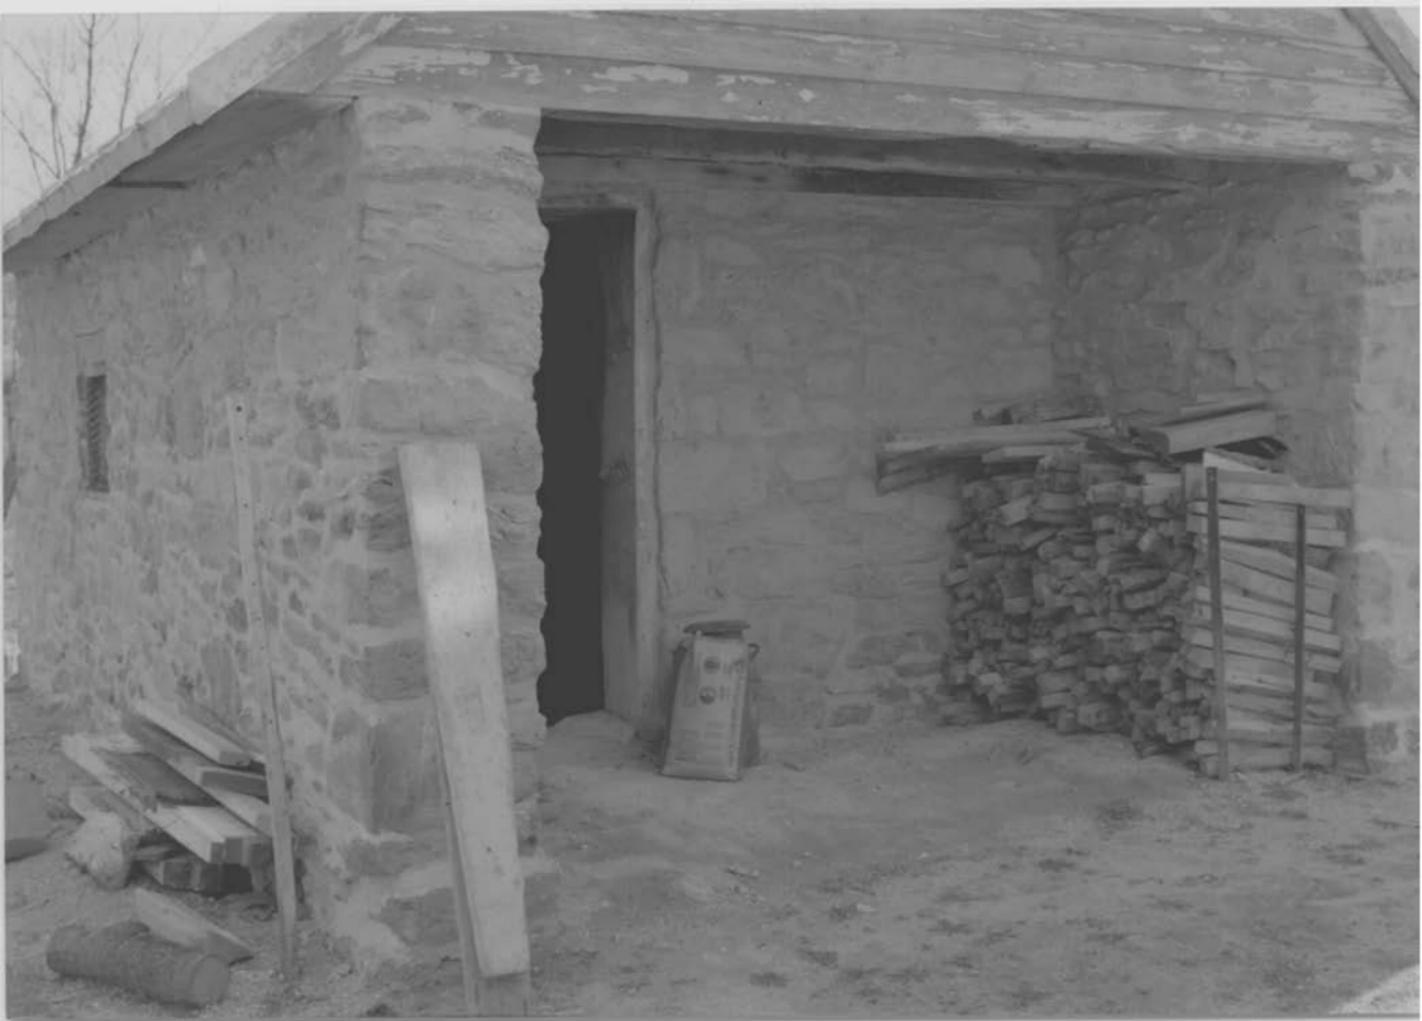
50F17

Slave Quarter

E & N. Elex

The "slave quarter" is located about 12 feet south of the house. It is a rubble stone one-story building, is one bay by one bay, and has a gable roof with standing seam metal and a north-south ridge. On the north elevation the stone wall is recessed about 5 feet back from the eave of the roof and the end walls project out to the east. There is a doorway in this wall that is set to the east. It has a mortised and tenoned and pegged frame and a vertical board door with a Suffolk latch. The gable end has German siding with wire nails. The east elevation has a wood frame for horizontal wood louvers that is very deteriorated. The south elevation gable end has a small wood door or shutter. The west elevation has a mortised and tenoned and pegged frame that is now boarded over. The building has recently been repointed and the north wall rebuilt. It is now used for a smokehouse. On the interior the walls are parged and there is a dirt floor. The east and west walls each have three wood brackets set in them, just below sill level, to support a shelf. The attic joists are hewn and there are new 2 by 4 circular-sawn rafters that are mitered at the ridge and support lath and wood shingles.

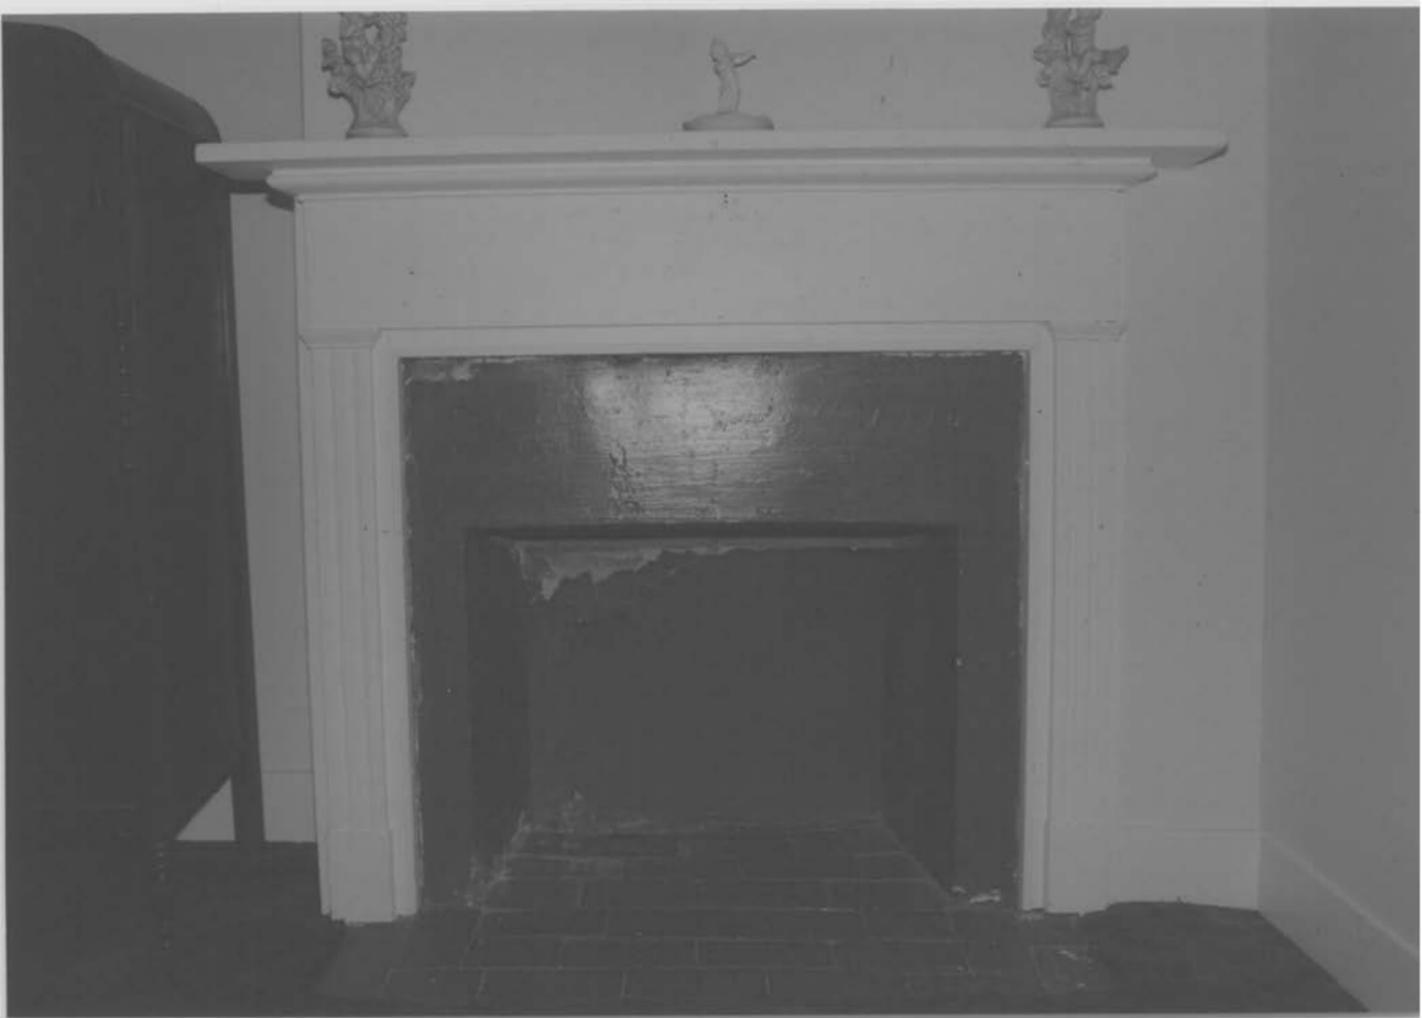
6 OF 17

House SE

Chamber Martel

The southeast chamber has a peg rail on the north wall and another on the west wall. There is a fireplace on the south wall that is identical to that in the northwest chamber. A door on the west elevation leads to the southwest stair hall. The stair here has a balustrade of five horizontal rails. There is a winder stair to the attic that is enclosed with beaded-edge vertical boards and a matching door. The north wall has peg rail.

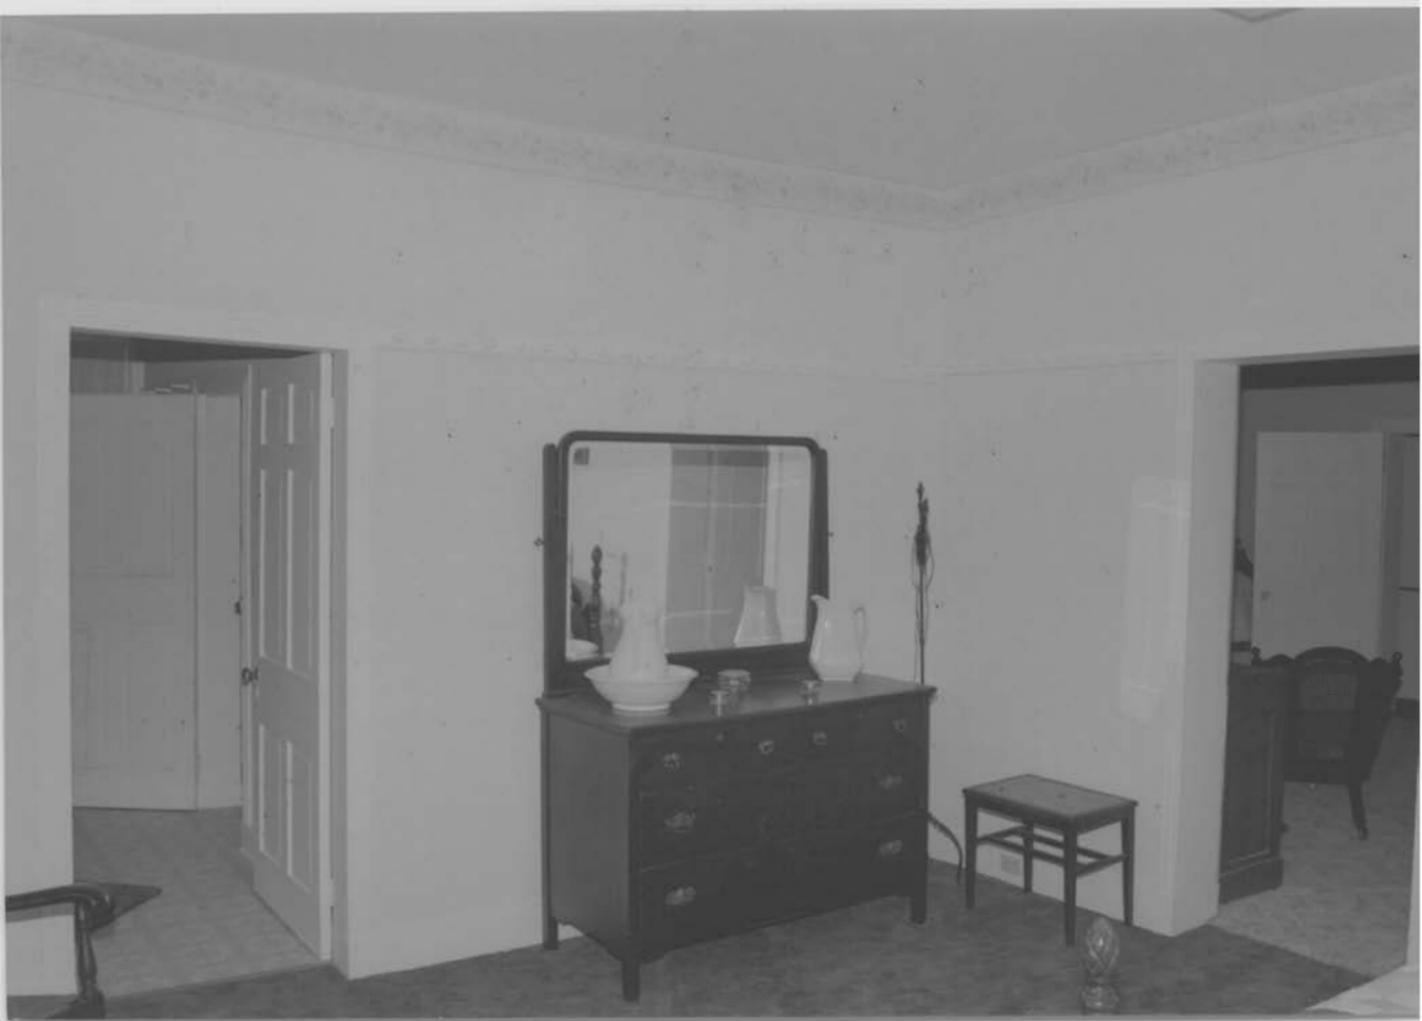
70F17

House - SE

Chamber - VW Northwest

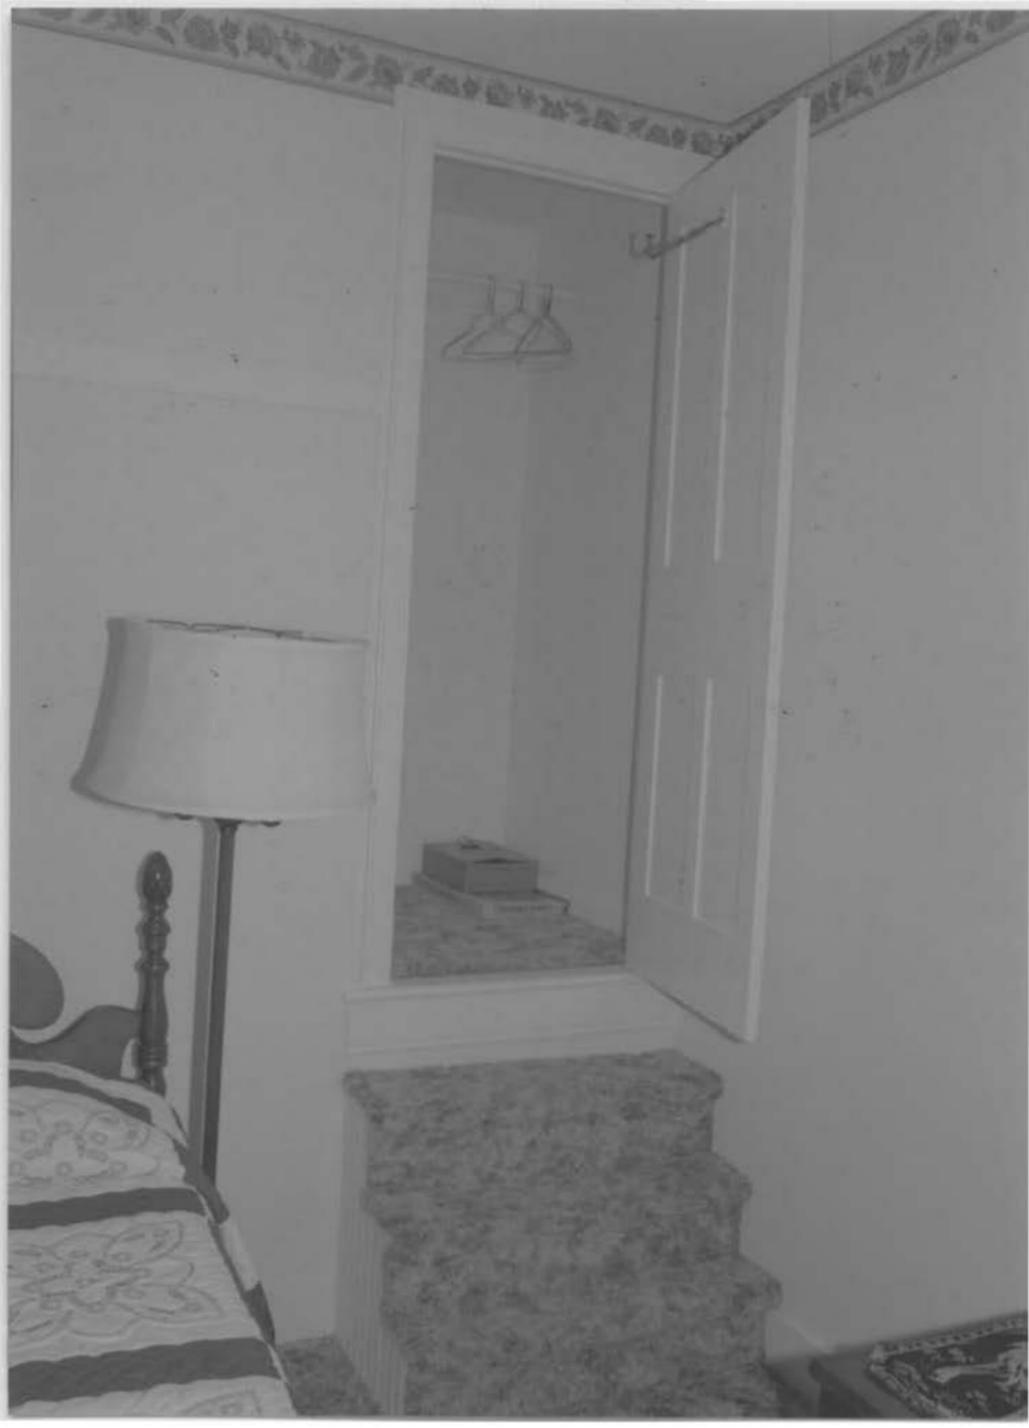
90F17

House - N.W.

Chamber Closet over stairway

The northwest chamber has a fireplace centered on the north wall that has a brick hearth and splayed, plastered jambs. The wood mantel has pilasters that have three fillets, and has a plain frieze. East of the fireplace is a closet with a new door. The south elevation has three steps set to the west that lead up to a closet with a four panel door. The closet is set above the winder stair from the first to the second stories, and this is an original treatment. Inside the closet is a peg rail.

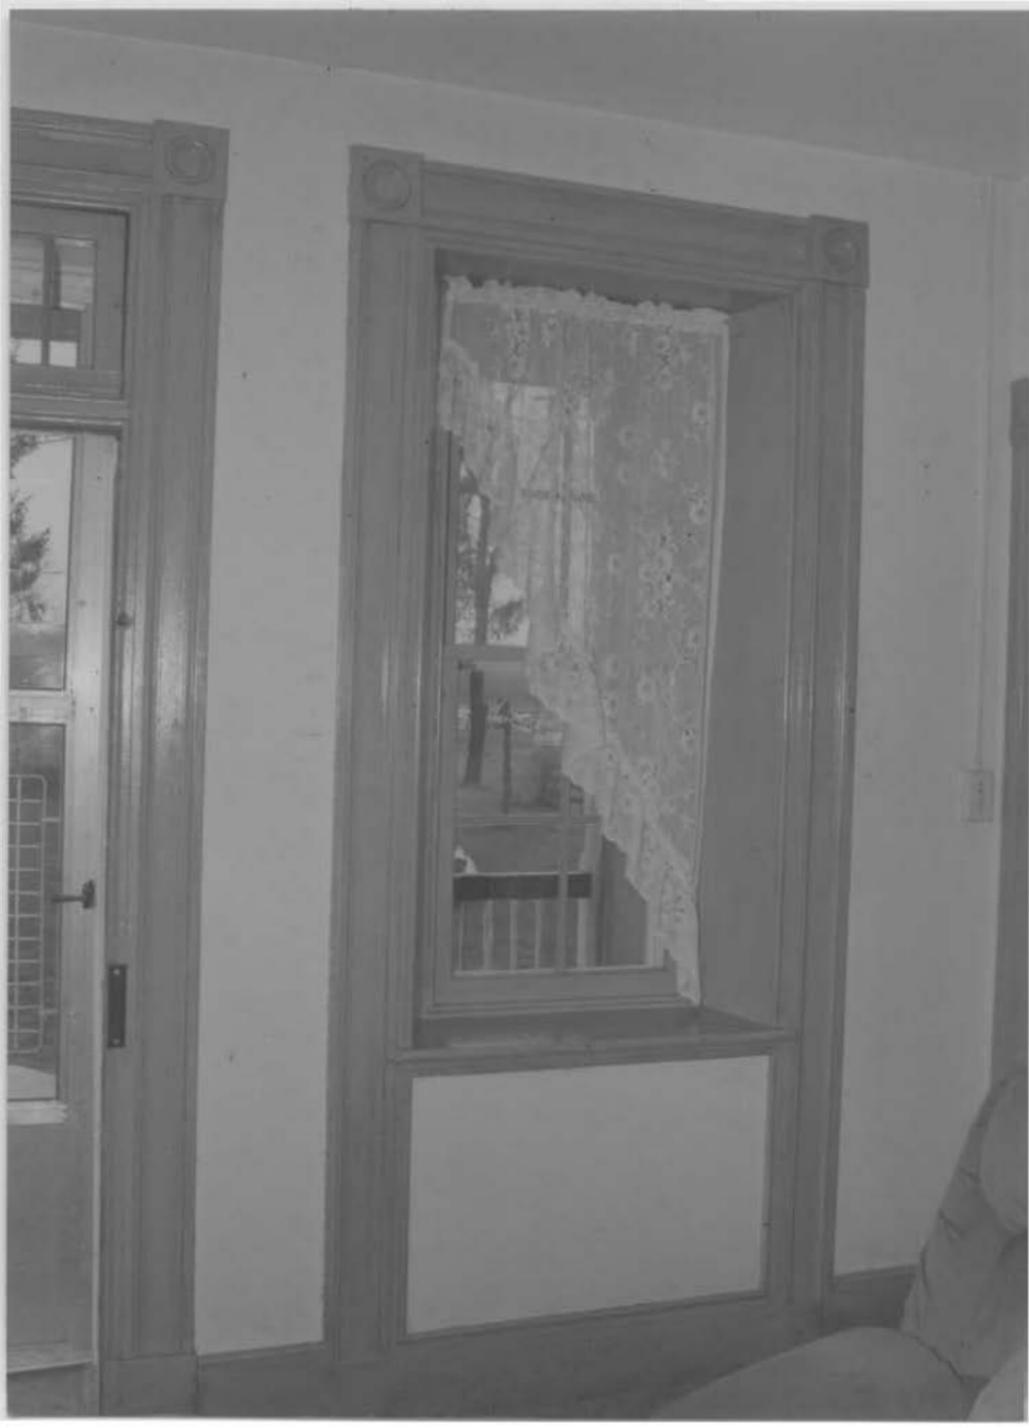
House Center

RM- E. Elev

Window architrave

The center room has a fireplace on the south wall with a wood mantel that has pilasters and a plain frieze. In the northwest corner are three steps below a typical interior door that leads to the stairway to the second story. The stairway is not actually placed in the center room, but is in the northwest room. The typical interior doors have eight fielded panels. The architraves in the center room are symmetrical, with a sunk field and quirked Greek ovolo moldings to each side. The architraves are carried down to the baseboard and there are bull's-eye corner blocks. The window jambs are splayed. The west elevation has a door with a four-light transom and a six-over-six sash to the north. The south elevation has two doors and the north elevation three.

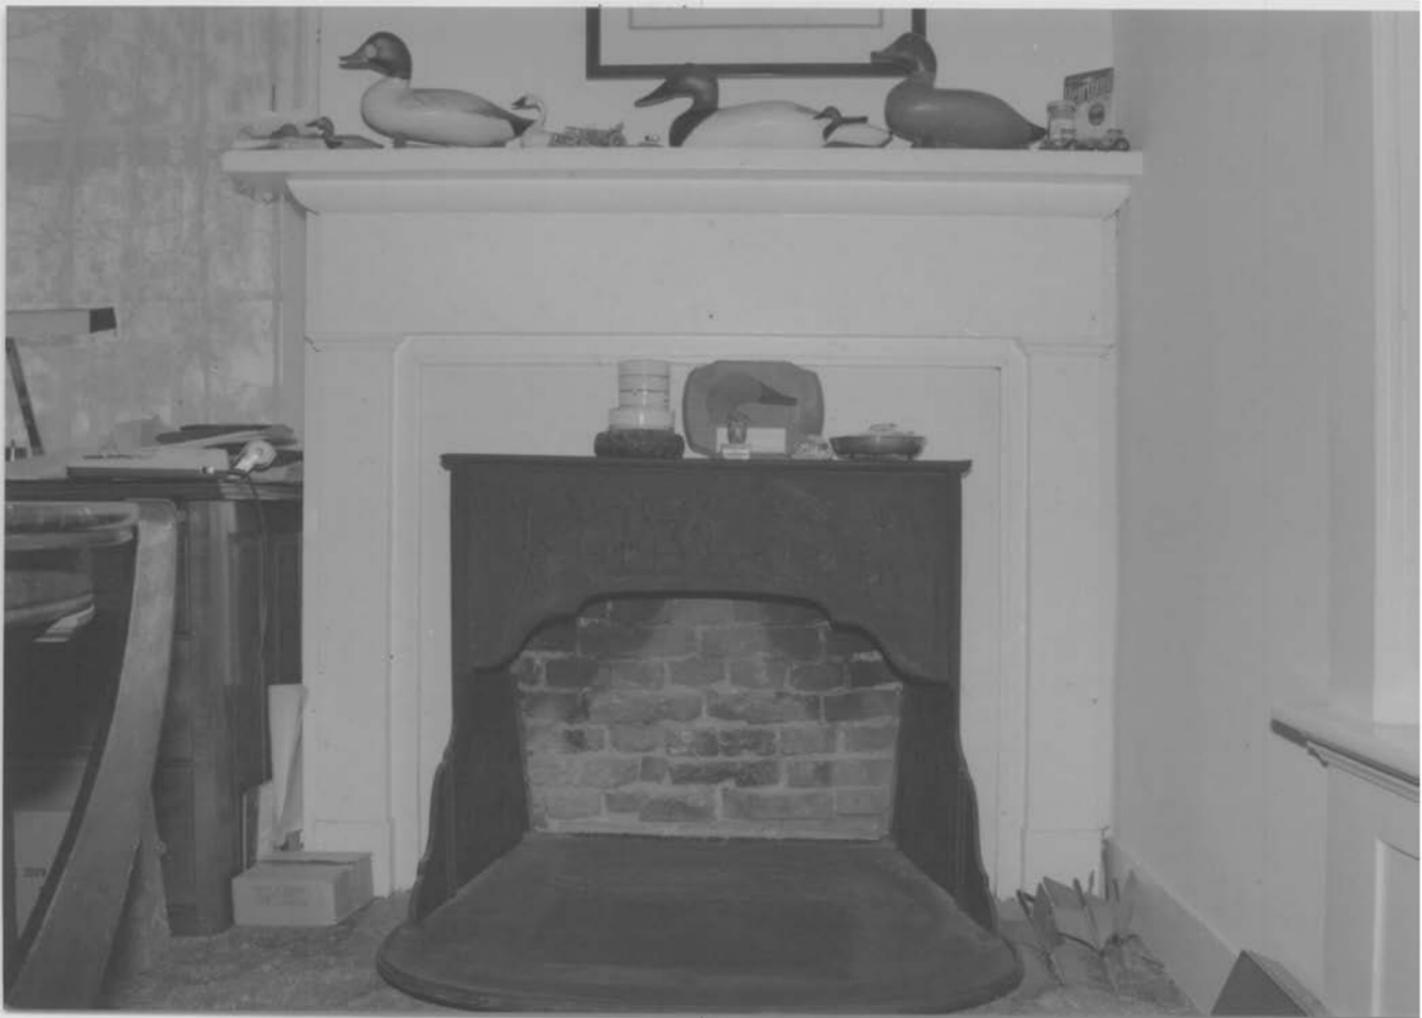
11 OF 17

House N.W. RM

Mantel & Franklin Type Stove

The door to the northwest room is hung on cast iron butt hinges marked "Baldwin" and "Patented." There are cellar stairs that have been added to beneath the winder stair that leads up to the second story. The window on the west wall was converted to a door circa 1920 according to the owners. There is a fireplace on the north wall, set to the east, with a wood mantel that has plain pilaster strips and a plain frieze. There is a Franklin-type stove of cast iron set into here, with brick on the back wall of the stove. The top face plate of the stove has a woman sitting on a broken column and a banner that is marked "Pine Grove". The stove appears to original to the fireplace.

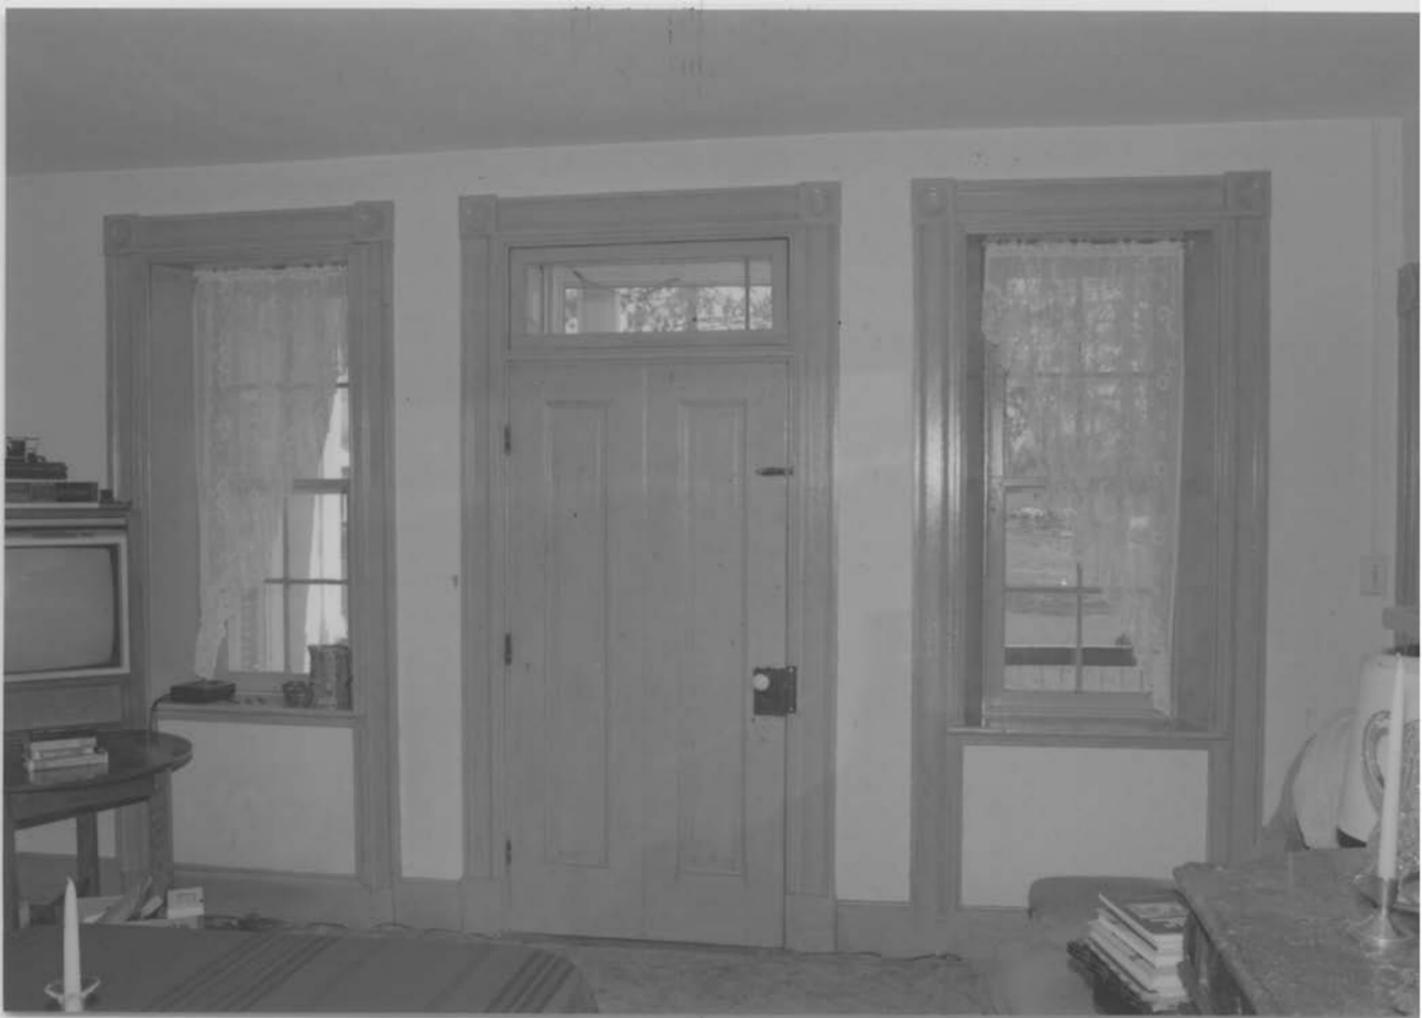
12 OF 17

House - Center Room

E-Elev

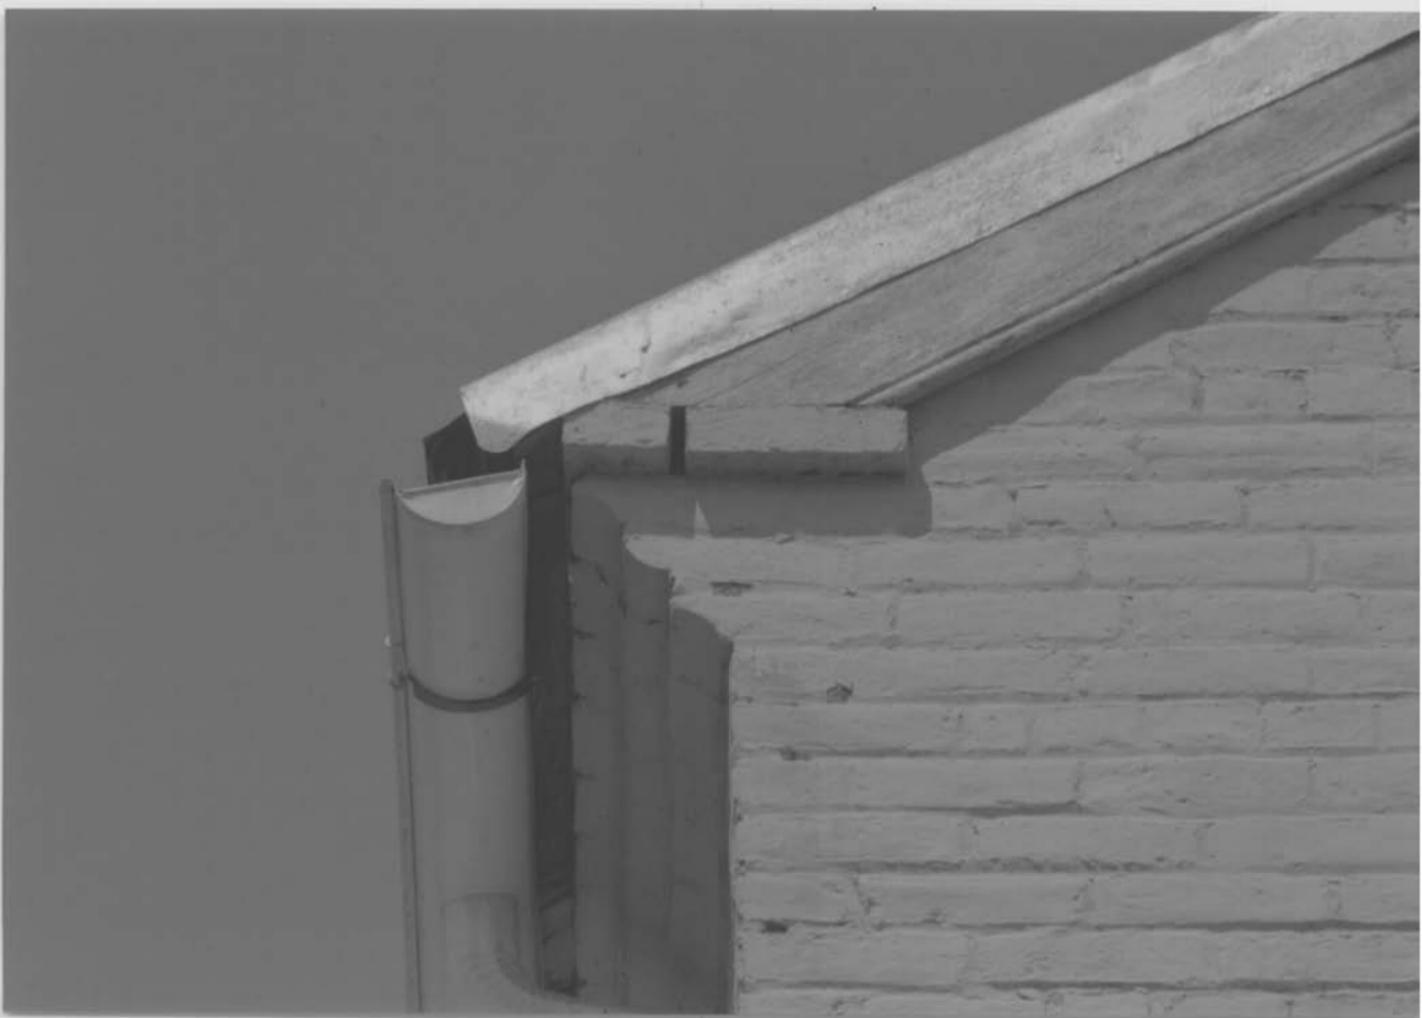
Smith Family Farm  
524 Smith Rd  
House cornice detail

S. Elev.

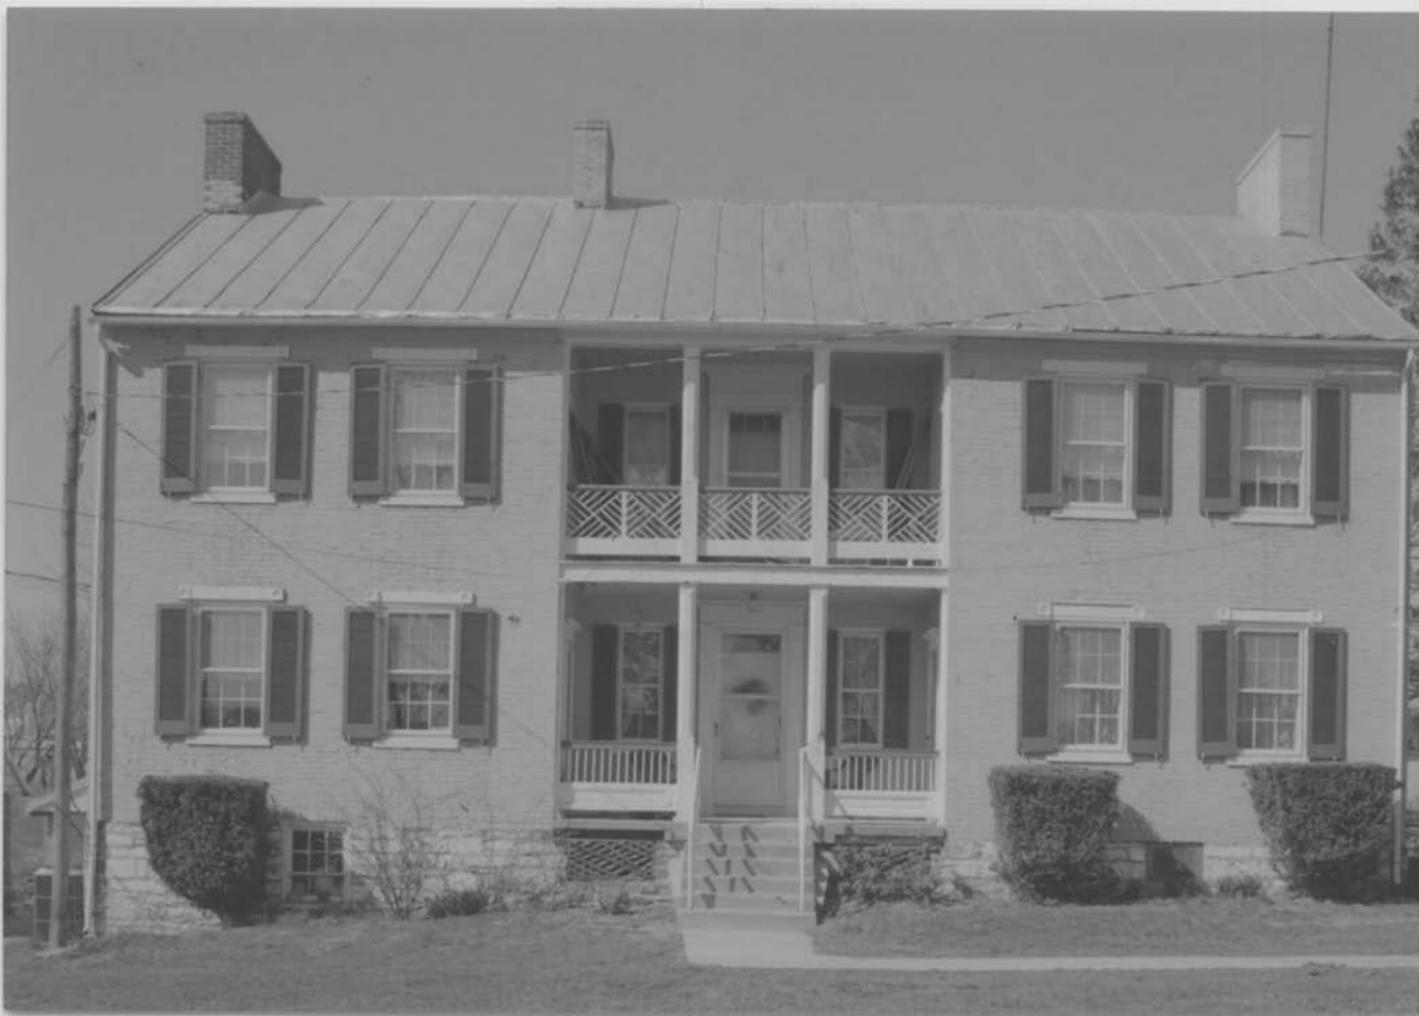
14 OF 17

House - E. Elev

The house is a two-story, seven-bay by two-bay, U-shaped brick structure that faces east toward Smith road. The foundation is a combination of rubble and ashlar stone, with the east elevation consisting mostly of ashlar. The east elevation has Flemish bond brick and the other elevations have four-to-one common bond brick. The center three bays of the east elevation are recessed and filled with a two-story porch creating the U-shaped plan. These three porch walls are parged. The gable roof has standing seam metal and a north-south ridge. There is an interior brick chimney on each end and another between the south-south-center and south-center bays, where one of the recessed walls is.

On the east elevation, the first story has two six-over-six sash with wood sills and wood lintels with bulls eye corner blocks in the two south bays and the two north bays. The three center, recessed bays, have a central door of two tall panels with a marble sill and a three-light transom. The jambs and soffit are paneled and the door surround has plain pilasters with a plain frieze and a cornice. The doorway is framed by a four-over-four sash on each side. Each side bay of the recessed porch has a doorway with a marble sill and a door identical to the center door, but without a transom. The porch has a new concrete deck and new concrete steps. The first story central posts have been rebuilt to match the originals and are chamfered on the top half. The balustrade has rectangular vertical balusters above a horizontal, paneled board rail. The second story has two typical six-over-six sash on each end. The three center bays match the first story, but the north and south elevations flanking the porch have no openings. The porch railing has a Chinese Chippendale lattice balustrade. The east elevation has a moulded brick cornice with an ovolo above a cavetto and another ovolo at the bottom.
