CARR-1551

524 Smith Rd., New Windsor Vicinity

**Maryland Historical Trust  
State Historic Sites Inventory Form**

historic Smith Family Farm

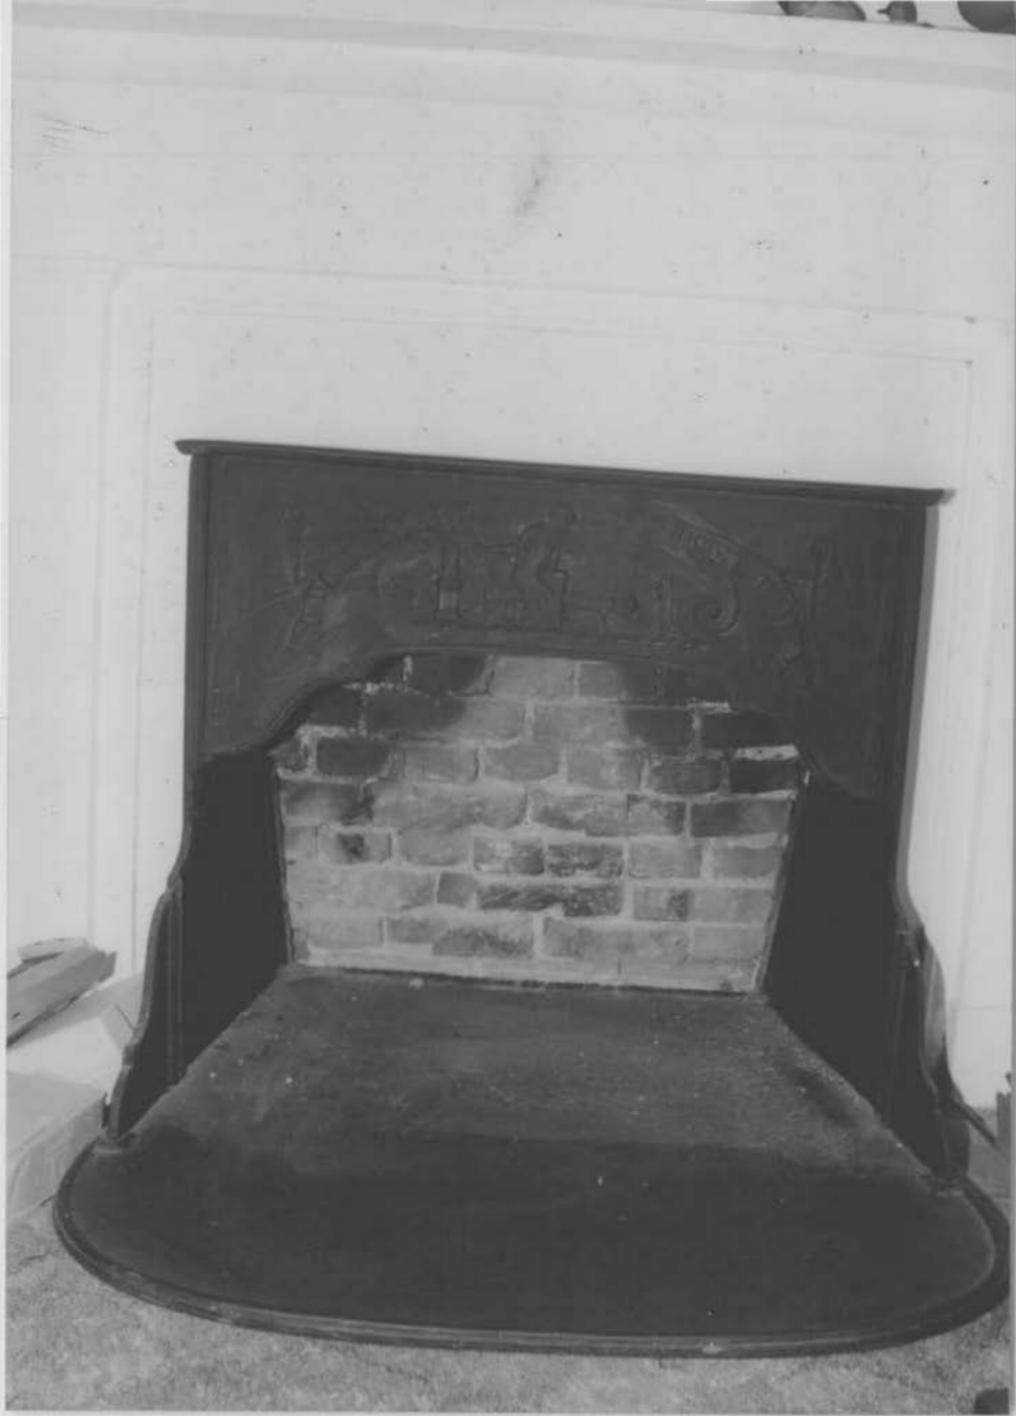
150F17

NEG. LOC: MARYLAND HISTORICAL TRUST  
NORTHWEST ROOM - FRANKLIN TYPE  
FIREPLACE

The door to the northwest room is hung on cast iron butt hinges marked "Baldwin" and "Patented." There are cellar stairs that have been added to beneath the winder stair that leads up to the second story. The window on the west wall was converted to a door circa 1920 according to the owners. There is a fireplace on the north wall, set to the east, with a wood mantel that has plain pilaster strips and a plain frieze. There is a Franklin-type stove of cast iron set into here, with brick on the back wall of the stove. The top face plate of the stove has a woman sitting on a broken column and a banner that is marked "Pine Grove". The stove appears to original to the fireplace.

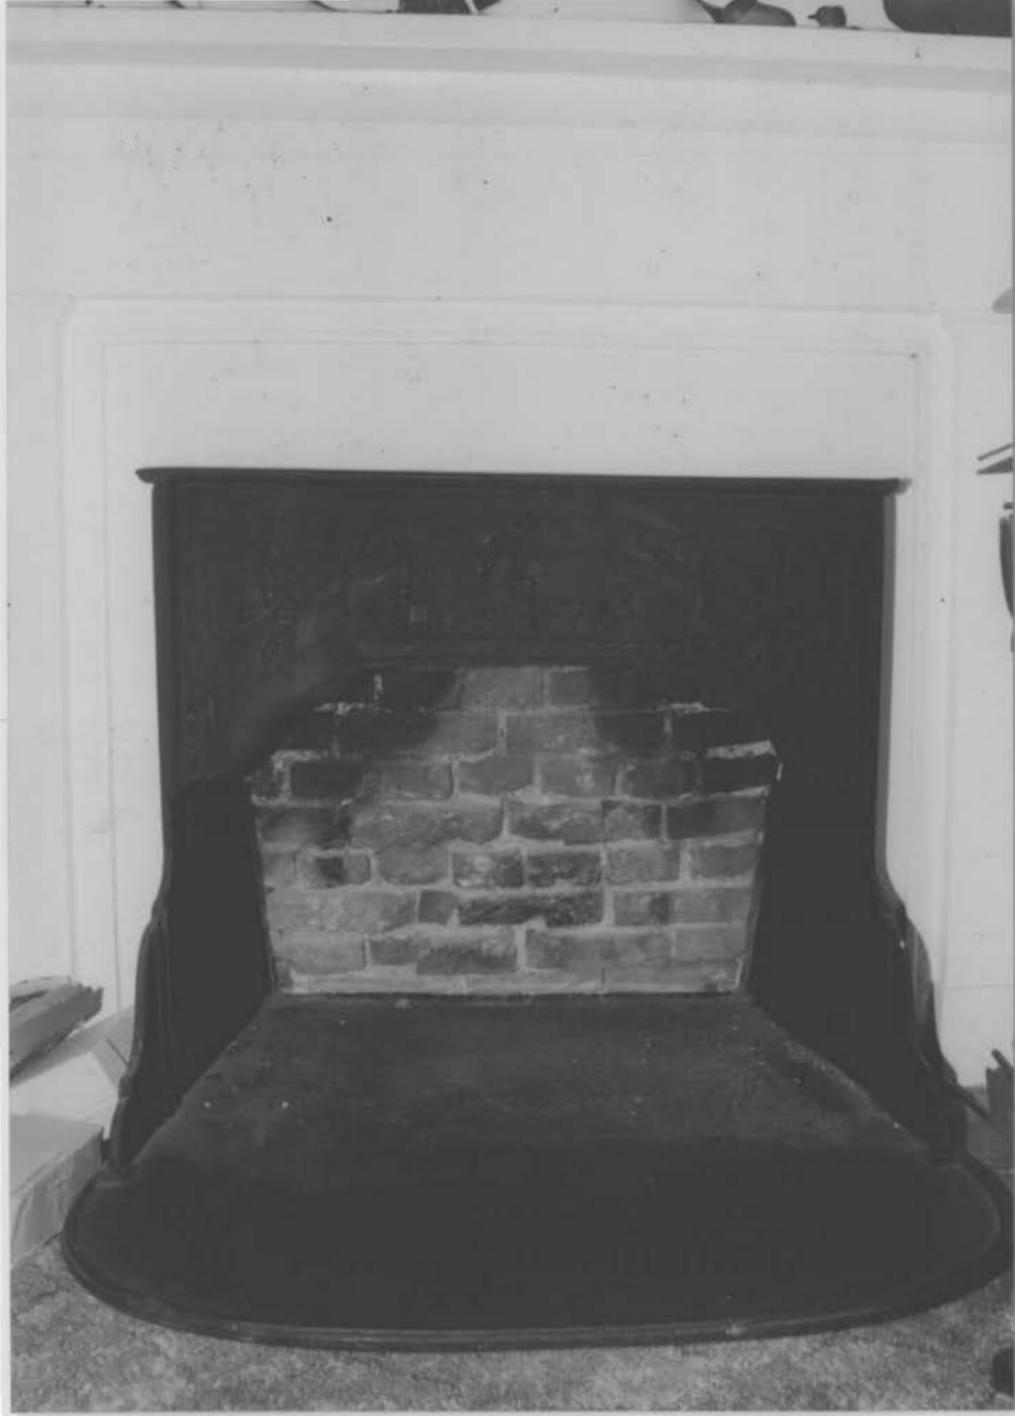
16 OF 17

NORTHWEST ROOM - FRANKLIN TYPE  
FIRE PLACE
