# Maryland Historical Trust State Historic Sites Inventory Form

Survey No. CARR-1554

historic Davis Family Farm

street & number 2932 Sykesville Road  not for publication

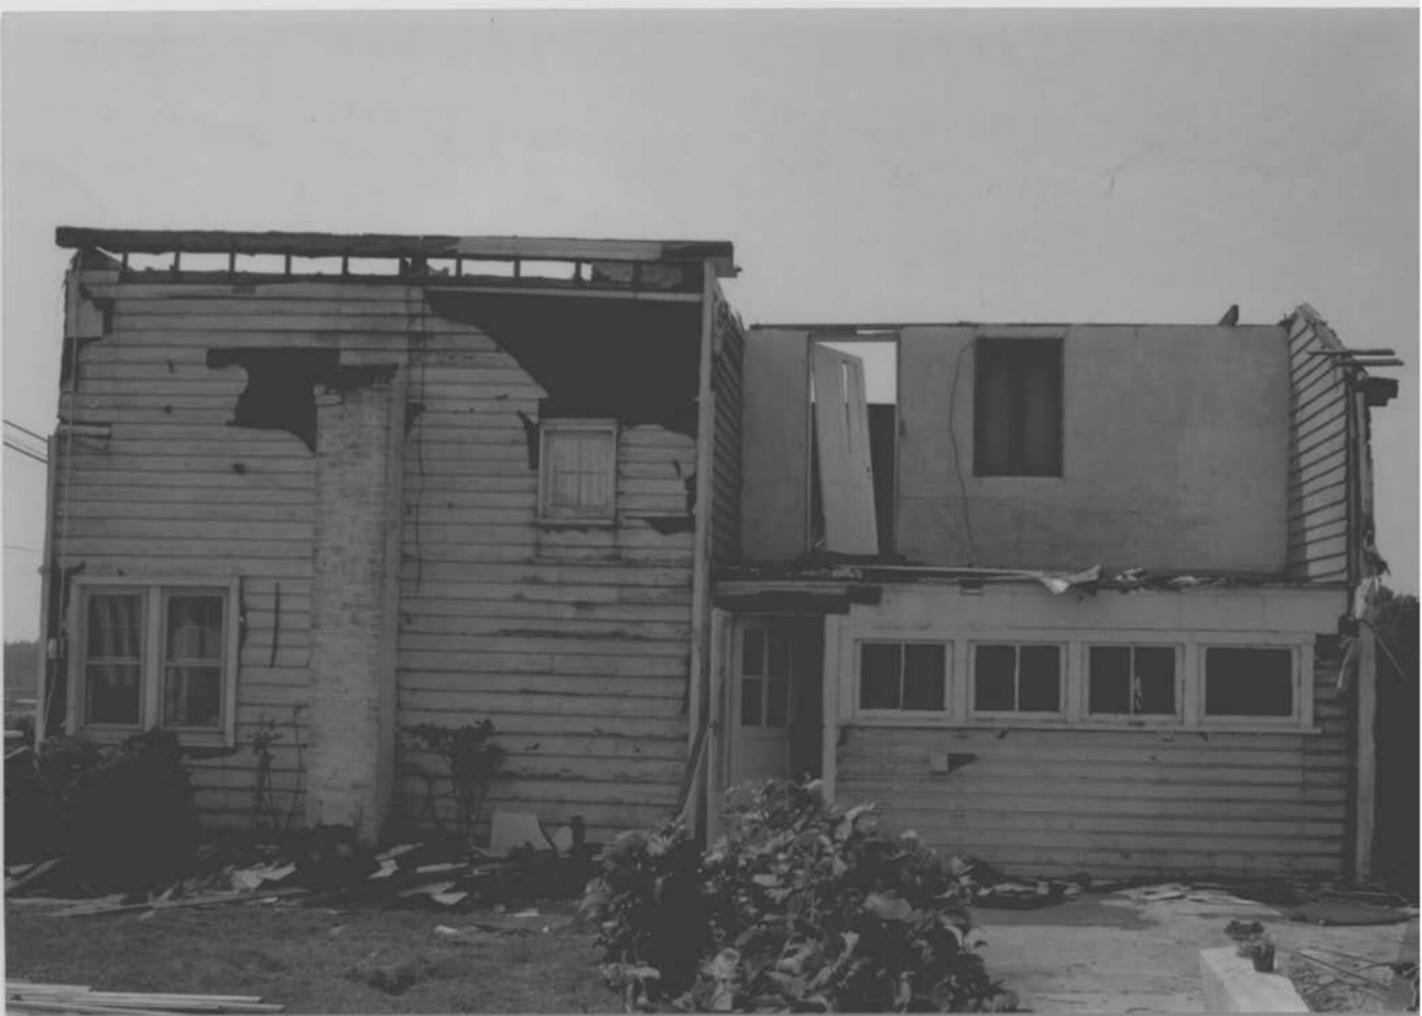
10F4

Neg Loc: Maryland Historical Trust  
N. Elev.

The north elevation of the log section has circular-sawn weather boards with cut nails. On the first story the east bay has two six-over-one sash. There is an exterior brick chimney in the center that has a metal clean-out door on the exterior. On the second story the west bay has a four-light sash, and there are traces of asbestos shingles over tar paper here.

The north elevation of the wing has infill on the first story with German siding and four two-

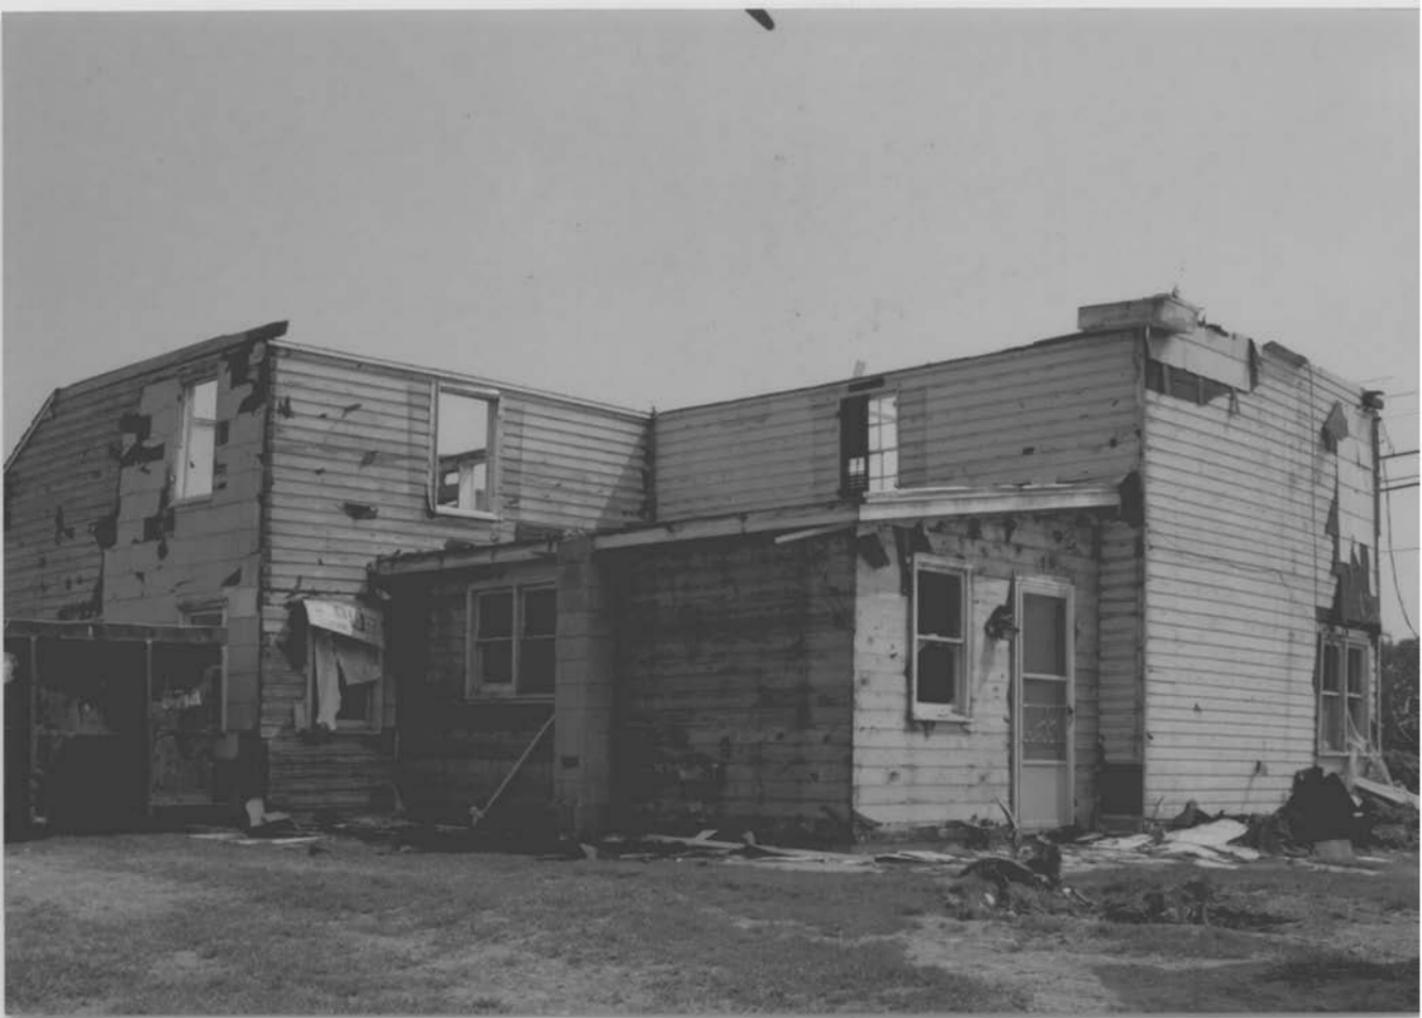
2 OF 4

E. Elev.

The east elevation indicates the house was built in at least two stages. The southern three bays are frame, while the northern three bays are of log. Most of the siding has been removed; it is German siding that is sash sawn and fastened with cut nails. On the frame section, the German siding with corner boards was covered by tar paper and asbestos shingles. Judging from the nail-hole pattern, the German siding is the earliest siding on the frame section. This section has heavy timber, braced, mortised-and-tenoned-and-pegged framing with hewn post and girts, and braces from the post down to the sill and from the post up to the plate. The joists rest on top of the front girt and two of them are pegged to this girt from above. The studs are sash sawn 2 by 4's with a tenon on top that sits in a mortice on the bottom face of the girt. The interior has riven lath. The first story of the east elevation has a center entrance with a door that has one light over two panels. There is a two-over-two sash on either side of this opening. The second story has window openings in the end bays and no opening in the center. There is a large wood peg driven through the northeast corner post into a log to the north to tie the frame section to the log section, suggesting that the log section is the earlier of the two.

The northern log section has v-notch cornering. The logs were whitewashed and there are ghosts of vertical nailers on the second story. The first story has a center entrance with a door that is identical to that on the south section. There are ghosts of vertical lath fastened to the logs and evidence of lath nails in them. There is some lath and plaster on the ground, and it would appear the lath is circular sawn and fastened with cut nails. On either side of the center door is a two-over-two double-hung sash. The second story has window openings in the end bays but no opening in the center bay. There was formerly a porch across the whole six bay front of the house, but it is now gone. Seven brick piers with concrete caps survive, as does the wood deck that is wire nailed to the joists below.

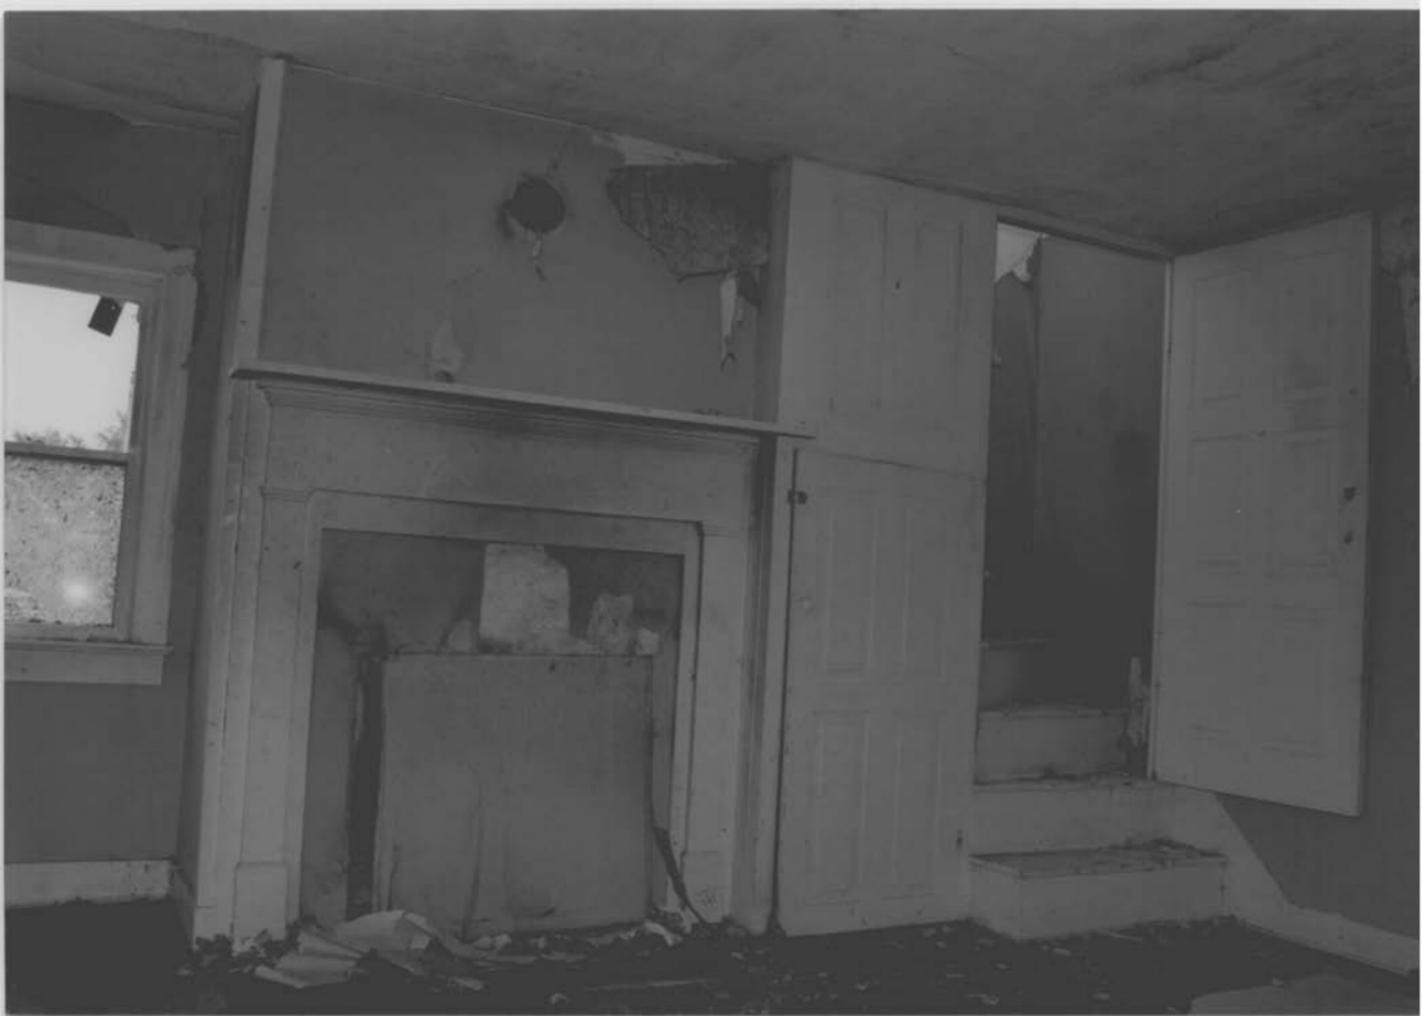
4 OF 4

SE. RM- 5. elev

The southeast room in the frame section has 3 ½ to 5 inch wide pine flooring that runs north-south. There is a fireplace centered on the south wall that has slightly splayed brick jambs that are plastered. There is a wood mantel with plain pilaster strips and a plain frieze. It has a quirked ogee and bevel bed mould. There is a winder stair in the southwest corner that has one step set below a six-panel door. There is a closet beneath the stair that has a four-panel door. The door appears to be a shortened version of the six panel door on the stairway. The lath on the south wall is circular-sawn, but the rest of the room has riven lath with cut nails. The door on the north elevation, leading to the log section, has the same architrave as that in the log section. The door on the west elevation has four panels and has a beaded-interior-edge frame.
