CARR-1555

2011 Snydersburg Rd., Hampstead Vicinity

MARYLAND INVENTORY OF
HISTORIC PROPERTIES

historic Sharrer-Hosfeld Farm

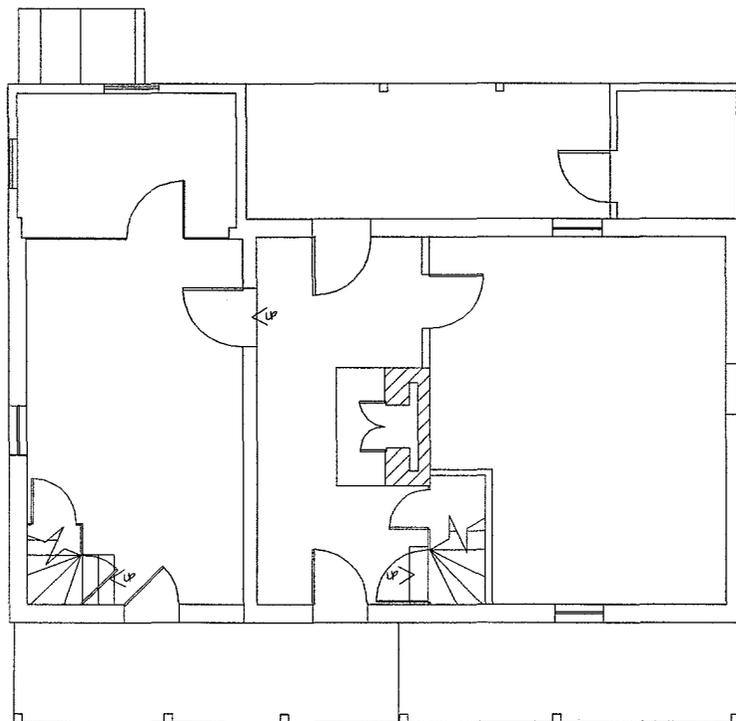
CARR-
1555

FIRST FLOOR PLAN

The original log section to the east has two rooms, one to the east and one to the west. The west addition is a single room, with a room to the north of it where the north porch has been enclosed. The west room has double-beaded-edge vertical board half wainscot on the east and west elevations. There is an enclosed winder stair in the southwest corner that has two steps below a short beaded-edge vertical board door. The stairs are enclosed by a beaded-edge vertical board wall and have a matching door on the north side of the enclosure that leads to a closet beneath the stairs. There is 2 1/2 inch wide flooring that runs north-south and is primarily covered by linoleum. On the east wall, to the north, is a beaded-edge vertical-board door with tapered battens that leads to the center room. The north wall has vertical boards that appear to be added later, as the northern log wall appears to have been cut out and the ends boxed in before the vertical board wall was added. There is a beaded-edge vertical-board door set in this wall that leads to the northwest room. The northwest room has linoleum on the floor. The ceiling is of pressed metal with a lozenge pattern, and has egg and dart moulding at the cornice.

The center room is set one step down from the west room. The flooring here runs east-west and is of random width, between 9 and 11 inches wide. There is a door on the north elevation to the exterior porch. The east elevation has a beaded-edge vertical-board door set to the north. There is a fireplace centered on this wall that has a wood mantel with plain pilasters and a frieze with a Tudor arch. The mantel also has a pair of board doors. The hearth is gone, but was much wider than the mantel. The firebox is not a true fireplace but has two brick piers at the front that make the front opening narrower than the back. These piers contain wood nailing blocks to fasten the mantelpiece to. There is also a narrow wood lintel to this opening and a wood board across the bottom of the opening. Much of the wood is charred. The brick piers are not added, but are integral with the rest of the brickwork of this chimney and must have been constructed for a stove, with the doors inside the mantel serving as a clean-out. There is a winder stair in the southeast corner that has one step set below a beaded-edge vertical-board door. The inner side of the door, the stringer, and the risers and treads all have a combed, grained finish. The door has squiggles in it after the combing was done. There is a hewn beam running east-west, just south of the center, on the ceiling.

The east room has a mantel shelf on the west wall with no fireplace. The bed mould of the mantel is a piece of German siding. The woodwork in this room all has combed, grained finishes. The stairway in the center room is built out into the southwest corner of this room, and the beam in the center room runs across this ceiling as well. The east wall has riven lath fastened with cut nails. The logs beneath this lath are whitewashed. The front and rear sash have spring latches. The second story has the same floor plan as the first story. All of the rooms are unheated, and do not retain significant details.

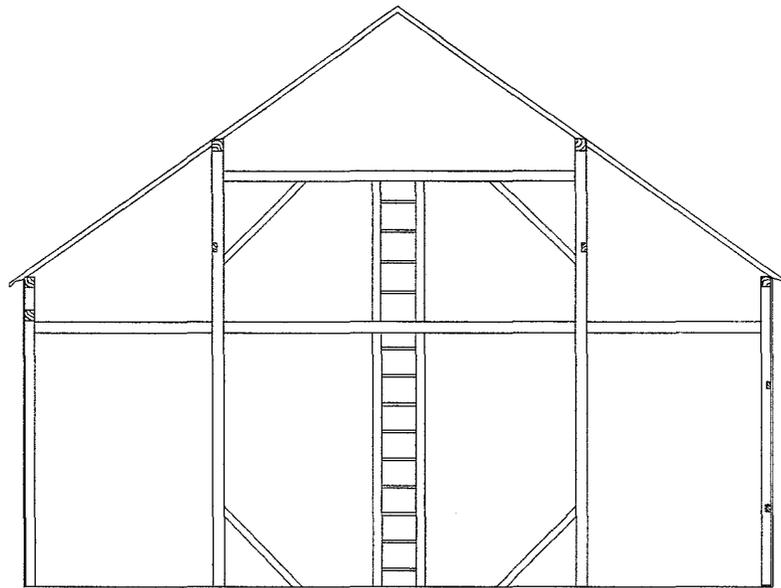
CARR-
1555

BARN - FRAMING SECTION

In the lower story the joists are reused v-notch corner logs that run from the bank on the north to the summer beam, and from the summer beam to the forebay on the south. The summer beam runs east-west and is hewn on all four sides. It is supported by five posts, at least two of which are later. The west end has a hewn lintel with pegs in it, and there is a box set in the west wall. There is a horse stall on the west end with a trough and wood boxes below it on the east end of the stall. The rest of the stalls are altered. The upper story has four mortised and tenoned and pegged hewn bents. There is a center threshing floor with a hay mow at each end and a granary in the northwest corner. The rafters are both sawn and $\frac{3}{4}$ round, and they appear to be mitered at the ridge. They support lath and wood shingles. There are center posts beneath the purlins in each hay mow.

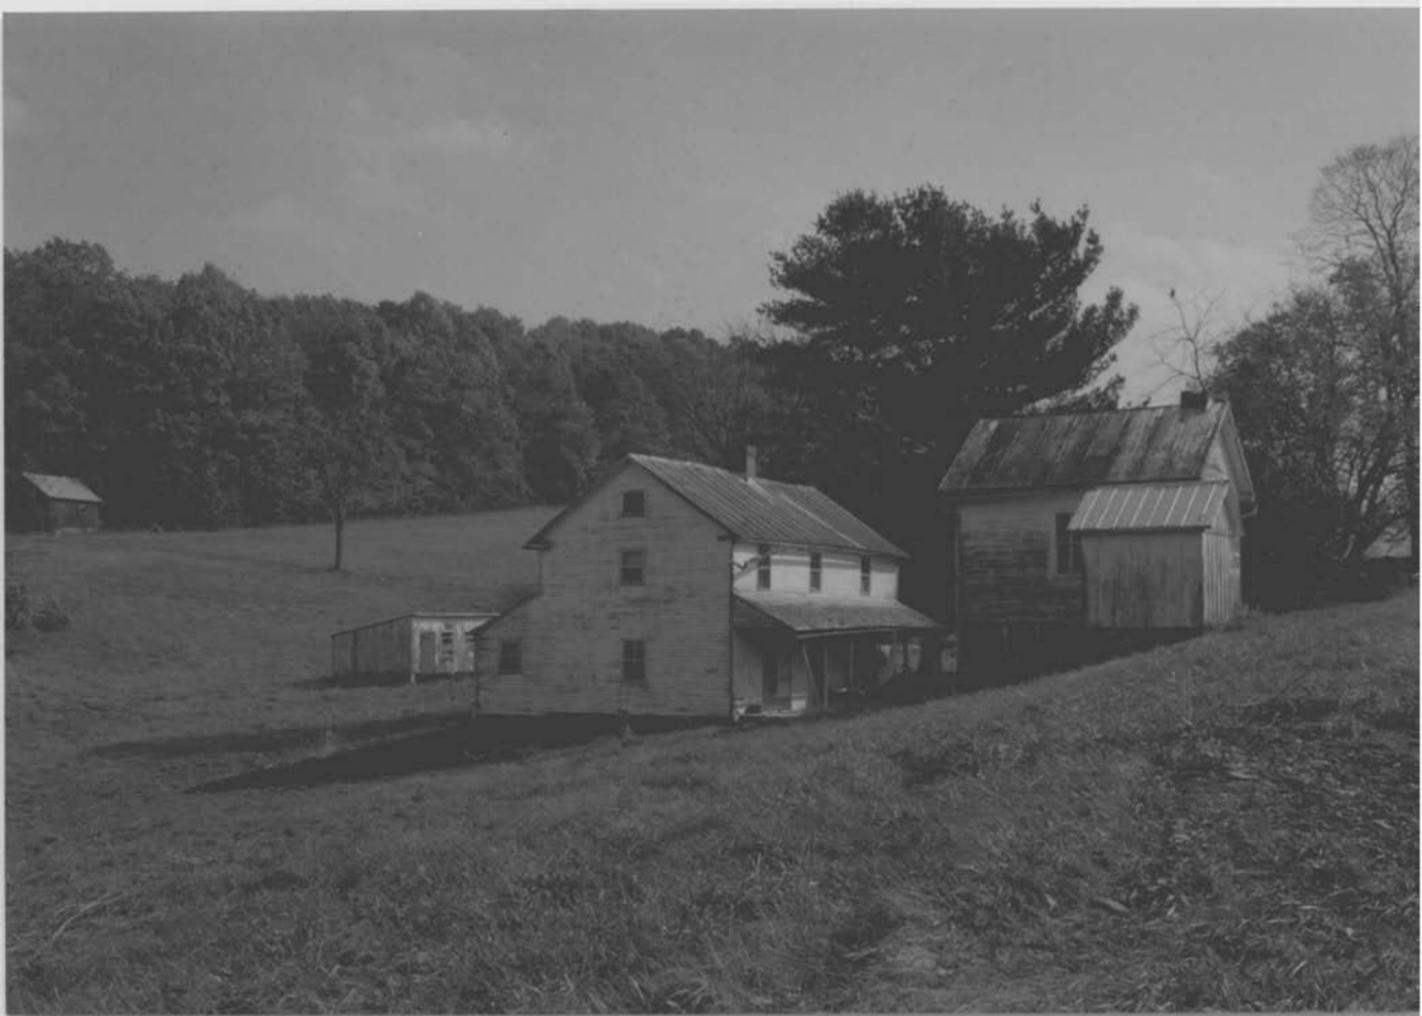
1 OF 18

General VW Fr S.W.

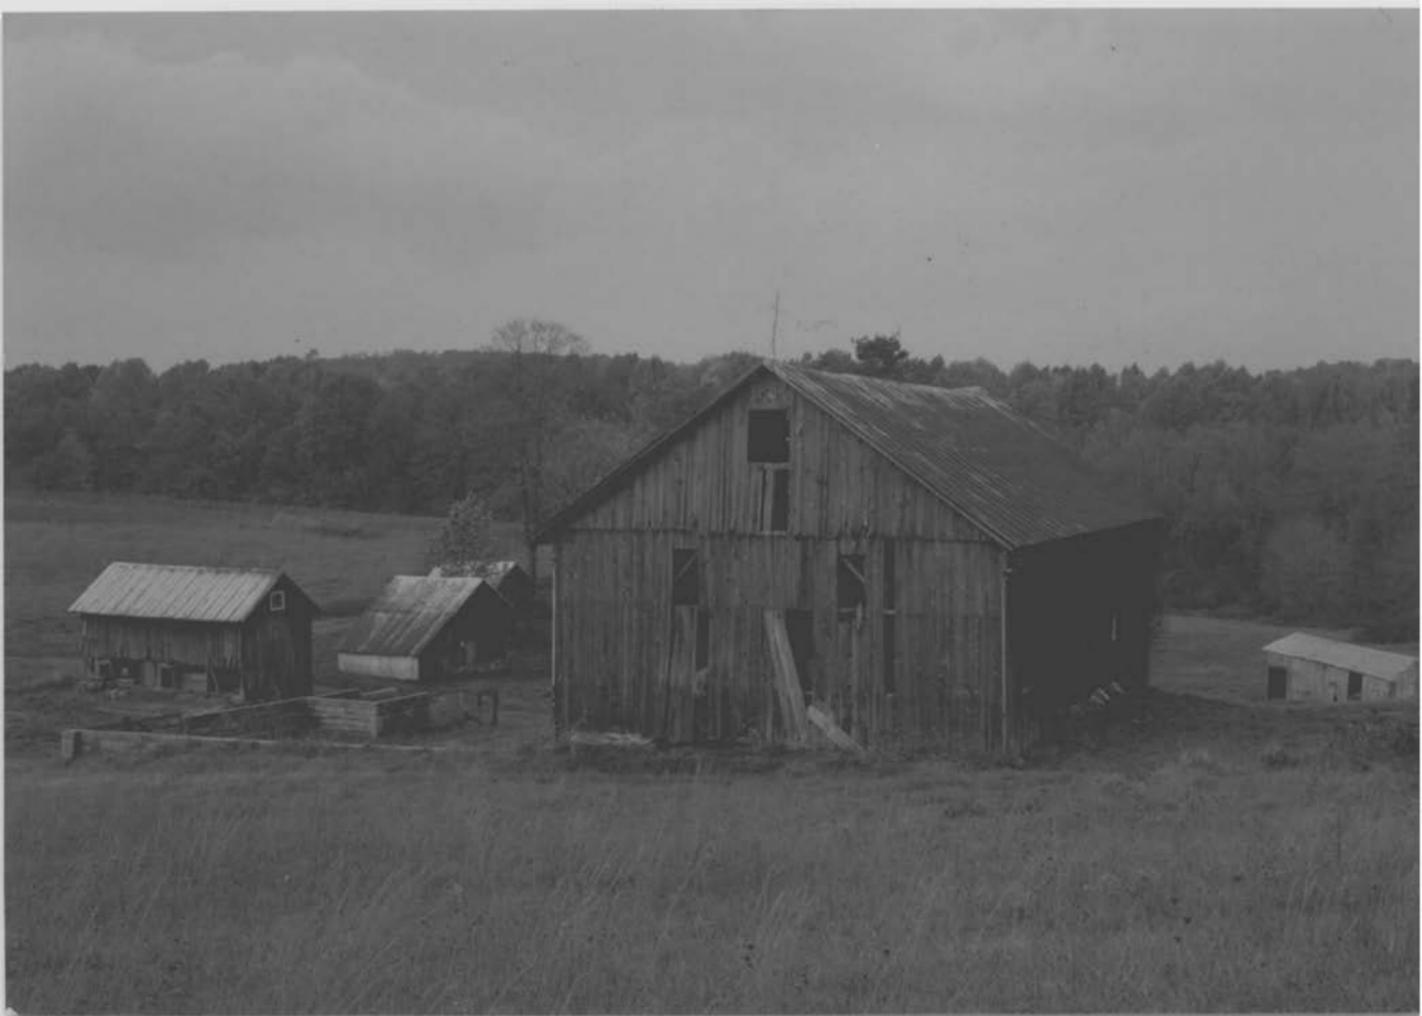
20F18

General VW FR. N E.

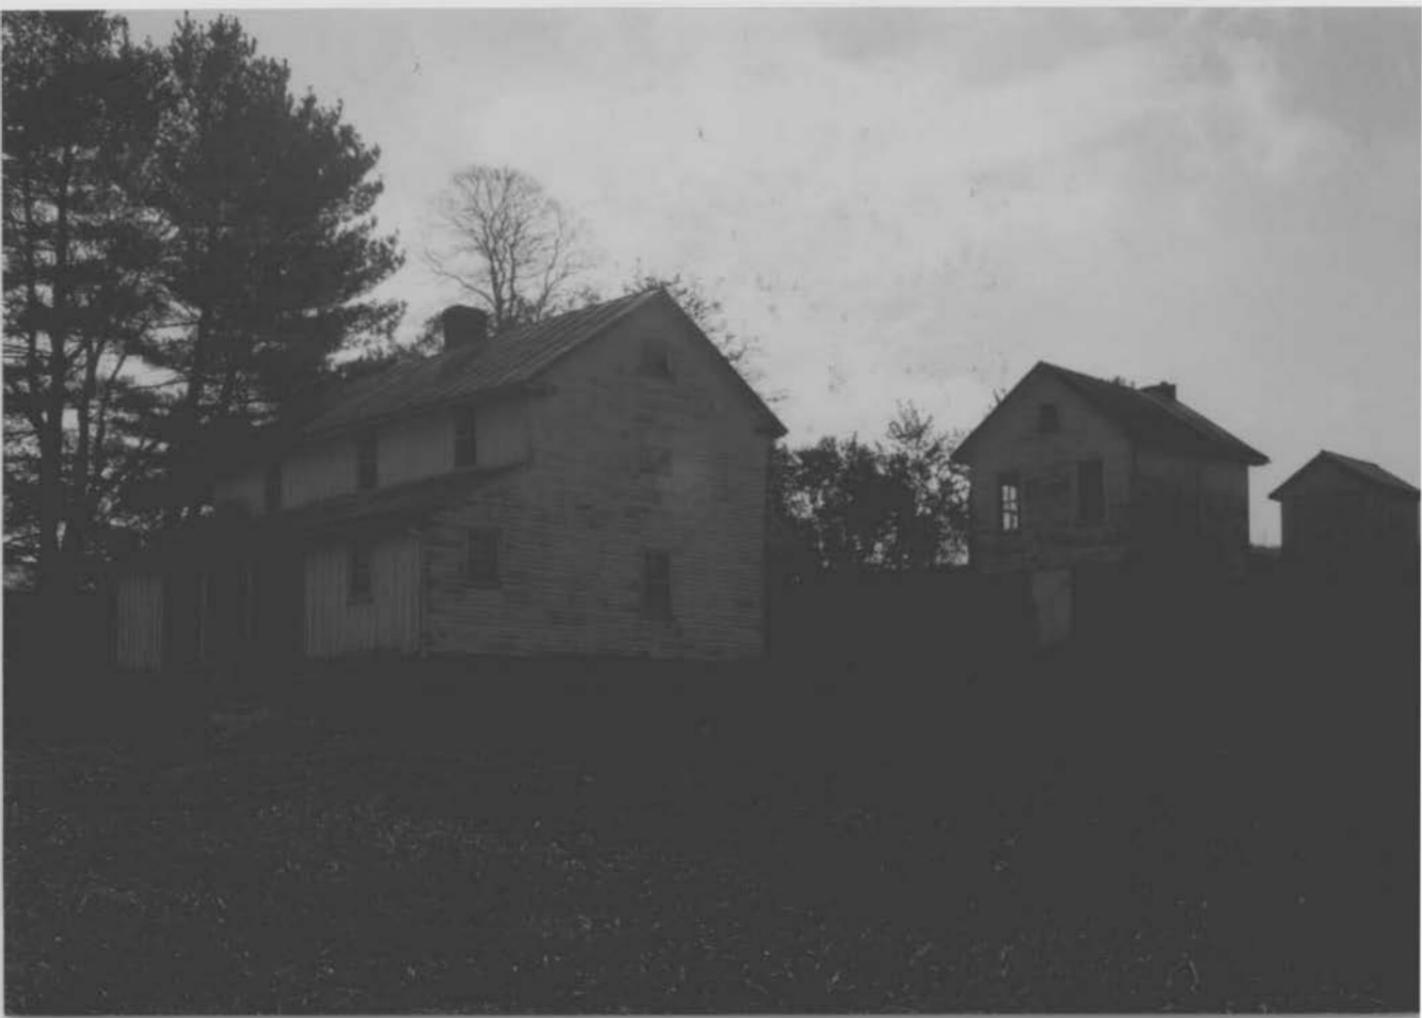
40F18

House, Smokehouse & Summer Kitchen
N & W Elevation

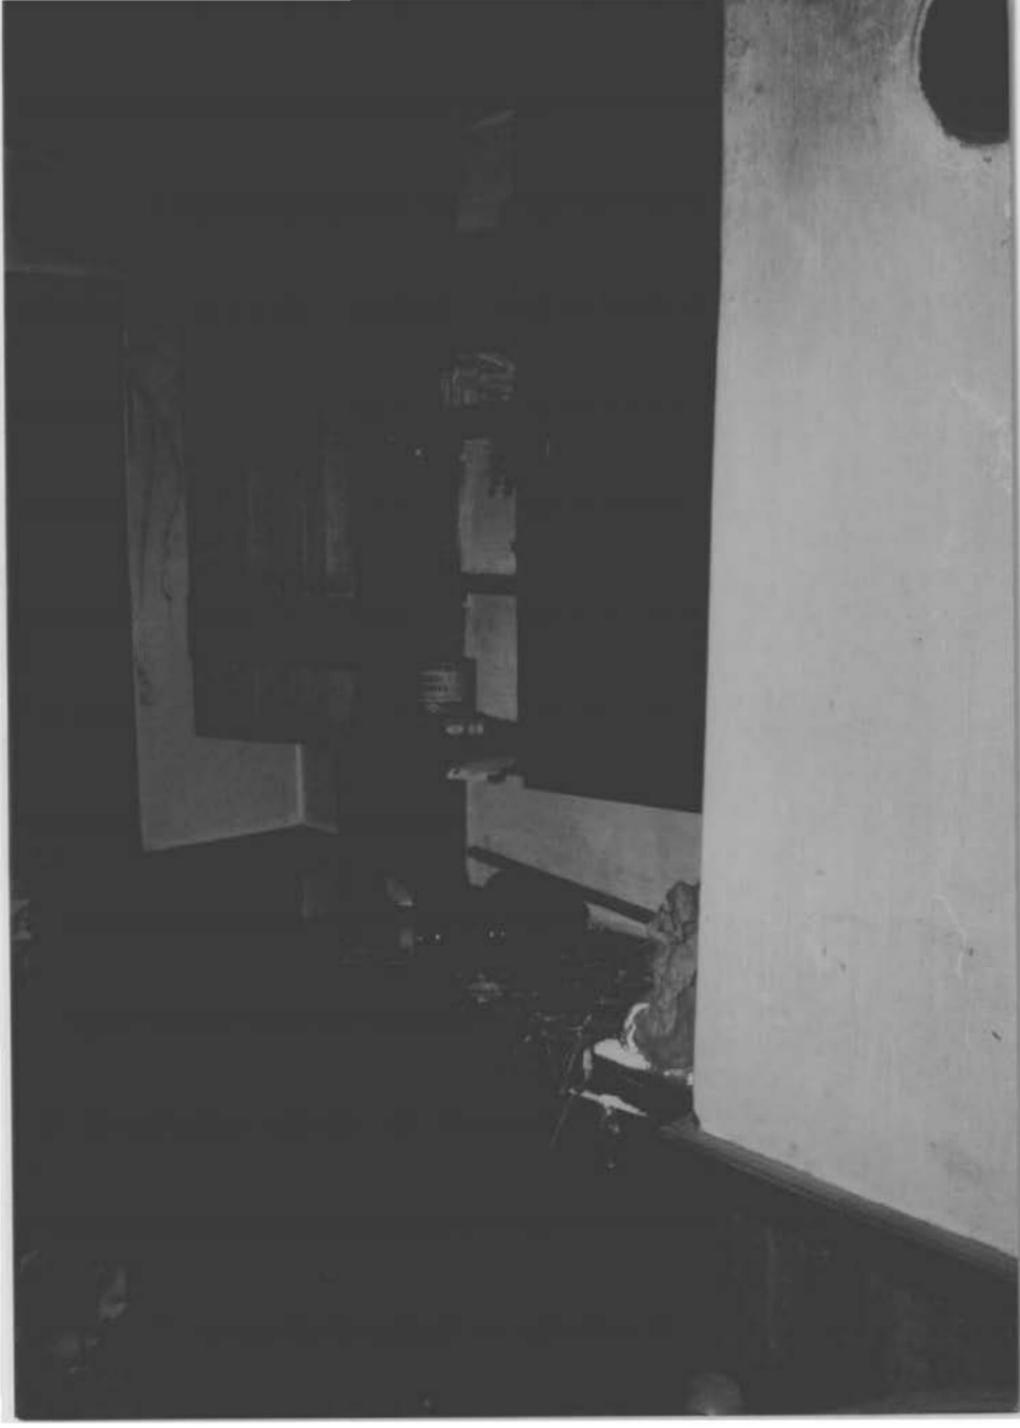
Summer Kitchen - Upper story cabinet

elevation. To the east of this chimney is a built-in cupboard of the same material as the wainscot. The bottom section has two doors with a shelf, then there is an open space above and two doors above it, with four shelves behind these doors. To the west of the chimney is a hatch leading to the attic area, which is unfloored.

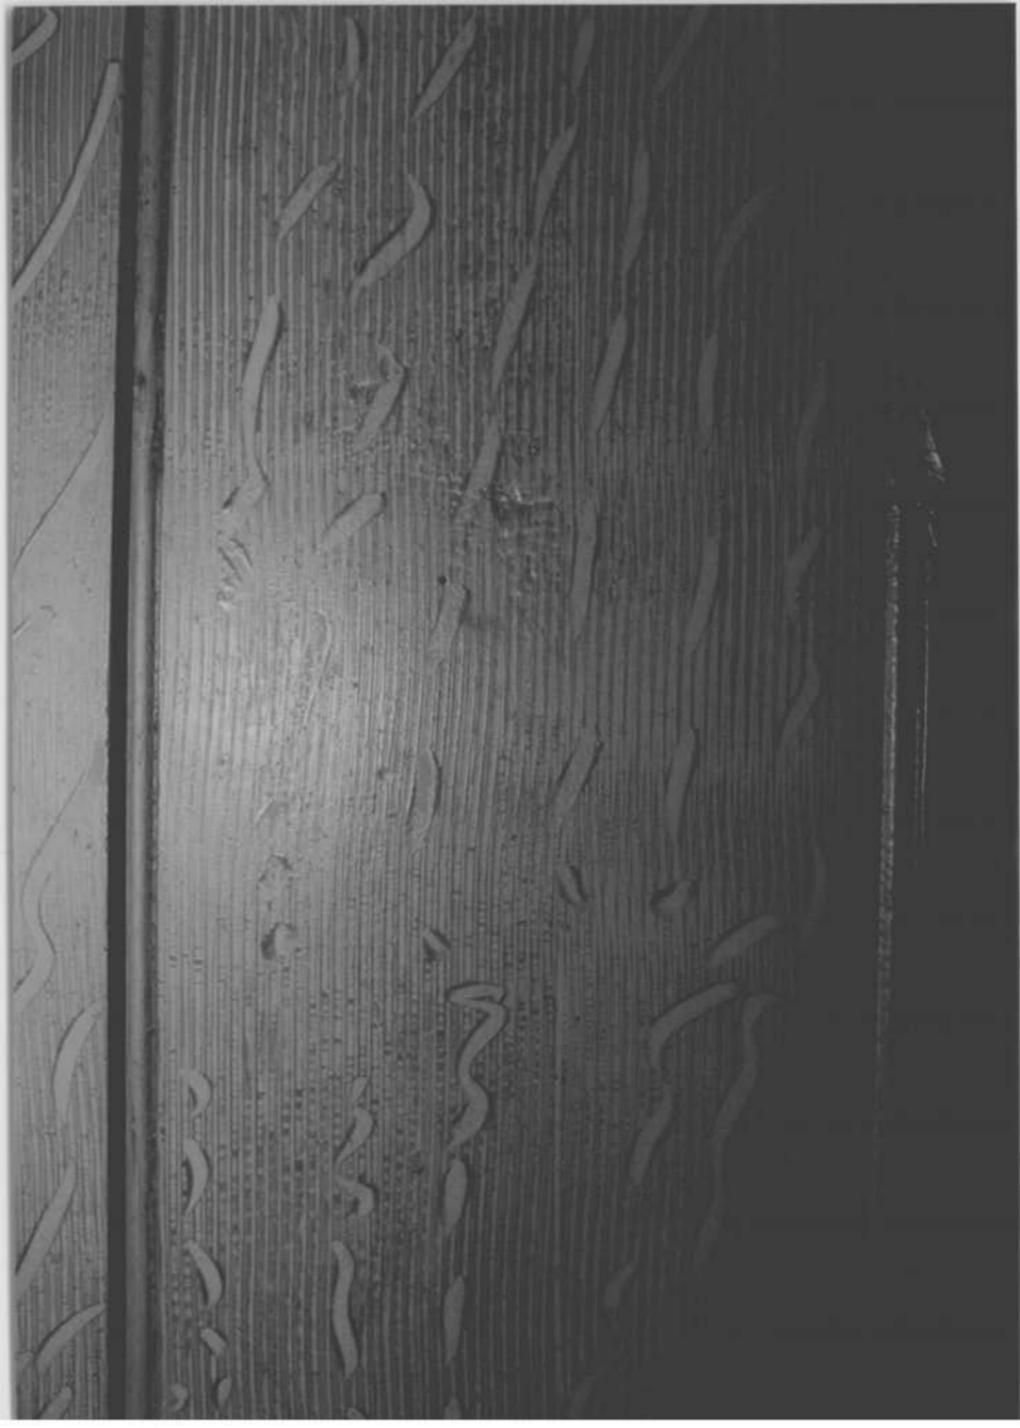
6 OF 18

House - Center

Rm Stair Door graining

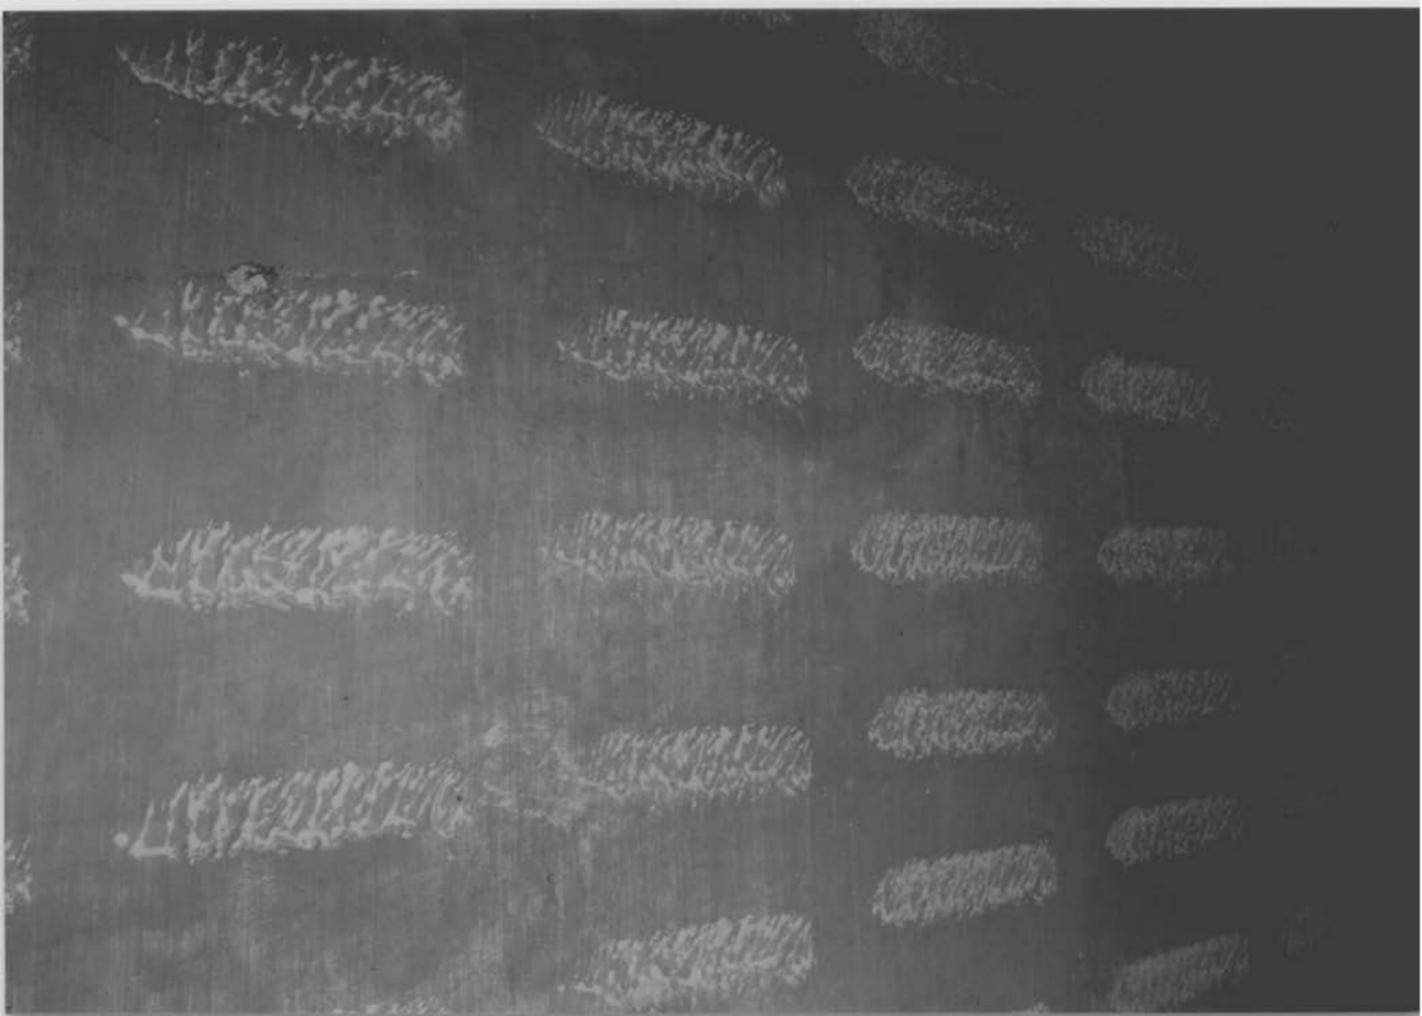
7 OF 18

House NE RM - Sponge Painting

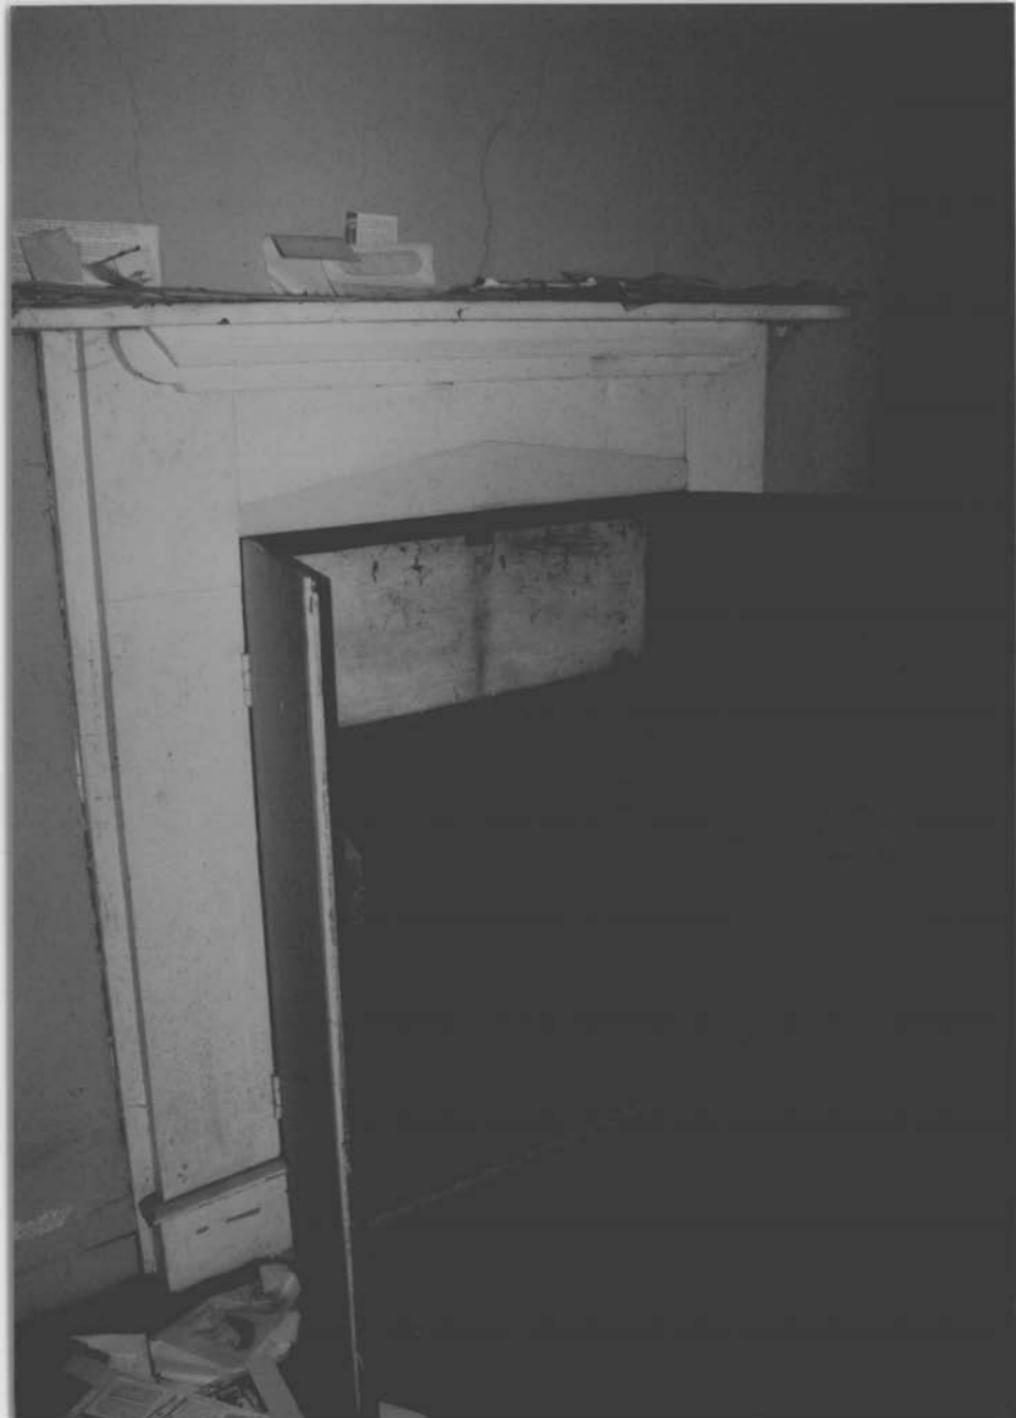
8 OF 18

House - Center

RM Martel

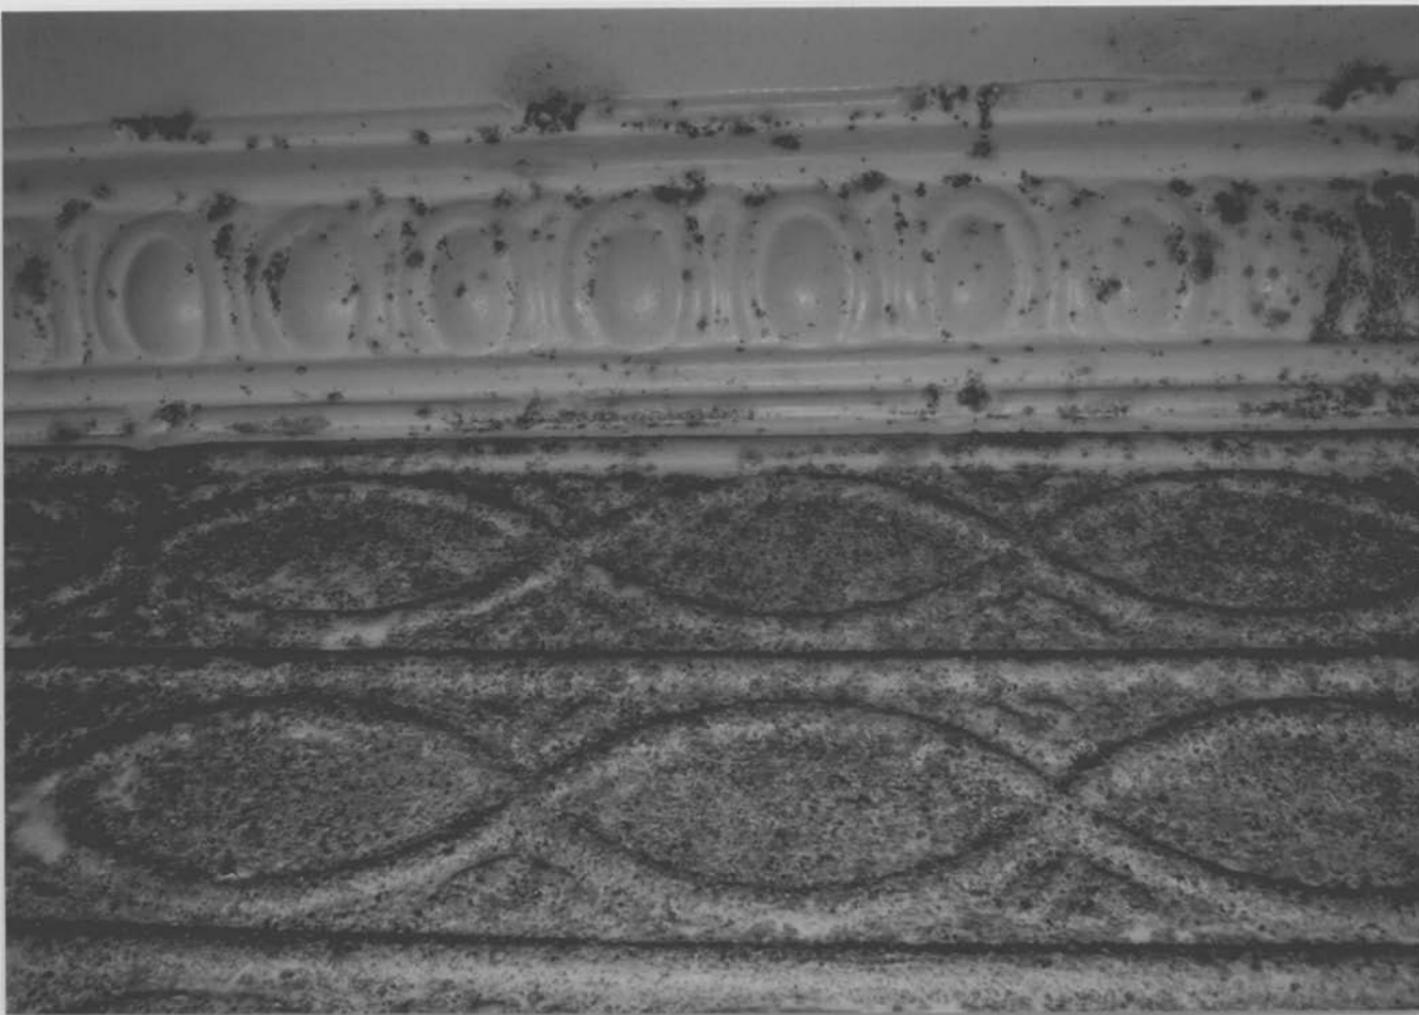
19 OF 18

House - N.W. RH Metal Ceiling

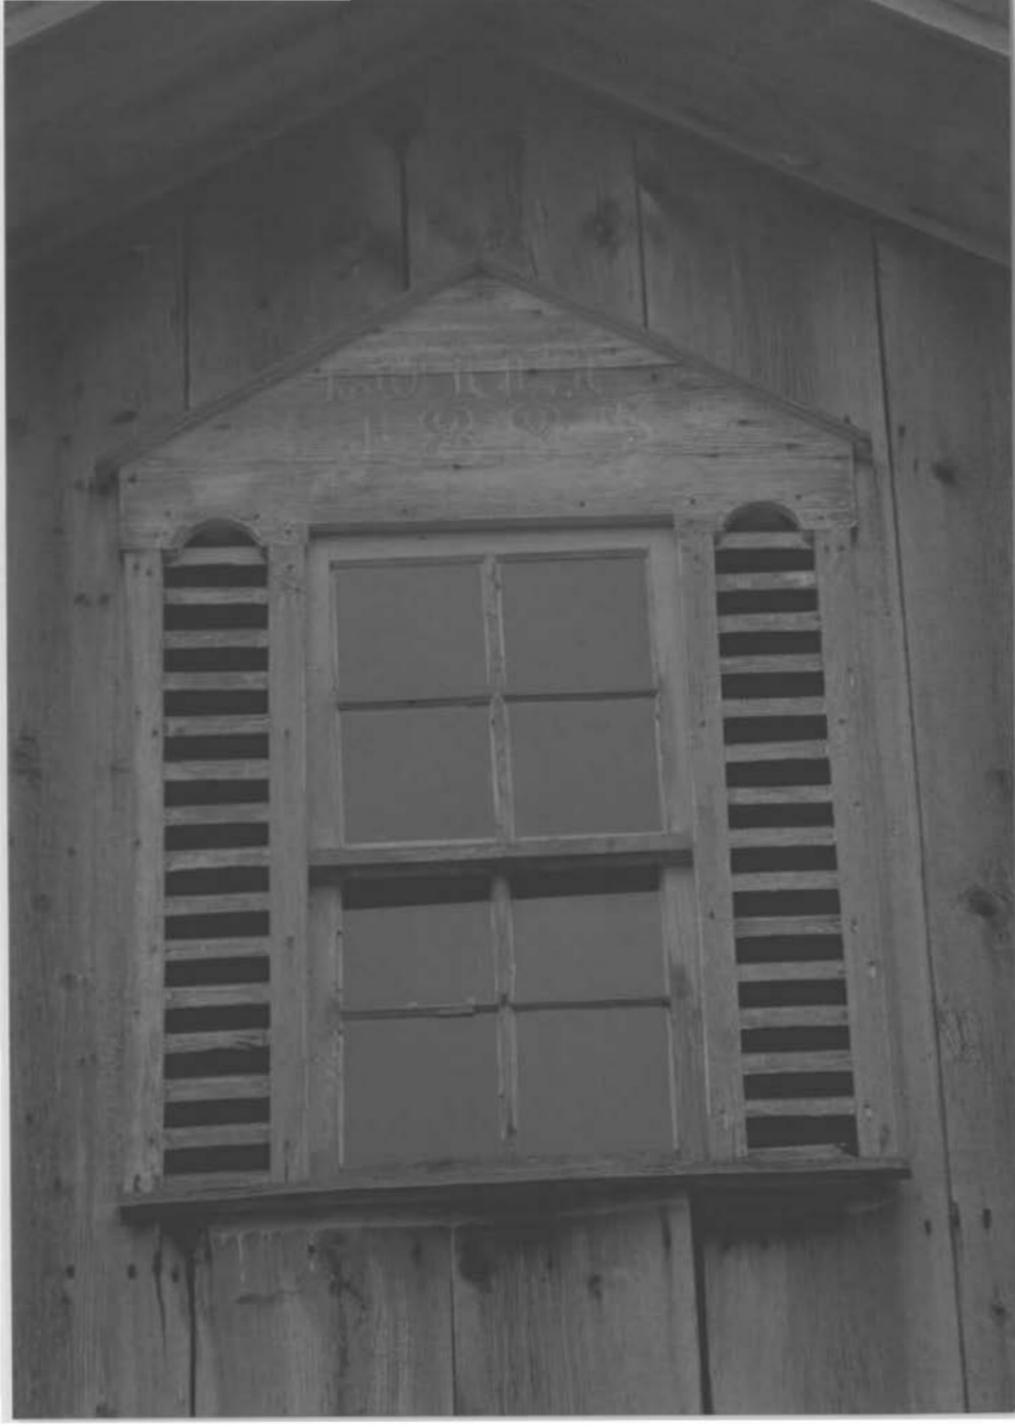
10 OF 18

Barn - wigable end vent

The west elevation has a typical Dutch door in the center of the lower story. There is a vertical board door on rollers beneath the forebay. The upper story has a vertical board door on machine cut strap hinges set to the north and three vents, with two vents above this. The gable end has a 4/4 sash with a narrow vent on each side. This opening is pedimented and the tympanum is painted "BUILT 1885." On the north elevation, the bridge or ramp extends across the whole length of the barn. The upper story has a pair of wagon doors on rollers in the center that are made of beaded-edge-and-center vertical boards. There are two four-light sash set west of the doors. The east elevation is banked on the lower story and the wall is partially collapsed. The upper story apparently had two vents and the gable end was the same as that on the west, but these are all now gone.

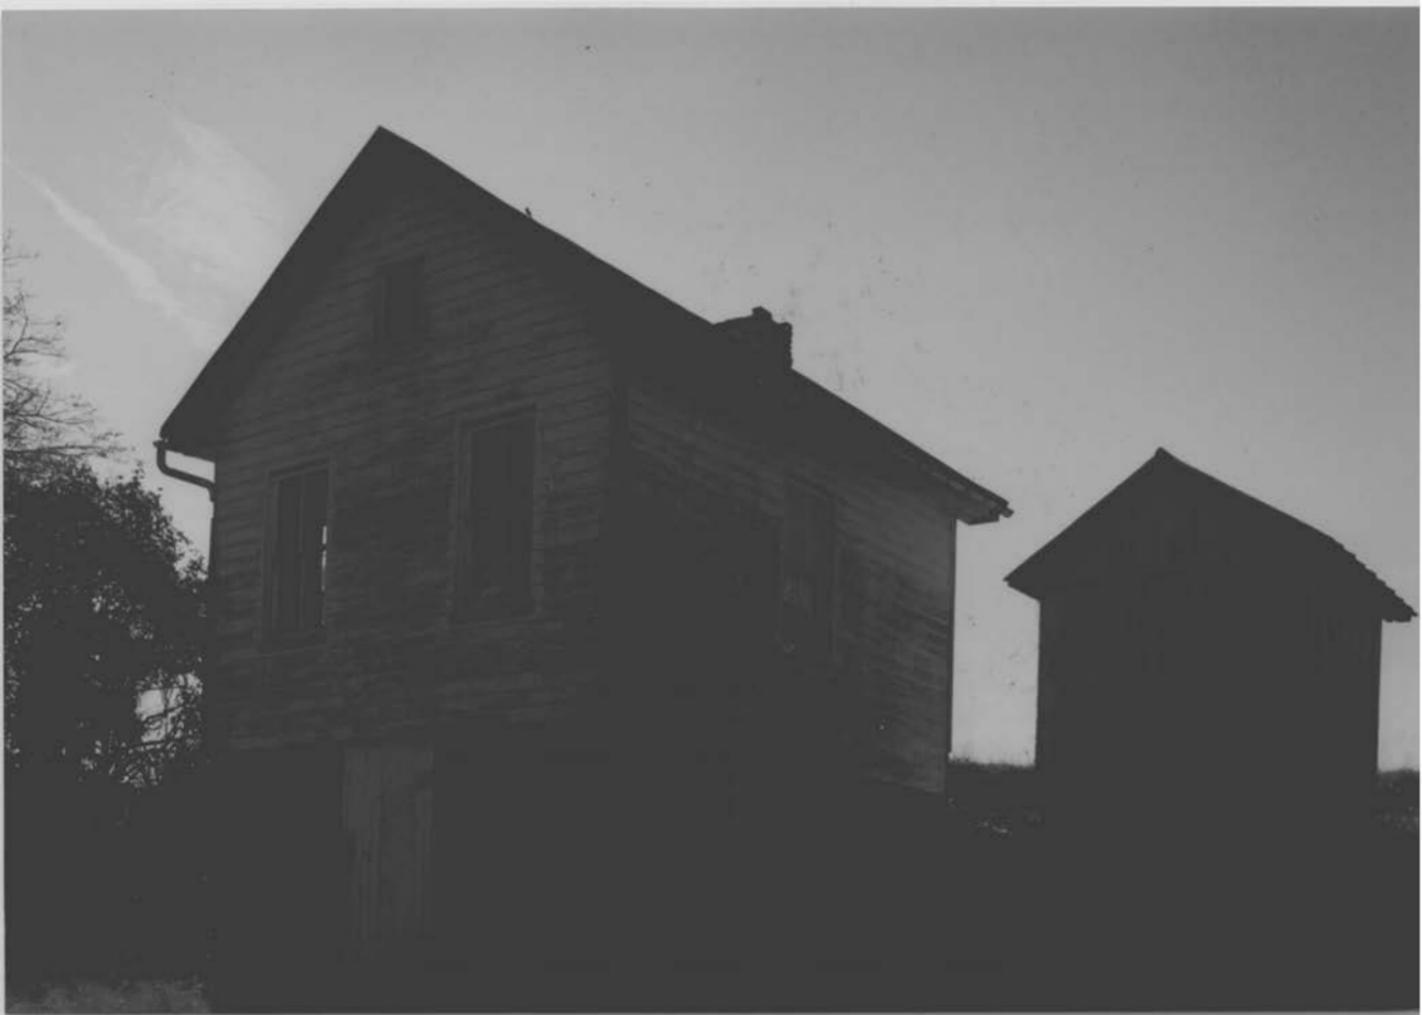
11 OF 18

Neg Loc: Maryland Historical Trust
Smokehouse & Summer Kitchen

N & W. Elev.

There is a smoke house located about four feet west of the summer kitchen. It has a rubble stone foundation and sash-sawn board and batten siding that is wire-nailed. There is a gable roof of inverted-v-seam metal with a north-south ridge, and a wood box cornice. There are no openings on the south or west elevations. The north elevation foundation has an opening to the fire pit that has brick jambs. The east elevation has a board and vertical batten door set to the south, and it is hung on butterfly hinges. The smokehouse has a hewn sill, hewn plate, and hewn corner posts. The end girts are sawn and are half-lapped. Horizontal beams in the center of the walls and down braces are of round logs and are nailed. The rafters are sawn 2 by 4's that are mitered at the ridge.

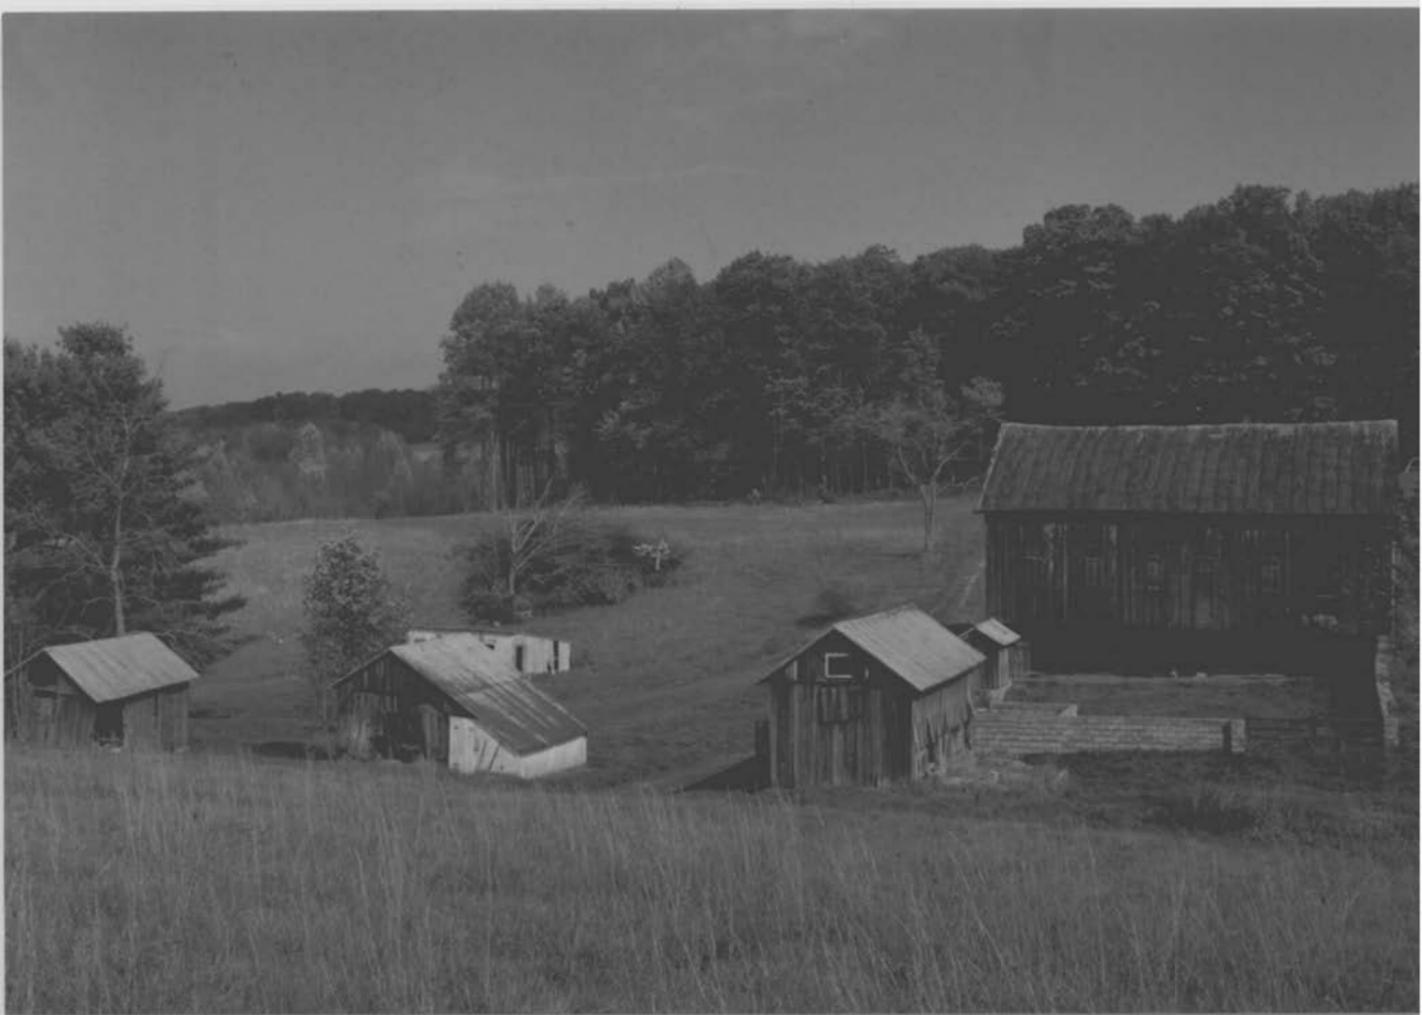
12 OF 181

Sheds & Barn - general VW. FR. South

About 45 feet southeast of the house is a small shed with a rubble stone foundation, vertical board siding with cut nails and with battens on the north elevation only, and a gable roof with a north-south ridge and standing seam metal. There are no openings on the west, south or north elevations. The east elevation has a wide door opening set to the south.

About 15 feet east of the small shed is a large shed with a rubble stone foundation, vertical board siding with cut nails, and a gable roof with inverted- v-seam metal on the west and corrugated metal on the east. The ridge runs north-south. The south elevation has paired vertical-board wagon doors on machine cut strap hinges. A wing added to the east has paired, beaded-edge vertical board doors on t-hinges. The west elevation has a vertical board door on machine made strap hinges, set to the south. There are no openings on the north or east elevations. The east elevation has beaded-edge-and-center vertical board siding on the added wing. The shed has the same construction as the smokehouse, and the framing is fastened with cut nails.

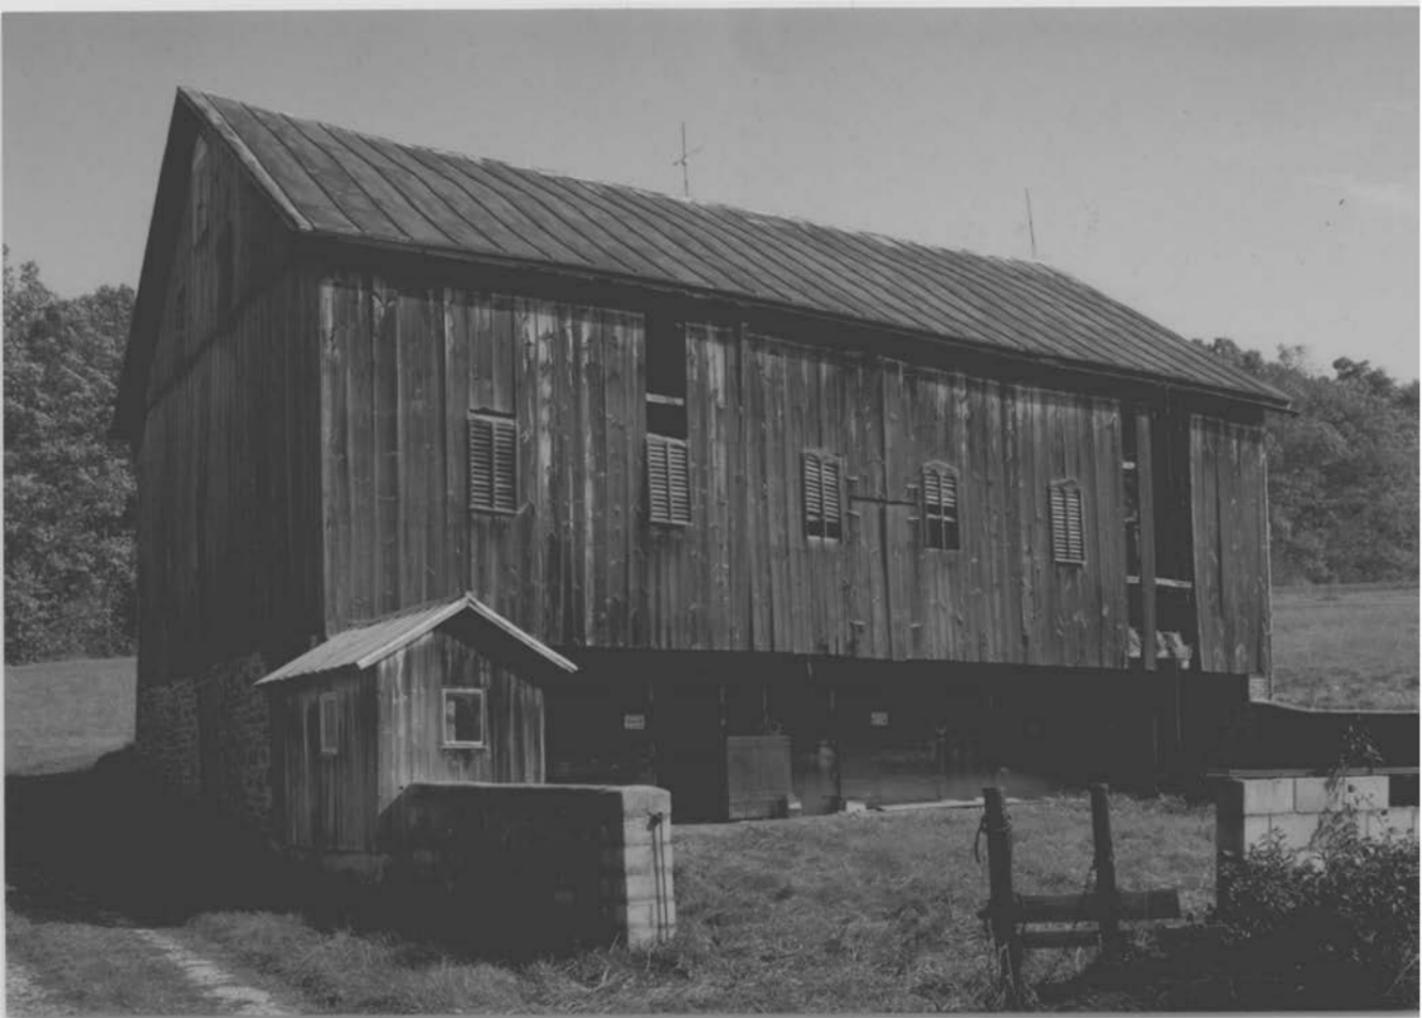
13 OF 18

Barn - W & S Elex

There is a bank barn with a south-facing forebay located about 50 feet north of the hog pen. It has a rubble stone lower story with some brick at the southeast and southwest corners. The south elevation of the lower story has horizontal boards that are sash sawn and fastened with cut nails. The upper story has vertical board siding with wire nails, and the gable roof has an east-west ridge with standing seam metal. On the south elevation the lower story has, from west to east, five vertical board Dutch doors on machine cut strap hinges. A stone and brick wall closes off the forebay on the east end, and there is also a stone barn yard wall on the east side that appears to be integral. The upper story has five wood louver vents. There were probably originally six, but the east one, and some siding in that vicinity, is now gone. In the center are a pair of doors set above a pair of doors, all of them hung on machine cut strap hinges.

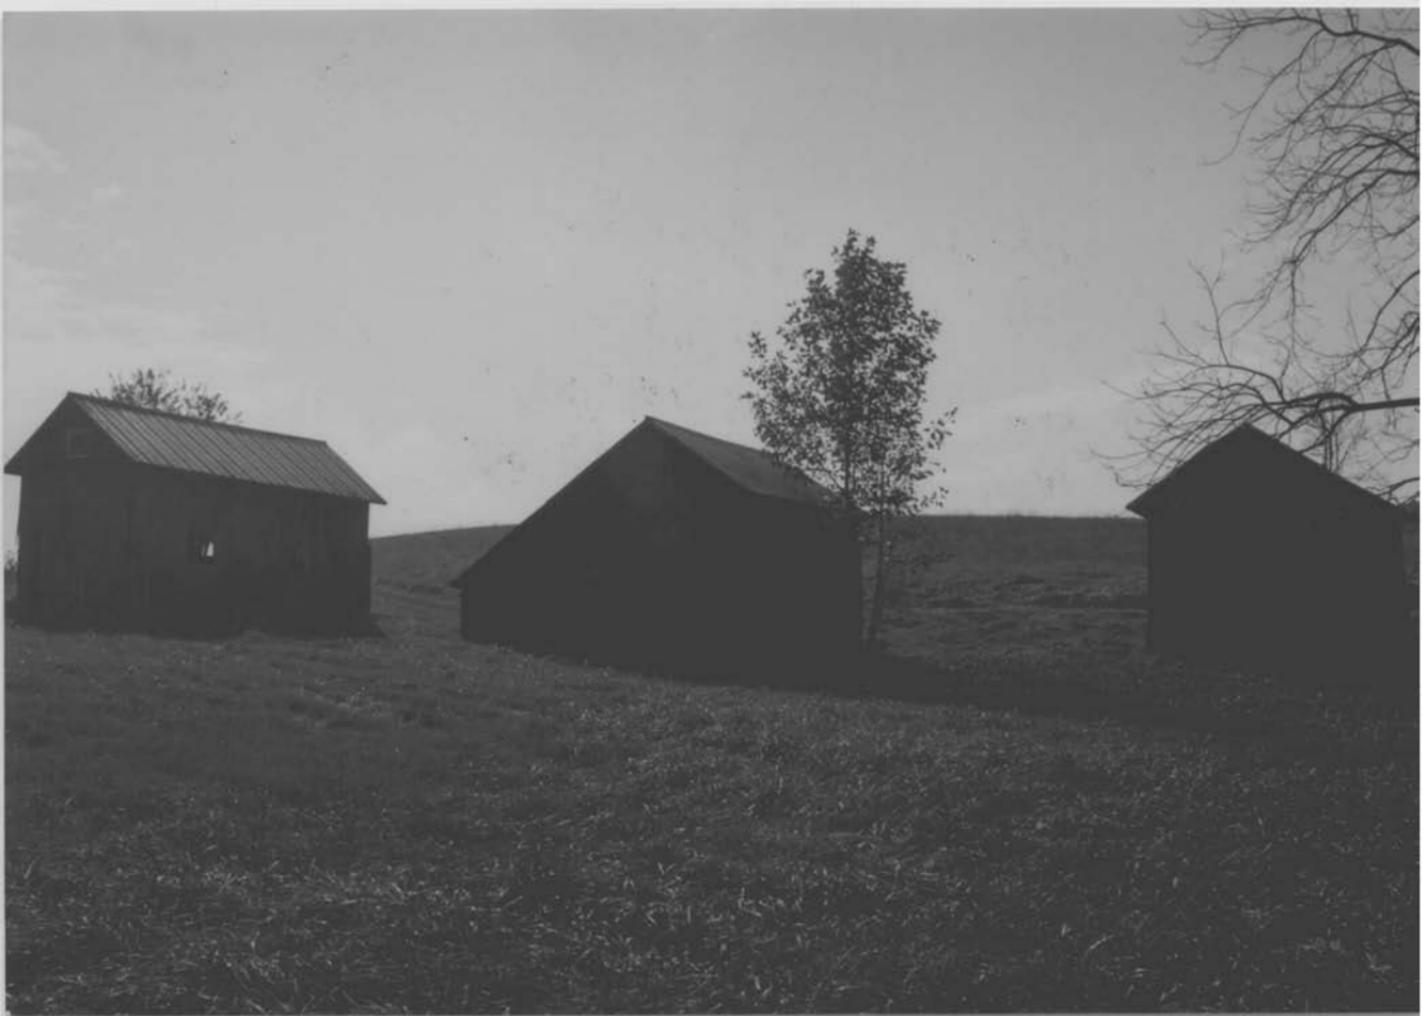
14 OF 18

Three sheds N & W Elys
