CARR-1555

2011 Snydersburg Rd., Hampstead Vicinity

MARYLAND INVENTORY OF
HISTORIC PROPERTIES

historic Sharrer-Hosfeld Farm

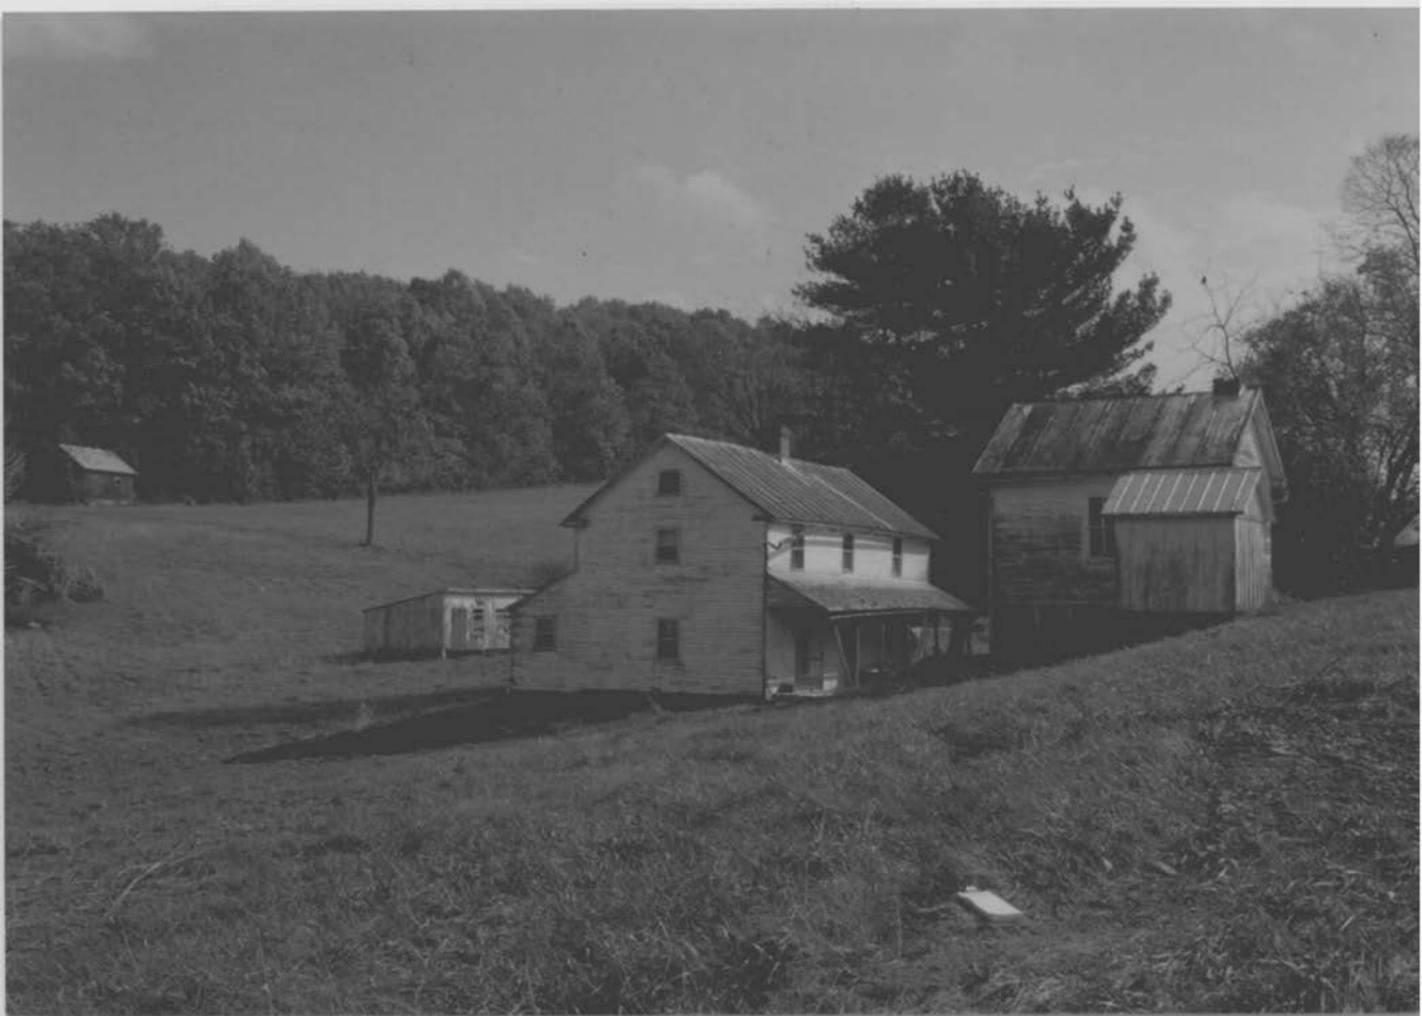
15 OF 18

General VW FR. S.W.

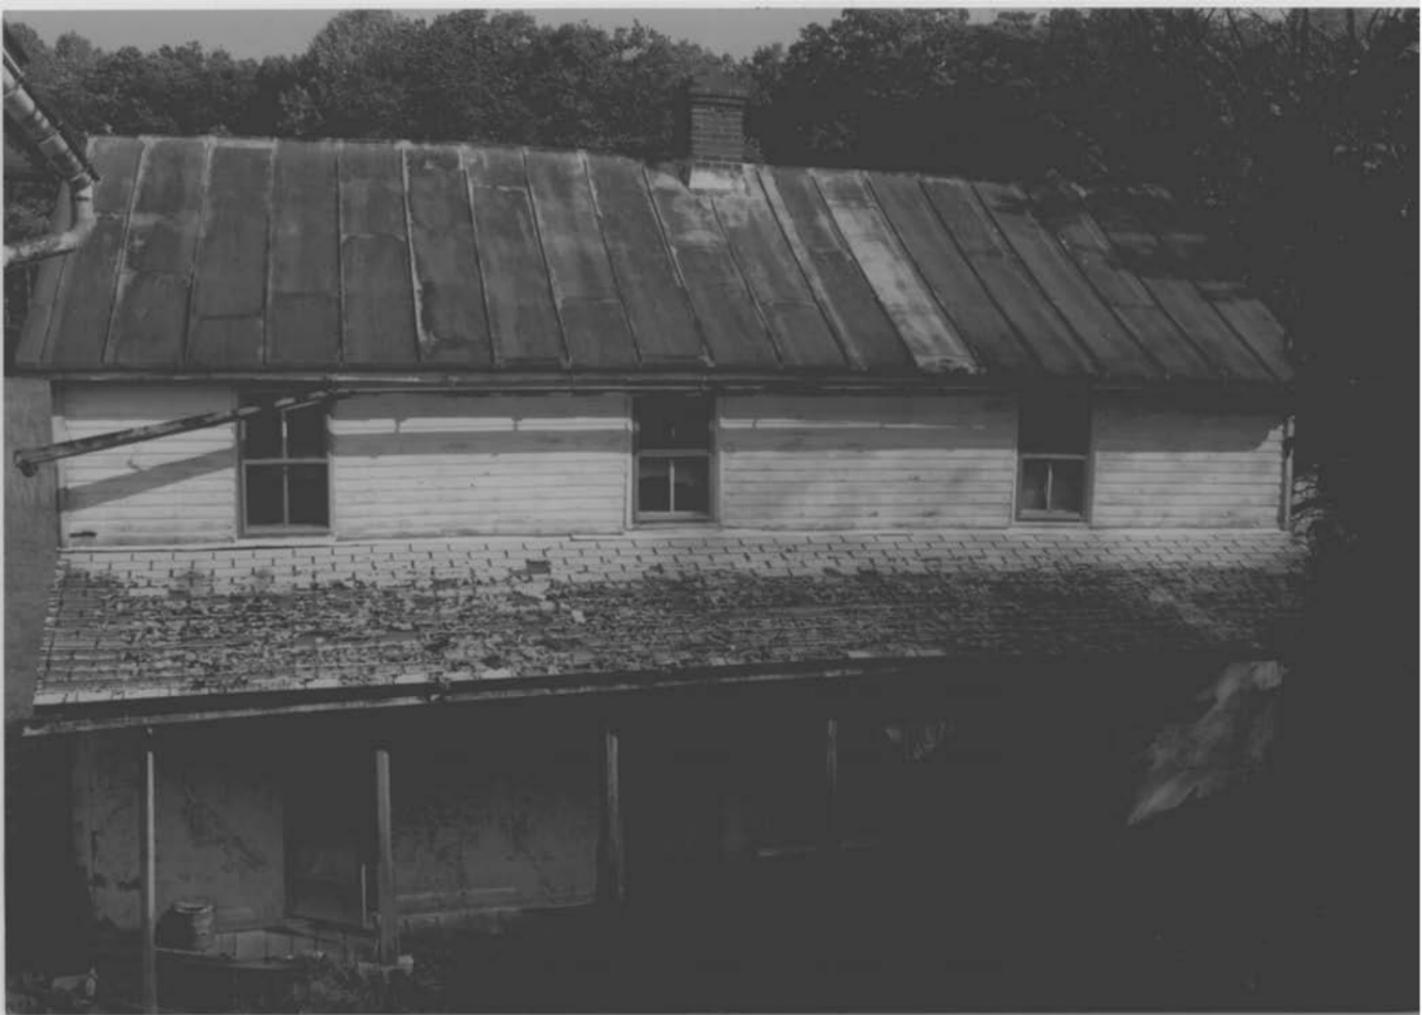
16 OF 18

House - S. elev.

The house is a two-story, three-bay by one-bay structure that faces south toward the uphill side of a slope. It has a gable roof with an east-west ridge that is covered in standing seam metal, and is set on a low rubble stone foundation wall. There is a brick chimney set just east of center. On the south elevation the first story has rough casting with corner boards and a base board. The rough casting is whitewashed. The west bay has a beaded-edge vertical board door with a four-light sash and later hardware. The center bay has a nine-light-over-two-panel door and a three-light transom. The east bay has a 2/2 sash. The rough casting is laid over sawn vertical lath fastened with cut nails. The log structure beneath has weathered v-notch corner logs that are whitewashed. The two bays to the east are the original section of the house and the west bay has been added. There is a corner post just west of the center bay that butts up against the v-notches of the original section. This post has a continuous mortise on its west face and the logs are tenoned into the post but are not pegged. The posts and the logs to the west of it have several coats of whitewash on them as well. The vertical lath is circular sawn and is fastened with cut nails. It supports the rough casting, which is painted white, then an olive green, and then white. There is a one-story, three-bay porch with a shed roof. The porch deck is set on three sleepers set on the ground. The sleepers are hewn on one side. There were originally six chamfered posts, but several of the posts are now missing. The porch plate is hewn and supports primarily ¾ round log rafters. The second story has weather boards with an ogee moulding on the bottom edge. There are three 2/2 sash, and there is a wood box cornice with returns.

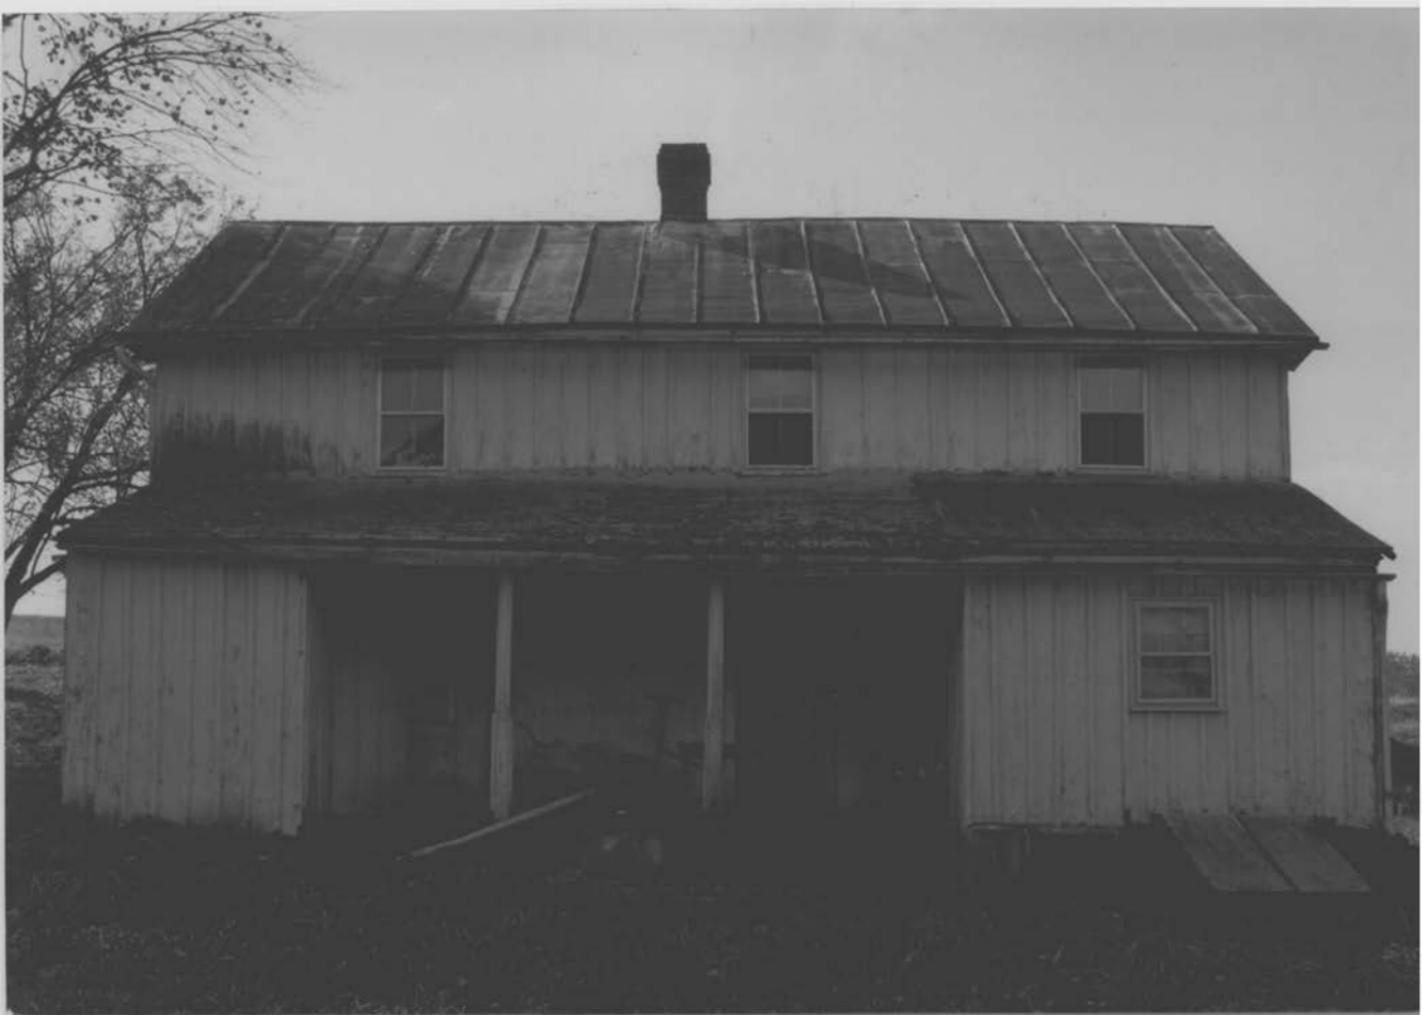
17 OF 18

House - N. elev.

The north elevation has a one-story, three-bay porch with a shed roof. The east and west bays of the porch are enclosed with board and batten siding, and there are two chamfered posts between these enclosures. The eastern enclosure has a vertical board door on the west elevation. The porch, deck and soffit are all fastened with wire nails. The east bay of the porch enclosure has a 2/2 sash. The center bay has rough casting and a nine-light-over-two-panel door with a three-light transom above. The west enclosure has a 6/3 sash and a bulkhead to the cellar with bulkhead doors covering stone cheek walls. The second story has board and batten siding and

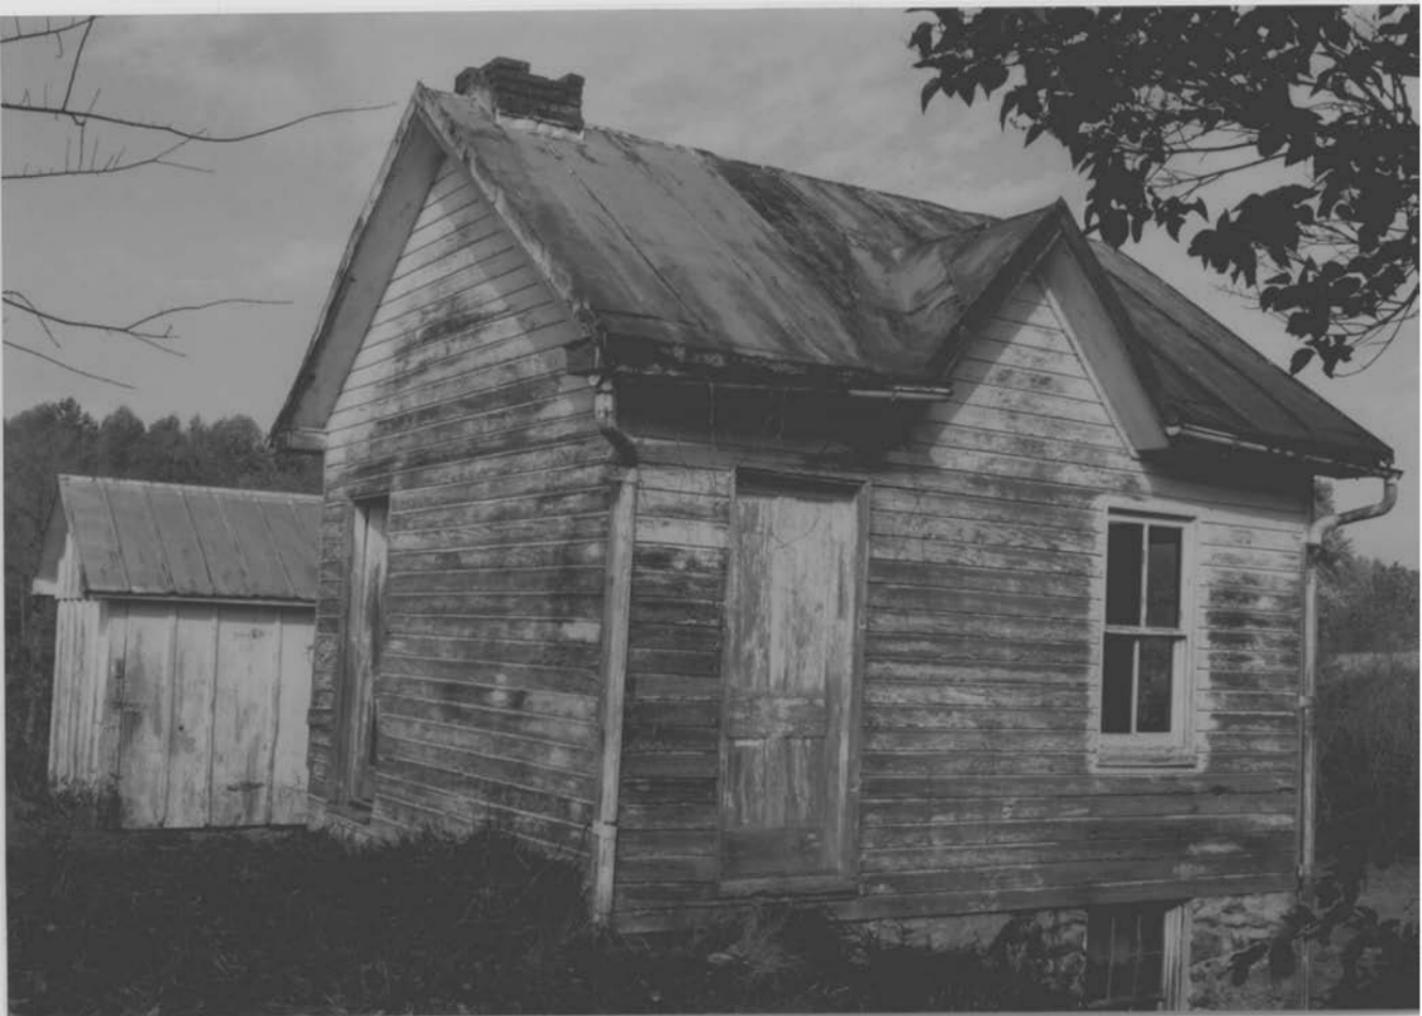
18 OF 18

Summer Kitchen

S & E Elevation

The summer kitchen is set about 12 feet south of the west end of the house. It is banked into the hill at the south and is a one-story, two-bay by two-bay structure that has a rubble stone foundation, German siding with corner boards (all fastened with cut nails), and a gable roof of standing seam metal with a north-south ridge. There is an interior brick chimney centered on the south end of the gable. The south elevation has a four panel door in the west bay. The west elevation foundation has a 6/3 sash in the north bay of the foundation. The first story has a 2/2 sash in the center, and there is a wood box cornice. The north elevation has a beaded edge-and-center vertical board door on machine cut strap hinges in the center of the foundation. The first story has two 2/2 sash and the gable end has a four-light sash. The east elevation has a 6/3 sash in the north bay of the foundation. The first story has a four panel door, like that found on the south elevation, in the south bay, and the north bay has a 2/2 sash. There is also a central gabled wall dormer with no opening, and a wood box cornice.
