CARR-1583

626 Francis Scott Key Hwy., Keymar Vicinity

National Register of Historic Places
Registration Form

historic name Cover's Tannery

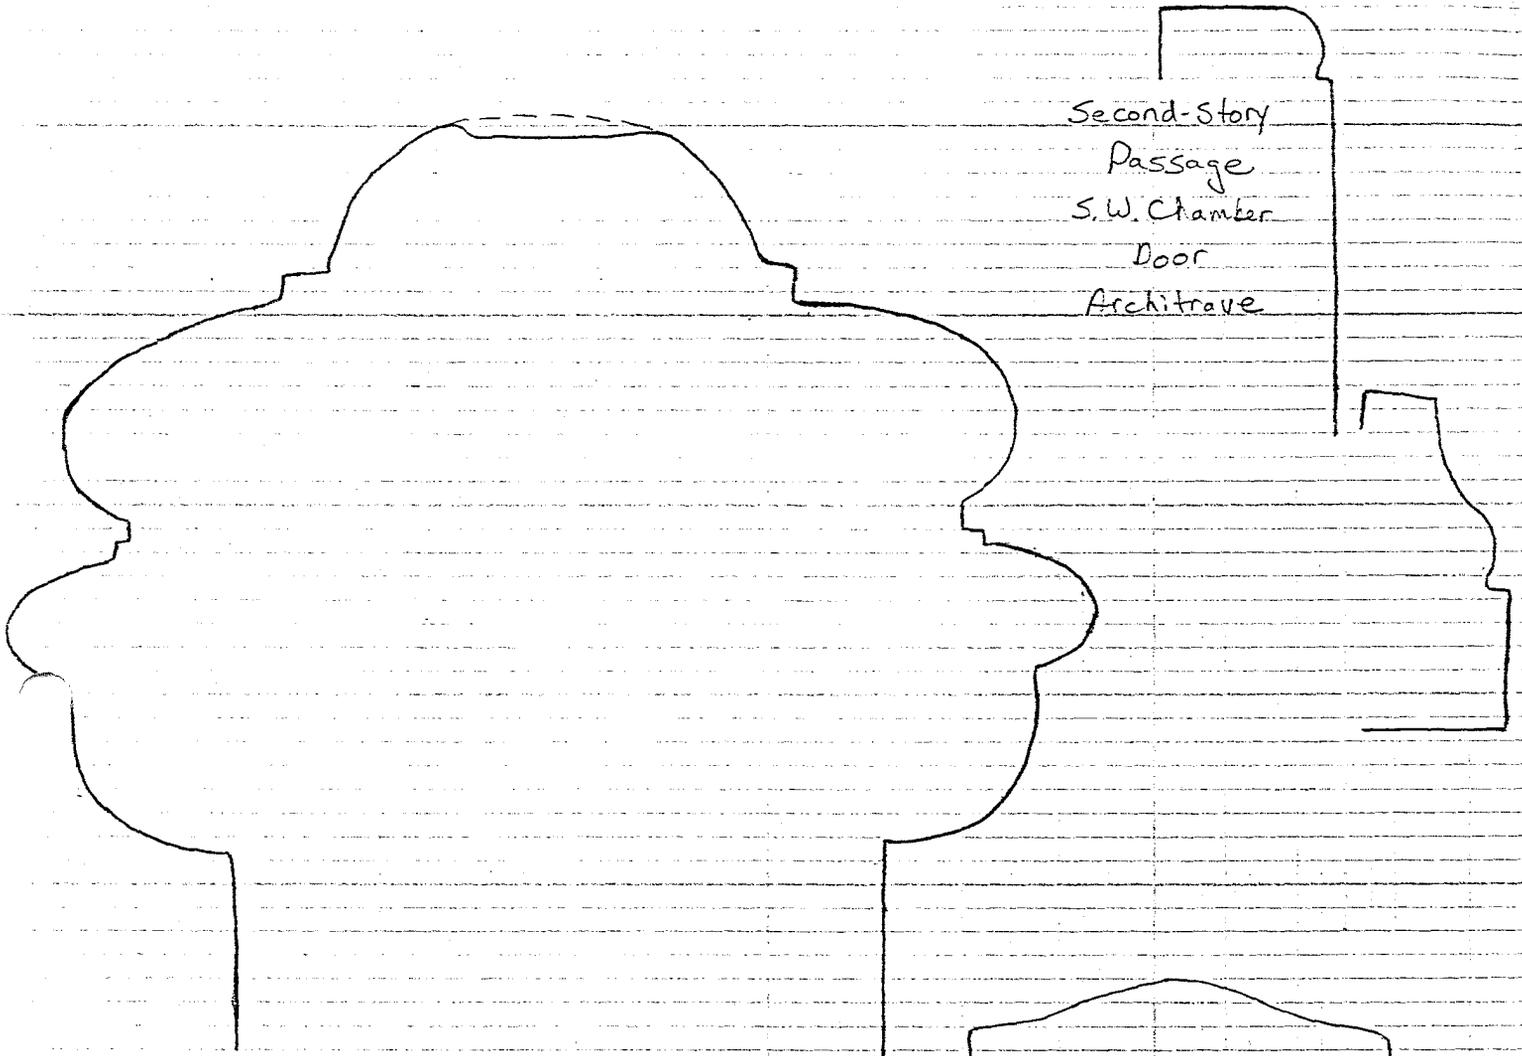
626 Francis Scott Key Hwy
Moulding Profiles

Newel Post Cap

Second-story
Passage
S.W. Chamber
Door
Architrave

Handrail

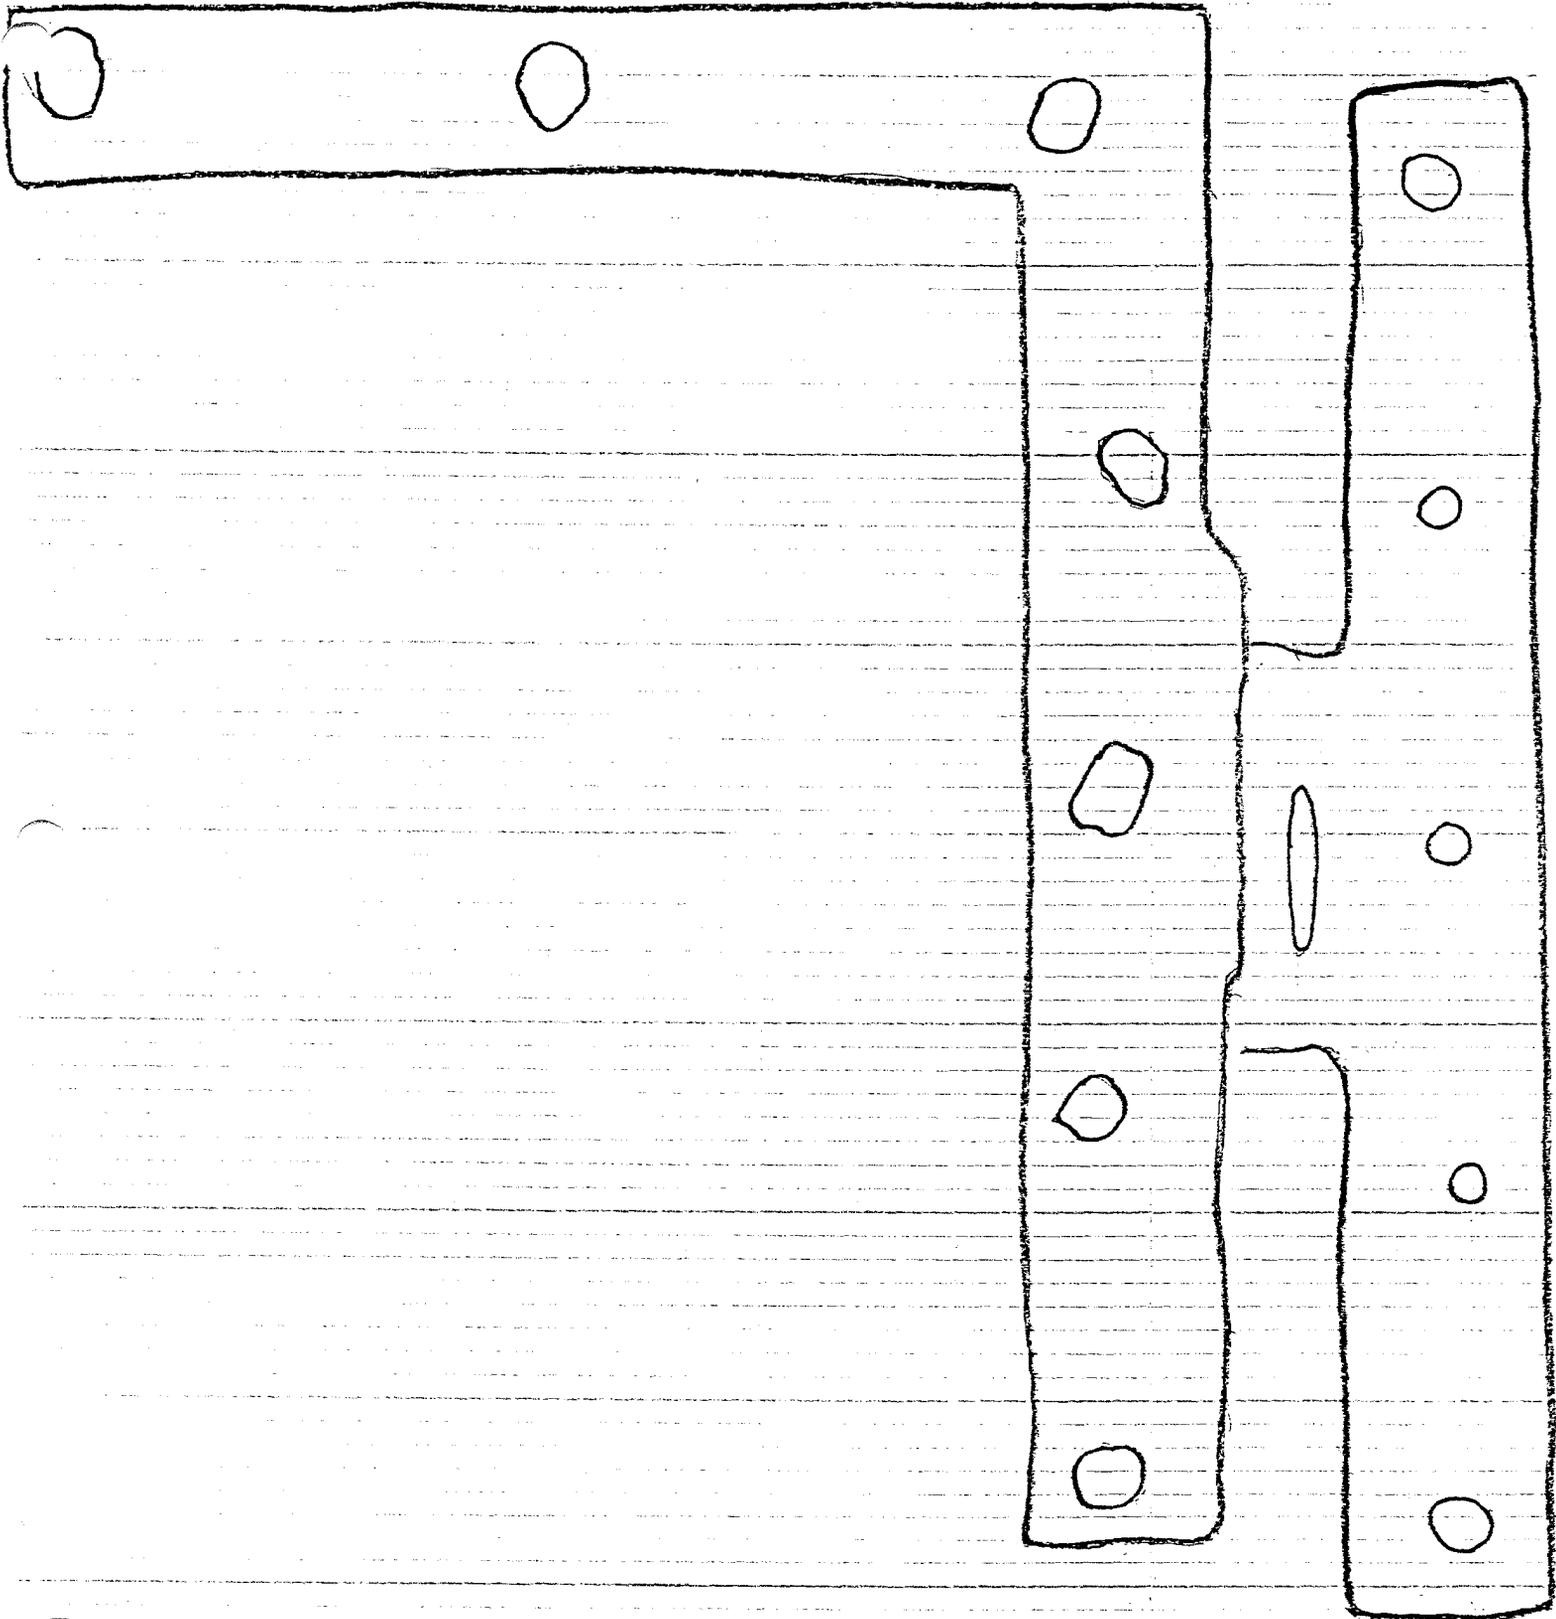
626 Francis Scott Key Hwy
N.E. Chamber Door H/C Hinge

Broken and out
of alignment now.

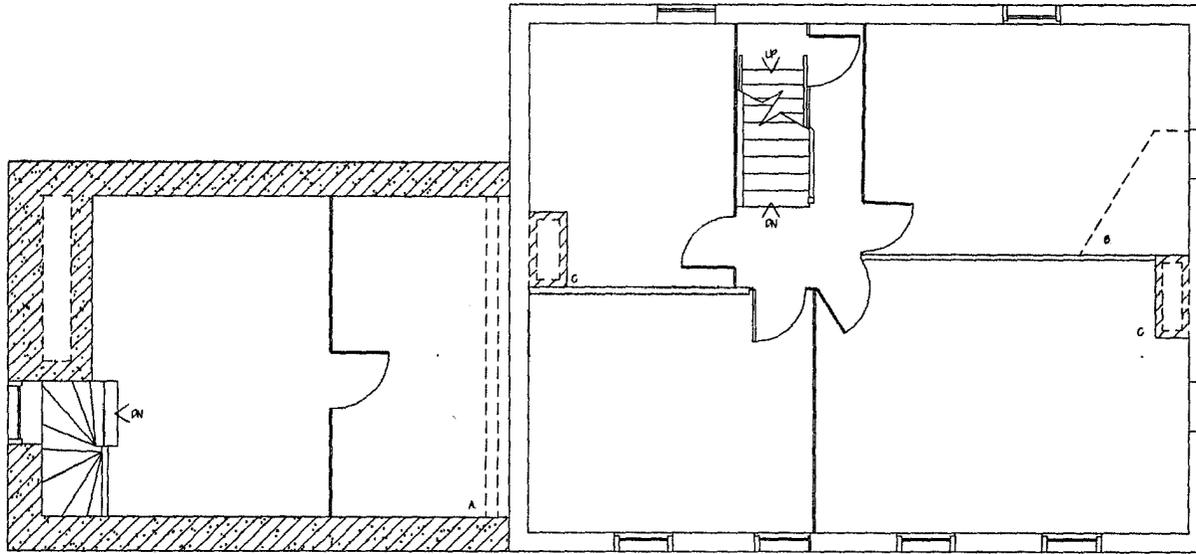
SECOND FLOOR PLAN

- A. REFLECTED TO BEAM
- B. CHOP IN FLOORING OF EARLIER
- CORNER FIREPLACE CHIMNEY
- C. CHIMNEYS ADDED LATER

The second story of the main block has a center passage in the north half with two rooms across the south and a room in each northern corner. In the passage the stairway has square balusters in a square newel post with a molded cap. The hand rail is also molded. There is a straight run of stairs to the attic that is enclosed with beaded-edge-tongue-in groove boards that appear to be nailed with t-headed nails. The doorway to the attic has beaded-edge-vertical boards with straight batons. The door is hung on cast iron butt hinges marked "T. CLARK'S COM~N". The northeast chamber door has head cut trim with no evidence of a back band. The door opening may have been narrowed with the addition of one vertical board. The door is of tongue and groove vertical board with no beads and has three straight batons, it is hung on hl hinges, nailed to the door and wall, it now has a cast iron rim lock with mineral knob that replaces an earlier lock and knob. The southeast chamber door is set at an angle and has the same head cut trim as the northeast chamber door. Several boards above the door are flush and have no tongues and grooves and no beads, this may be because the summer beam projects into the passage at this location. The door has three batons and is hung on hl hinges, it had a rim lock that is now gone. The southwest chamber door has head cut trim and applied ogee back band fastened with rose head nails. The door has two batons, there is an escutcheon with florida leaves on top and bottom on the passage side of the door, while the room side has a Dutch elbow lock. Nailed to the door with wrought nails, this lock has a dead bolt at the bottom. The door is hung on strap hinges that are tapered with round end and instead of pintles it has a dove tail that is nailed to the jamb with wrought nails. The northwest chamber door has the same architrave latch, escutcheon, strap hinges and batons as the southwest chamber door. The floor runs east/west around the second story and is random width pine.

The southeast chamber has board wall on the west elevation and plaster walls on the north, south and east elevations. The summer beam runs through this room and is plastered and has a flush board on the soffit. The window on the east has architrave with mitered joints and an ogee back band, the jambes are covered with boards. The south windows have an ovolo applied to the jamb boards. The northeast chamber has a board wall on the west elevation and plaster walls on
