McKinstry Homestead
McKinstry's Mill

Maryland Historical Trust State Historic Sites Inventory Form

historic McKinstry Homestead

street & number 4504 Sam's Creek Road ___ not for publication

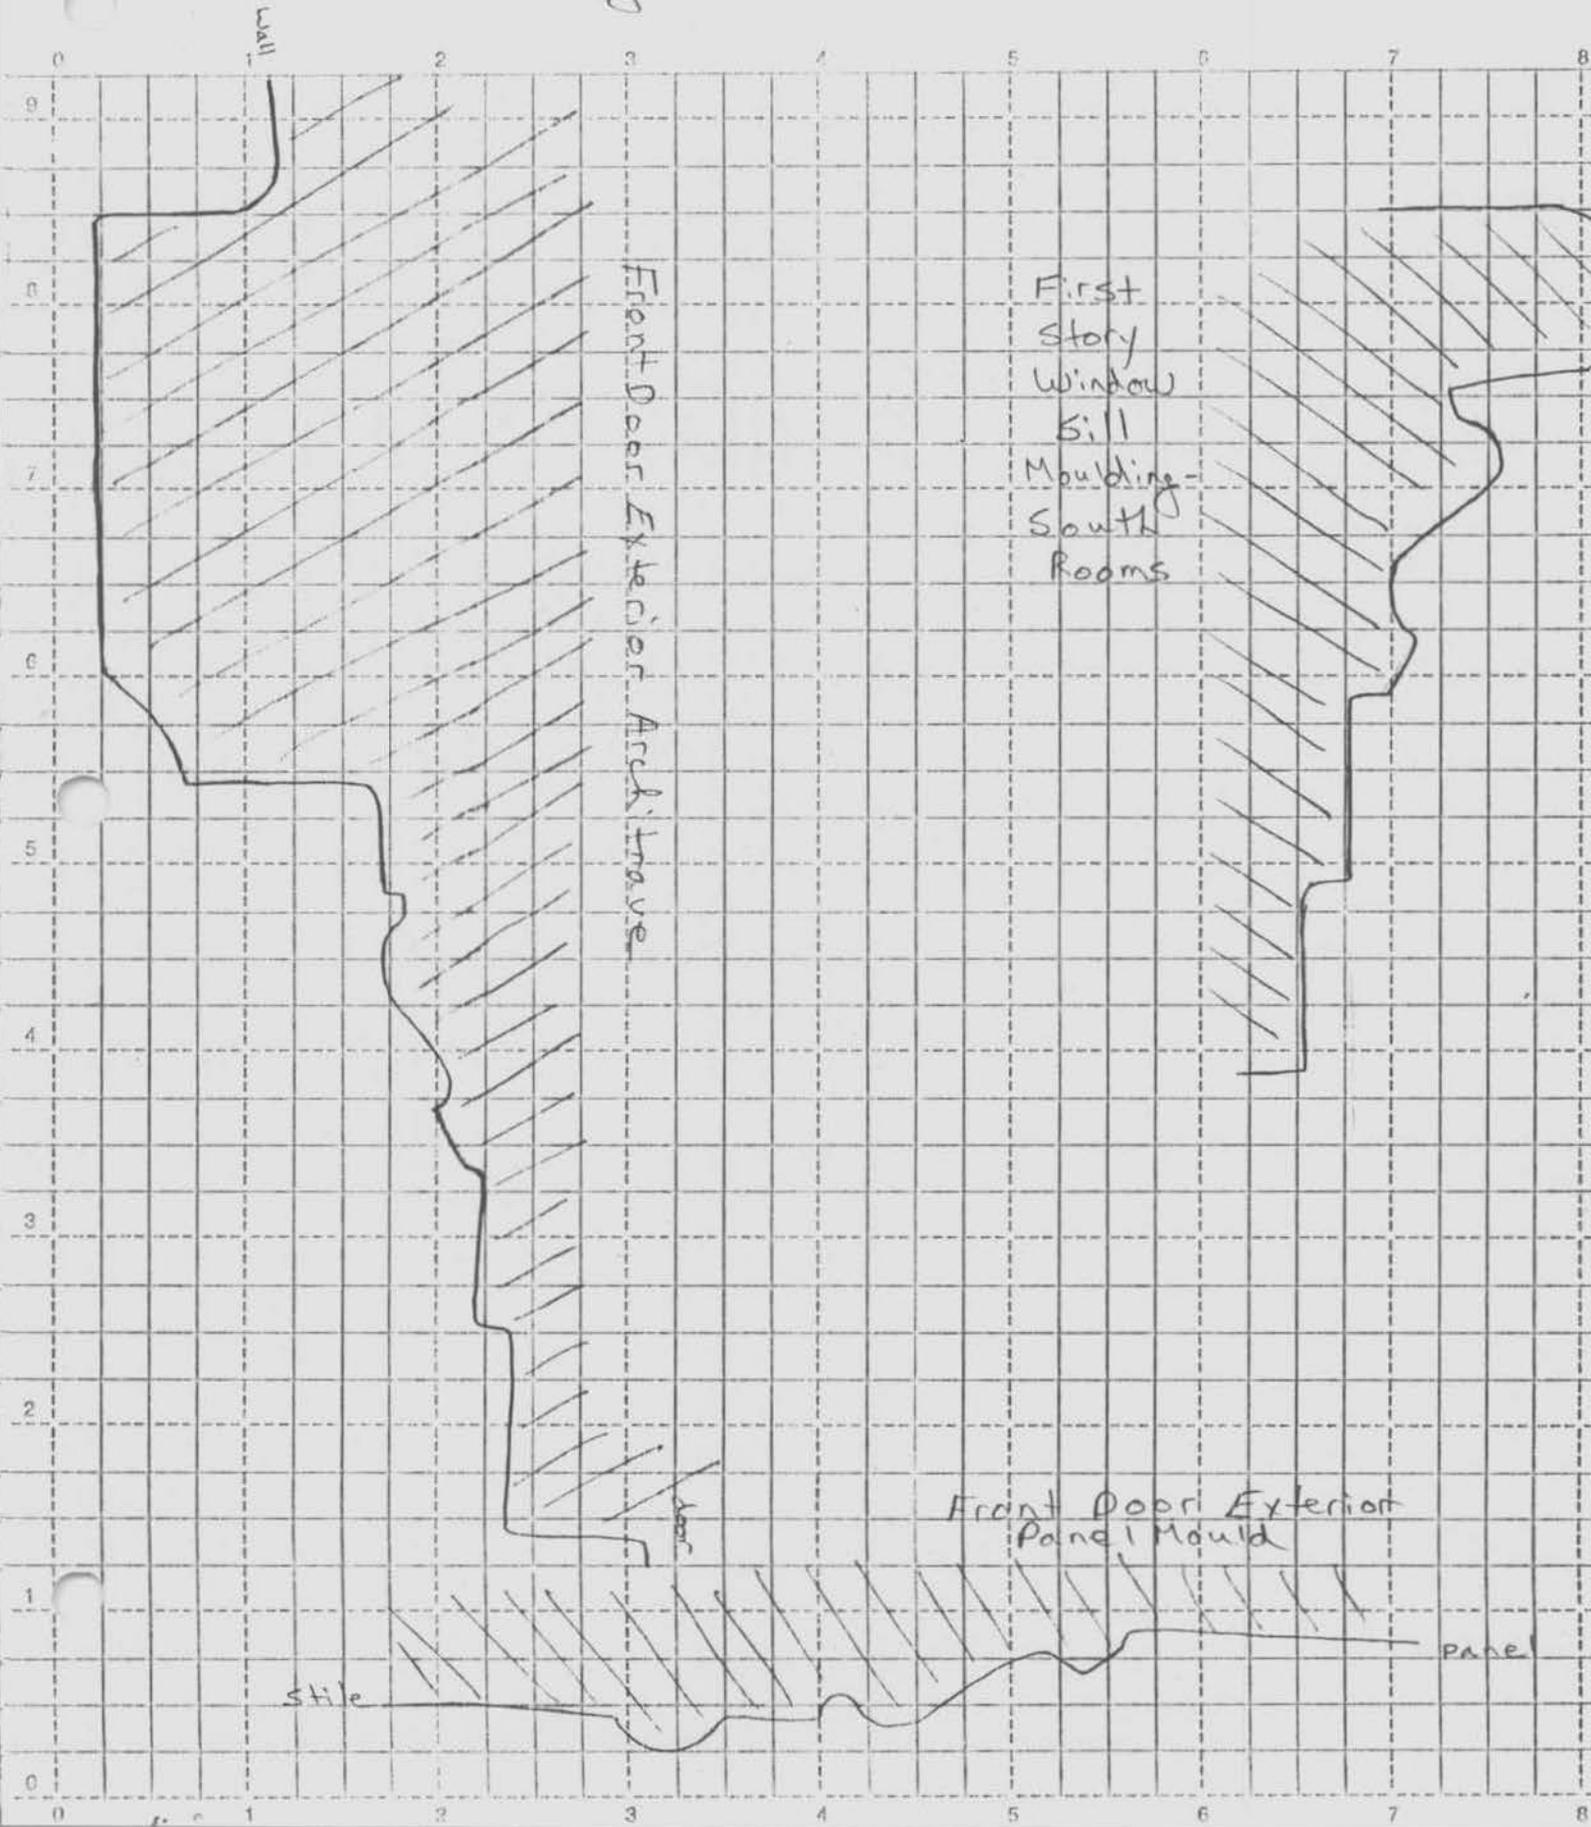
Front Door Exterior Architrave

First
Story
Window
Sill
Moulding -
South
Rooms

The south elevation has a center entrance on the first story, with a six-panel door that has square panels in the center. The panels are flat and sunk with bolection mouldings that include a quirked Greek ogee and bevel. There is a three-light transom that has frosted glass with lines in it. The architrave has a broken field, a quirked Greek ogee and bevel, and a wide, flat backband with a cavetto moulding on the inner corner of the backband. On either side of the doorway is a single 6/6 sash with a wood sill, a bullnose frame, a splayed-brick jack arch, and new shutters hung on original hardware. The door frame has a ceramic bell pull. There is a one-story, three-bay, shed-roof porch with standing-seam metal. It has rock-faced concrete block piers with wood lattice set between them and four wood Doric columns. The second story has three shorter 6/6 sash. There is a wood boxed cornice with returns. The cornice has an ogee moulding; below it is a bed mould with a Greek cavetto set below a Greek ovolo. The south elevation has Flemish bond brick.

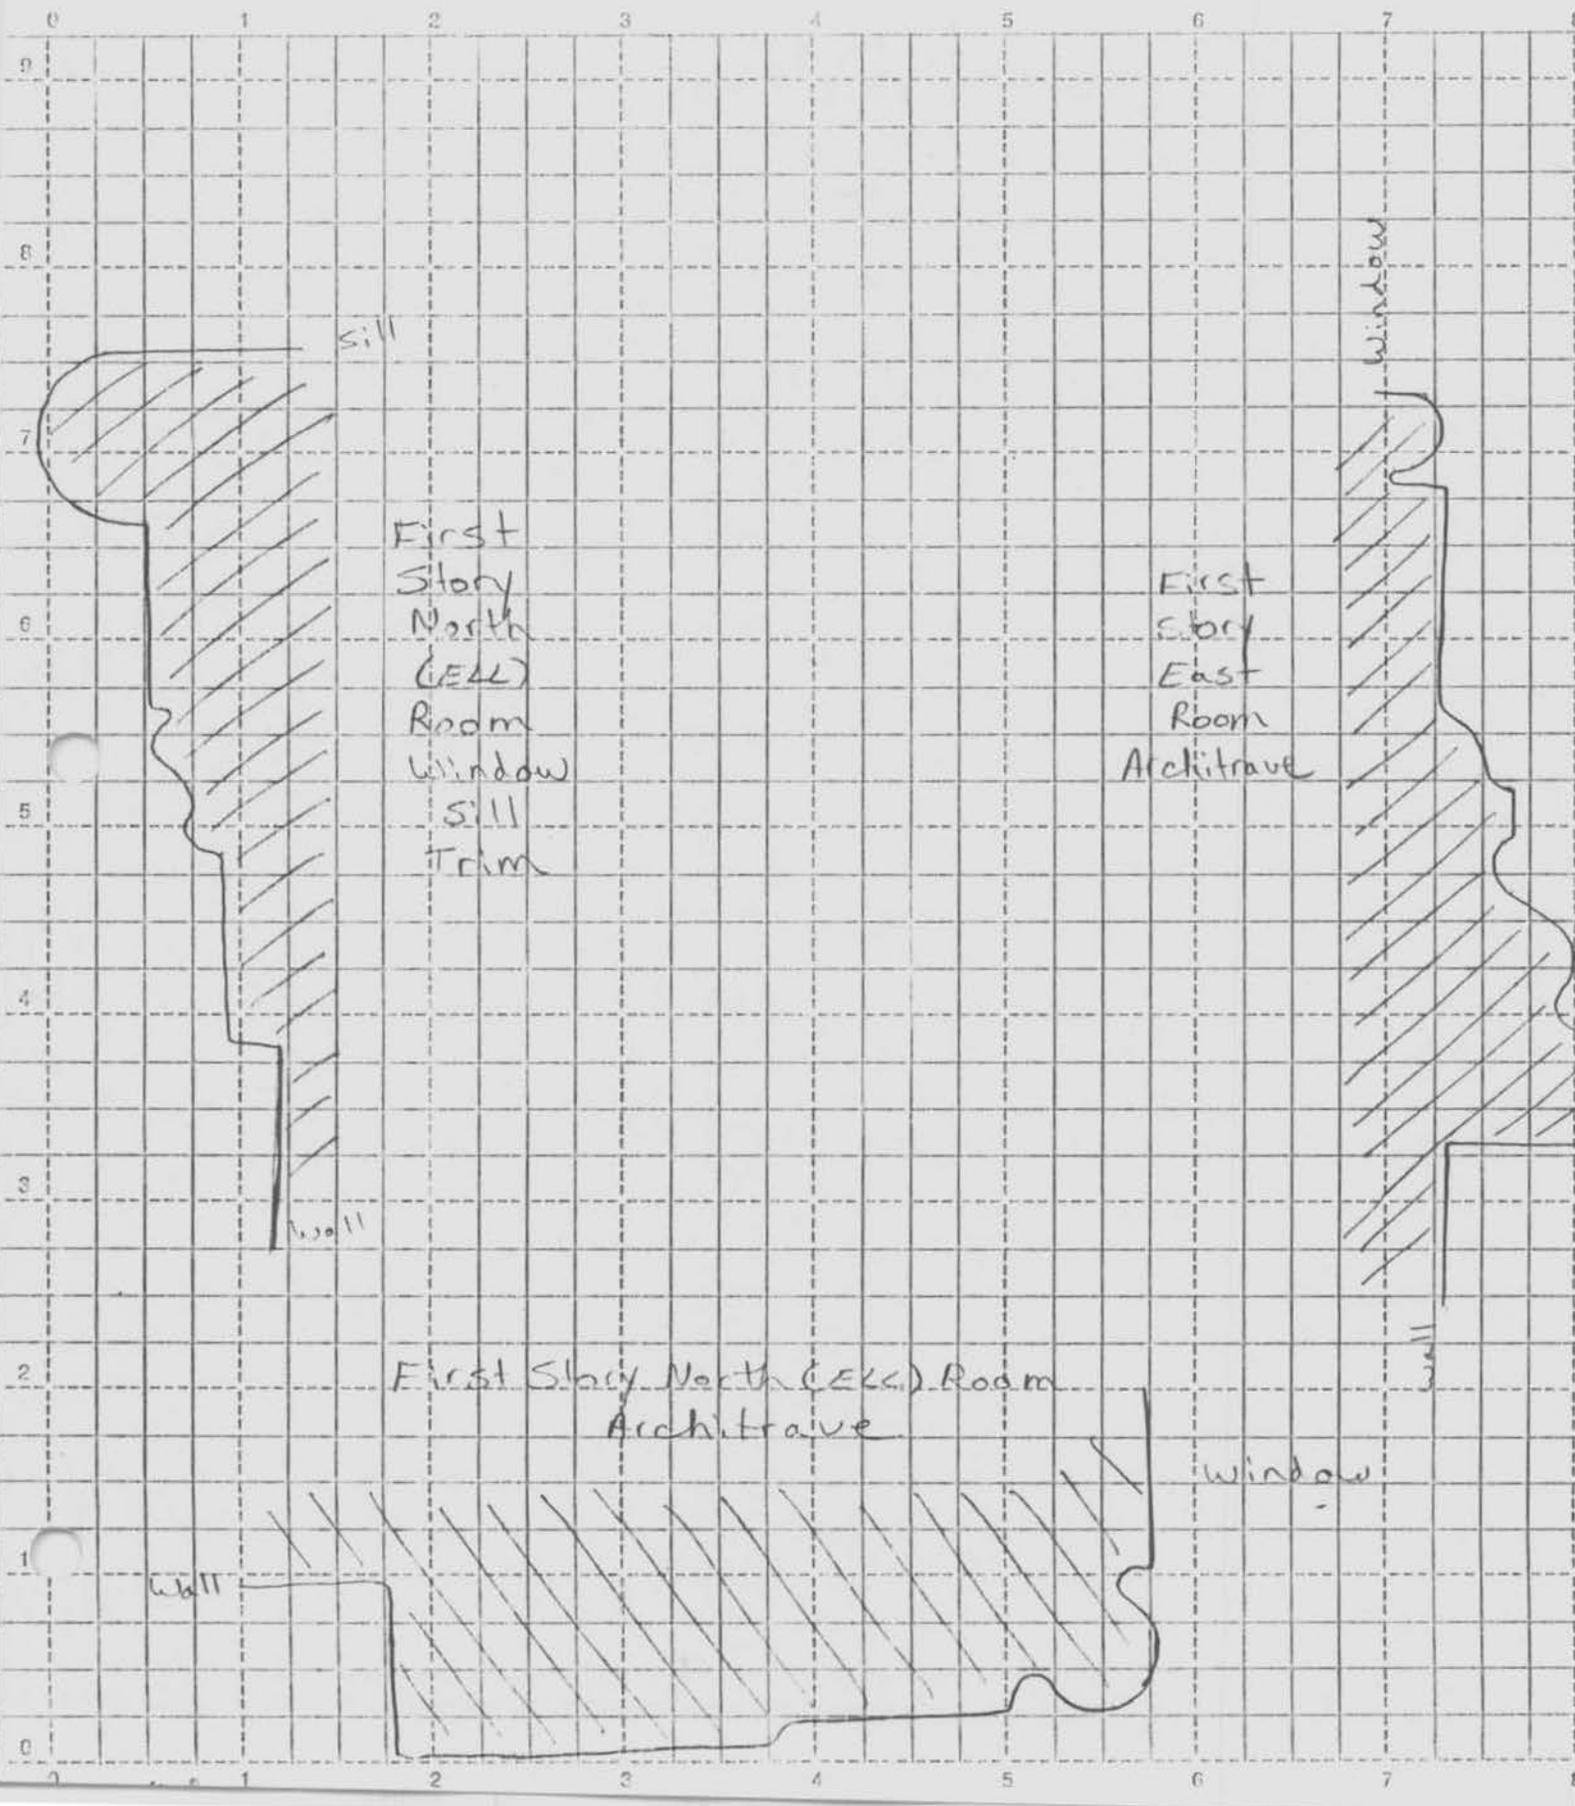
First
Story
North
(ELL)
Room
Window
Sill
Trim

First
Story
East
Room
Architrave

The ell room has a fireplace centered on the north wall. The front of the fireplace has been cased in a new brick veneer wall. The brick firebox has splayed jambs. The room has plain baseboards, and the architraves on the doors and windows match those found in the landings. The doors have plain cast iron rim locks with mineral knobs. The trim underneath the window sills has a small ogee and bevel in the center. There is linoleum on the floors, and there is a typical six-panel door that leads to the cellar stairs. The north elevation door to the outside is a typical six-panel door on the interior, with a plain cast iron rim lock and a porcelain knob. On the east elevation are two doors that to the south leads to the east room. It has four panels with sunk fields and ovolo panel moulds. The architrave matches those on the rest of the ell, and the door has a two-light transom. The doorway to the north of this one was originally an exterior door, but the porch to the east has now been enclosed. It is a typical six-panel door with a three-light transom, has a typical architrave, but has a mortised lock with a brass knob. Both of the sashes have spring latches on the top and bottom.

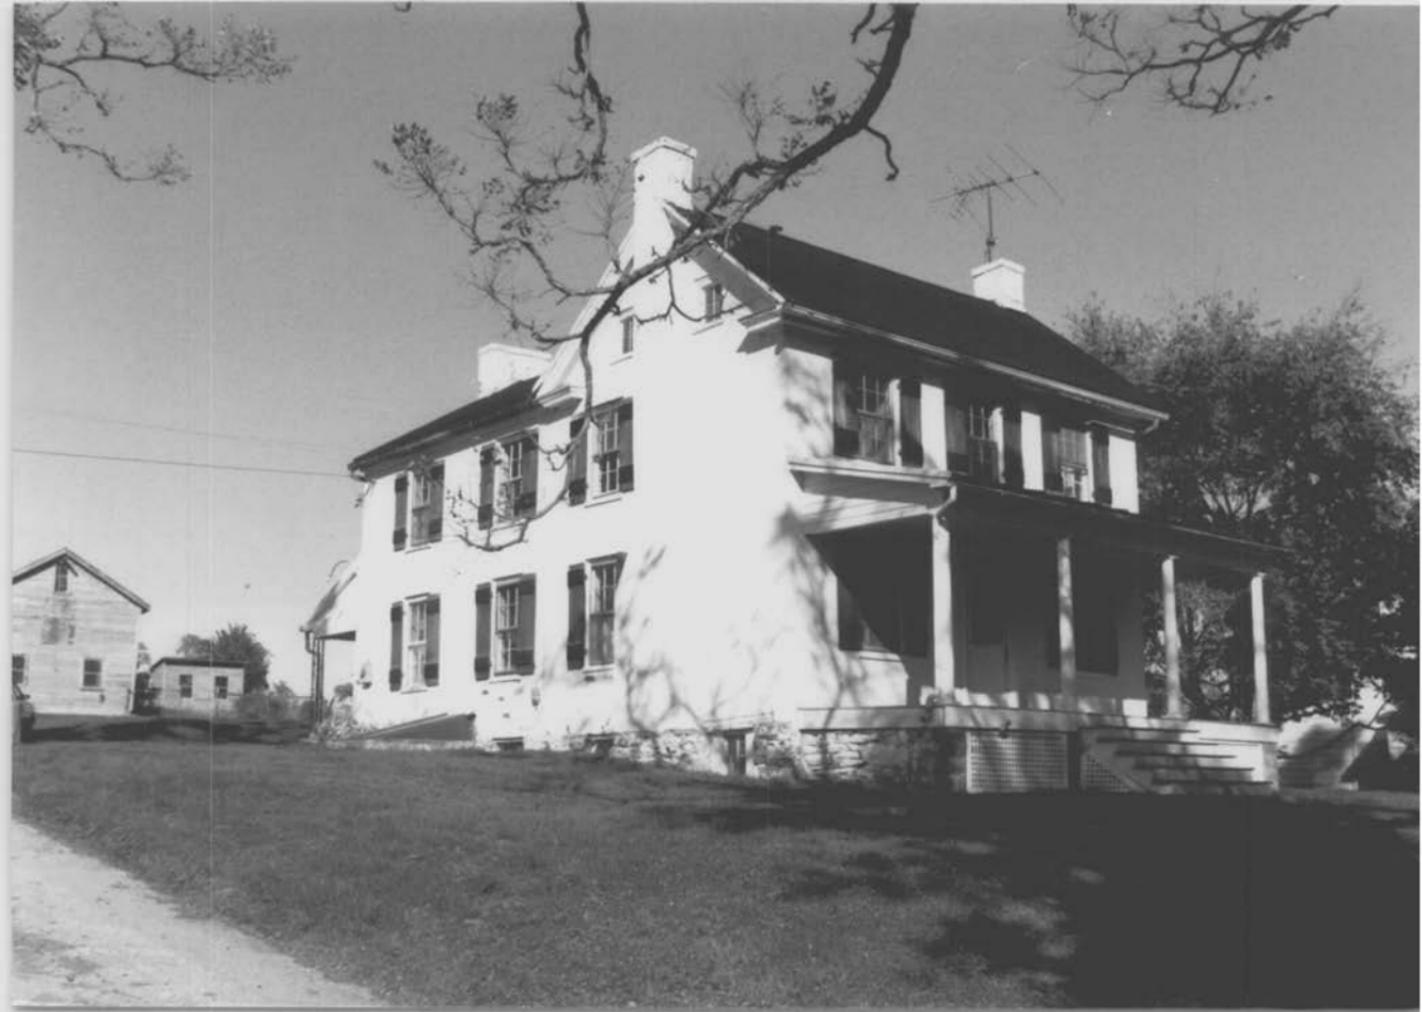
14

Neg. Loc.: Maryland Historical Trust
House - west; south elevs.

The west elevation foundation has a one light sash set in a mortised-and-tenoned-and-pegged frame in the north bay. The south bay has a four-light sash set in an altered opening with a wood lintel. This may have once been a doorway to the cellar. The first story has 5-to-1 common bond brick, except on the exterior brick chimney, which is 7-to-1 common bond, and appears to have been added later. This chimney has a shoulder on both the north and south sides. The first story has a typical 6/6 sash in the north bay. The second story also has a 6/6 sash in the north bay, but this opening has no jack arch. The gable end has two four-light sash set in mortised-and-tenoned-and-pegged frames that have an ovolo backband and a wood sill. There is a header course above the window frame. The raking cornice has an ogee moulding identical to that on the south elevation.

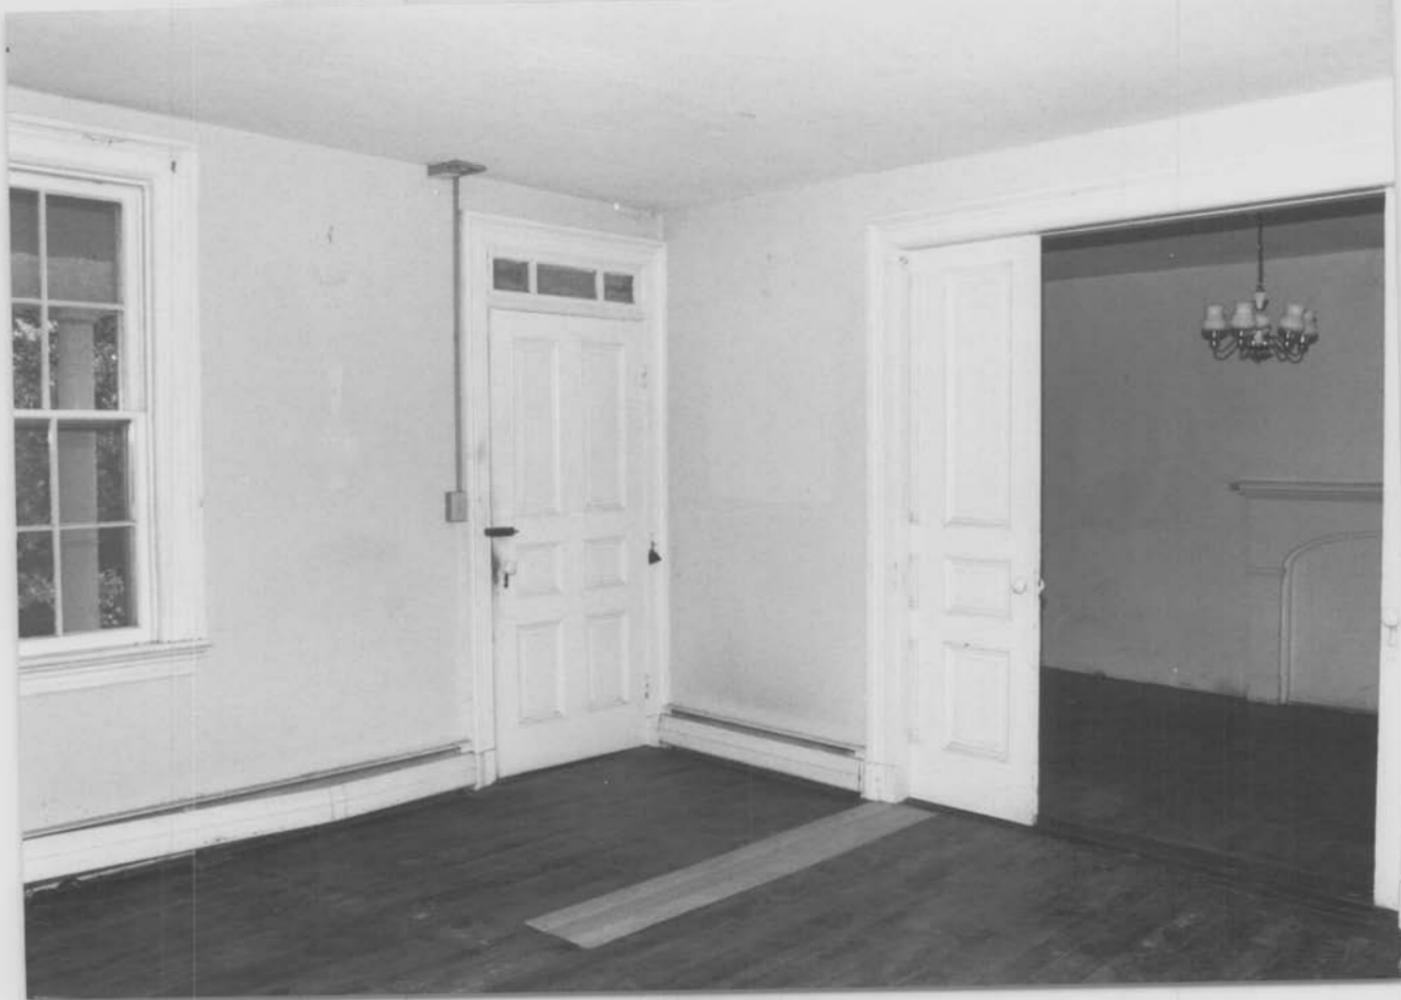
2/4

House - 1st story southeast room looking southeast

The first story has a two-room or hall-parlor plan with enclosed stairs along the south wall of the ell, one room in the ell, and one room added to the east side of the ell. The front door opens into the southeast room. This room has a random-width pine floor that runs east-west. The baseboard has a quirked ogee-and-bevel on top. The architraves have a beaded interior edge and a quirked ogee-and-bevel backband. Below the window sills is a quirked ogee-and-bevel moulding with a broken field below it. The front door has sunk fields with quirked ogee-and-bevel panel moulds. There are spring latches on the south window, top and bottom sash, and the east window, bottom sash only. Centered on the east wall is a fireplace with a semicircular-arched brick opening and splayed jambs with traces of plaster. There are also traces of striping on the brick surround, but it is not clear which treatment preceded the other. The brick hearth was probably rebuilt. There is a narrow, but thick, metal lintel supporting the brick arch. The wood mantel has plain pilaster strips with jigsawn applied trim at the capitals, and a quirked Greek ovolo and bead. The frieze is plain, and the bed mould has a Greek ovolo with a cavetto below it. There is a typical six-panel door on the north wall to the landing at the bottom of the stairs. This door has square panels in the center. The panels have sunk fields with quirked ogee-and-bevel panel moulds on both sides. It is hung on plain cast iron butt hinges, and has a cast iron rim lock with a porcelain knob. On the west is a wide opening with typical architrave and double pocket doors that are identical to the typical six-panel doors throughout the house. The pocket doors have white porcelain knobs and run on a metal track fastened to the threshold on the floor.

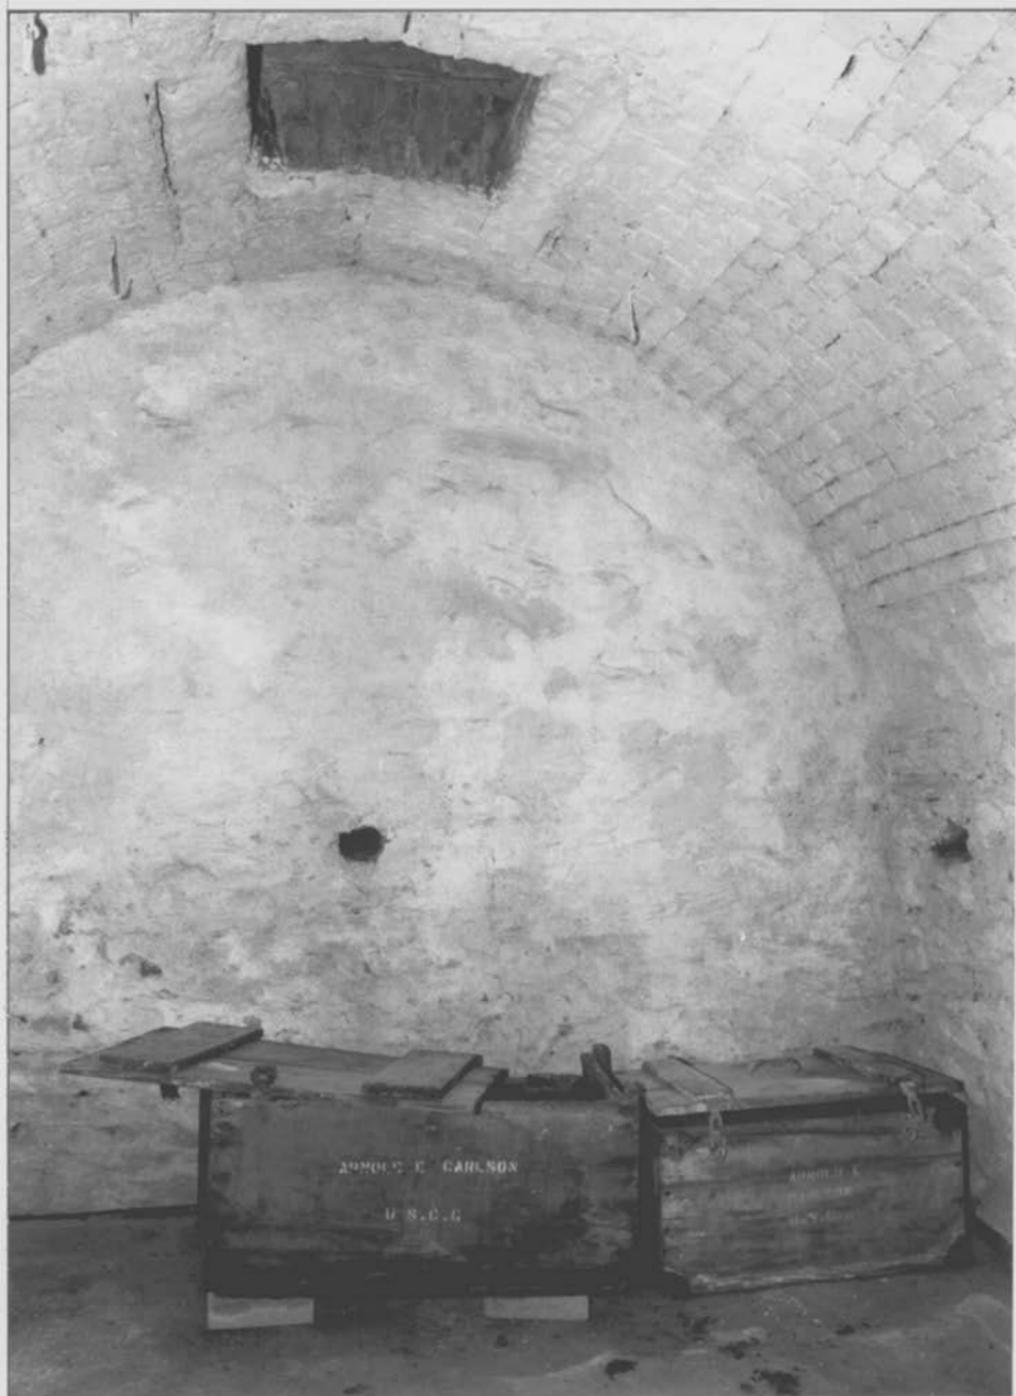
3/4

Neg. Loc.: Maryland Historical Trust
ground cellar

through the floor of the ell cellar to a ground cellar. The ground cellar has rubble stone walls with a brick barrel vault. The vault has small holes on the inside and the rear or east wall, possibly for horizontal supports that held shelves. There are three metal hooks hanging from the ceiling on each side. The east end ceiling has an approximately 19-inch square vent opening that goes up to above ground level. It is now closed off because there is an addition above it.
