Morgan Run NEA

CARR-1679

Carroll County, Maryland

Maryland Inventory of Historic Properties Form

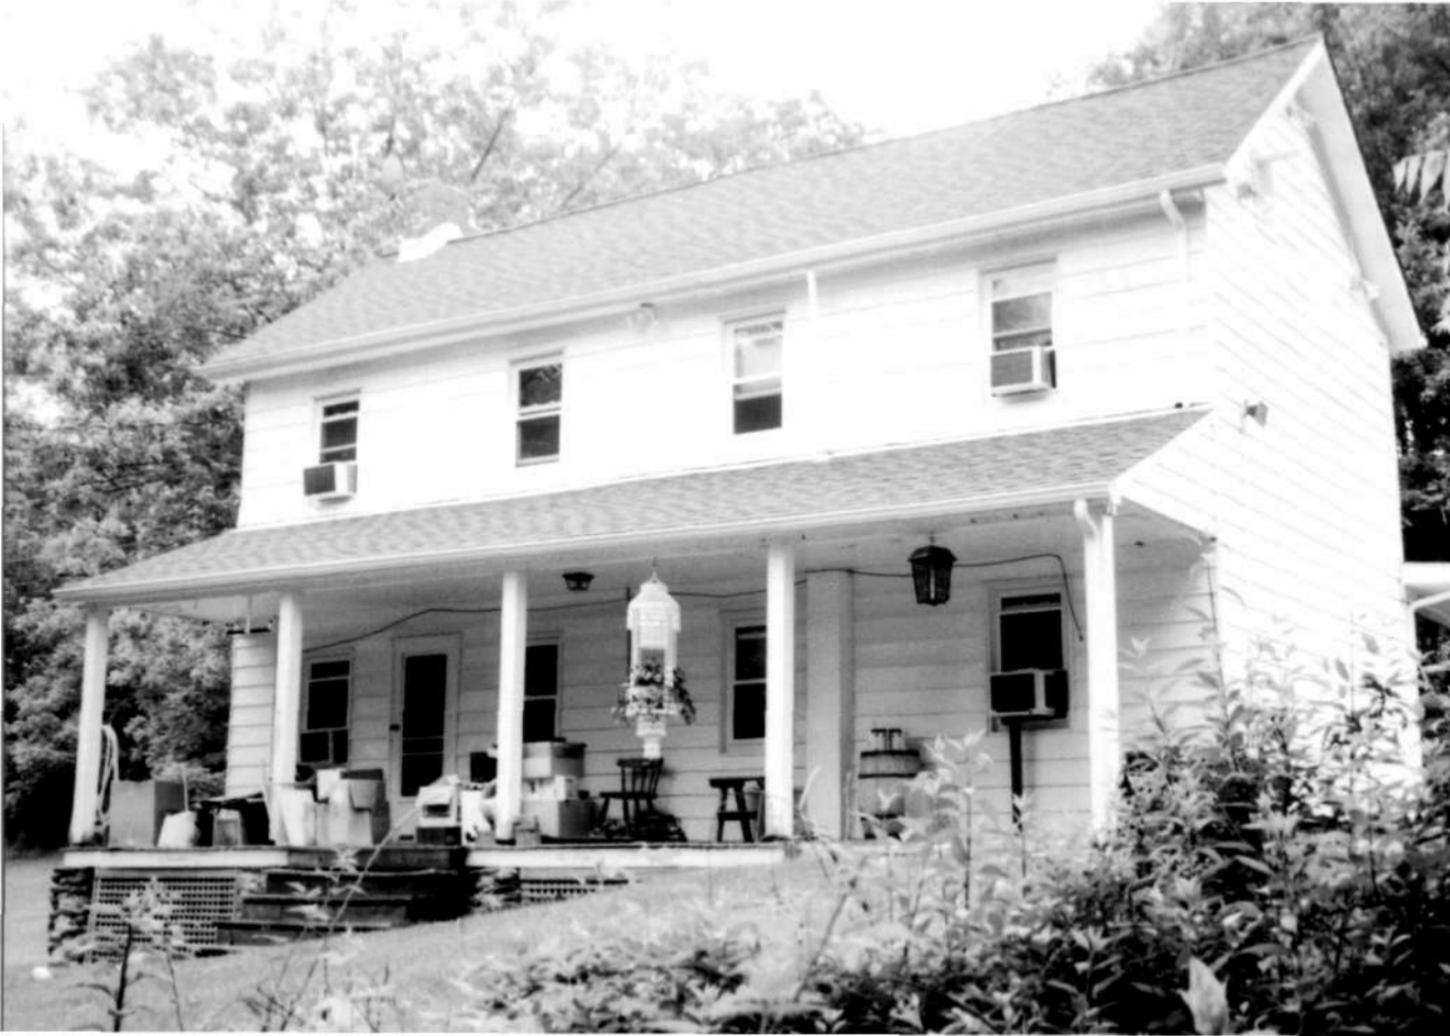
2/25

The L-shaped dwelling faces south and consists of a two-story main block with a one-story rear wing extending from the western half of the rear elevation. Both sections have gable roofs. The main block has five bays on the first story, four bays on the second story, and a single-pile plan. Evidence observed in the attic and documented in the 1979 MIHP form suggests that the main block was built in two periods, with an original east half that was expanded to the west. The form reports circular-sawn roof rafters and supporting members, suggesting that either the original house was built after approximately 1840 or that a new roof was constructed over the entire main block after that date. The house was most likely expanded after George Barnes purchased the property sometime between 1862, when Isaac Kelly, an African American, was reported as the resident on the property, and 1877, when Barnes was recorded to be living there (Martenet 1862; Lake 1877).

The two-story main block rests on a coursed foundation of thin stone slabs. The roof is sheathed in asphalt shingles. Vinyl siding was installed in 1980 across the front (south) and east elevations; the rear (north) and west elevations are clad with horizontal wood siding. A metal cornice covers the eave. An interior brick chimney rises from the roof ridge at the west gable; an exterior concrete-block chimney is located behind the brick chimney. The 1979 MIHP form reports two interior, gable-end brick chimneys; the east chimney has been removed. Gable returns reported in the form also have been removed. The MIHP form documents the house as having six bays with an entry in the second and fifth bays. The fifth bay is no longer functional, leaving the house with an off-center single entry on the front elevation. Although door details were not visible, the detailed maintenance inventory indicates the installment of a wood replacement door in 1960. One-over-one-light, double-hung, metal-sash windows were installed in 2002 (MdDNR 2002c). A one-light casement window is located in each gable. A full-width, shed-roof porch supported by square wood posts spans the front elevation. The wood porch floor rests on stone piers.

The one-story rear wing has a stone foundation, horizontal wood siding on the east and west elevations, and vinyl siding on the rear (north) elevation. The roof is sheathed in asphalt shingles. The wing features a shed-roof addition along the west elevation and a shed-roof porch with a concrete-slab floor along the east elevation. The wing's east and west elevations house exterior wood replacement doors. The house is in good condition, despite paint failure on some areas of the wood siding and on the porch. The porch foundation exhibits cracks and eroded mortar.

Barnes House CARR-582,
Selection

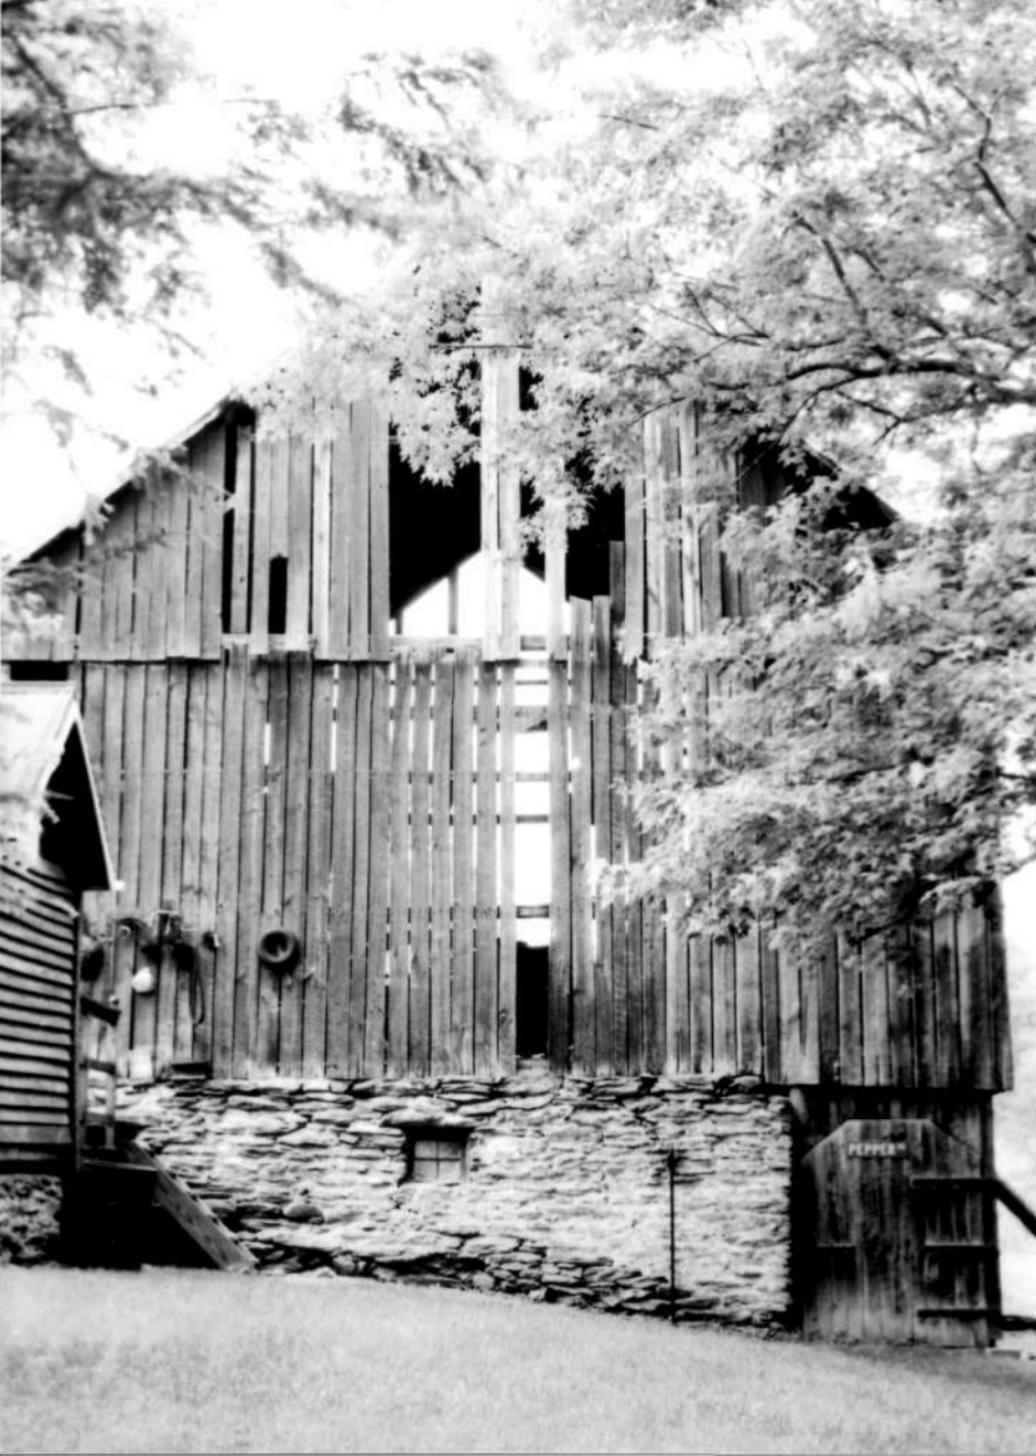
4/25

The wood-frame bank barn follows the form of a standard Pennsylvania Barn, with a symmetrical gable roof and a projecting forebay (Ensminger 1992:67). Framing structure suggests that the barn was constructed in the third quarter of the nineteenth century. The barn features wood post-and-beam construction, with mortise-and-tenon joinery. The rectangular building rests on a random-rubble fieldstone foundation. Exterior walls are clad with vertical board siding. The roof is sheathed in pressed metal shingles. Wood double doors are centered on the bank elevation of the barn. Square ventilation openings are located on the elevation opposite the bank elevation. Livestock space is present below the main story. The barn is in fair condition. The foundation mortar is cracking and eroding in some locations. Much of the vertical wood siding is missing. The roof is rusting.

Barnes Bank barn CARR-582,
S elevation

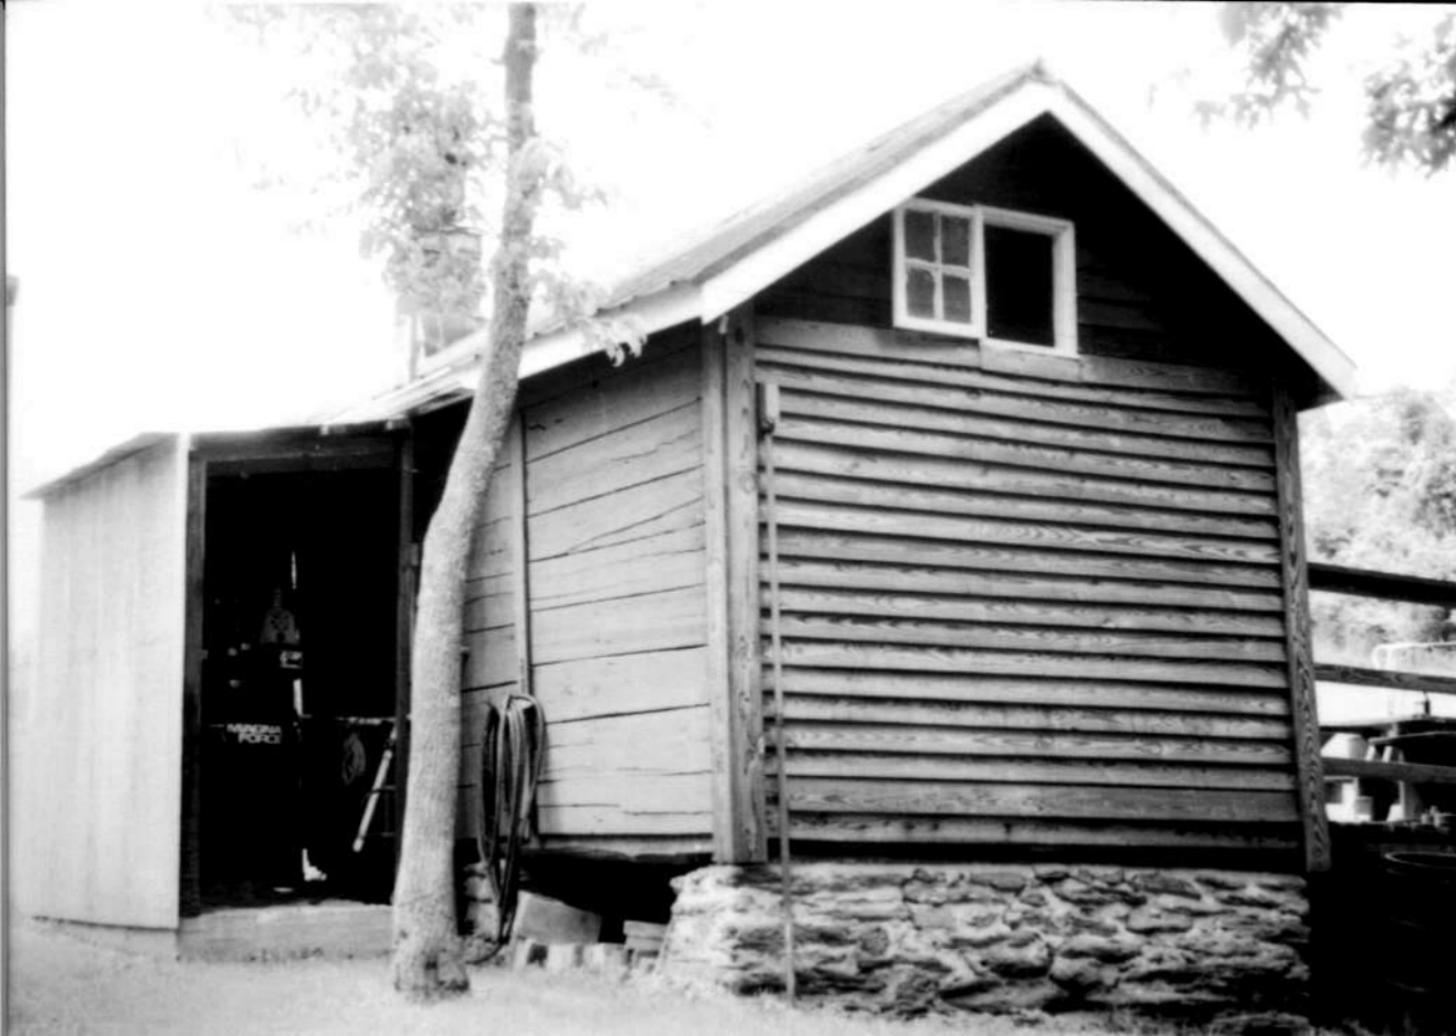
5/25

The tool shed is located near the bank barn and faces north. The one-story, wood-frame, gable-roofed building consists of a rectangular main block with a small, shed-roofed addition attached to the western half of the rear (south) elevation. The main block rests on three evenly spaced, irregularly-coursed stone piers that run the width of the building. The stonework of the foundation is similar to that of the bank barn, suggesting that the tool shed also was constructed in the third quarter of the nineteenth century. Hewn oak joists support the floor. Exterior walls are clad with beveled wood siding and flush horizontal wood siding. The roof was sheathed in standing-seam metal in 1960 (MdDNR 2002c). An off-center, exterior concrete-block chimney rises on the west gable elevation. A board-and-batten door is centered on the front (north) elevation. A wood deck was added to this elevation in 1988 (MdDNR 2002c). A wood-frame, four-light casement window is located in each gable. A corrugated-steel addition, resting on a concrete-slab foundation, is attached to the western half of the rear elevation. The addition, which houses an air compressor, is open on the east side. The tool shed is in good condition. Minimal erosion has occurred on the stone foundation piers.

Barnes Tool Shed CARR-582
SE corner

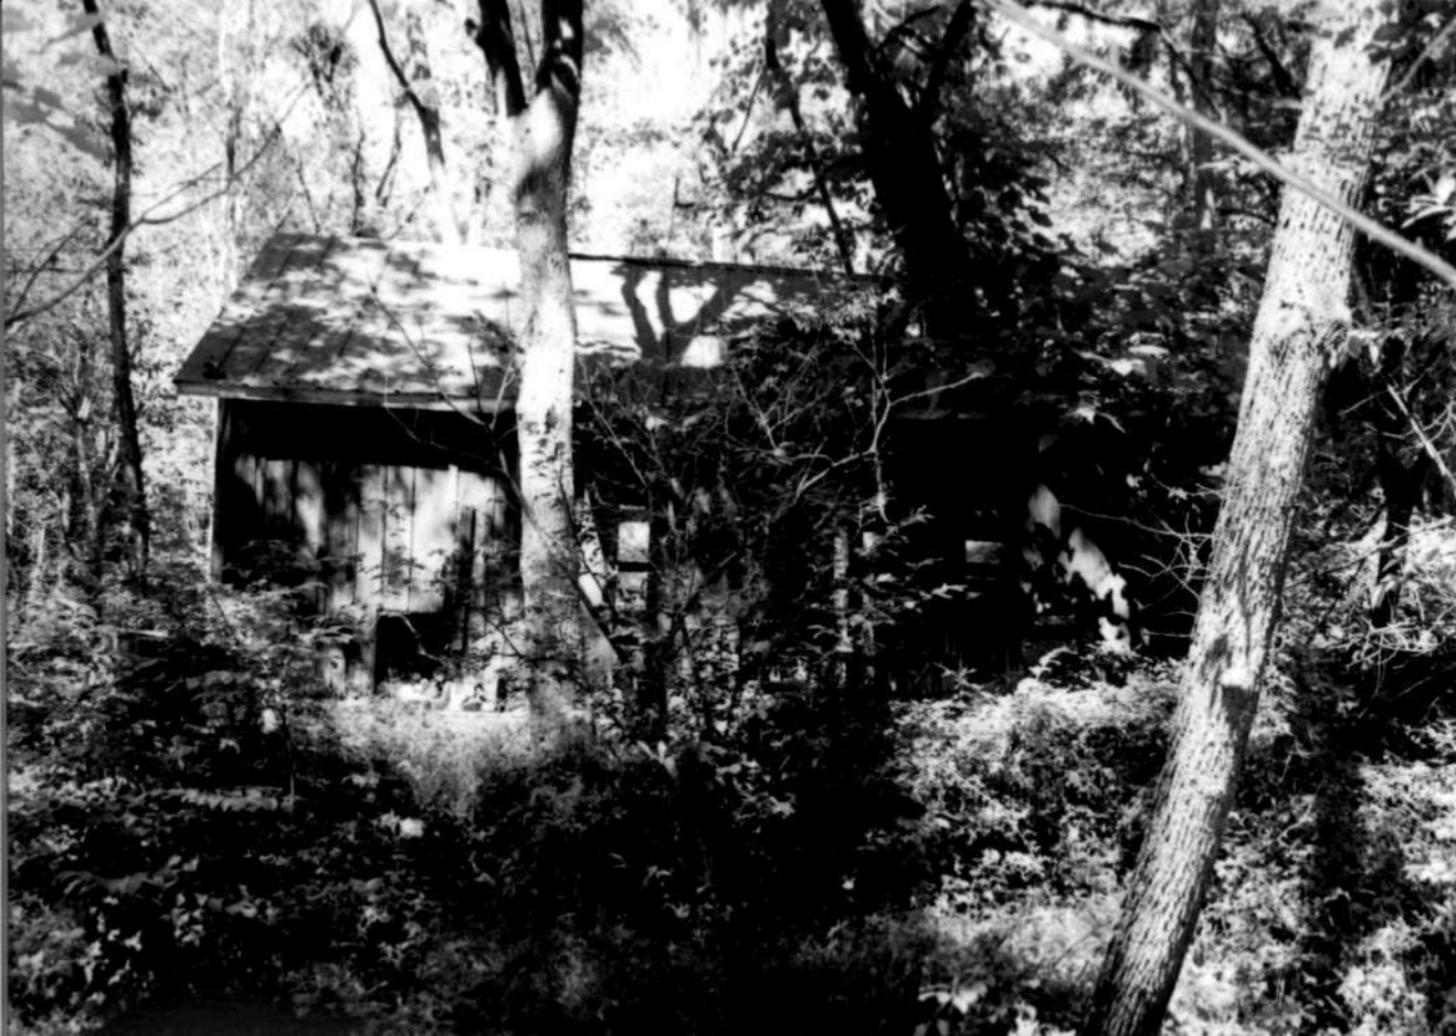
6/25

The small barn is located northwest of the milking parlor, on the north side of the stream. Materials and construction technique suggest that the barn was constructed in the late-nineteenth or early-twentieth century. The rectangular, wood-frame building has a gable roof. The barn rests on a fieldstone foundation. A fieldstone well is present beneath the wood plank floor. Round timbers with bark serve as floor joists. The barn features circular-sawn structural members with mortise-and-tenon joints. The exterior walls are clad with vertical wood planks. The roof is sheathed in standing-seam metal. A date-inscribed concrete block was found on the ground by the north elevation of the barn, but the origin of the date block is unclear. The inscribed date on the block is 1938, which appears to be late for this barn; the date block likely came from another building. The barn is in fair condition.

Berger Small Barn,
S elev

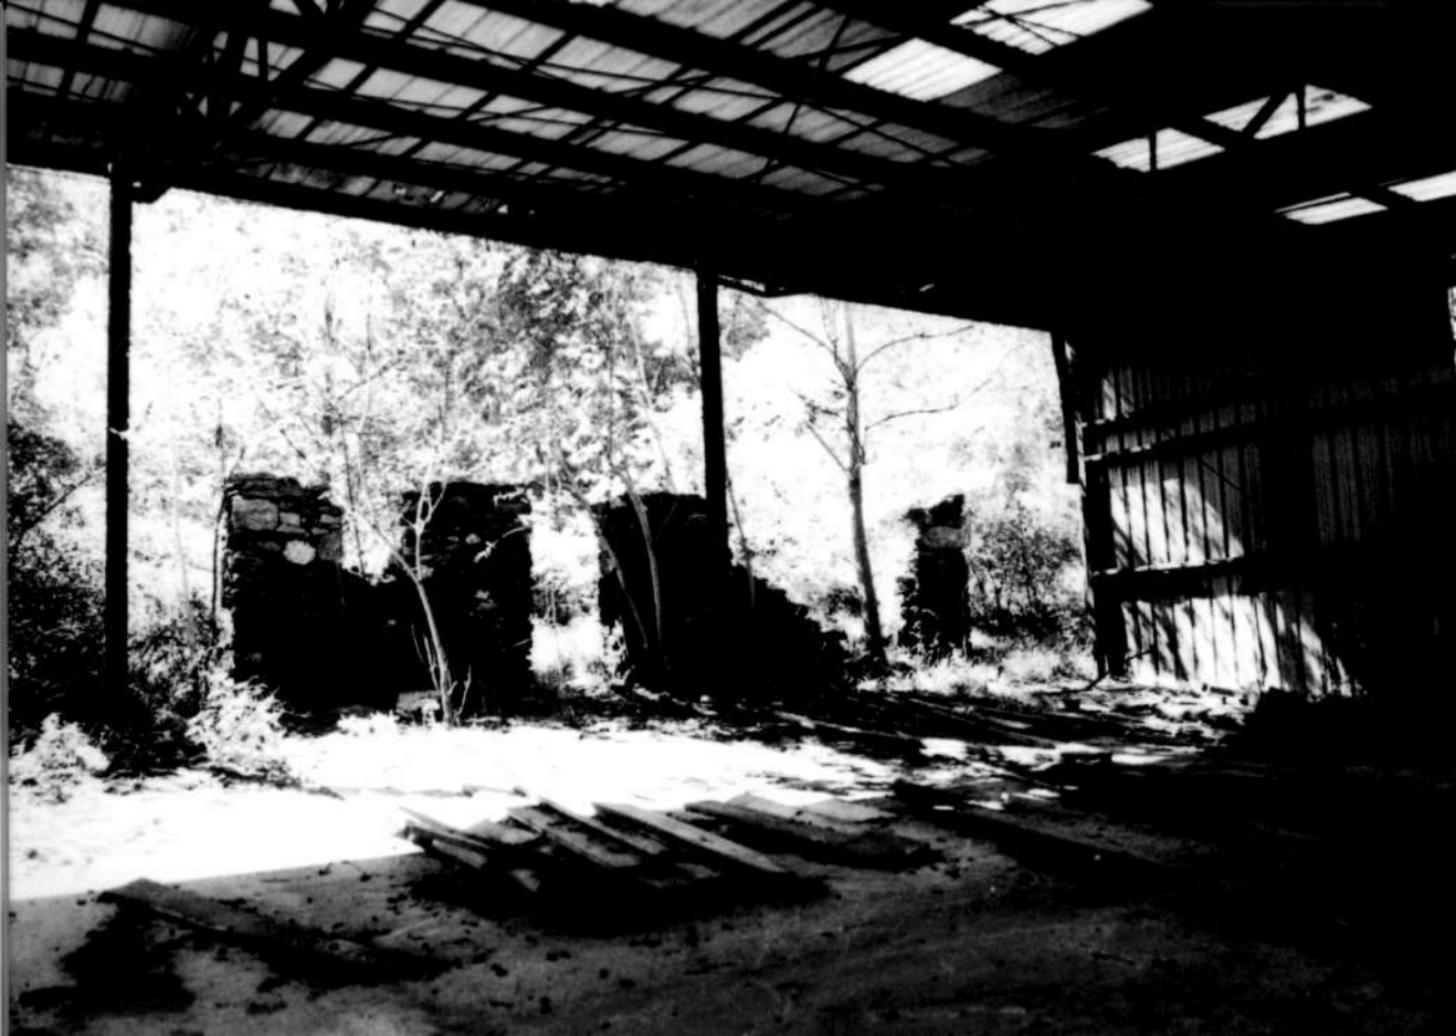
7/25

concrete-block foundation. The concrete-slab floor slopes from south (highest point) to north (lowest point). The shed is constructed with steel posts and beams. The north elevation is open, and several half-height utility poles rise from the edge of the floor. The east and west elevations are enclosed by walls clad with ribbed metal siding that feature off-center, wide door openings. The south elevation adjoins stone foundation walls that are remnants of the bank barn. (See description below.) The roof is sheathed in corrugated metal. The building is in fair condition. Cracks were noted in the concrete floor. The ribbed metal siding is missing in some locations, and the color is deteriorating. The steel posts and beams are rusted.

Remnants of the bank barn foundation are adjacent to the south elevation of the loafing shed. The 1984 MIHP form describes the mid-to-late nineteenth century bank barn as a wood-frame building with a gable roof. The forebay was located on the north elevation. Much of the fieldstone foundation is still present.

Bowers Loafing Shed + Barn foundation
CARR-583, East elevation

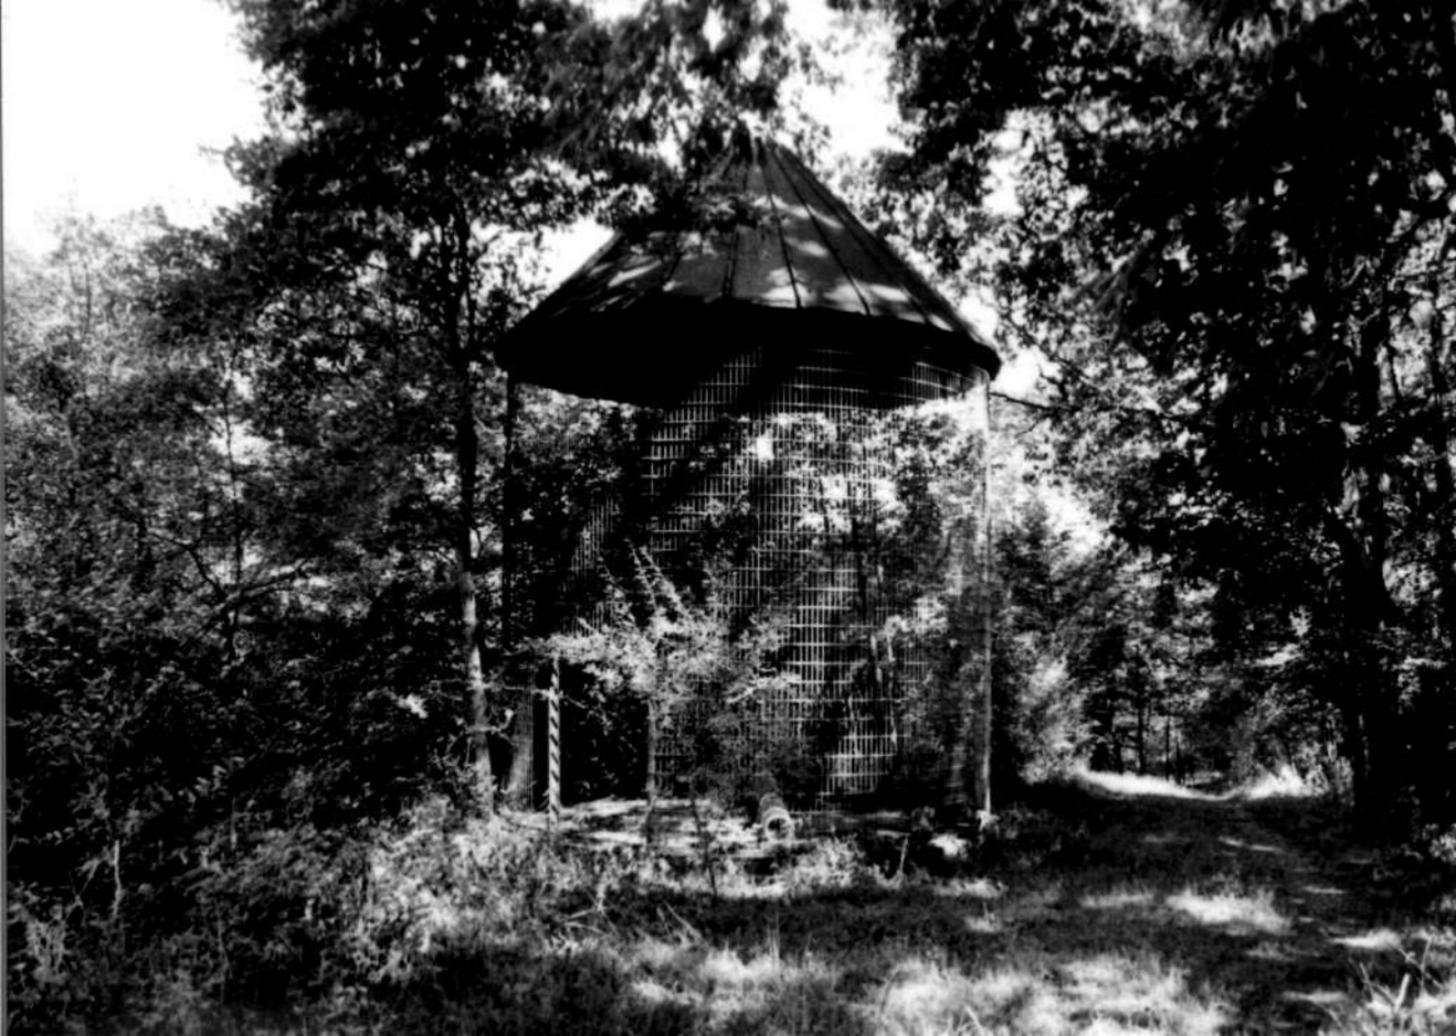
8/25

The corncrib stands east of the loafing shed, across the former road. Based on his knowledge of the property, Ranger Frank Ryan estimated that the corncrib was constructed ca. 1950 (Ryan personal communication 16 September 2003). The cylindrical structure consists of a concrete-slab floor, wire walls, and a conical roof sheathed in standing-seam metal. There is one door opening with no door present. The roof has a circular opening at the peak and an oval opening on the side for purposes of loading corn. The structure is in fair condition. The wire walls are rusting.

Bowers cornerib CARR-583,
sw elevation

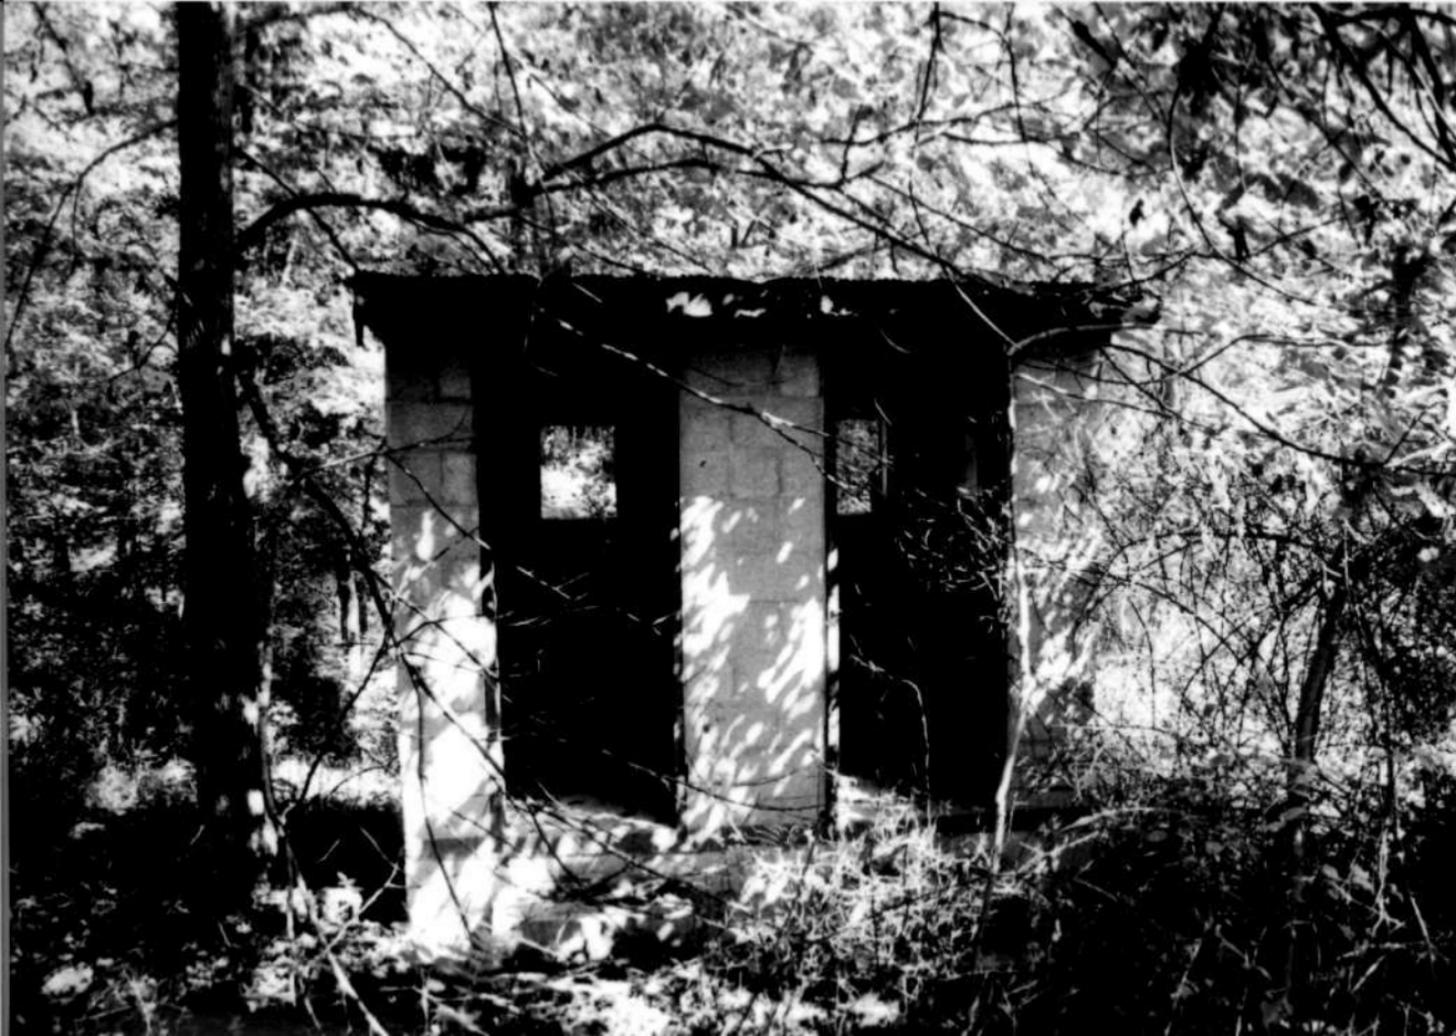
9/25

The privy is located west of the loafing shed and north of the house foundation. Materials suggest that the privy was constructed in the early to mid-twentieth century. The privy faces southwest. The one-story, concrete-block building has a shed roof sheathed in corrugated metal. Two doorways accessed by concrete steps are located on the front (southwest) elevation. The wood doors have five panels. The rear elevation has two small window openings. On the interior, wainscoting has been applied under the seats. The privy is in fair condition. Vegetation surrounds the building, and the roof is torn.

Bowers Pkwy CARR-583,
SW elevation

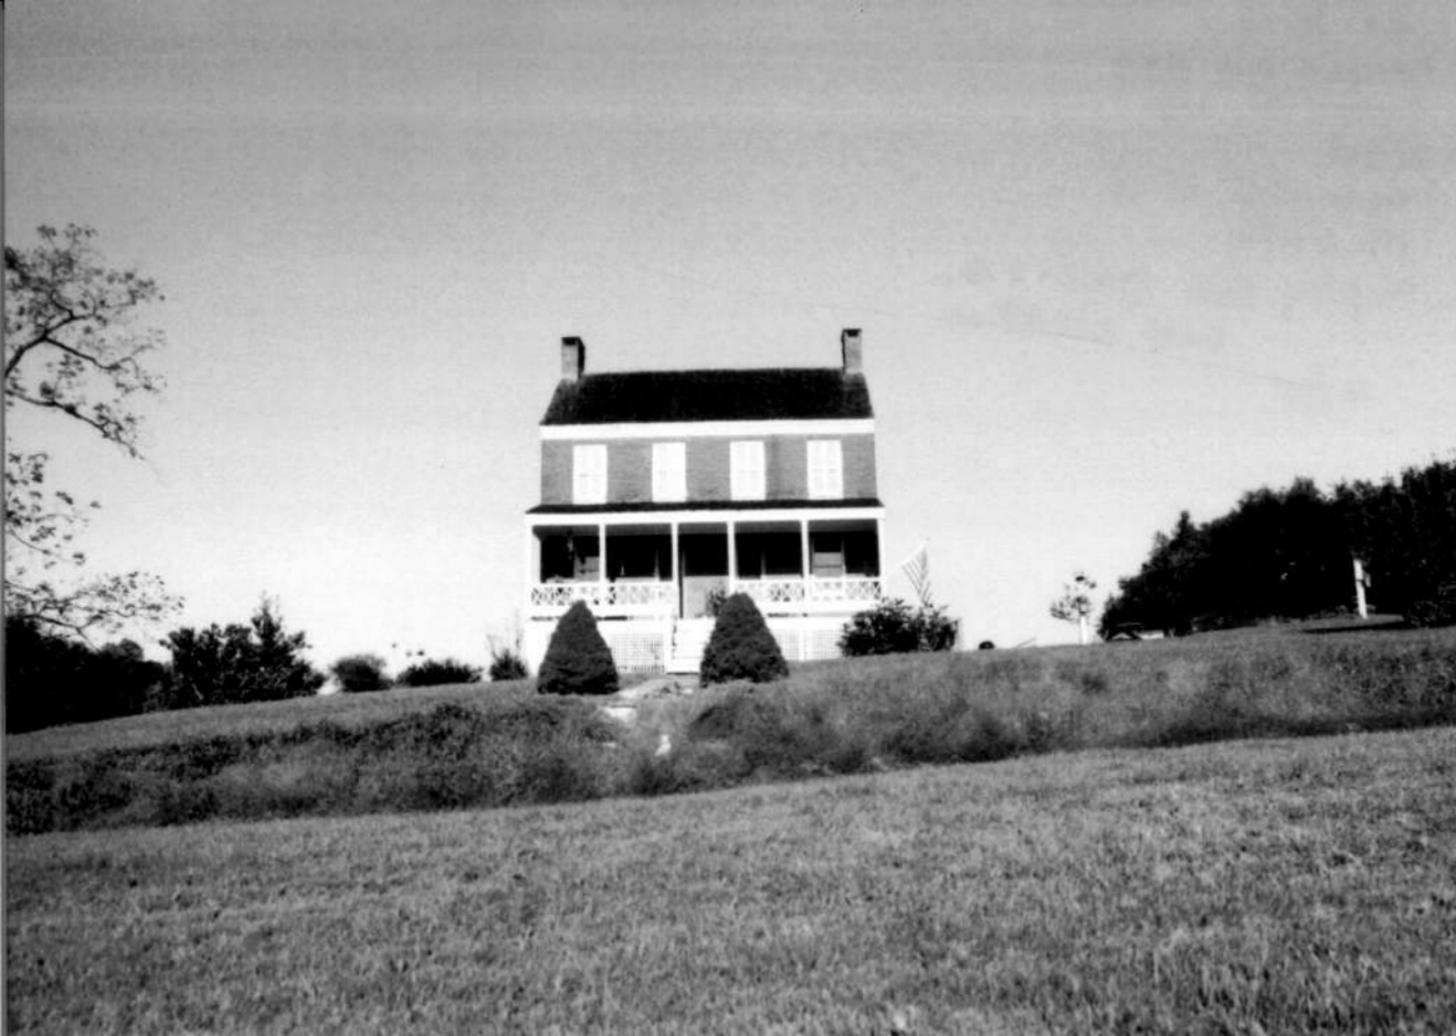
10/25

The main block rests on a rubble stone foundation; the basement is visible above ground on the front (east) and south elevations. The brick walls exhibit a stretcher bond pattern on the front elevation and 7:1 common bond on all other elevations. The roof of the main block is sheathed in wood shingles, which were applied in 1986 (MdDNR 2002c). A flush brick chimney rises on each gable elevation. The gables have slightly tapered fascia boards that are narrow at the roof ridge and wider at the bottom edges. The front and rear elevations of the main block feature a three-step corbelled brick cornice. The front elevation has symmetrical fenestration with two first-story main entrances located in the two center bays and one window in each end bay. Each four-panel wood door is hung within paneled recesses. The south door has a three-light transom, and the north door has a single-light transom. Windows are wood-frame, six-over-six-light, double-hung sash units with flat gauged arches. Closed louvered wood shutters concealed the four second-story windows on the front elevation at the time of inspection. The first and second stories of the gable elevations have two wood-frame, six-over-six-light, double-hung sash windows with flat gauged arches and louvered wood shutters. Two wood-frame, four-pane windows are present in each gable. The full-width front porch has a shed roof that is supported by square wood columns. The porch has a wood railing designed in an X pattern and a wood floor. Porch gables are clad with wood drop siding. A brick front walk leads to central wood porch steps. The steps have handrails with wood posts and finials at the base. Wood lattice encloses the space beneath the porch. A central stone wall divides this space. The south half of the space beneath the porch features a wood-frame, six-over-three-light sash in the basement wall. The north half has one window that is covered in plywood.

The rear wing of the house rests on a rubble stone foundation. The brick walls are laid in a common-bond pattern. The roof is sheathed in wood shingles. A flush brick chimney rises on the rear (west) elevation. A two-story wood porch spans each side elevation. The first and second stories of each side elevation have one door and one wood-frame, six-over-six light, double-hung sash window with flat gauged arches. The west end of the south elevation is partially enclosed by a one-and-one-half-story wall clad with wood drop siding. The rear elevation has two wood-frame, four-pane windows. The house is in good condition. Paint failure was noted on the porches on the front and south elevations and on the windowsills on the south elevation. The wood floor of the first-story porch on the north elevation has rotted and is currently being replaced. Some wood shingles on the roof are loose.

Shipley Hse CARR-816,
East elevation

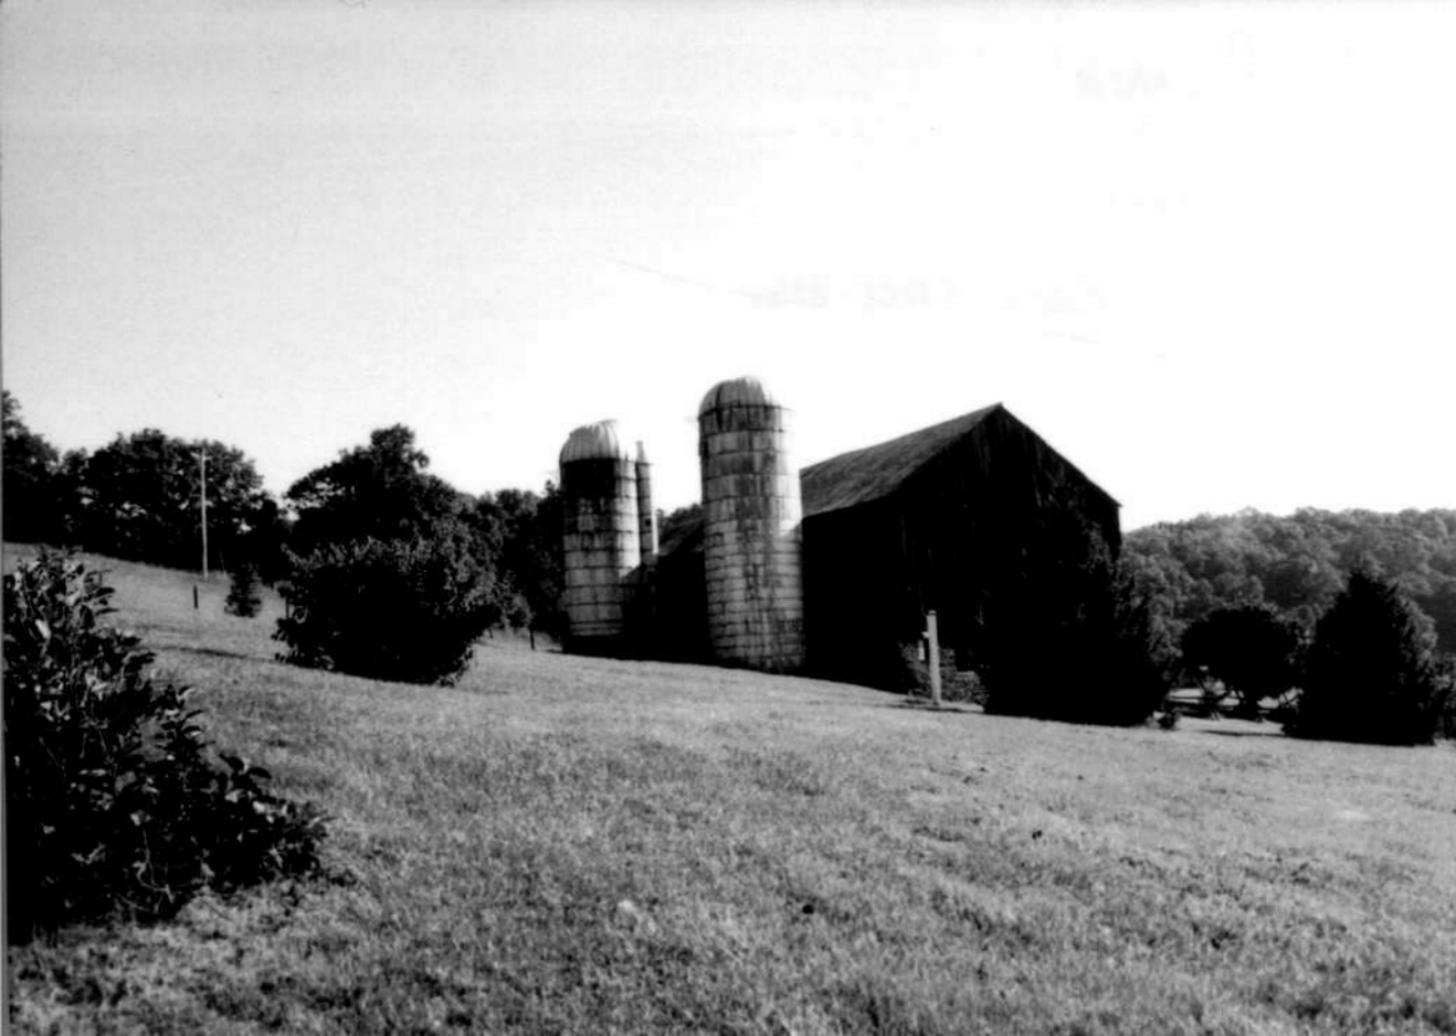
12/25

The wood-frame bank barn, located northeast of the dwelling, was built in the second half of the nineteenth century. According to Short's 1994 MIHP form, an 1866 tax assessment of the property recorded a wood-frame barn on the property, but it is not clear whether or not this was the present barn. A public-sale notice for the farmstead published in 1886 listed a large bank barn, which is likely the current barn. Short stated that the lower story of the bank barn was converted to a dairy operation in the 1930s. The barn rests on a stone foundation and has a gable roof. The west elevation is built into a bank. The foundation on the east elevation has been renovated and is now constructed of concrete block. The roof is sheathed in standing-seam metal. The building is clad in vertical, beaded wood siding. Eight metal-frame, four-light, fixed windows are found on the east elevation, and two are found on the south elevation. A barbed-wire fence prohibited access to the north elevation. Two wood-plank, sliding doors extend almost the width of the west elevation. A deteriorated, poured-concrete ramp leads to the doors. An arched opening is located on the south elevation; no door is present. The four door openings on the east elevation are enclosed with vertical beaded board. The barn is in fair condition. Lights are missing from some of the windows. The sliding doors are coming off the tracks. Missing and deteriorated wood boards, and rust on the metal roof, were noted.

Shupley Bank Barn CARR-816,
SW corner

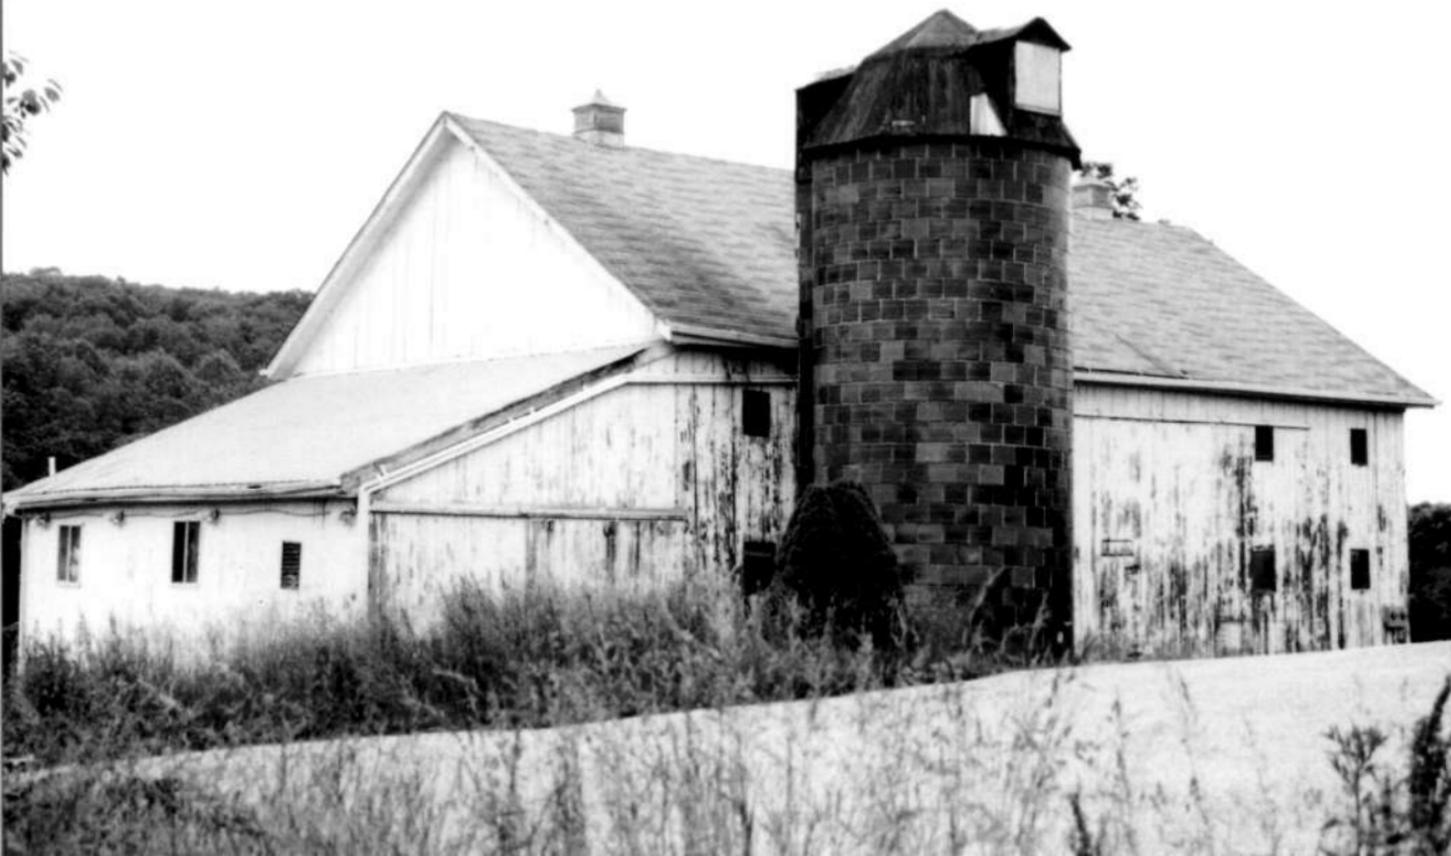
18/25

The wood-frame bank barn, located north of the house, stands on the edge of a bluff overlooking a valley. The barn was built ca. 1900, shortly following the construction of the house (Ryan personal communication 11 June 2003). The barn has a symmetrical gable roof. Shed-roof additions are appended to the north and south gable elevations. The building rests on a fieldstone foundation, which was veneered on the east elevation with stretcher-coursed brick in 1970 (MdDNR 2002c). The north, south, and west elevations are clad with vertical beaded wood siding; the east elevation is clad with flush horizontal wood siding. The roof is sheathed in composition roll roofing and is capped with three square, symmetrically set cupolas. The center cupola has a metal weathervane. A molded cornice board runs the length of the barn. Paired wood doors are centered on the east elevation, which also features four wood-frame, double-hung sash windows with slip sills. The south and west elevations have rectangular ventilation openings. The north addition is constructed of concrete block. The south addition rests on a concrete slab and is constructed of glass panes, set in simple wood frames. The roofs of both additions are sheathed in composition roll roofing. The barn is in good condition, although paint failure was noted. The lower level of the barn has been converted to office space.

DeWilde Barn, NW Corner

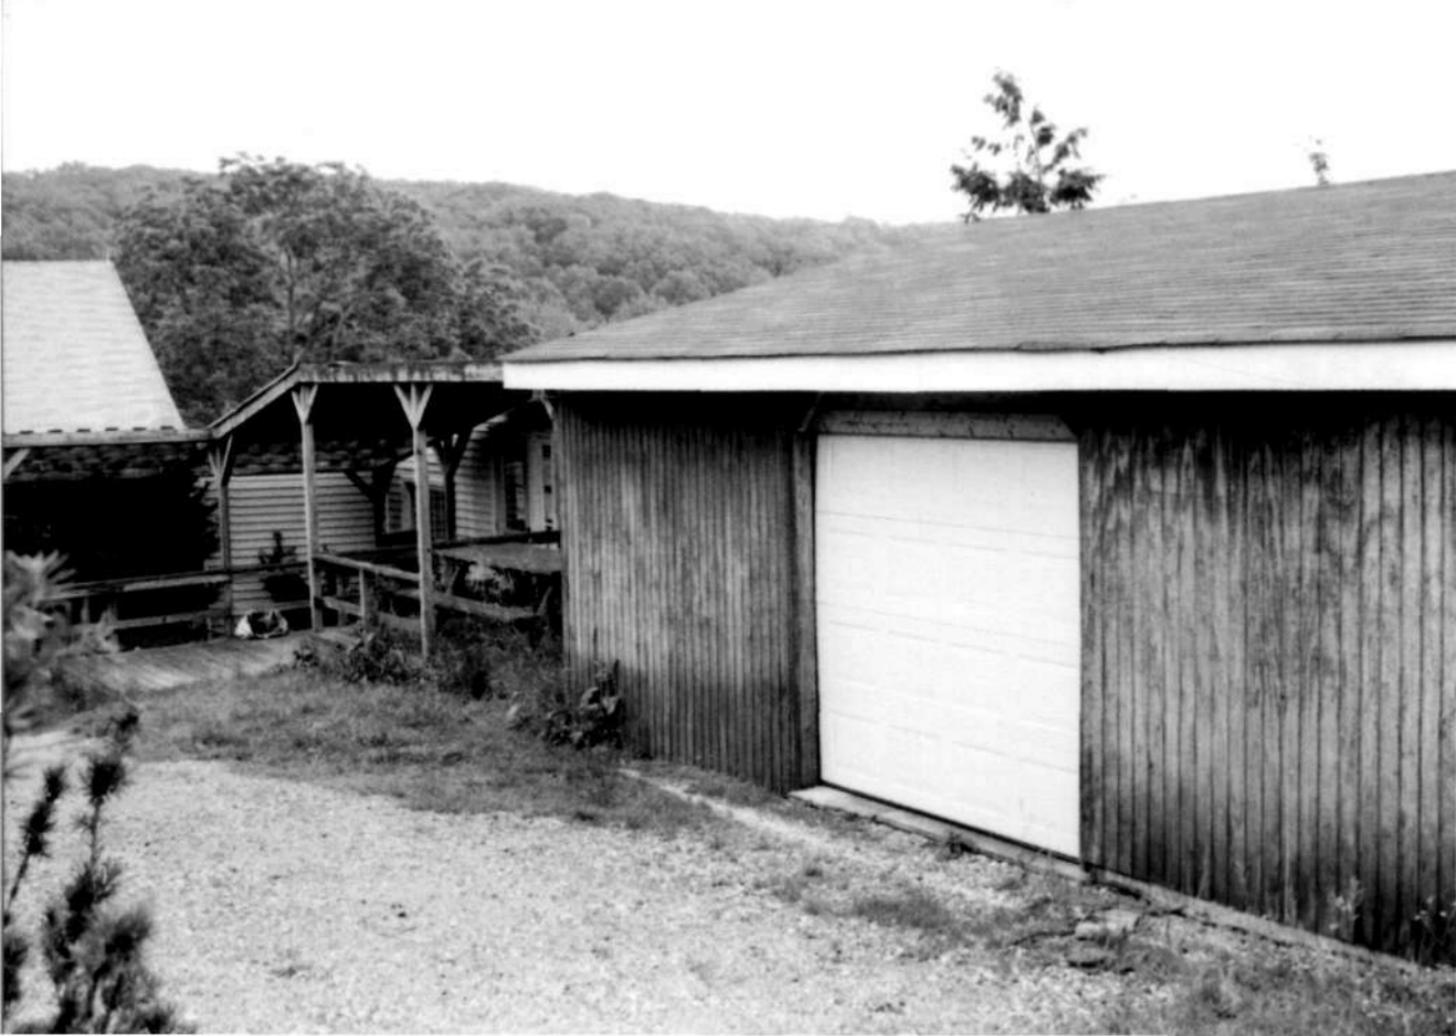
19/25

The office building is located west of the barn. The one-story building faces north and consists of an office section flanked by a trellis-covered porch on the east and a garage on the west. The office section has a low-pitched shed roof; the garage has a gable roof. The building was constructed ca. 1955 according to the detailed maintenance inventory (MdDNR 2002c). The building is clad with vinyl siding that conceals construction technique and foundation material. The roofs are sheathed in composition roll roofing, which was applied in 2001 (MdDNR 2002c). A wood-latticed pergola supported by square wood posts spans the front elevation of the central office section. The fenestration pattern is asymmetrical, with modern doors and windows. The office section features doors on the front (north) and rear (south) elevations and metal-frame, one-over-one-light, double-hung sash windows. The garage has a metal overhead door on the front elevation. A greenhouse was formerly attached to the rear of the garage. The building is in good condition and serves as a regional forestry office. The building formerly served as the office for the Greenway Gardens arboretum.

DeWilde Park Office, N. Elevation

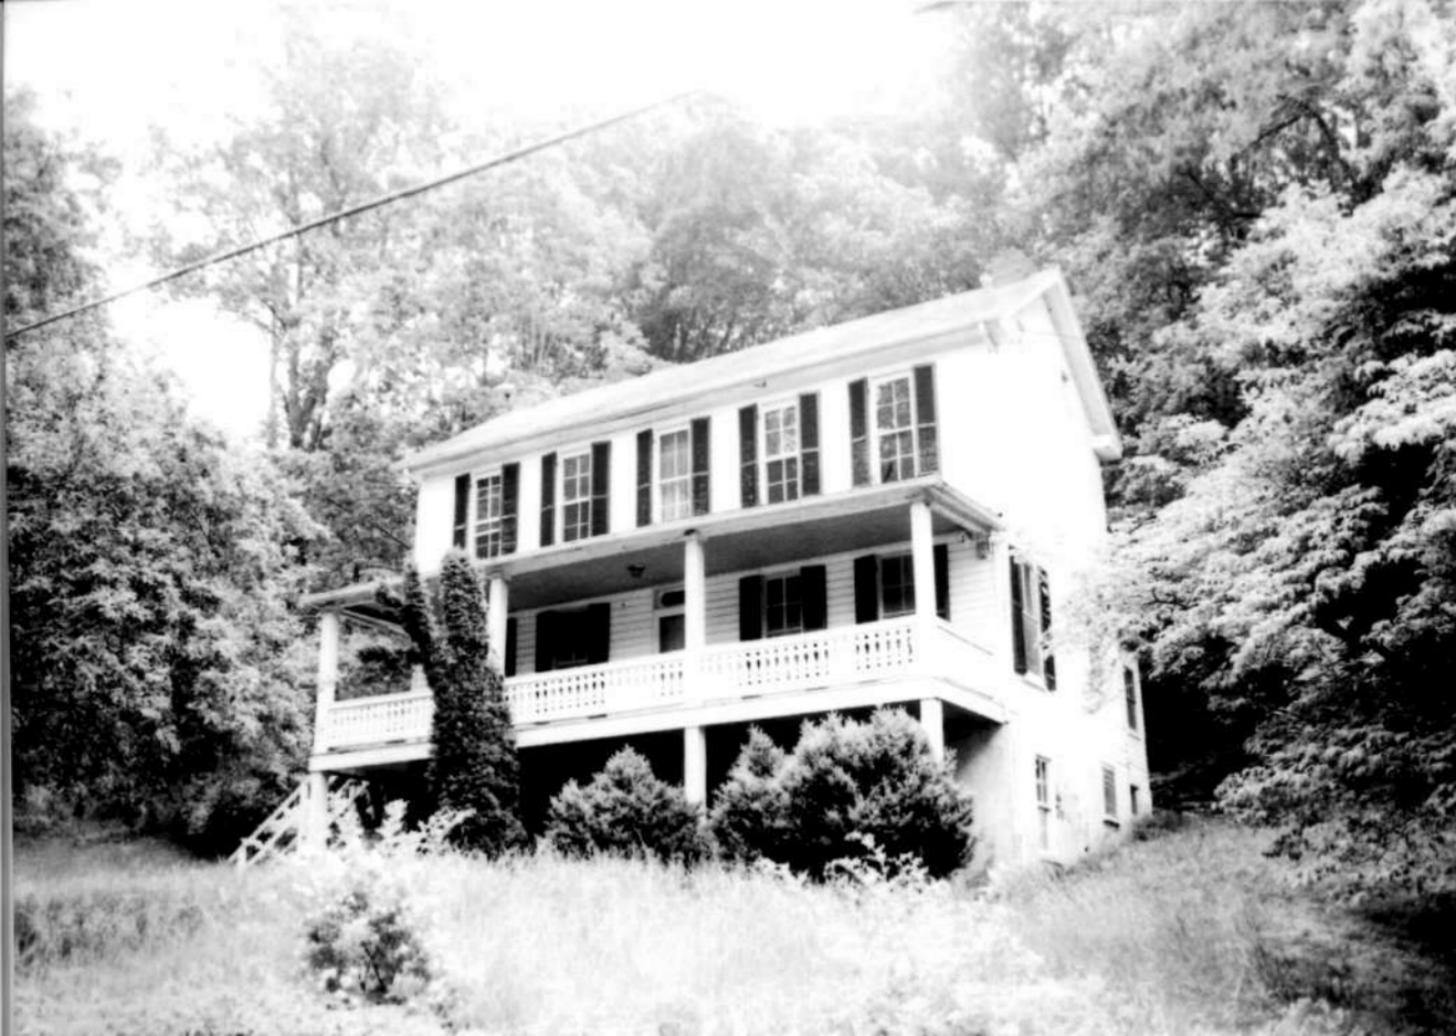
21/25

The two-story, wood-frame dwelling was constructed in the Folk Victorian style. Design and materials suggest a ca. 1900 construction date. The five-bay-by-two-bay house has a full basement and a gable roof. The house faces north. The house rests on a fieldstone foundation, which is finished with plaster. The rear (south) elevation is set into a slope, exposing the stone basement on the front (north) elevation. Exterior walls are clad with drop wood siding. The roof is sheathed in composition roll roofing. A box cornice runs along the front elevation. Gables have eaveboards and gable returns. The main entry is centered on the front elevation and consists of a wood-paneled door surround and a wood door with two arched lights and a transom. The wood-frame, double-hung sash windows have slip sills and louvered blinds. Windows are four-over-four-light units; with the exception of those on the first story of the rear elevation, which are two-over-two-light units. Each gable features two four-light windows. The basement level on the front elevation has a door on each end and two central windows. The doors have four lights over two wood panels; the windows have solid wood shutters. A full-width, hipped-roof, front porch shelters the first-floor and basement levels. Square wood posts rise from the ground to the porch roof. The porch features a wood floor, a wood ceiling, and a jigsaw-cut balustrade. The porch is accessed by a staircase on the east side. A concrete slab is located beneath the porch at the basement level.

porch. The door to the enclosed area has six panels, and the door to the house has two lights over two panels. A small, second-story addition projects from the center bay and rests on the rear porch roof. Stone retaining walls were constructed in front of and behind the house. A series of terraced gravel platforms leads to the rear of the house. Woods are located behind the dwelling. The house is in fair to good condition. Missing sections of gutters have allowed water to soak the foundation walls and plaster. Foundation mortar erosion and plaster failure were noted in some locations. The wood siding and wood trim have experienced paint failure. A hole due to deterioration was noted on the front porch floor. Some windows have broken panes. Deterioration was noted on the boxed cornice and gable returns.

Wachter Hse., NW corner
