Morgan Run NEA

CARR-1679

Carroll County, Maryland

Maryland Inventory of Historic Properties Form

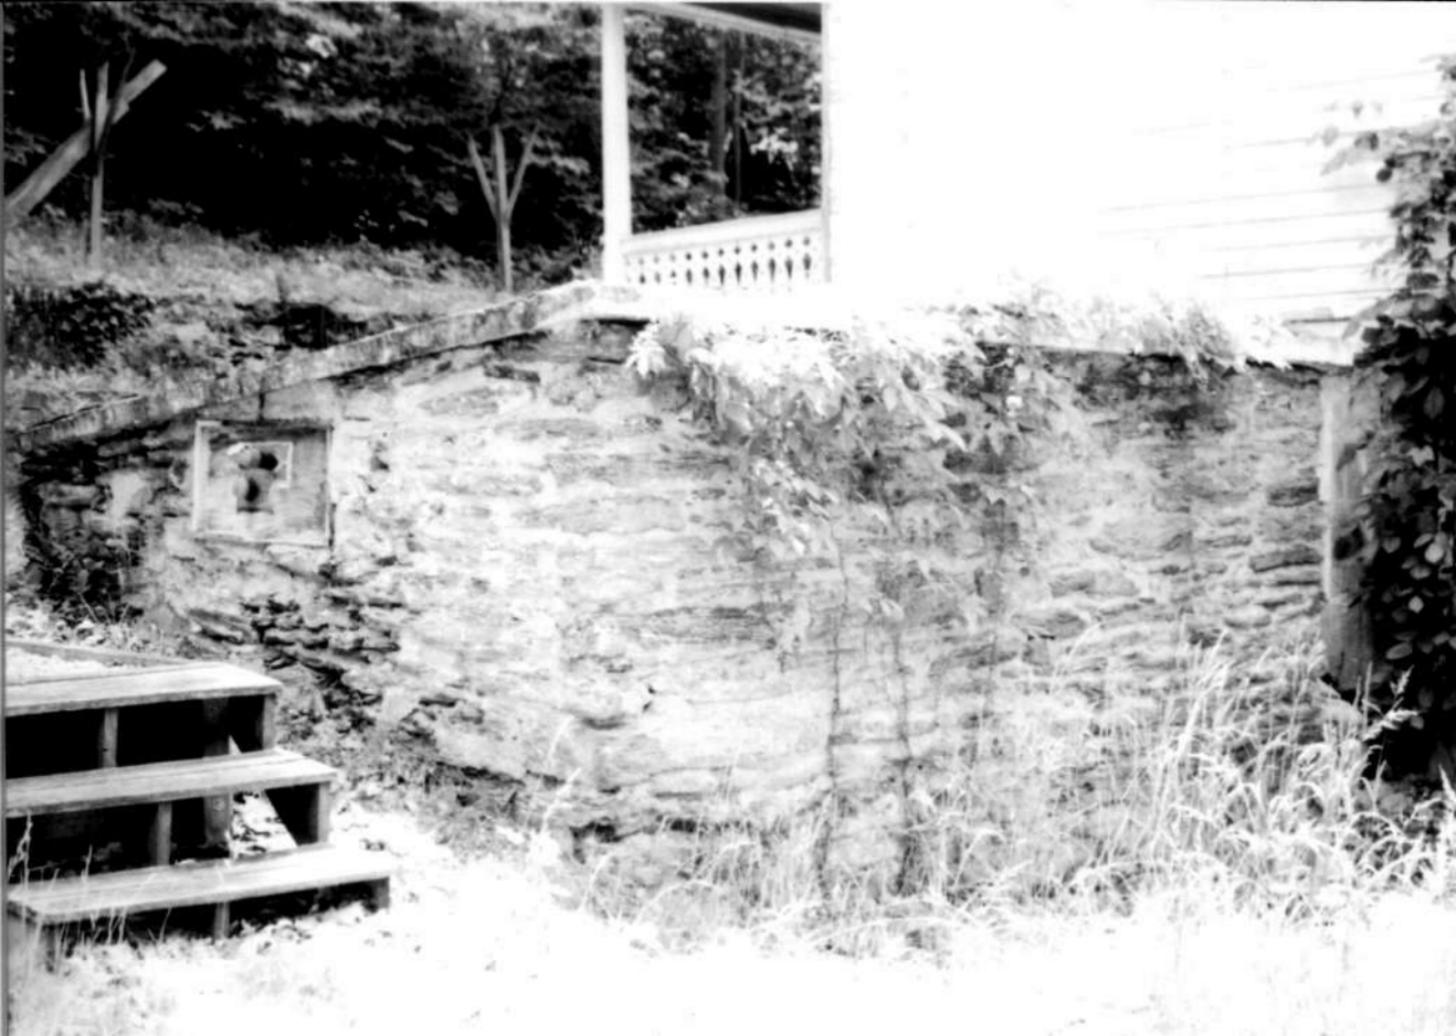
22/25

The stone, half-story, rectangular root cellar was built into the ground. Materials suggest that the cellar was constructed ca. 1900. The shed roof consists of concrete slabs covered in tar paper. The open west wall faces the house. A single window is located in the east elevation; the opening has been sealed with boards. The root cellar is in fair condition. Vines are growing on the exterior walls. The concrete slab roofing has collapsed, and the tar paper sheathing has deteriorated.

Wachter Root Cellar, NE
corner

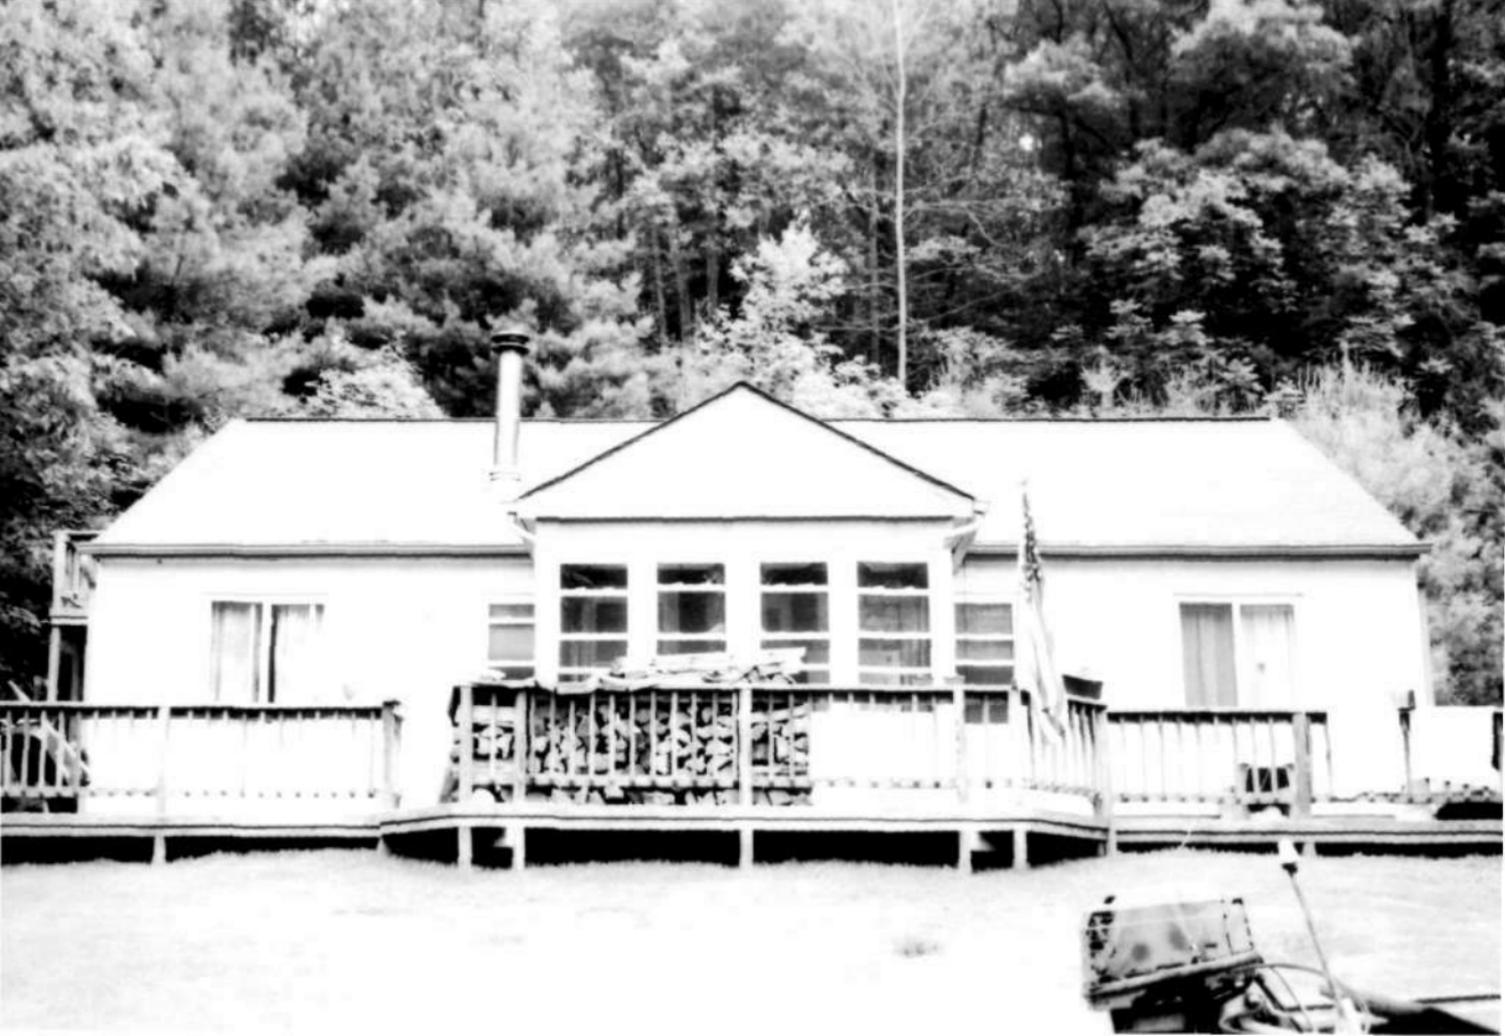
23/25

The BARKER HOUSE is located at 664 Klees Mill Road in Parcel A, at the base of a rising slope. The house was depicted on a topographical map for which the survey was conducted in 1944 and the data revised in 1953 (USGS 1955). Design and materials of the ranch-style house suggest a ca. 1950 construction date. The property includes a ca. 1972 wood-frame shop. A pond, a vegetable garden, and evergreens characterize the landscape. The one-story, wood-frame, five-bay rancher has a T-shape and a gable roof. The house faces south. The dwelling rests on a poured-concrete foundation. Exterior walls are clad with wide aluminum siding. The roof is sheathed in composition roll roofing. A metal stove pipe projects from the roof. The front (south) and rear (north) elevations feature a boxed cornice; flush raking boards define the gables. The main entry, which consists of a four-panel wood door with four small lights across the top, is concealed by a central, enclosed porch projection on the front elevation of the house. This one-bay projection features a front-facing gable roof with wide wood fascia. Centered doors are located on each side of the porch projection, which is enclosed by windows and aluminum siding. An open wood deck spans the dwelling's front elevation and wraps around the east gable end. The house has metal-frame, one-over-one-light, double-hung sash windows and vinyl-frame, one-by-one-light sliding units. The vinyl-frame windows were installed in 2001 (MdDNR 2002). An exterior wood staircase on the west elevation provides access through the gable. The house is in good condition. Mold is present on the aluminum siding, and paint is deteriorating on the wood eave boards. Recent design modifications and replacement materials have compromised the integrity of the house.

Barker Hse., S. Elevation

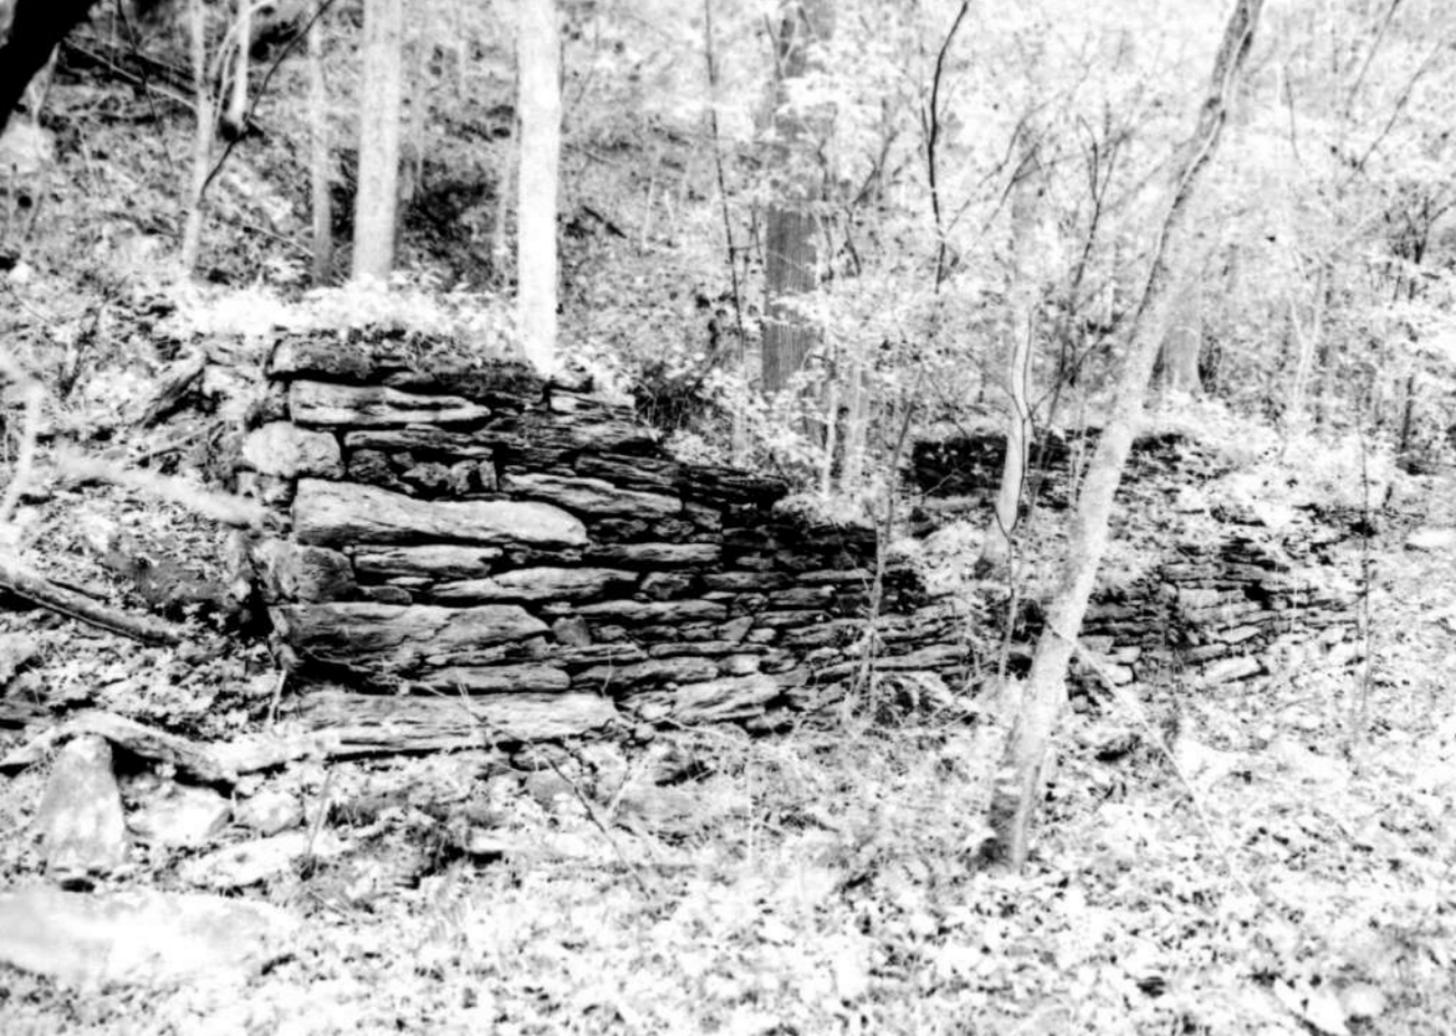
A MILL FOUNDATION is located upstream from the ruins of the two Klee Mill dams. The foundation is set in front of a hill in a lightly wooded area on the north side of Morgan Run as it curves to the west. The foundation may be that of the Fulling Mill, which was depicted on Martenet's 1862 map and Lake's 1877 atlas. The square foundation is constructed of random stones. An opening in the south elevation suggests the location of the former mill wheel. The east elevation has a door opening on the north end. The north elevation foundation wall is covered by dirt. A mill race is present on the south side of the foundation.

MD SHPO
Mill Foundation, View NE
