**MARYLAND HISTORICAL TRUST
DETERMINATION OF ELIGIBILITY FORM**

Property Name: Ephraim Stouffer Farm Inventory Number: CARR-1721
 Address: 2290 New Windsor Rd. City: New Windsor Zip Code: 21776
 County: Carroll USGS Topographic Map: New Windsor
 Owner: Lehigh Portland Cement Company Is the property being evaluated a district? yes
 Tax Parcel Number: 0037 Tax Map Number: 0056 Tax Account ID Number: 11-003435
 Project: New Windsor Quarry Expansion Agency: _____
 Site visit by MHT Staff: no yes Name: _____ Date: _____
 Is the property located within a historic district? yes no

MARYLAND HISTORICAL TRUST
NR-ELIGIBILITY REVIEW FORMContinuation Sheet No. 1

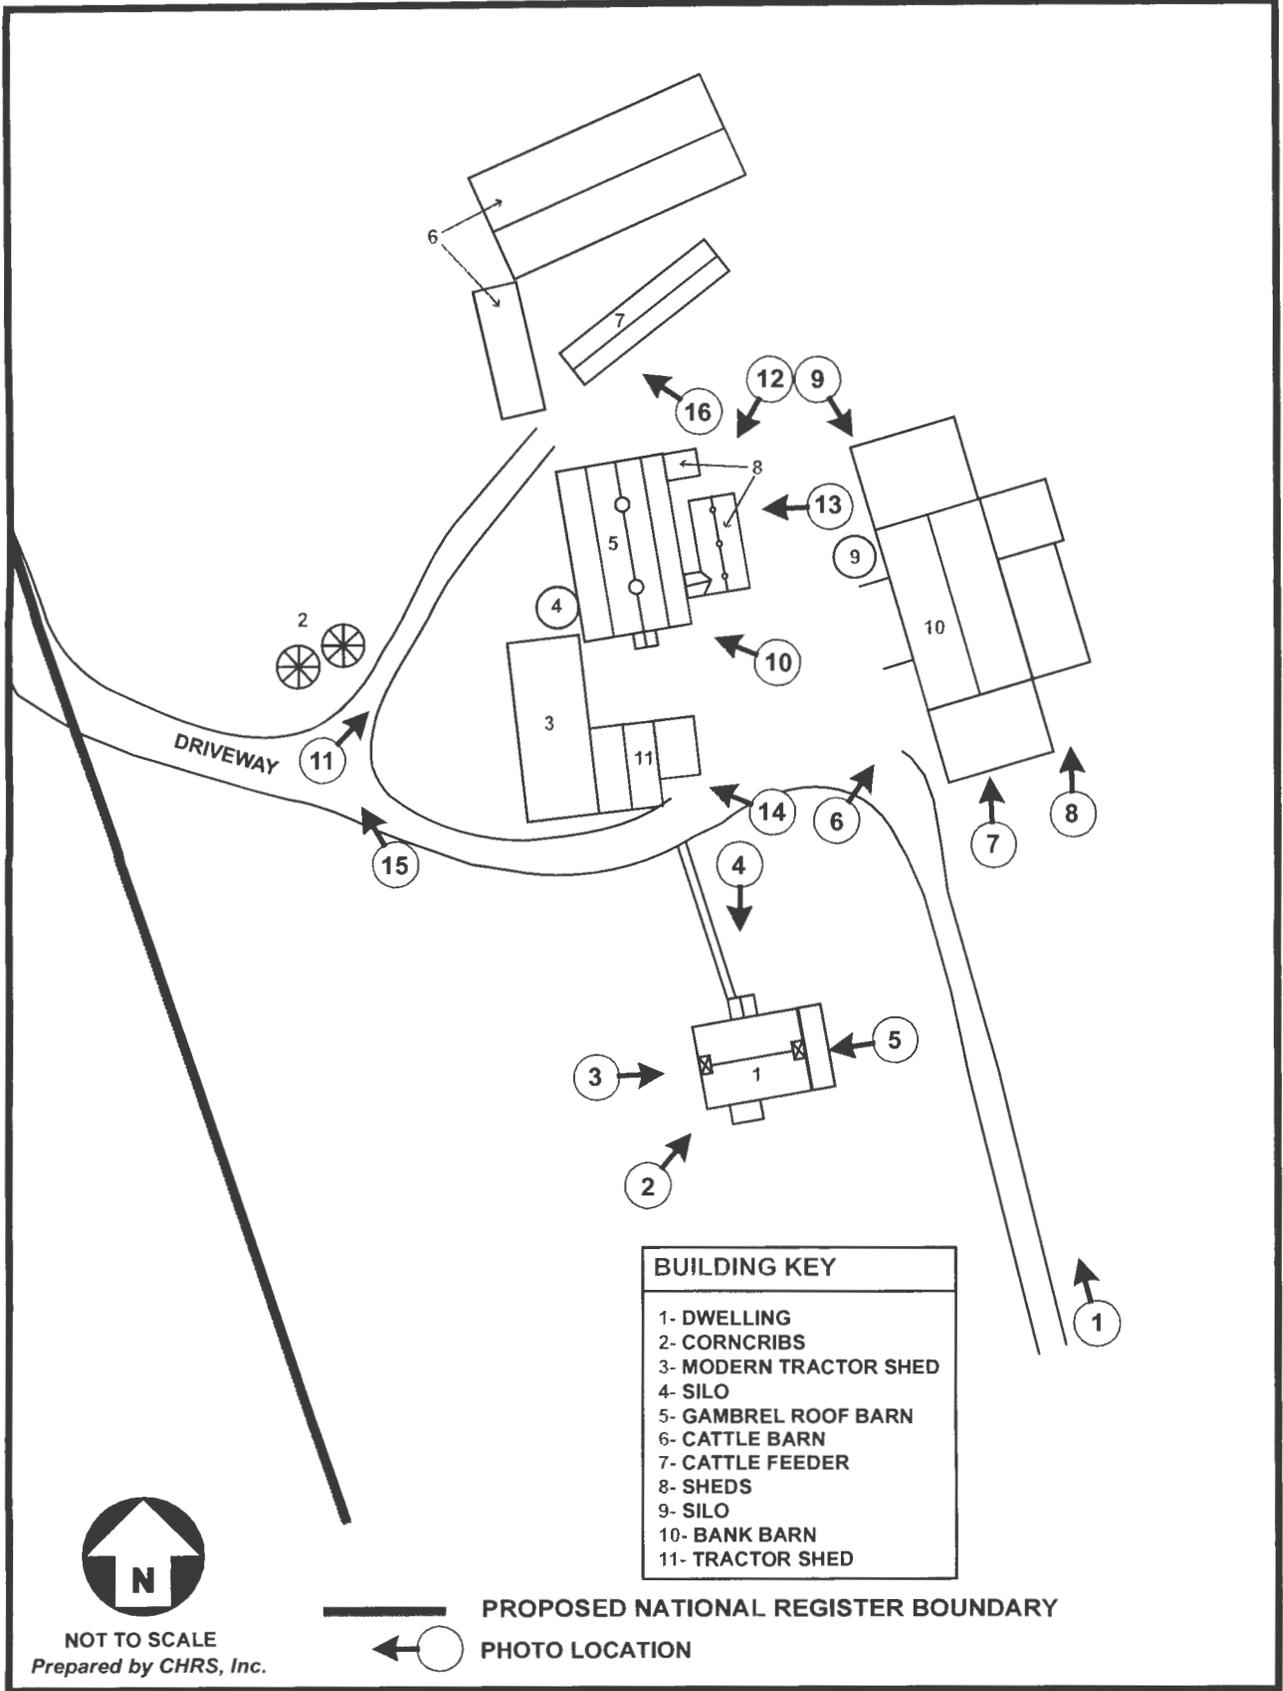
CARR-1721 - EPHRAIM STOUFFER FARM - SITE PLAN AND PHOTO LOCATION MAP

BUILDING KEY	
1-	DWELLING
2-	CORNCRIBS
3-	MODERN TRACTOR SHED
4-	SILO
5-	GAMBREL ROOF BARN
6-	CATTLE BARN
7-	CATTLE FEEDER
8-	SHEDS
9-	SILO
10-	BANK BARN
11-	TRACTOR SHED

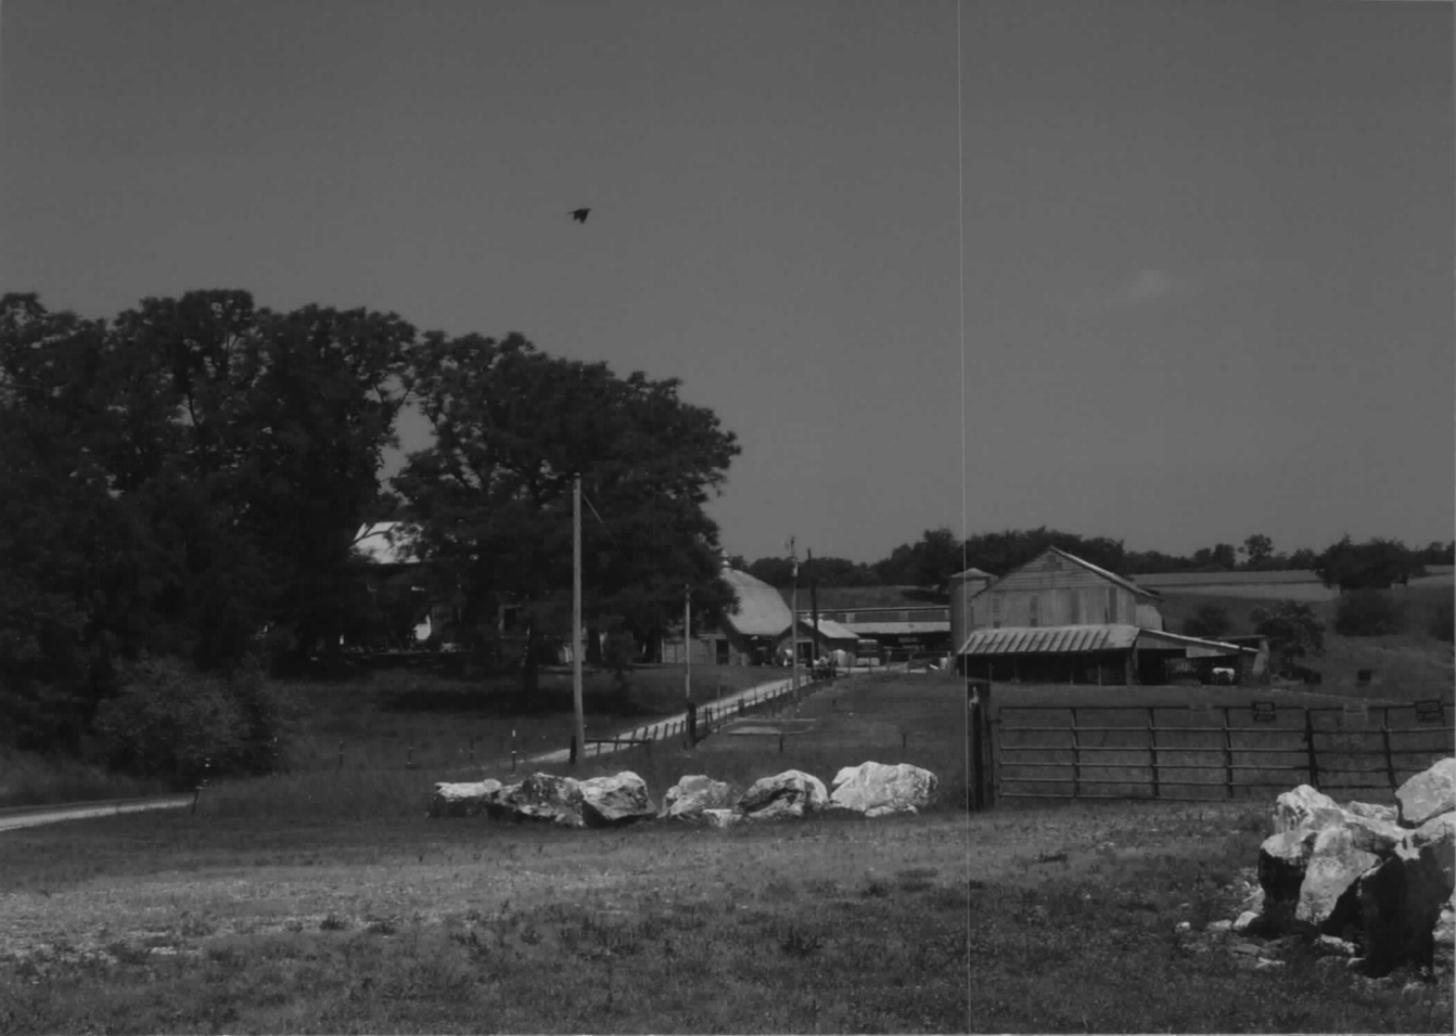
1/16

View facing northwest, showing an overview of the farm.

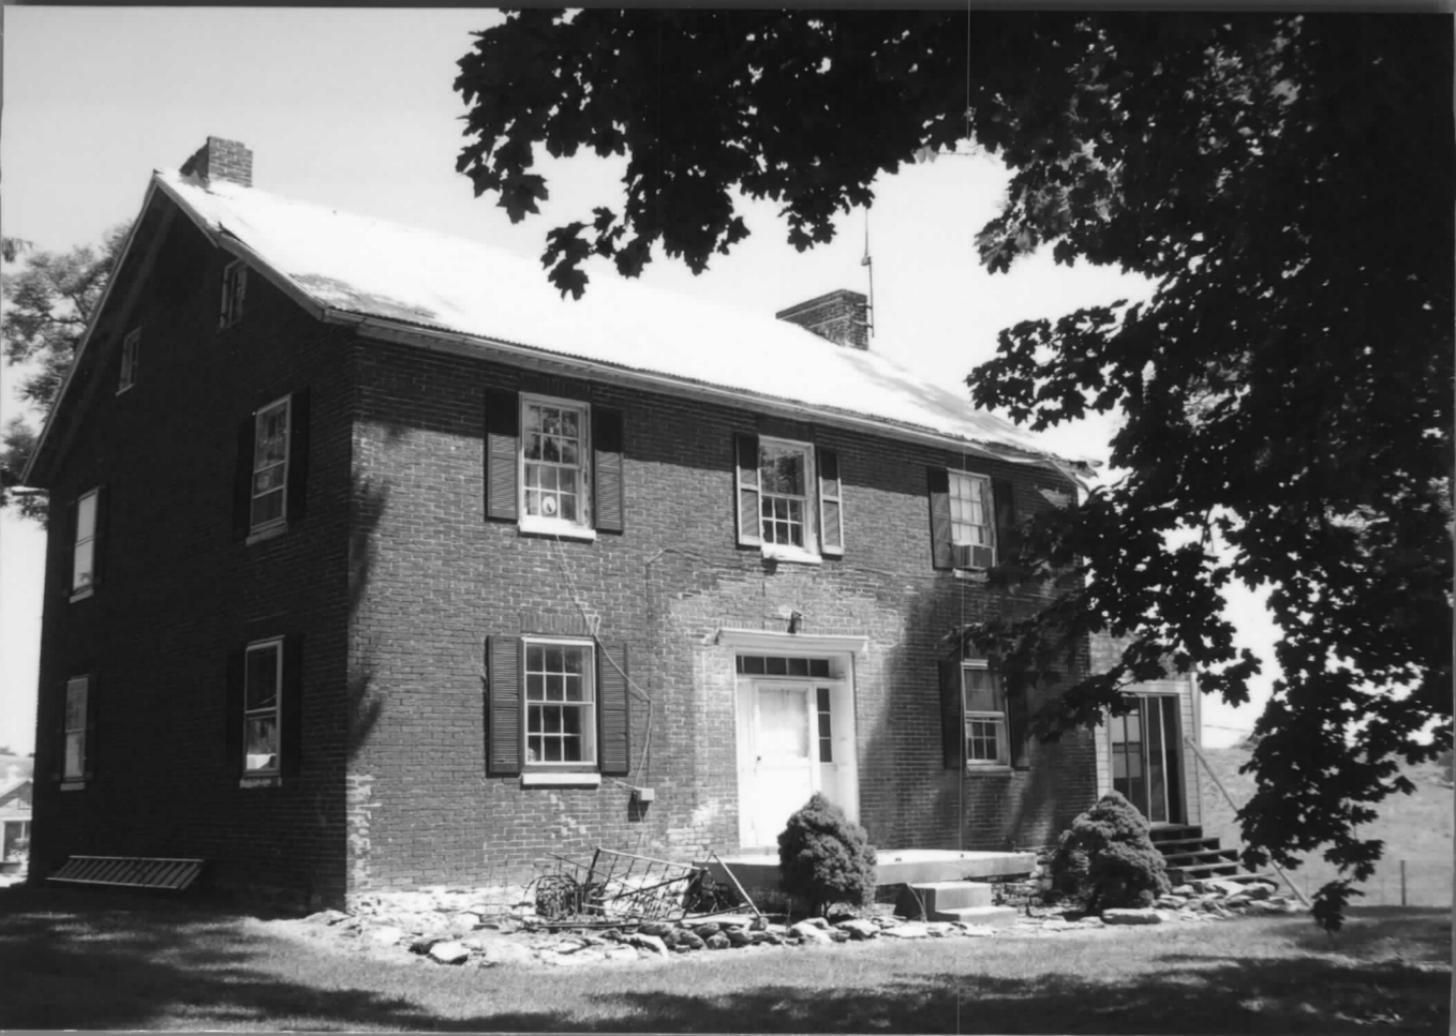
2/16

The main, south elevation has a window-door-window pattern (Photograph 2). The second floor has three windows that are symmetrical with the openings on the first floor. The windows on both the first floor and the second floor are original, six-over-six wood windows with wood sills, brick lintels and wood louvered shutters. The entrance contains the original wood panel door with a modern storm door. The entrance has a five-light transom and three-light sidelights. There is a modern concrete slab that sits on a stone foundation which makes up the front porch. There is a discoloration on the bricks around the door, which indicates that there used to be a single-story, one-bay porch surrounding the door. The cornice has triangular wood molding underneath the modern metal gutter.

View facing northeast, showing the main elevation of the dwelling on the farm. Note the marks on the brick where the original porch was.

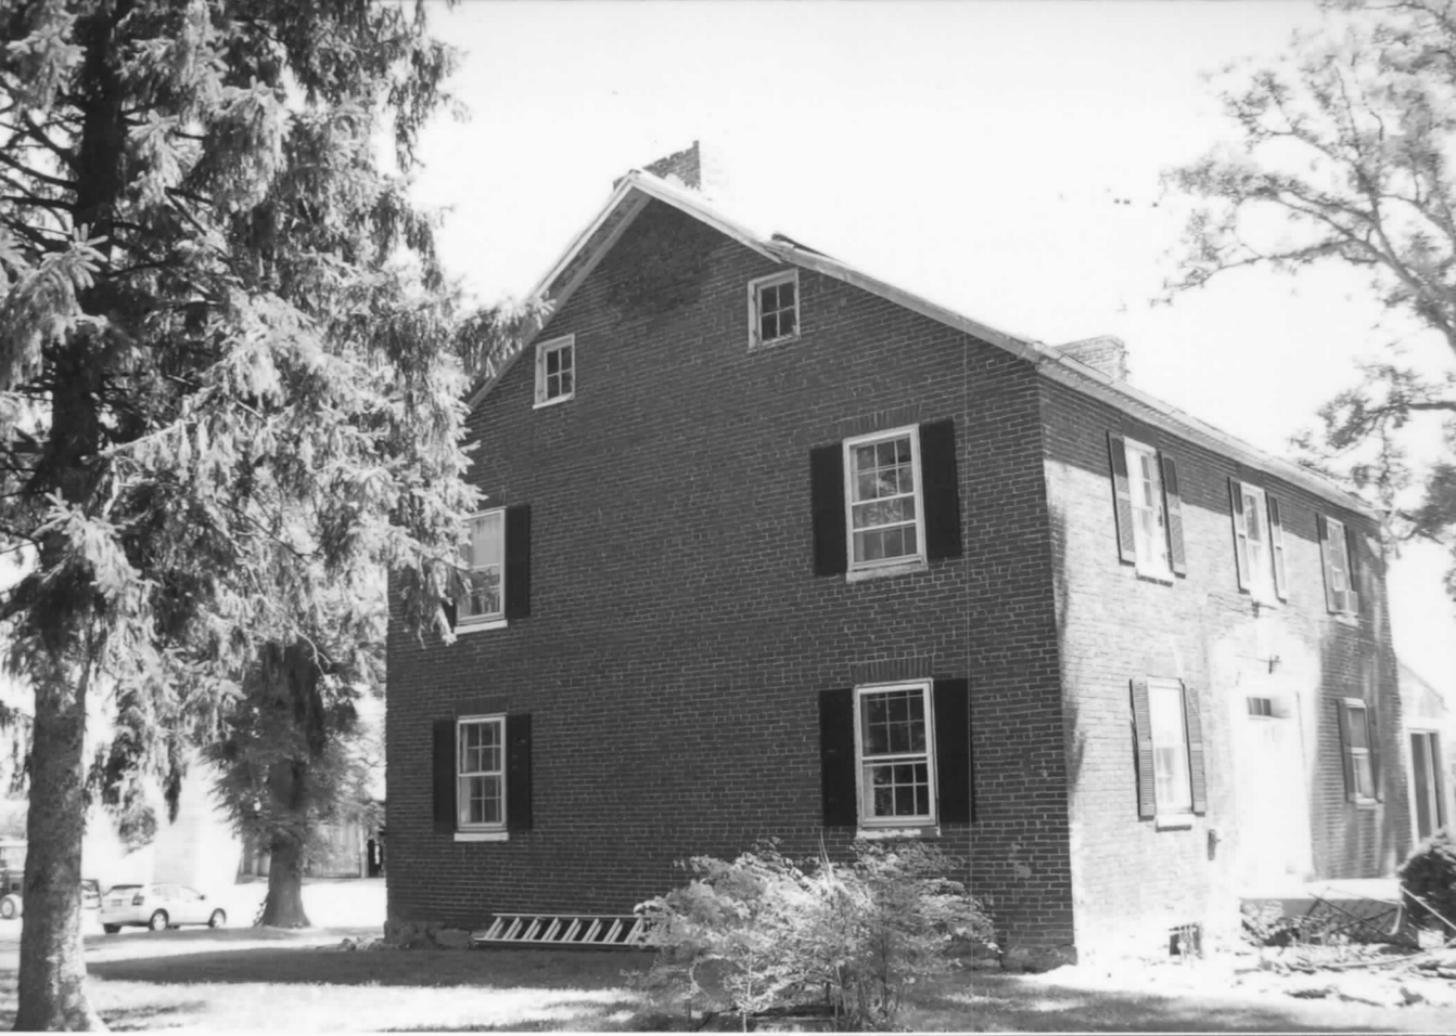
3/16

The west elevation consists of six windows (Photograph 3). The first and second floors each have two six-over-six wood windows. All four of these windows have wood sills, brick lintels and wood louvered shutters. The last two windows on this side are in the gable peak and they are original four-light wood windows.

View facing east, showing the west elevation of the dwelling

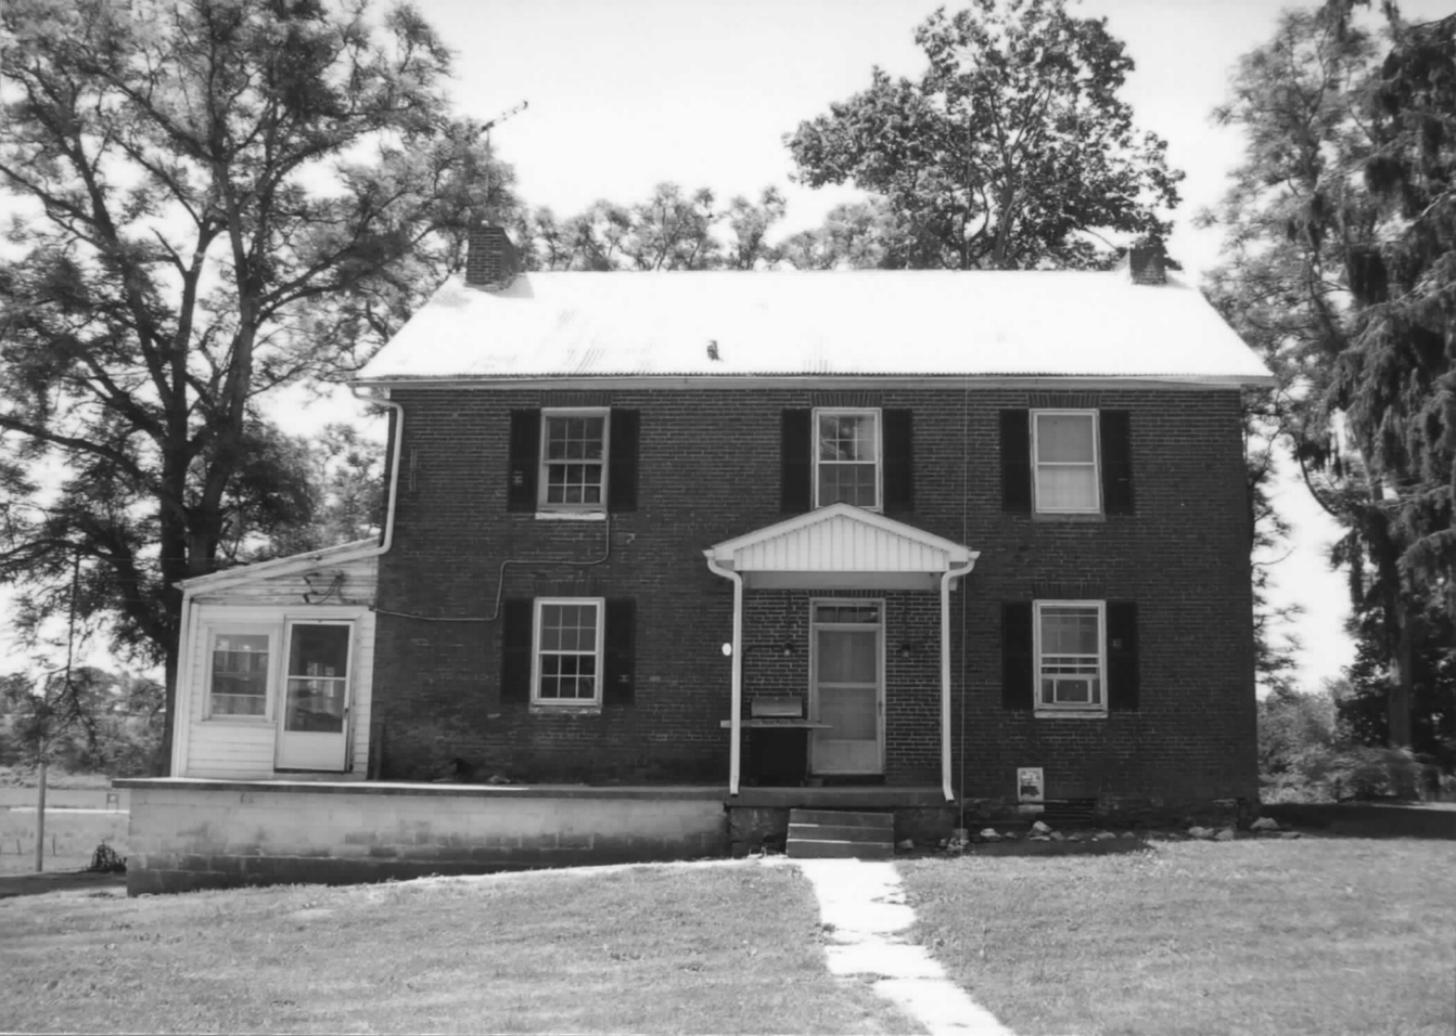
4/16

The rear, north elevation of the dwelling is identical to the front elevation except for the entrance (Photograph 4). The rear entrance contains an original wood panel door with a three-light transom. The entrance is covered by a modern pediment roof, which rests on a concrete slab that is supported by a stone foundation. The slab continues to the east for the remainder of the north elevation; however, the foundation for this section is concrete block.

View facing south, showing the rear elevation of the dwelling.
Note the modern porch and the addition.

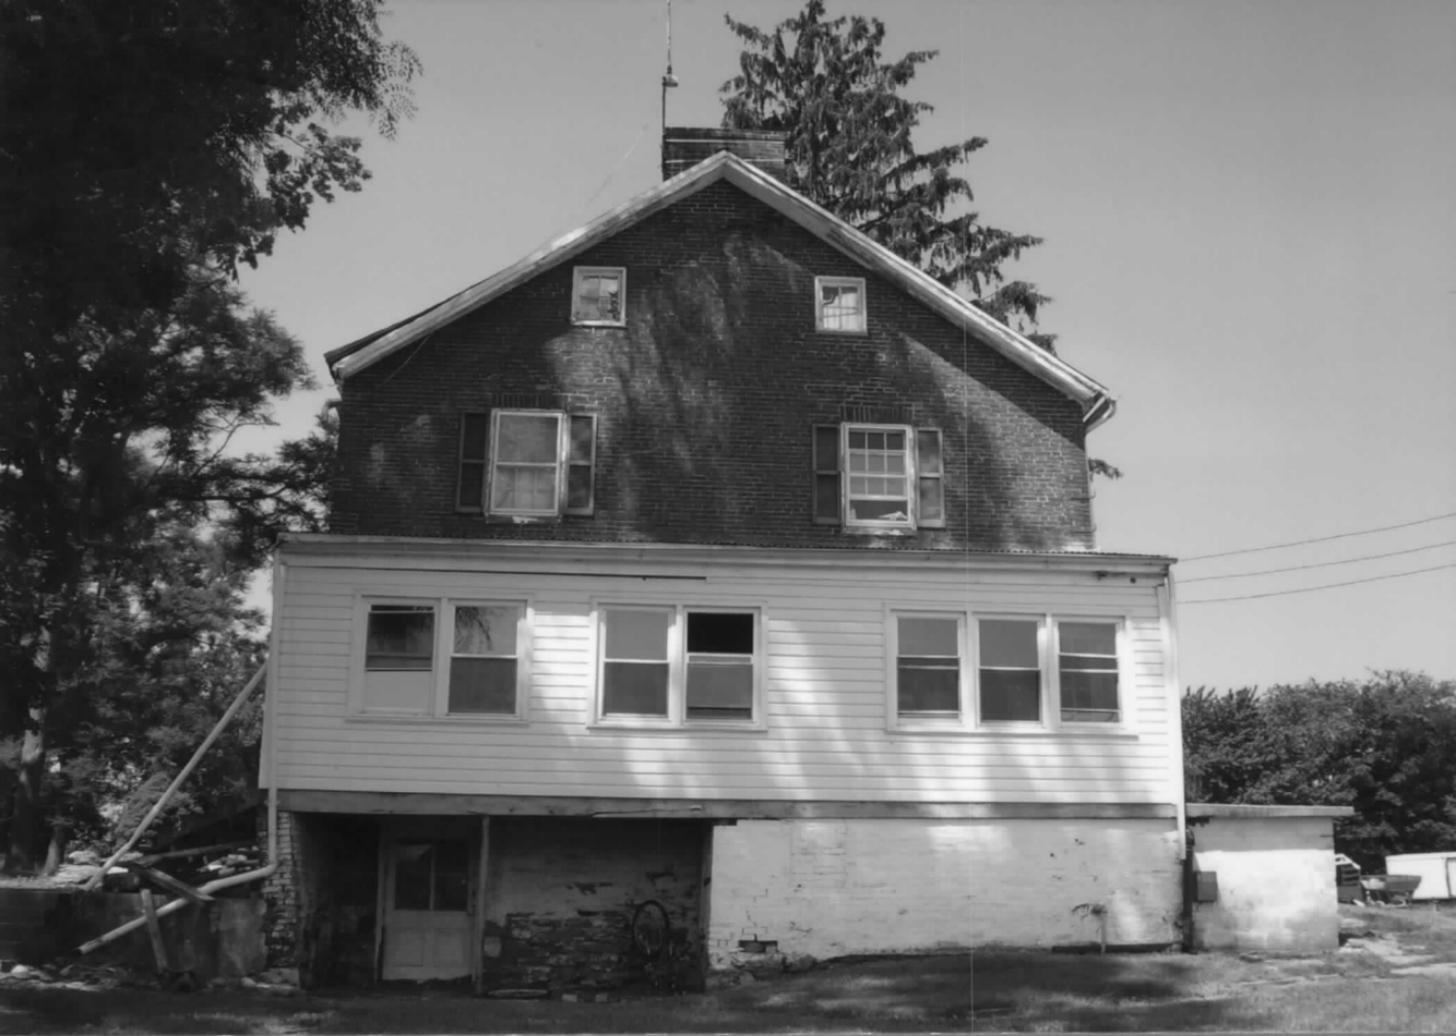
5/16

The east elevation has two original six-over-six wood windows. Both of the windows have wood sills, brick lintels and wood louvered shutters. There are two original, wood, four-light windows in the gable peak. The first floor of the east elevation is obscured by a large modern addition (Photograph 5). The addition rests on a brick foundation that has a large opening on the south end for access to a basement door. The northern part of the brick foundation is closed off and has an access door for storage.

View facing southwest, showing the east elevation of the dwelling. Note the modern addition.

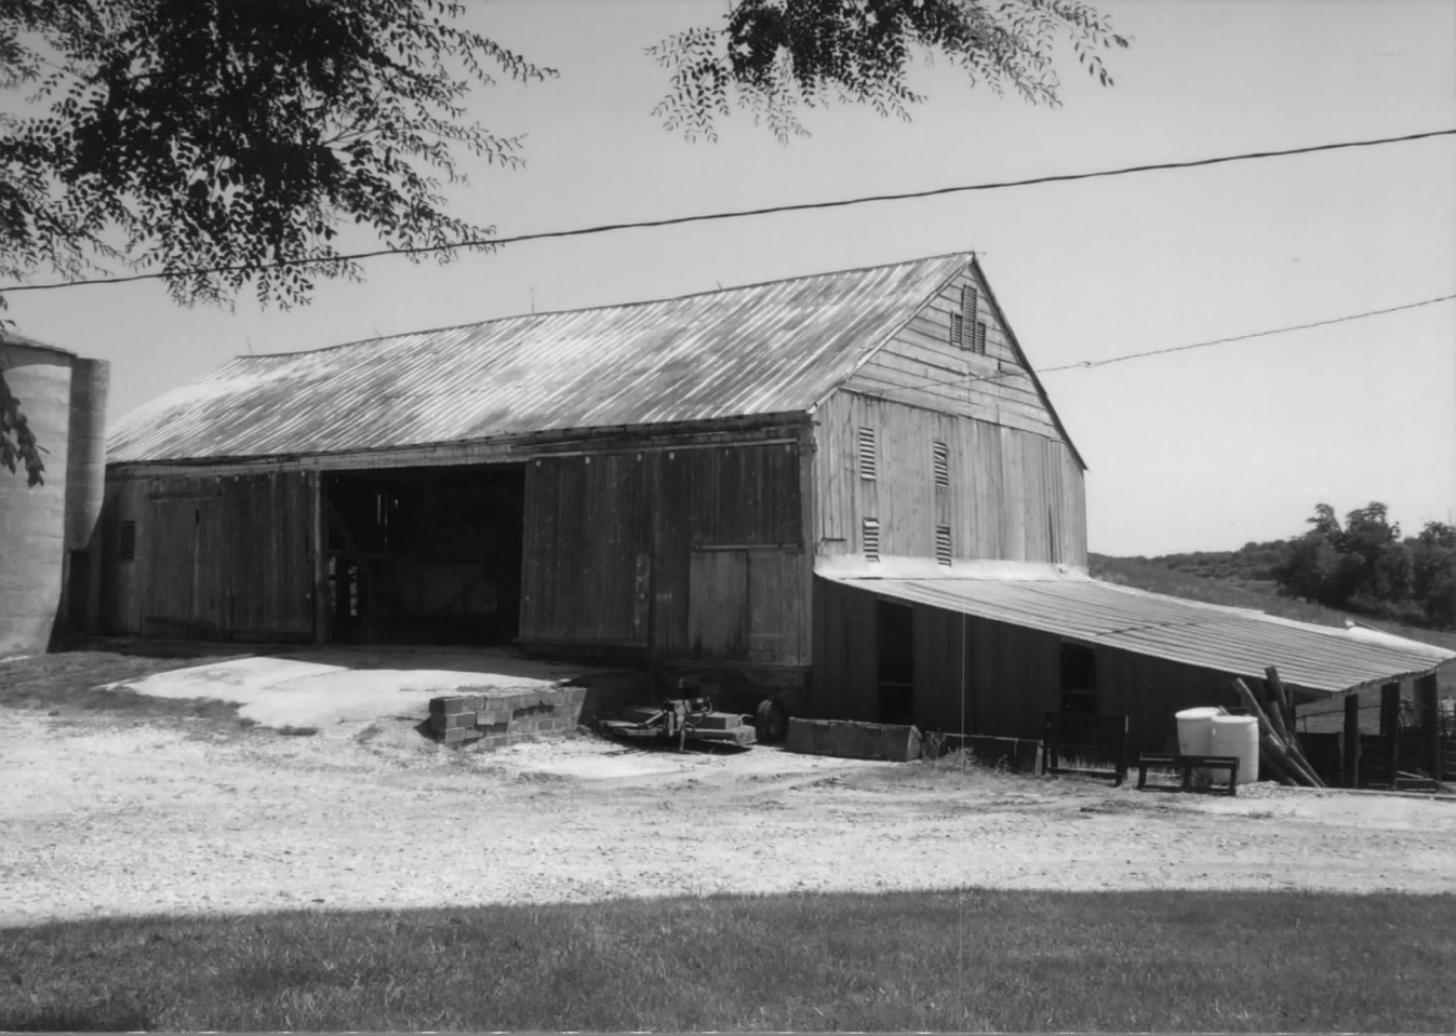
6/11

A ca. 1858 bank barn is located northeast of the dwelling. The barn stands two-and-one-half stories tall and is three bays wide. It has a stone foundation and is clad in vertical boards, except in the gable peaks which have horizontal boards. The side gable roof is sheathed in standing seam metal. The bank side of the barn has three sets of doors (Photograph 6). The doors in the center and on the northern end are large sliding vertical board doors. The door on the southern end is a smaller, pedestrian-sized vertical board door. The ramp to the barn has been paved and is reinforced with concrete block.

View facing northeast, showing the bank side of the bank barn. Note the large addition.

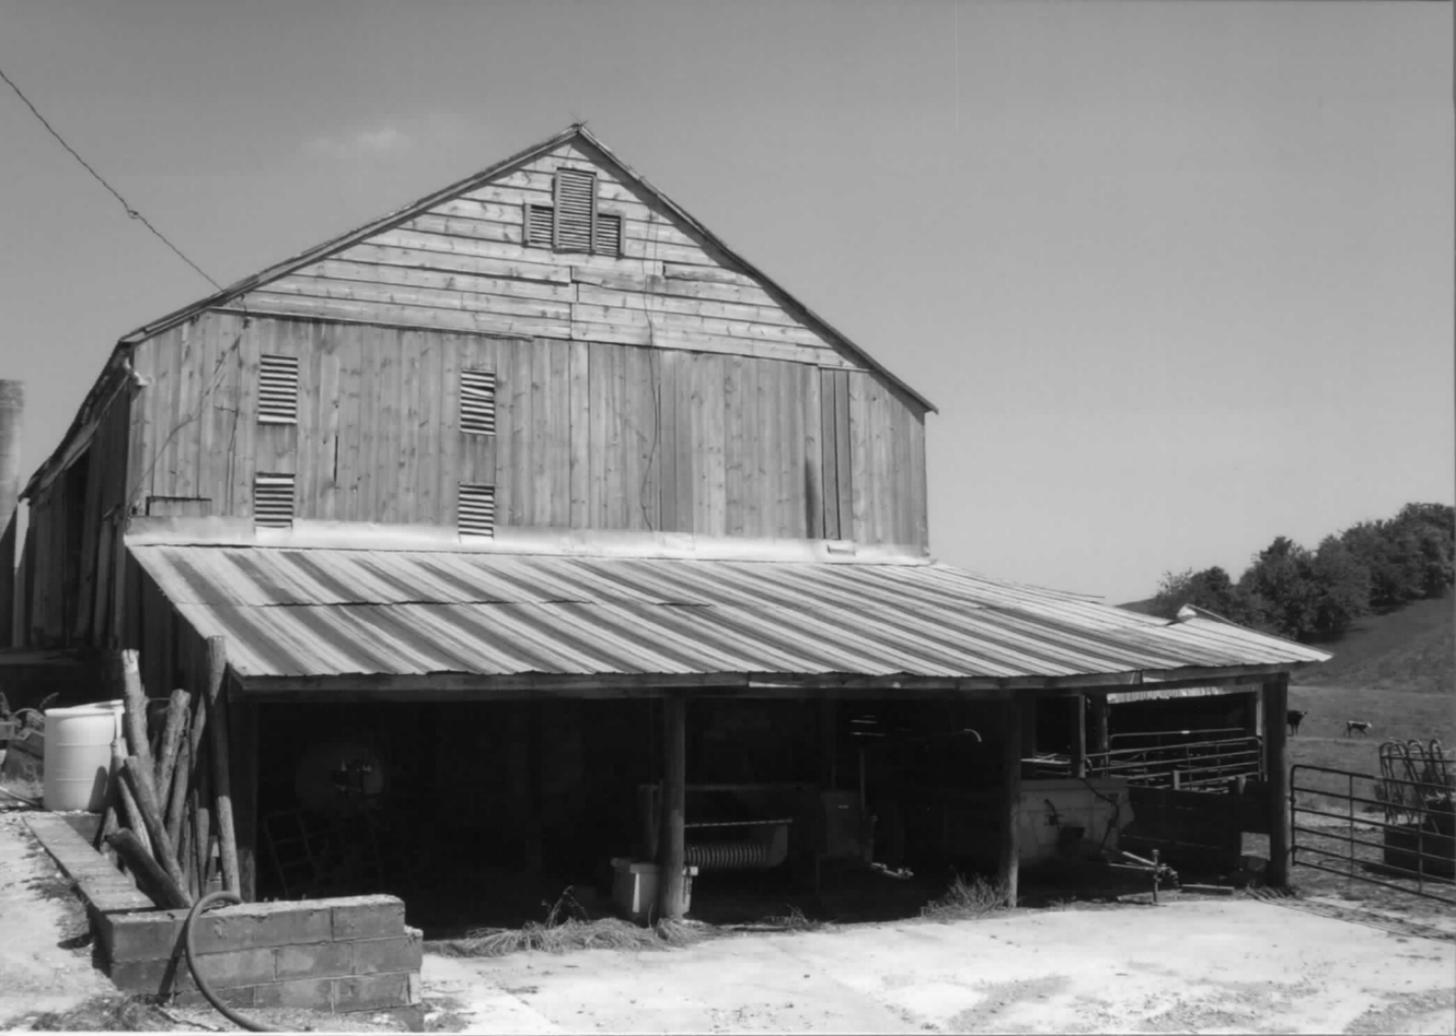
7/11/11

The first floor of the remaining sides of the barn is obscured by modern additions. The second floor on the south side has four wood louvered vents on the west end and three in the gable peak (Photograph 7). The second floor on the east side has seven wood louvered vents (Photograph 8). The second floor of the north side of the barn is located under a modern addition (Photograph 9). There are openings in the wood siding on the north side of the barn where there were once vents. There is one vent located above the addition roof on the east end. Located at the northwest corner of the barn is a ca. 1940 concrete silo.

View facing north showing the south side of the barn.

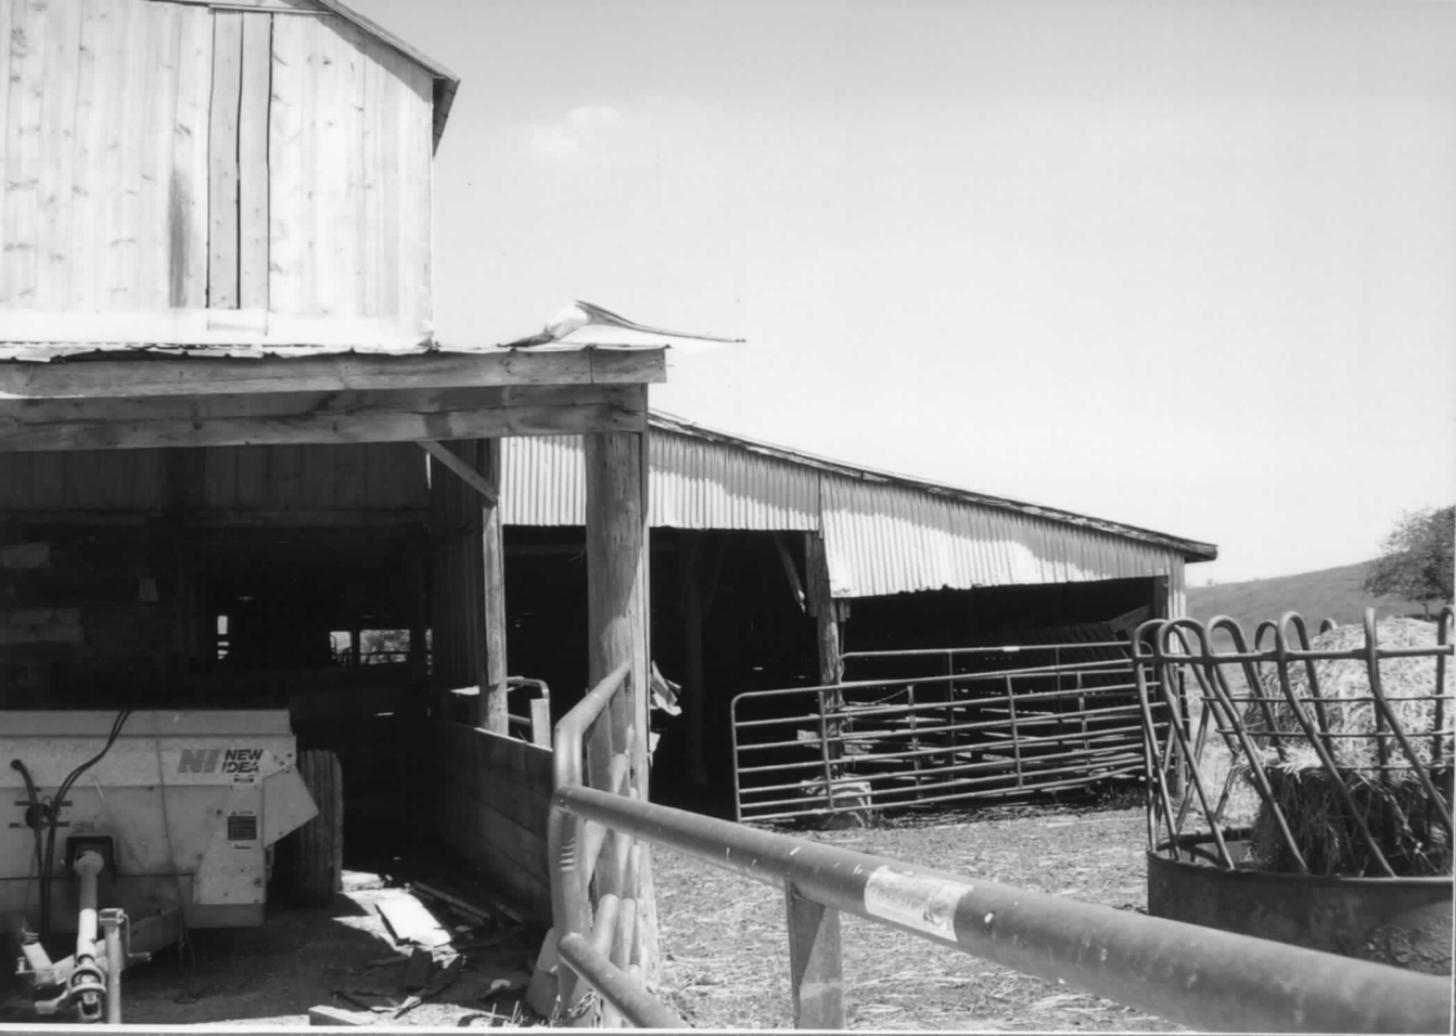
9/16

View facing southeast, showing the north side of the barn.
Note the modern addition.

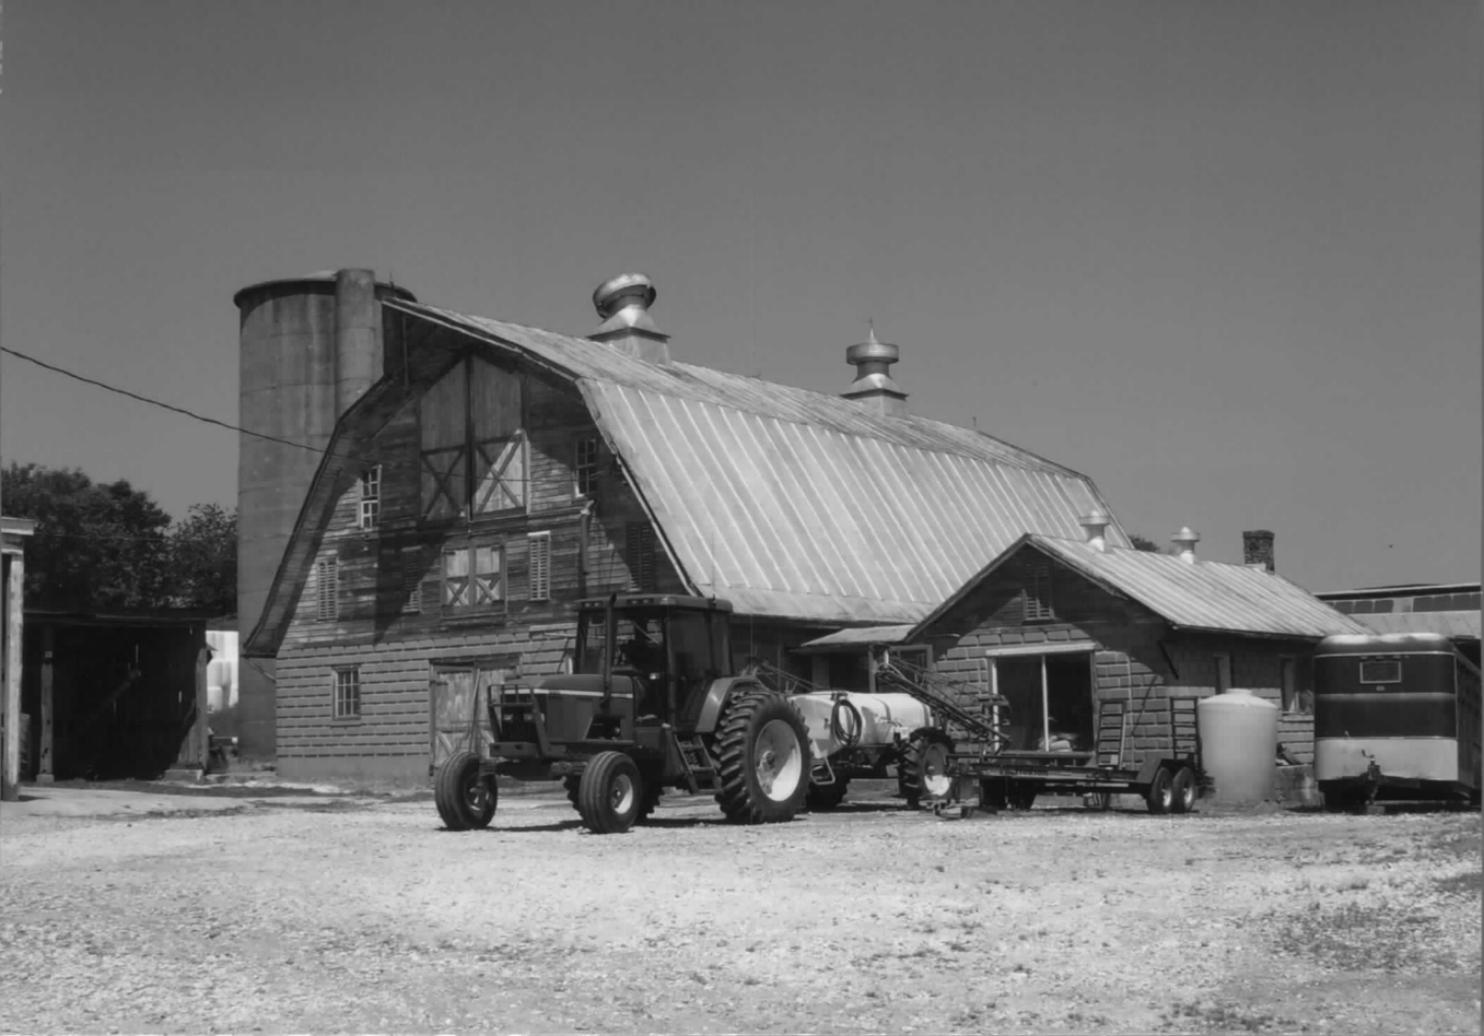
EPSON
10/1/10

A ca. 1920 gambrel roof barn is located west of the bank barn. This barn is two-and-one-half stories tall and three bays wide. It has a concrete block foundation and the first floor walls are constructed in a stamped concrete block pattern. The second floor and the gable peaks are clad in horizontal boards. The roof is sheathed in standing seam metal and has two circular roof vents along the ridge (Photograph 10).

View facing northwest, showing the southeast corner of the gambrel roof barn.

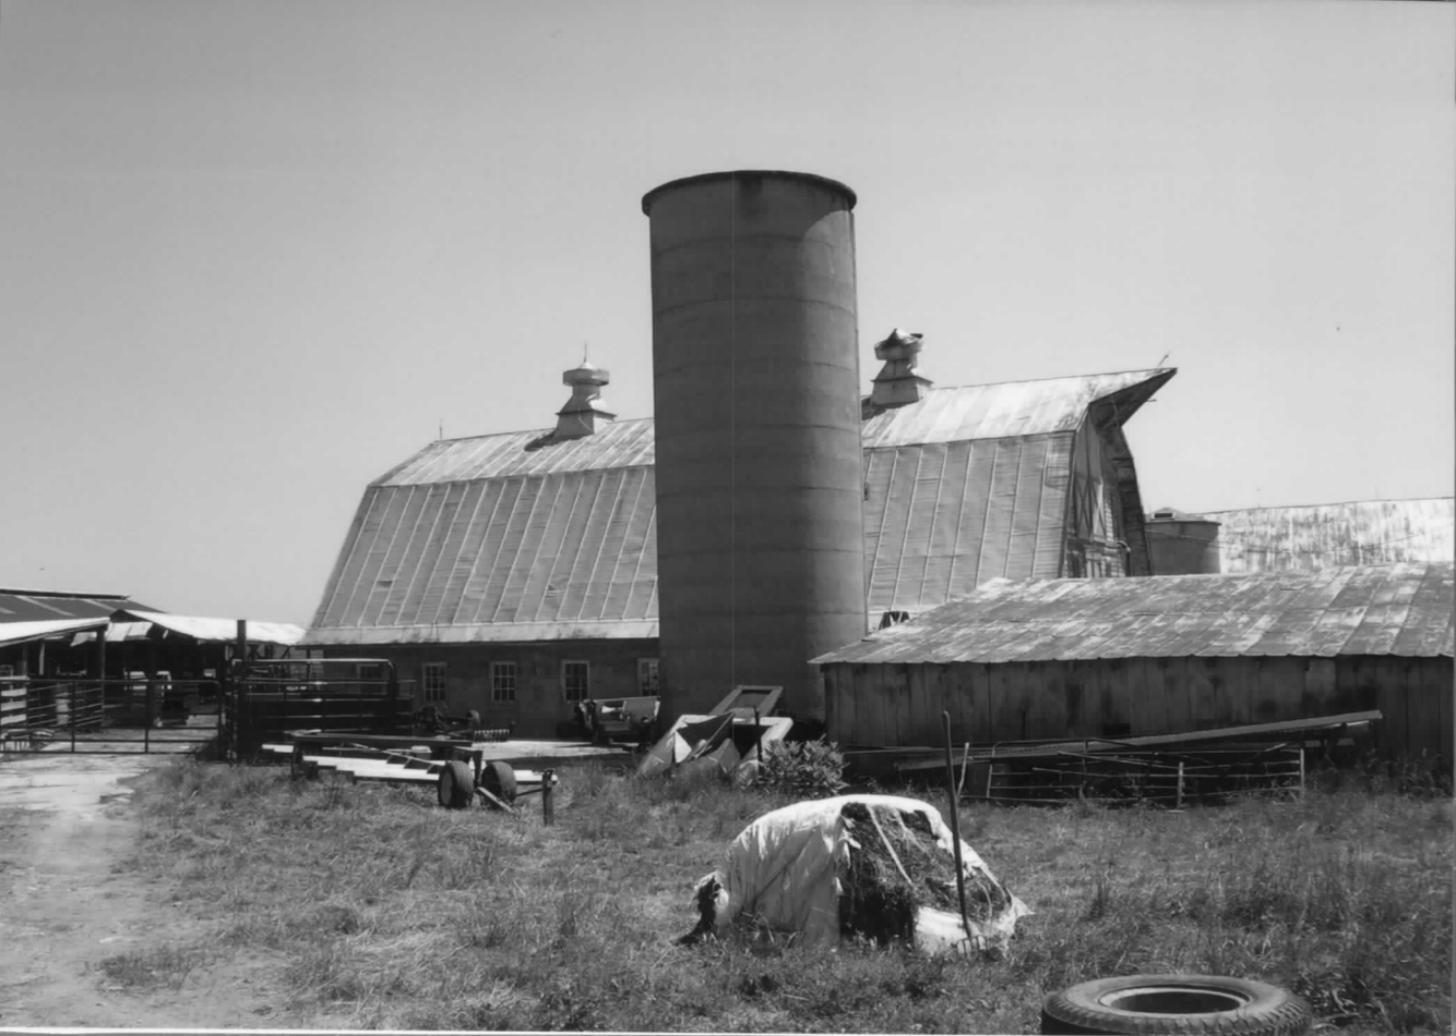
13/116

View facing west, showing the east side of the gambrel roof barn.

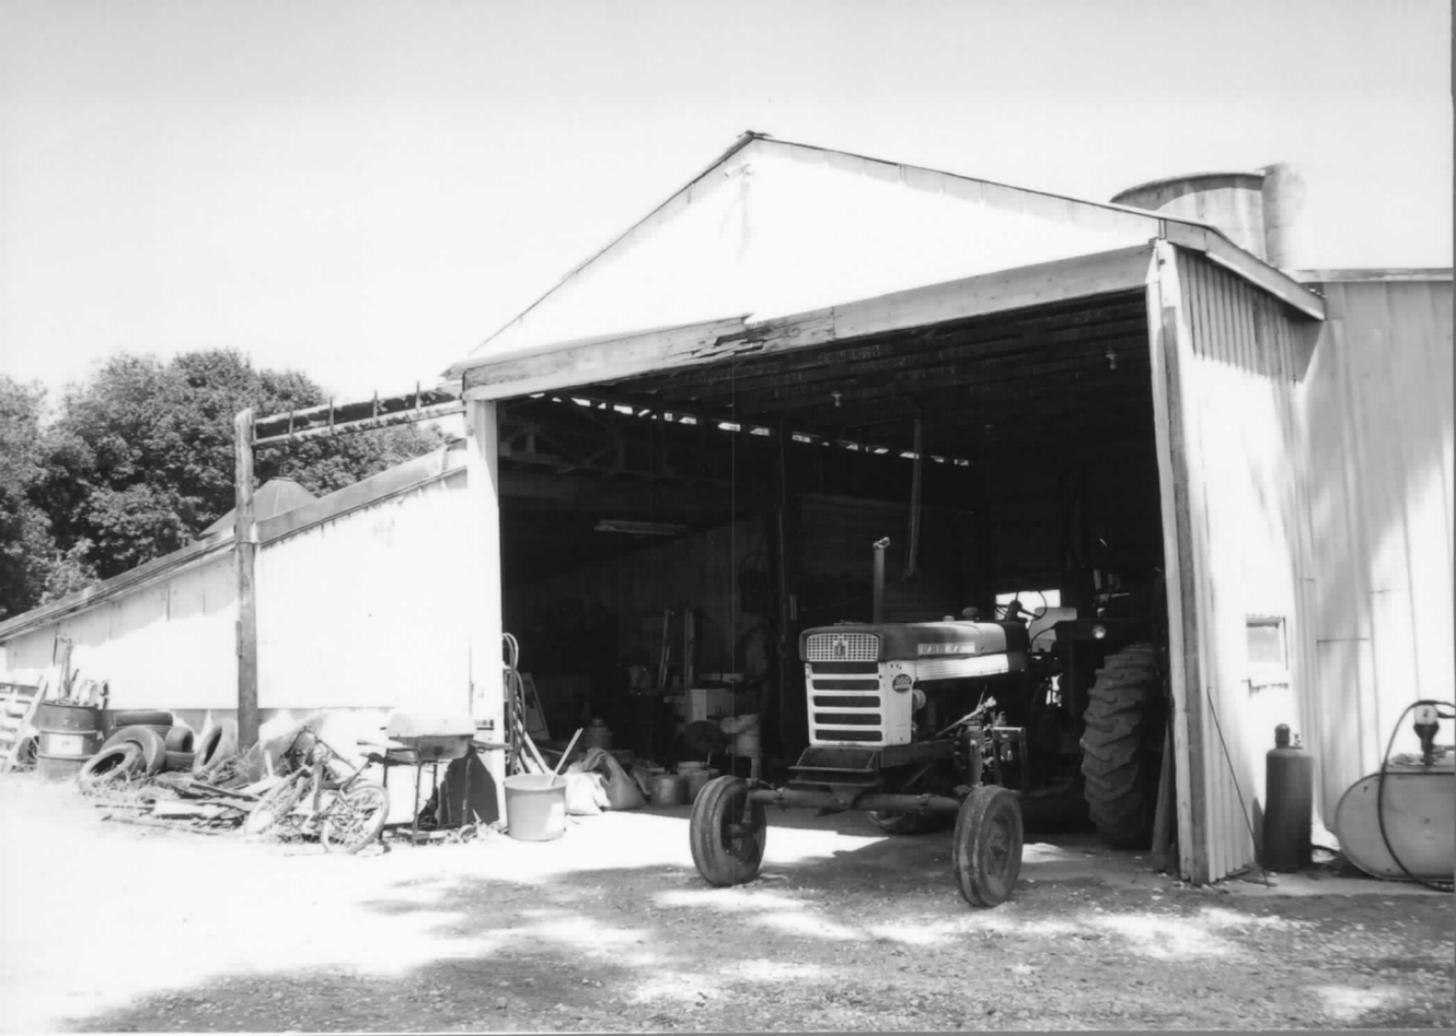
14/16

There are two tractor sheds south of the gambrel roof barn (Photograph 14). The first tractor shed was constructed ca. 1920. It has a wood frame that is partially clad in vertical boards and partially clad in corrugated metal. It has a shed roof that is sheathed in corrugated metal. Attached to the southern end of the eastern side of the tractor shed is a larger, modern tractor shed. Located northwest of the two tractor sheds are two modern metal corncribs (Photograph 15).

View facing northwest, showing the south side of the tractor shed.

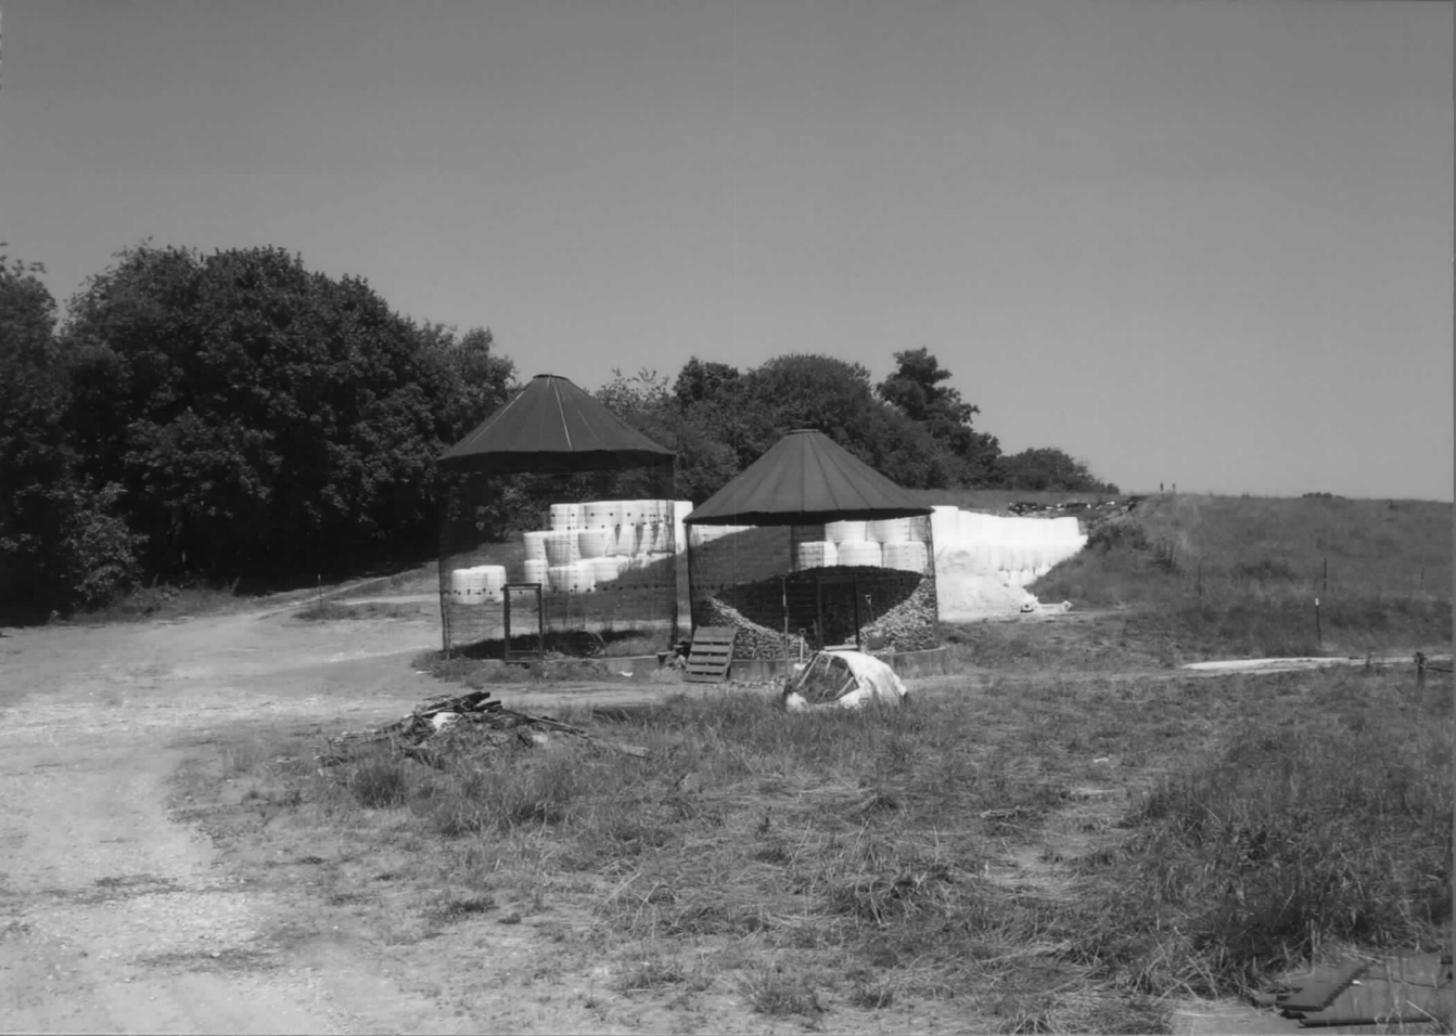
15/16

View facing northwest, showing the corner cribs on the farm.
