**MARYLAND HISTORICAL TRUST
DETERMINATION OF ELIGIBILITY FORM**

Property Name: Ephraim Stouffer Farm Inventory Number: CARR-1721
 Address: 2290 New Windsor Rd. City: New Windsor Zip Code: 21776
 County: Carroll USGS Topographic Map: New Windsor
 Owner: Lehigh Portland Cement Company Is the property being evaluated a district? yes
 Tax Parcel Number: 0037 Tax Map Number: 0056 Tax Account ID Number: 11-003435
 Project: New Windsor Quarry Expansion Agency: _____
 Site visit by MHT Staff: no yes Name: _____ Date: _____
 Is the property located within a historic district? yes no

MARYLAND HISTORICAL TRUST
NR-ELIGIBILITY REVIEW FORMContinuation Sheet No. 1

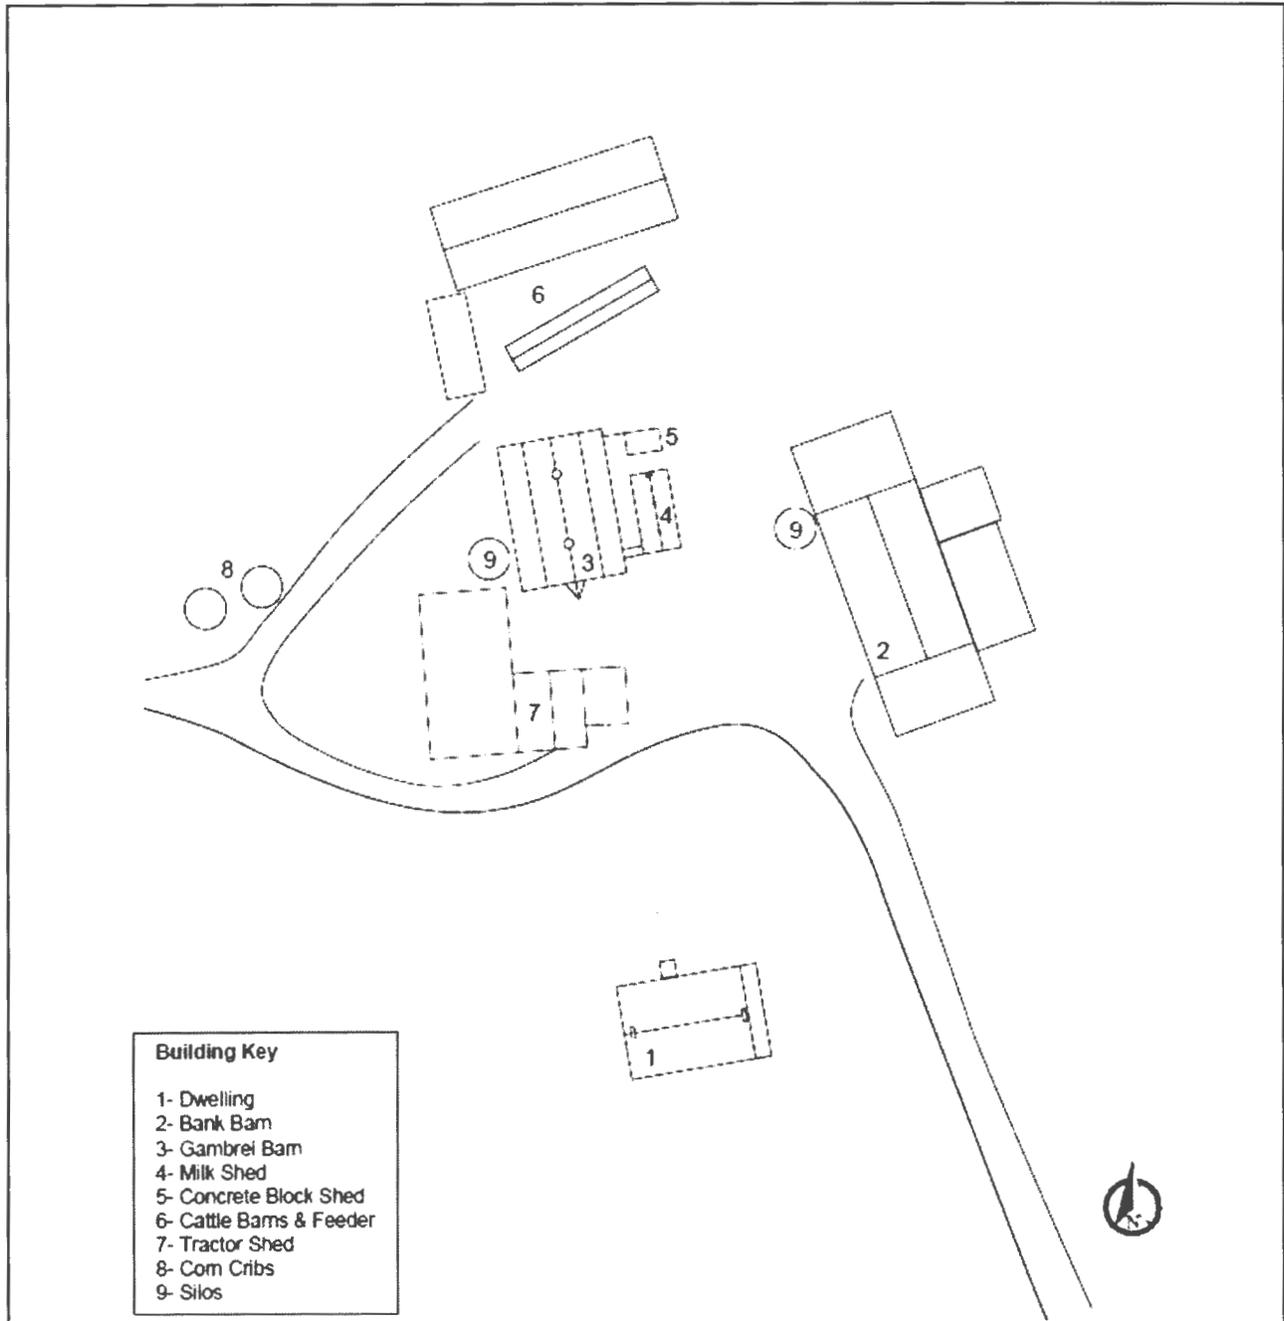
Figure 3: Ephraim Stouffer Farm, Site Plan

Building Key
1- Dwelling
2- Bank Barn
3- Gambrel Barn
4- Milk Shed
5- Concrete Block Shed
6- Cattle Barns & Feeder
7- Tractor Shed
8- Corn Cribs
9- Silos

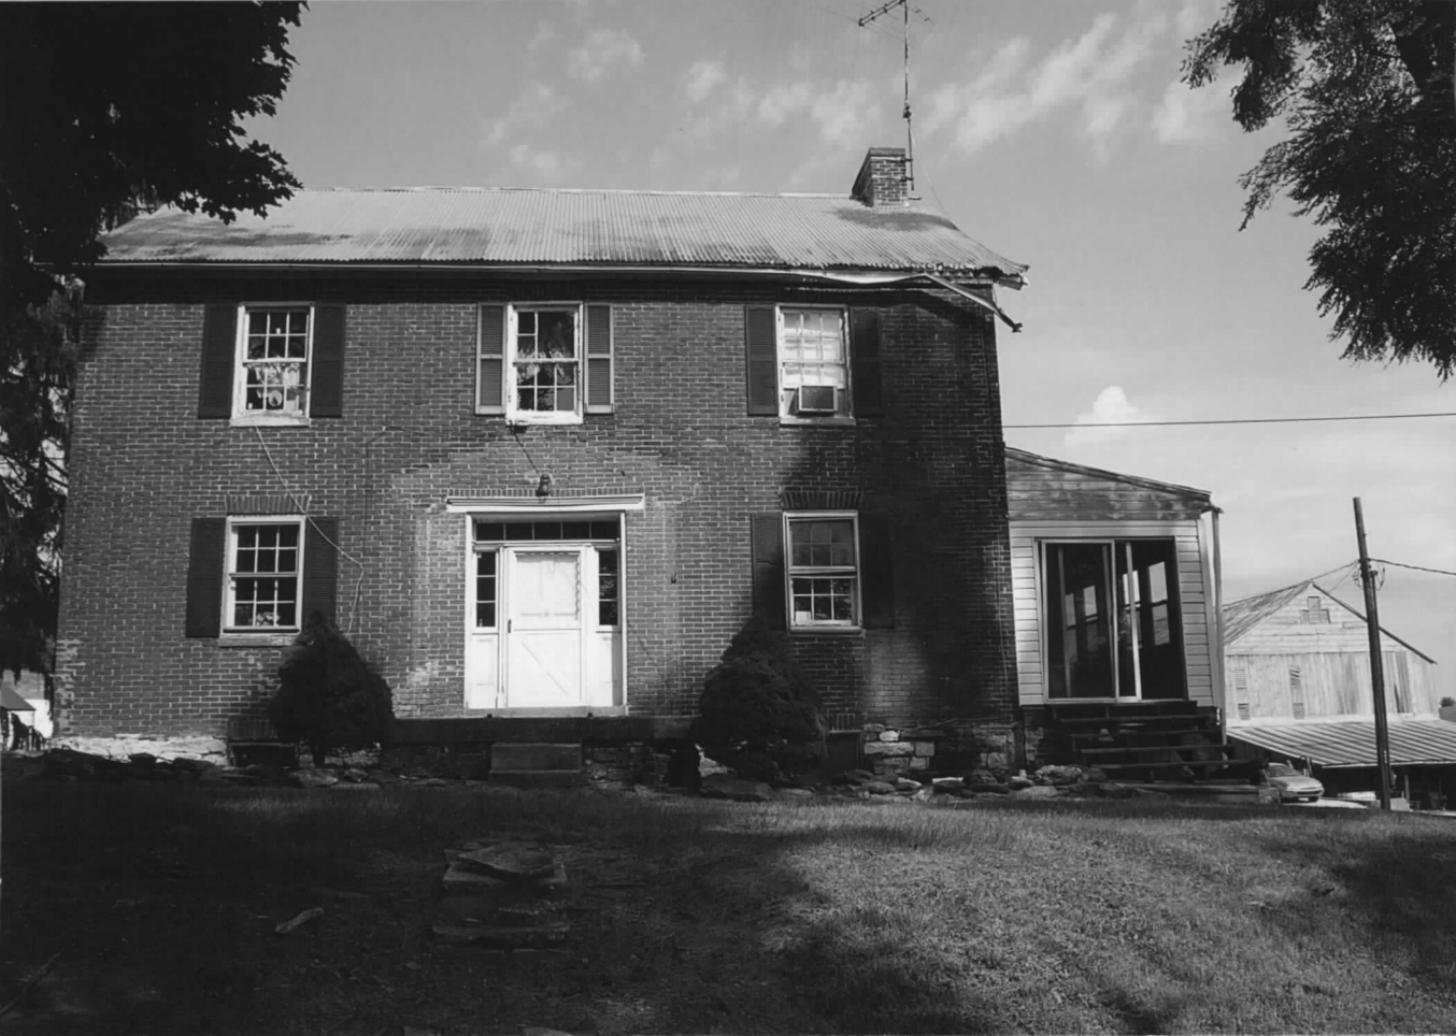
1/67

The primary elevation has two individual windows flanking the recessed, centered entrance. The original wood panel door is extant and shielded by a modern storm door. Original wood casing, three-light sidelights and a five-light transom surround the entry. Two concrete steps lead up to a centered, modern, concrete slab that sits on a brick foundation providing access to the entryway. Discoloration on the bricks surrounding the door indicates that a single-story, one-bay, pedimented portico surrounding the entry is no longer extant. The second floor has three windows that are vertically aligned over the first floor fenestration. All of the windows are six-over-six double-hung wood sashes with wood sills and angled soldier brick lintels and modern louvered shutters (Photographs 1-2).

South ELEVATION of the Dwelling, Looking NORTH

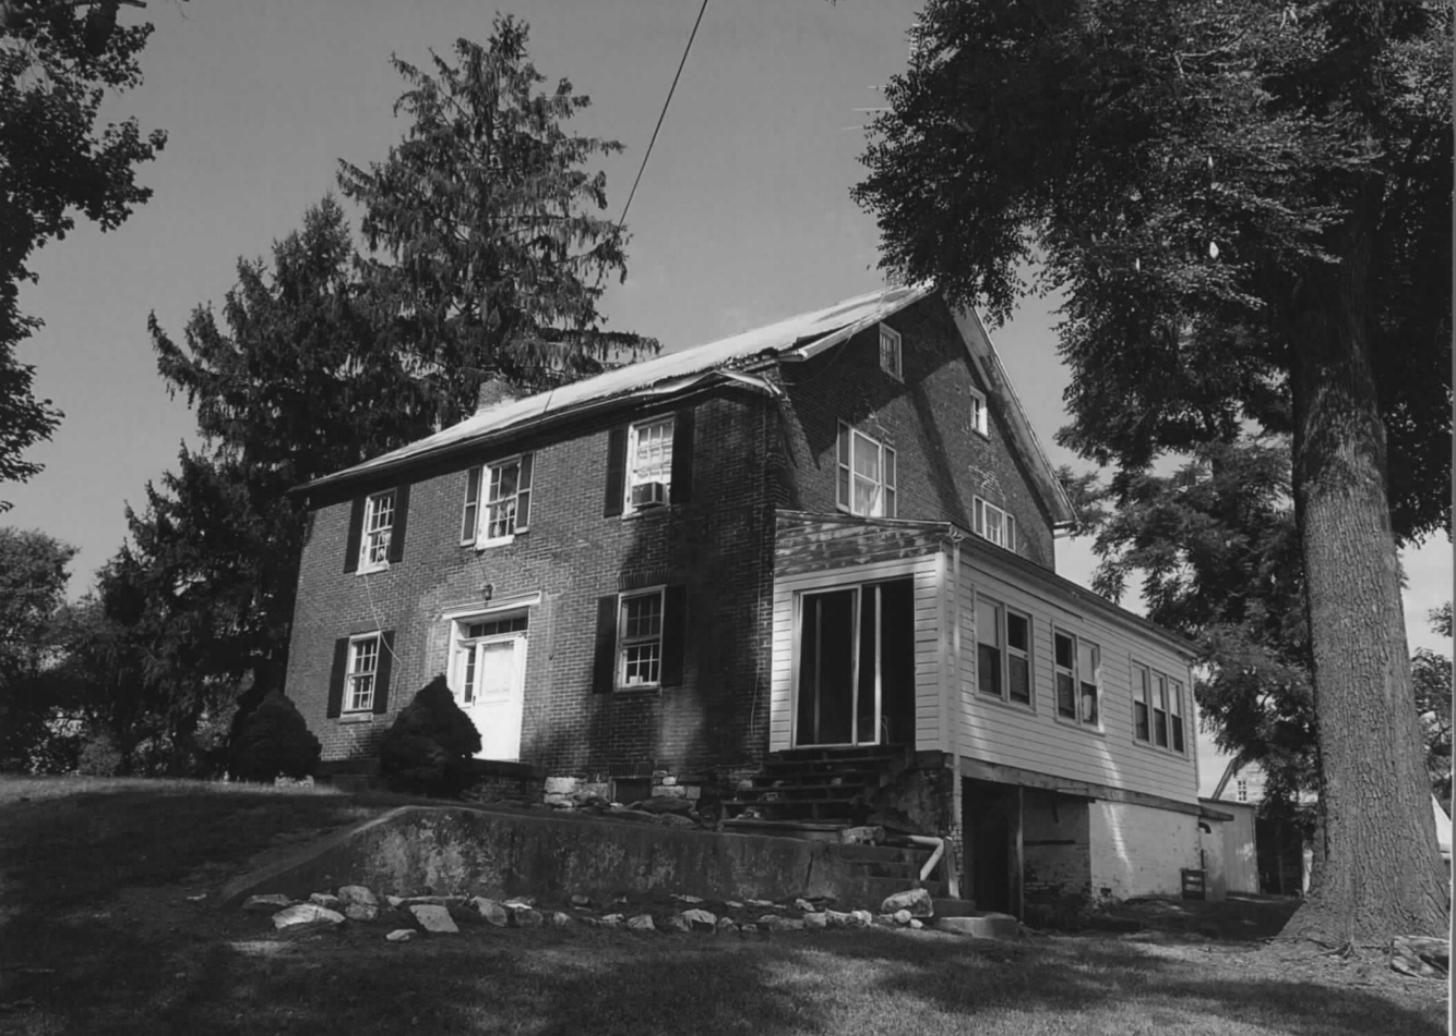
2/67

South and east elevations of the Dwelling,
Looking Northwest.

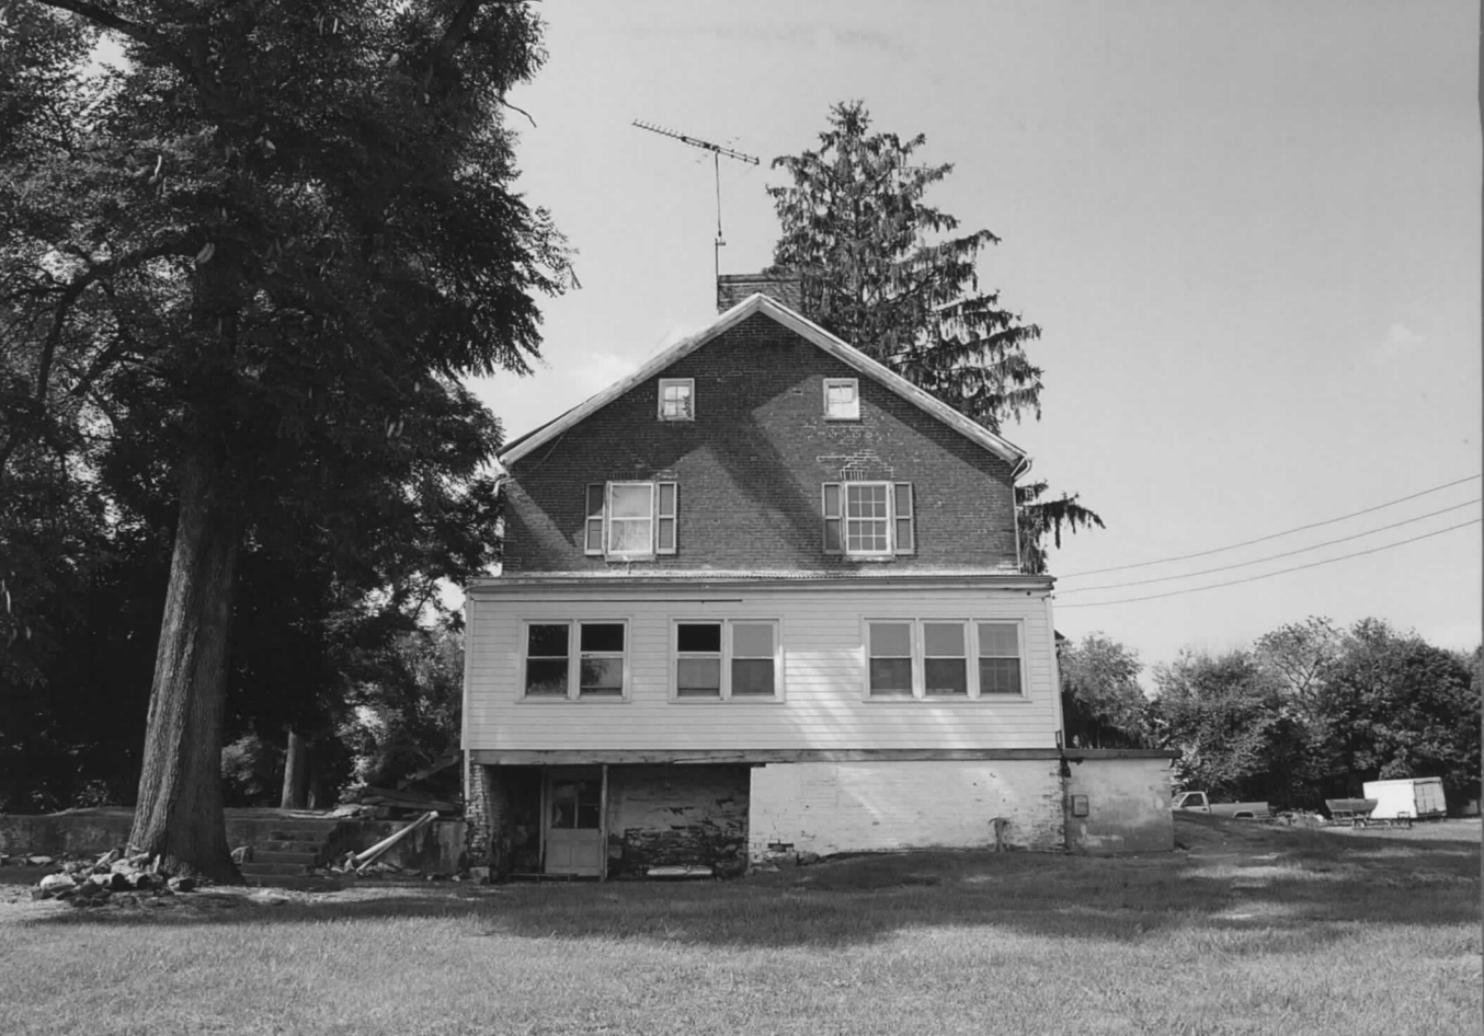
3/67

East elevation of the dwelling, looking West.

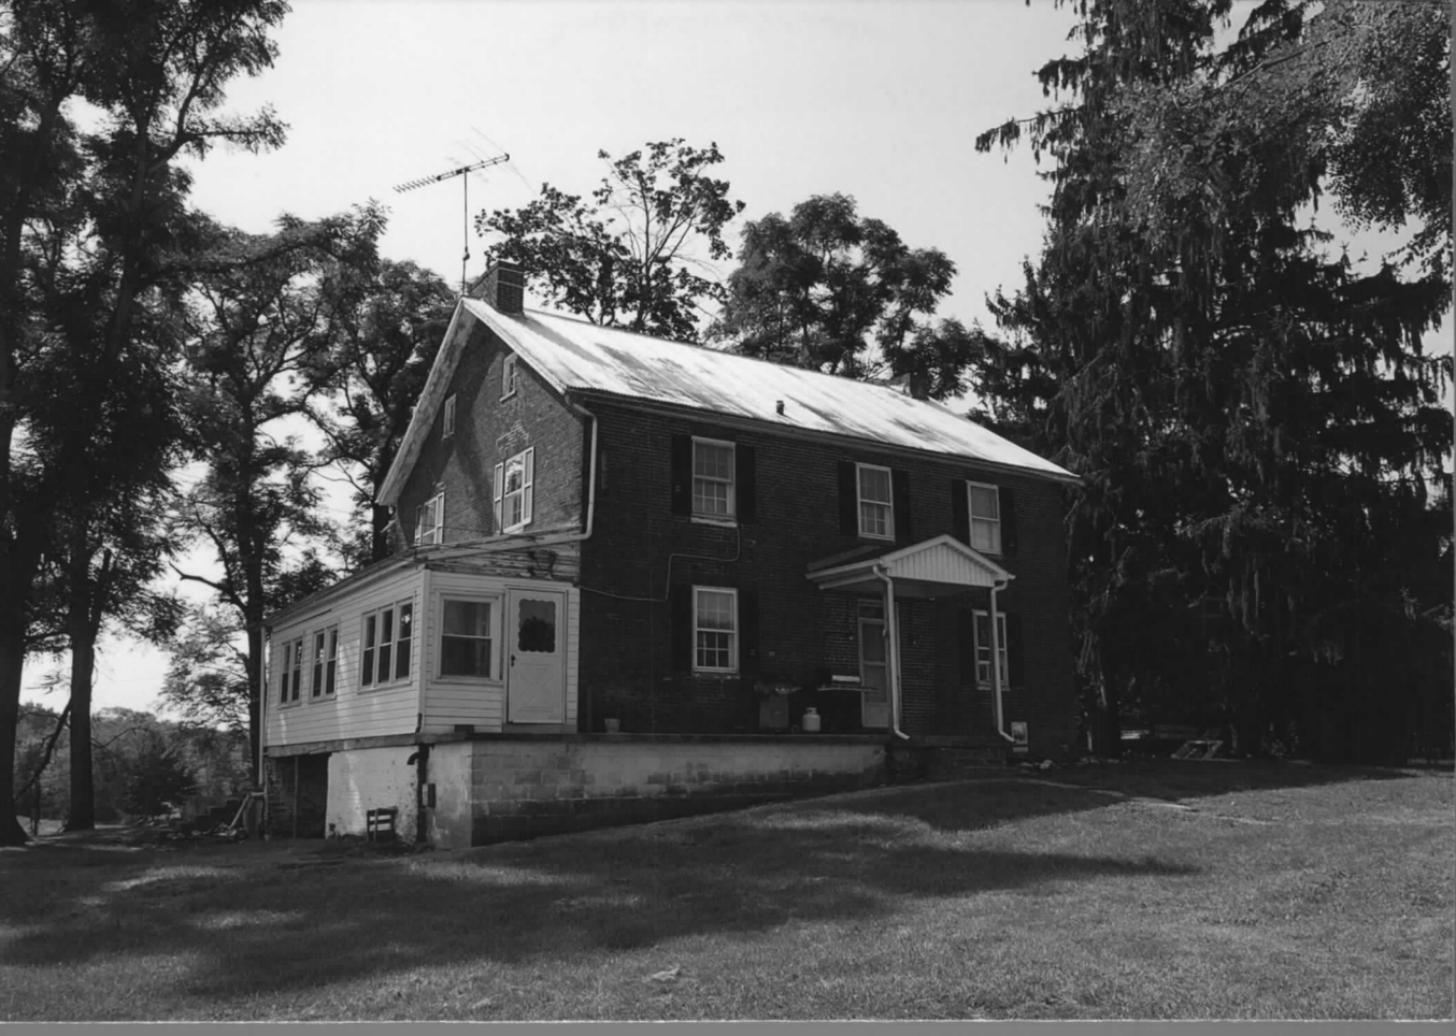
4/67

The rear (north) elevation of the dwelling is identical to the front elevation except for the entrance and the addition of a three-quarter length, CMU and concrete slab landing. The recessed entrance contains the original wood panel door with a three-light transom. The entrance is surrounded by a modern pedimented portico clad with vinyl siding and topped with asphalt shingles. The portico rests on the westernmost end of the concrete landing on top of the original slab, which is supported by a stone foundation and accessed by three concrete steps. The modern slab extends eastward atop a concrete block foundation for the remainder of the north elevation and provides access to the single-story shed addition on the east side of the dwelling (Photograph 4).

East and North Elevations of the Dwelling,
Looking southwest.

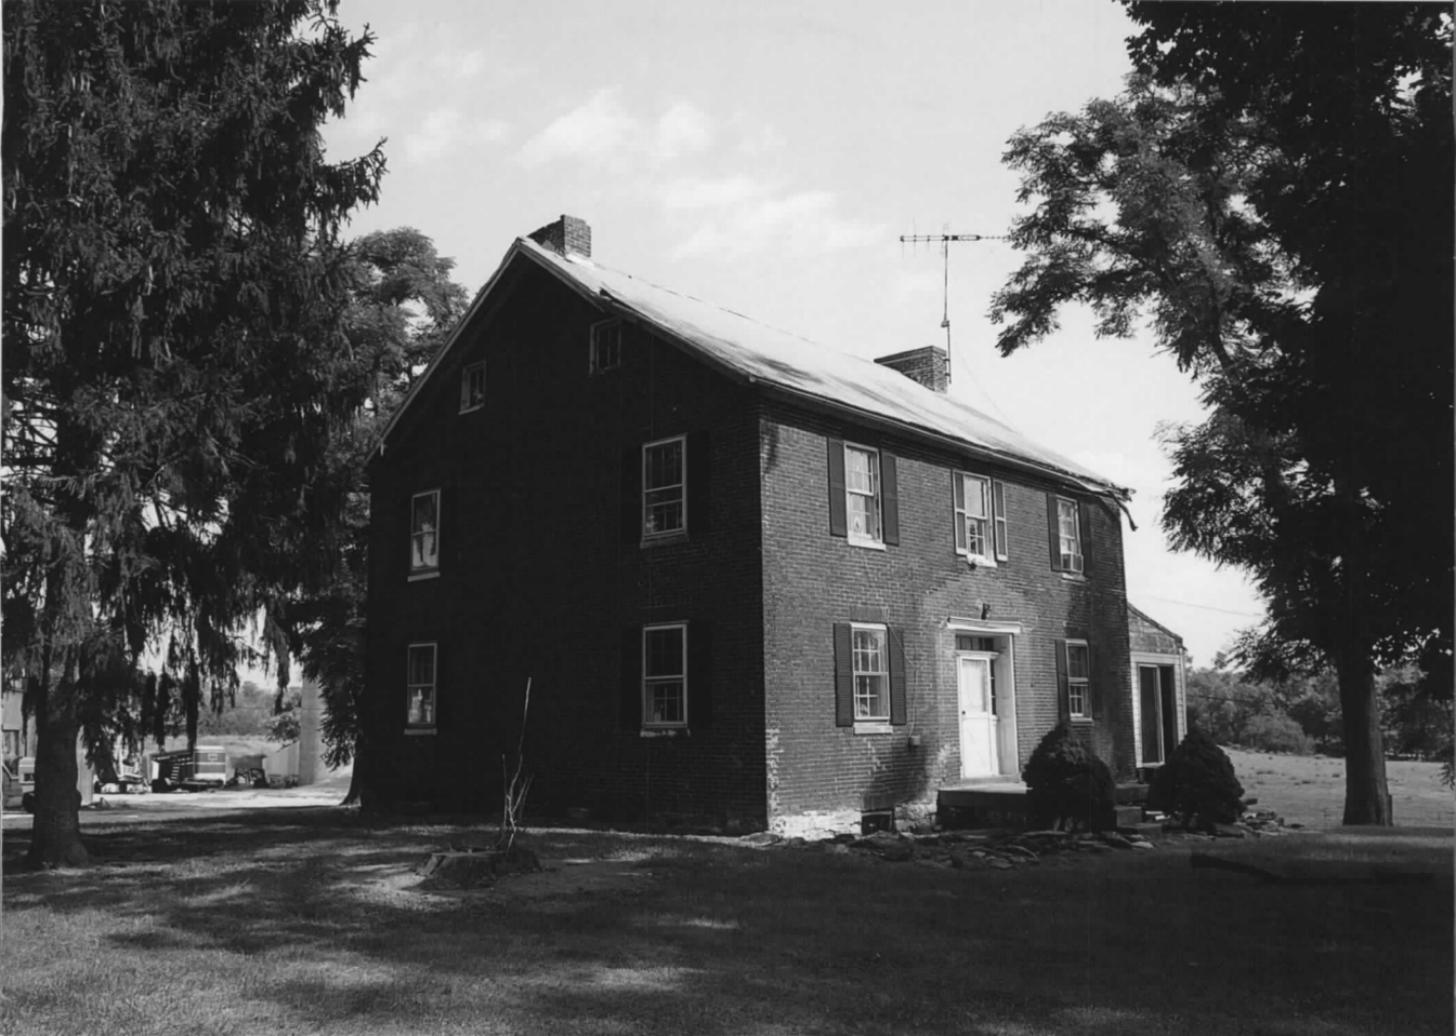
5/67

West and South Elevations of Dwelling,
Looking Northeast.

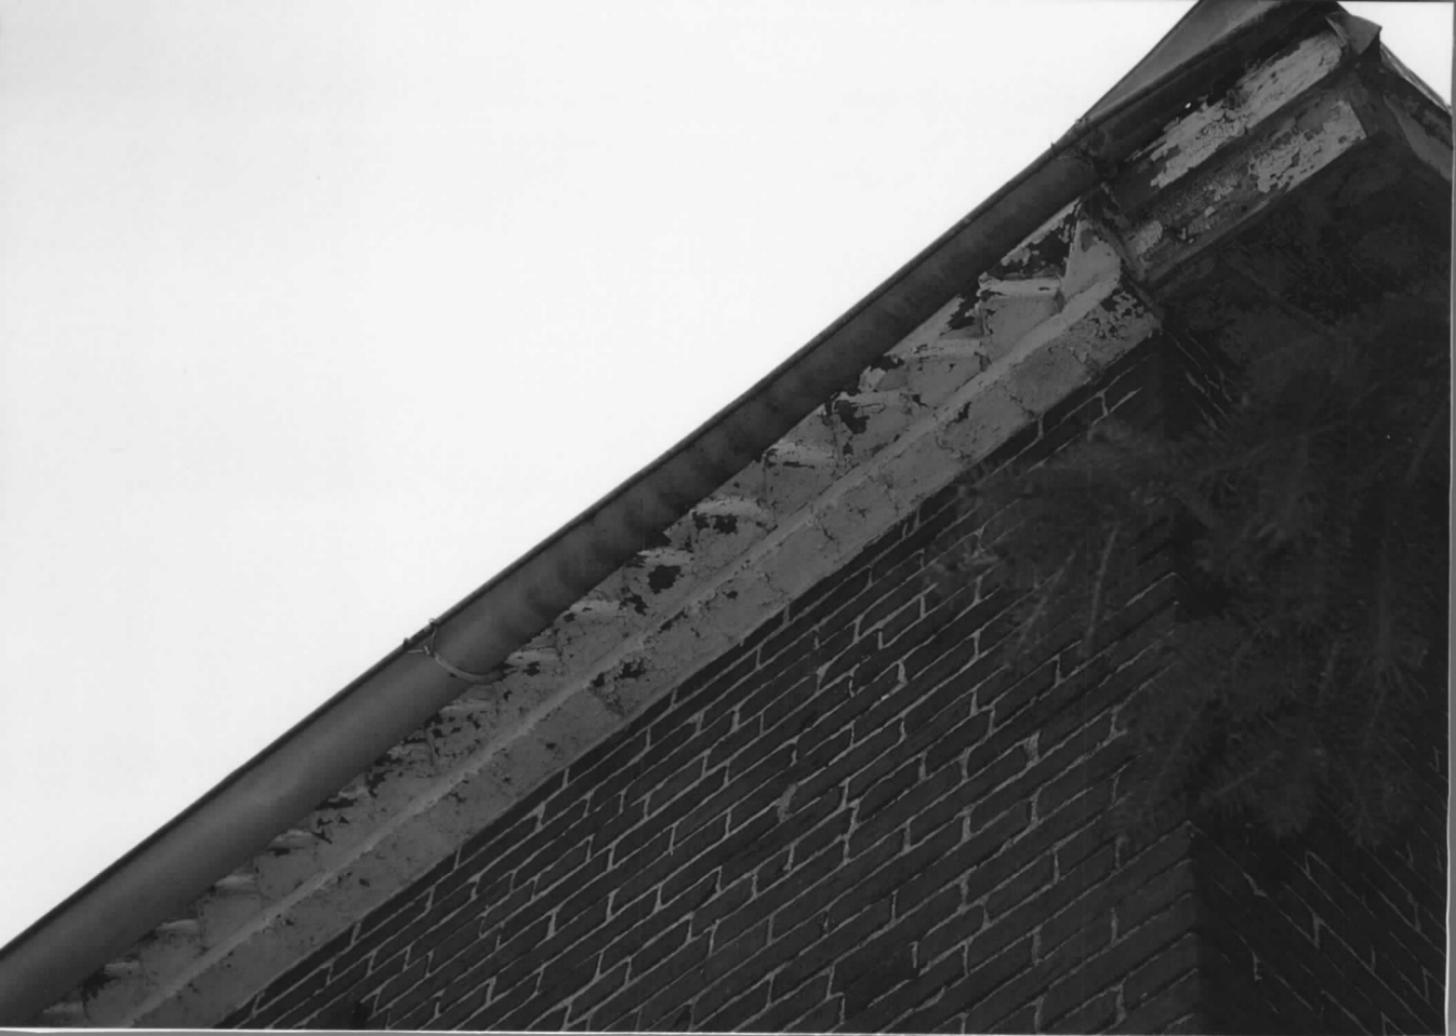
6/67

Detail view of Brick capping cornice on
north elevation of Dwelling.
