CARR-274

Jonas Ecker House
New Windsor

Maryland Historical Trust State Historic Sites Inventory Form

Survey No. CARR-274

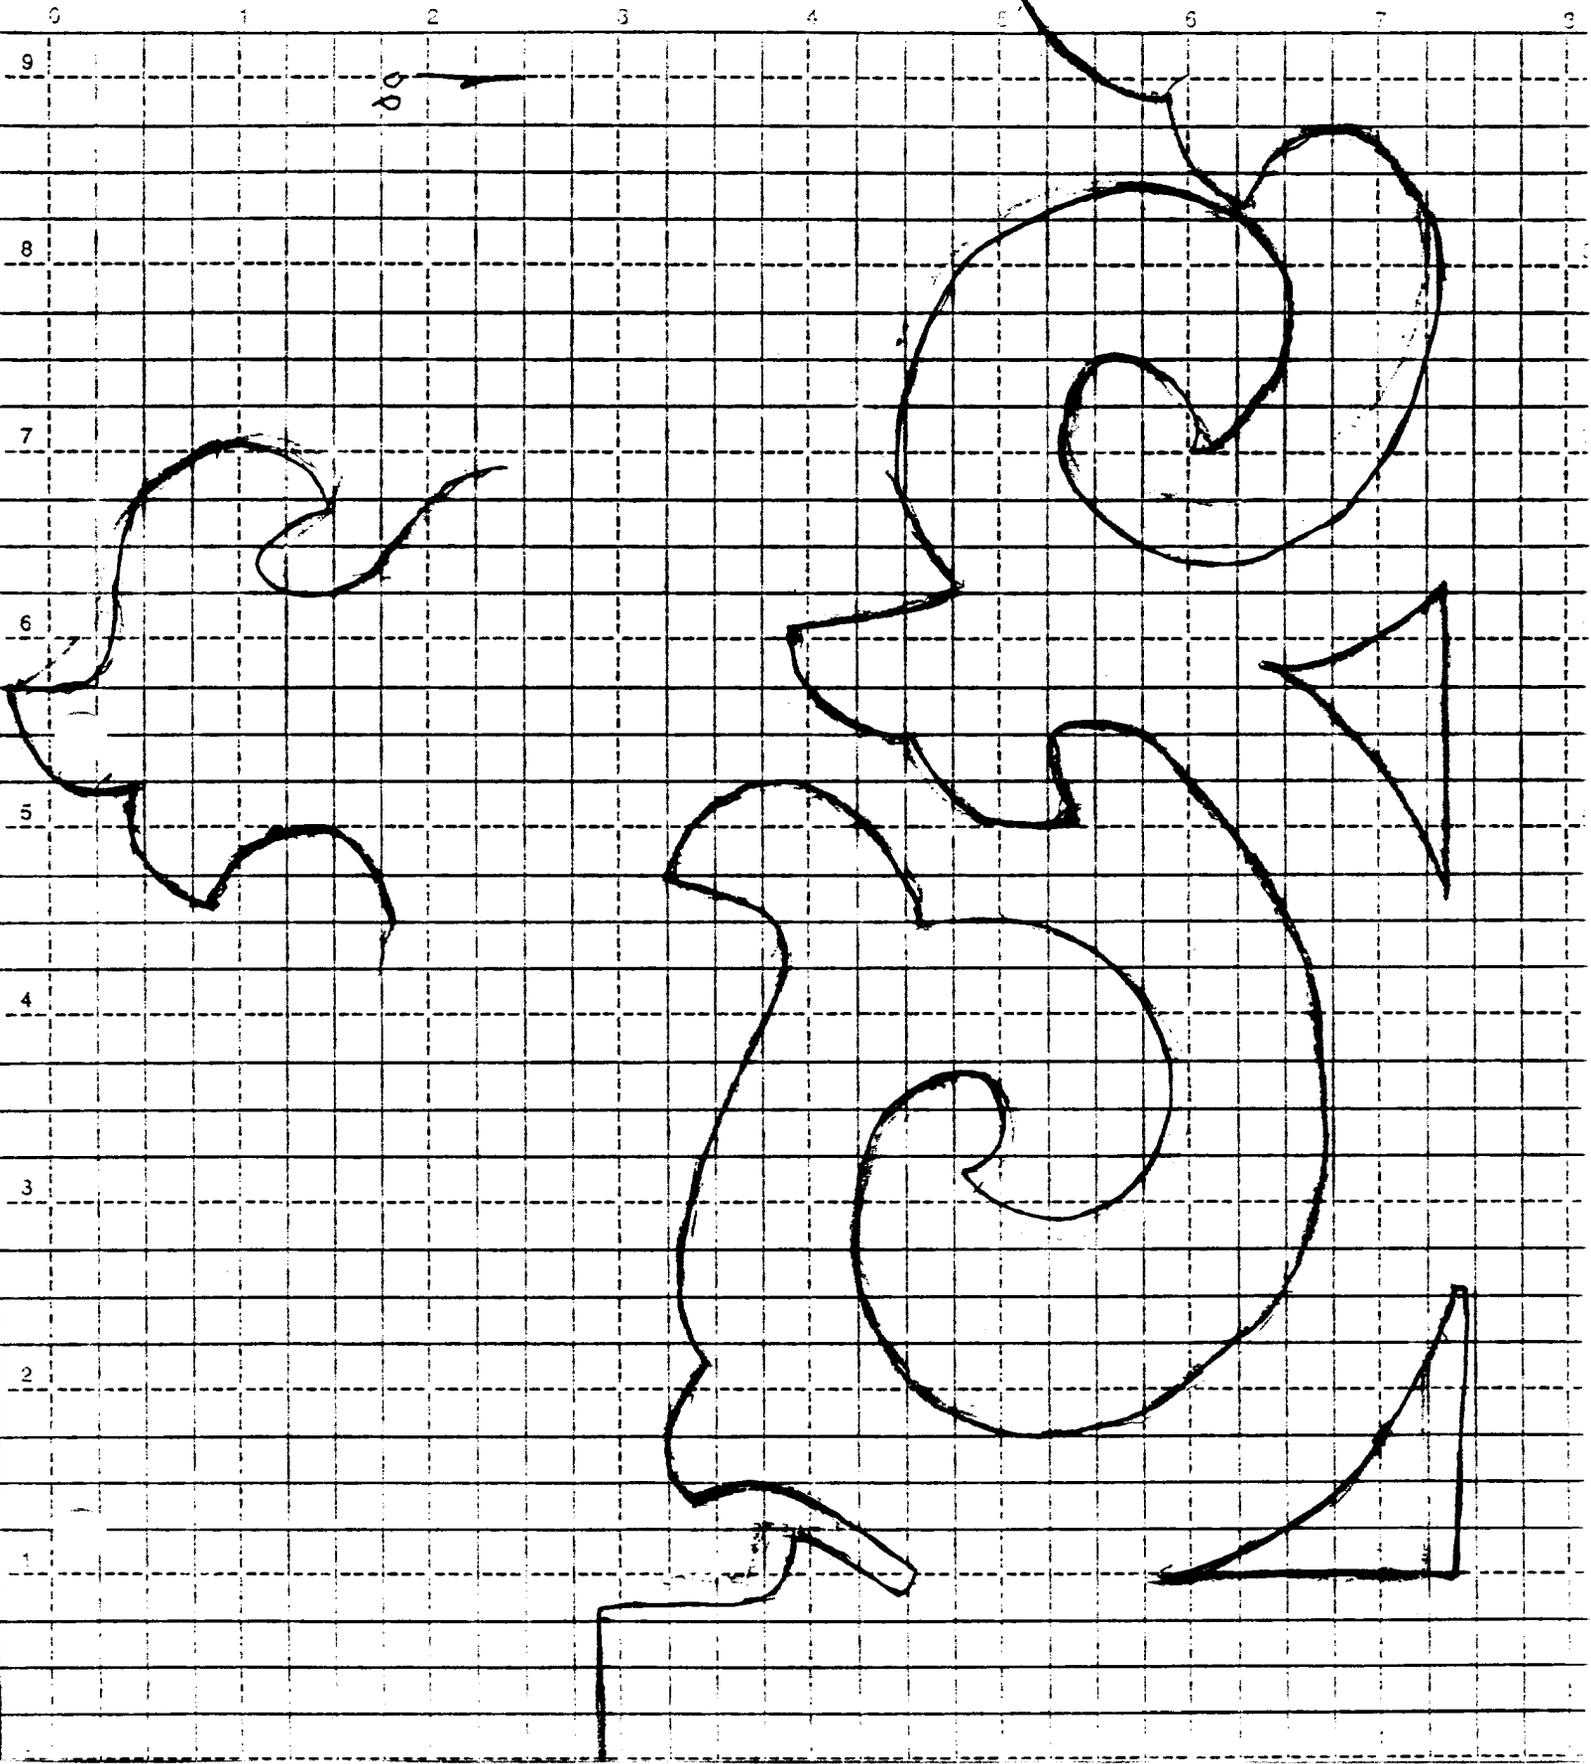
PAGE NO. 1/4

311 High St. - New Windsor
Stair Bracket

The first story has a center passage double pile plan with one room in the ell. The center passage has six panel doors with mortise locks and paneled soffits and jambs. There is a straight run of stairs on the north wall, set far back to the west, that has a winder at the west end. The stairs have a grained, combed finish, an open stringer with jigsaw brackets, turned balusters and newel, and a handrail with a ramp at the bottom. There is a closet beneath the stairs.

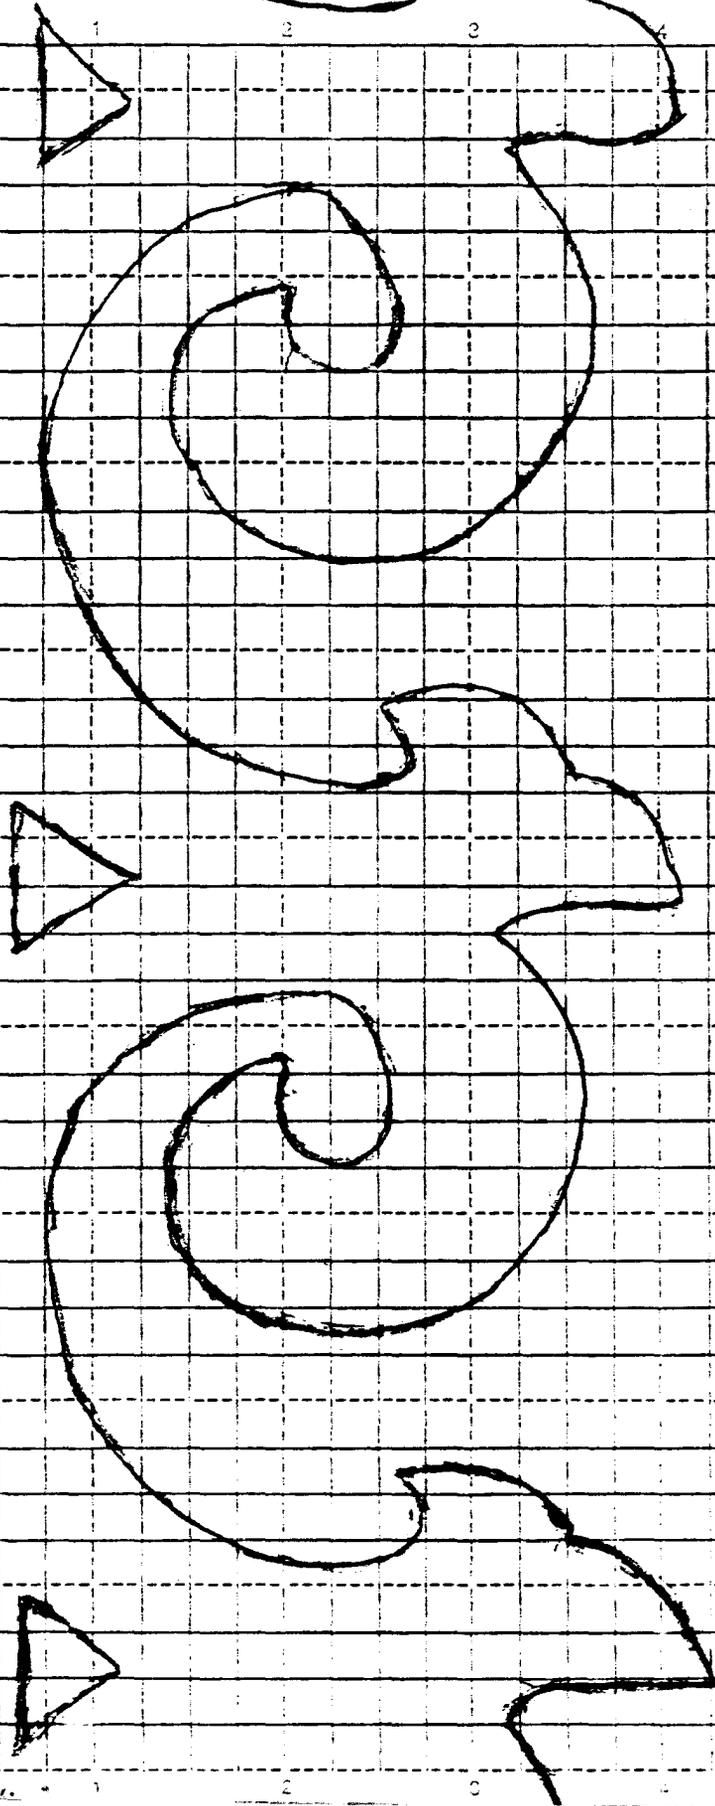
2/4

311 High St - New Windsor
Stair Apron

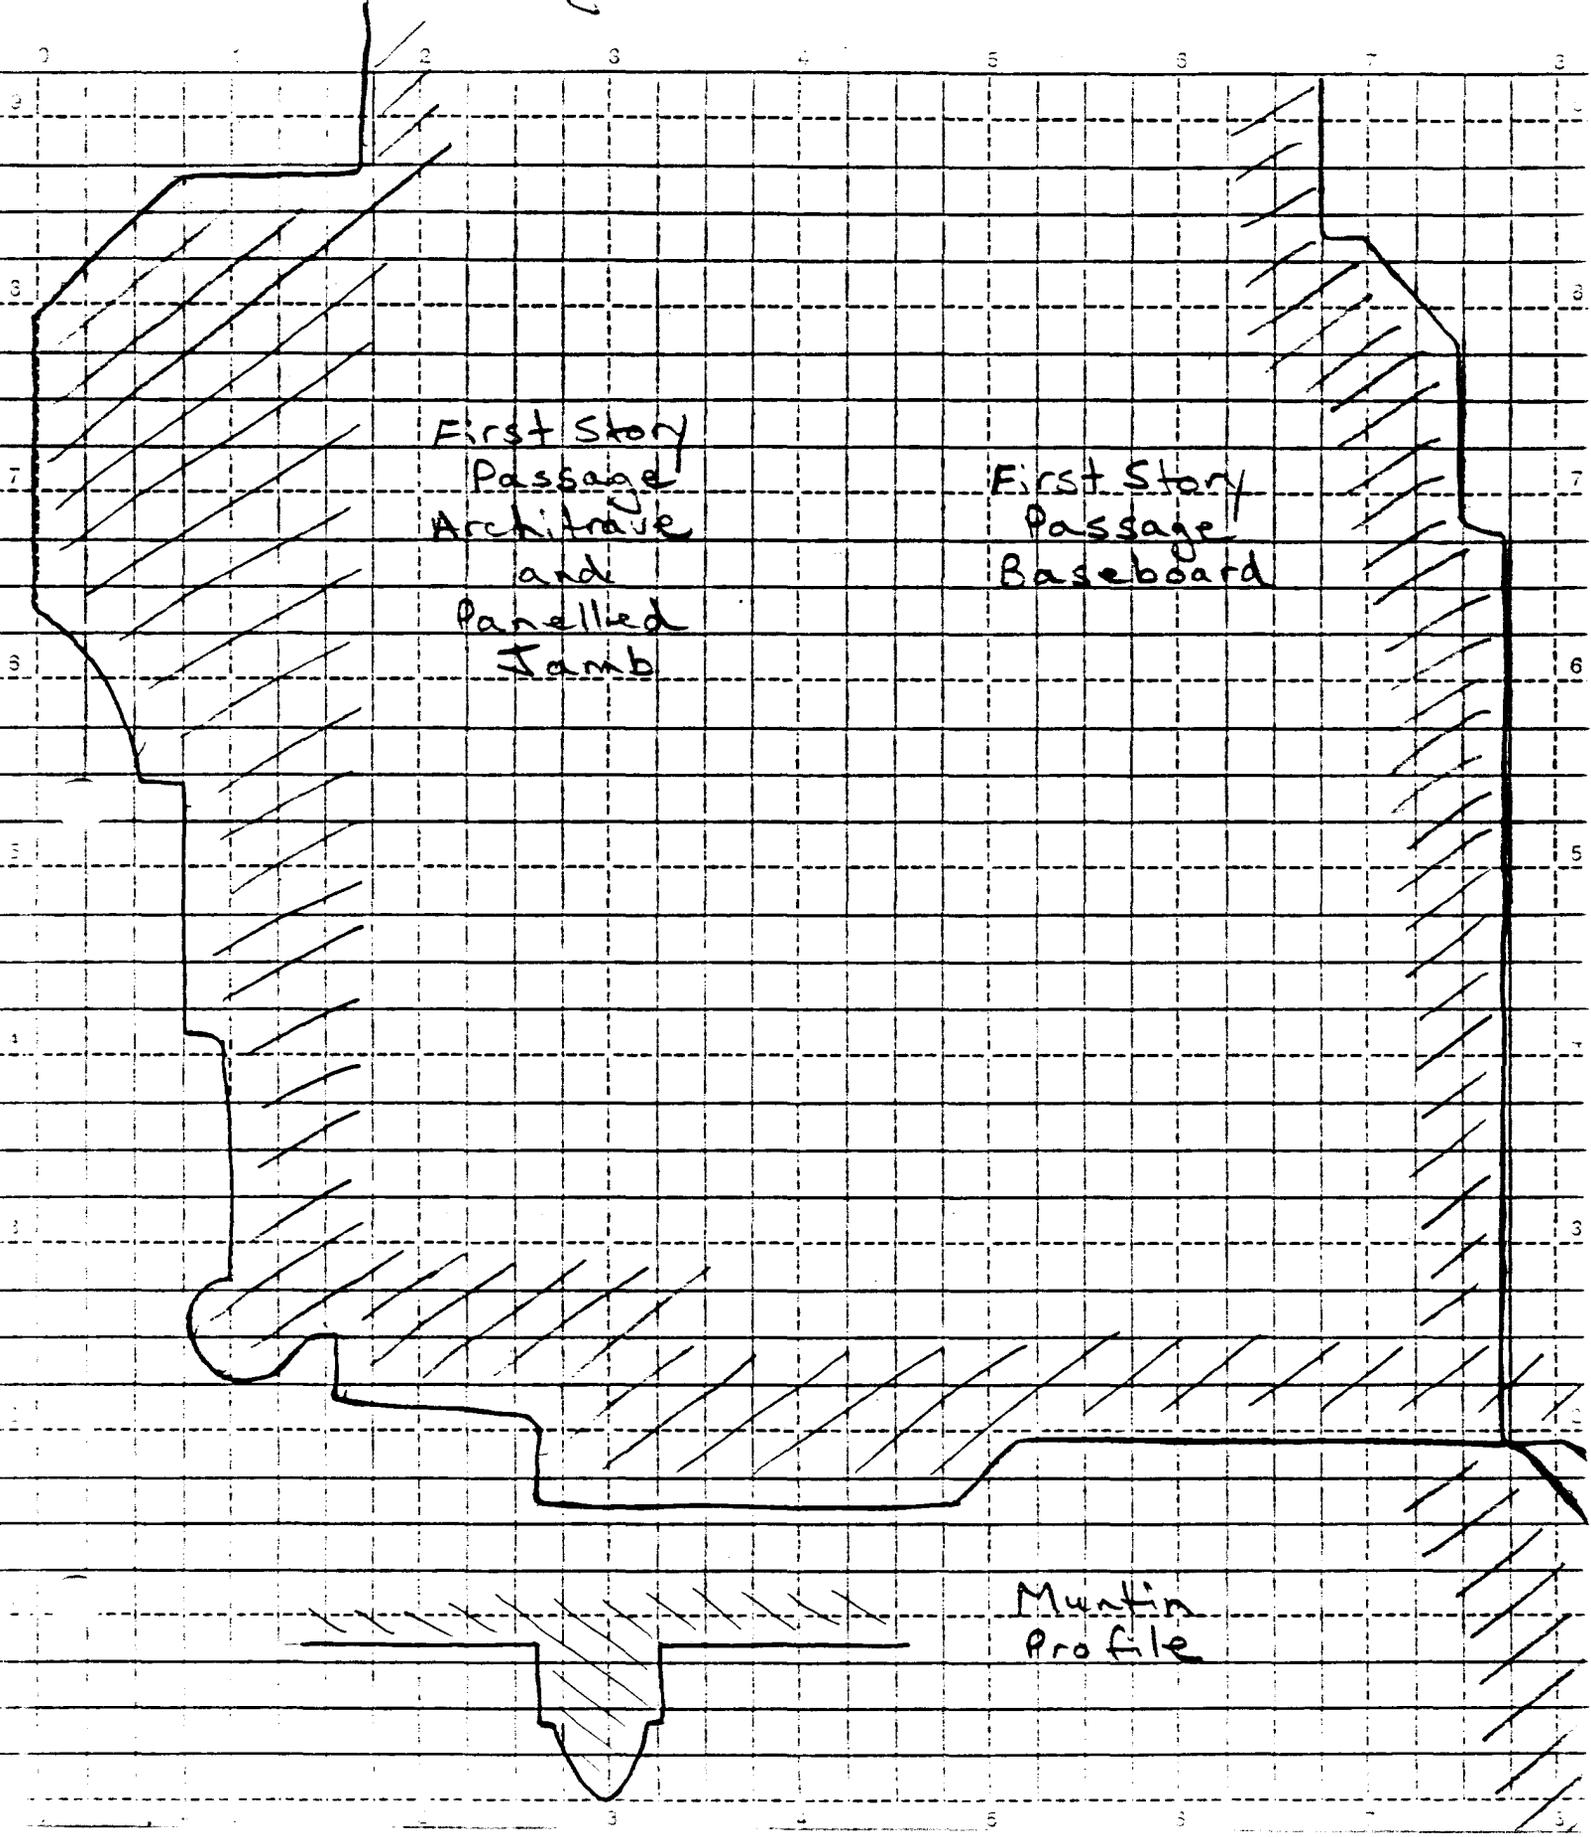
4/4

311 High St - New Windsor
Moulding Profiles

First Story
Passage
Architrave
and
Panelled
Jamb

First Story
Passage
Baseboard

Muntin
Profile

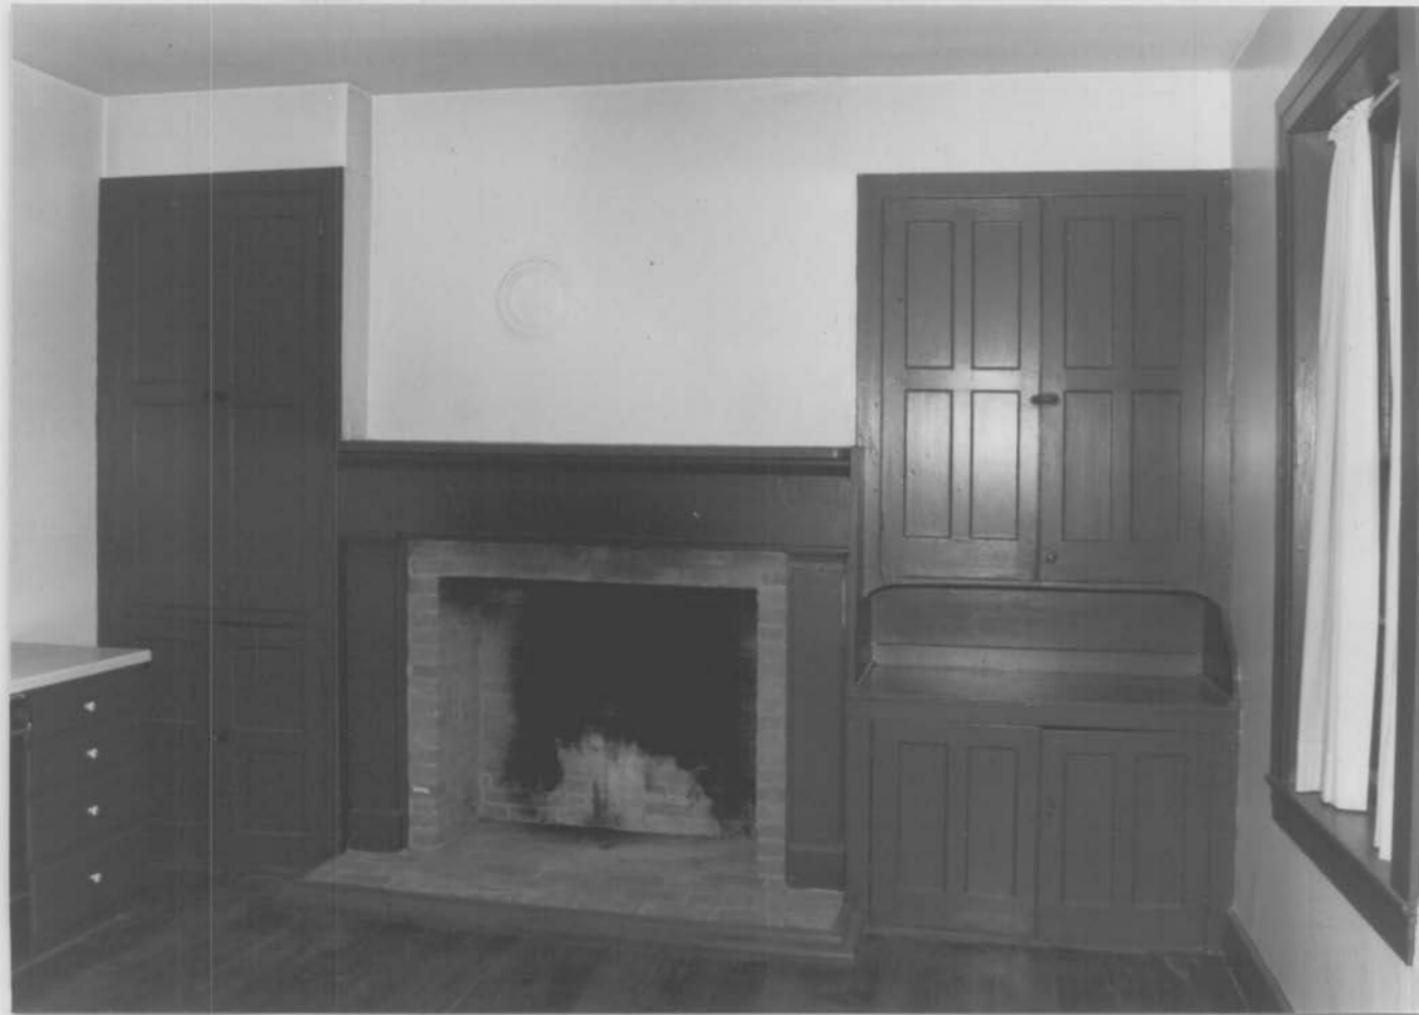
13/15

SE chamber - south elev.

In the southeast chamber the south wall has a fireplace with a wood mantel that has pilasters and a plain frieze. To the west of it is a closet with a large six-panel door and two rows of metal hooks inside. The southwest chamber has a fireplace on the south wall that is identical to that in the southeast chamber. To the east of it is a closet with a six-panel door and with drawers below the door. The northeast chamber has no fireplace. On the north wall, to the west, is a tall closet with a three-panel door. The northwest chamber has a fireplace centered on the north wall that is identical to that in the southeast chamber. The west wall has a typical door to the ell.

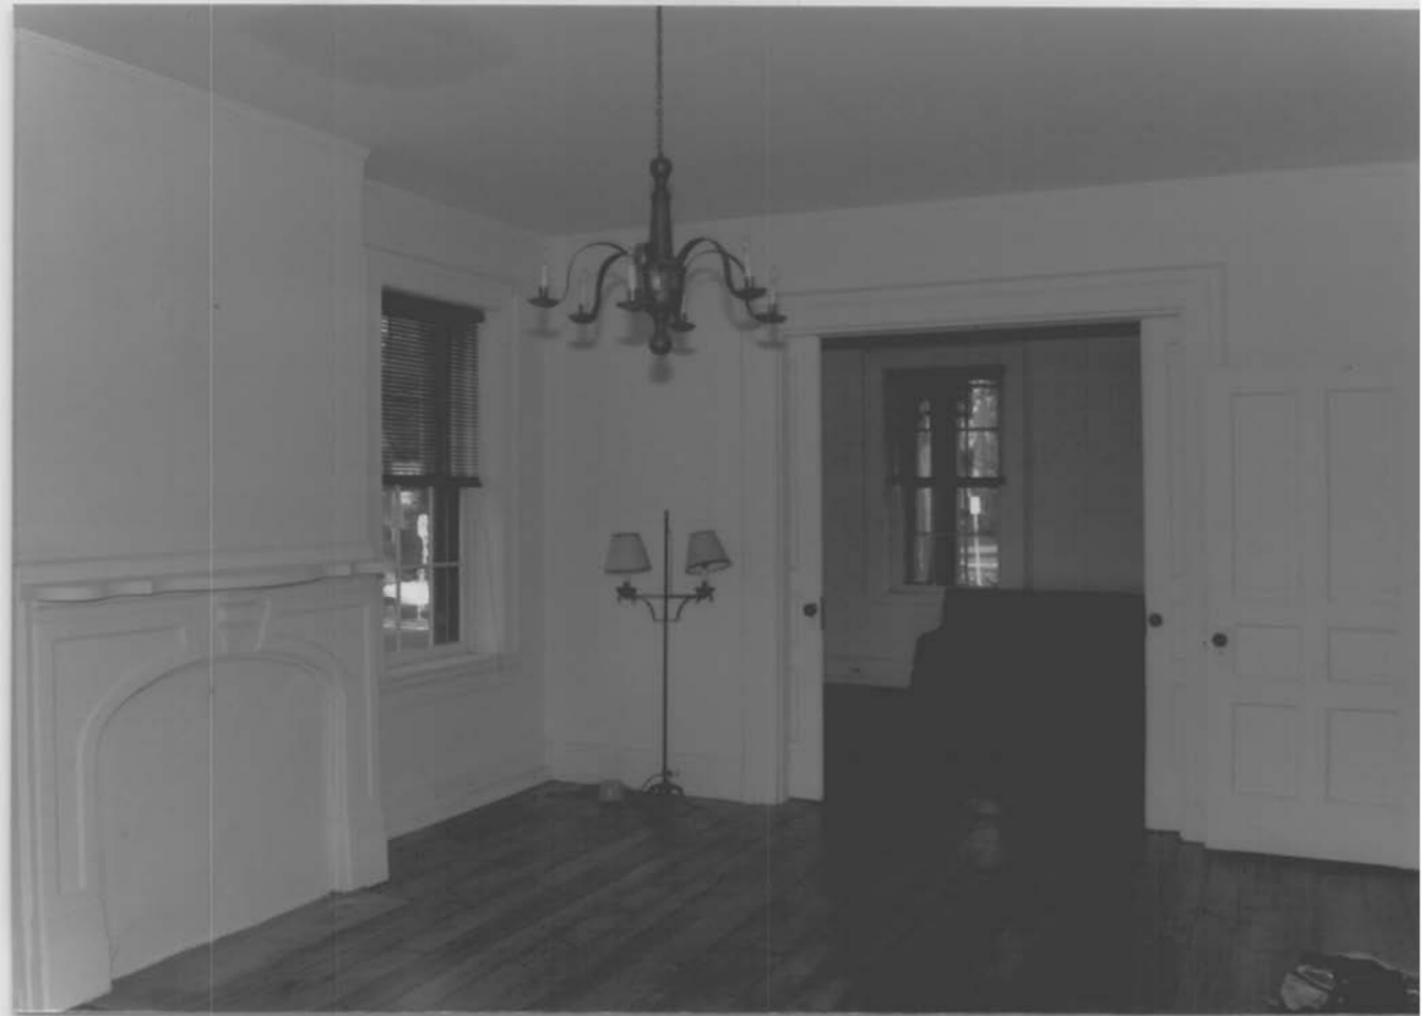
11/15

SE & SW rooms - view SE

The southeast room has a fireplace centered on the south wall. It has a segmentally-arched wood mantel with a center bracket and the shelf is decoratively cut. The fire box is parged and has splayed jambs. The windows also have plain splayed jambs. The west end has double pocket doors. The southwest room is smaller than the southeast, but the south wall has a fireplace identical to that in the southeast room.

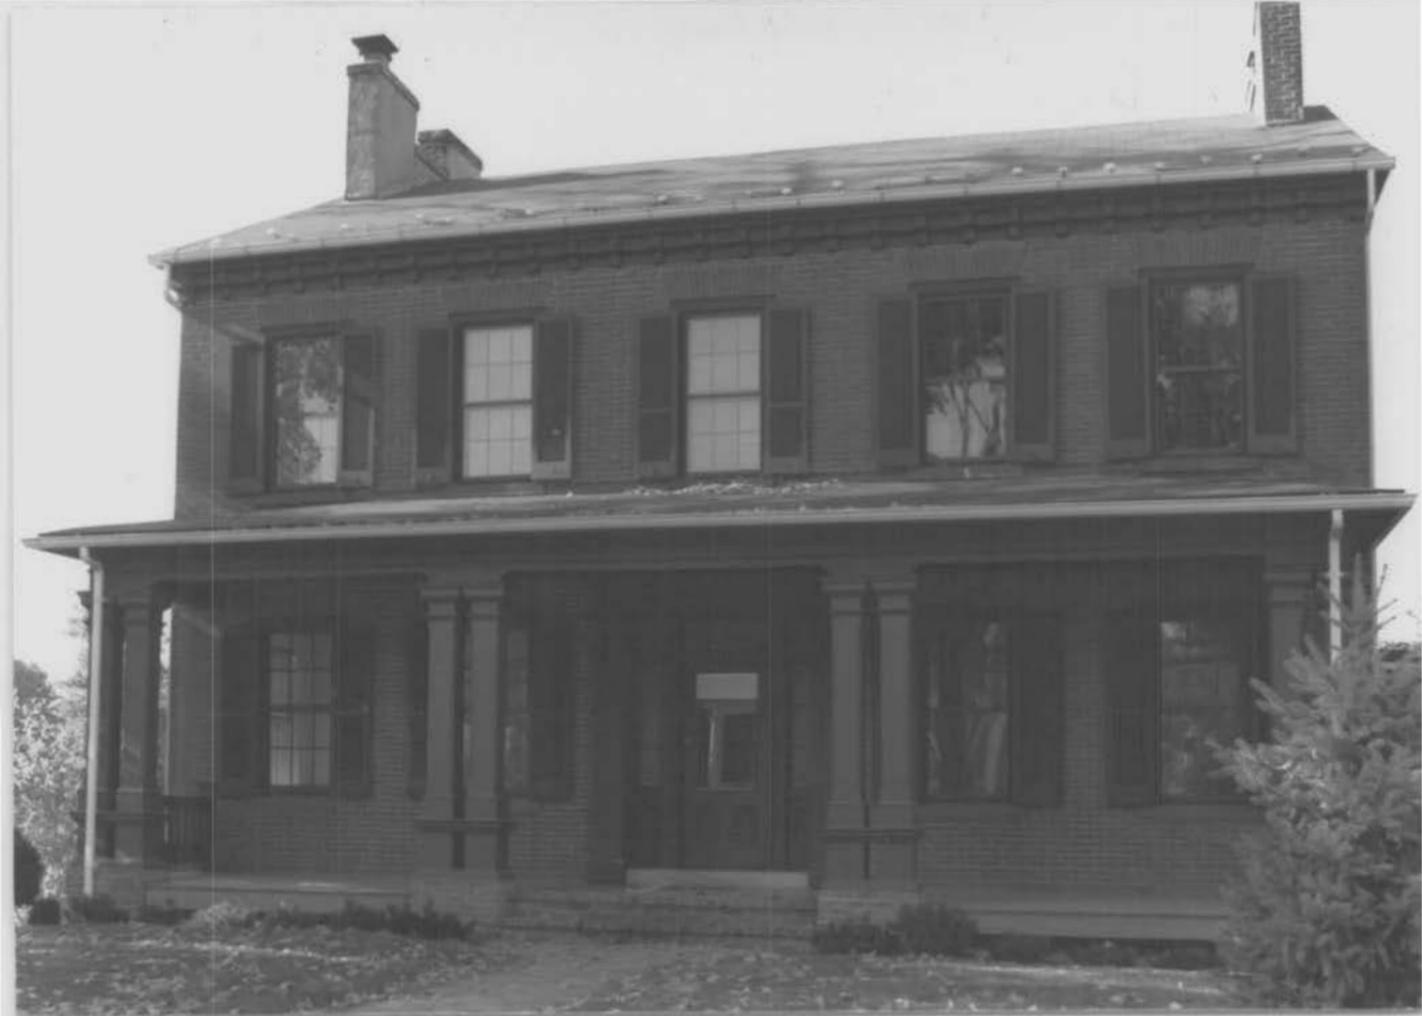
3/15

Neg. Loc.: Maryland Historical Trust
east elev. - doorway

light of beveled glass over two belection-moulded panels. The side lights each have three lights of pressed glass and there is a two-light transom above the door and one light above each sidelight. The doorway has a marble sill and paneled jambs and soffit. There are paneled pilasters, and a plain frieze and ogee cornice above the transom. On either side of the center doorway are two 6/6 double hung sash with exterior architraves, brownstone sills, and blinds. The brick is painted red and was probably penciled although now the paint is mostly gone. There is a one-story, five-bay porch with four pairs of large square columns supporting a full entablature and a hip roof with asphalt shingles. The balustrade has rectangular vertical balusters set between horizontal board rails that have semi-circular cut outs between the balusters. The second story has five typical 6/6 sash. The brick cornice has two corbelled courses.

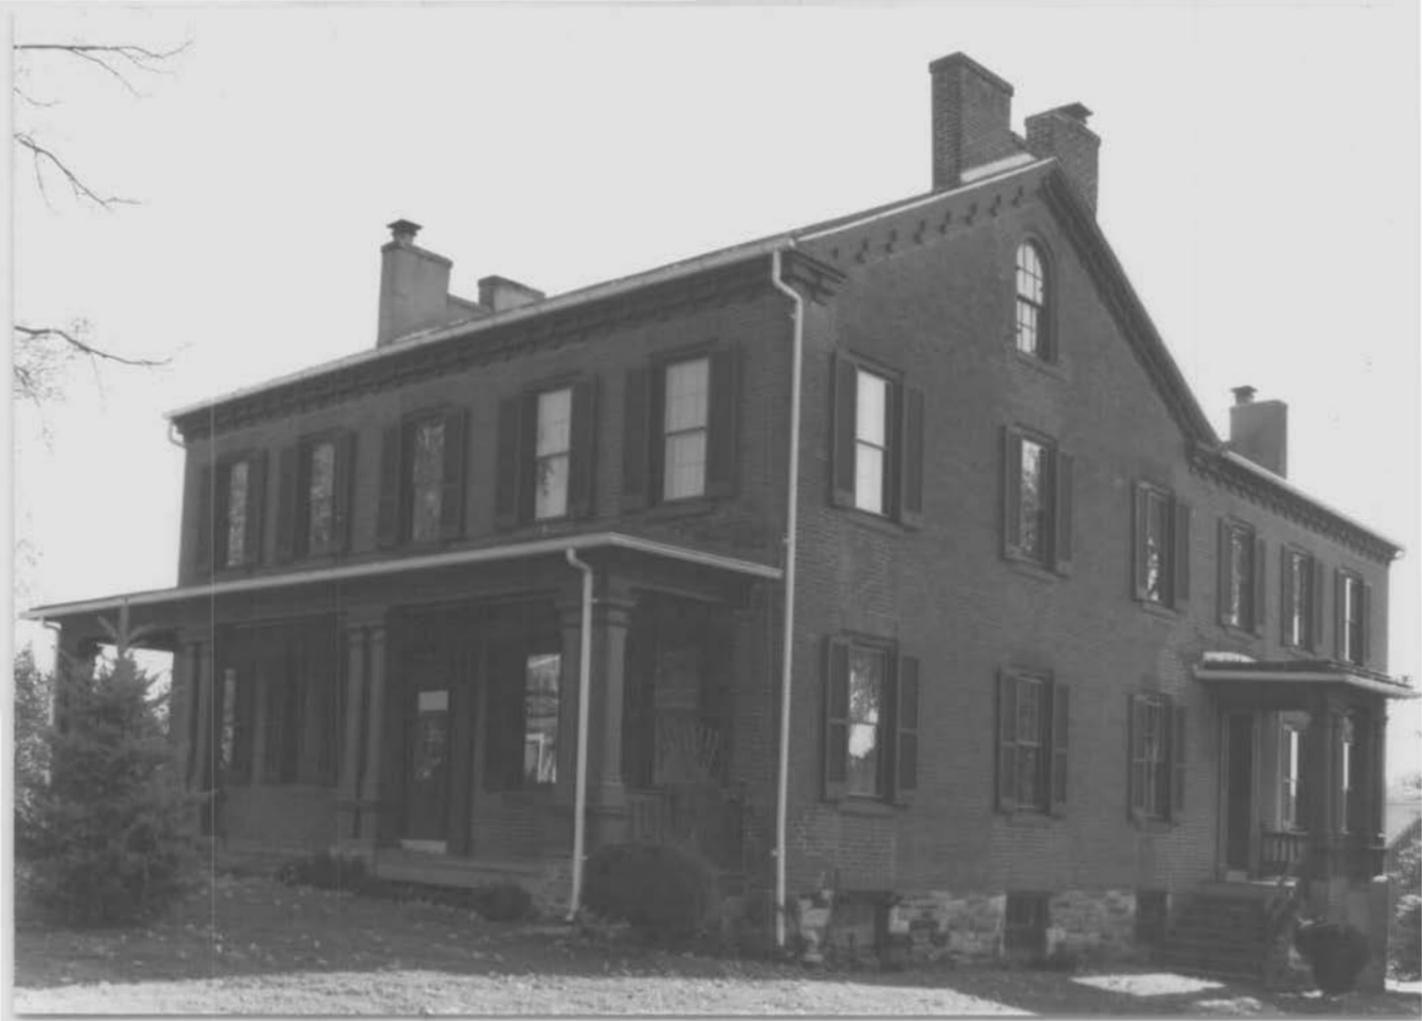
2/15

Neg. loc.: Maryland Historical Trust
east elev.

On the east elevation the first story has a center entrance with a door that has one
