National Register of Historic Places  
Inventory—Nomination Form

historic Rockland Farm (preferred); Arter House

Continuation sheet Rockland Farm  
Carroll County, Maryland Item number 7 Page 1

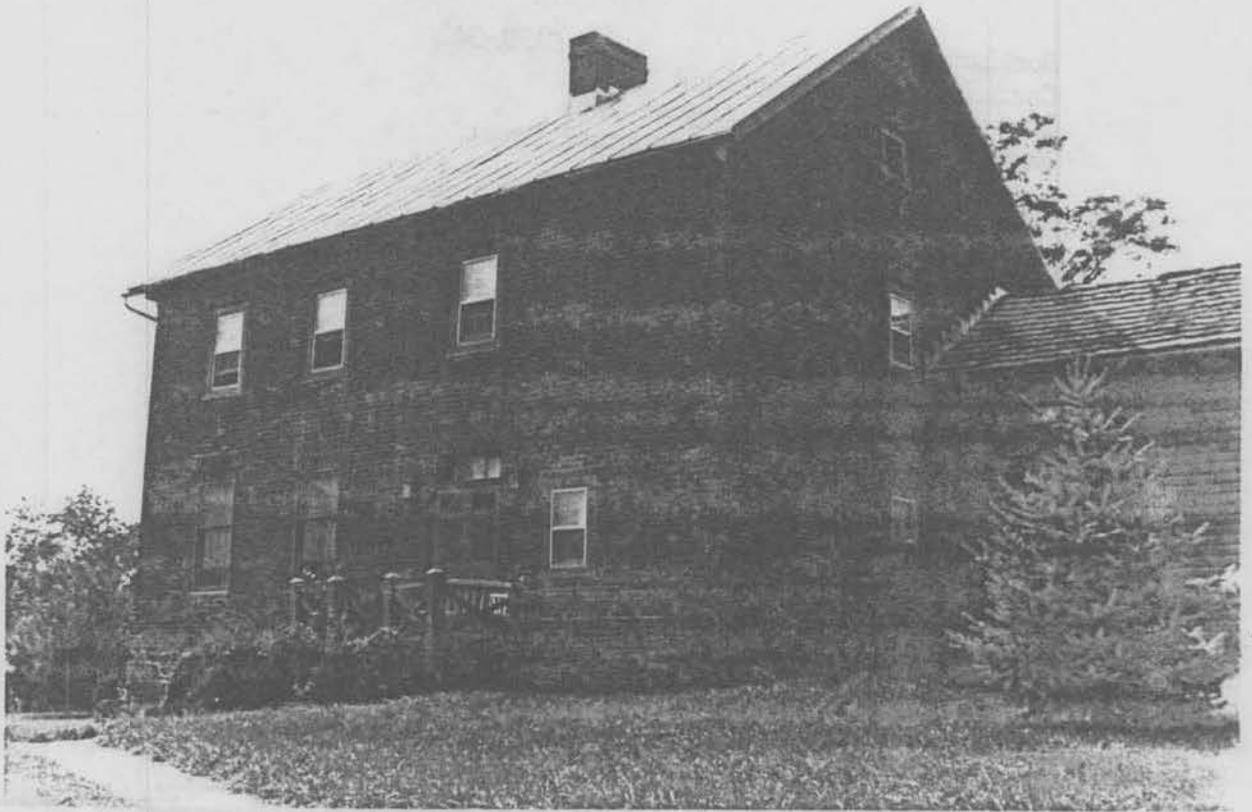
1/24

view from northeast

This farmhouse is a two-story, three-bay by two-bay brick structure on a stone foundation. It is built into a slope so that the main facade has both a ground level basement entrance on the southern side and an entrance on the northern side of the first story. The brickwork on this facade is Flemish bond, while the other elevations are laid in common bond. A molded watertable runs along the main and south facades. The house has a gable roof covered in standing seam sheet metal and a boxed cornice. The chimney is centrally located along the ridge of the roofline.

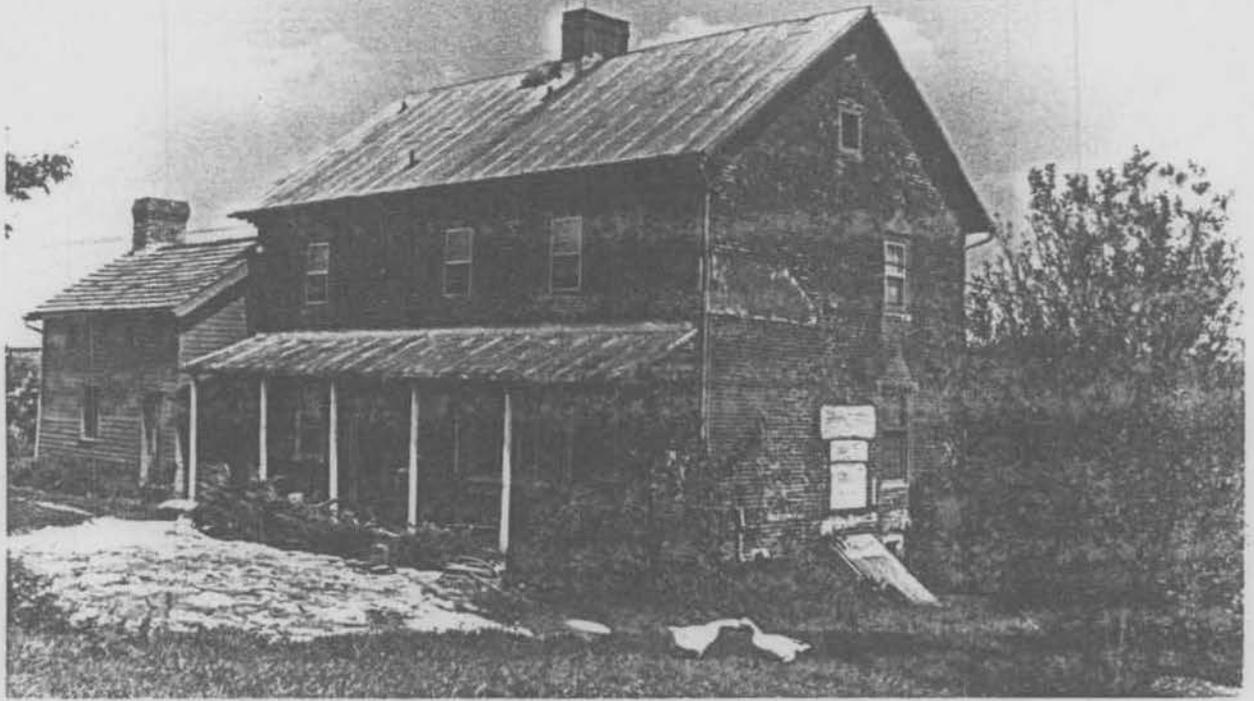
5/24

Rockland Farm  
Carroll County, Maryland  
Photo by Joe Getty, August 1985  
Negative at Maryland Historical Trust  
view from southwest

The south gable end of the brick house has windows located towards the east side. There is a basement window with arched brick lintel, an eight-over-twelve sash window on the first story, a six-over-six window on the second story and four-pane casement window centrally located on the gable. A bulkhead entrance centrally located at the basement is a 20th century alteration. This facade also contains evidence, including paint marking,

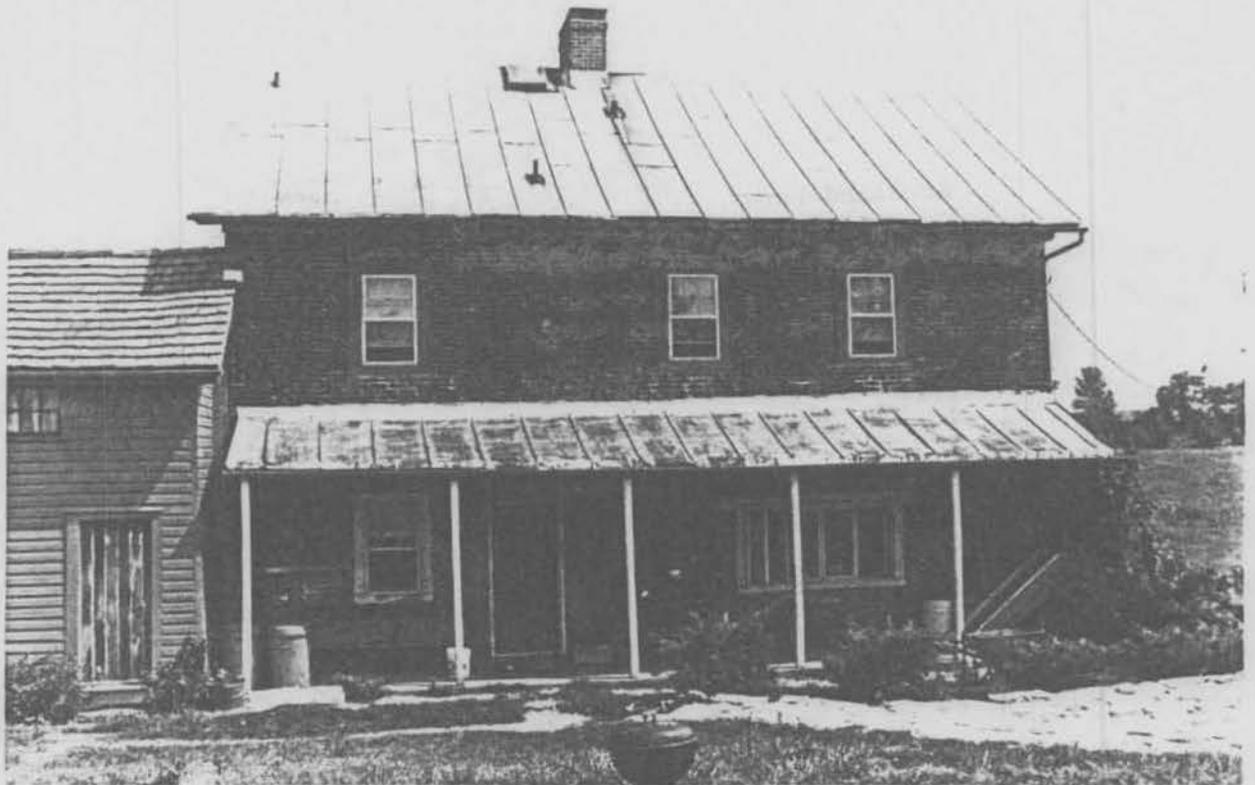
6/24

Rockland Farm  
Carroll County, Maryland  
Photo by Joe Getty, August 1985  
Negative at Maryland Historical Trust  
west elevation

The west facade is three bays wide with an asymmetrical arrangement. The entrance is located off-center in the second bay from the north (so that it is in line with the entrance on the main facade). The northernmost bay, and the three bays on the second story contain six-over-six sash windows with wide pegged frames. An unusual feature is the wide, horizontal window in the southernmost bay of the first story. While the panes in this window have been replaced, the framing appears to be early. However, this conflicts with the traditional use of this room as a bedroom, and probably the window is an early-to-mid 19th century alteration. The full-length, one-story porch on this facade also dates from that period.

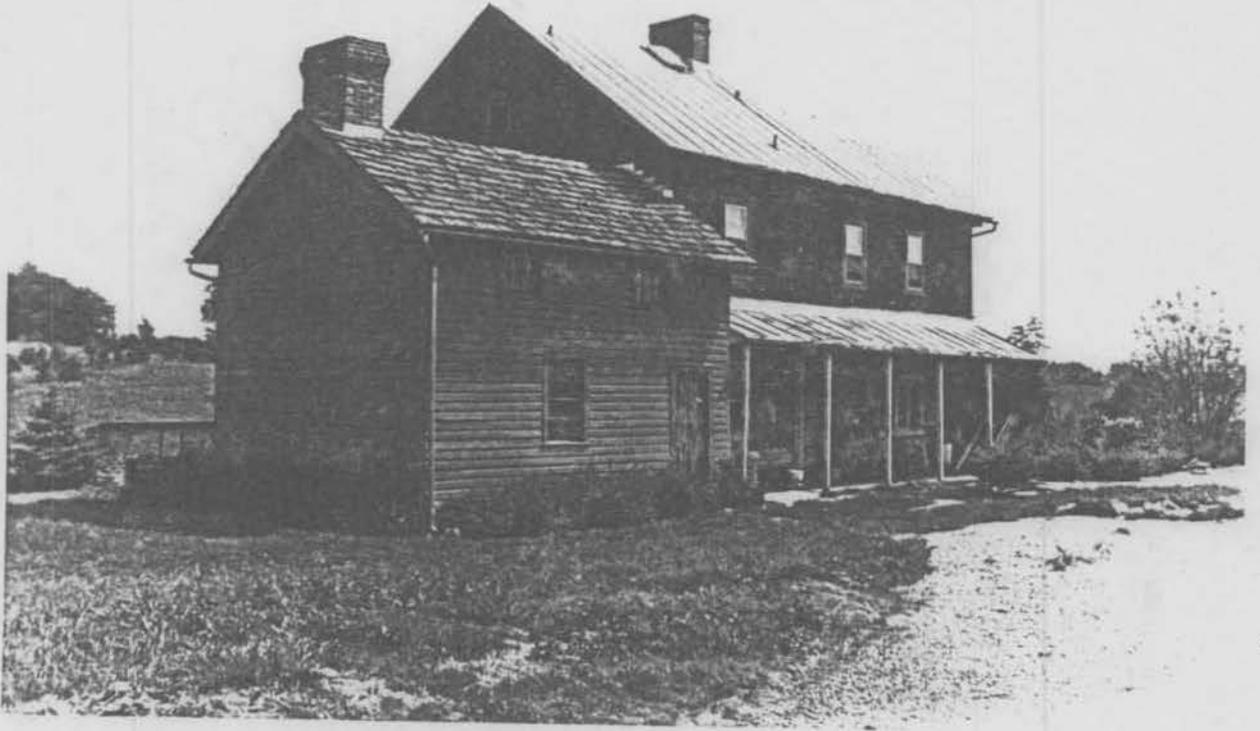
8/24

Rockland Farm CARR-342  
Carroll County, Maryland  
Photo by Joe Getty, August 1985  
Negative at Maryland Historical Trust  
Kiche, camera facing southwest

The Kiche, or original kitchen, on the interior is the northernmost room and originally ran from the front to the back of the house. The evidence for the partition wall being a later alteration includes the fact that the chairrail on the partition does not match the other walls of the room. Also, the partition wall on the south side of the house (between the Stube and Kammer) is brick while the one on the north side (in the Kiche) is constructed of frame with lath and plaster. This room contains the corner stairway to the second story. The stairway has a double flight in the northeast corner of the Kiche, with the upper section boxed in. The mantel on the large fireplace has a plain shelf with serpentine molding. The room has a molded chairrail and the door frames have quarter-round molding. The interior doors have six-panels, and retain their original Pennsylvania German hardware with wrought strap hinges and wooden box locks.

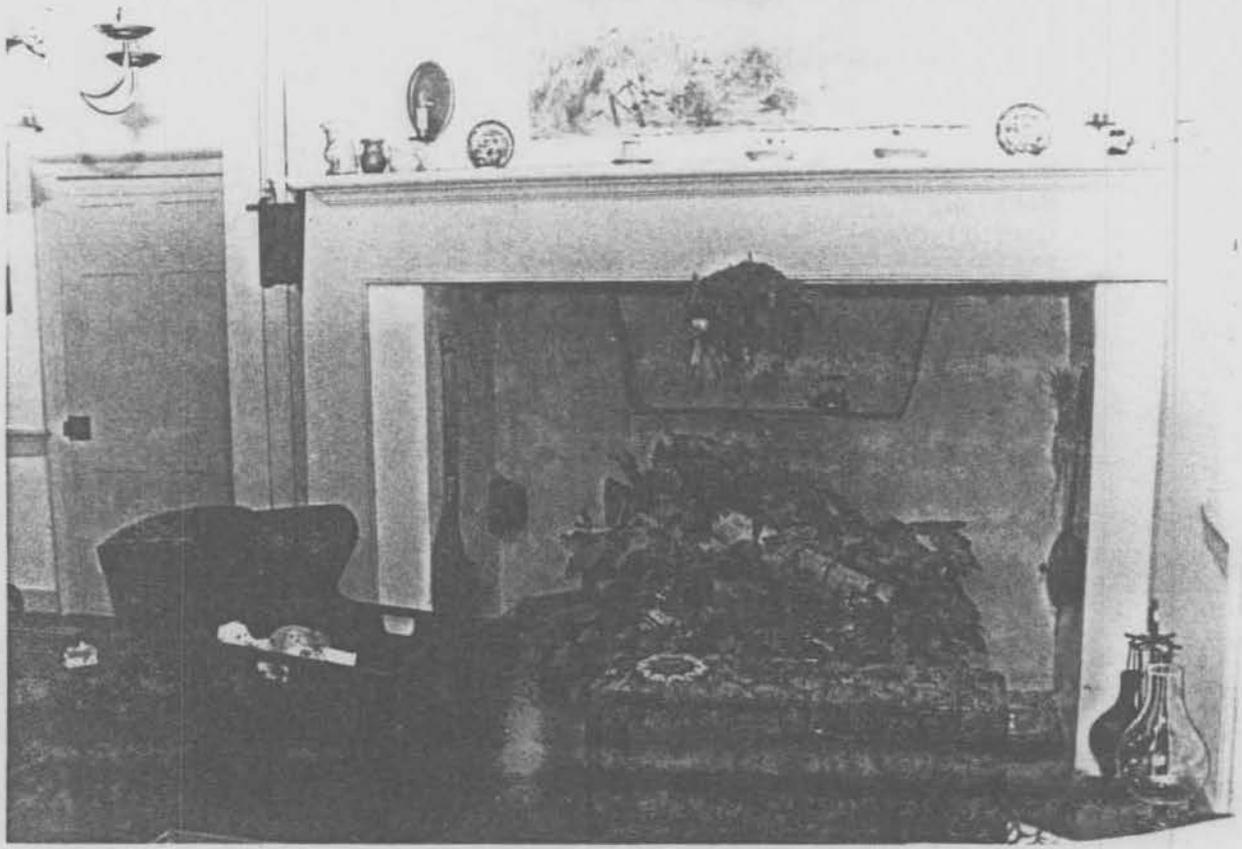
9/24

Rockland Farm  
Carroll County, Maryland  
Photo by Joe Getty, August 1985  
Negative at Maryland Historical Trust  
Kiche, fireplace detail

A number of Pennsylvania German architectural traditions are present in the farmhouse. Foremost is the retention of the central chimney, which provides a large fireplace on the first story that serves as a partition wall in the three-room Kiche, Stube, and Kammer plan. In the traditional Pennsylvania German plan, the fireplace serves the large kitchen which has a cross-passage with doors to the outside in the front and rear facades. At Rockland Farm, the current plan is a variation of the original because there is a partition wall in the kitchen that is apparently a later alteration that appears to be from the mid-19th century. Thus, the traditional use of first floor rooms at Rockland Farm - kitchen, parlor and bedroom - reflects a cultural persistence of the Pennsylvania German region.

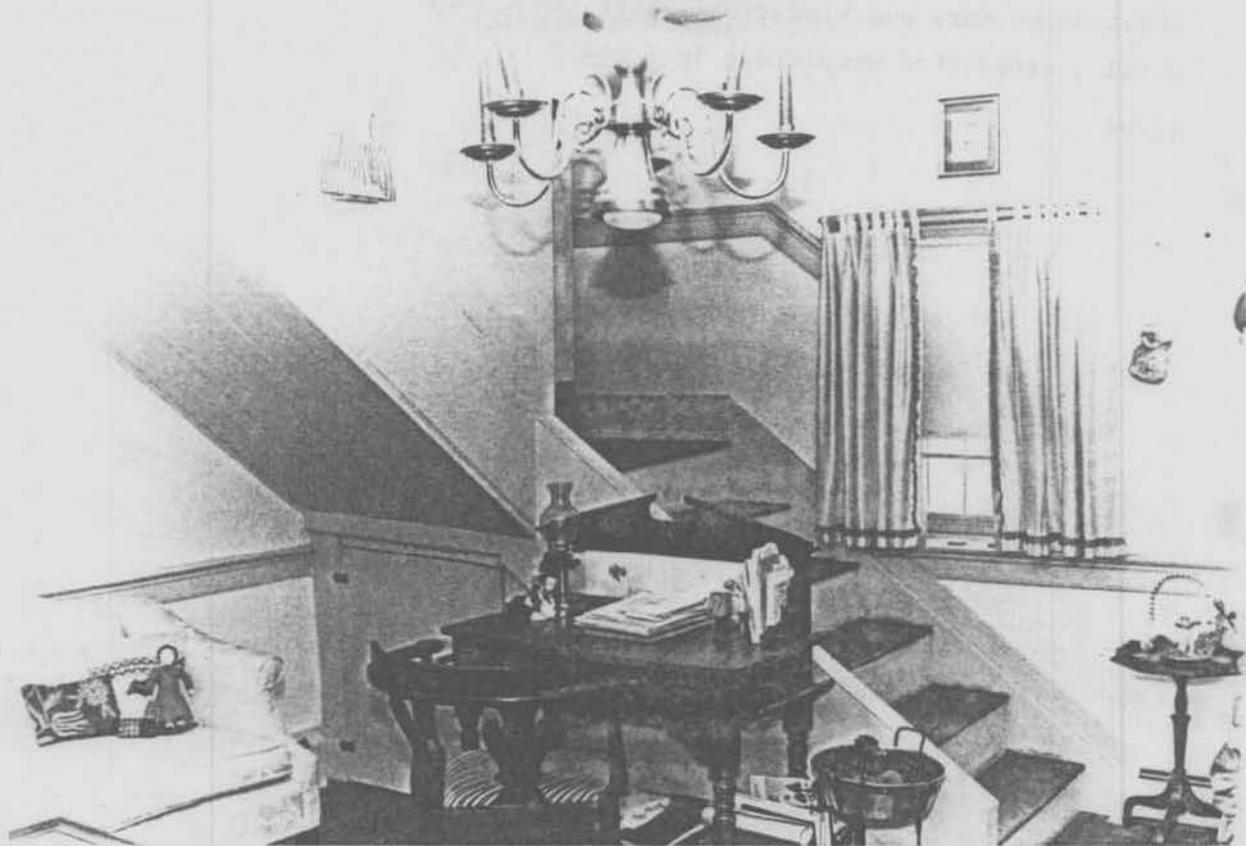
12/24

Rockland Farm  
Carroll County, Maryland  
Photo by Joe Getty, August 1985  
Negative at Maryland Historical Trust  
detail, crossetted architrave in Stube

The Stube, or parlor, is the southeast room and contains molded chairrail, molded window frames with crossettes, and six-panel doors with original hardware. In a traditional Pennsylvania German layout, this room would have been heated by a cast-iron stove with the flue feeding into the main chimney.

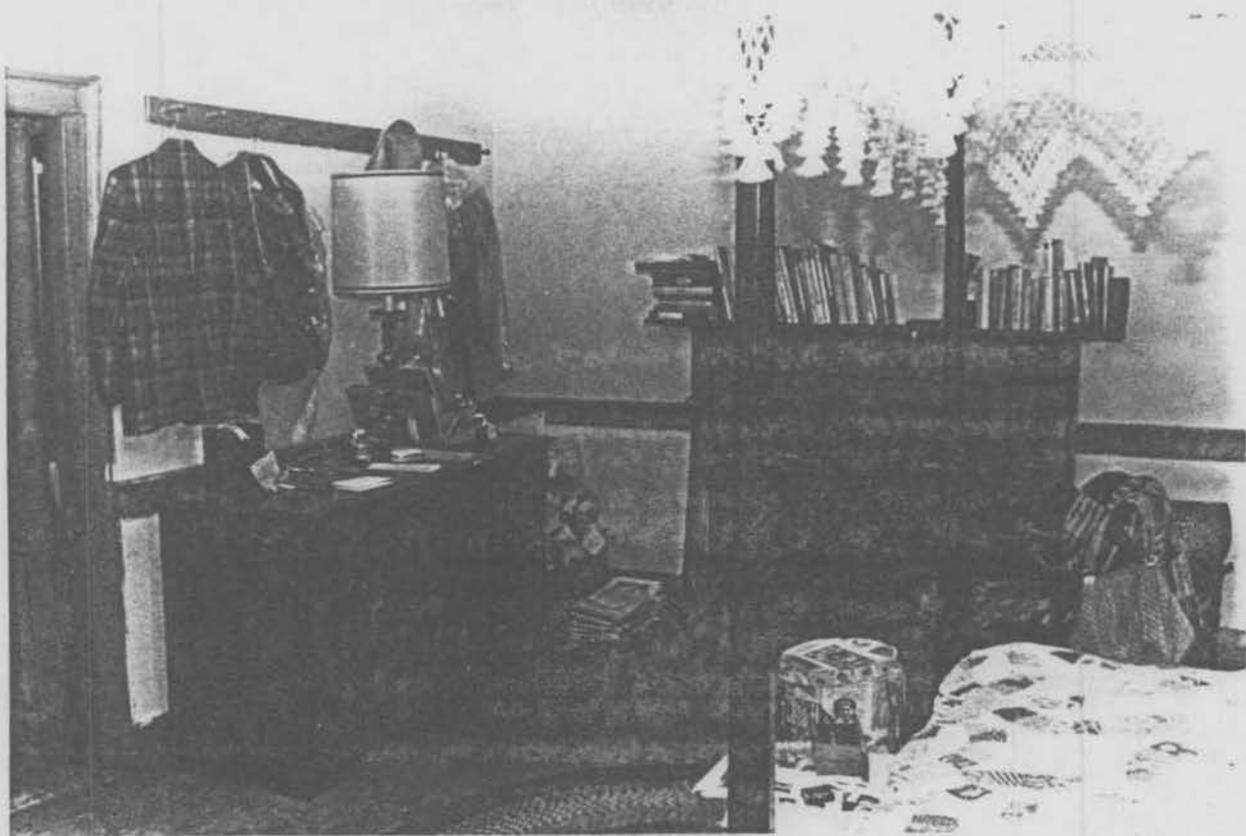
13/24

southeast room, 2nd floor

The southeast room is a bedroom with refined woodwork. In the Pennsylvania German cultural tradition, this was the guest room and usually had the best woodwork in the house and was almost always located on the second floor over the parlor. The guest room was used not only for accommodating visiting family and friends, but also for storage of the best material possessions of the family, such as furnishings and Sunday clothes. At Rockland Farm, the guest room has a molded chairrail, plain fireplace mantel, door frames with quarter-round molding, and peg rails. The six-panel interior doors have strap hinges and the door to the northeast room retains a Dutch elbow lock.

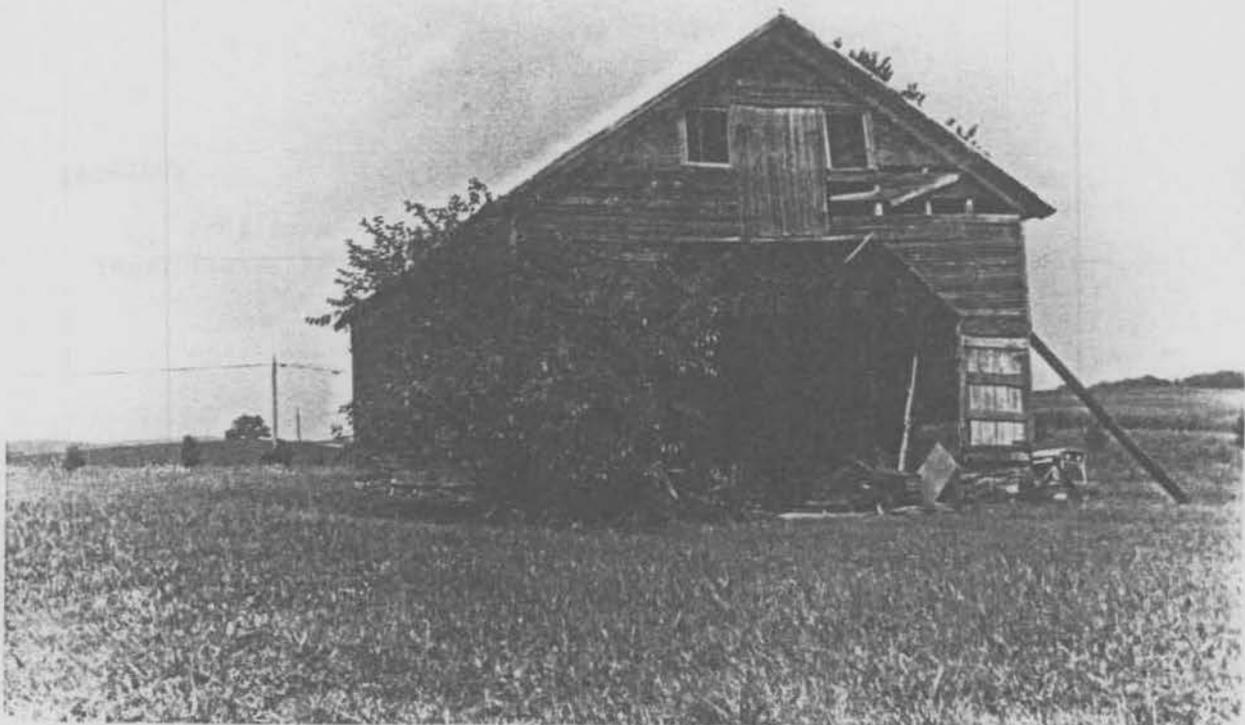
24/24

Rockland Farm  
Carroll County, Maryland  
Photo by Joe Getty, August 1985  
Negative at Maryland Historical Trust  
corn crib, view from southwest

Two other historical outbuildings remain on the property, both from the late nineteenth century. One is a frame barn with a rectangular-shaped plan and a gable roof with a cross-gable. Built in 1888, it departs from the bank barn tradition popular in this area, with its one and one-half story height, board-and-batten exterior, and Victorian style pointed arch window trim. The August 11, 1888 edition of the Democratic Advocate provides the following information about the barn: "Charles B. Roberts is building a barn 40' by 84' on his Rockland Stock Farm. Raising took place on Wednesday afternoon. Charles C. Crumbacker of Linwood is the builder." The other structure, which is contemporaneous to the barn, is a corn crib in deteriorated condition. The structure is frame, covered with German siding, and has a gable roof. The corn crib's design provides a through-passage for a wagon with cribs on both sides.
