CARR-660

Baughman Mill Farm  
4808 Baughman Mill Road  
Lineboro (vicinity)

# Maryland Historical Trust State Historic Sites Inventory Form

historic John Shauck Farm Baughman Mill Farm (preferred)

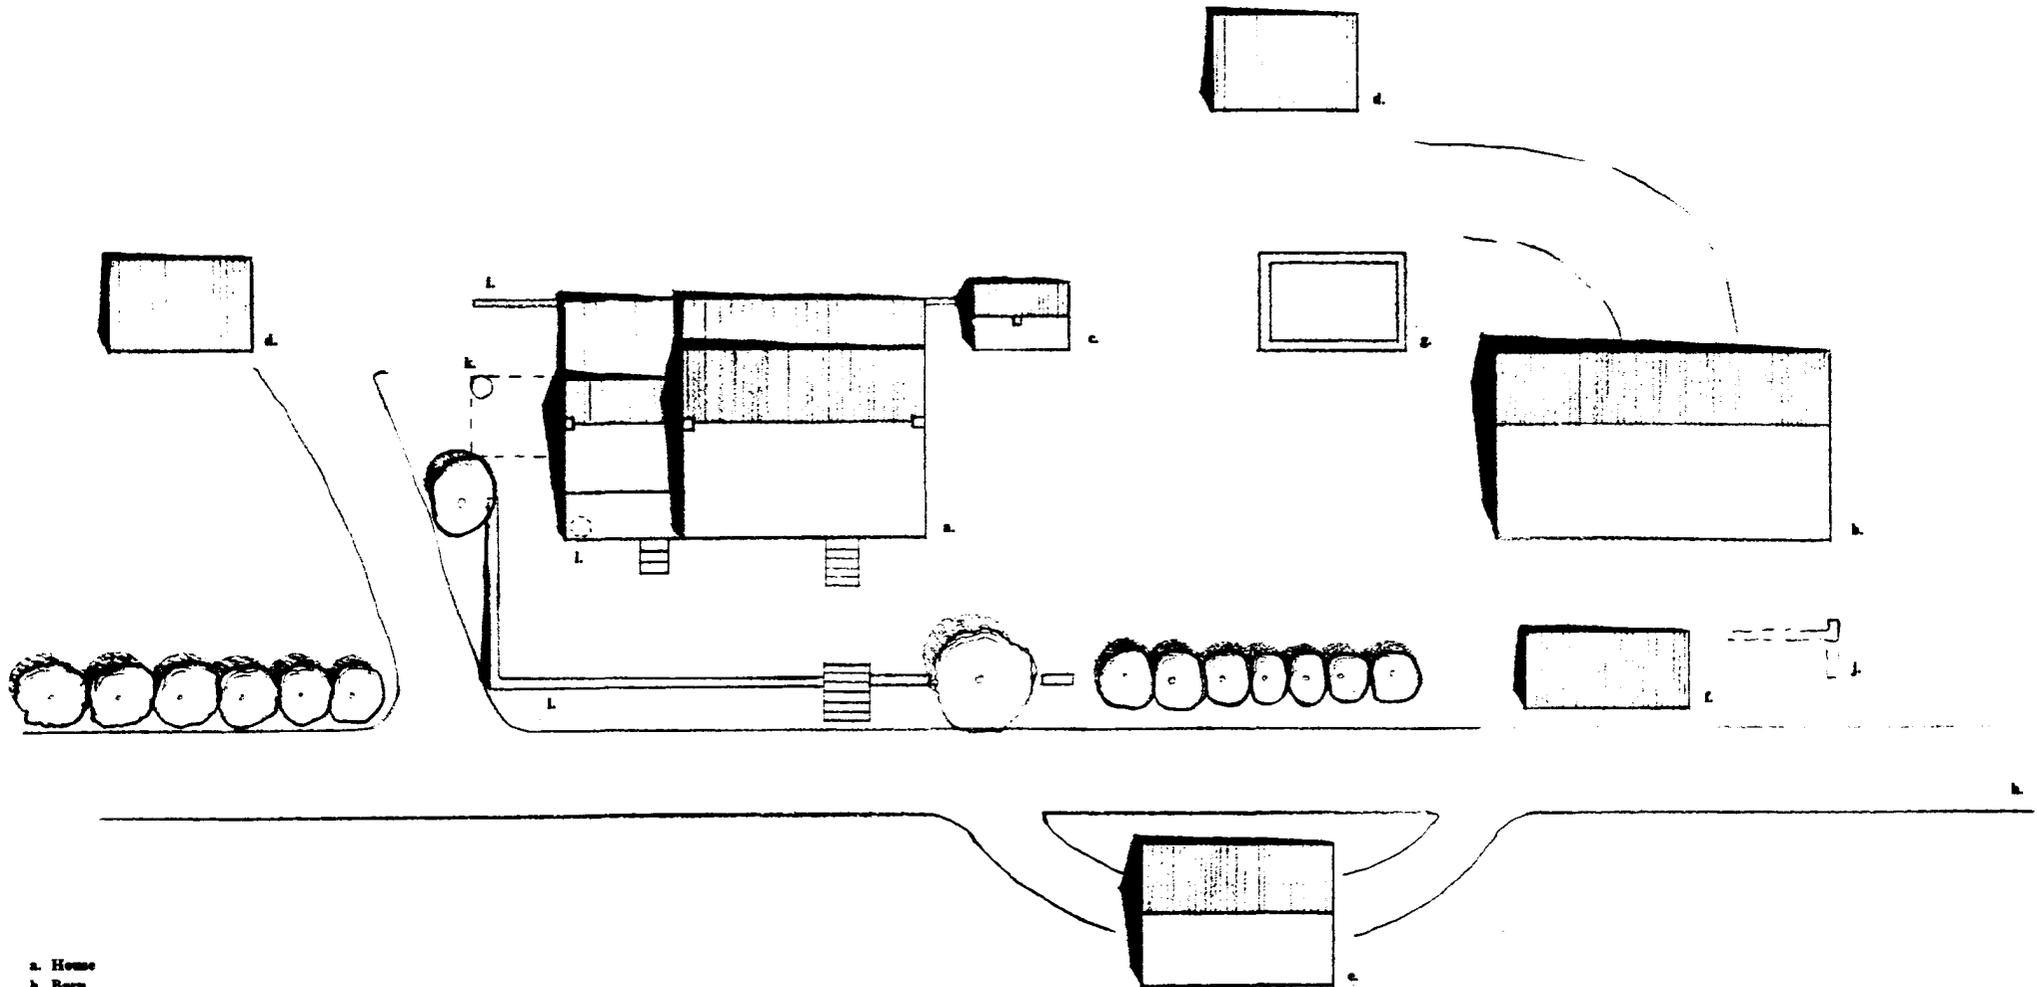
<p><b>CARR 660</b></p>	<p><b>BAUGHMAN MILL FARM 4808 BAUGHMAN MILL ROAD</b></p>	<p><b>SITE PLAN</b></p>	<p><b>FEBRUARY 1992 KENNETH M. SHORT</b></p>	<p><b>NOT TO SCALE</b></p>

- a. House
- b. Barn
- c. Bakehouse
- d. Chicken house
- e. Corn crib
- f. Hog pen
- g. Stone foundation
- h. Baughman Mill Road
- l. Stone wall
- j. Stone rubble
- k. Current well
- l. Original well

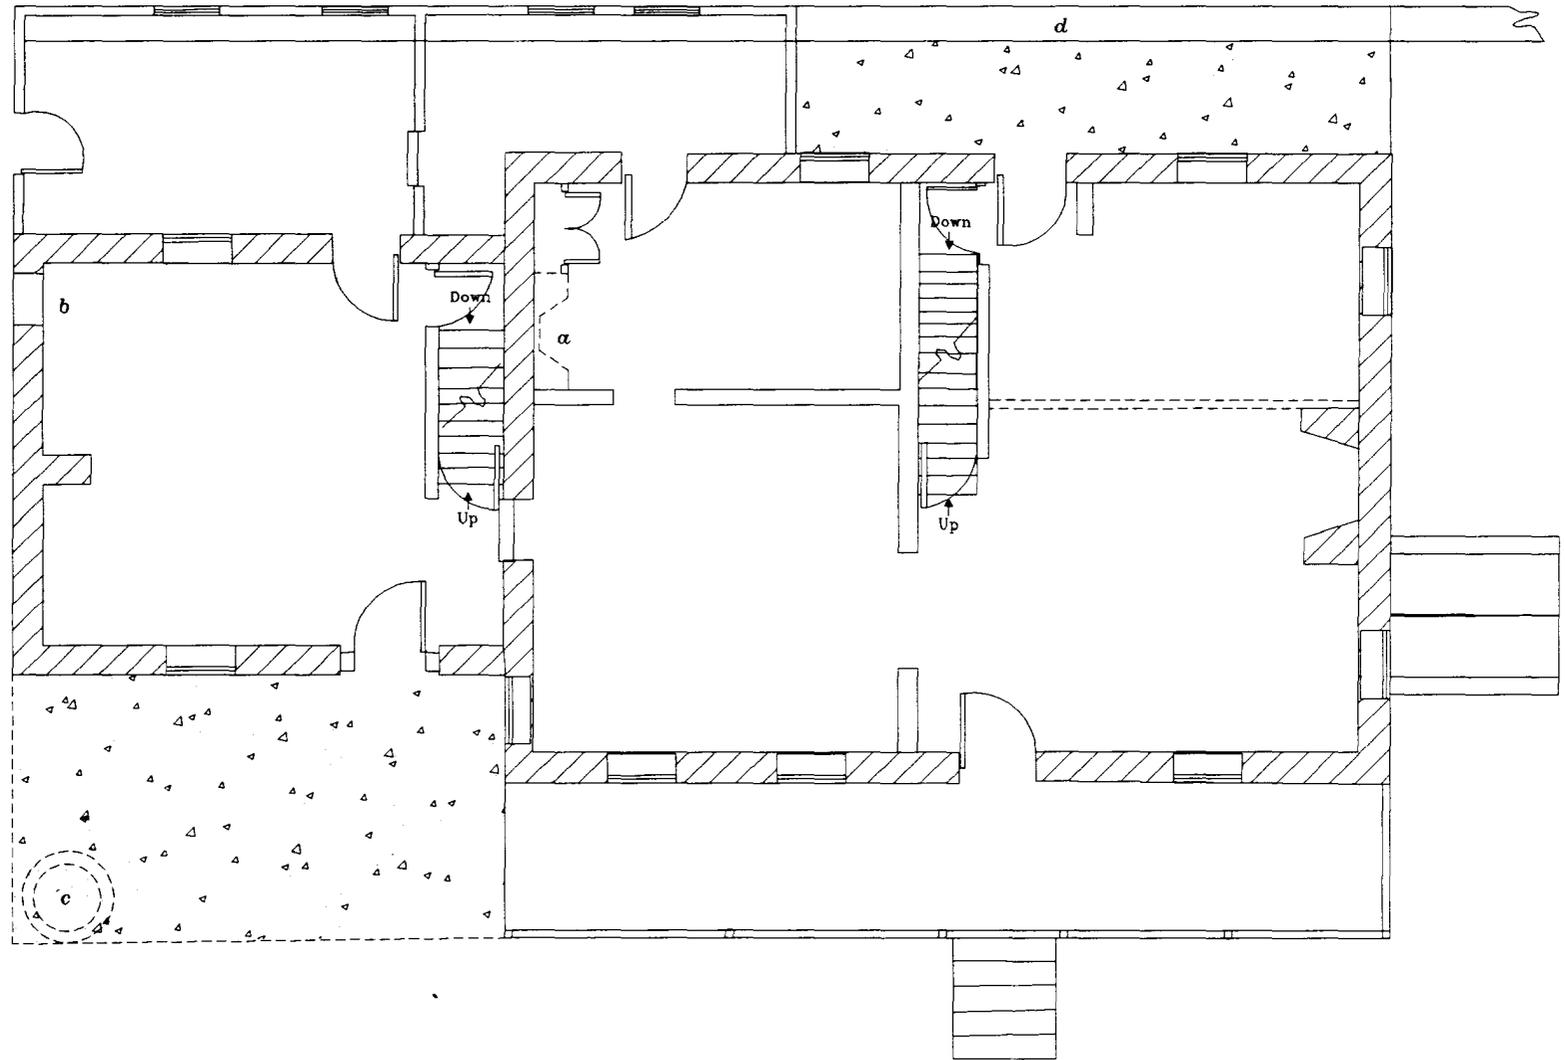
- a. Bricked In
- b. Bricked In Oven Opening
- c. Original Stone-lined Well Under Porch
- d. C.M.U. Wall Replaces Original Stone

Note:  
Recent Additions Of  
Bathrooms and Closets Have  
Been Omitted.

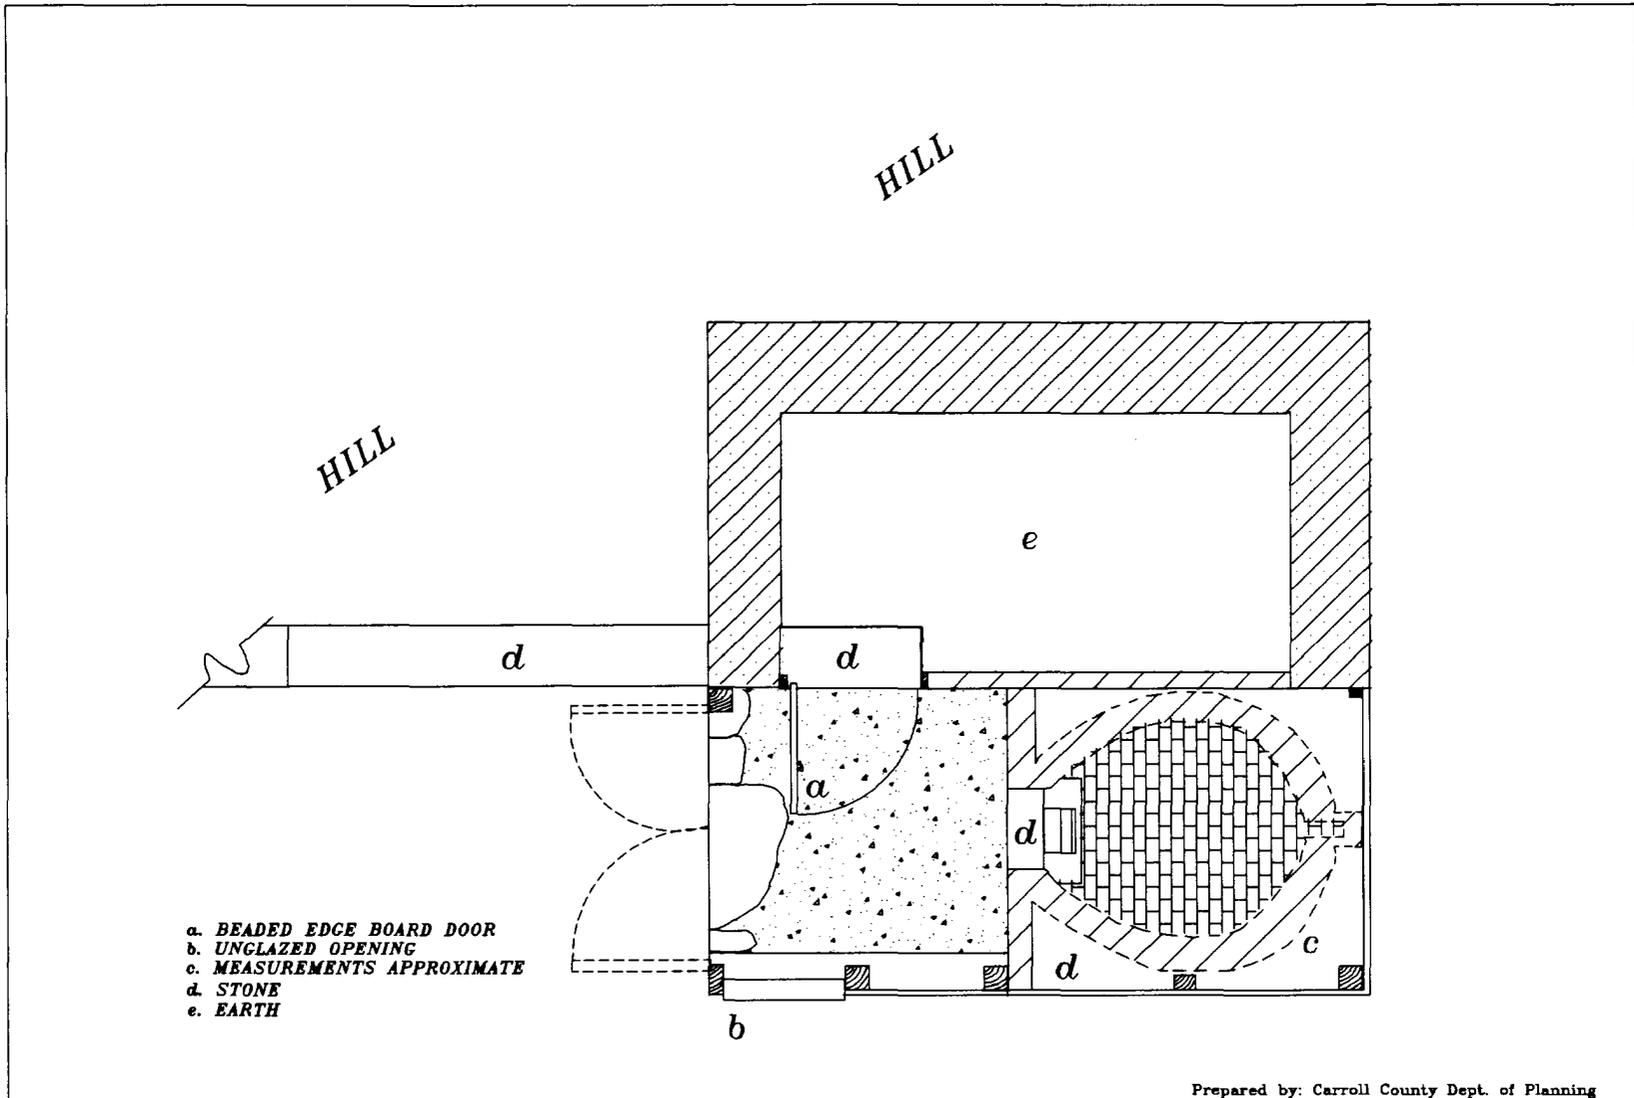
CARR 660B	Baughman Mill Farm - Bake House	Plan	February 1992

Near the northeast corner of the house stands a one-story square uncoursed fieldstone, wood frame and clapboard bakehouse and smokehouse. The structure is banked into the hill with a slate-covered gable roof. It is divided in the center by an east-west running brick wall. The smokehouse is to the north, the squirrel-tail flue brick oven to the south.

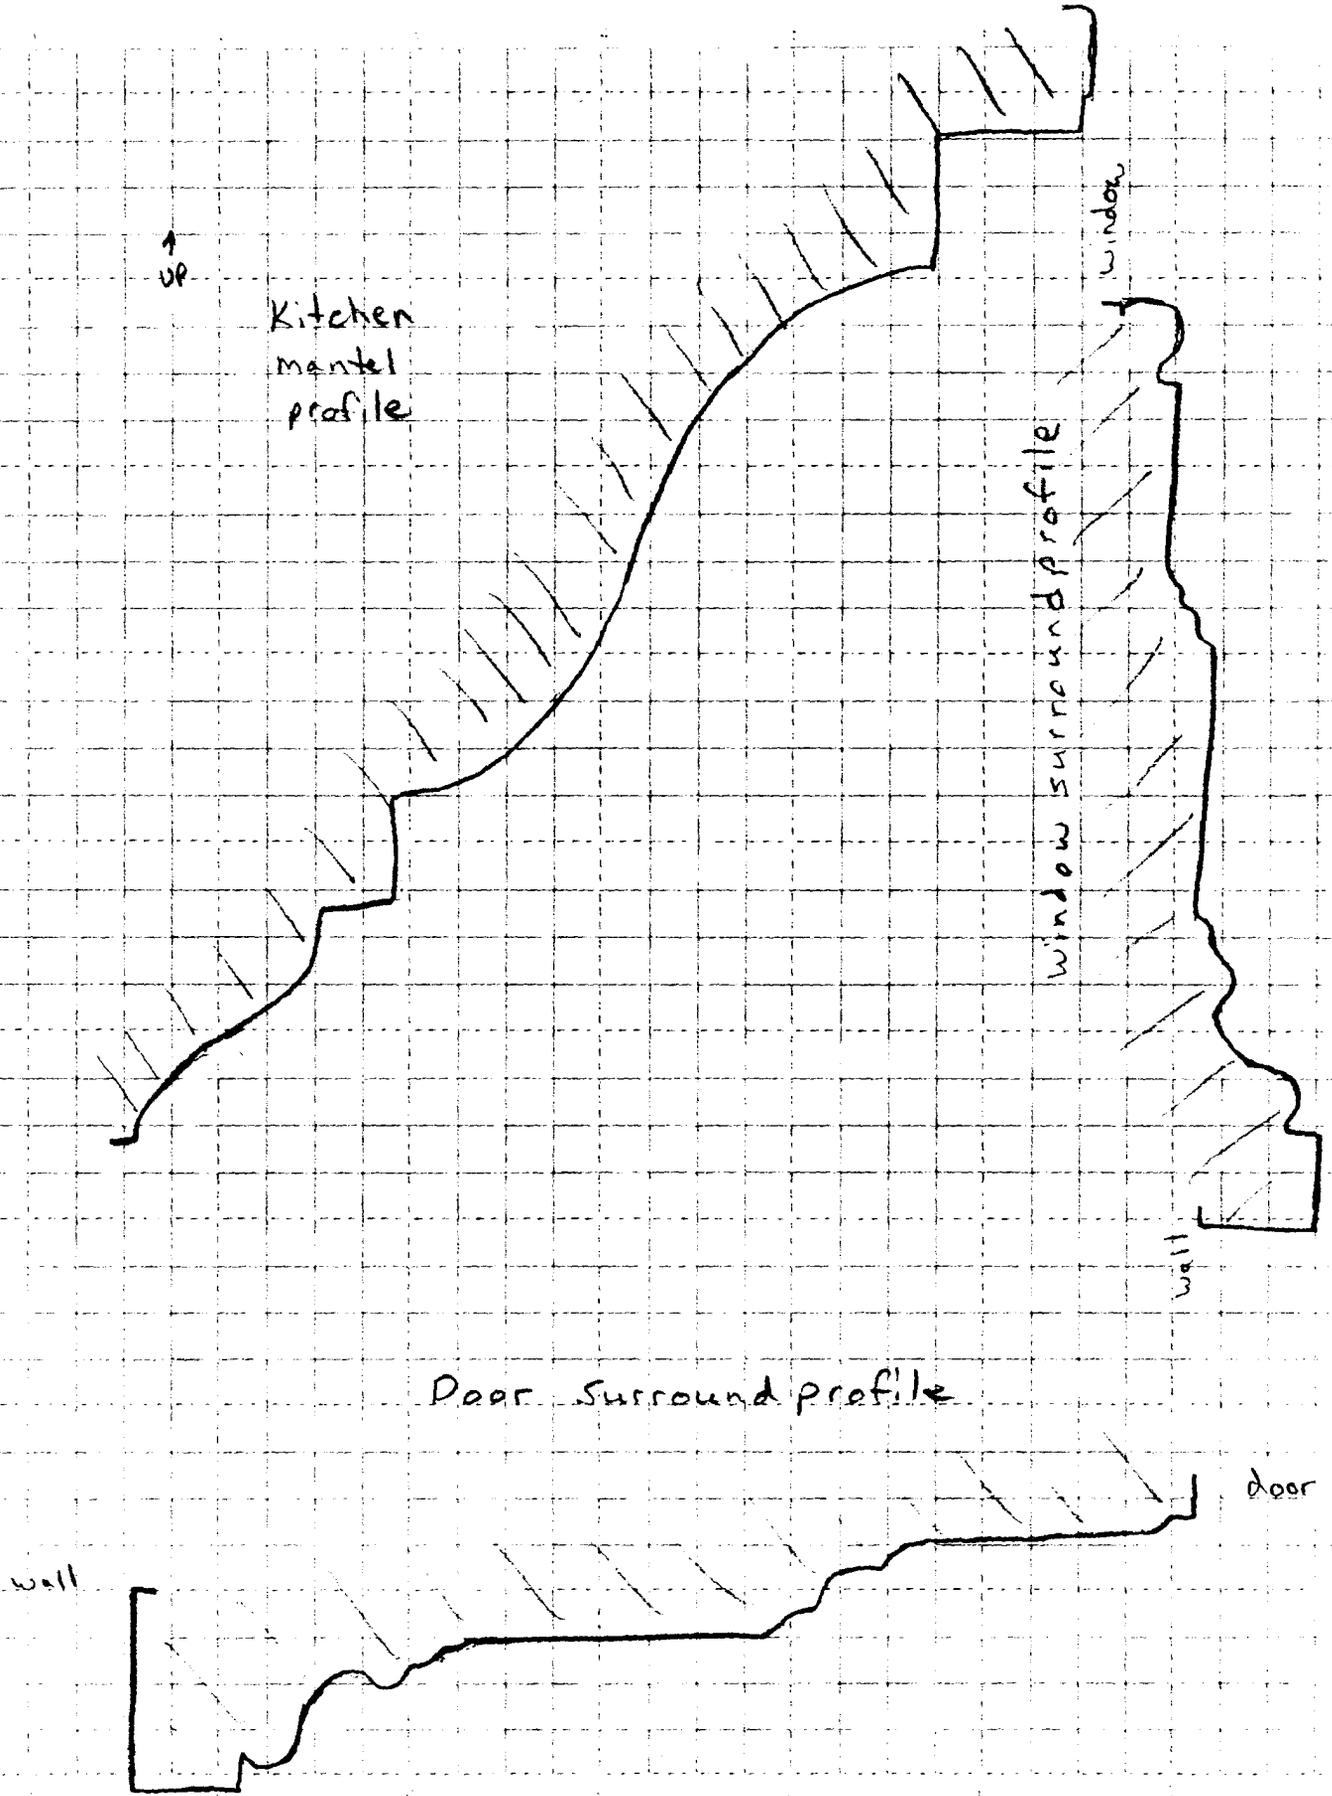
Kitchen  
mantel  
profile

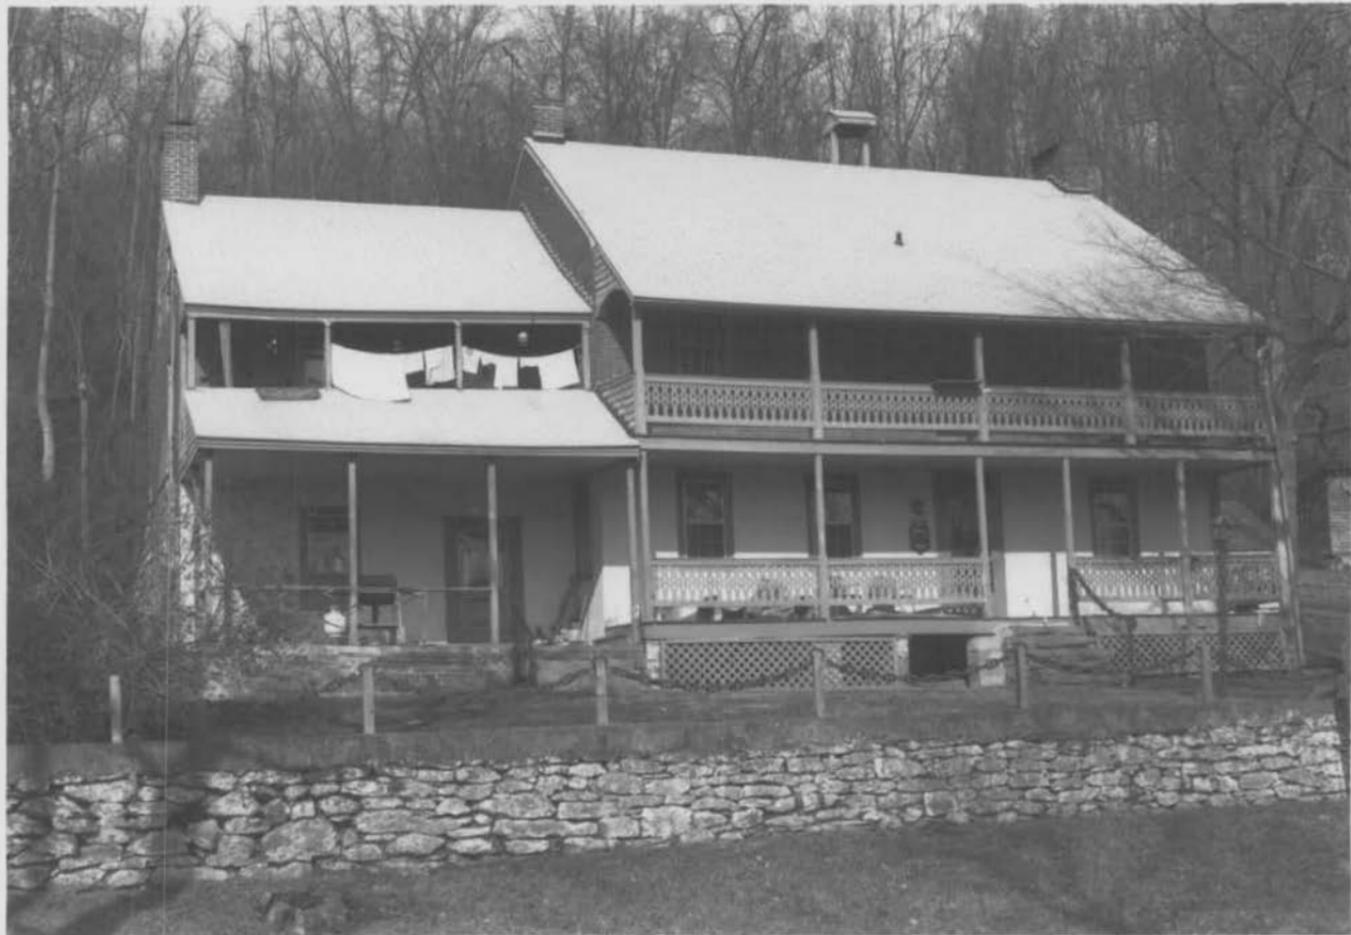
1/19

The front facade of the house faces south. The entrance is offset to right (east) of center, flanked by two 6/6 windows to the left and one 6/6 to the right. This fenestration pattern is repeated on the second floor, with the door opening onto a second story porch. The first story door is an early door with paired vertical raised panels interrupted at the top by inserted glass panes. The soffit and jambs are paneled with flat recessed panels set in ogee panel molds. There is a three-light transom above the door and a worn stone sill below. The windows are set in heavy pegged frames trimmed with ovolo backband; the lintels are splayed brick jack arches.

The brickwork on the facade is laid in Flemish bond and is painted a soft cream color on the first story. The two story porch is supported by brick foundation piers and chamfered posts; a sawn scrollwork balustrade is carried across both stories. The porch roof is a continuation of the main roof pitch, concealing any early cornice on this facade. The second story door opening onto the porch has been bricked in above the door head, suggesting either a blocked transom or an enlarged window opening.

House - south elevation

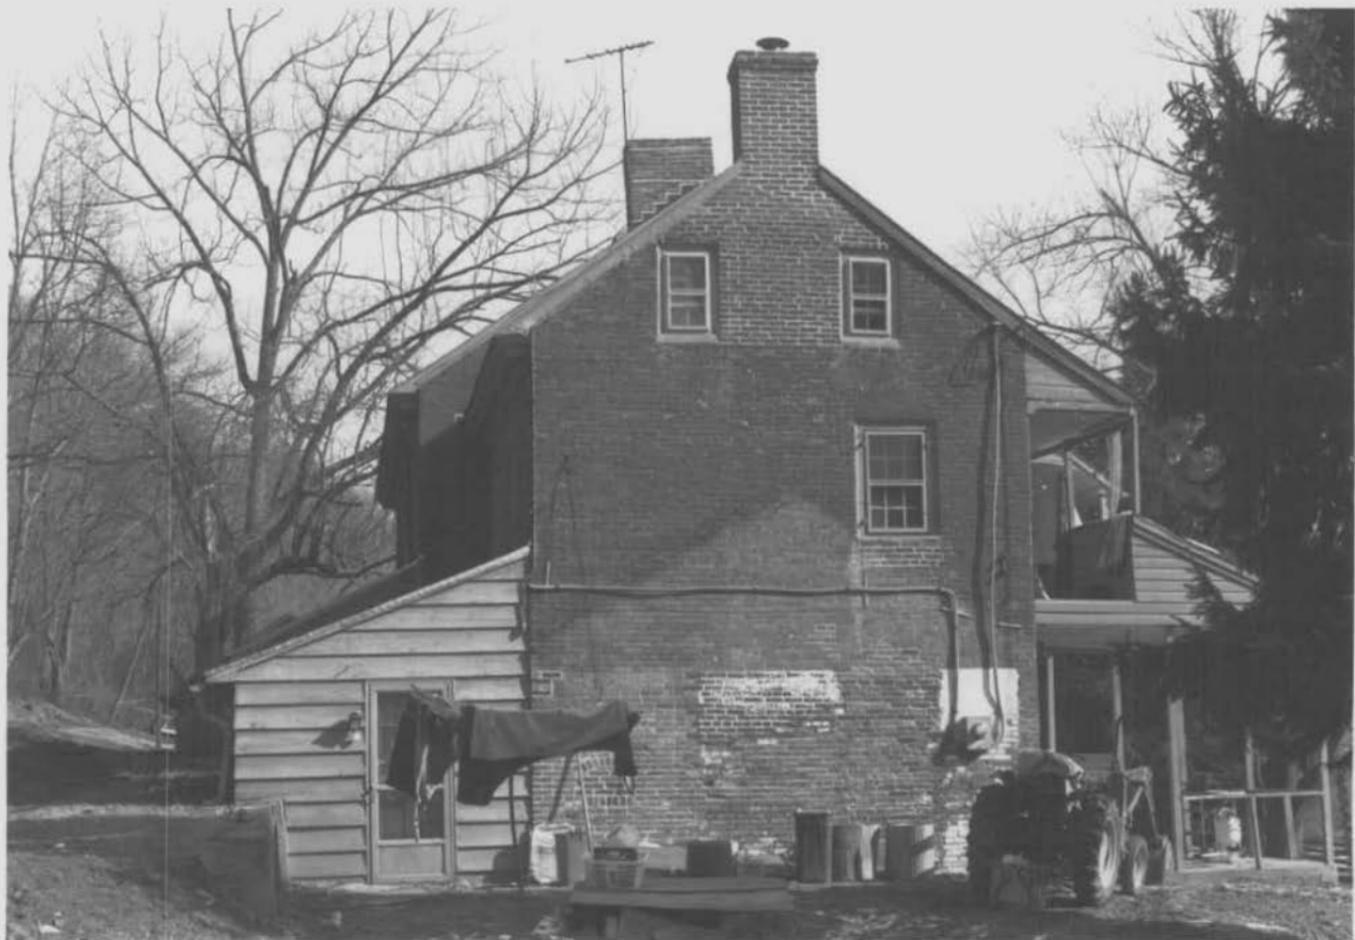
2/19

House - West elev.

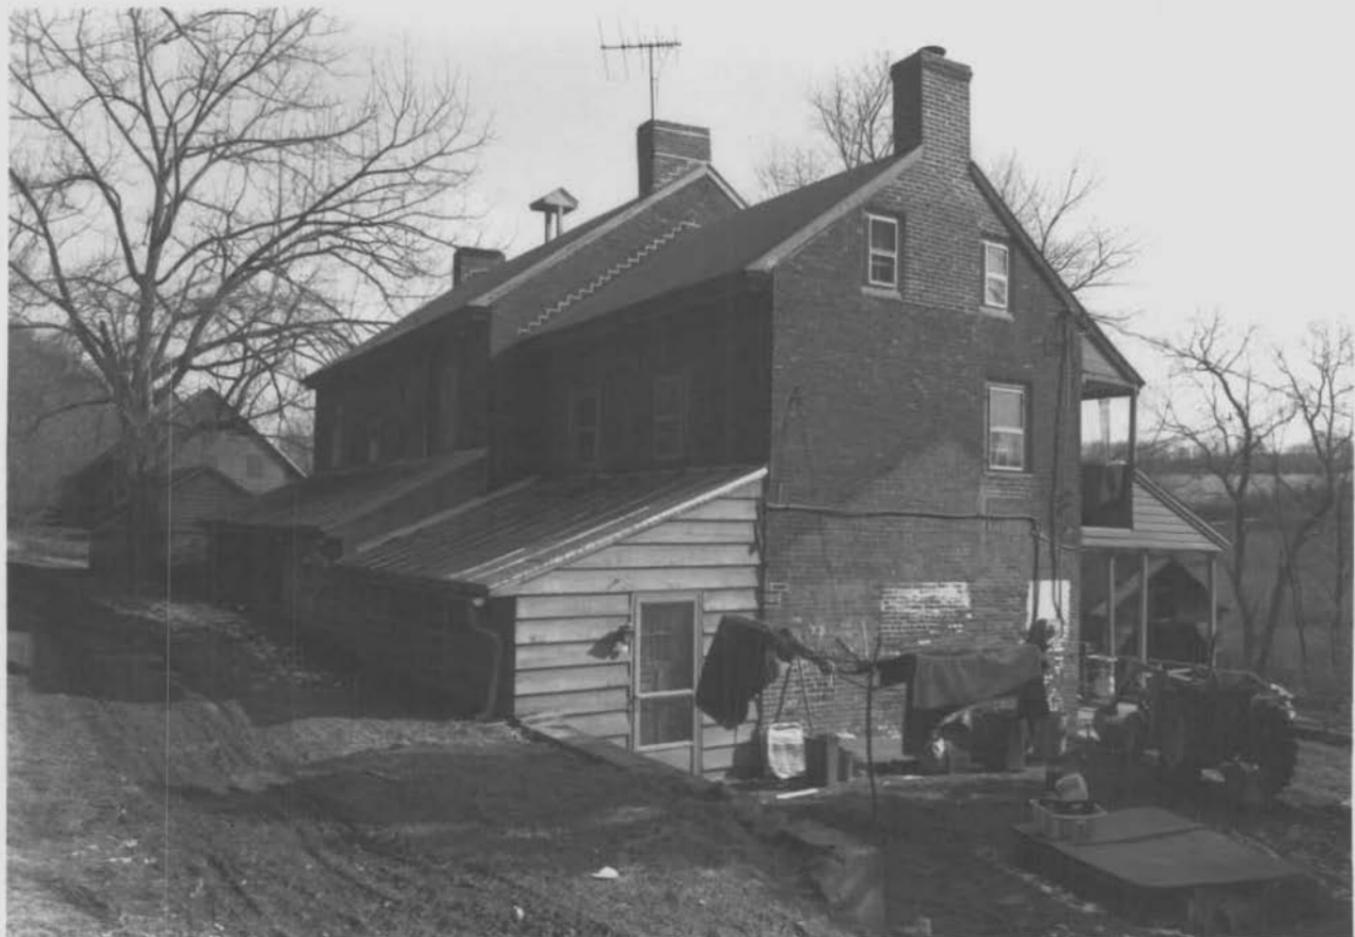
3/19

House - north & west elevs.

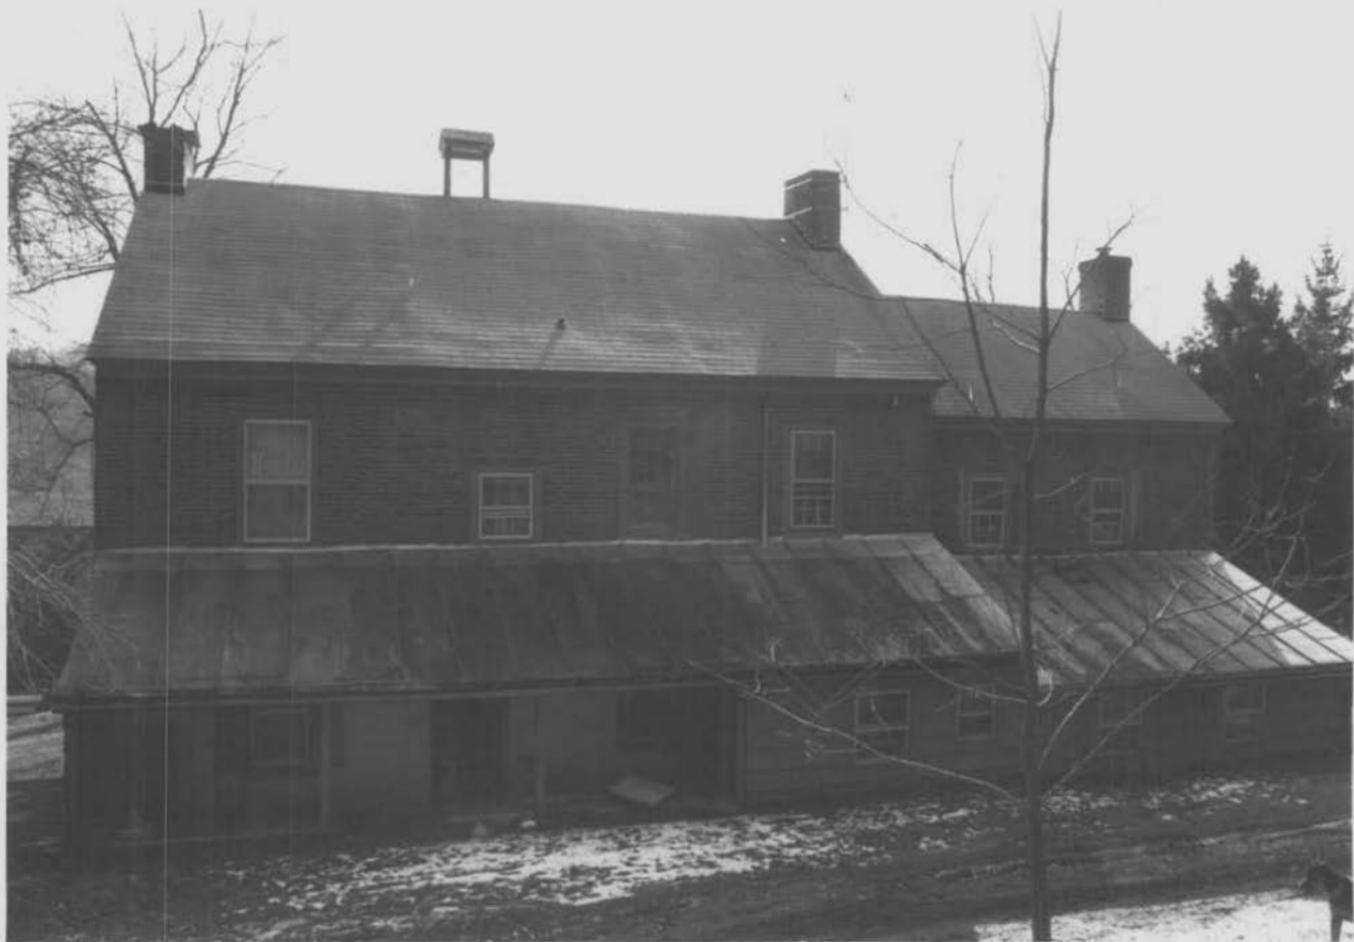
4/19

The brickwork on the rear facade is laid in four-to-one common bond and is painted a cream color on the first story. The window openings have plain soldier course lintels; the first floor door opening has been reduced in size about four inches on each jamb. The jambs and soffit are not paneled; the door is replaced. The original cornice survives on this facade, and consists of a box cornice with complex crown-mold applied to the fascia and a complex bed mold below the soffit. The crown mold has probably been repaired or replaced.

House - north elev.

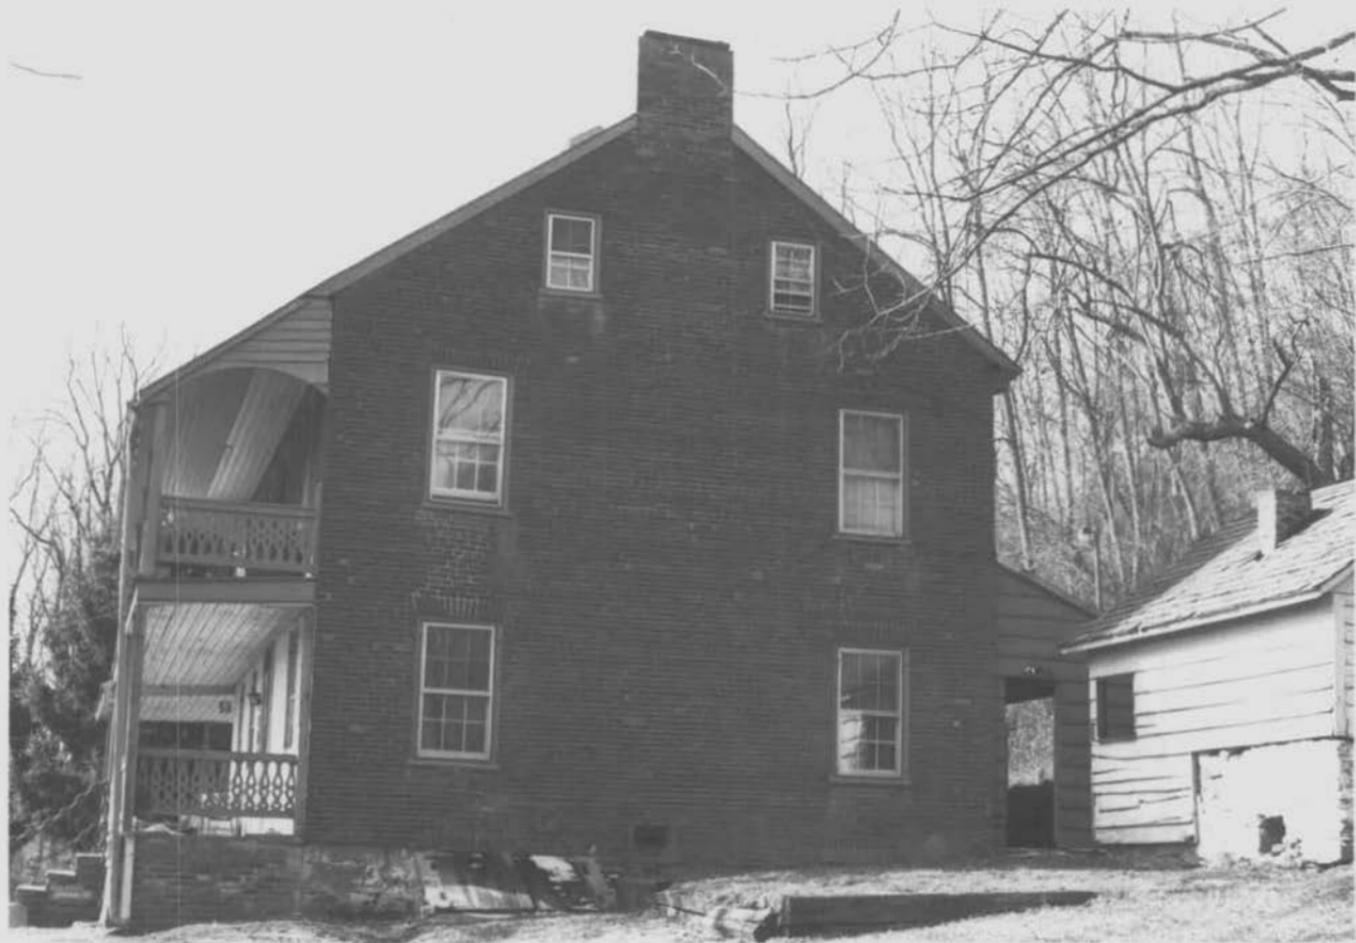
5/19

On the east gable wall, there are single 6/6 windows flanking the flush center chimney on the first and second story and small 4/2 windows in the upper gable. A cellar window in the south bay has been enlarged to form a bulkhead cellar entrance; the north window has been blocked. The brickwork on this facade is laid in four-to-one common bond; the openings have splayed jack arches and wood sills. The window frames are beaded but otherwise plain. One early tapered and beaded rakeboard survives.

House - east elev.

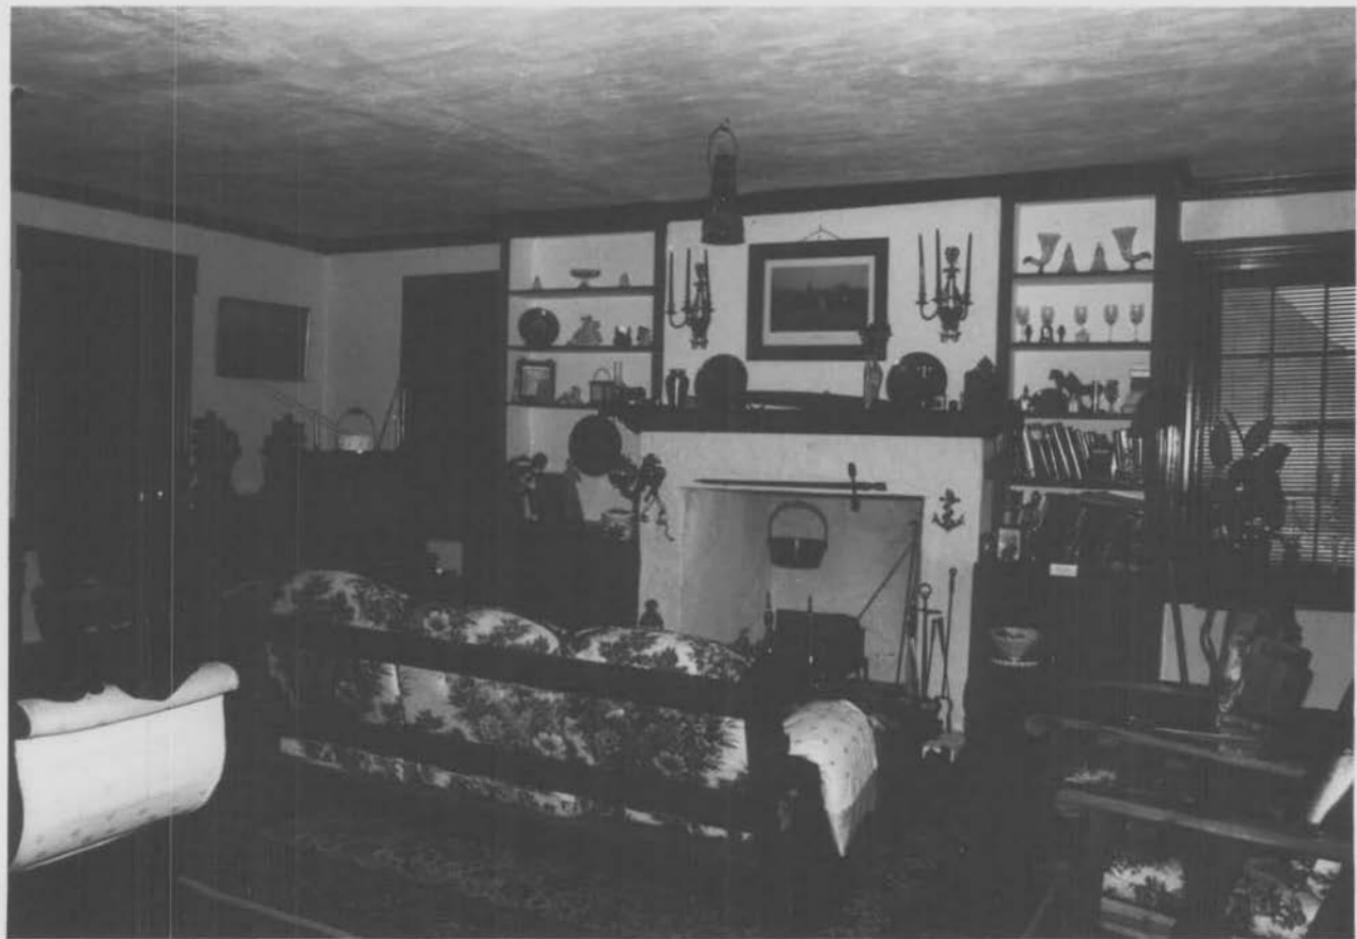
6/19

House - east room interior - vw. east

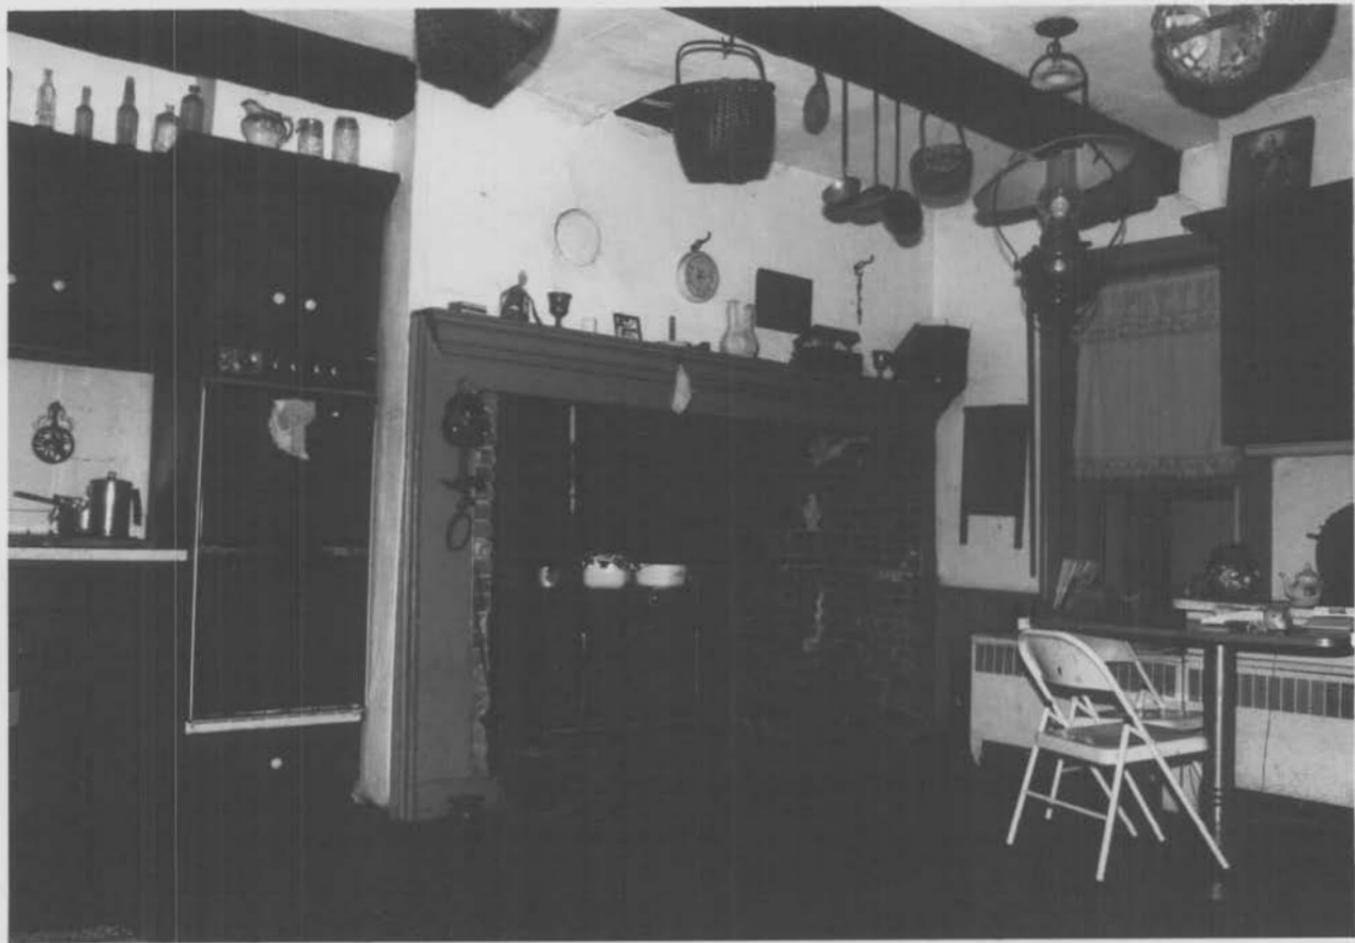
7/19

House - Kitchen interior - vw. west

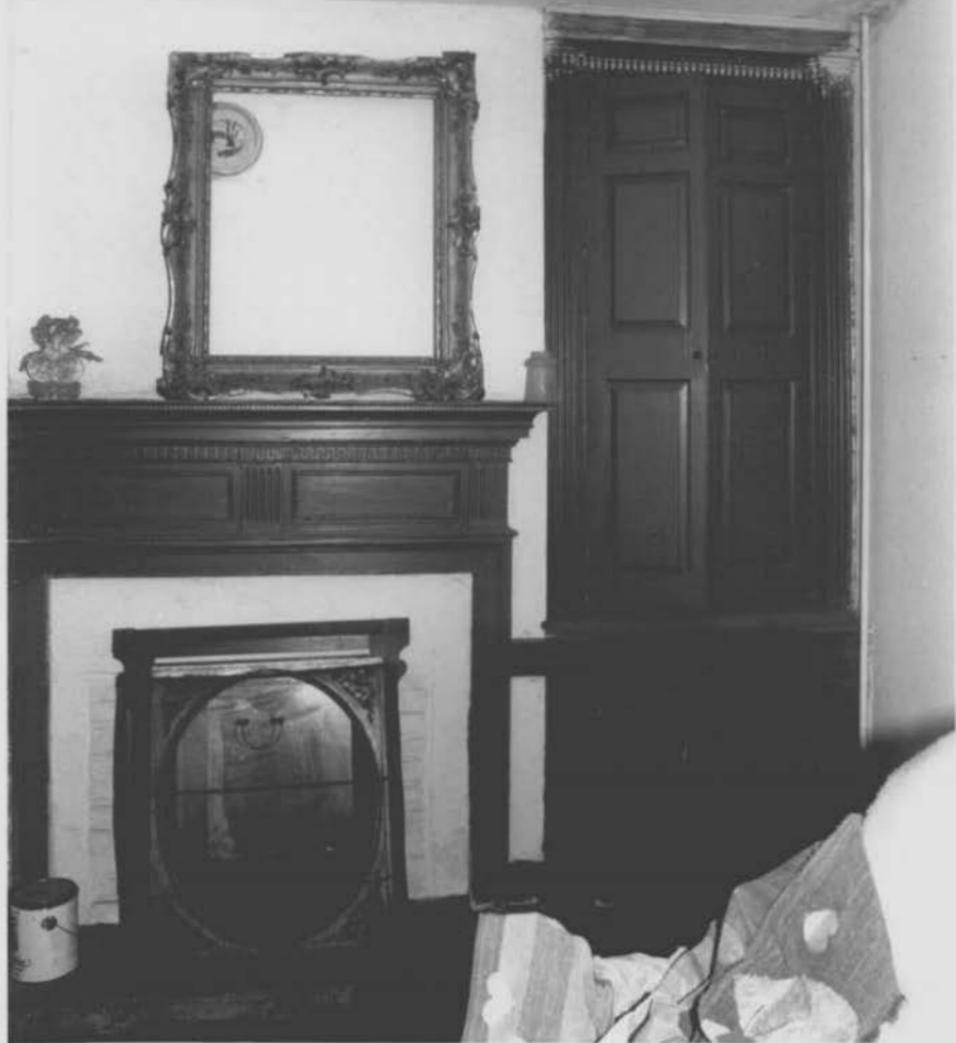
Baughman Mill Farm CARR-660  
4808 Baughman Mill Rd  
Carroll County, Maryland  
Photo: Kenneth M. Short  
Date: February 1992  
Neg. Loc.: Maryland Historical Trust  
House - north rm. interior, west wall  
8/19

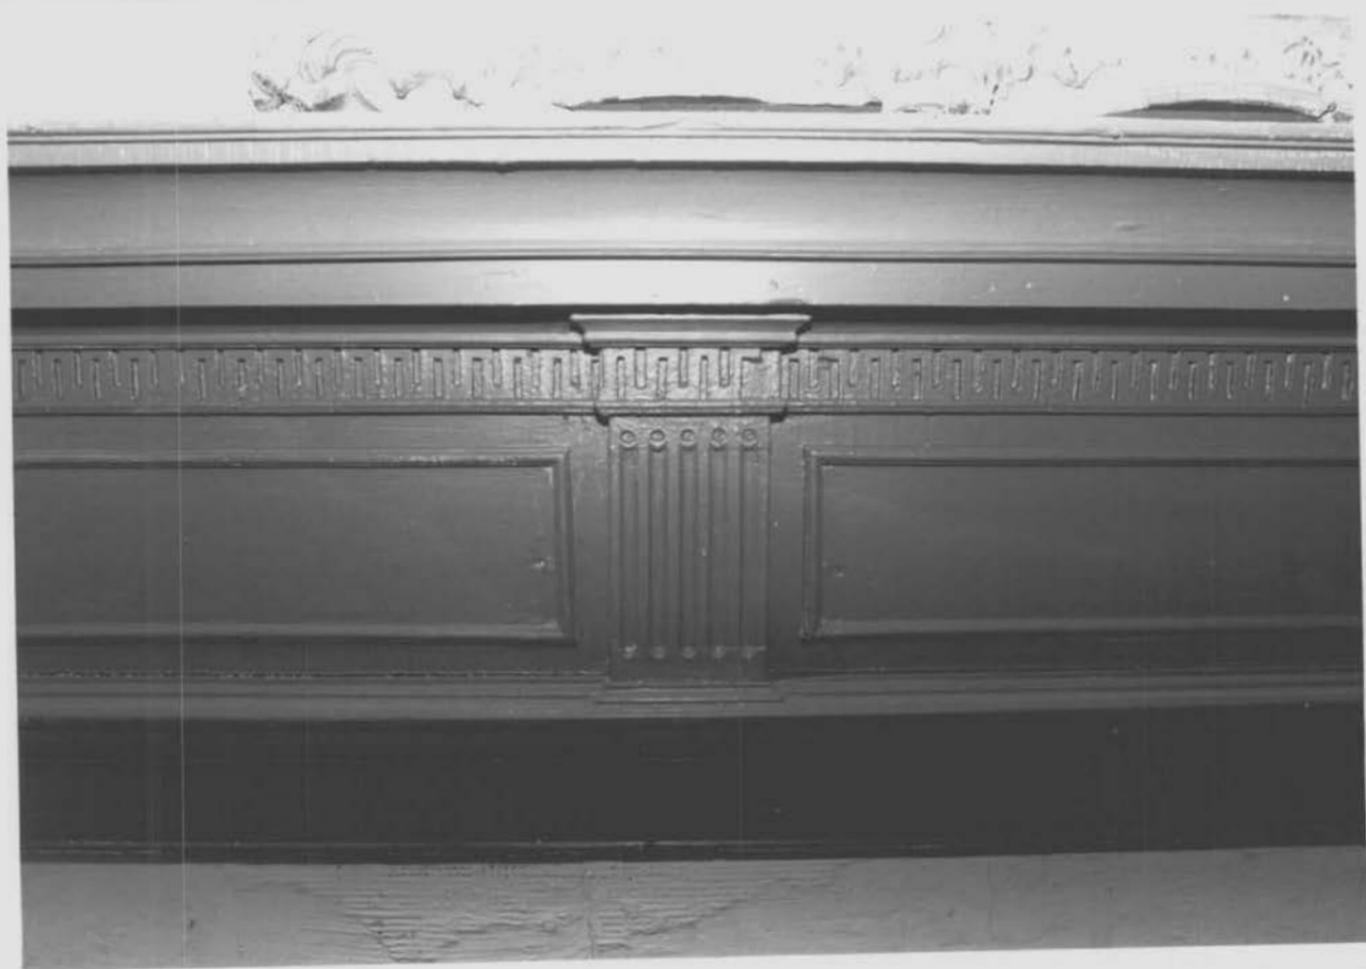
9/19

House - north rm. mantel detail

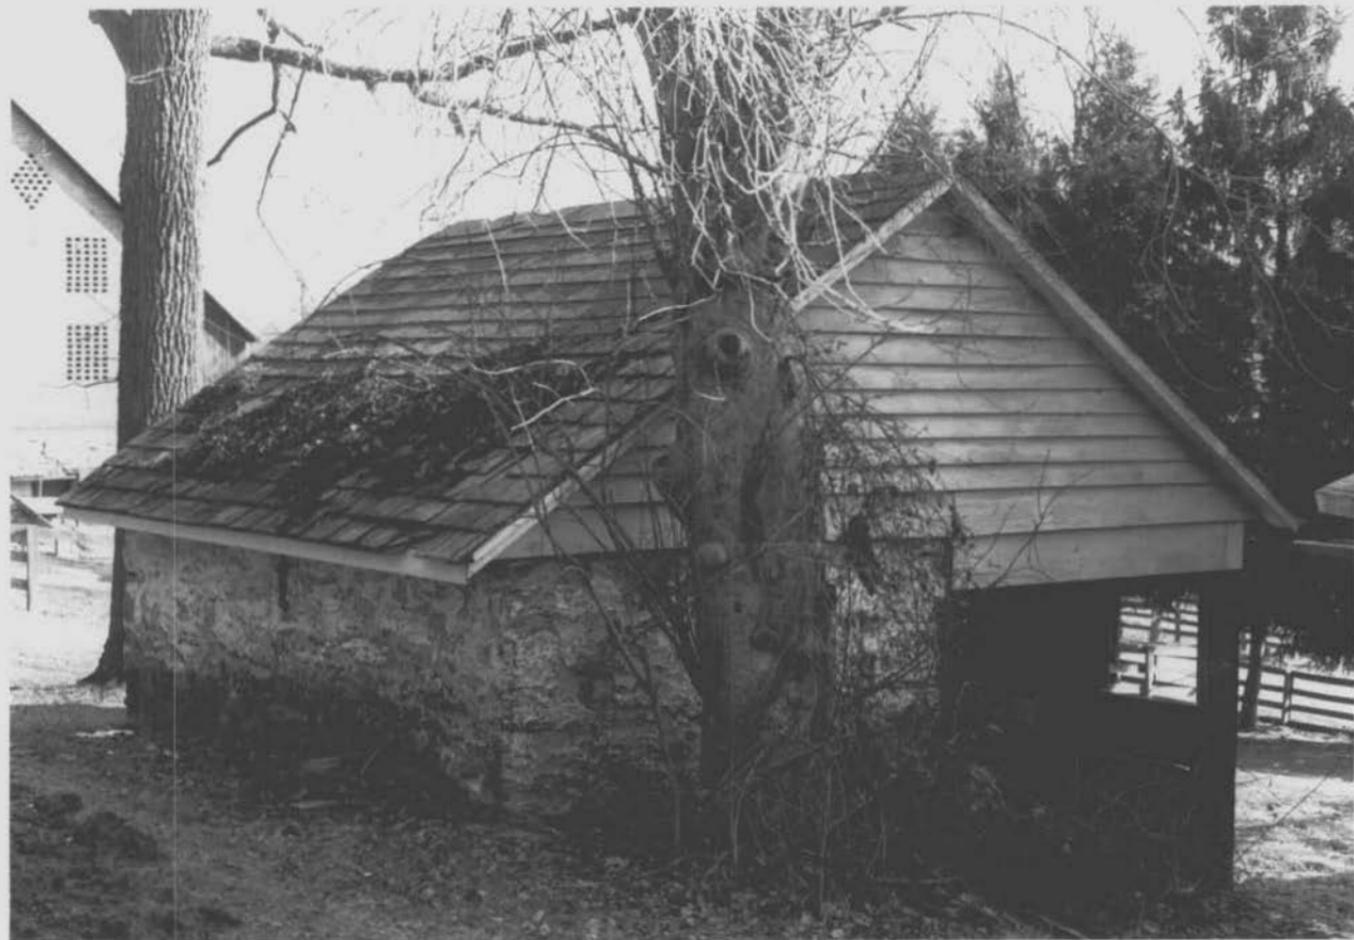
10/19

Bakeryhouse: North & West elevs.

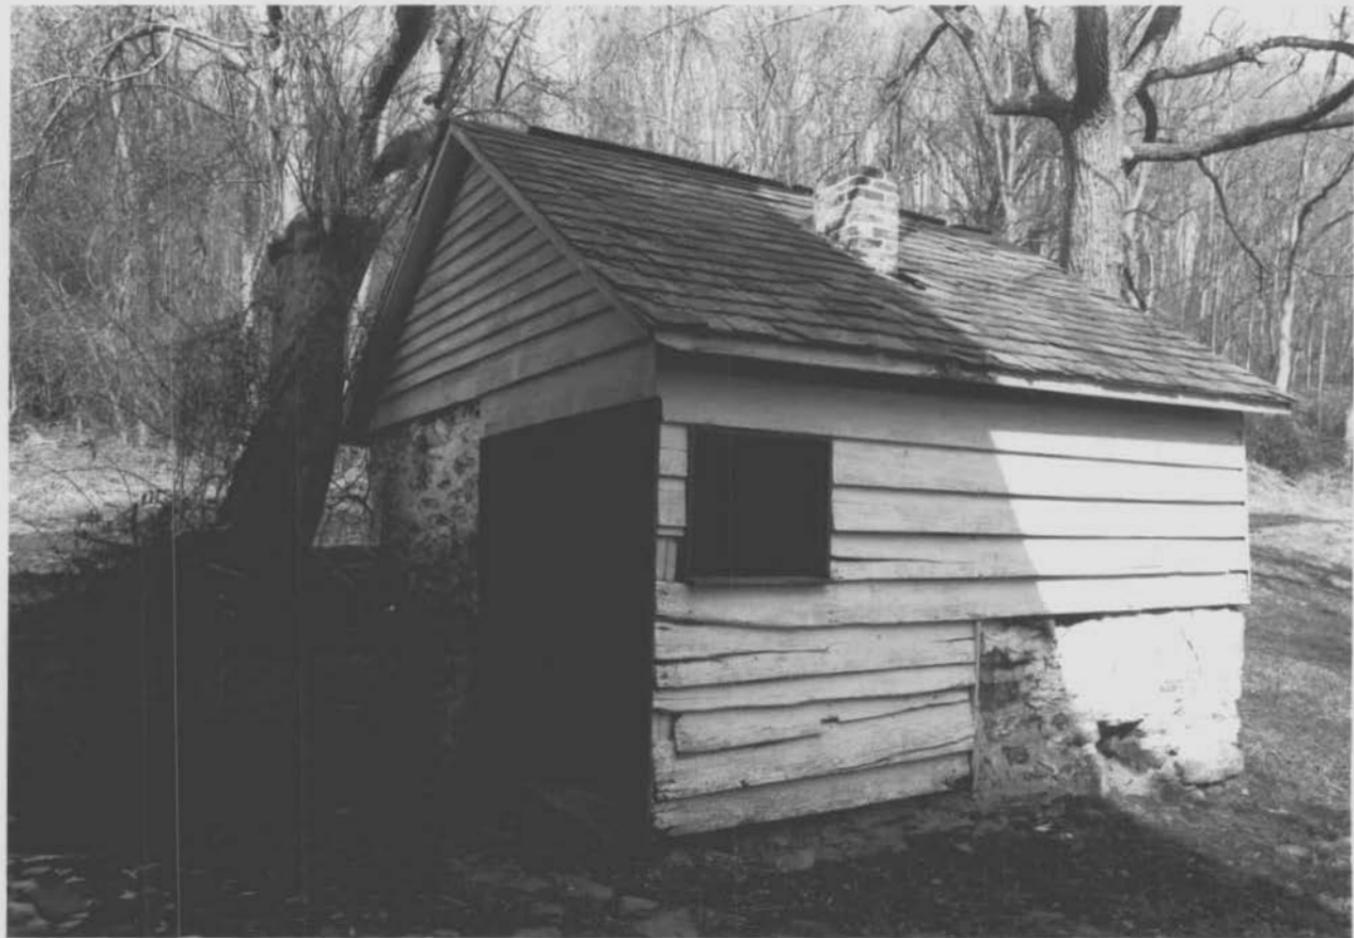
11/19

Bakehouse - west & South elevs.
