CARR-660

Baughman Mill Farm  
4808 Baughman Mill Road  
Lineboro (vicinity)

# Maryland Historical Trust State Historic Sites Inventory Form

historic John Shauck Farm Baughman Mill Farm (preferred)

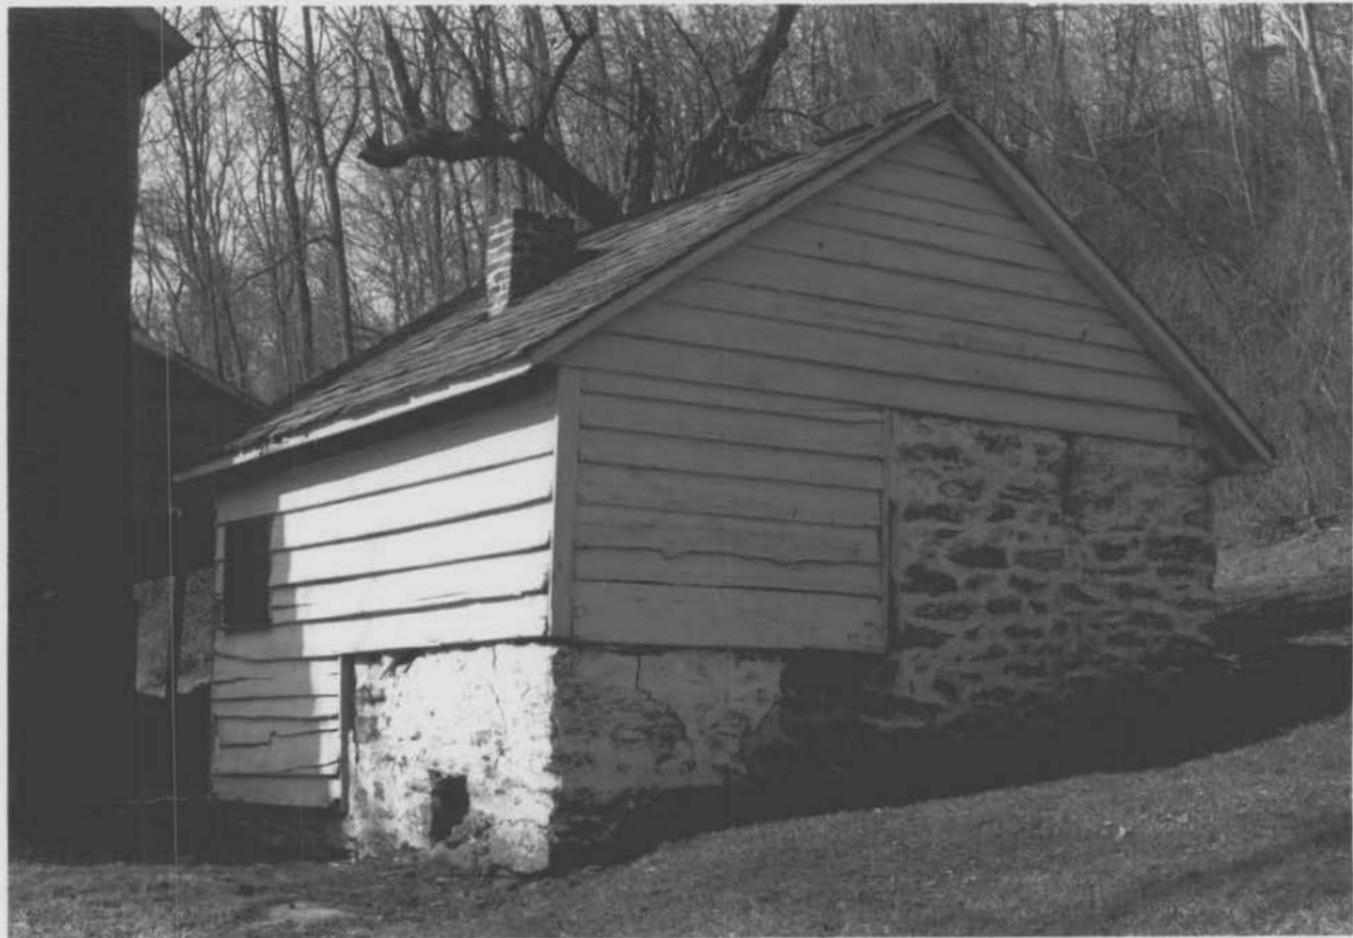
12/19

Bakehouse - south & east elevs

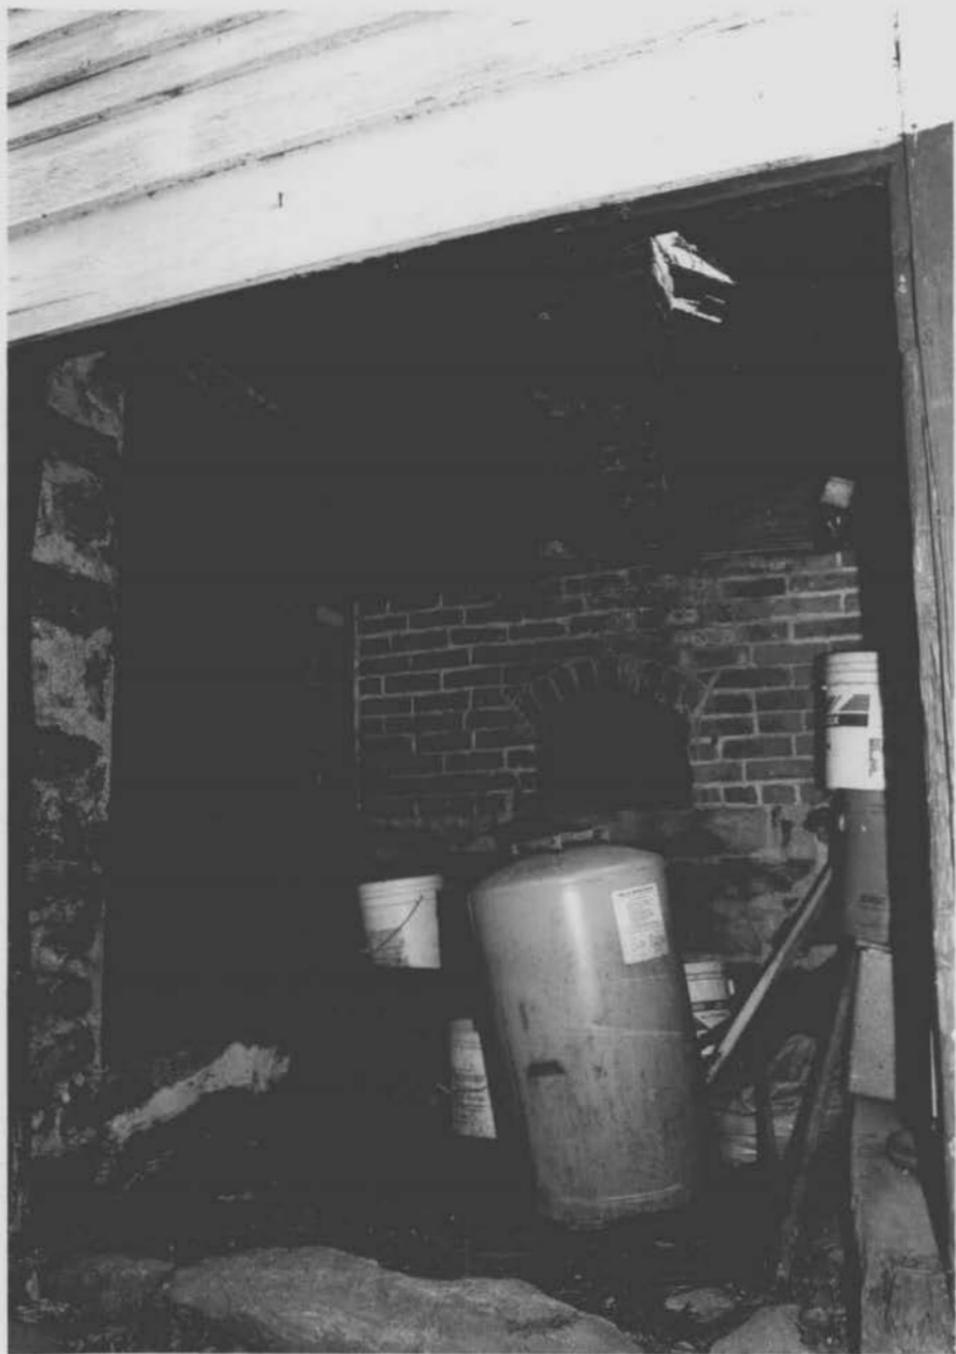
<sup>13</sup>/<sub>19</sub>

Bakehouse - interior, vw. east

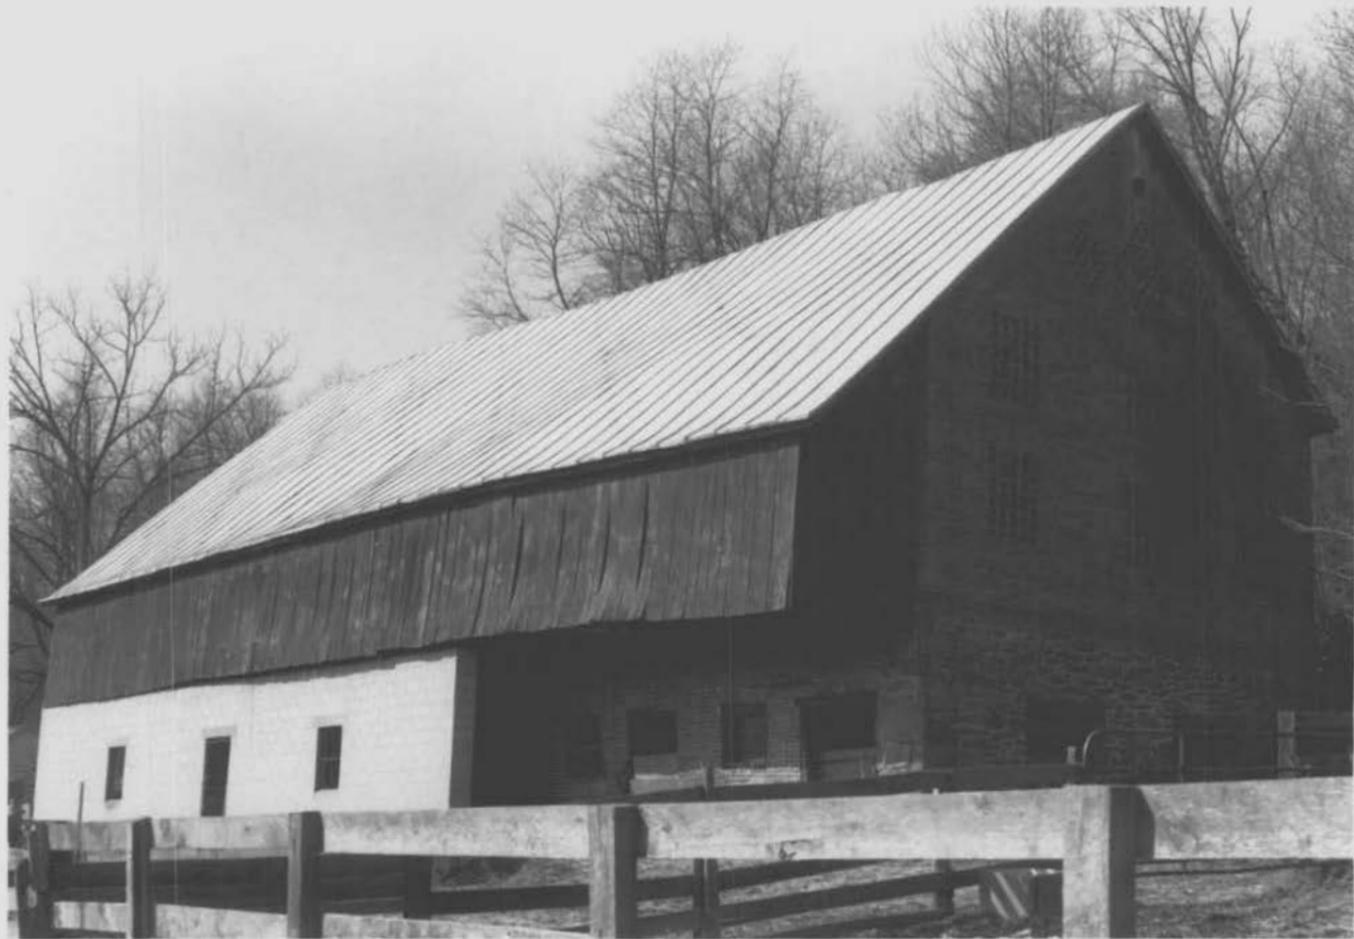
14/19

The barn is located approximately 100 yards to the east of the house and is set nearly parallel with the ridge of the house. It is a brick and stone barn built into the hillside with an overshot forebay facing south, and measures 81 feet long and 38½ feet deep including the 8 foot forebay. This barn is notable for its Flemish bond brickwork and molded water table, and for the fine decorative brick ventillated gables. Unfortunately the foundation walls are failing and the barn is in danger of at least partial collapse.

The front facade, facing south, is the most seriously threatened part of the building and has been partially shored up and stabilized. The ground floor level, protected by the forebay, is of brick construction on a fieldstone foundation, with worked stone quoining on the gable ends where the stone gable foundations turn the corner. One of these stones on the west end of this wall is inscribed:

Barn - south & east elevs.

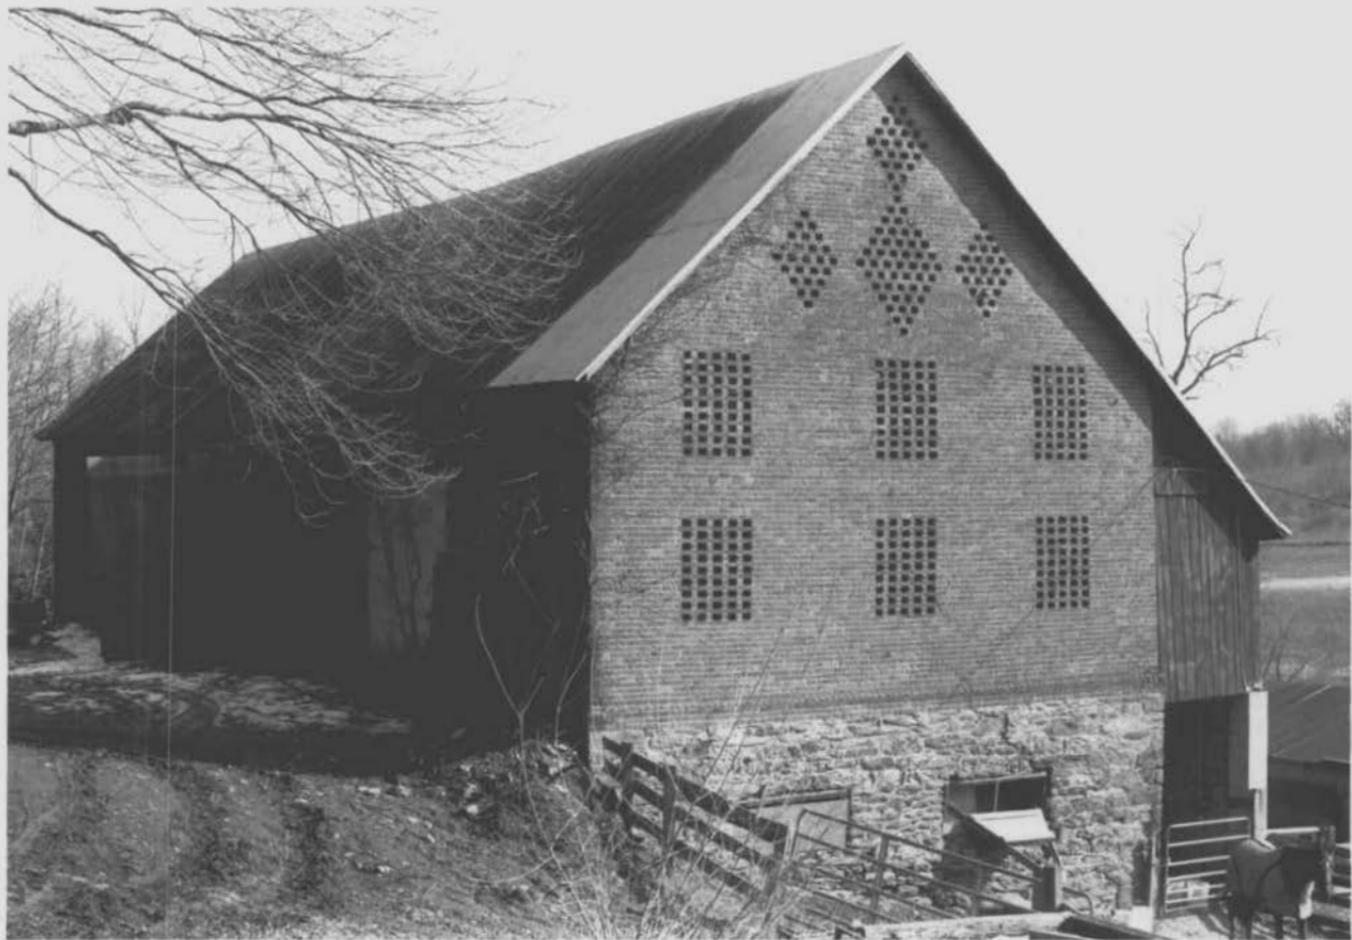
15/19

The west gable wall is constructed of brick laid in Flemish bond above a fieldstone foundation. The fourth brick course above the stone foundation is an ovolo molded watertable, an extremely unusual feature for a barn. Openings in this wall include a pair of horizontal cellar openings originally fitted with horizontal bars and an elaborate series of ventilators formed by omitting bricks in a pattern. These include two rows of three rectangular ventilators and four diamond pattern openings in the upper gable.

The north or uphill facade of the barn is laid in four-to-one common bond above an ovolo watertable and stone foundation. The center opening is unusually wide and consists of paired double doors serving a double aisle inside. There are two rectangular ventilator openings to each side with a rectangular window opening above. The upper wall to the left of the doors is in danger of collapse; the right jamb of the door opening has been rebuilt.

Barn - north & west elevs.

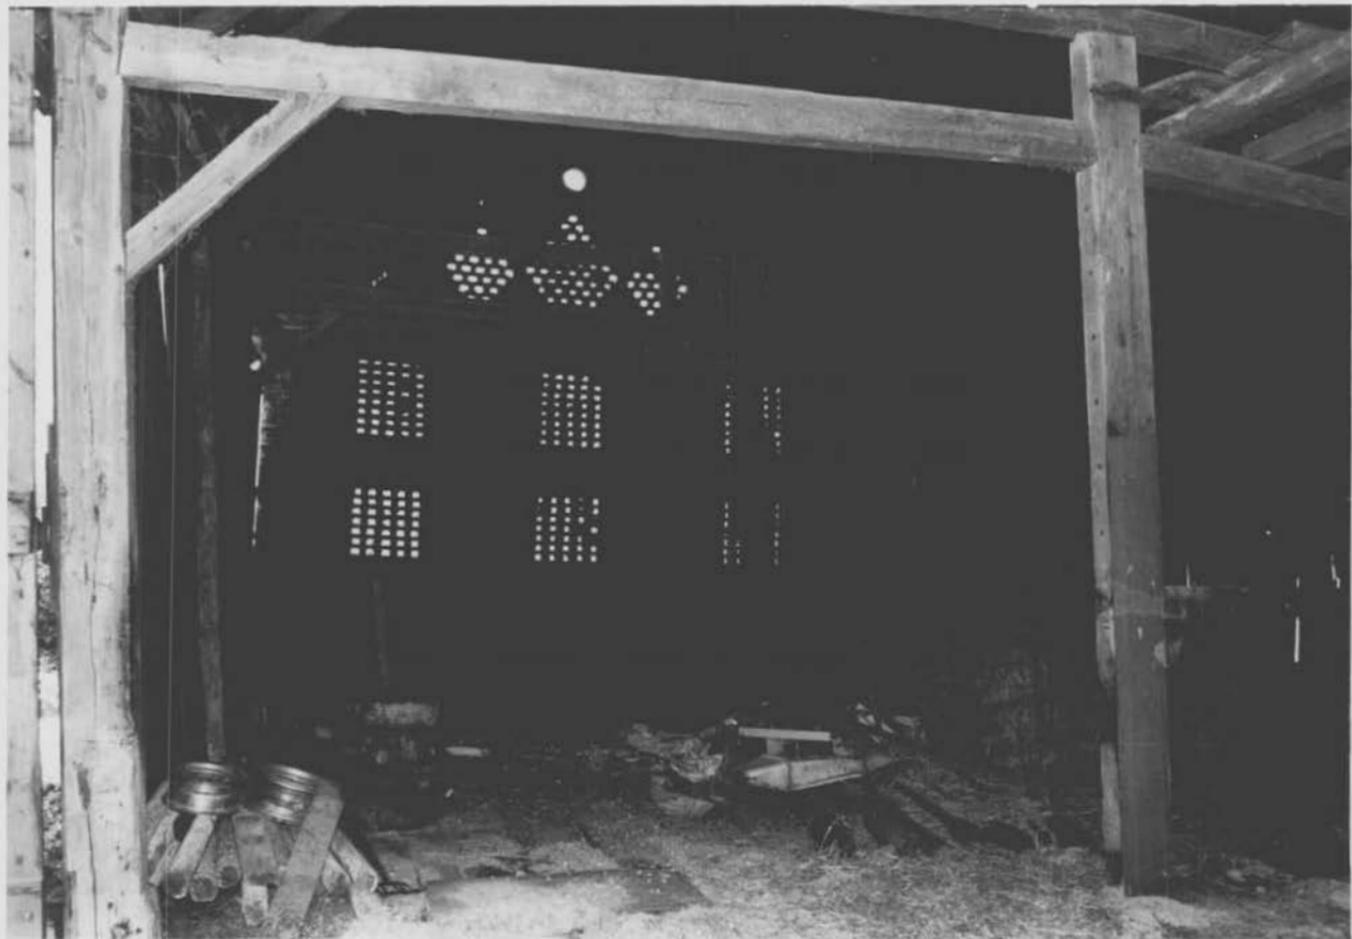
16/19

The upper, main floor of the barn is divided into four principal bays formed by three interior bents. The two center bays are aisles presumably used for threshing and for unloading hay. The end bays were evidently used for hay storage, and movable joists and loose

The roof consists of seven pairs of principal rafters with continuous common rafters laid over butt purlins. The east and west bays are larger than the center aisles, and so the roof over these two bays is divided in half by principal rafters joined by a tie beam and supported by two unbraced posts.

Barn-interior, vw. east

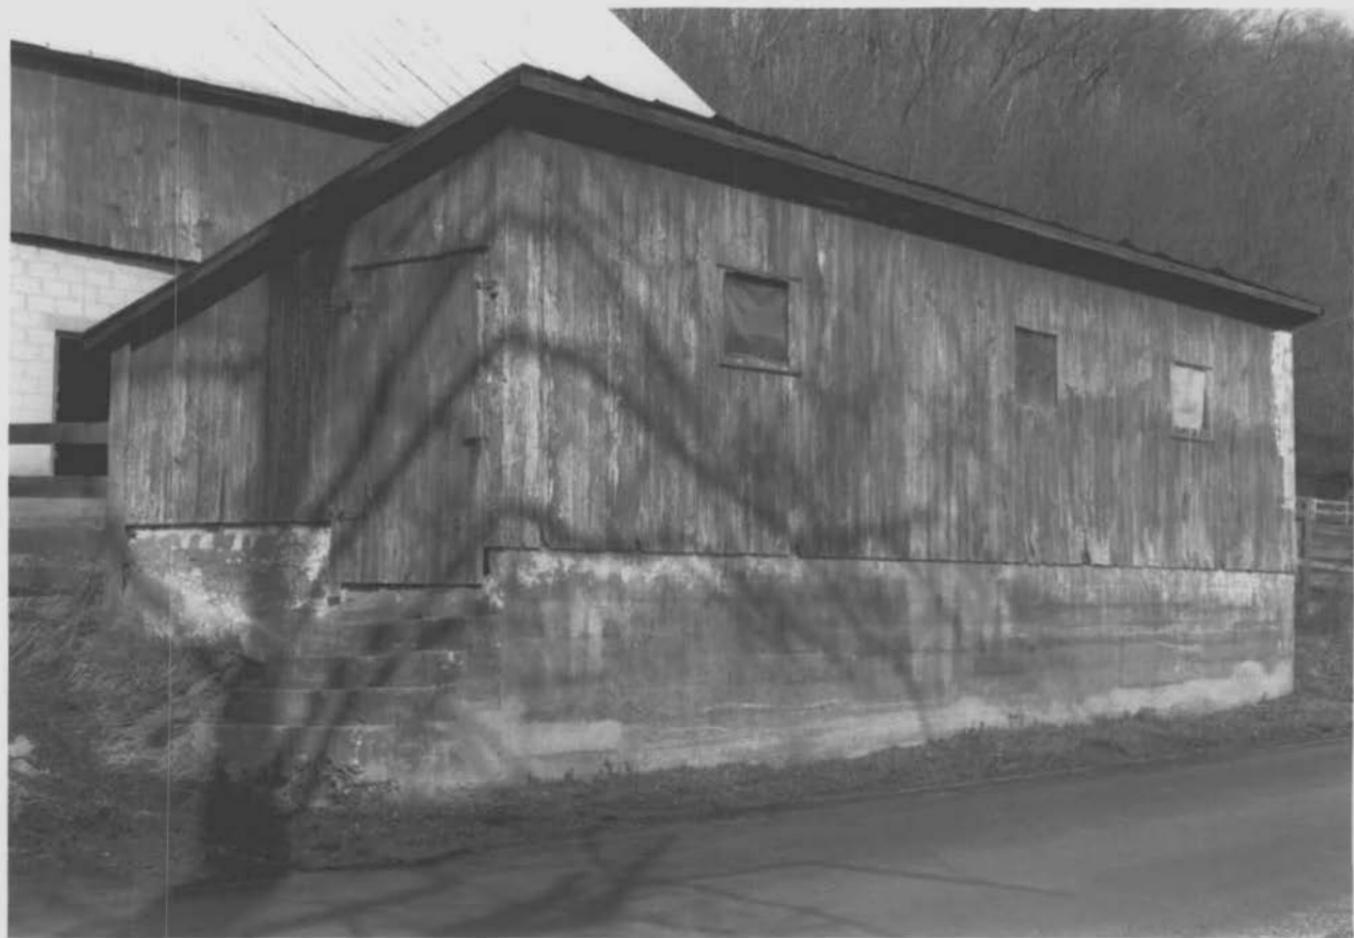
Baughman Mill Farm      CARR-660  
4808 Baughman Mill Rd.  
Carroll County, Maryland  
Photo: Kenneth H. Short  
Date: January 1992  
Neg. Loc: Maryland Historical Trust  
Hog Pen - west & south elevs.  
17/19

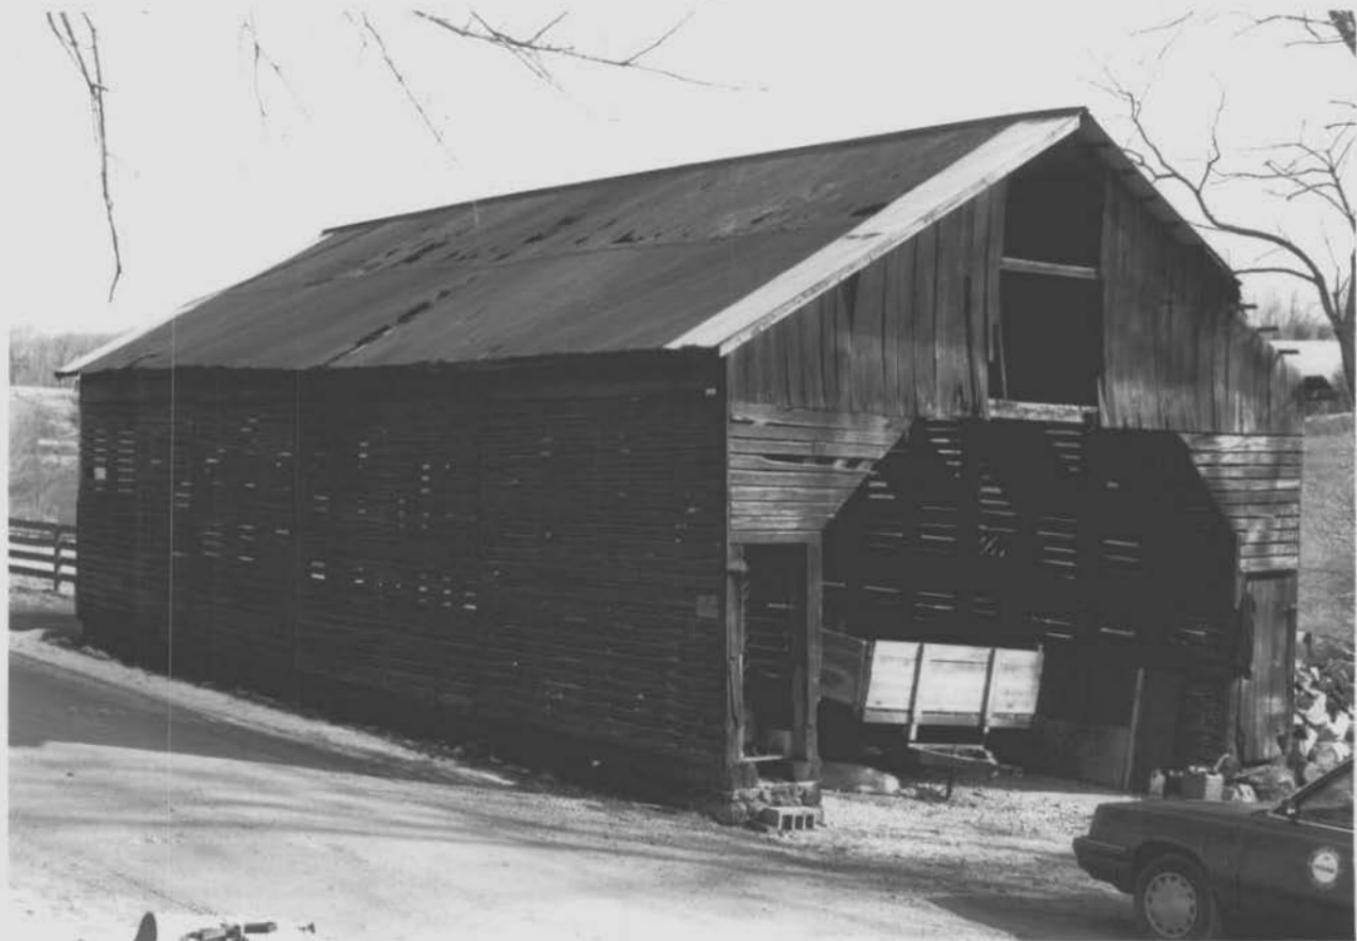
18/19

In addition, the farm includes a wood frame wagon shed set upon stone piers. It is open on both ends and has corn cribs on both sides. It is covered with horizontal wood slats and has a gable roof with corrugated metal covering. There is a one-story, three-bay, shed roofed, wood frame hog pen with concrete foundation, vertical wood siding, and corrugated metal roofing. There are two very similar three-bay, one-story shed roofed poultry houses. They have stone foundations, wood frames with German siding, central entrance "dutch" doors of vertical boards, six-light sash, and corrugated metal roofing over wood shingles.

Corn Crib - north & west elevs.

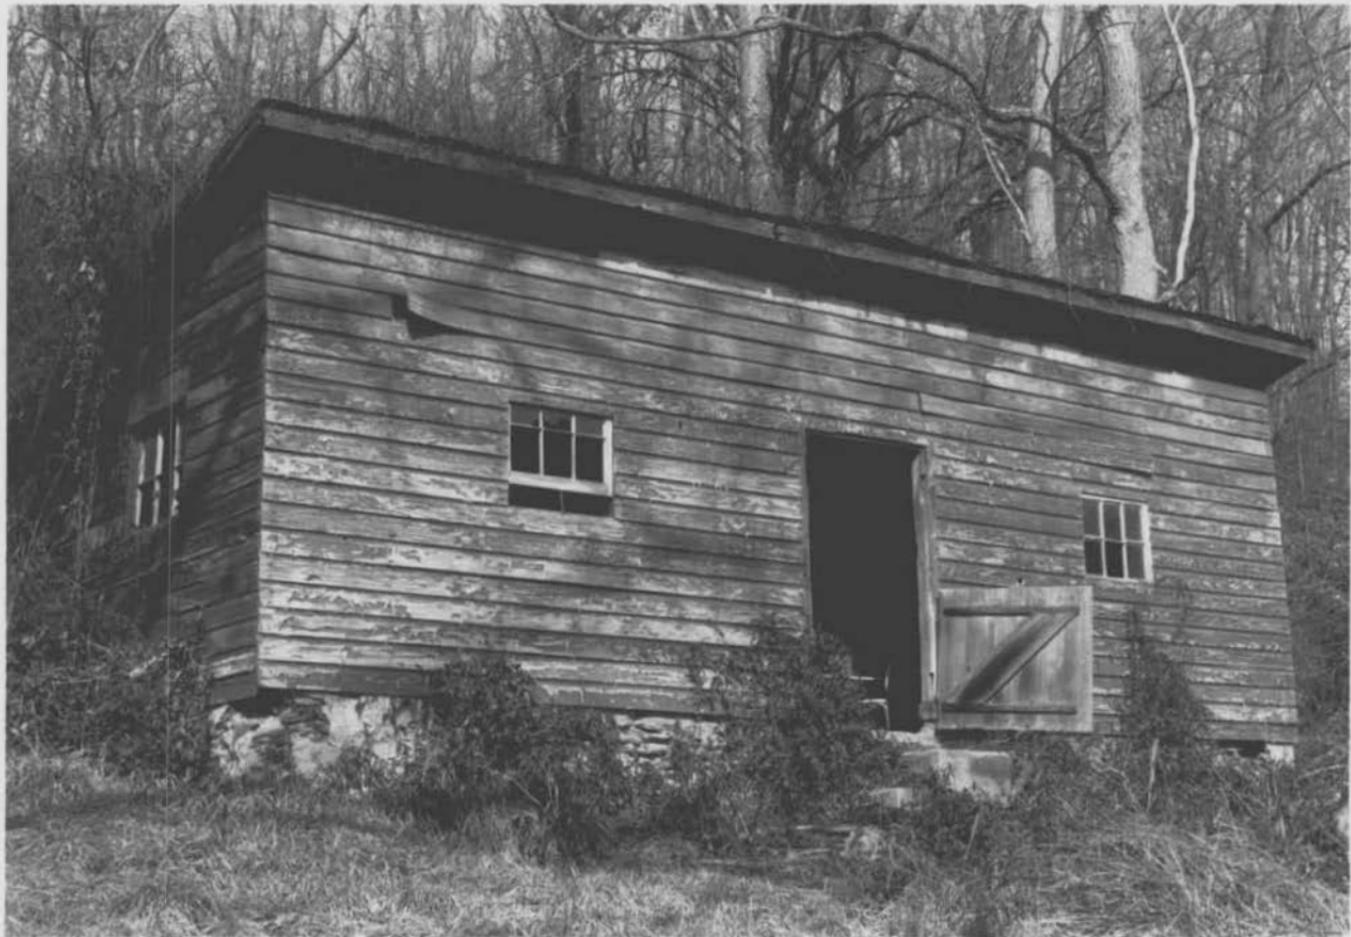
19/19

Poultry House - west & south elevs.
