CARR - 742

630 LUCABAUGH MILL ROAD

FIELD SHEET--HISTORIC RESOURCES SURVEY

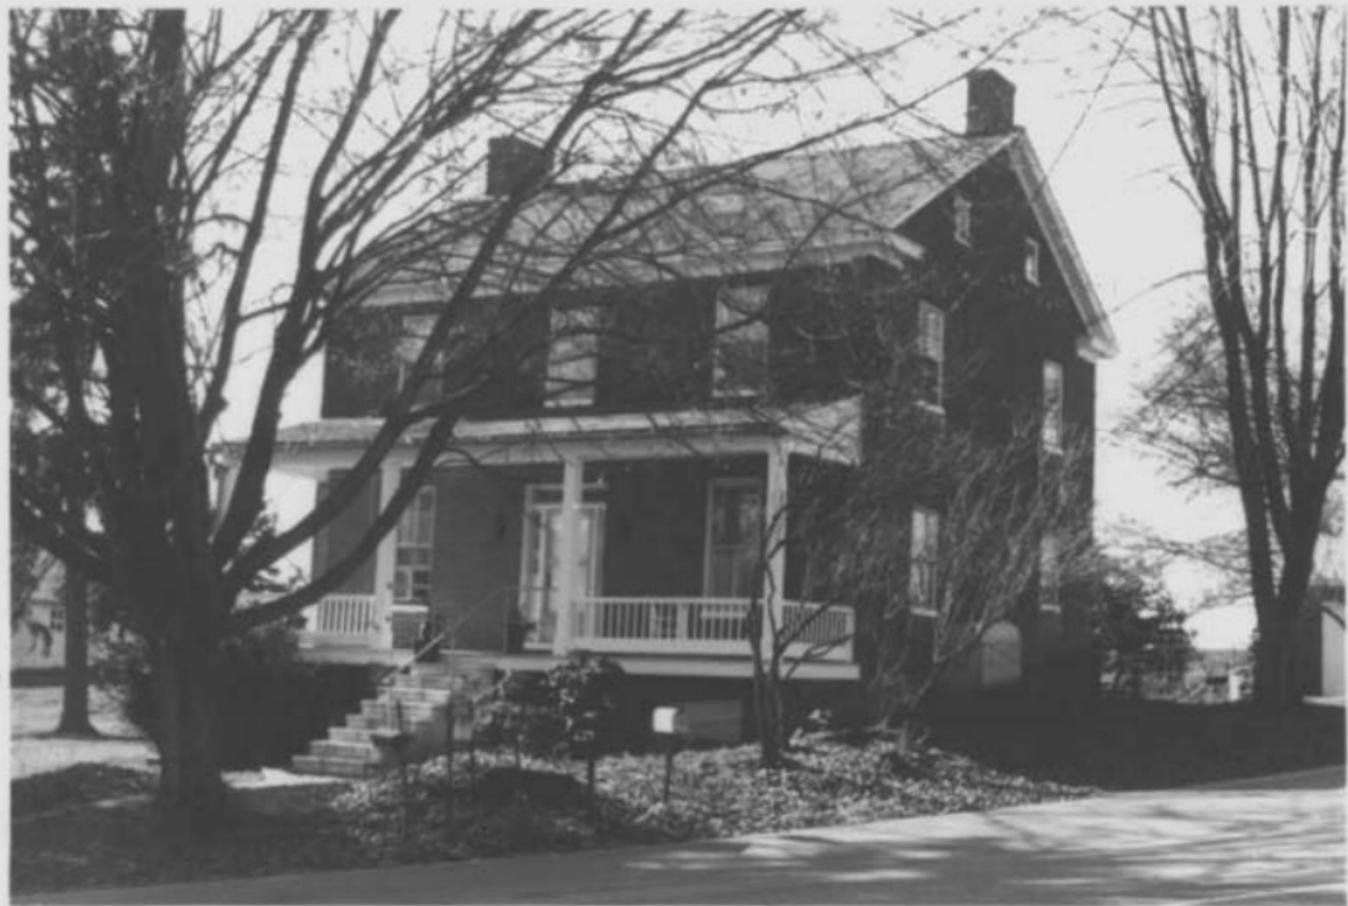
CARR-742

full-length - 1 st. front porch  
6/6 windows, jack each lintels  
interior end chimney at each gable end

1. 630 Lucabaugh Mill Rd.
2. Carroll Co. Md.
3. J. Betty
4. 11/83
5. Md. Hist. Trust, Annapolis, Md
6. north west elevation
7. 1/2

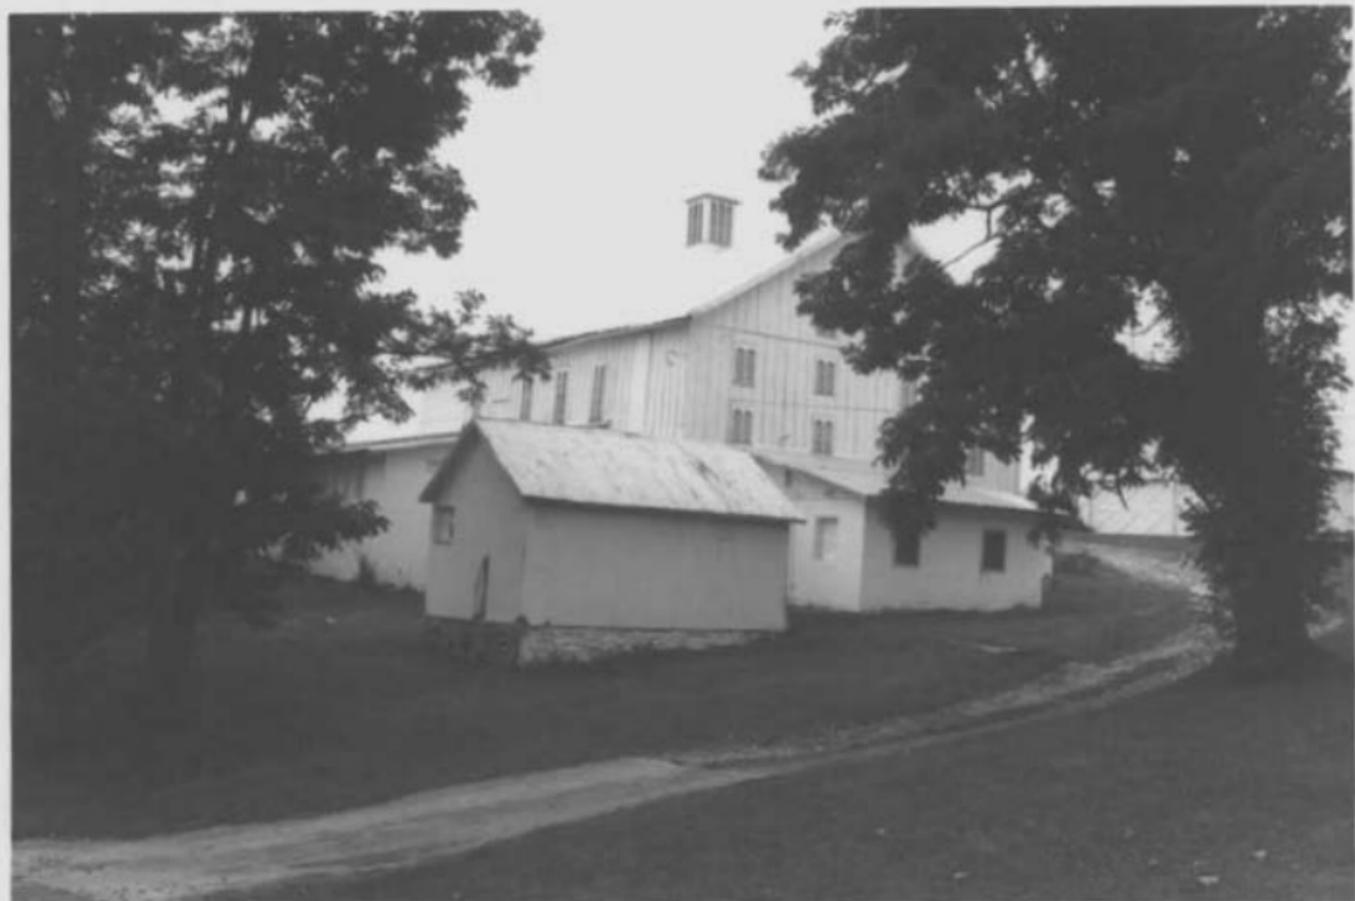
CARR. 742

frame bank barn

1. 630 Lucabaugh Mill Rd.
2. Carroll Co. Md.
3. J. Getty
4. 11/83
5. Md Hist. Trust, Annapolis Md.
6. bank box, northwest elevation
7. 2/2
