National Register of Historic Places  
Inventory—Nomination Form

historic Arter, Solomon, House (preferred)

and or common Arter-Davidson House

Arter, Solomon, House  
Carroll County, Maryland

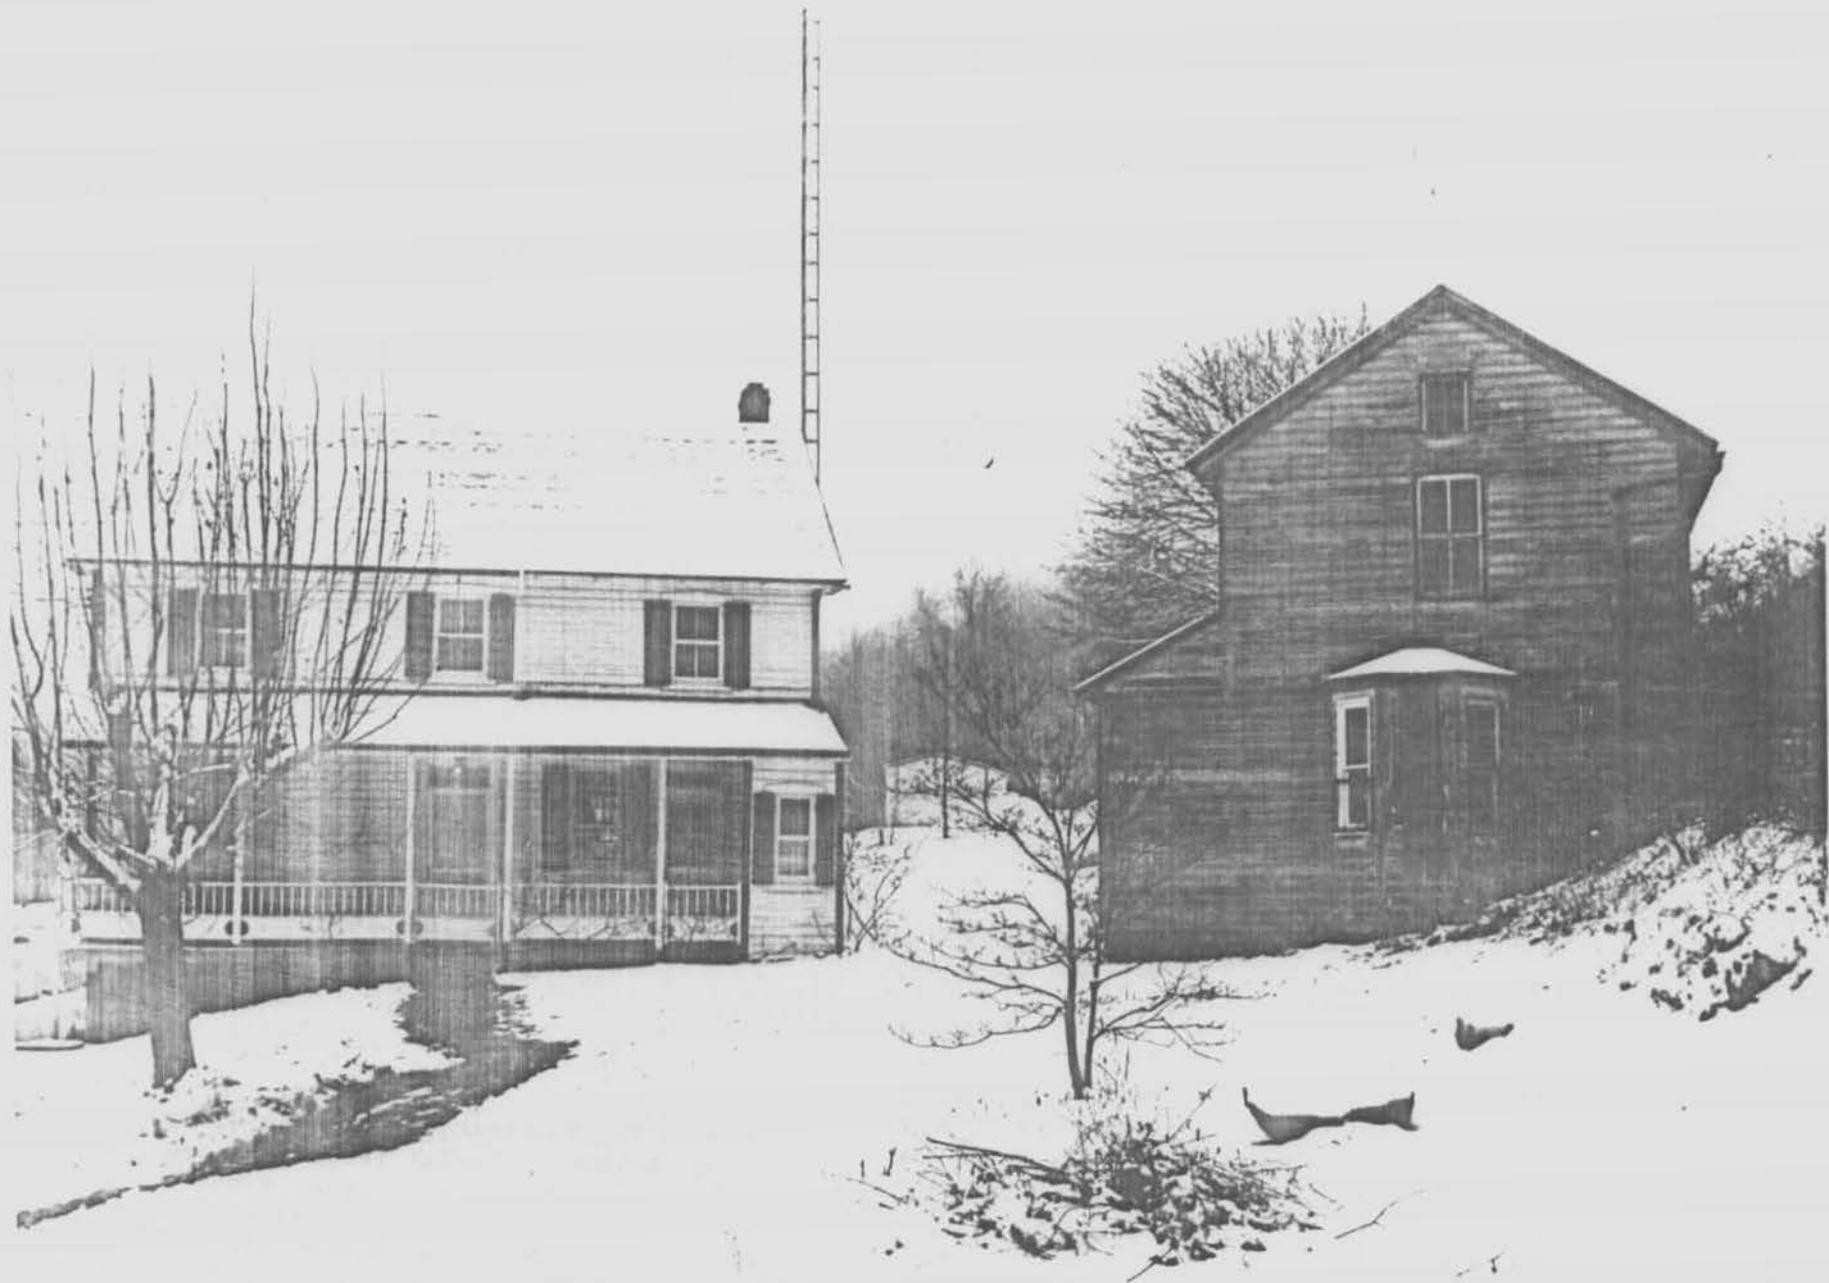
1. CARR-824 Arter-Davidson House
2. Carroll County, Maryland
3. Joe Getty
4. January 1985
5. Md. Historical Trust, Annapolis, MD
6. South elevation (camera facing north)
7. 1/19

The main (south) facade is three bays wide with a central entrance. All but one of the windows on the first story throughout the house are nine-over-six, and most of the second story windows retain original six-over-six (some of the second story windows were replaced with 2/2 sash in the late 19th century). The windows on the second story of the main facade and on each story around the house have a flat pointed-arch cornice. All of the windows have louvered shutters. The central entrance has a four-pane transom, a six-paneled door, and its original box lock. The box lock is constructed so that the exterior handle can be unscrewed as a means of locking the front door. The full-length, one-story front porch with shed roof was constructed in the late 19th century. It was supported by tapered posts and has a square bannister railing. The easternmost bay of the first story was apparently altered at the same time. These alterations include shifting one story window to an asymmetrical position, the insertion of a second doorway that leads directly to the southeast room, and the addition of a narrow pantry that projects out under the front porch roof.

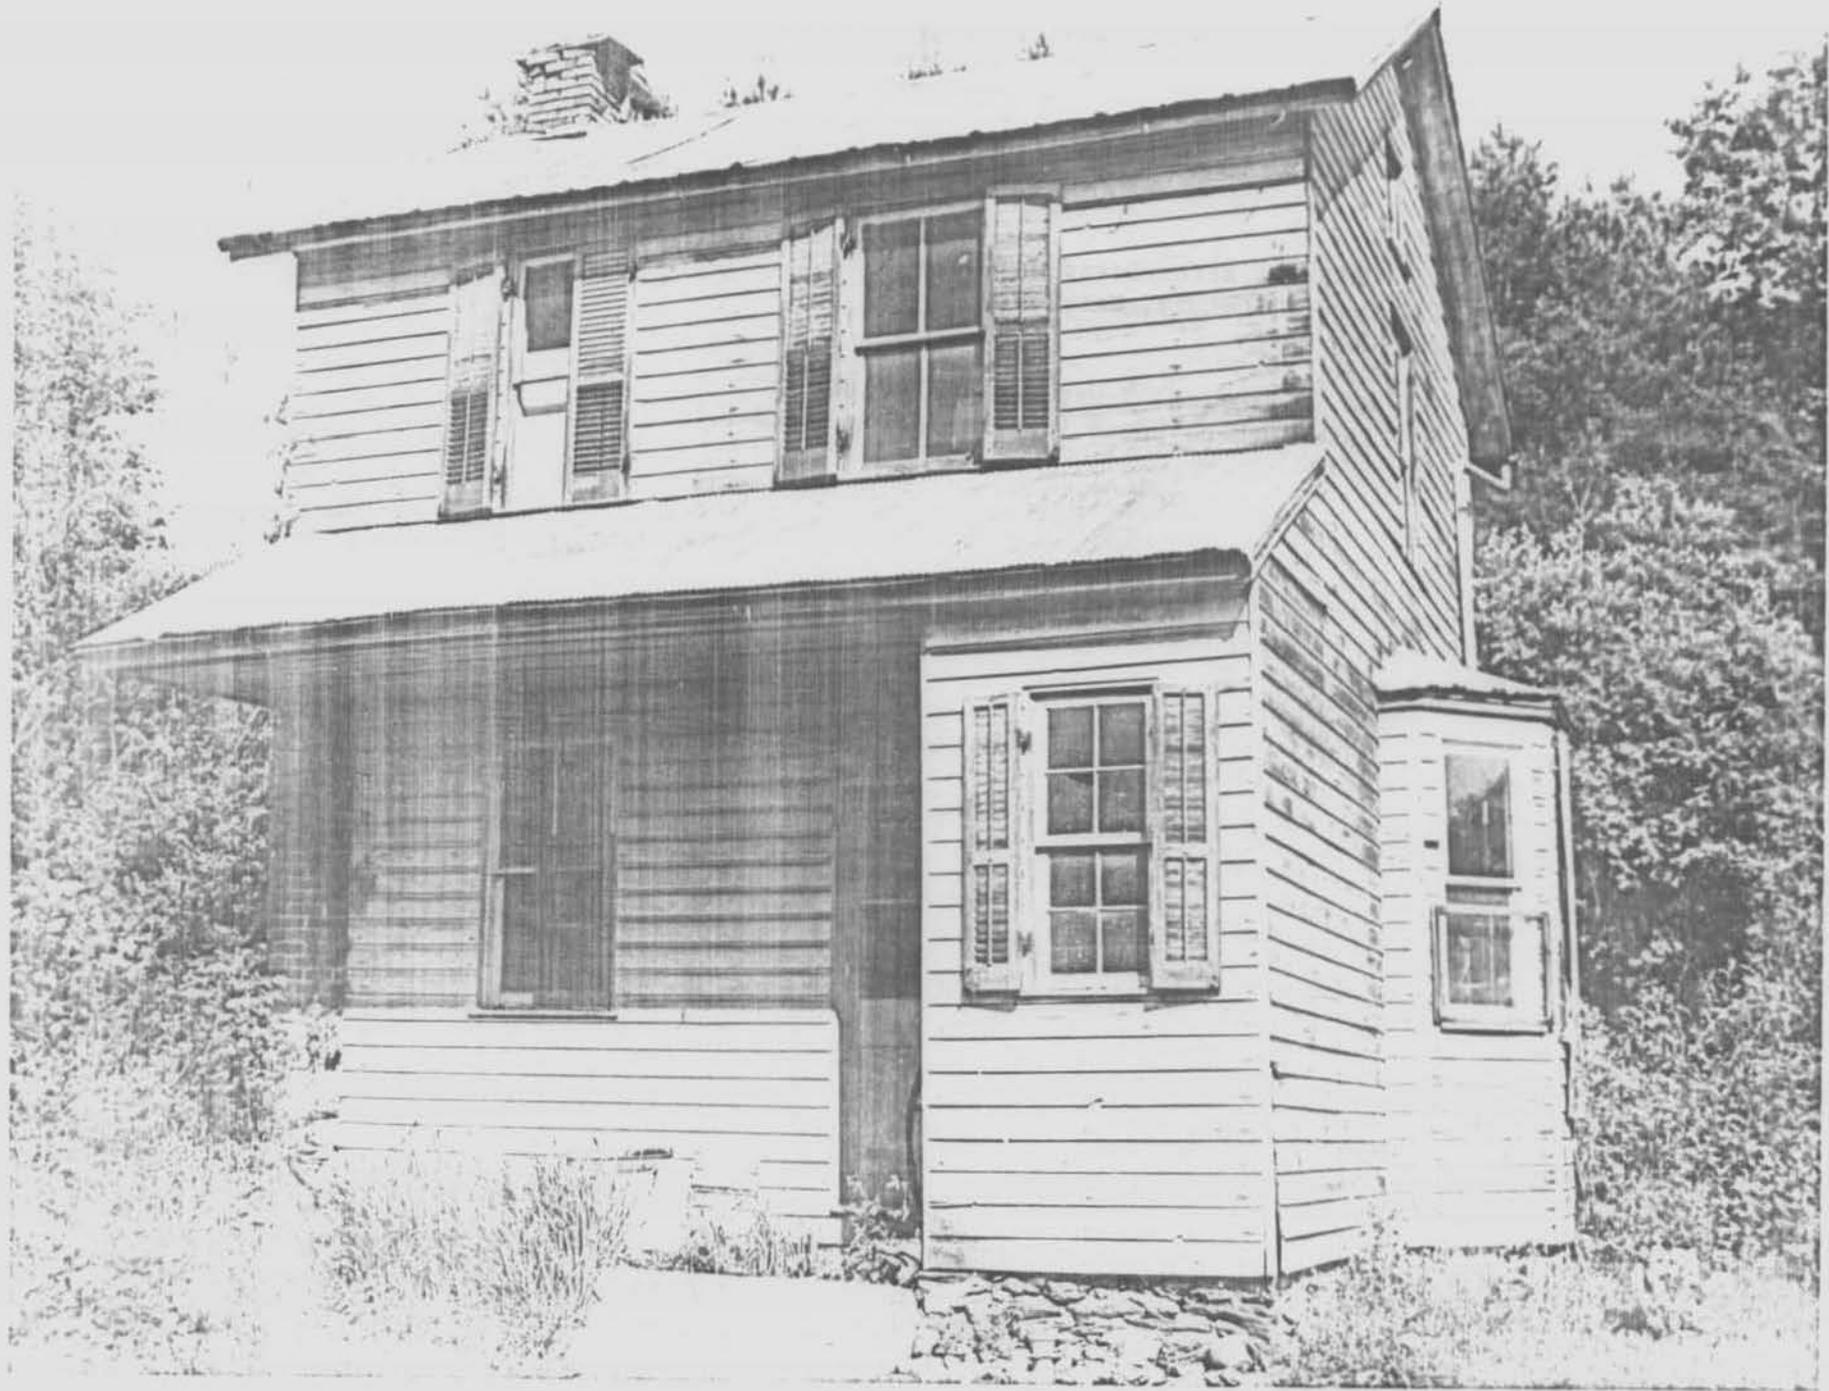
1. CARR-824 Arter-Davidson House
2. Carroll County, Maryland
3. Joe Getty
4. May, 1985
5. Md. Historical Trust, Annapolis, MD
6. Late 19th c. house (camera facing east)
7. 3/19

Also on the east side of the road is a small frame house constructed in 1883 as a retirement house for Solomon Arter, Jr., who was by then planning to turn over the operation of the farm to his son, Enan. This house is interesting in the way it incorporates Victorian design features while reflecting the conservative nature of this region. The house is constructed into a sharp slope with the main facade facing west. The slope is located on the east side so that the entire first story of the east side is covered by the ground. The north gable end is constructed of brick and contains an interior-end brick fireplace. The west, south and east facades are constructed of frame covered in German siding. This structure is built on a stone foundation. It is two-stories, two-bays by one-bay in size with a gable roof. The main facade has a full-length, one-story porch with a shed roof and a projecting pantry, similar to the one added to the main house, at its southwest corner. The interior of the structure consists of a one-room plan with a corner stair beside the fireplace. On the south facade is a one-story, three-sided, projecting bay window.

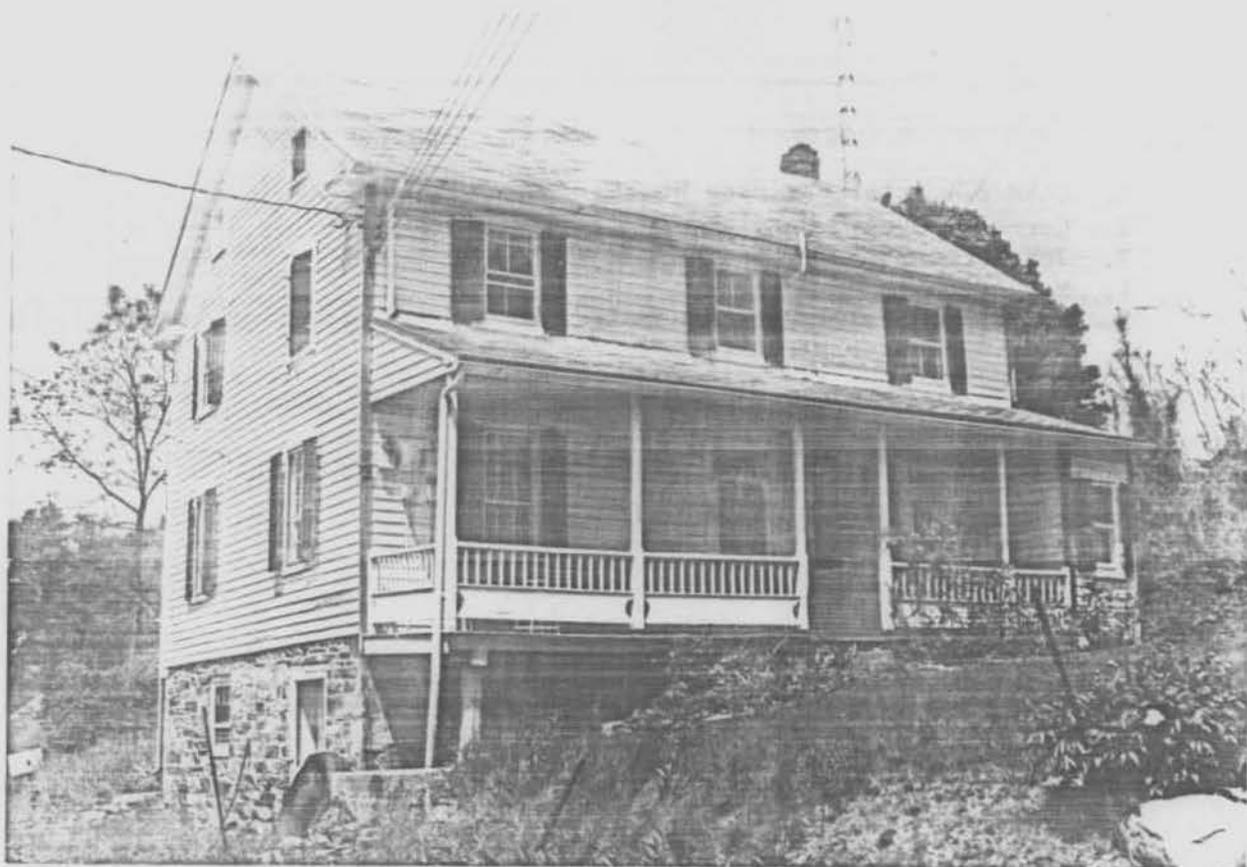
1. CARR-824 Arter-Davidson House
2. Carroll County, Maryland
3. Joe Getty
4. May, 1985
5. Md. Historical Trust, Annapolis, MD
6. South and West Elev. (camera facing n.e.)
7. 4/19

The basement is exposed at ground level on the west elevation. The basement is constructed of rough-coursed fieldstone with a bevelled joint. The southernmost bay contains a wide entrance and the northernmost bay contains a six-over-three sash window. Small four-pane windows are also located on the north and south elevations of the western portion of the foundation level. Also, the sloping ground is cut out underneath the porch on the south elevation to provide a sheltered working area. The west elevation has two nine-over-six windows on the first story, two six-over-six windows on the second story, and two square four-pane windows in the gable. The east gable end has an identical pattern of fenestration.

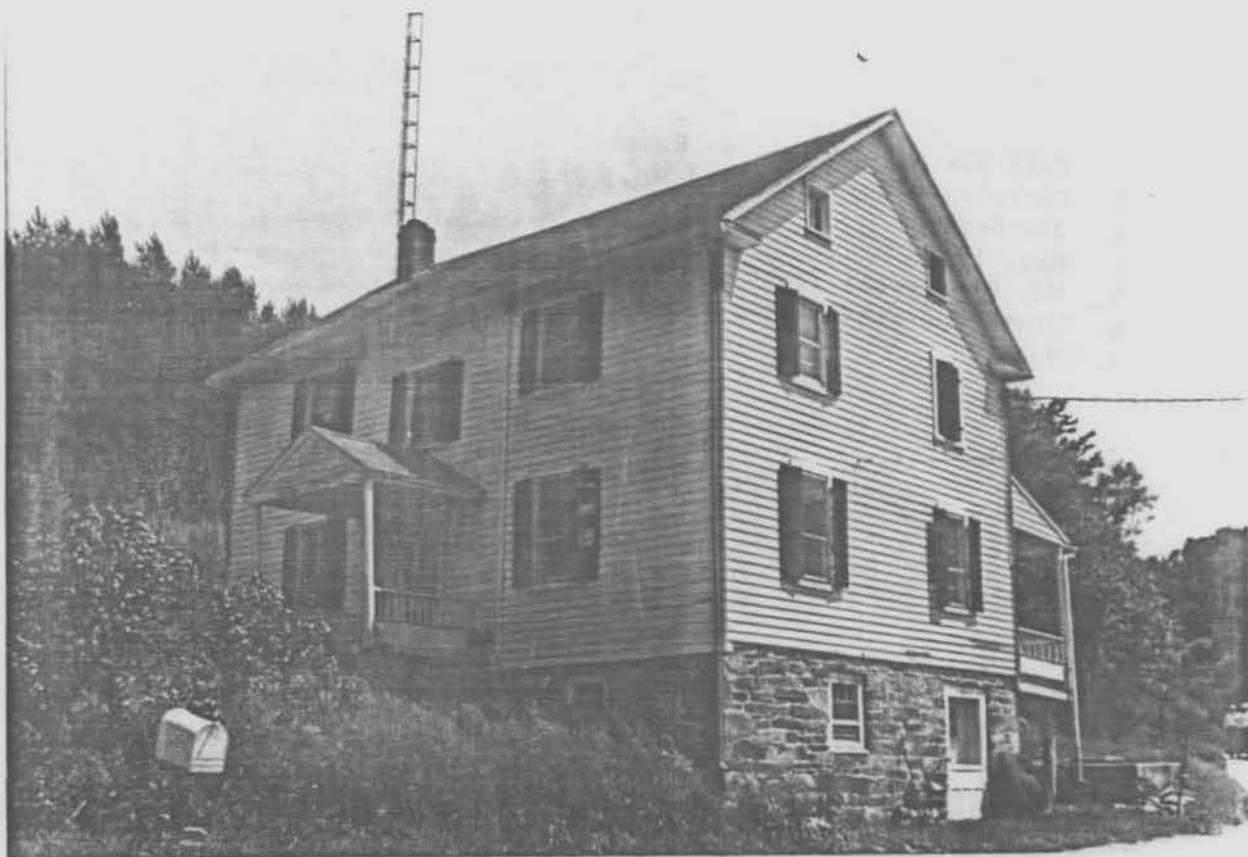
1. CARR-824 Arter-Davidson House
2. Carroll County, Maryland
3. Joe Getty
4. May, 1985
5. Md. Historical Trust, Annapolis, MD
6. North and West elev. (camera facing s.e.)
7. 5/19

The north elevation has a central entrance with a one-bay, one-story entrance porch with a gable roof. The westernmost window on the first story retains its nine-over-six sash while the easternmost window contains two-over-two sash. The central window on the second story is offset at a lower level to light the staircase. All three second story windows contain six-over-six sash.

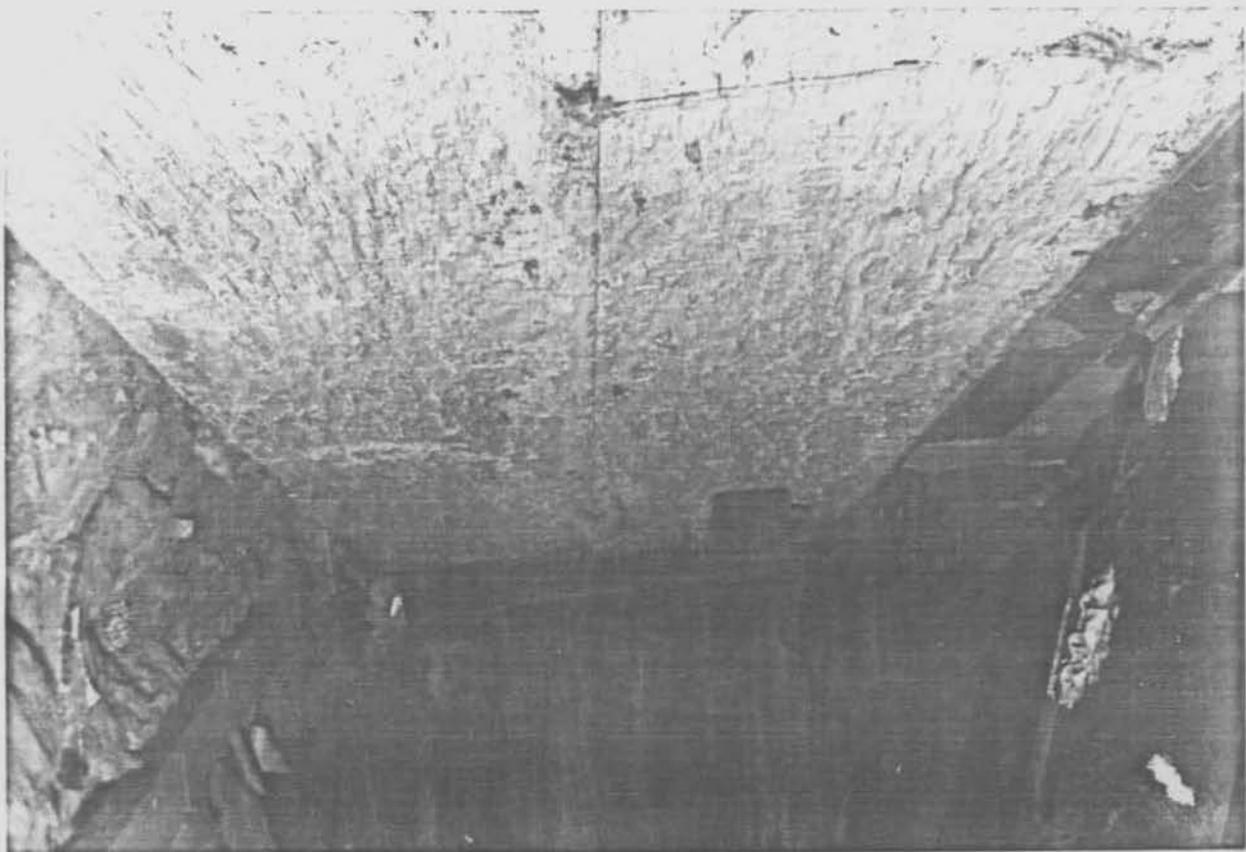
1. CARR-824 Arter-Davidson House
2. Carroll County, Maryland
3. Joe Getty
4. May, 1985
5. Md. Historical Trust, Annapolis, MD
6. Original siding under south elev. porch  
roof
7. 7/19

The c. 1810 Solomon Arter house is a two-story, three-bay by two-bay structure of log construction. It rests on a field stone foundation that is built into a partially-excavated slope with the western part of the foundation exposed at ground level. The logs are presently covered with German siding, but were originally covered with mill-sawn weatherboard. The German siding is part of a late 19th century remodeling that also included the construction of a full-length, one-story porch on the main facade. The portion of the main facade covered by the porch roof contains the original wood siding of the main facade still in place, which can be viewed by removing boards in the porch ceiling. This area reveals the original siding (14-16 inches wide) and also shows that a one-bay gable roofed porch existed over the main entrance at one time. The house has a gable roof with a boxed cornice that returns at the corners. Originally, brick interior chimney stacks rose at the peak of the roof at each gable end.

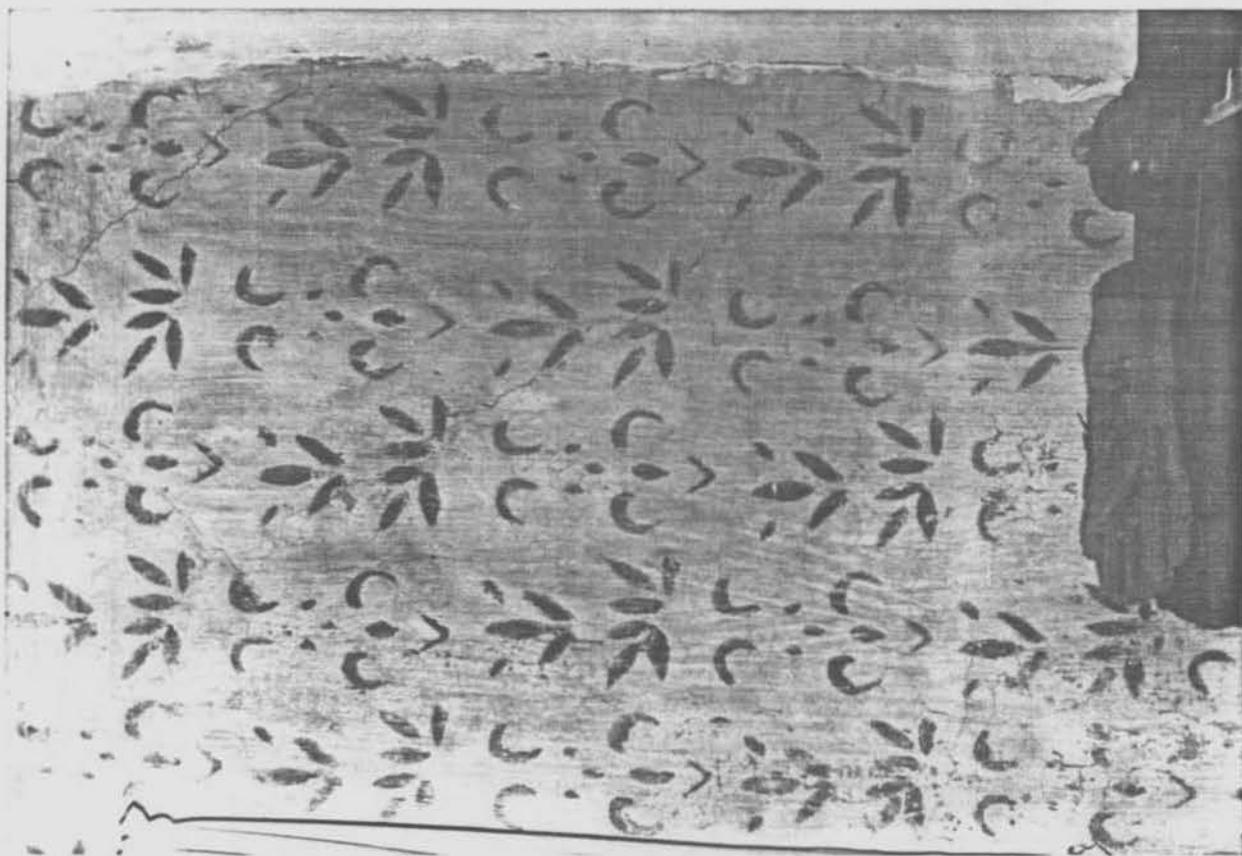
1. CARR-824 Arter-Davidson House
2. Carroll County, Maryland
3. Joe Getty
4. January, 1985
5. Md. Historical Trust, Annapolis, MD
6. Stenciled wall in northeast bedroom
7. 9/19

The walls of the northeast bedroom retain two sections of original stenciling. One section runs floor-to-ceiling and the other runs part of the way up the wall before it is painted over. The stenciling pattern of both sections is identical consisting of two large motifs, a red tulip rising from a heart and a green abstract leaf. The motifs run alternately in both a horizontal and vertical pattern. The heart and tulip motif was a popular design in Pennsylvania German decorative arts. It is possibly a reference to scripture (Matthew 7:17, 18; Matthew 12:3-25; and Luke 6:43-45) where it is stated that from the heart rose good deeds, and the tulip frequently represents good things or good fruit in the Pennsylvania German culture. This section of stenciling was revealed by the current owners in the late 1940s, when they removed a layer of wallpaper. They left these panels exposed, and while the light has probably faded the colors to some extent, the stencils and their colors are still quite vivid. The red color is deep and the green on one wall is dark, while on the other wall it is a blue-green.

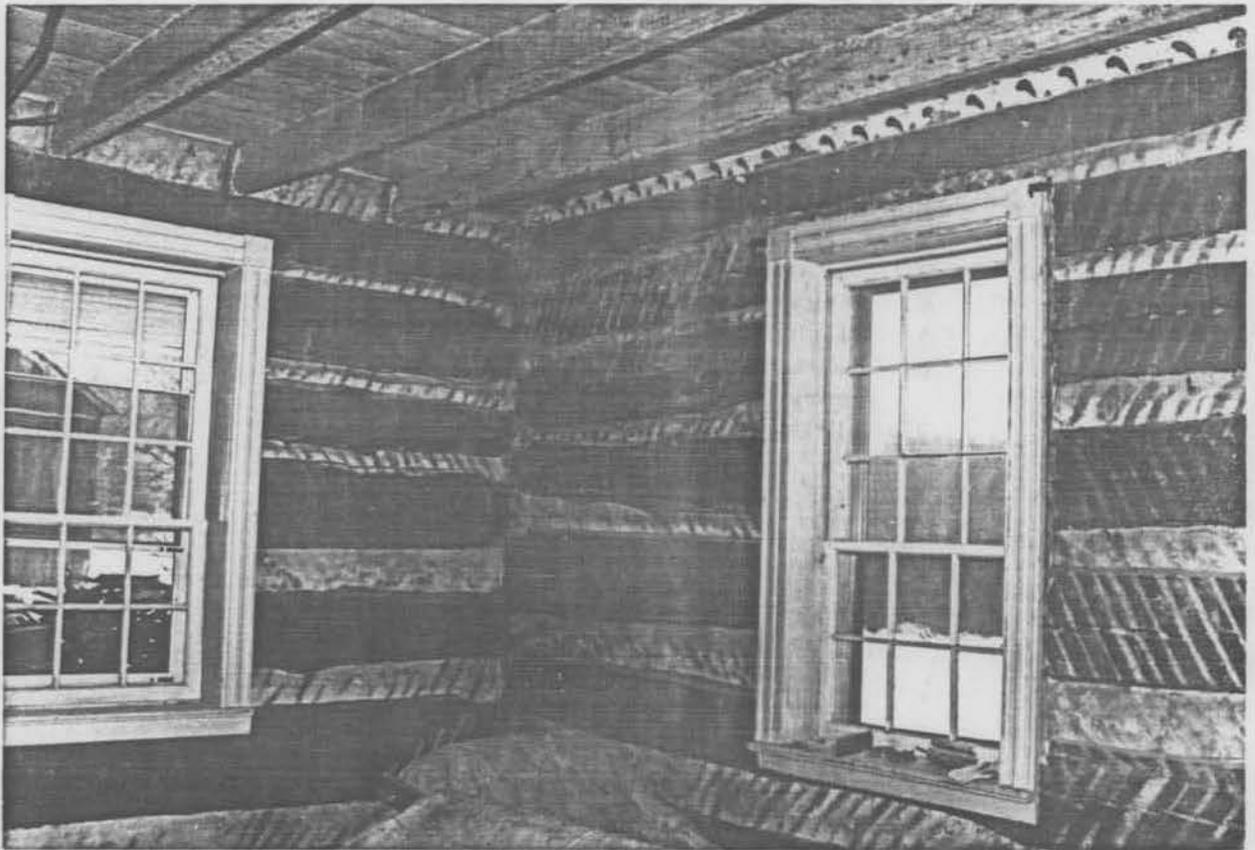
1. CARR-824 Arter-Davidson House
2. Carroll County, Maryland
3. Joe Getty
4. January, 1985
5. Md. Historical Trust, Annapolis, MD
6. Remnants of southwest room stenciling, 1st  
story
7. 11/19

On the first story, the west interior walls were exposed during a remodeling in January 1985. With the ceiling and wall plaster dating from the early 20th century removed, the location of the former partition between the two rooms became evident. Further, the ceiling joists and underside of the second story floor boards were found to have been painted a pink color in the southwest room and whitewashed in the northwest room. Apparently, the ceilings were covered with lath and plaster in the mid 19th century and in the early 20th century the walls of both rooms were completely replastered. When this new plaster was removed during the 1985 remodeling, the only original plaster that was found was a 7 to 8 inch strip at the cornice level, which had been concealed by the earlier plastering job. This preserved strip revealed two different stencil patterns, both consisting of floral motifs. In the southwest room, the pattern had two different designs. It begins in the southeast corner of the room with a green maple leaf pattern above blue swirls, but becomes more abstract along that wall changing to a leaf pattern

with three petals (instead of maple leaf five petals). The colors are quite bright in this room and the way the pattern is interrupted makes it appear that it continued in some manner from floor to ceiling. In the first story stairhall, evidence suggests that the blue floral and yellow pattern from the upstairs would have continued. There is no current evidence of stenciling in the rooms on the east side of the stairhall.

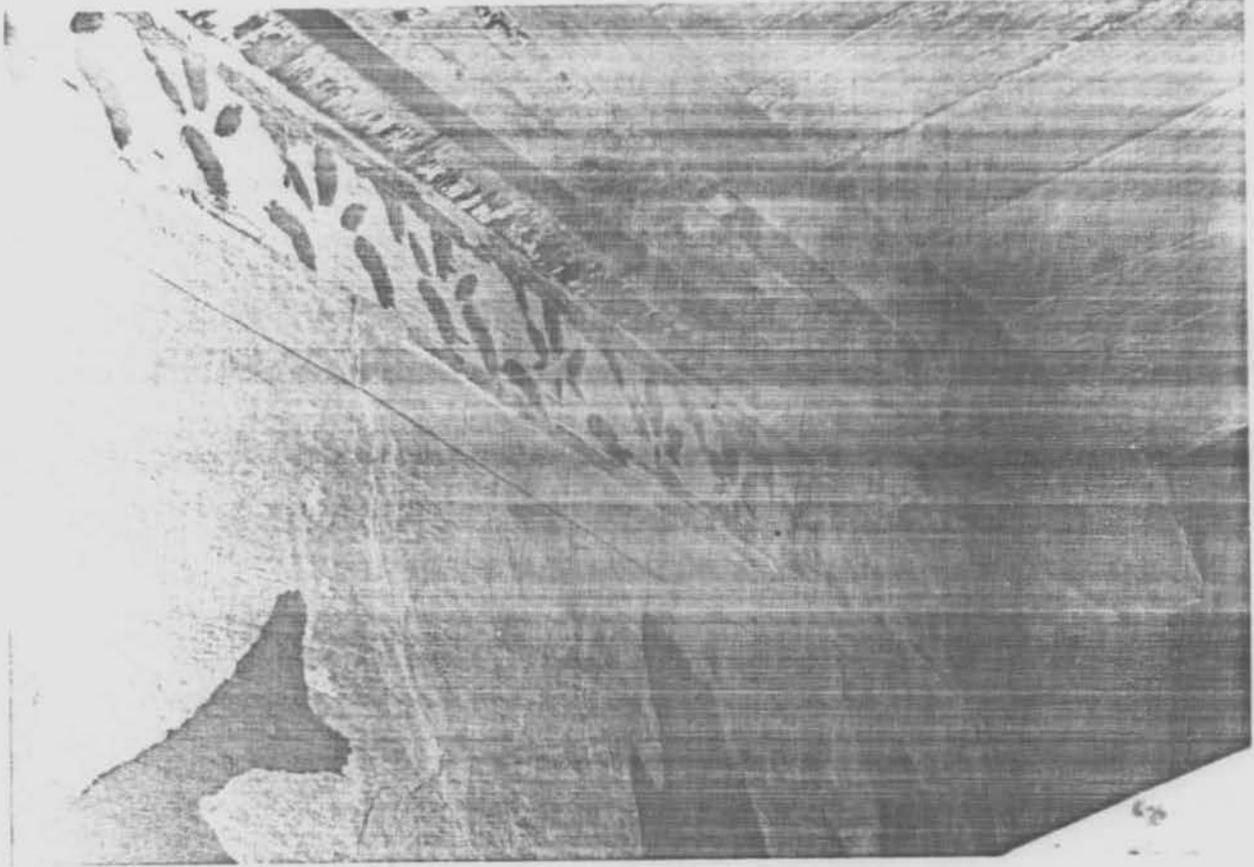
1. CARR-824 Arter-Davidson House
2. Carroll County, Maryland
3. Joe Getty
4. January, 1985
5. Md. Historical Trust, Annapolis, MD
6. 1st story, southwest room stenciling  
(southeast corner)
7. 12/19

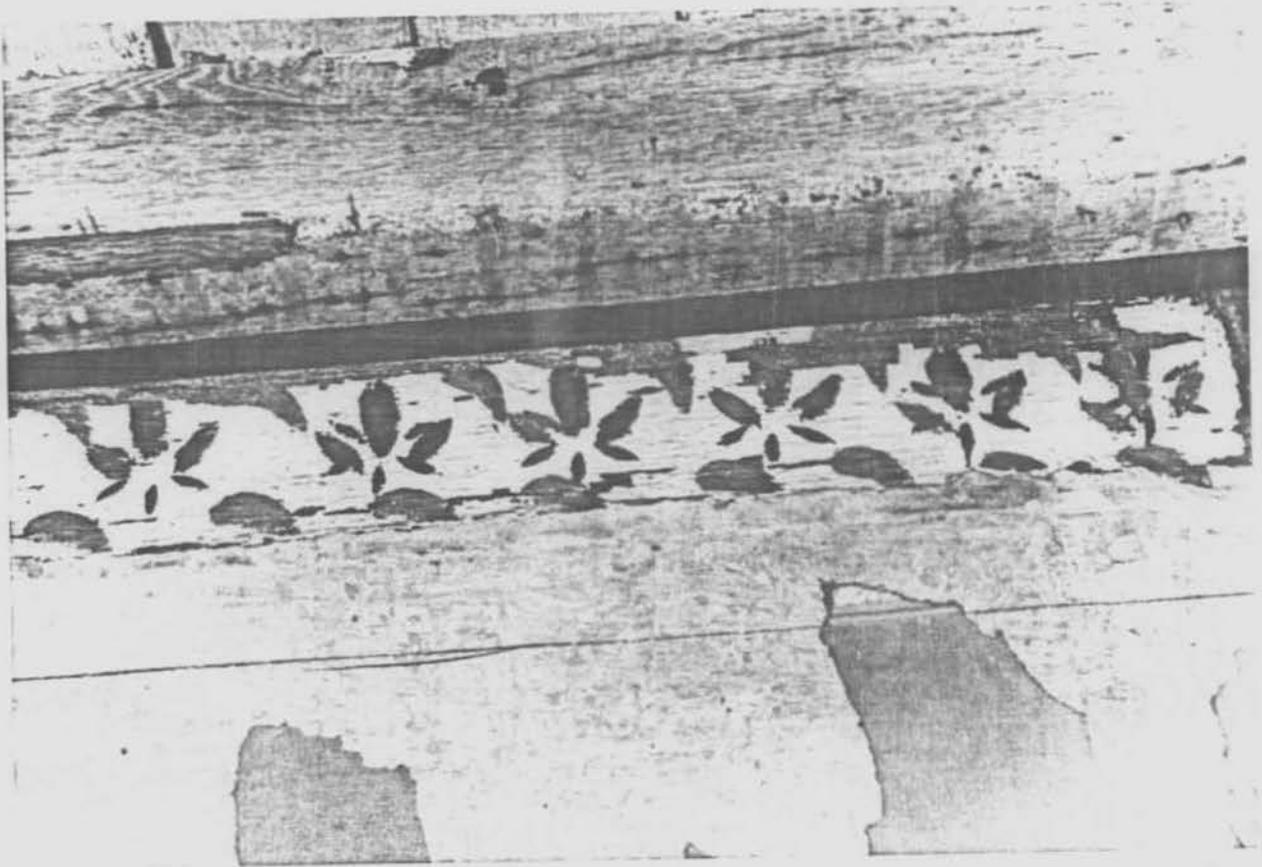
1. CARR-824 Arter-Davidson House
2. Carroll County, Maryland
3. Joe Getty
4. January, 1985
5. Md. Historical Trust, Annapolis, MD
6. 1st story, detail of southwest room  
stenciling
7. 13/19

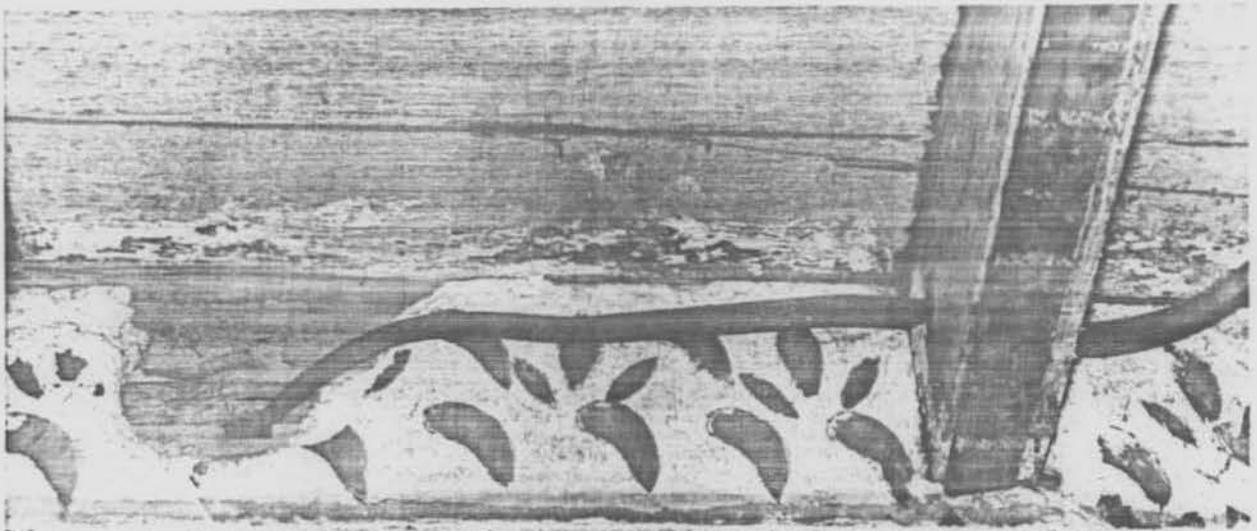
1. CARR-824 Arter-Davidson House
2. Carroll County, Maryland
3. Joe Getty
4. January, 1985
5. Md. Historical Trust, Annapolis, MD
6. 1st story, detail of southwest room  
stenciling (northeast corner)
7. 14/19 <

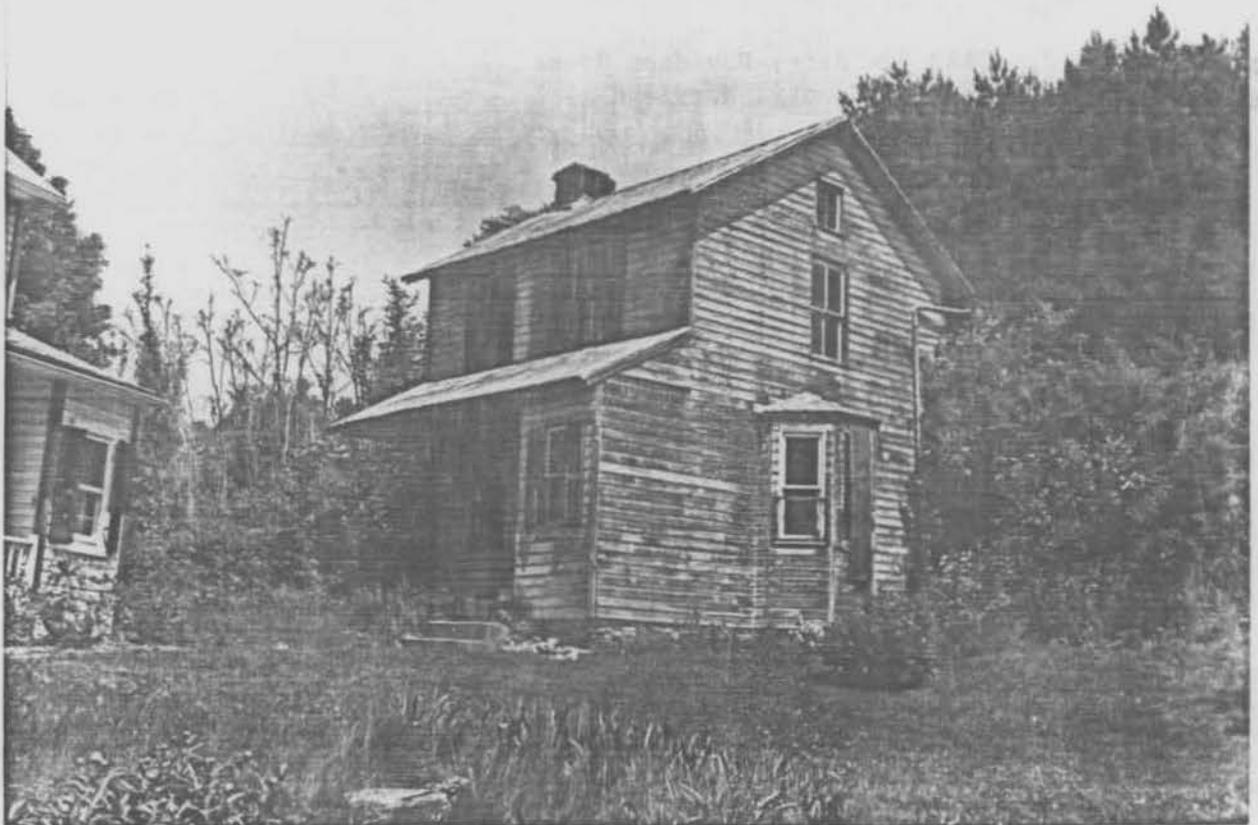
1. CARR-824 Arter-Davidson House
2. Carroll County, Maryland
3. Joe Getty
4. May, 1985
5. Md. Historical Trust, Annapolis, MD
6. Late 19th c. house, South and West elev.
7. 15/19

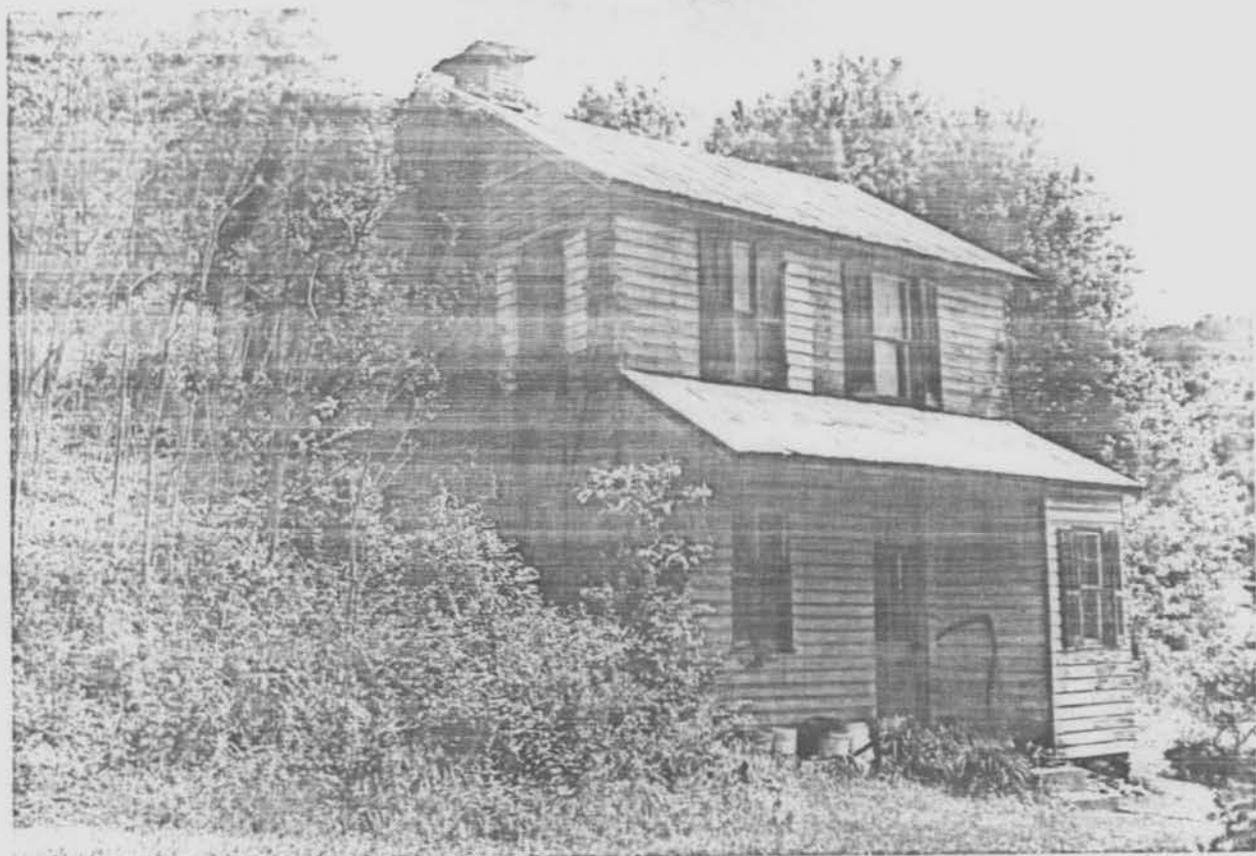
1. CARR-824 Arter-Davidson House
2. Carroll County, Maryland
3. Joe Getty
4. May, 1985
5. Md. Historical Trust, Annapolis, MD
6. Late 19th c. house, north and west elev.
7. 16/19

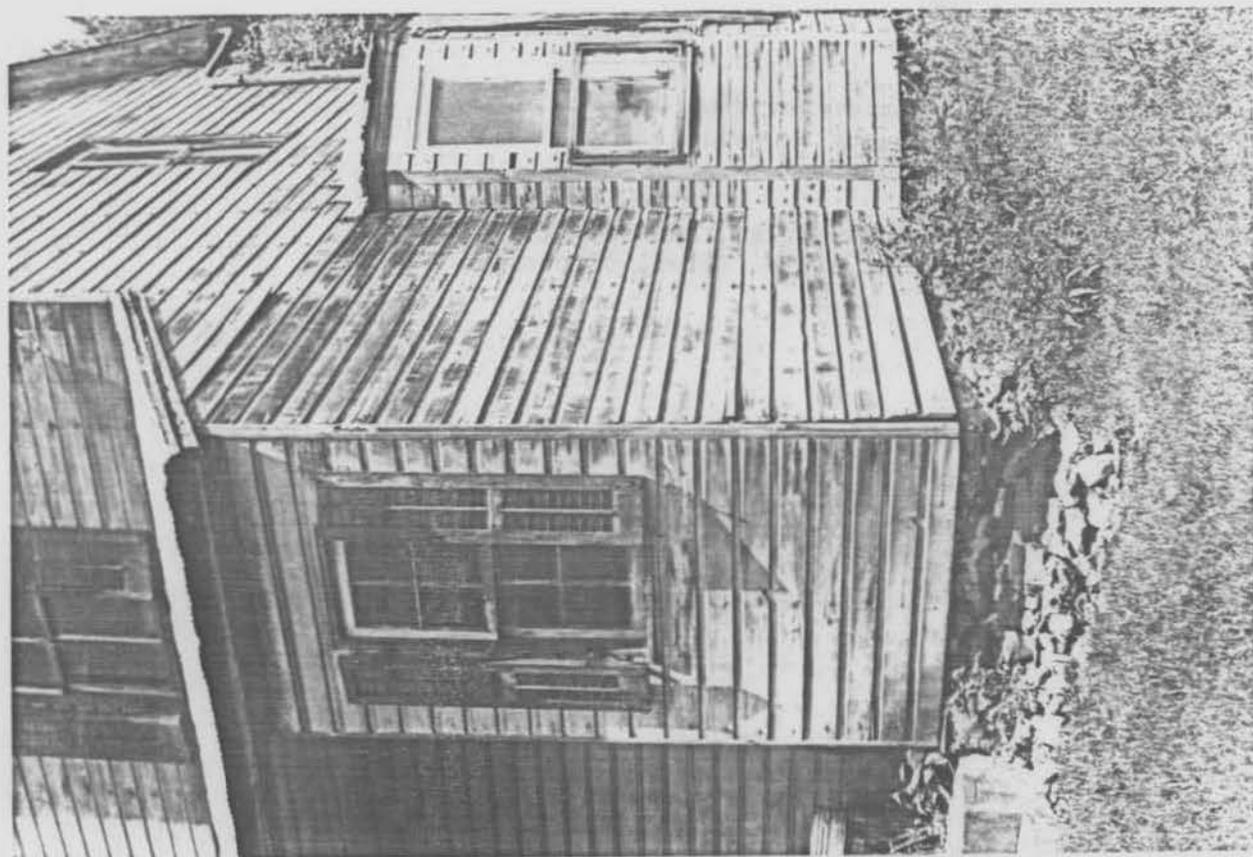
1. CARR-824 Arter-Davidson House
2. Carroll County, Maryland
3. Joe Getty
4. May, 1985
5. Md. Historical Trust, Annapolis, MD
6. Late 19th c. house, detail of porch feature
7. 17/19

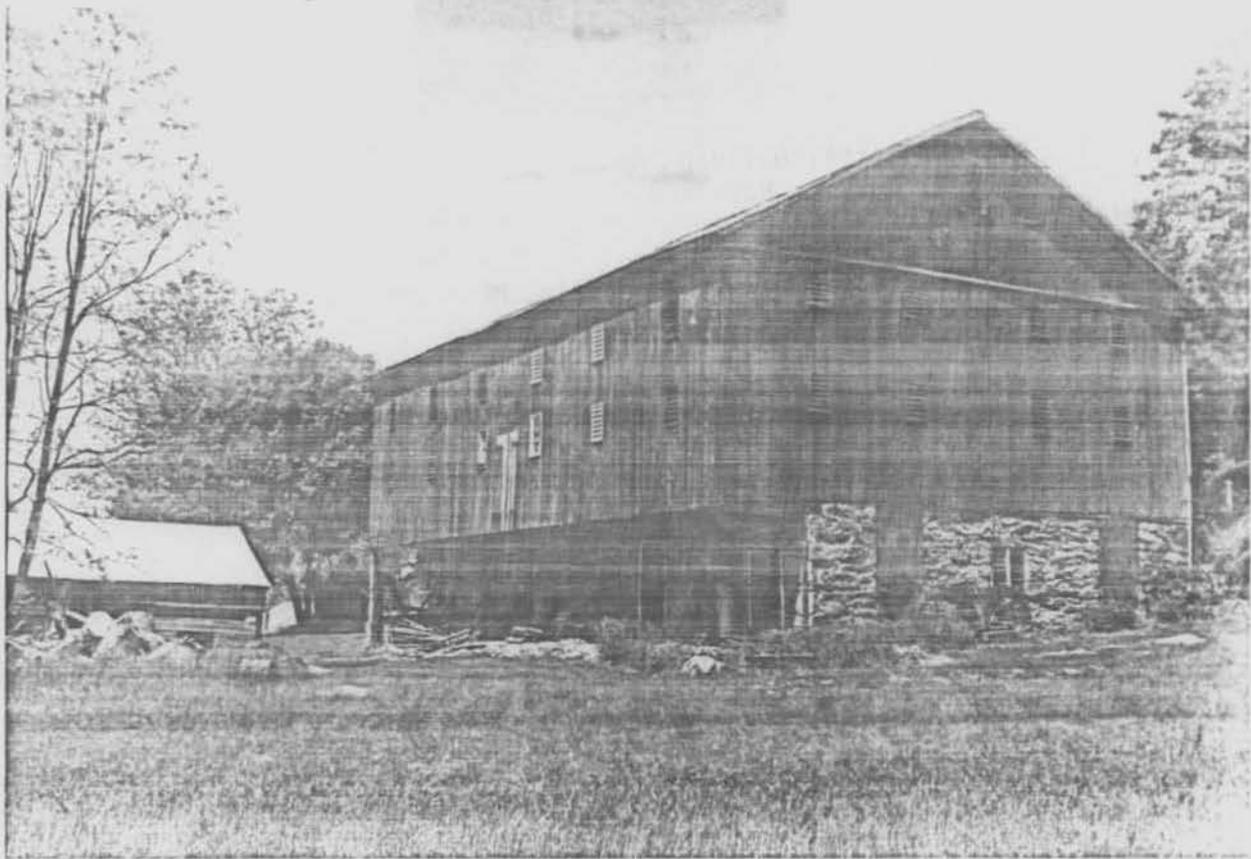
1. CARR-824 Arter-Davidson House
2. Carroll County, Maryland
3. Joe Getty
4. May, 1985
5. Md. Historical Trust, Annapolis, MD
6. Bank barn, South and West elev.
7. 18/19

The frame bank barn was constructed in 1872. It is a large structure constructed in the regional style with a stone foundation built into a slope so that the east side has ground level entrance to the threshing floor. The west side has a projecting forebay with doors leading into the stalls. The foundation is constructed of uncoursed fieldstone. The frame section is covered in vertical boards and has louvered openings in two rows (four in each row on the gable ends). In the gables are a pattern of round-arched central-louvered windows flanked on each side by a square louvered window. The west facade forebay section has a row of six louvered windows on the

second level and four (in the outer two bays on each side) on the first level with the center bay containing two four-over-two sash windows in a central doorway of double doors. The east elevation (bank side) contains two large double doors in the center of the elevation, four louvered openings on the top level and two four-over-two sash windows on the first level on the northern side of the elevation. A man-door within the large wagon doors contains Pennsylvania German style hardware with a strap hinge that is connected to a double-flange patterned pintle.

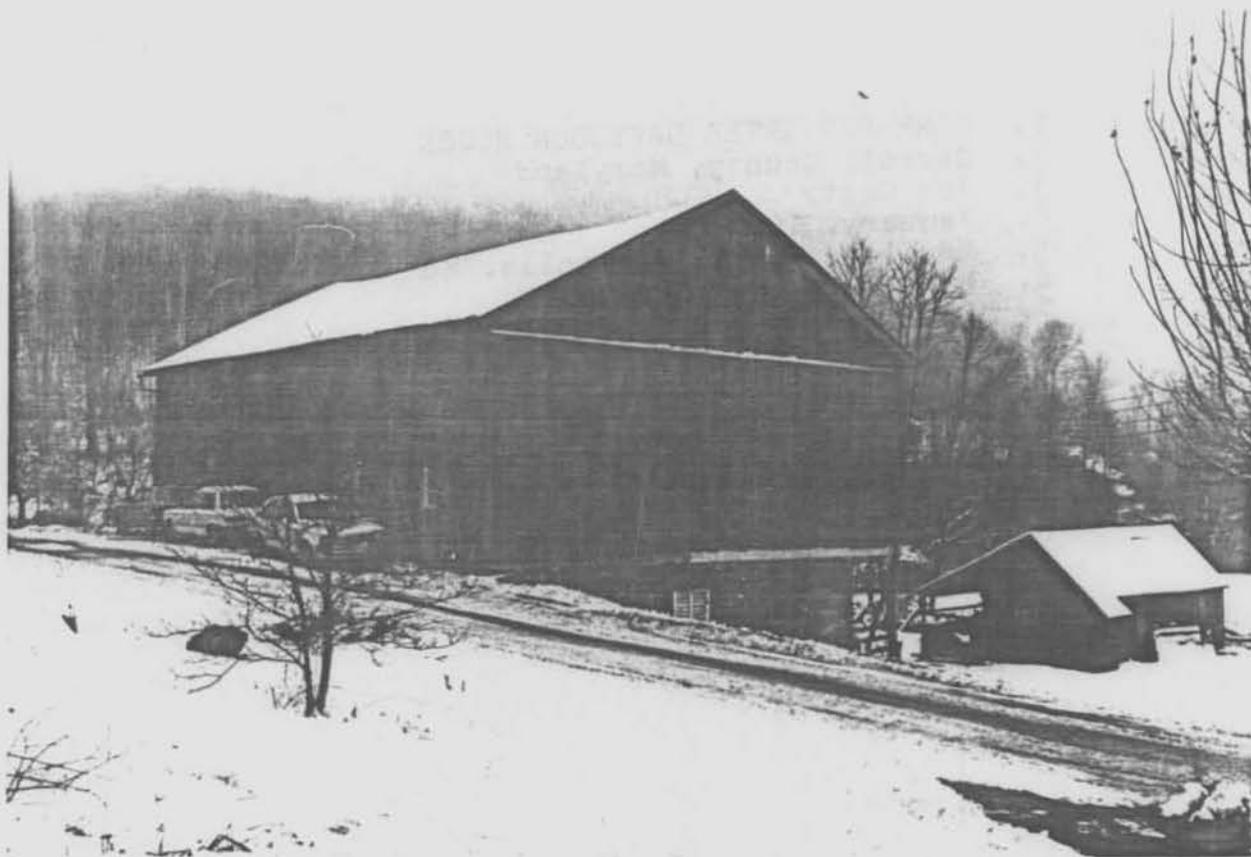
1. CARR-824 ARTER-DAVIDSON HOUSE
2. Carroll County, Maryland
3. Joe Getty
4. January, 1985
5. Md Hist. Trust, Annapolis, Md
6. Bank barn, N & E elev.
7. 19/19
