**Maryland Historical Trust
State Historic Sites Inventory Form**

Survey No. CE-1355

historic Elkton Bank of Maryland; National Bank of Elkton; Cecil Co. Library
and/or common Historical Society of Cecil County

street & number 135 East Main St. not for publication

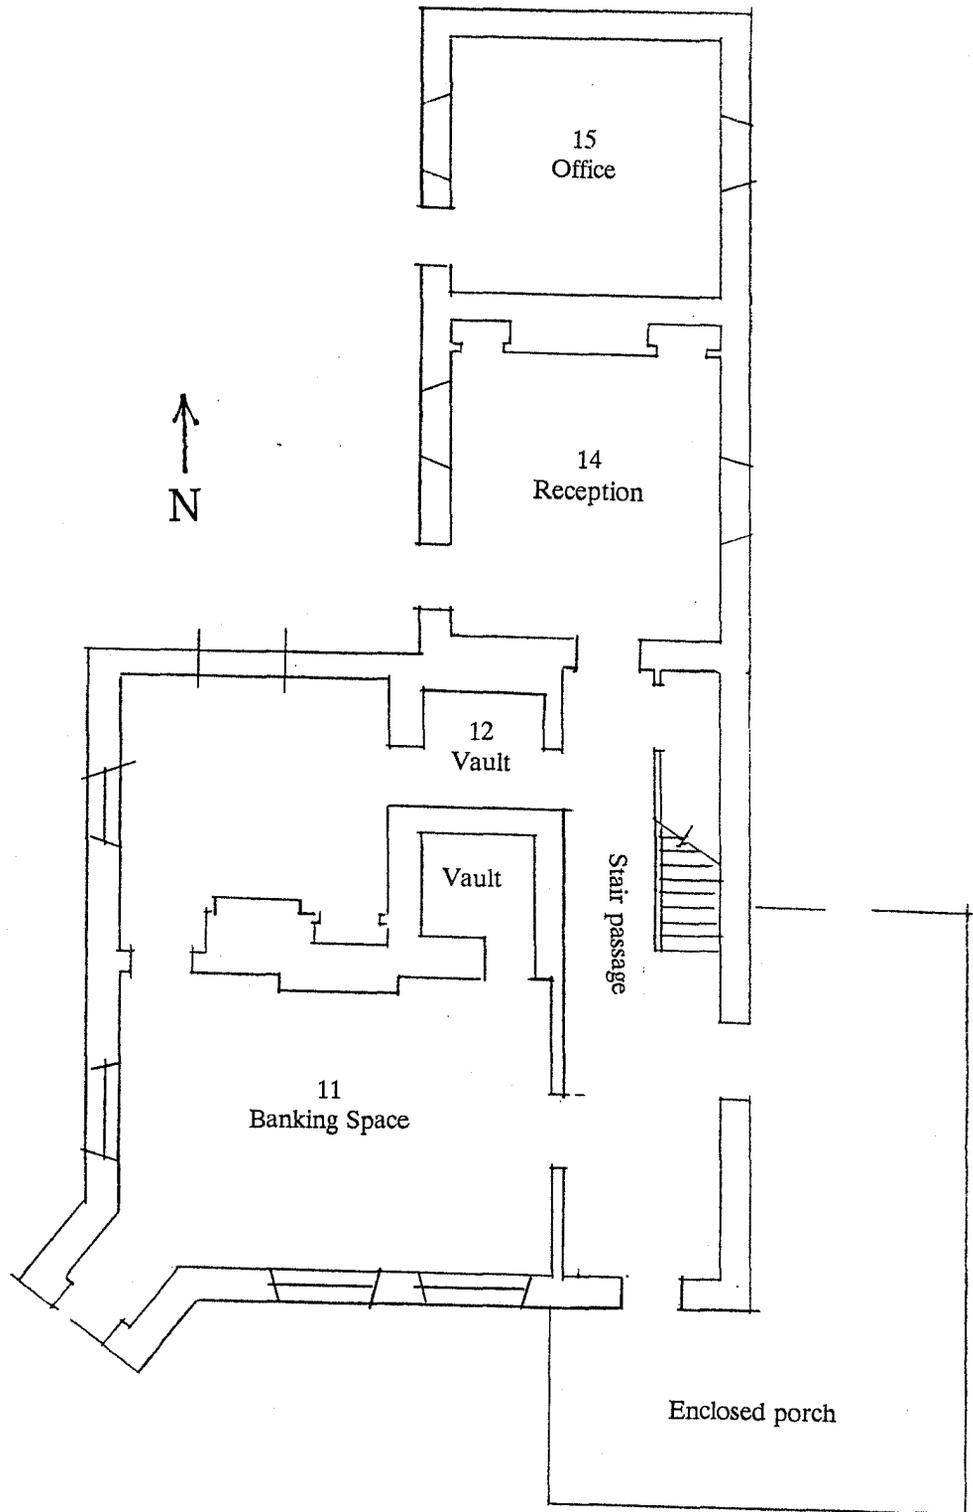
FIRST FLOOR PLAN
(not to scale)

On the interior, the original banking space occupies the south room of the main block. A fireplace (now blocked) is centered on its north wall. This room features an exceptionally elaborate pressed metal ceiling, installed in the ca. 1900 renovation. Other significant trim from this period includes raised-paneled wainscoting, chair rail, and baseboard in the vestibule and along part of the south and west walls, and window frames with a heavy quirk ogee backband, concave field, and beaded edge, framing splayed jambs with a shallow recessed panel. An important early feature is a massive masonry vault located to the east of the fireplace; currently used as a supply closet, this vault confirms the original function of the space for banking purposes.

Behind the banking space is a smaller room which probably originally performed a secondary commercial function, such as an office. This room is entered through a doorway in the north wall of the banking room, west of the fireplace. This opening retains its original late Federal decorative detailing: the jamb is finished with a low fielded panel featuring an ogee/astragal panel mold. Other trim in this room is consistent with that in the banking space, and reflects the ca. 1900 remodeling. A fireplace in the south wall is fitted with a Colonial Revival mantel featuring paired columns, a mirrored overmantel surmounted by a broken pediment, and cream-colored tile surrounding a cast-iron firebox with a large central cartouche. An early built-in cupboard adjoins the chimney breast on the east side; its doors have low fielded panels with quirk ogee panel molds. A door in the east partition wall opens into an arched masonry vault which

The residential entrance, located in the easternmost bay (within the enclosed porch) holds a large six-panel door with a central vertical bead providing a double-leaf appearance, framed in a paneled jamb with low fielded panels enriched with Greek ogee/astragal panel molds. The ghost of a large box lock remains on the door. An unusual fanlight with spiderweb tracery surmounts the door. The vestibule features complex symmetrically-molded architrave trim with plain corner blocks, a Greek ovolo chair rail, and a stepped baseboard with ogee/astragal cap, all dating from the second quarter of the nineteenth century, and a polychrome tile floor installed in the Victorian period. In the passage, the west partition wall has two openings. A doorway near the south end of the passage provides access to the former banking space; this opening has been refitted with stock Colonial trim of modern manufacture. The second opening, toward the north end of the passage, opens into the office vault; this retains its original late Federal architrave, with a Greek ogee/astragal backband, a broken fascia with an ogee/astragal transition, and a beaded inner edge. At the north end of the passage, there is a doorway with a paneled jamb and symmetrical architrave trim. This opens into the first floor of the former service wing; the room is currently used as a meeting space for the Historical Society. It features symmetrically molded architrave trim comprising Greek ogee/astragal backbands flanking a plain field, and a Federal/Greek Revival mantel with engaged columns. The fireplace is faced with mottled brown tile, and composition ornament has been added to the mantel; both of these treatments appear to date from the turn of the twentieth century. Chair rail, baseboard, and cornice moldings are of recent date. A former window opening in the east exterior wall has been blocked.

The broad, open-string stair rises against the east exterior wall of the passage. It features a slender turned newel post, square balusters (three per tread), a rounded walnut handrail, and scrolled step-ends. It rises to a landing, off which the second story of the former service wing opens to the north. The opening has a paneled jamb, is framed with an elaborate symmetrical architrave and holds a six-panel door. The architrave trim and mantel in this room are consistent with those in the room below; chair rail matches that in the first floor room behind the banking space, and baseboard is continuous with that in the passage. A closet with (recent) glazed doors flanks the chimney breast on the left; at the right of the fireplace, a small cabinet with a batten door backs up to the chimney stack; a section of peg rail survives inside this cabinet. A six-over-six window is centered in the east and west exterior walls of the room.

Note: Numerical designations of rooms conform to sketch plans provided by Historical Society of Cecil County

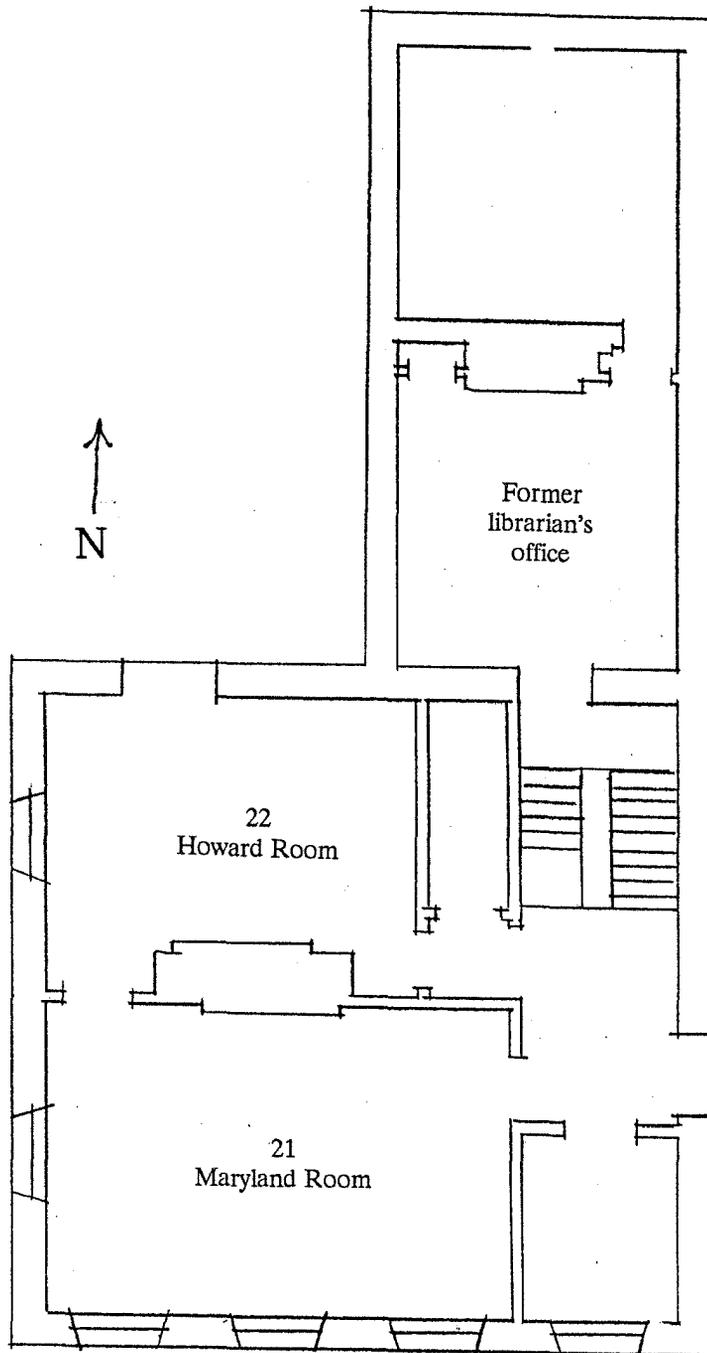
SECOND FLOOR PLAN
(not to scale)

In the main block, the architrave trim on the second floor of the passage is similar to that below with a slight simplification: the molded central element is lacking, replaced with a flat field. Two large gilded pier mirrors are located in the passage.

The second floor front room has a large fireplace approximately centered in the north wall, featuring an elaborate Federal/Greek Revival mantel. This mantel is distinguished by paired columns supporting corner blocks with recessed ovals; the frieze has a central block with a recessed panel and quarter-round cutouts at the corners. Architrave trim in this room matches that in the passage. The four windows in the south wall have large two-over-two sash, a Victorian-period replacement; these windows were retrimmed with broad asymmetrical molding typical of the late 19th century. Much of the baseboard was replaced with late-19th/early 20th century material; early baseboard survives in the northeast corner and to the left of the fireplace. Chair rail has been removed; evidence of its former existence is provided by a "ghost" in the plaster on the west wall. The west window retains its original six-over-six sash and symmetrical architrave trim; the area below the sill is paneled, as is the splayed jamb. Early pine flooring survives in this room.

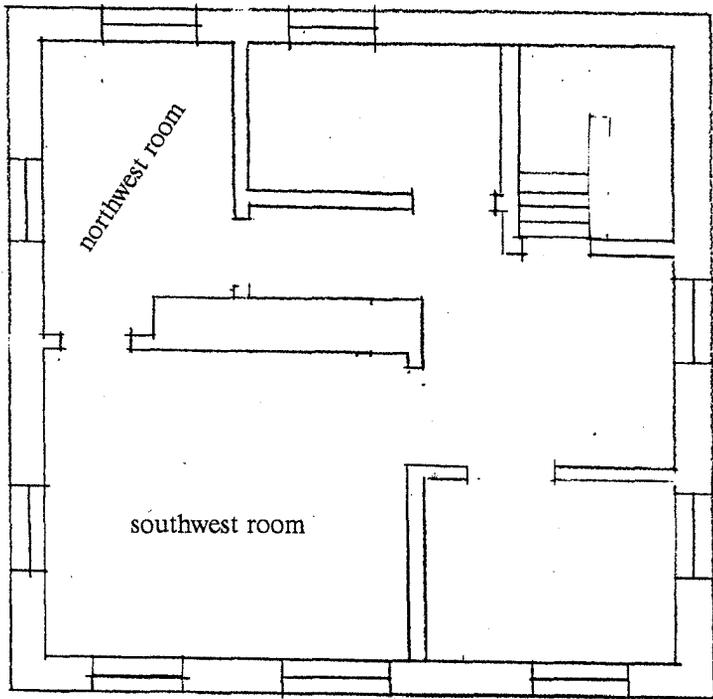
THIRD FLOOR PLAN
(not to scale)

The third floor was created in the late 19th century, when the original half-story was raised to a full story by the addition of a mansard roof. This area is divided into five rooms; the level of finish is generally plain, utilizing mass-produced millwork of the period.
