MARYLAND HISTORICAL TRUST
DETERMINATION OF ELIGIBILITY FORM

Property Name: Woodlands Farm Historic District Inventory Number: CE-145

Project: MARC Maintenance and Layover Facility Agency: MTA

Agency Prepared By: URS Corporation

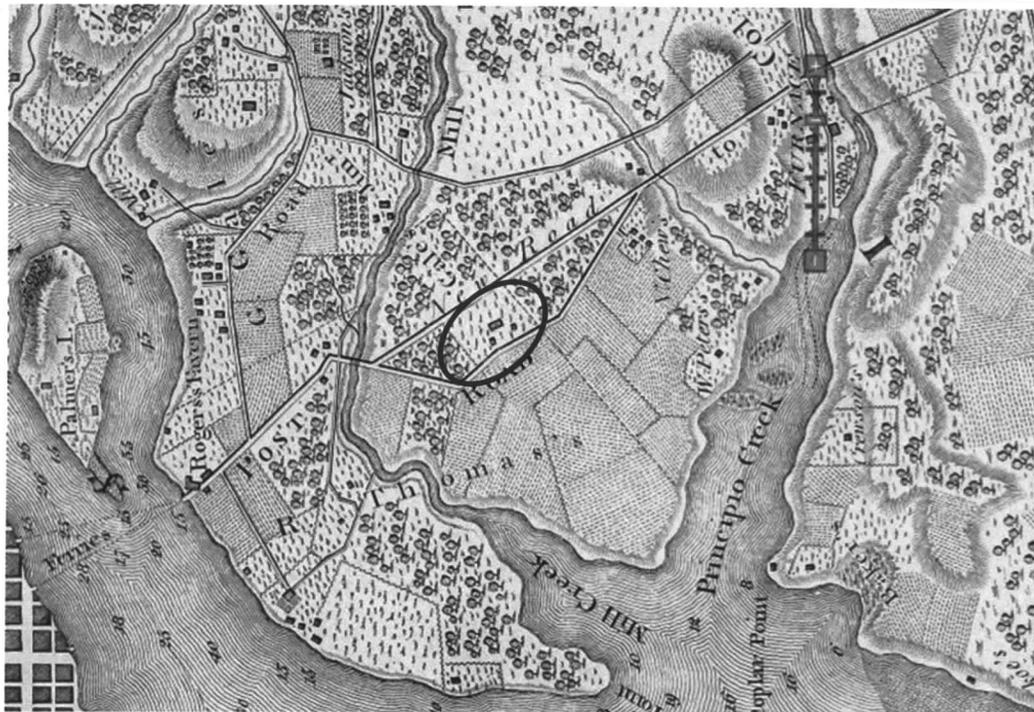
Figure 1. Vicinity of Farm Complex on 1799 Hauducoeur Map of the Chesapeake Bay and the Susquehanna River; The Three structures Shown on the Map are in the Vicinity of the Existing Structures within the Farm Complex

The land on which this farm complex is situated was first patented by merchant John Bateman in 1659 as part of a 2,200 acre tract that included Perry Point (where the Perry Point Veterans Administration Medical Center campus is presently located), and Perry Neck, the historical name of the peninsula of land that is east of Perry Point between Mill and Principio Creeks (Miller 1949). The tract changed hands numerous times during the 18th century, with little indication when improvements occurred that are apparent in the 1799 *Map of the Chesapeake Bay and Susquehanna River* by CIRCAP. Haudecoeur (Attachment 1, Figure 1).

The 1799 Haudecoeur map is the earliest map of southern Cecil County that provides information on land ownership and land use. Along Perry Point and Perry Neck, the map shows that "R. Thomas" is the owner of the land. The 1799 map indicates the location of the Post Road as well as a "New Road" which forms a shorter, northern cut off of the Post Road (Attachment 1, Figure 1). This map indicates that the area was being farmed, with cultivated fields located south of the Post Road, and three structures located in the general vicinity of the present farm complex. In 1800, John Stump purchased Perry Point and Perry Neck from George Gale (Land Records of Cecil County JB Vol. 19 f. 384). John's daughter Ann married Joseph Coudon II in 1820, and in 1822 Joseph Coudon II purchased a 149-acre parcel north of the Post Road containing Woodlands from Robert Archer, and the portion of Perry Neck south of the Post Road from John Stump (Land Records of Cecil County, JS Liber 20 f. 84 and JS Liber 20 f. 341).

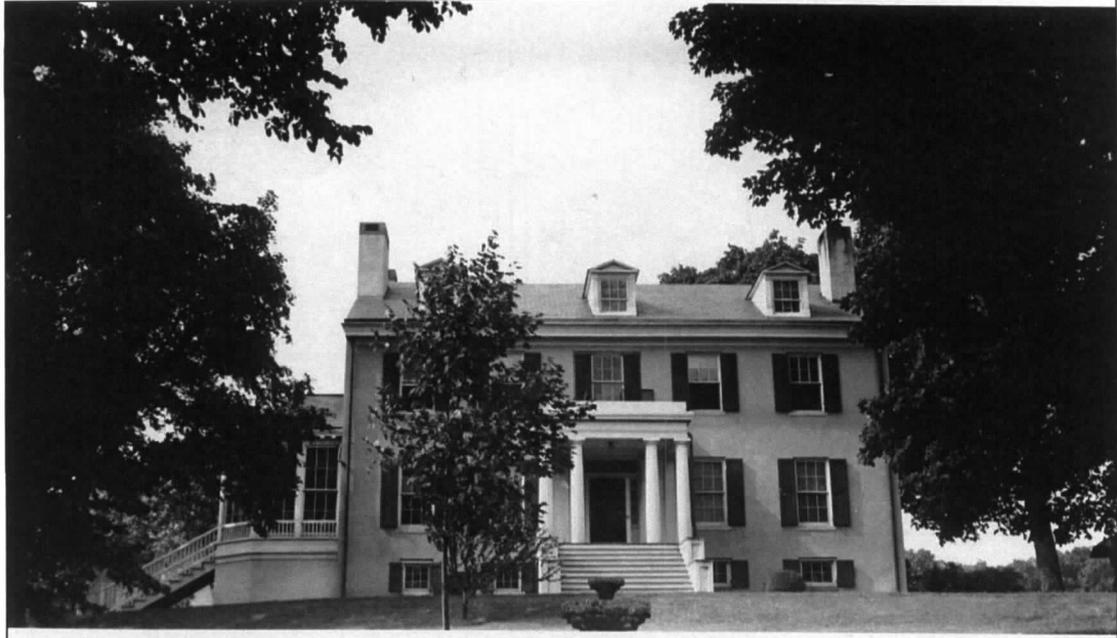
Figure 3. Woodlands Farm North, Woodlands Mansion, Front View

The Woodlands Main House is eligible for architectural significance, being an important example of Greek Revival style architecture in the area (Attachment 1, Figure 3). Originally, this was only a side-hall-and-parlor house type, with a rear kitchen ell. The mid-19th century side and rear additions, the conservatory addition and the upper floors reflect the family's economic prosperity and awareness of popular architectural trends. Although restrained in terms of decoration, the Greek Revival style is evidenced by the attenuated first floor windows and the more squat second floor windows, providing a stately yet weighted massing associated with the heaviness of the Greek Temple form. In addition, the front portico that dominates the façade with its large paired Doric columns, and full entablature and flat roof make a clear and deliberate association with the Greek Revival style.

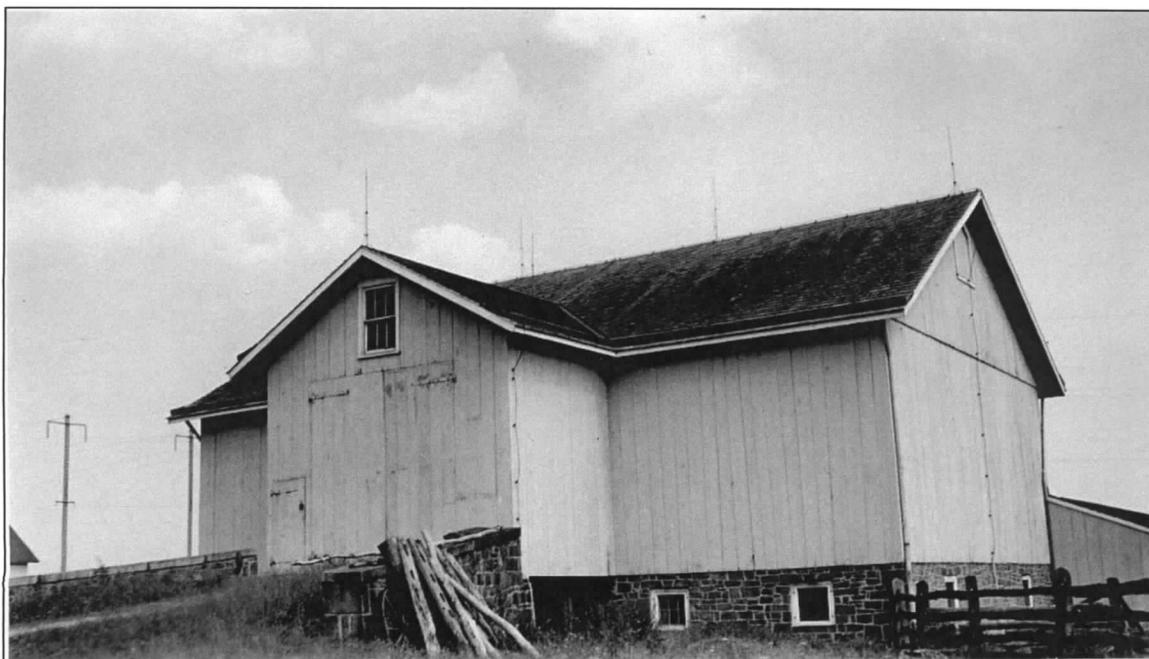
Figure 10. Woodlands Farm South, Bank Barn with Loafing Sheds

Other noteworthy buildings on the farm include the bank barns with their earthen banks and stone retaining walls, barn doors leading to the threshing floor, and loafing sheds comprising a feedlot for what was an impressive dairy operation (Attachment 1, Figures 7 and 10). These buildings, along with the variety of outbuildings—root cellars, cornercrib, chicken coop, various sheds and residences for the foreman and tenant farmers—provides evidence of an active and prosperous agricultural landscape that reflects the several generations of single family ownership (Attachment 1, Figure 4-15). The Woodlands Farm is a landscape containing a variety of agricultural buildings, structures and cultivated fields that collectively represents a unit that is significant as an agricultural historic district.

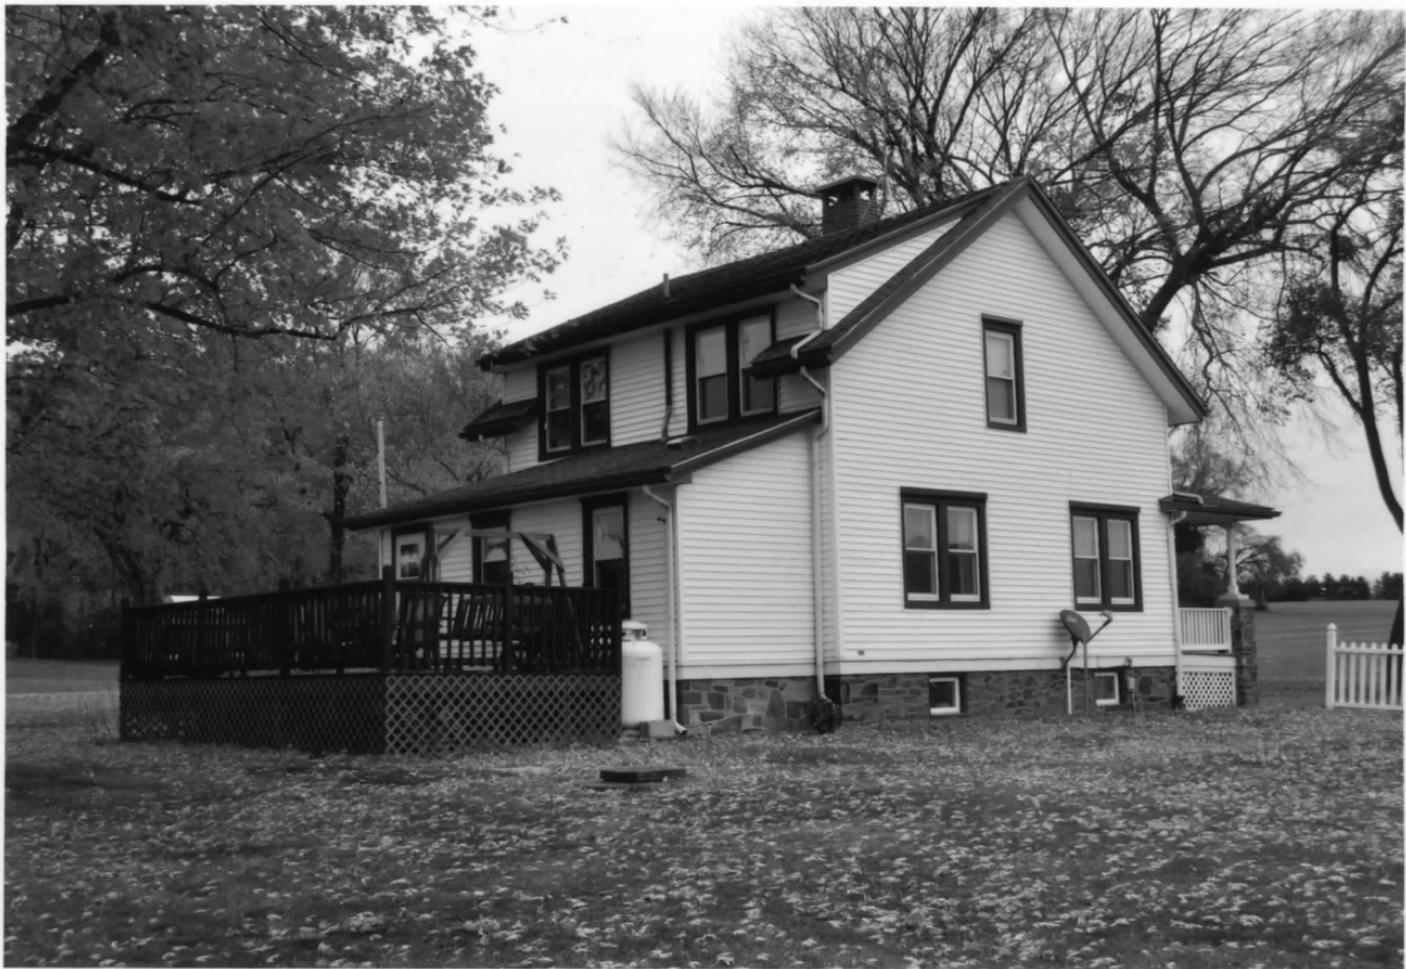
CE-145, TENANT HOUSE, WOODLANDS FARM HISTORIC DISTRICT

Tenant House and Privy, View Northeast

The west or rear elevation has a wood deck and a one-story, extension that rest on a fieldstone foundation (Attachment 3, Figure 22). It has an off-centered entrance, a small window at the center bay, and a window at the southwest bay. The extension has a hipped roof at the northwest side and a shed roof at the southwest side. The extension's roof is covered with asphalt shingles. The second story has two pairs of windows through the cornice. The west or rear elevation's roof has a large shed roof dormer. The south or side elevation has two casement windows at the foundation (Attachment 3, Figure 22). The first story has two pairs of windows and the second story has one centered window. West of the house is a privy and northwest of the house is a modern utility shed.

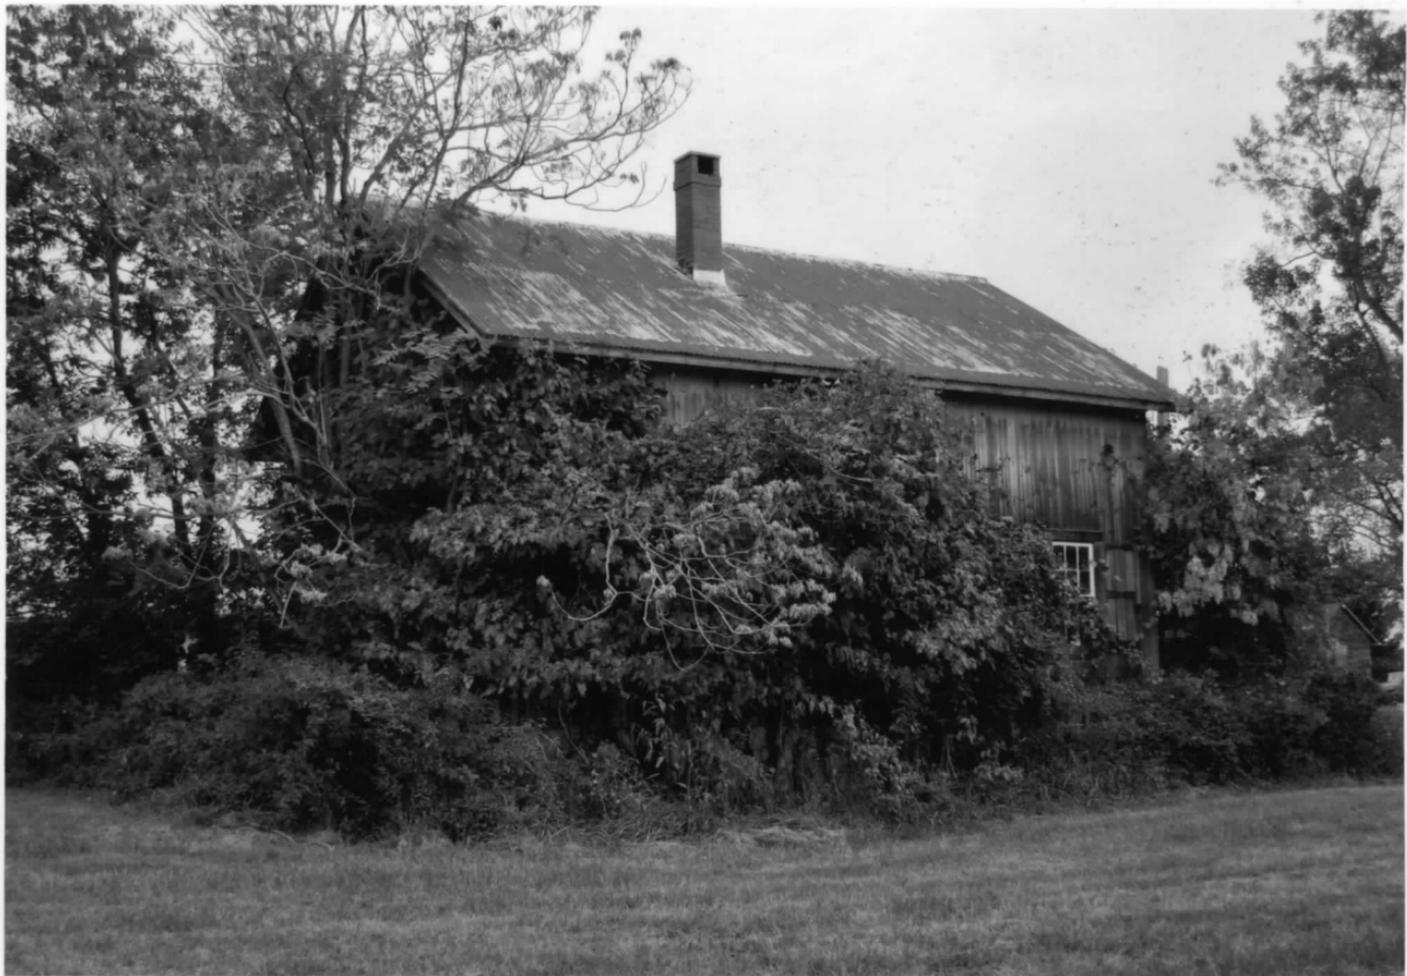
CE-145, Blacksmith Shop, Woodlands Farm Historic District

Blacksmith Shop, View North

East of the bullpen is a blacksmith shop. The one-and-half story building is one-bay by two-bays and has a rectangular plan. The blacksmith shop is built on a concrete slab foundation. It is of wood frame construction and is clad with vertical wood board. The side-gable, medium pitch roof is covered with corrugated metal. The roof has exposed rafters and a centered rear slope interior brick chimney. The following description begins at the north elevation and continues clockwise. The north or front elevation has two garage bays filled with double, wood clapboard doors (Attachment 3, Figure 35). The west elevation is not visible by the public-right-way or through aerial photographs. The south elevation has three double-hung, wood-frame window sashes with six-over-six lights (Attachment 3, Figure

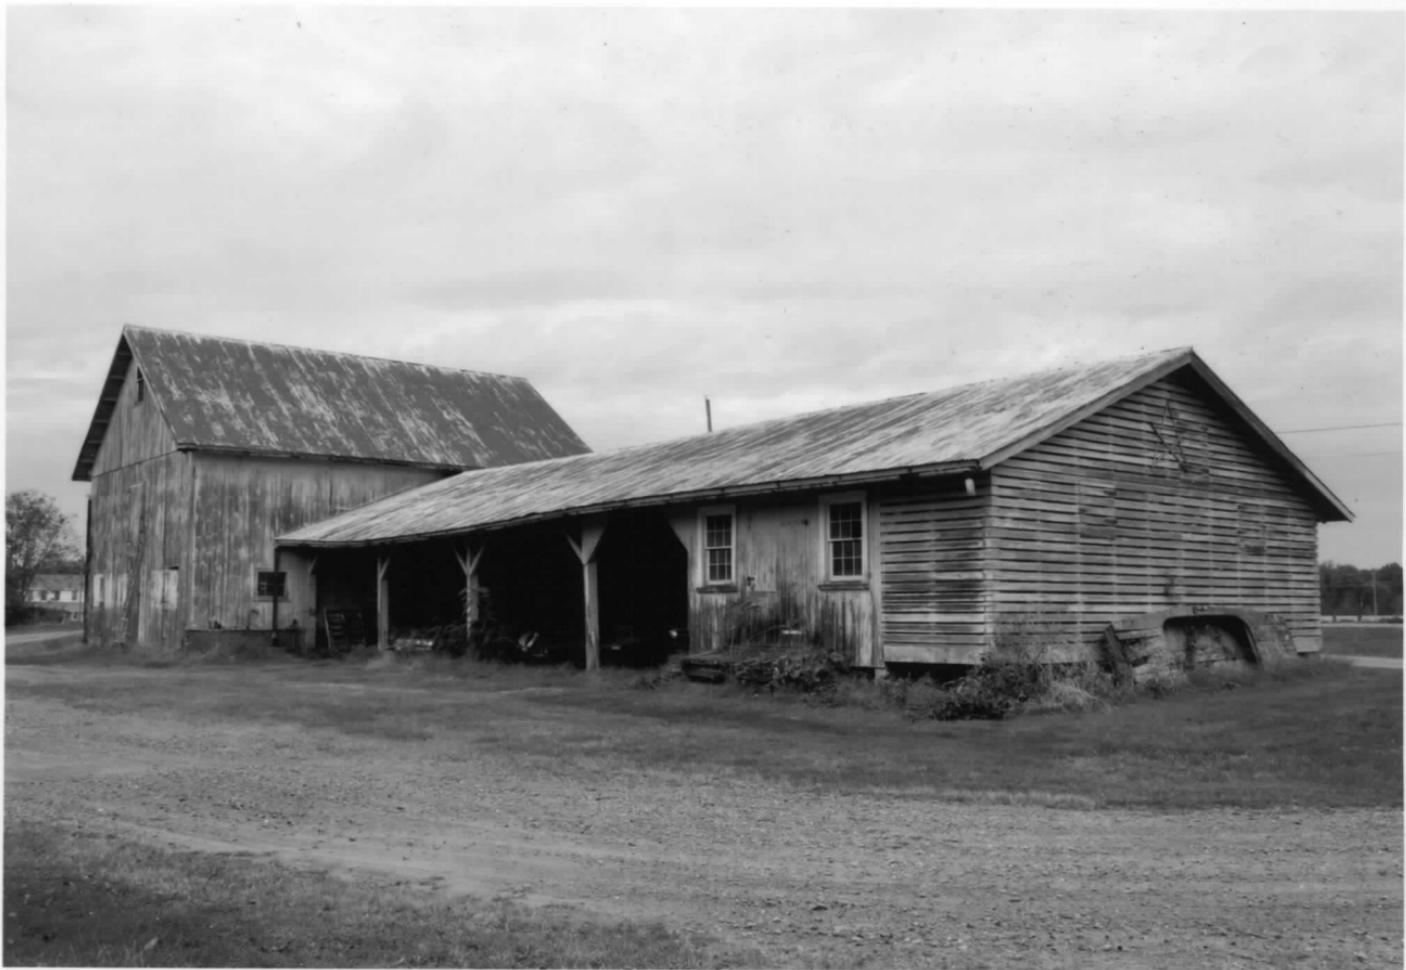
OE-145, Barn, Woodlands Farm Historic District

Northeast of the bank barn is a barn with a connecting loafing shed. The barn consists of two sections: a main barn that has two-and-half-stories and has three-bays by three-bays; the east elevation has a one-story loafing shed with six-bays (Attachment 3, Figure 42). The barn rests on a concrete foundation. The barn is wood frame construction and is clad with vertical wood board. The barn has a medium-pitch, front-gable roof covered with standing seam metal. The roof has exposed rafters. The loafing shed rests on a fieldstone and brick foundation. The loafing shed is wood frame construction and is clad with vertical board and horizontal wood clapboard. The loafing shed has a medium-pitch, front-gable roof covered with corrugated metal. The roof has exposed rafters. The following description starts at the façade (south elevation) and continues counterclockwise.

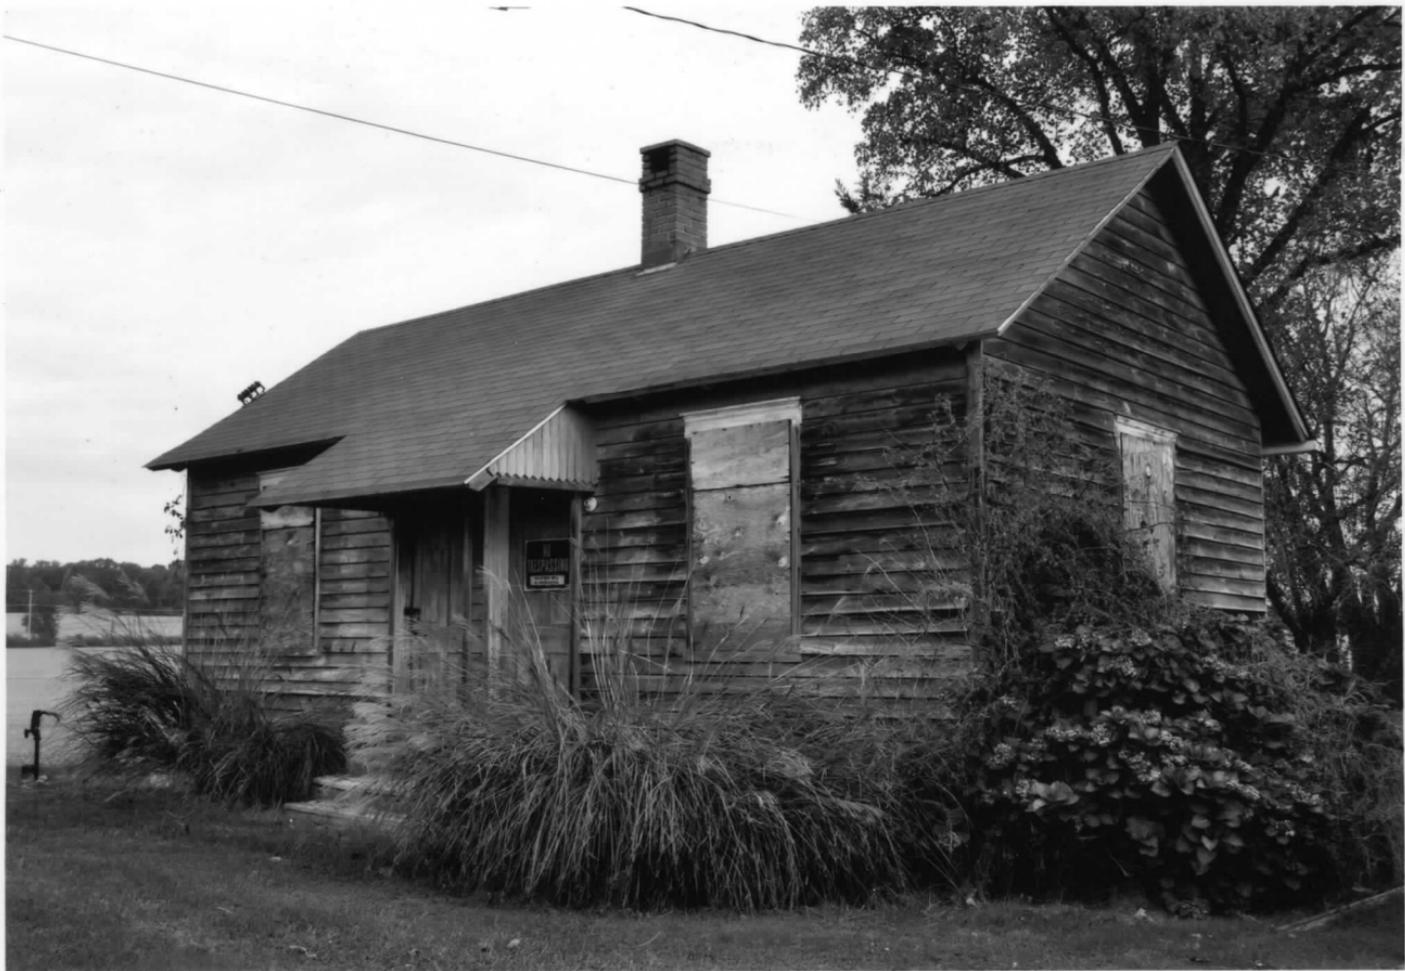
CE-145, Bungalow, Woodlands Farm Historic District

East of the barn and loafing shed is a small bungalow. The one-story building is four-bays by one-bay with a rectangular plan. The building sits on a foundation of wood piers. It has wood frame construction and is clad with horizontal wood clapboard siding. The building has a medium-pitch, side-gable roof covered with asphalt shingles. The roof has exposed rafter ends and a centered interior brick chimney.

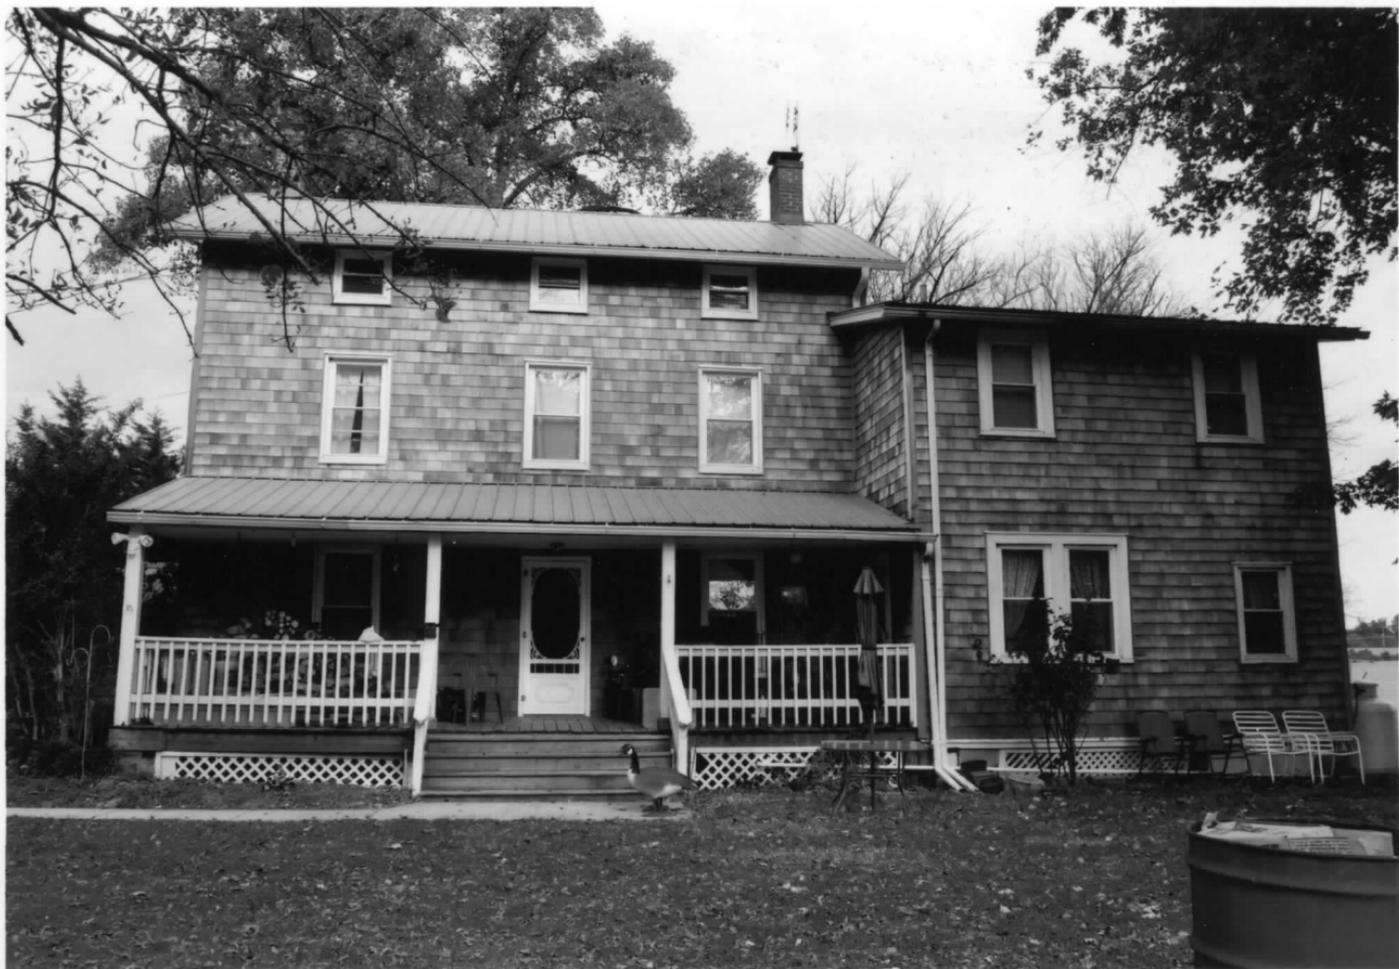
CE-145, Foreman's House, Woodlands Farm Historic District

At the far east of the property is the foreman's house. This building was originally built in the Greek Revival style. The house has two sections. The first section is the main house at the west elevation, which has three-stories and is three-bays long and two-bays wide. The second section is a two-story side addition at the east elevation that is two-bays by three-bays. Both sections are of wood frame construction and are clad with modern wood shingles. The house rests on a fieldstone foundation. The house has double-hung, vinyl-frame window sashes. The west elevation has a medium-pitch, side-gable roof covered with standing seam galvanized metal. The roof has interior end, brick chimneys. The side addition has a medium-pitch, saltbox roof covered with galvanized metal. The following description starts at the south or front elevation and continues clockwise.

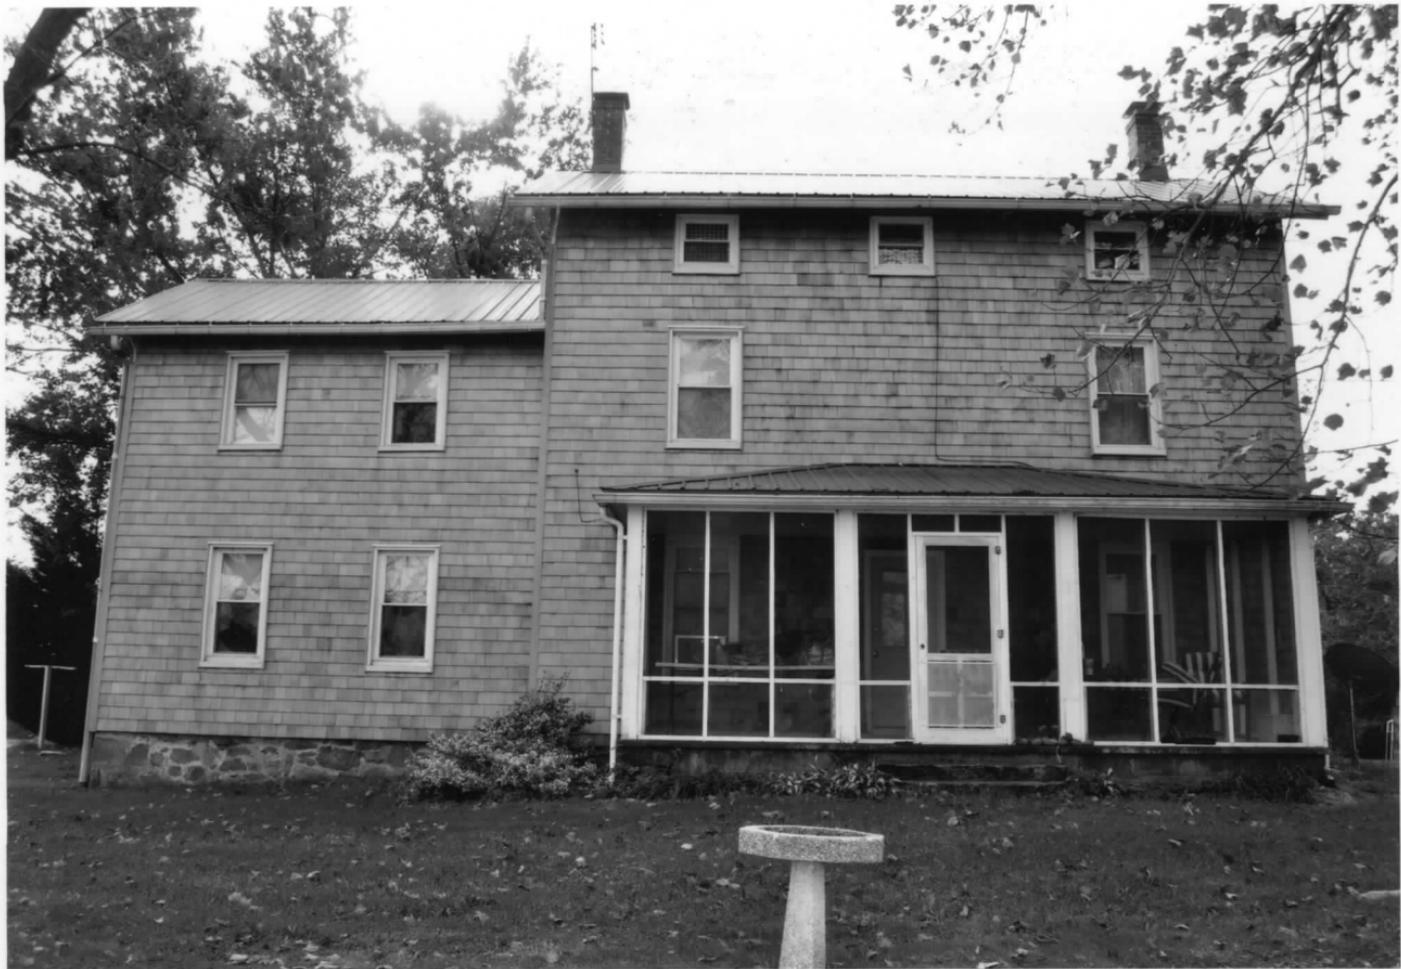
CE-145, Foreman's House, Woodlands Farm Historic District

The main house's north elevation first story has a screen-enclosed almost full-length porch with a concrete block foundation and a hipped roof covered with standing seam galvanized metal panels (Attachment 3, Figure 49). The porch roof is supported by wood square post. Inside the full-length porch is a centered rear entrance with a wood door with a light. Flanking both sides of the rear entrance are single windows. The second story has two windows and the third story has three small attic windows, a Greek Revival architectural design feature. The addition abutting the east elevation has two first story windows and two, second story windows.

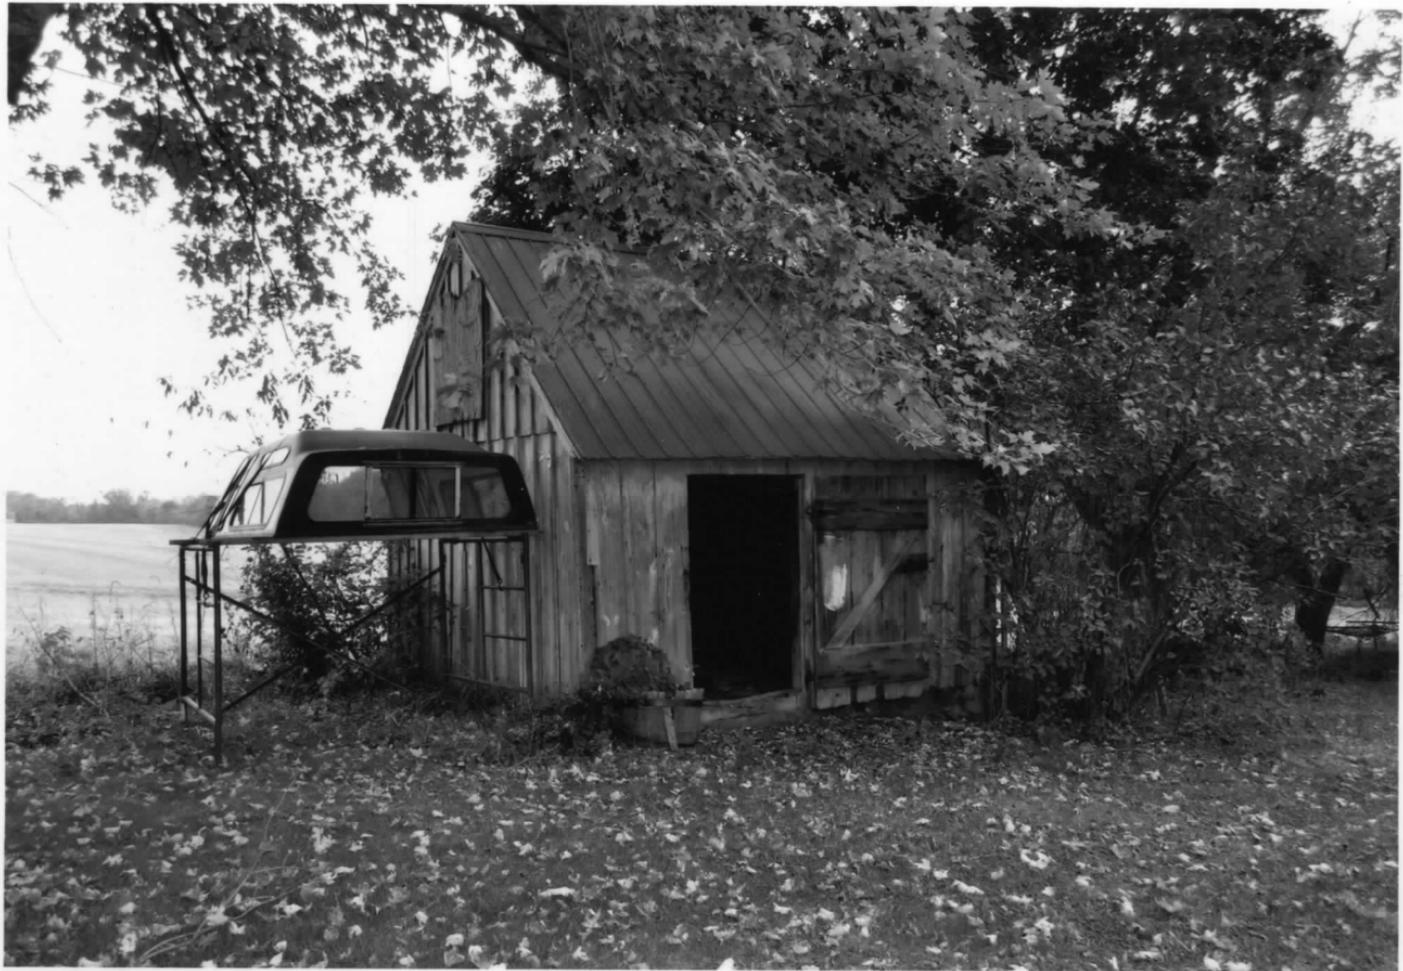
CE-145, Meat house, Woodlands Farm Historic District

East of the foreman's house is a meat house. The one-story meat house has one-bay and a rectangular plan. The meat house is on a fieldstone and concrete foundation. Made of wood frame construction, the meat house has board and batten siding. The east elevation has a single entry that is filled with a wood door (Attachment 3, Figure 51). It has a moderate-pitch, side-gable roof covered with asphalt shingles. The south elevation at the gable end has a covered window opening. The west and north elevations have blank walls (Attachment 3, Figure 52).

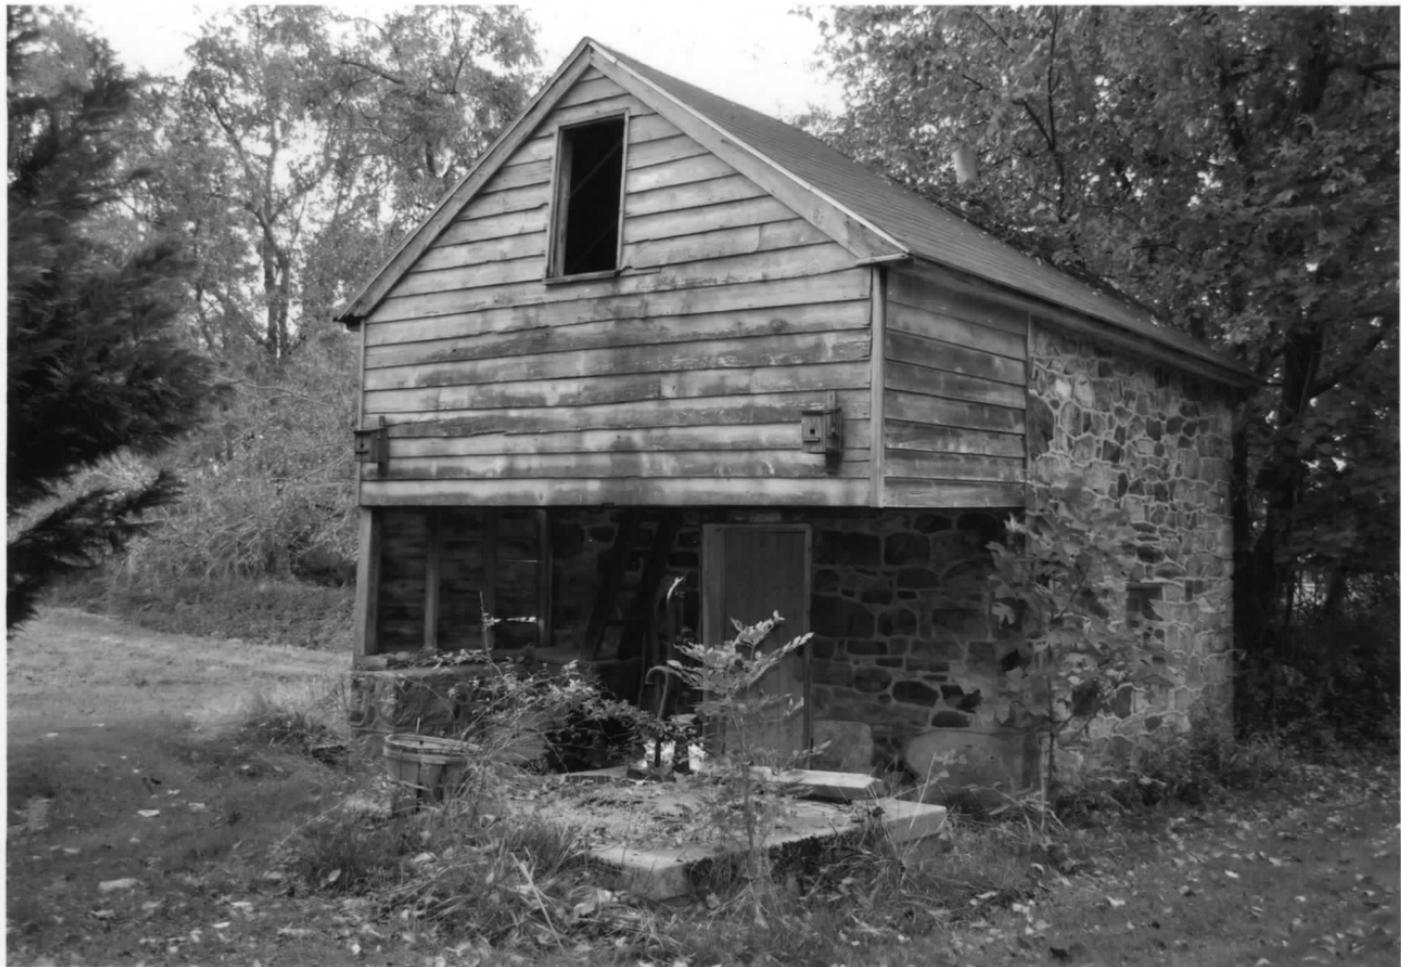
CE-145, Springhouse, Woodlands Farm Historic District

South of the foreman's house is a springhouse. The one-and-half story springhouse has one-bay and a rectangular plan. The springhouse is on a fieldstone foundation and the main block of the springhouse is made of fieldstone. The following description starts at the façade (north elevation) and continues clockwise. The north elevation at the first story has a centered entry filled with a wood door (Attachment 3, Figure 52). Adjacent to the entry are two wood steps and an L-shaped stone pier that is flush against the north and east elevation. On top of the stone pier is a wood ladder that leads into a projecting front-gable overhang. The half story of the north elevation is a projecting front-gable overhang. The overhang is constructed of wood frame and is clad with horizontal wood clapboard. The north gable end has a window opening. The first story of the west elevation has a fixed, wood-frame window sash (Attachment 3, Figure 53). Also at the west elevation is a wall extension made of wood clapboard. The south elevation contains a blank wall, with the south gable having a wood-frame window sash (Attachment 3, Figure 54). The first story of the east elevation has a fixed, wood-frame window sash (Attachment 3, Figure 54). The springhouse has a moderate-pitch, front-gable roof covered with asphalt shingles. There is a vent chimney near the south gable.
