Maryland Inventory of Historic Properties number: ~~CE-1467~~ CE-1486

Name: New Cut Rd over Mill Pond Stream

Bridge Name New Cut Road over Mill Pond Stream

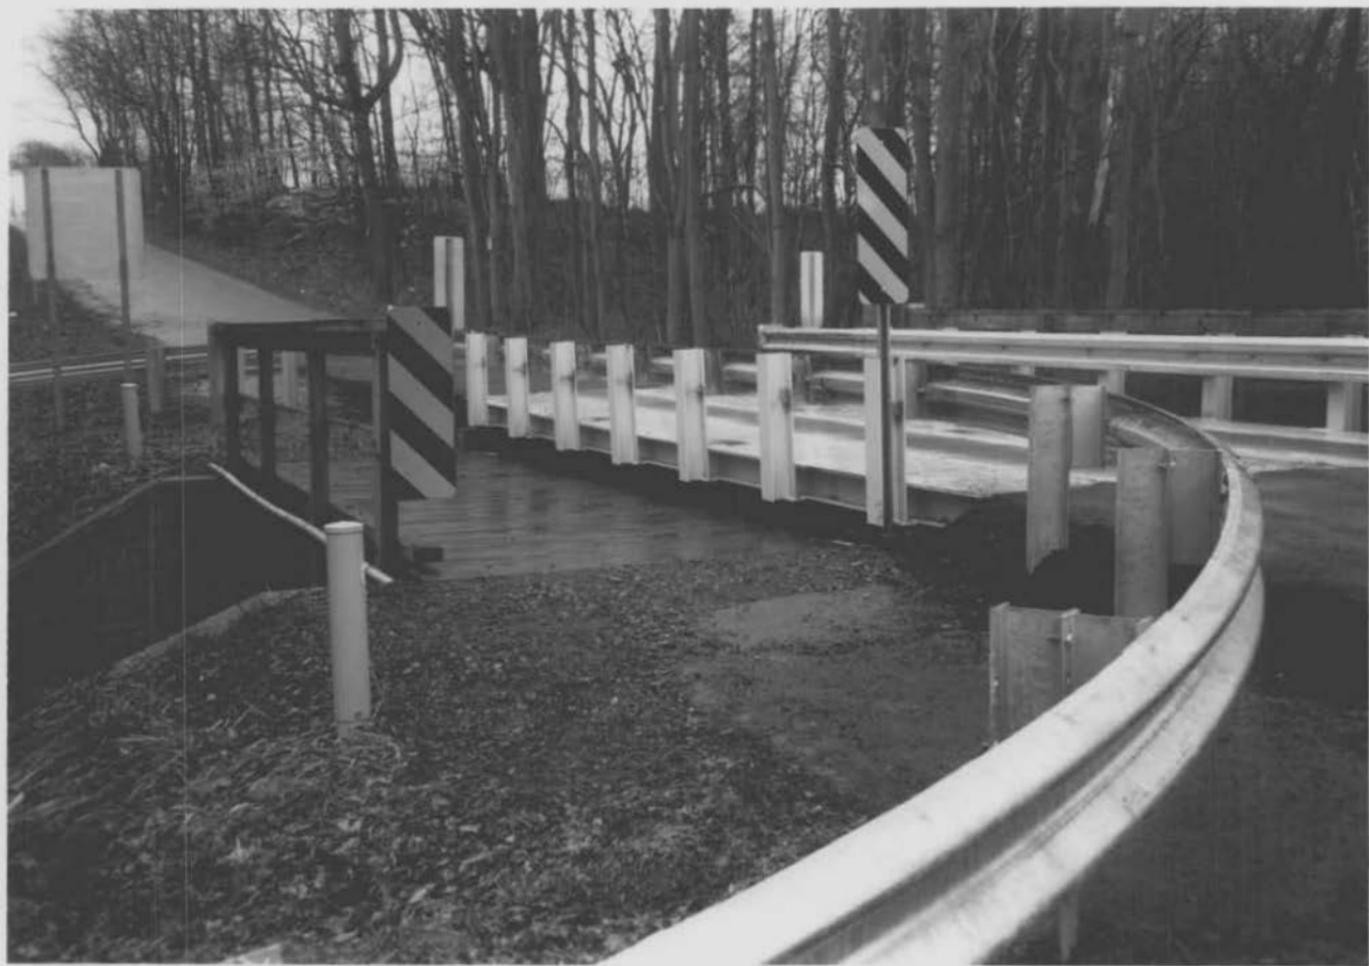
- 1 CZ-1486
- 2 New Cut Rd. (Lovers Ln) over Mill Pond Stream
- 3 Cecil Co, MD
- 4 3/98
- 5 Marris German, WMA
- 6 MD SHPO
- 7 Northeast corner looking south
- 8 1 of 6

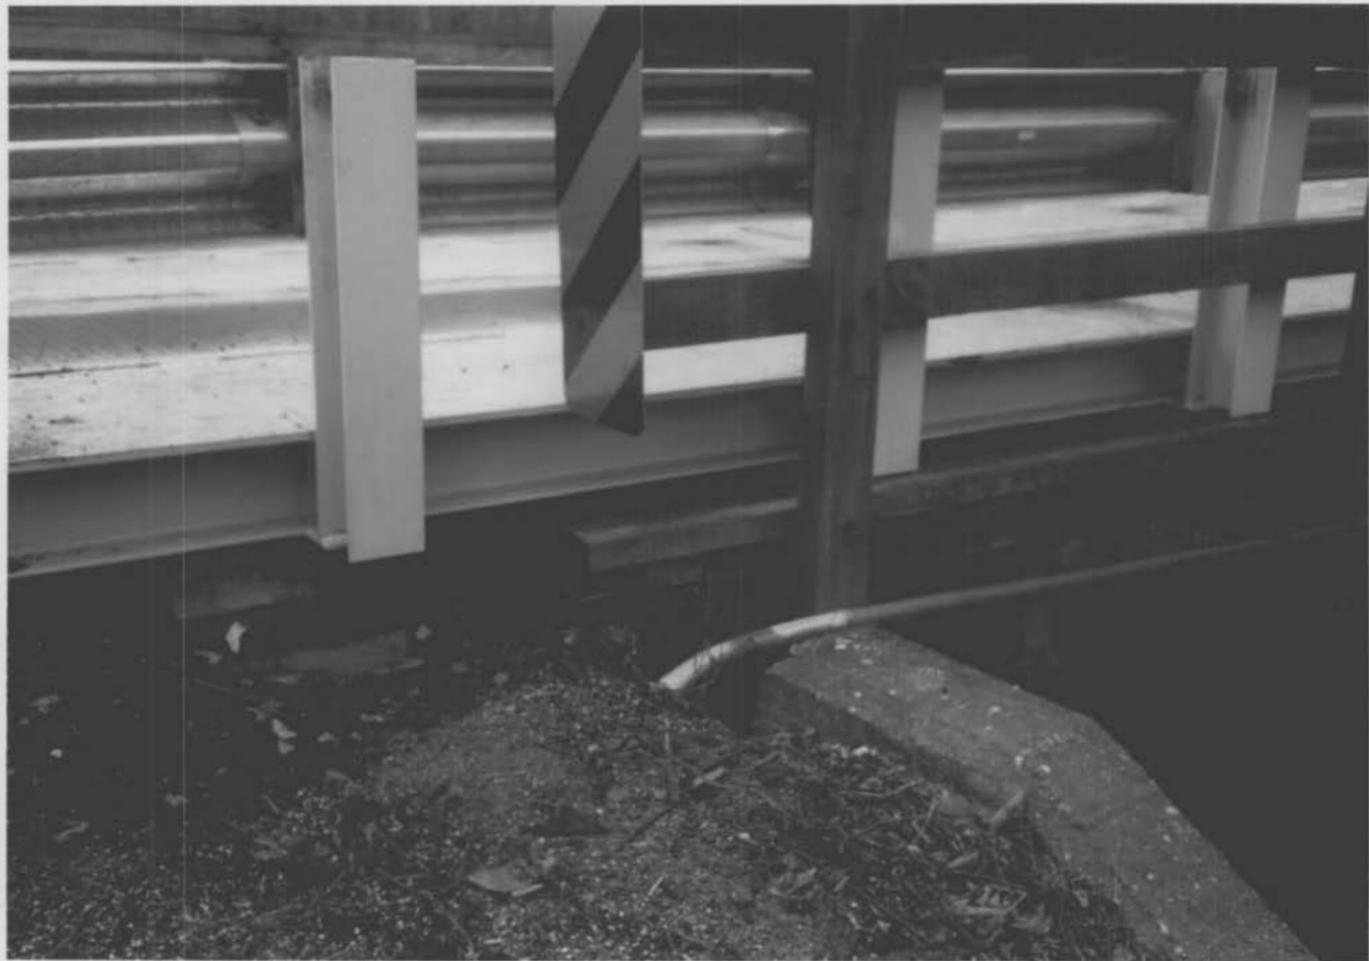
8. 2 of 6

7. Northwest Corner steel structure spanning existing timber

A steel structure has been constructed to span the original timber bridge and is aligned by steel guardrails.

There have been replacements of individual members of the railing and deck planks. These replacements cannot be dated. The repointing of the stone abutments is not dated in the inspection files either. Between 1995 and present, a steel structure was constructed which spans the timber structure and metal guardrails were added to the bridge.

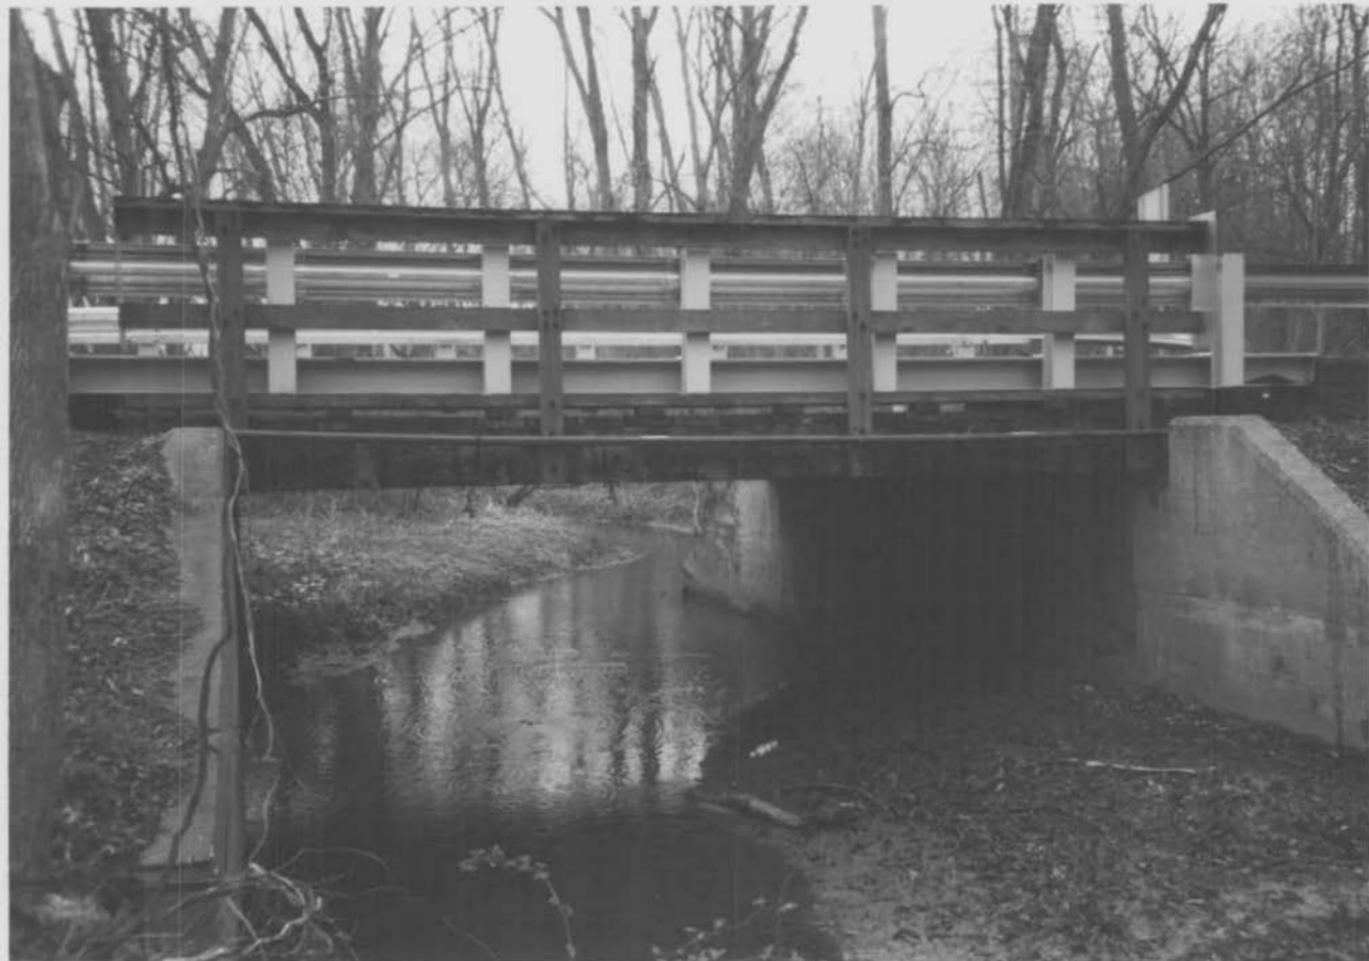
8. 3 of 6

7. Elevation looking upstream

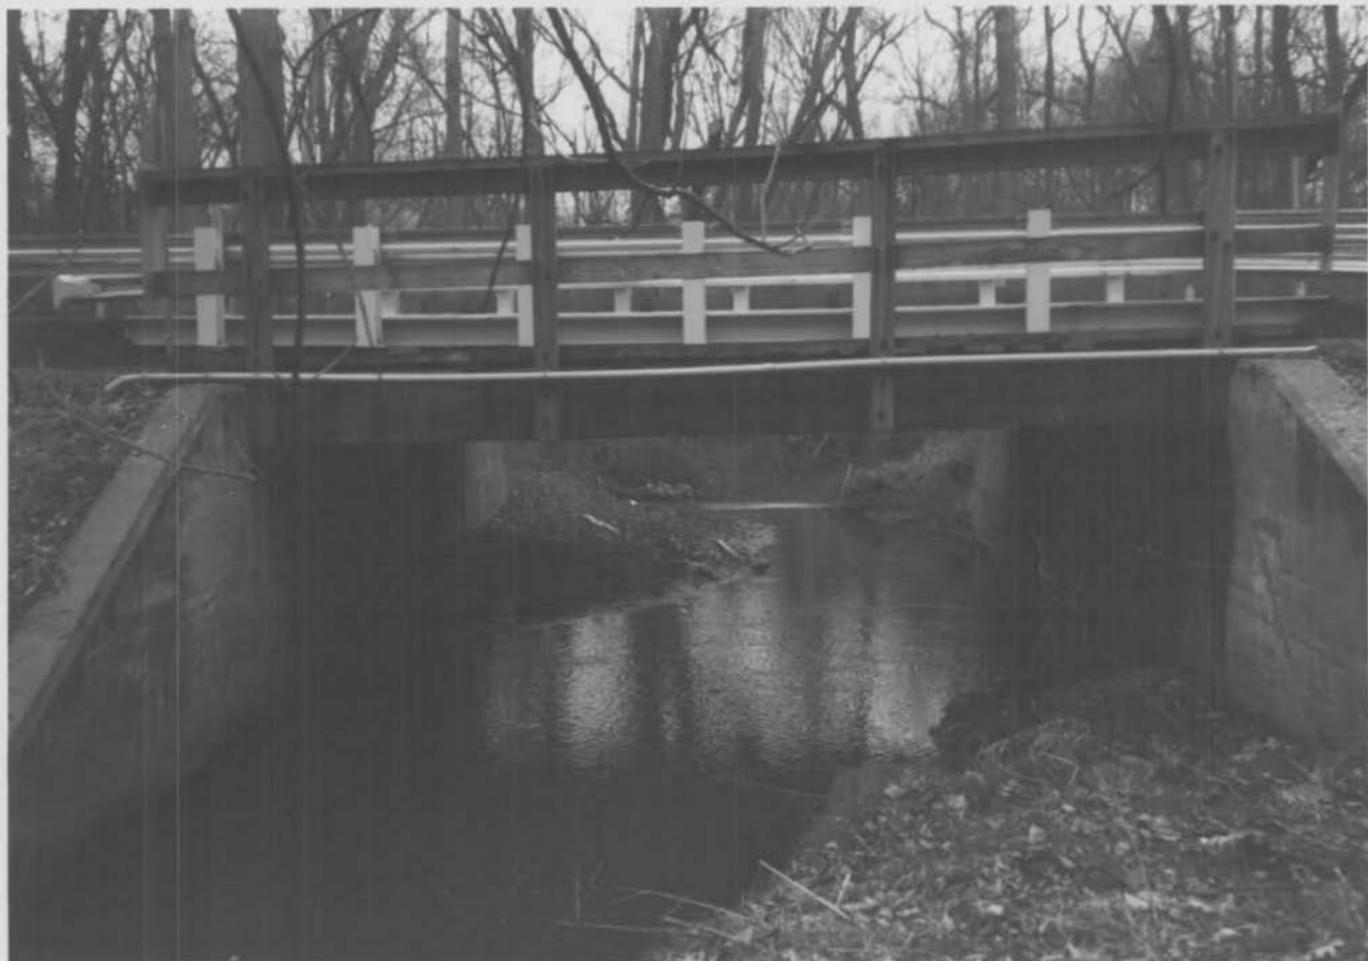
- 1 CE-1486
- 2 New Cut Rd (Lovers Ln) over Mill Pond Stream
- 3 Cecil Co, MD
- 4 3/98
- 5 Marris German, MD
- 6 MD SHPO
- 7 Elevation looking downstream
- 8 4 of 6

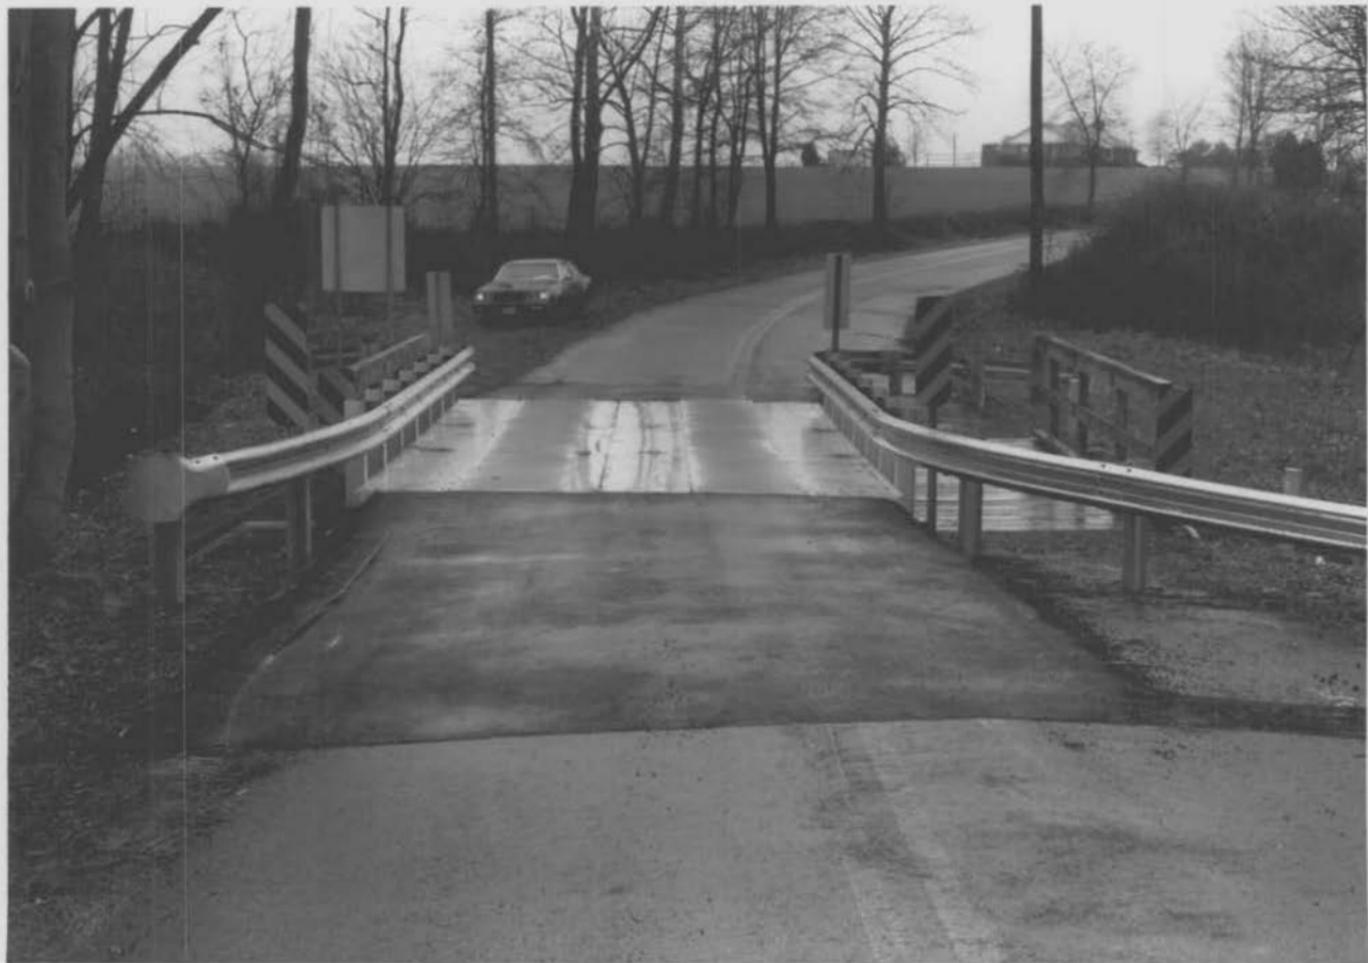
- 1 CE-1486
- 2 New Cut Rd (Lovers Ln) over Mill Pond Stream
- 3 Cecil Co., MD
- 4 3/98
- 5 Marris German, WMA
- 6 MD SHPO
- 7 Looking North
- 8 5 of 6

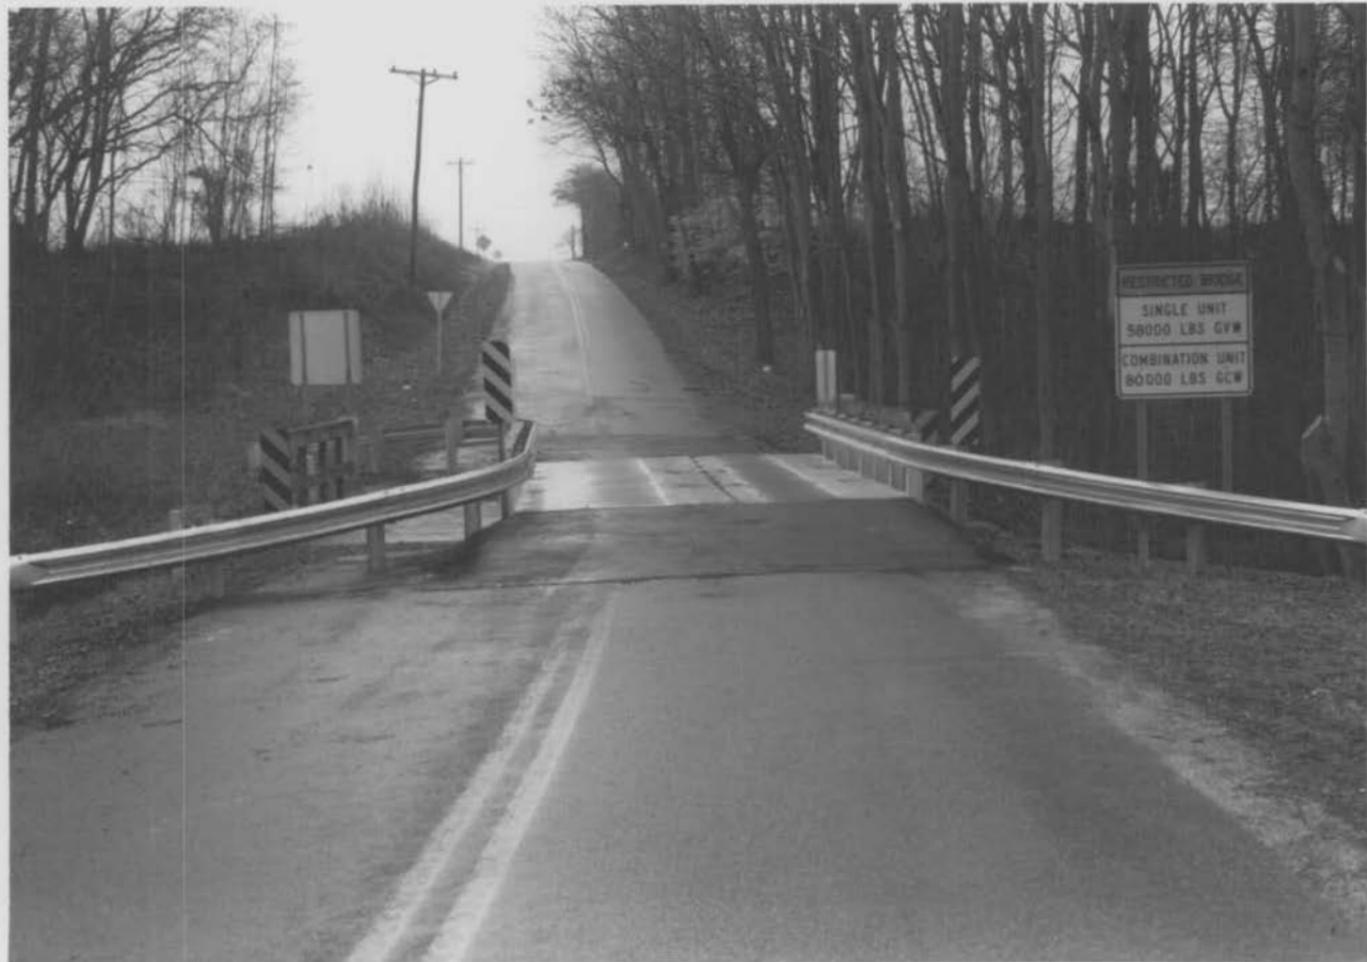
- 1 CE-1486
- 2 New Cut Rd (Covers Ln) over Mill Pond Stream
- 3 Cecil Co., MD
- 4 3/98
- 5 Marris German (NMA)
- 6 MD SHPO
- 7 Looking South
- 8 6 of 6
