Maryland Historical Trust Maryland Inventory of Historic Properties Form

historic Cann Stone House Ruins

Inventory Number: CE-1523
Cann Stone House Ruins
Cecil County, MD
C. Mazurek
June 1998
Section 7.1

name/title C. Mazurek, Historic Sites Surveyor

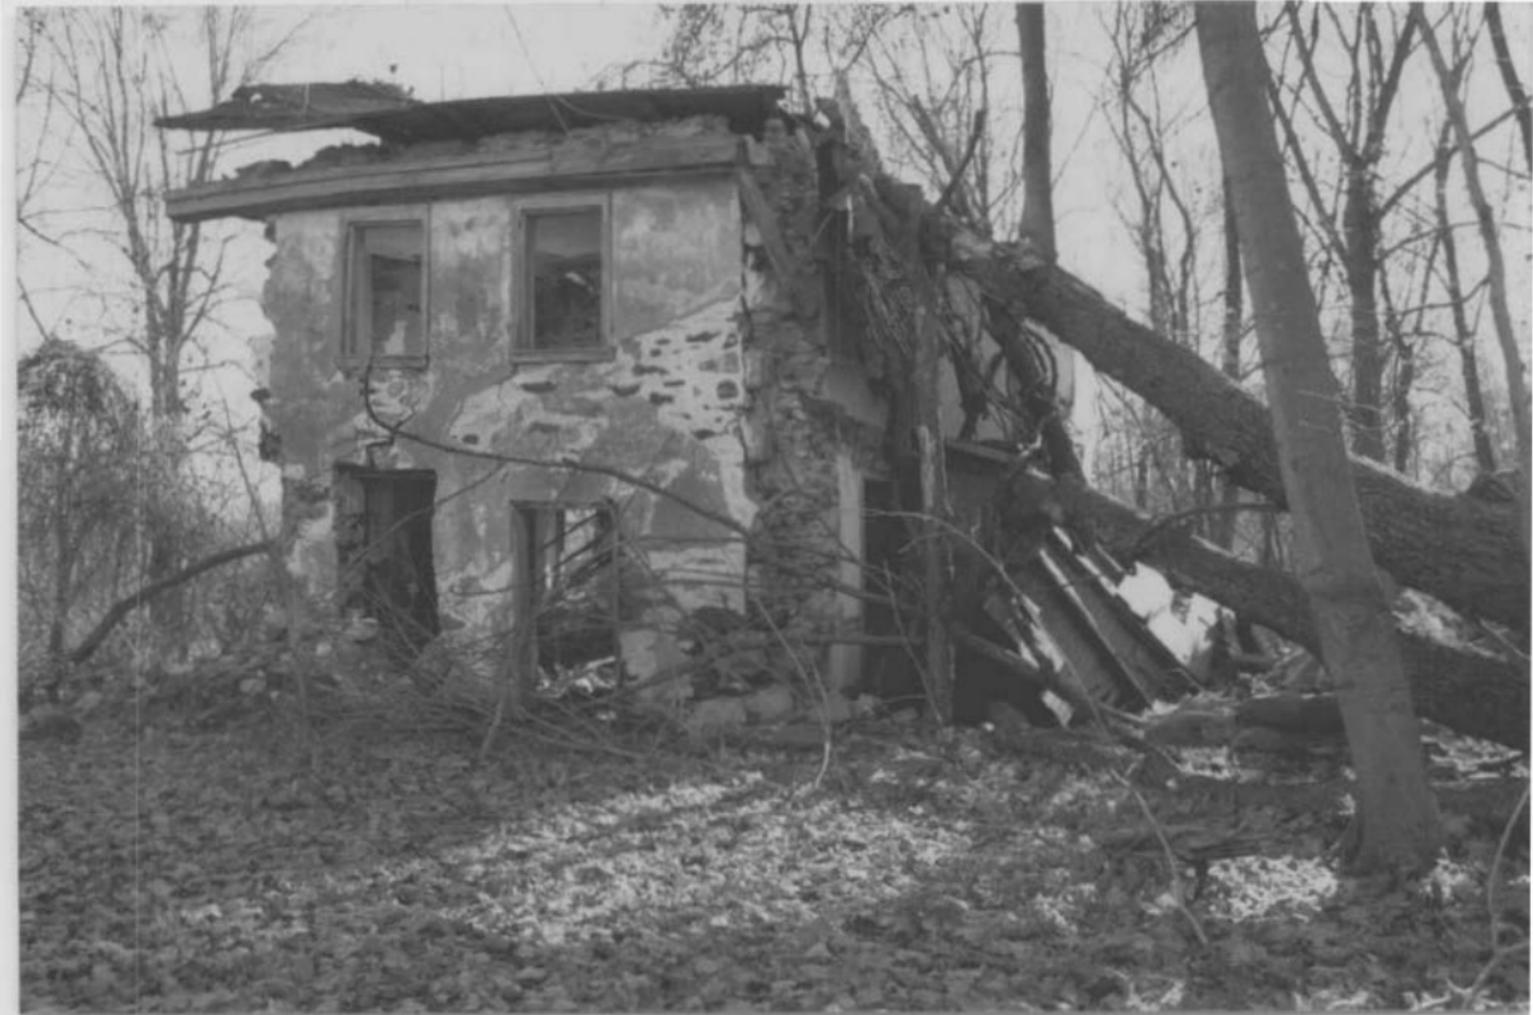
EAST VIEW OF HOUSE

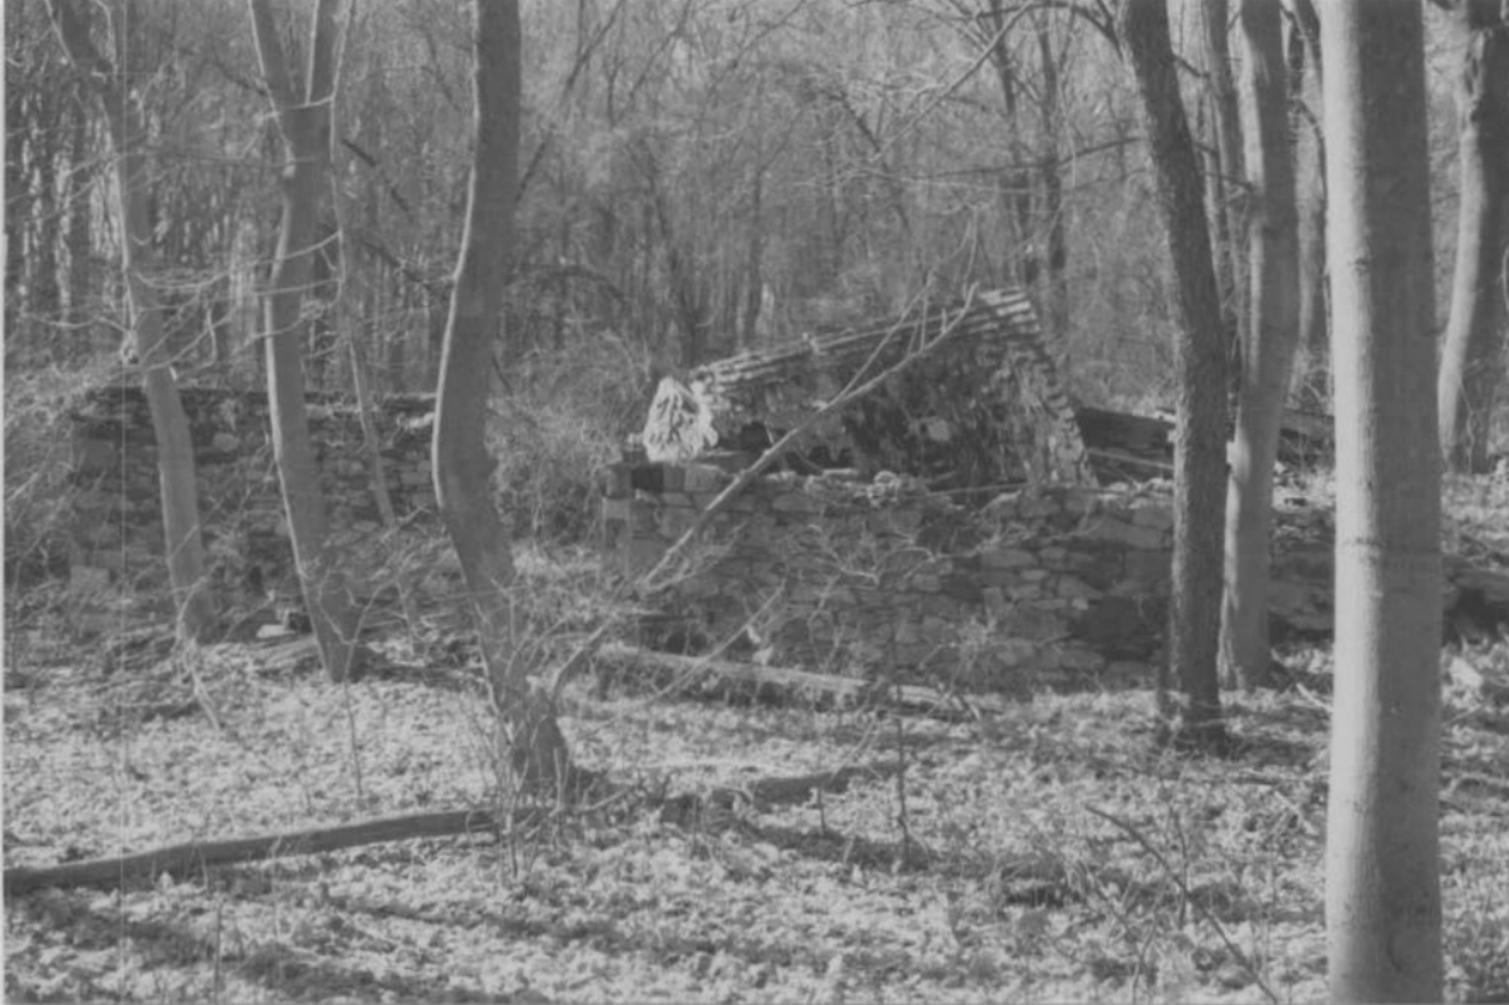
4.a

Also on the property are the remains of a structure that has a fieldstone foundation, but the upper structure is gone. It was probably a small barn.

WEST VIEW OF STONE BANK BARN

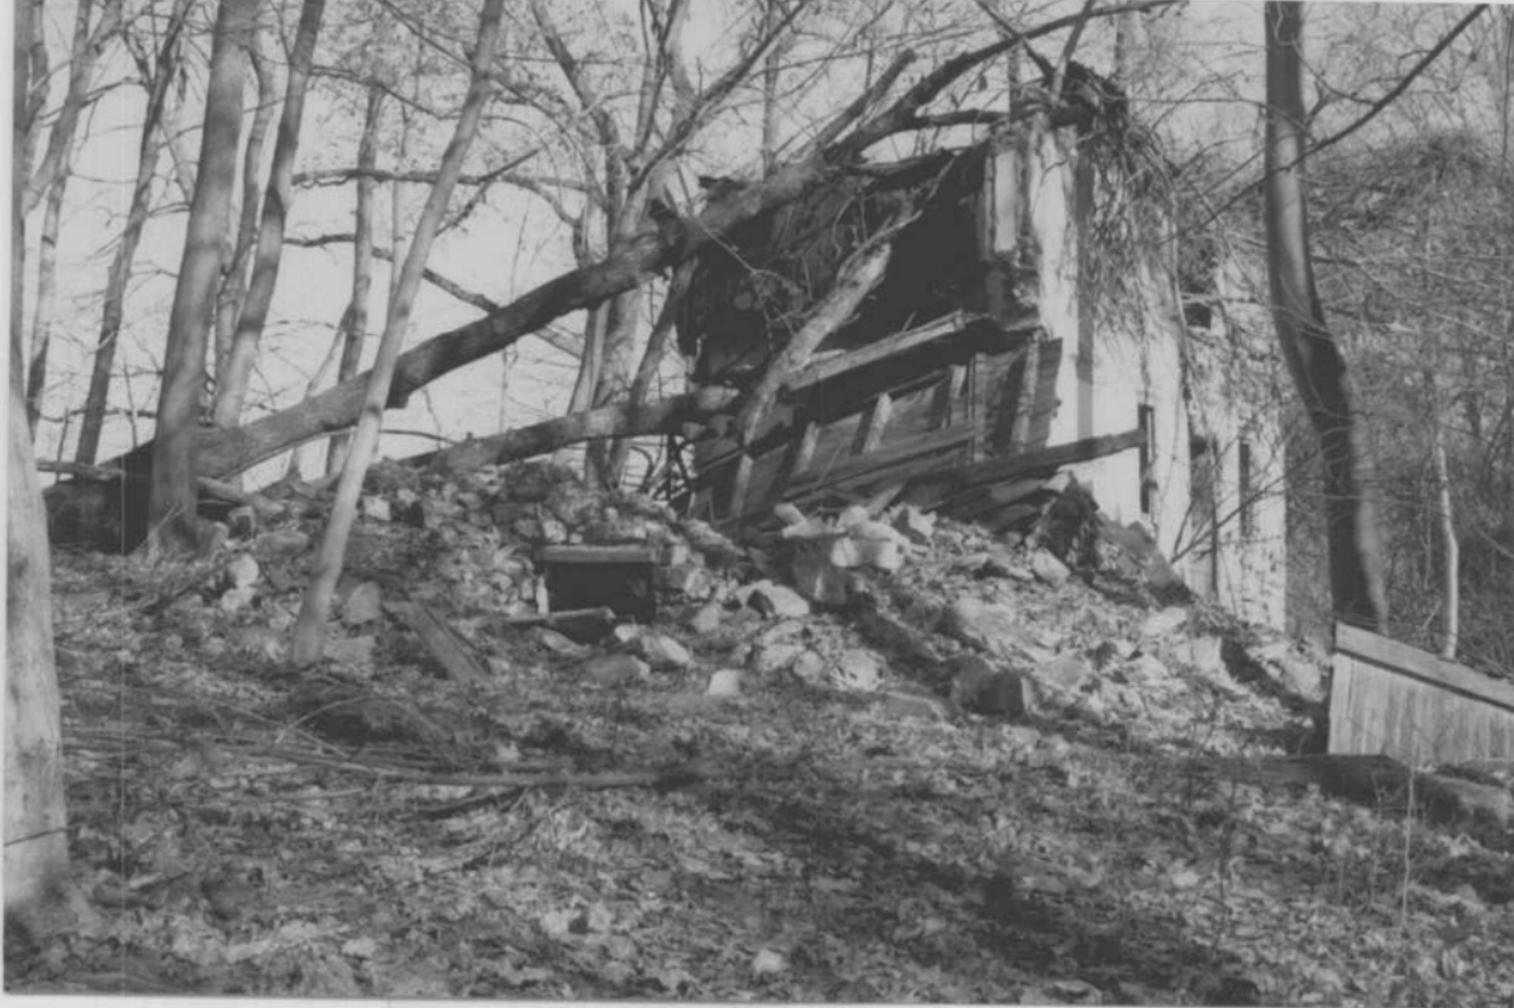
The condition of the house has deteriorated severely since the loss of the roof. It also appears that it has been hit by a couple of fallen trees which has demolished one whole half of the structure. Much of the interior fabric appears to have been stripped before the house was hit by the trees.

Dept. of NATURAL RESOURCES
NORTH VIEW OF HOUSE
