1. STATE <i>Maryland</i> COUNTY <i>Cecil County</i> TOWN <i>Cecilton</i> VICINITY STREET NO. <i>Rt 213</i> (<i>1 mile north of Cecilton</i> <i>(west side)</i>)	HISTORIC AMERICAN BUILDINGS SURVEY INVENTORY <i>CE-19</i>
ORIGINAL OWNER ORIGINAL USE <i>dwelling</i> PRESENT OWNER <i>Mr. Mrs. George C. Fry</i> PRESENT USE <i>dwelling</i> WALL CONSTRUCTION <i>Brick & frame</i> NO. OF STORIES <i>2 1/2</i>	2. NAME <i>The Anchorage</i> DATE OR PERIOD <i>c. 1790 + 1835</i> STYLE <i>Federal</i> ARCHITECT BUILDER <i>Comm. Jacob Jones (1835)</i>
3. FOR LIBRARY OF CONGRESS USE

4. NOTABLE FEATURES, HISTORICAL SIGNIFICANCE AND DESCRIPTION OPEN TO PUBLIC *No*

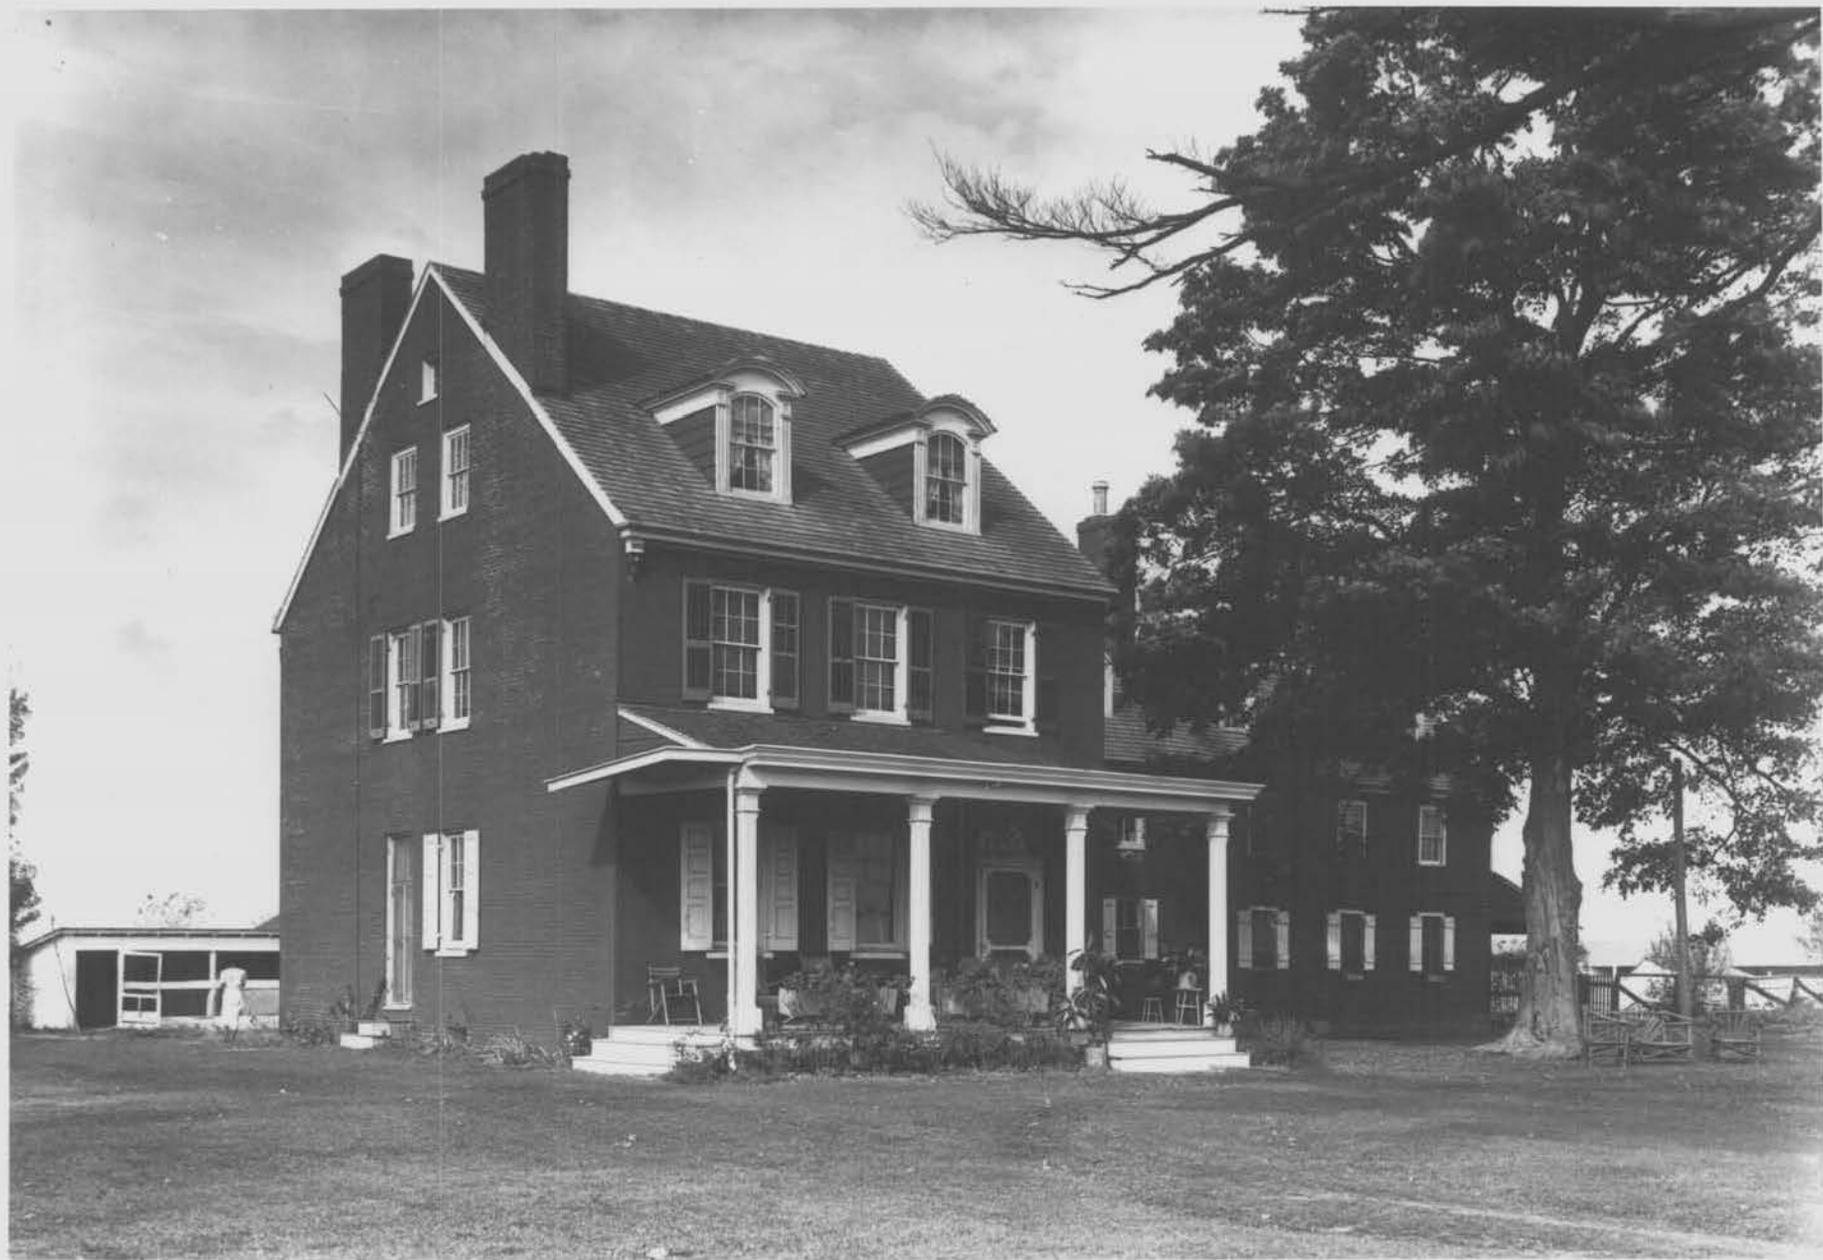
6. LOCATION MAP (Plan Optional) 7. PHOTOGRAPH *2128*

The Anchorage, located one mile north of Cecilton has at least four building stages. Presumably the first part was constructed in the late 18th century and now forms the 2 1/2 story brick center portion. It is three bays long with central door and a small wood stoop. On the "A" roof are two dormers with 3/6 sash and a very tall chimney on the north side, which is now the middle of the wing of the entire house, as there is an addition three bay long frame structure with the same dormers as the previous section. This wing also has a chimney on its north end. The latter frame wing is presumably of 19th century date.

On the south side of the house is a very large 2 1/2 story townhouse built in 1835 by Commodore Jacob Jones. It is of brick laid in Flemish bond, three bays long and two bays deep. The entrance is located on the north side of this portion and has paneled door, jab and semicircular fanlight above. All windows in this section have 6/6 sash; paneled shutters on first story. A pair of huge chimneys are on the south gable and two windows between them light the rooms within. At the very apex of the roof is a small casement which lights the supre-attic. Two large dormers with segmental arch roof and sash, and pilaster treatment pierce the "A" roof. The entire roof is covered with wood shingles.

A pyramidal ice house stands northeast of the house, the roof nearly reaching the ground.
