Name The Richard's House MHT# CE-231

Richards House

MHT# CE-231

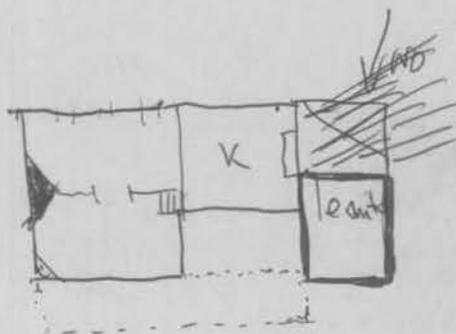
↑ N

has 2 rooms, each with corner fireplace having fine gouge-work mantels and a corner cabinet in the living room. The kitchen is located west of the latter 2 rooms & has a vacant area on both sides of it but a front enclosed room on the 2nd story. The entire house is heated as a unit, having one "A" ray covering the odd floor plan - the house also has a crude dentil cornice on both facades.

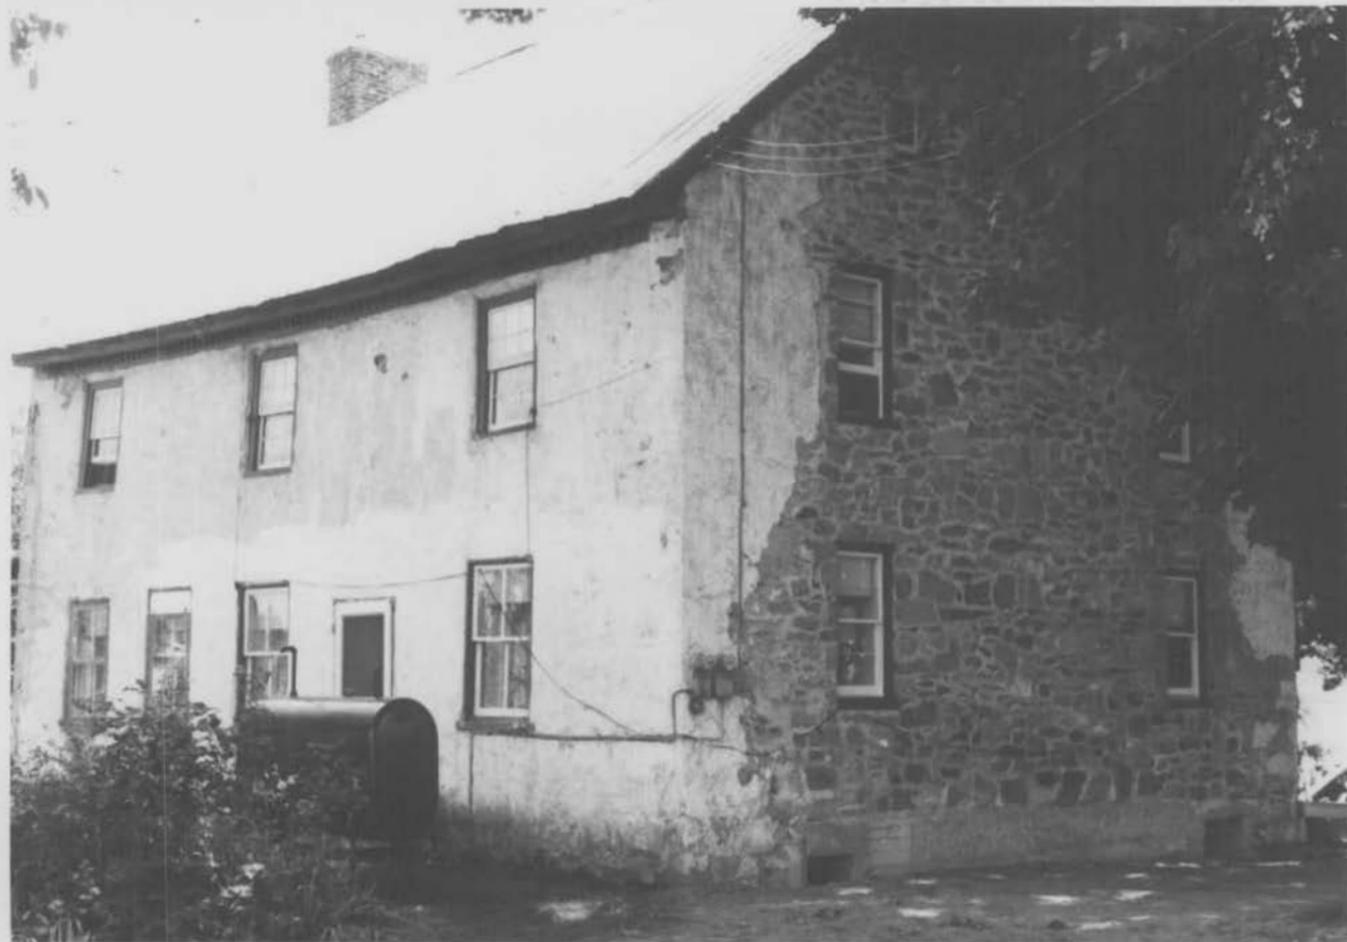
CE - 231

Richards House
Near Richardsmere
Northwest Elevation
MOB/1968
NEG - MD. Hist. Trust
