1. STATE COUNTY TOWN STREET NO.	Maryland Cecil VICINITY Oakwood	HISTORIC AMERICAN BUILDINGS SURVEY INVENTORY CE - 36
ORIGINAL OWNER ORIGINAL USE PRESENT OWNER PRESENT USE WALL CONSTRUCTION NO. OF STORIES	--- Dwelling --- Ruins Squared log grooved 2 construction	2. NAME DATE OR PERIOD STYLE ARCHITECT BUILDER
		3. FOR LIBRARY OF CONGRESS USE

1. STATE <u>Maryland</u> COUNTY <u>Cecil</u> TOWN <u>Oakwood</u> VICINITY <u>(36)</u> STREET NO. _____ ORIGINAL OWNER ---- ORIGINAL USE <u>Dwelling</u> PRESENT OWNER ----- PRESENT USE <u>Ruins</u> WALL CONSTRUCTION <u>Squared log grooved construction</u> NO. OF STORIES <u>2</u>		HISTORIC AMERICAN BUILDINGS SURVEY INVENTORY <u>CE-36</u>

Ruined Log House
Oakwood

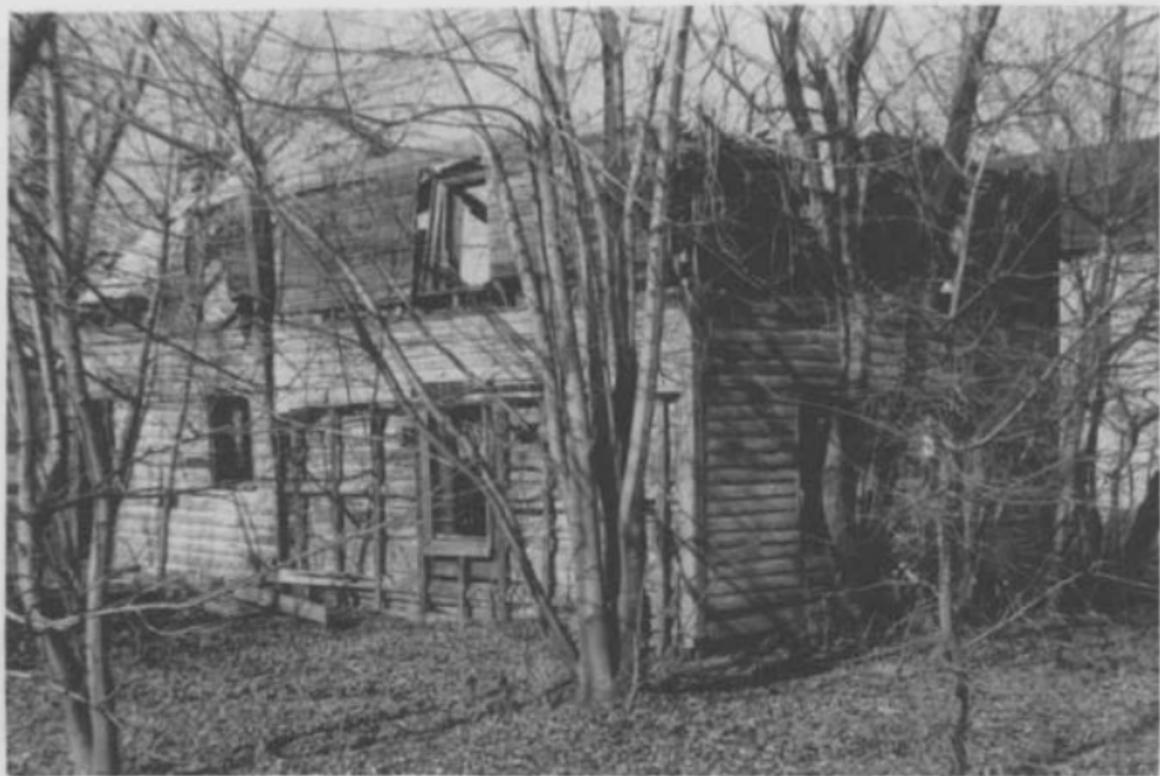
CE-36

This was a small log building two bays square and two stories in height which probably had an A-roof. (The roof is now completely gone.) This log dwelling was built into a slightly larger frames structure. The logs are square and laid in a grooved construction pattern, one on top of another. Many adze marks show on their surfaces. They are chinked between with plaster and fragments on broken brick.

Condition: RUINS

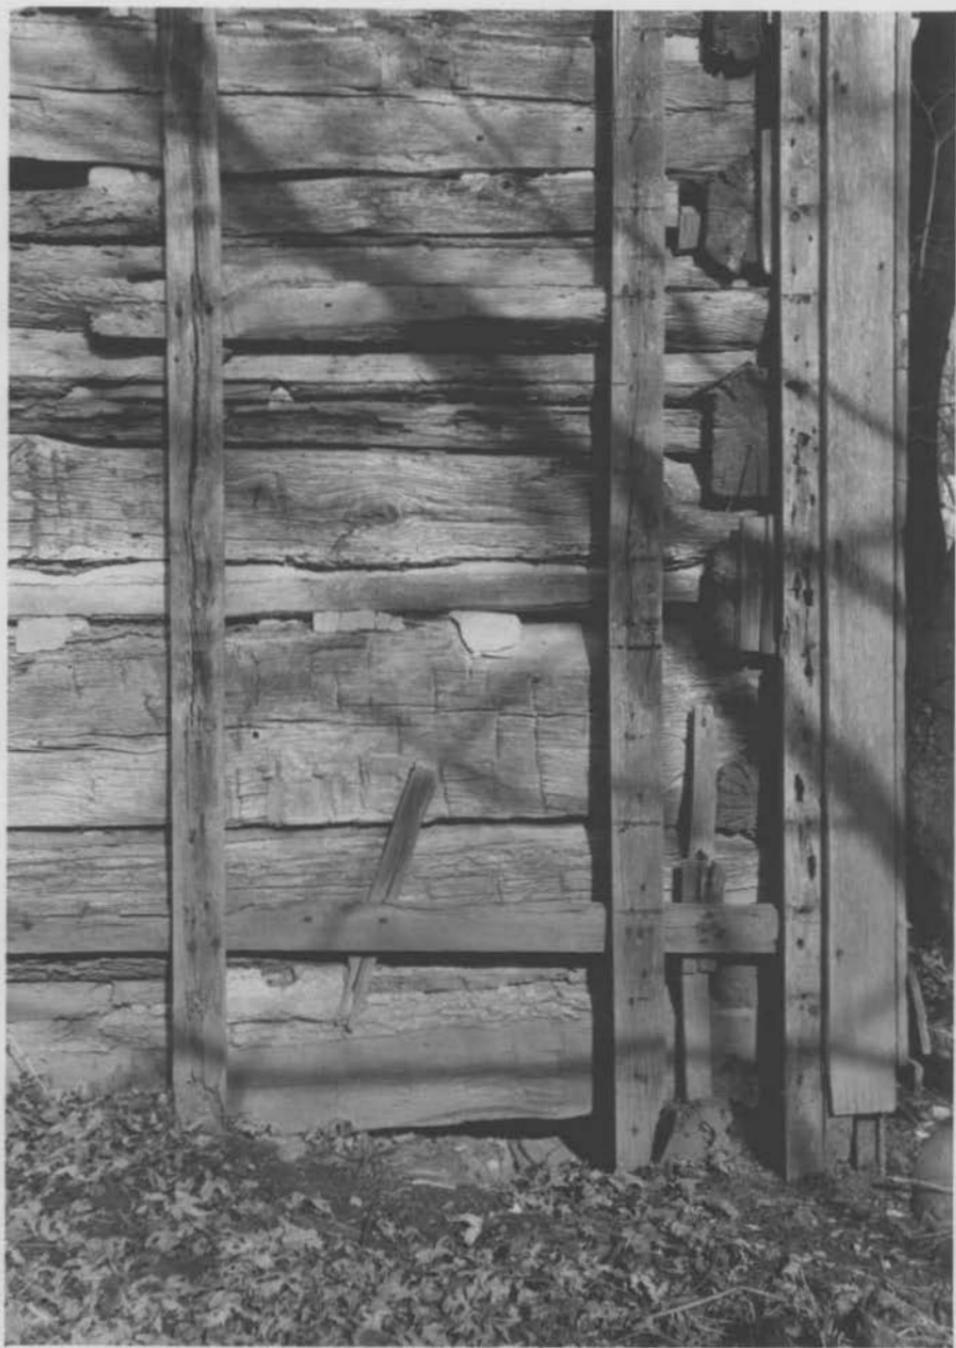
CE - 36

Ruined Log House
Oakwood
Cornering Detail
