Inventory Number:CE-527
Tyson House
Cecil County, MD
C. Mazurek
June 1998
Section 7.1

TYSON HOUSE, FAIR HILL N.R.M.A.

1 NAME

HISTORIC
TYSON HOUSE RUINS
AND/OR COMMON

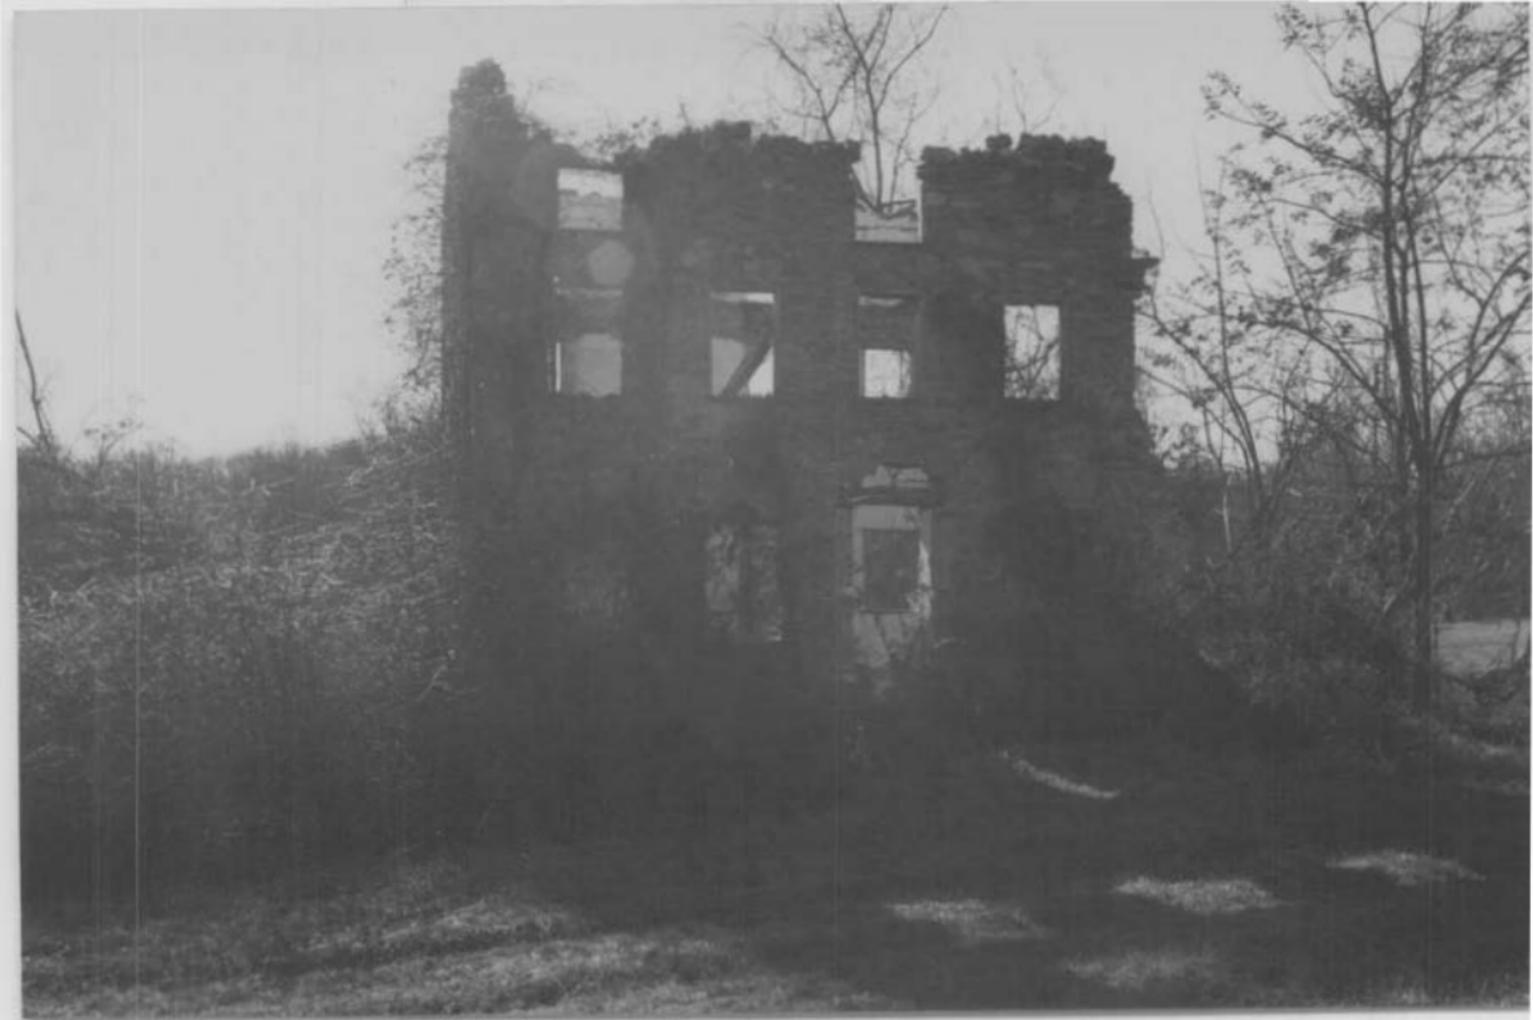
S.E. ELEVATION

This structure has been unoccupied for many years, and has deteriorated beyond livability. The loss of the roof has further compounded the problem of deterioration. It is a simple plan that may have been divided into two units, is two and one-half stories tall, and is four bays wide. According to the last historic sites survey in 1979 the roof, now gone, was gabled with a central chimney. The entire structure is constructed of uncut fieldstone, with no courses, that appears to have had a stucco finish applied to it at one time. All of the window sashes and doors have deteriorated or have been vandalized. The interior wood framing has fallen into the basement, but it is still possible to see that the walls were covered with a plaster coating. The entire west facade is missing. For the most part the Tyson House is just the shell of the original structure.
