CE - 797

Longview Farm

c. 1800 - 1850

INVENTORY FORM FOR STATE HISTORIC SITES SURVEY

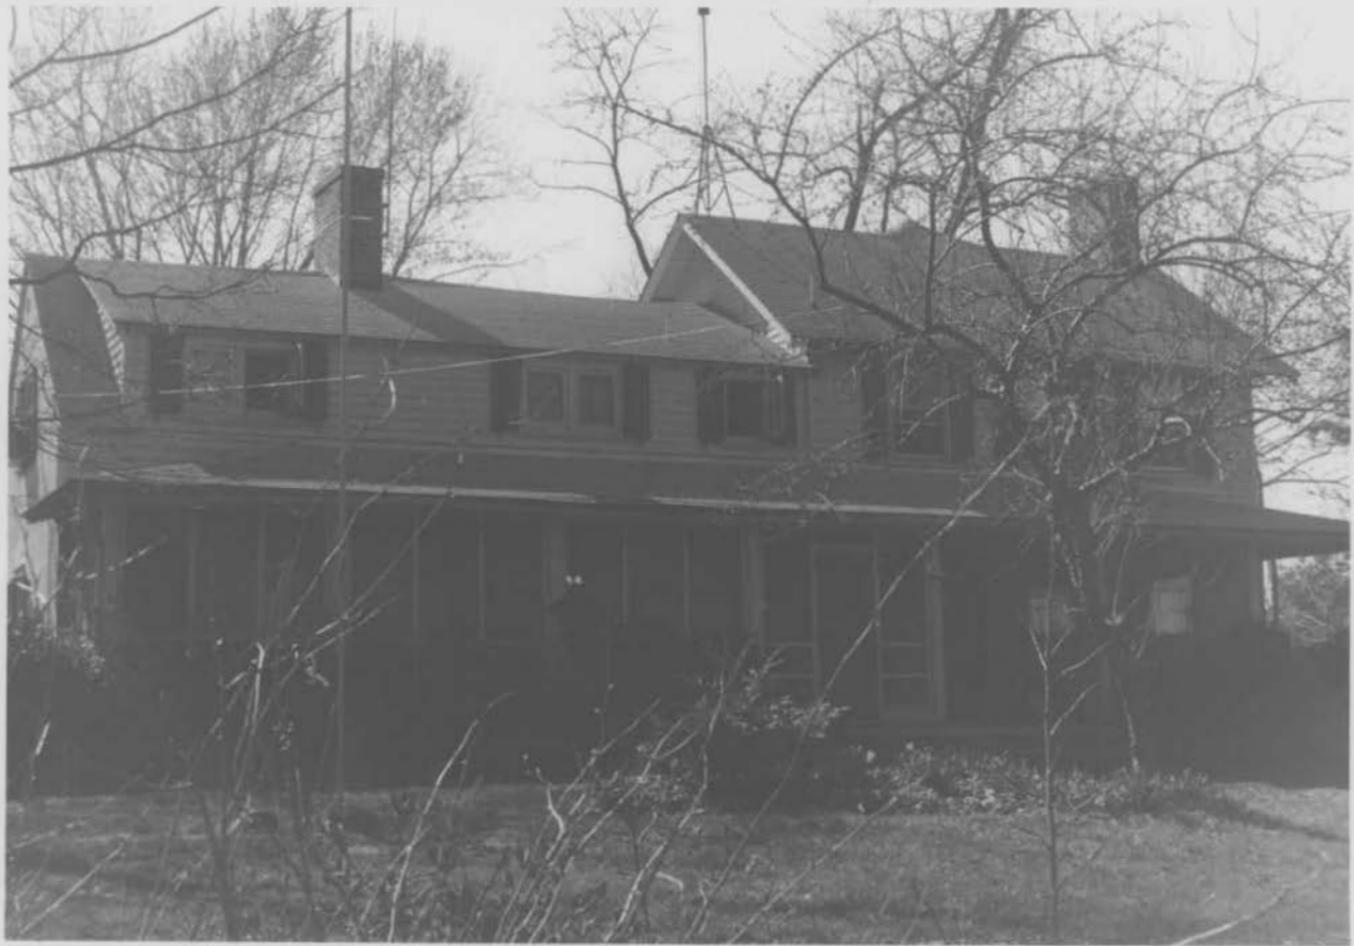
NORTH ELEVATION

Longview Farm c. 1800 is located on Hances Point Road and in the middle of a fork in the road at Hances Point Marina. The farmhouse faces north with the main gable running east/west.

The present farmhouse is the product of three separate building periods. What appears to have been the first structure is constructed of log and is a 1½ story 3 bay by one room section. The next stage c. 1825 was constructed on the west gable end of the log building. It is a 2½ story side hall/parlor section. The final addition is a 2½ story late 19th or early 20th century structure off the south side of the second section. A single story shed roof porch was attached to the south side of the log section and across the front of the entire structure. The log section has seen numerous alterations as can be evidenced in old photographs the owners possess. The log section used to have gabled dormers which have been replaced with a full shed dormer. Shed dormers also extend off the south slope of the roof. A central chimney does rise out of the log section remains in its original state. Much of the exterior details have been altered including sash windows and doors. The section rests on a stone foundation and is covered with weatherboard siding. The east end is stuccoed.

The main facade is 3 bays across with the entrance in the eastern bay. A later 19th century molded door has replaced the earlier one. Louvered shutters flank the windows. The roof was probably replaced in the late 19th century since the eaves are extended like the rear section. The eaves were left open on the rear section. 2/2 sash with plain trim are found throughout. A door is located between the double 2/2 sash windows of the north facade. It has a small gabled protection with decorative bracket supports.

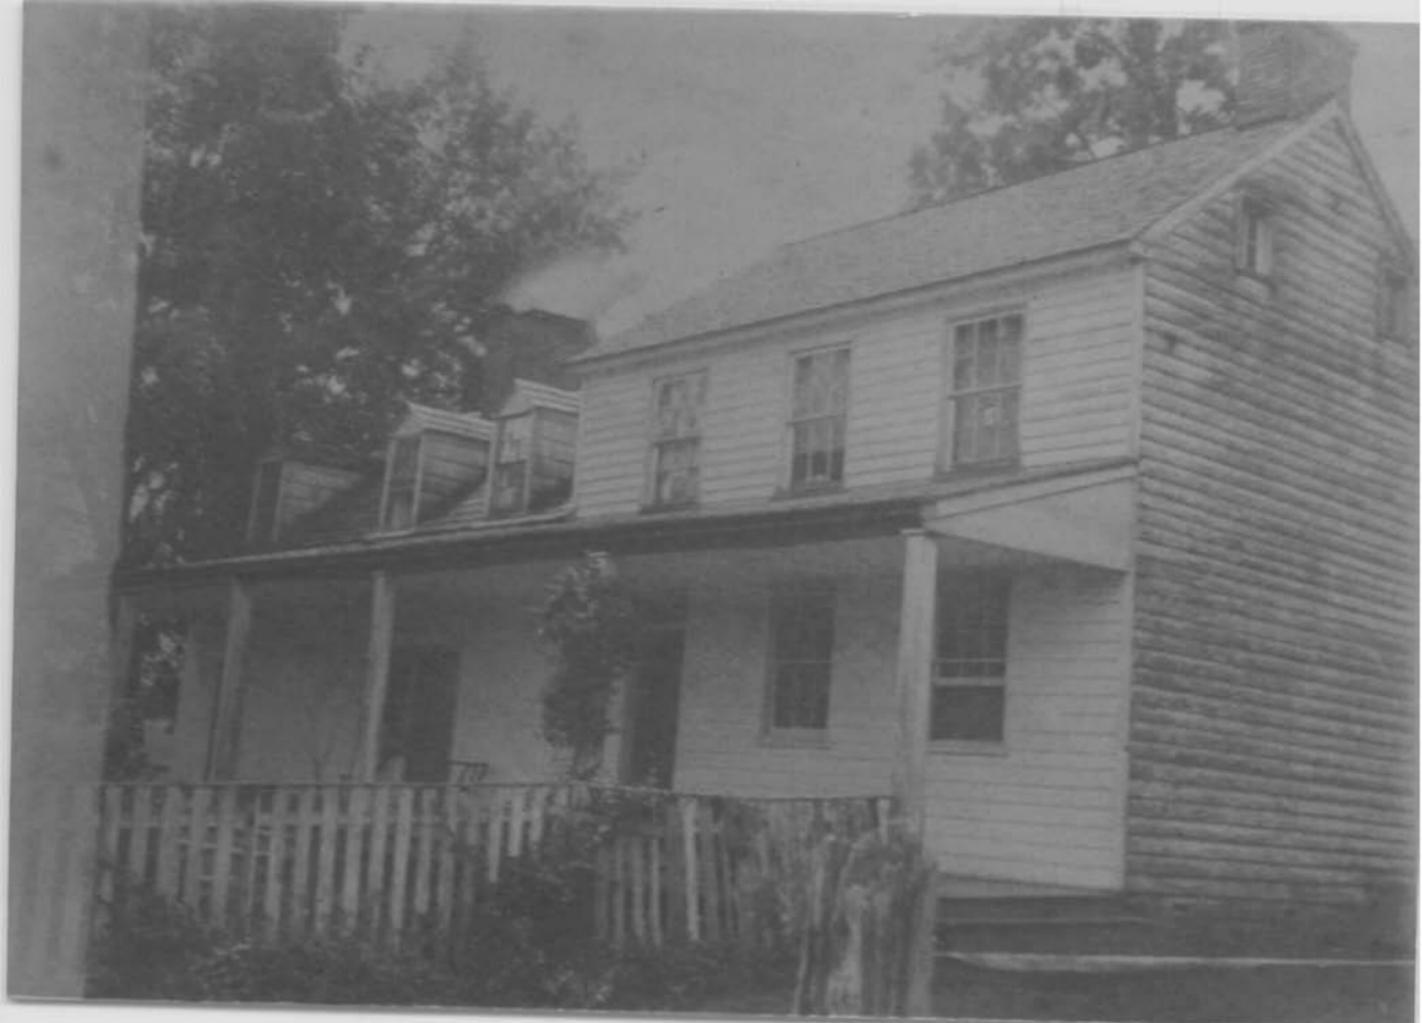
Longview Farm CE - 797
Owners Collection - Old Photo
North Elevation of House
Hances Point
5/78 PBT
NEG - MD. Hist. Trust

Longview Farm has been referred to in early records, according to the owner, as "The Plantation". The property was owned in 1877 by _____ and in 1858 by _____. Old photographs have survived to document this structure's early appearance.

The structure has obviously seen numerous alterations since these photographs and unfortunately the changes have deminished the architectural significance of the structure. The late 18th and early 19th century appearance is visible under close scrutiny but not readily recognizable under the changes.

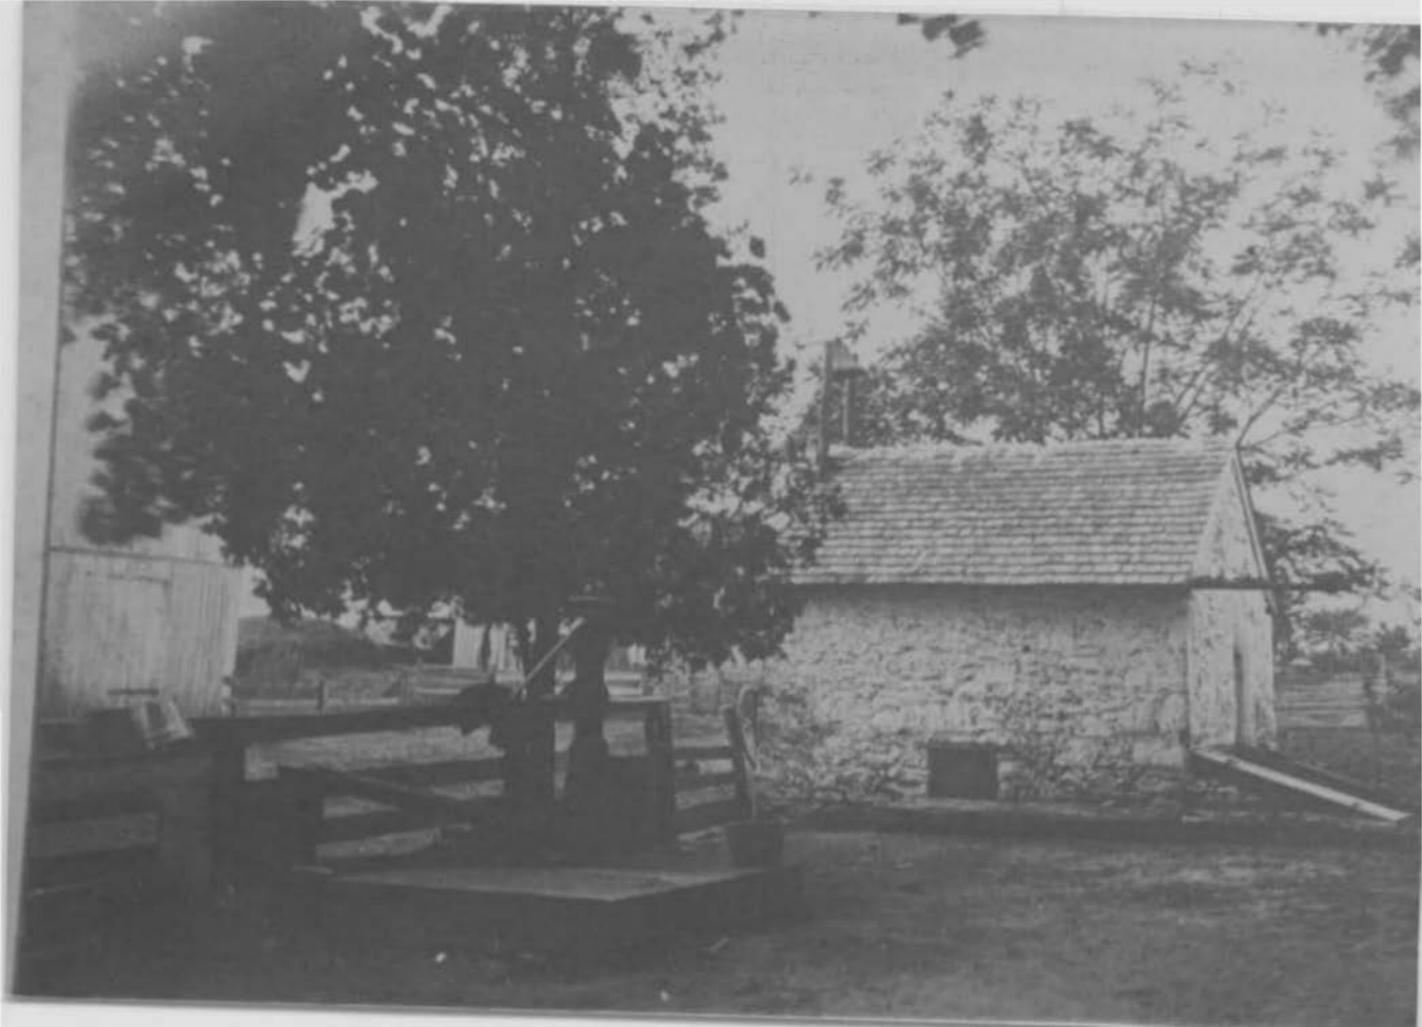
Springhouse/Milkhouse

Two barns and an uncoursed stone meat house or dairy remain to the east of the main house. The barns have typical vertical board sheathing. The stone outbuilding is also a common single story single bay and single bay structure.
