MARYLAND HISTORICAL TRUST
DETERMINATION OF ELIGIBILITY FORM

Property Name: Boettcher Property Inventory Number: CE-817

Project: Oldfield Point Road Improvements Agency: Cecil County

Agency Prepared By: A.D. Marble & Company

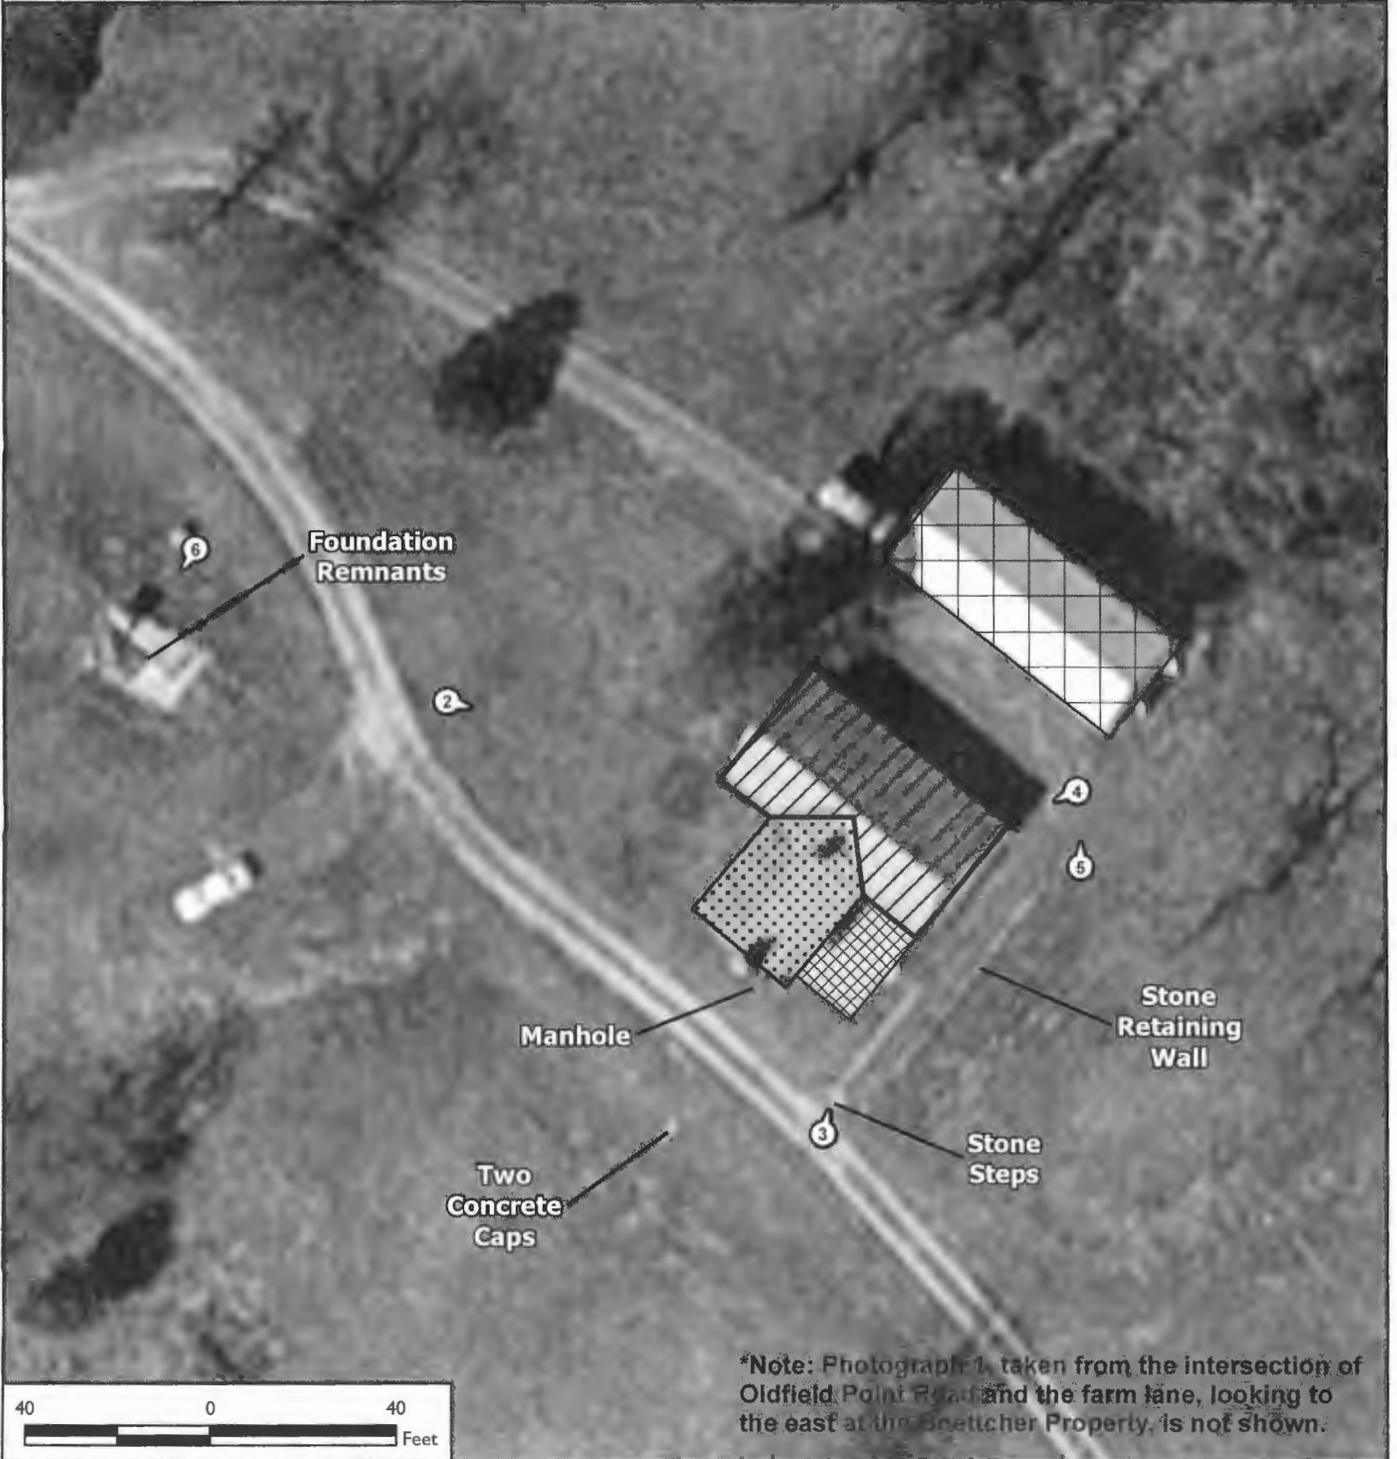
Site Plan and Photograph Location Map

Foundation Remnants

Manhole

Two Concrete Caps

Stone Retaining Wall

Stone Steps

ca. 1940 Addition
-

ca. 1928 Main Block
-

ca. 2000 Pole Shed
-

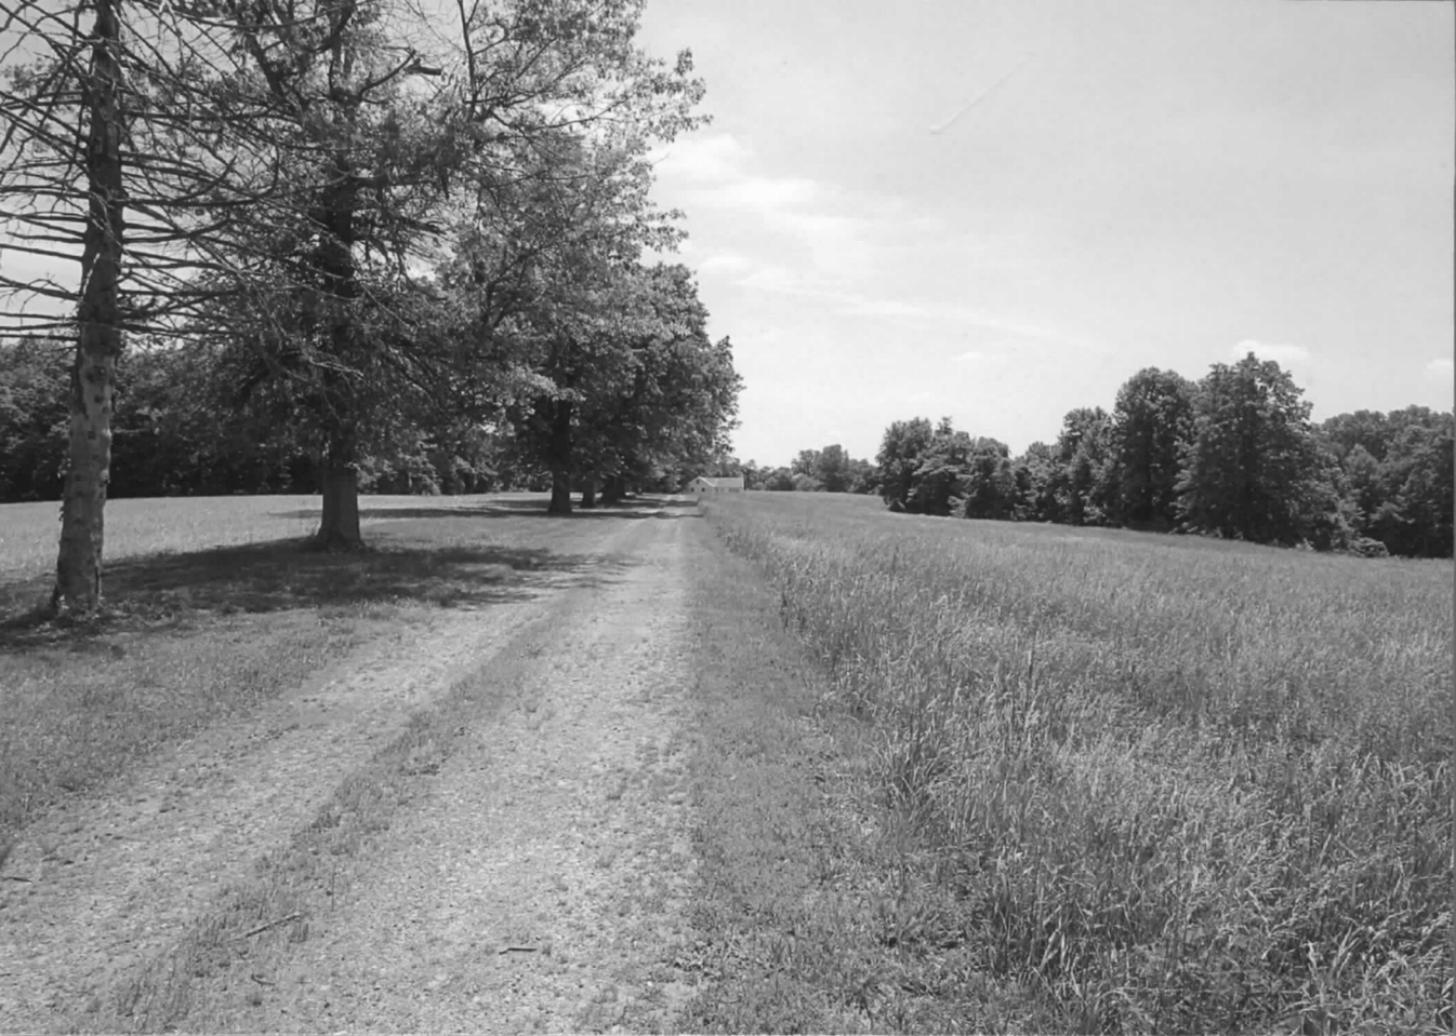
#1 of 6

Overview of 744 Oldfield Point Road and farm lane leading to the dwelling on the Boettcher Property, view to the east.

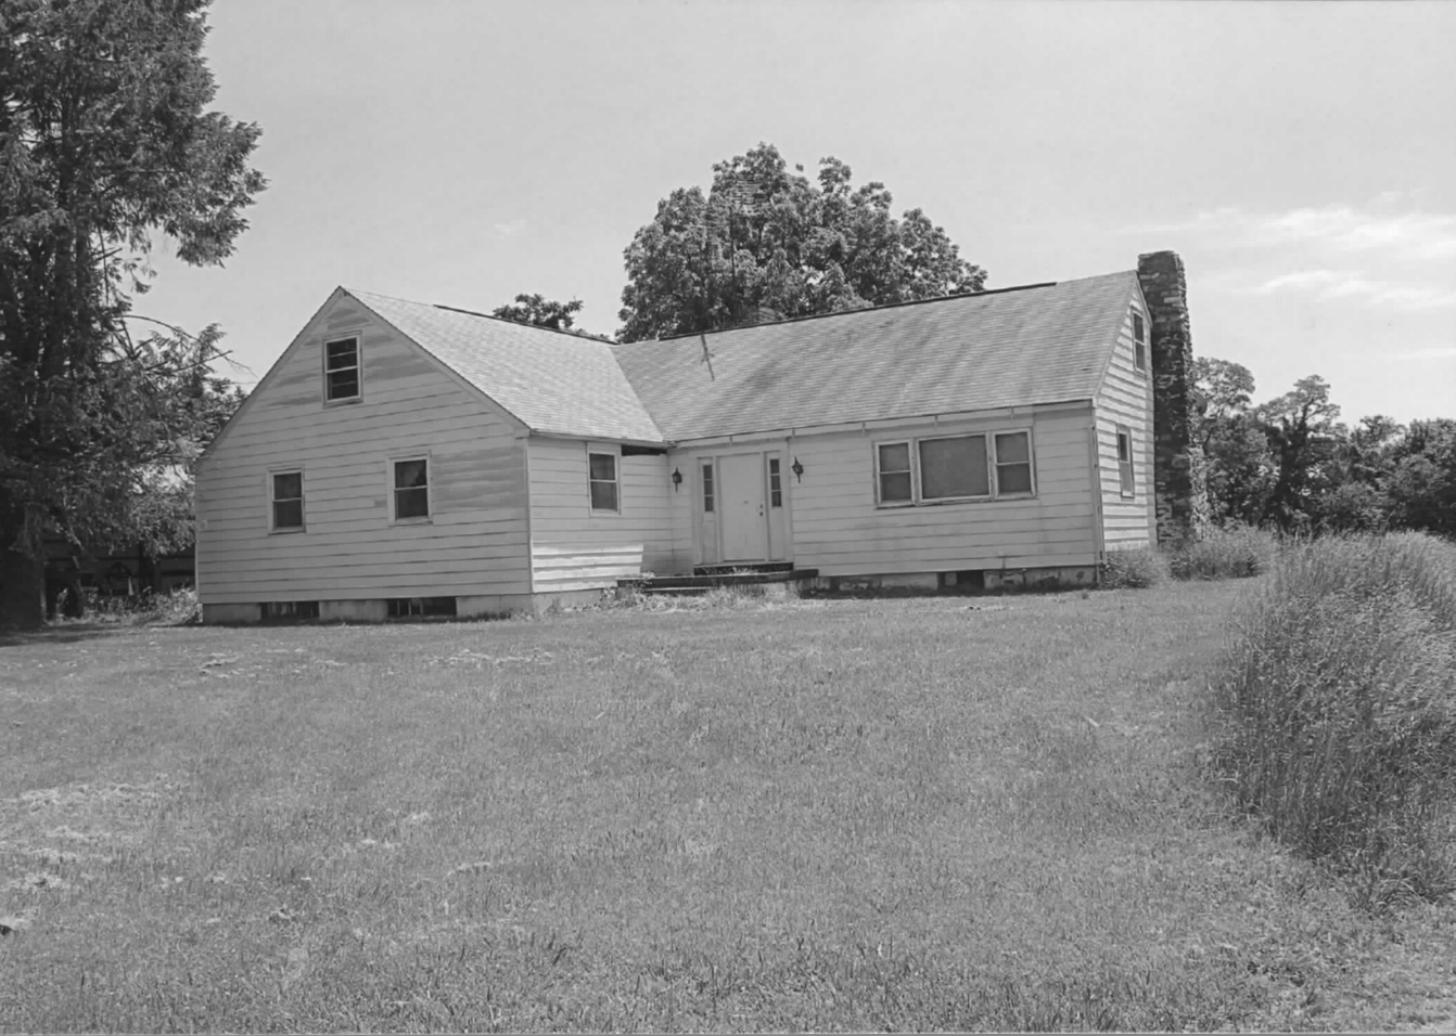
2 of 6

The west elevation (façade) is four bays wide (Photograph 2). The southern two bays are located in the main block, and from left to right contain the main entrance and a three-part picture window. The main entrance is accessed by a concrete block, brick, and stone masonry porch with two steps. The main entrance consists of a modern nine-panel metal door that is flanked on each side by three-light-over-one-panel sidelights. The door trim consists of flat metal, with a small portion of the original wood entablature visible above the door consisting of modillions and a simple profiled cornice. The southernmost bay of the main block contains a large vinyl picture window flanked on each side by vinyl replacement windows. A simple wood entablature that matches the entrance surmounts the windows. The basement level of the main block contains one three-light, hinged, wood window. The west elevation of the addition contains four evenly spaced three-light, fixed metal windows in the basement level; two evenly spaced windows in the first story; and one two-over-two-light, double-hung, wood window centered in the half-story.

West and south elevations of the Boettcher dwelling,
view to the east.

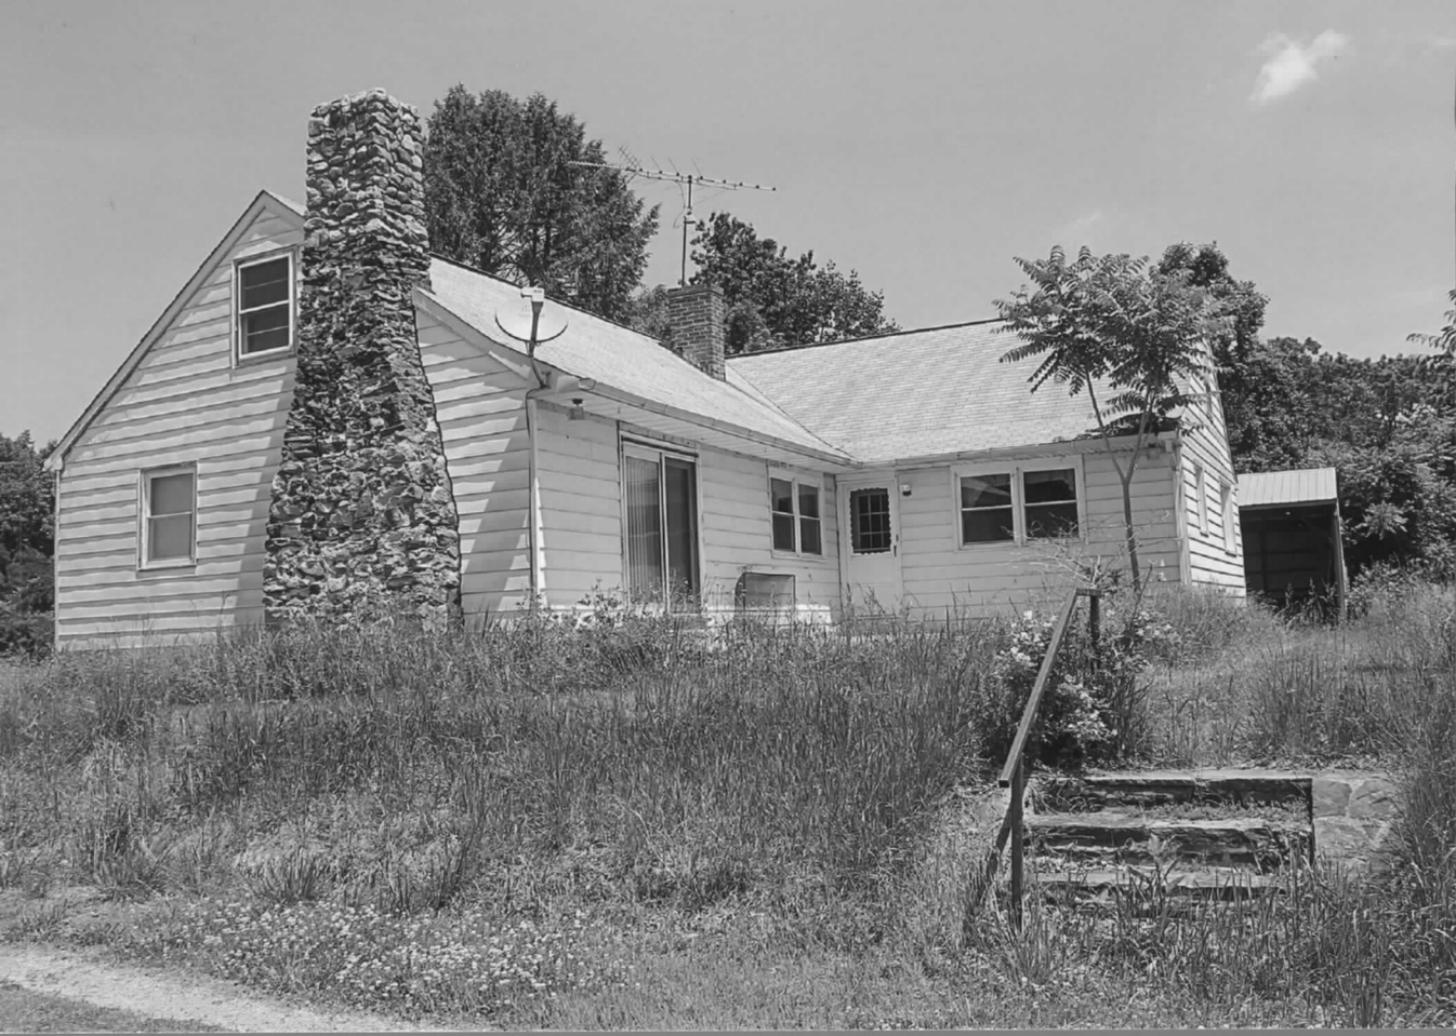
#3 of 6

The south elevation is four bays wide. The main block contains two bays and separates the south elevation of the addition; one bay is located in the western end of the addition, two bays are located in the eastern end of the addition. The south elevation of the main block contains one three-light wood window in the basement level, one typical window in the first story, and one two-over-two-light, double-hung, wood window in the gable peak (Photograph 3). The south elevation of the western portion of the addition, which faces the façade of the main block, contains one typical window (Photograph 2). The south elevation of the eastern portion of the addition features a nine-light-over-three-panel modern metal door protected by a modern metal storm door in the western bay and a set of paired typical windows in the eastern bay (Photograph 3).

A set of four stone steps lead from the farm lane to the north, providing access to the concrete deck on the east elevation of the main block (Photograph 3). The large concrete deck is accessed by two concrete steps on the east end. The east elevation is four bays wide. The southern two bays are located in the main block, while the northern two bays are located in the addition. The east elevation of the main block contains a modern sliding wood door in the southern bay and a set of paired typical windows in the northern bay (Photograph 3). The east elevation of the addition features four three-light, fixed metal windows in the basement level (Photograph 4). The first story of the addition features a set of paired windows in the northern bay and a single typical window in the southern bay. The half story contains one two-over-two-light, double-hung wood window in the gable peak. A small stone retaining wall is located east of the east elevation (Photograph 4).

South and east elevations of the Boettcher dwelling, view to the north.

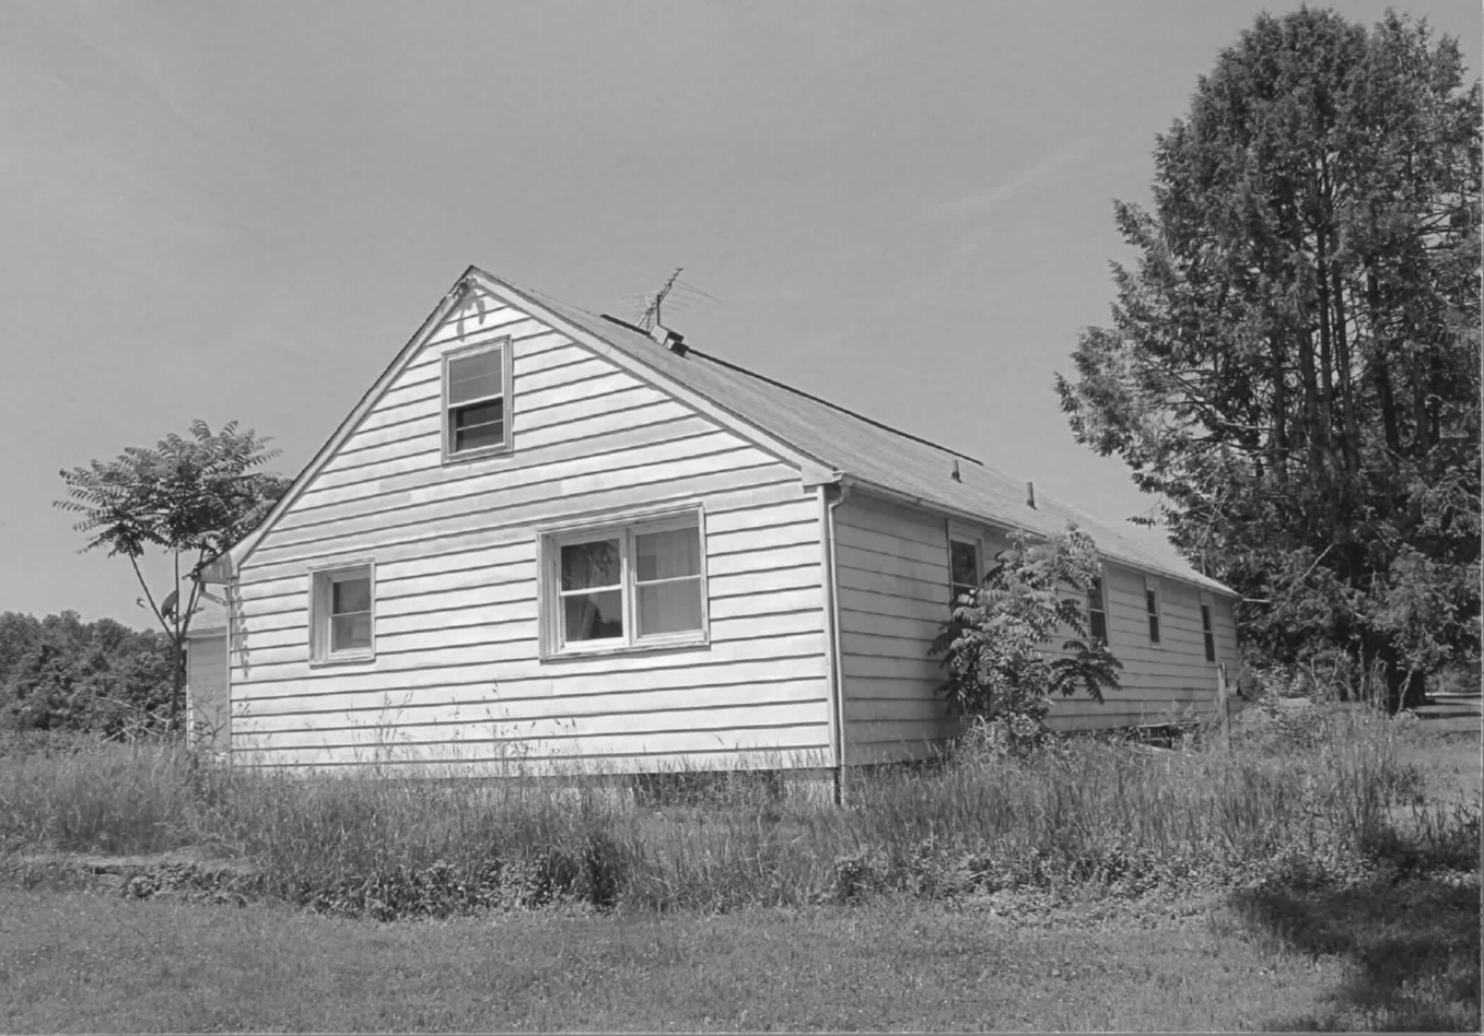
4 of 6

The north elevation of the main block is completely concealed by the circa-1940 addition. The north elevation of the addition contains five bays in the first story, all of which contain typical windows (Photograph 4). The basement level contains a metal bulkhead that provides access from the exterior and four three-light, fixed metal windows.

East and north elevations of the Boettcher dwelling, view to the west.

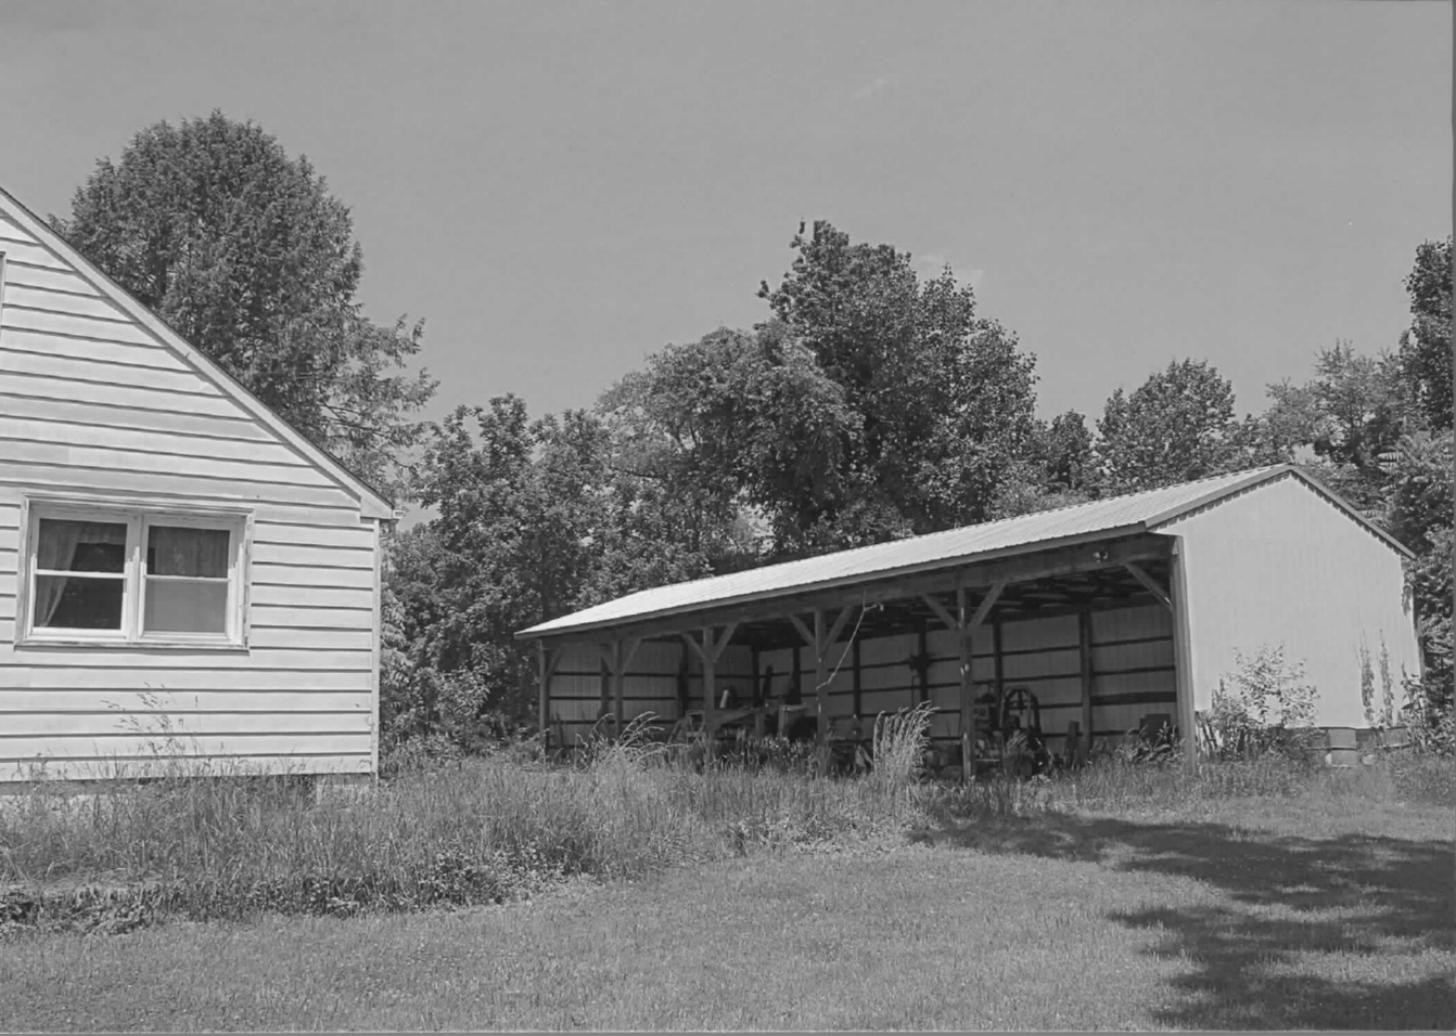
#5 of 6

A circa-2000 pole shed is located north of the dwelling (Photograph 5). Historic aerial imagery and an earlier foundation remnant indicate that the circa-2000 pole shed replaced an earlier pole shed at approximately the same location. The pole shed is open on the south elevation and enclosed on the west, north, and east elevations. The pole shed has a concrete floor, is constructed of wood beams, and corrugated metal comprises the siding and gable roof.

South and east elevations of a modern pole shed,
view to the north.

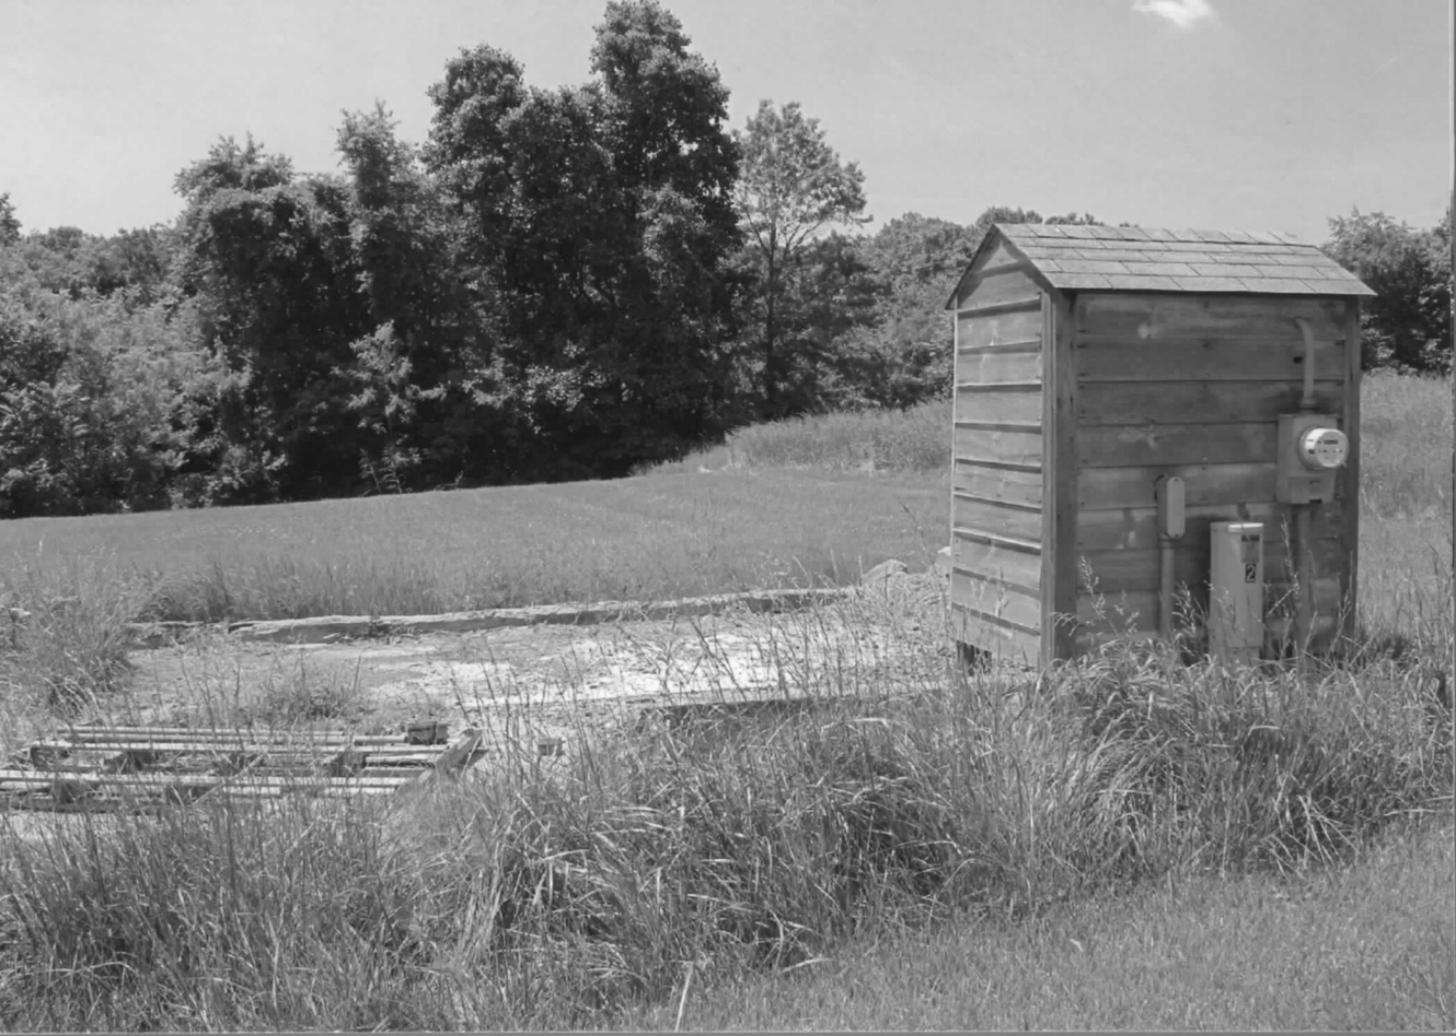
6 of 6

A concrete pad and small structure are located approximately 120 feet west of the dwelling (Photograph 6). Historic aerial imagery shows two large buildings at this location, one on the west side of the concrete pad and one on the east side, both of which are no longer extant. A small wood structure is located in the northwest corner of the concrete pad and protects an old electrical/fuse box that was likely associated with the two former buildings. The structure is open on the south elevation and clad in wood clapboard siding on the west, north, and east elevations. The side-gable roof is clad in asphalt shingles.

View of former foundation remnants and small electrical shelter, view to the southwest. Note that a former barn, large rectangular outbuilding, and silo stood in this location.
