## INVENTORY FORM FOR STATE HISTORIC SITES SURVEY File # 818

Pembroke Farms

PEMBROKE FARMHOUSE

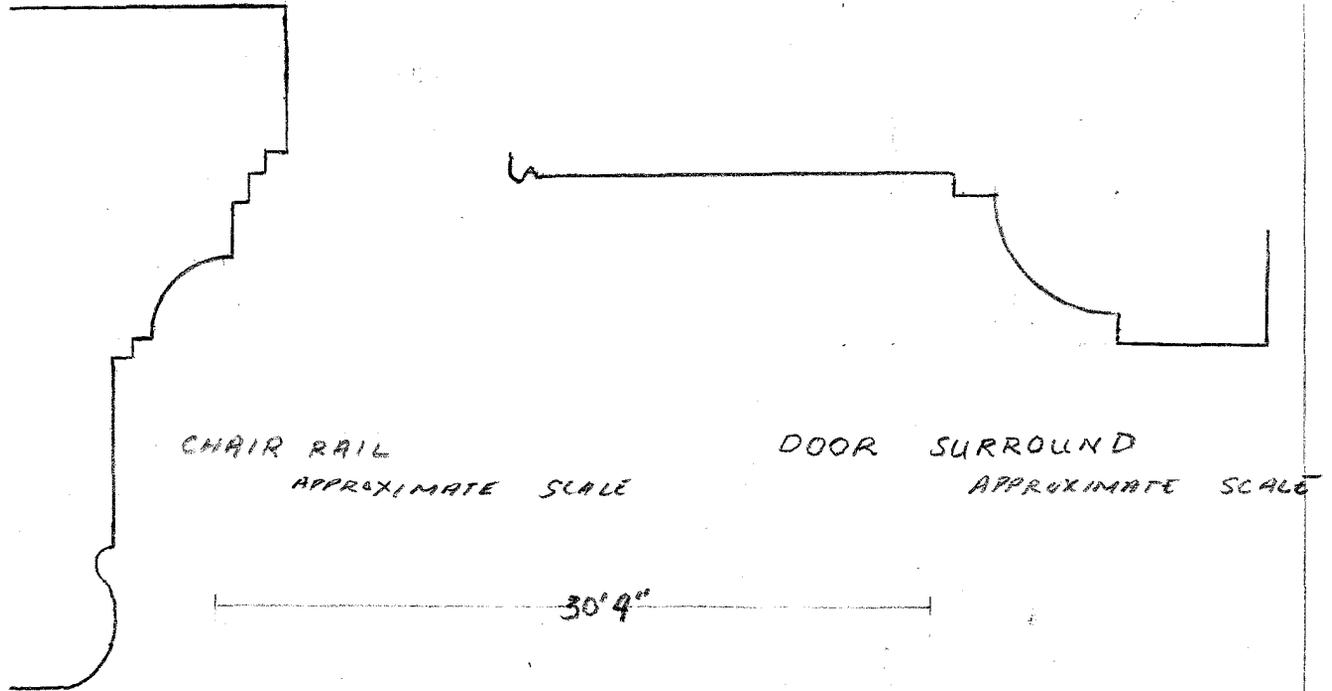
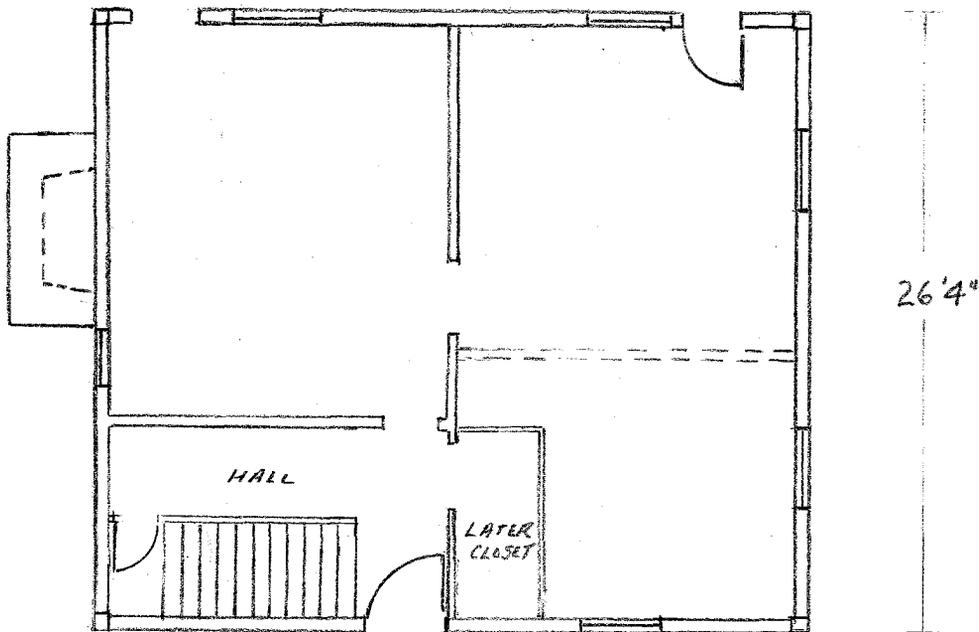
The interior is presently an arrangement of three rooms with the possible absence of one partition wall. (see floor plan) The dog-leg stairway is to the left of entrance along the east wall. The newel and balusters are later alterations. There is a raised six panel door to the inclosed cellar stair. The door surround is about five inches wide with an ovolo backband and a small bead on inside edge. The chair rail is found throughout the first floor. (see profile)

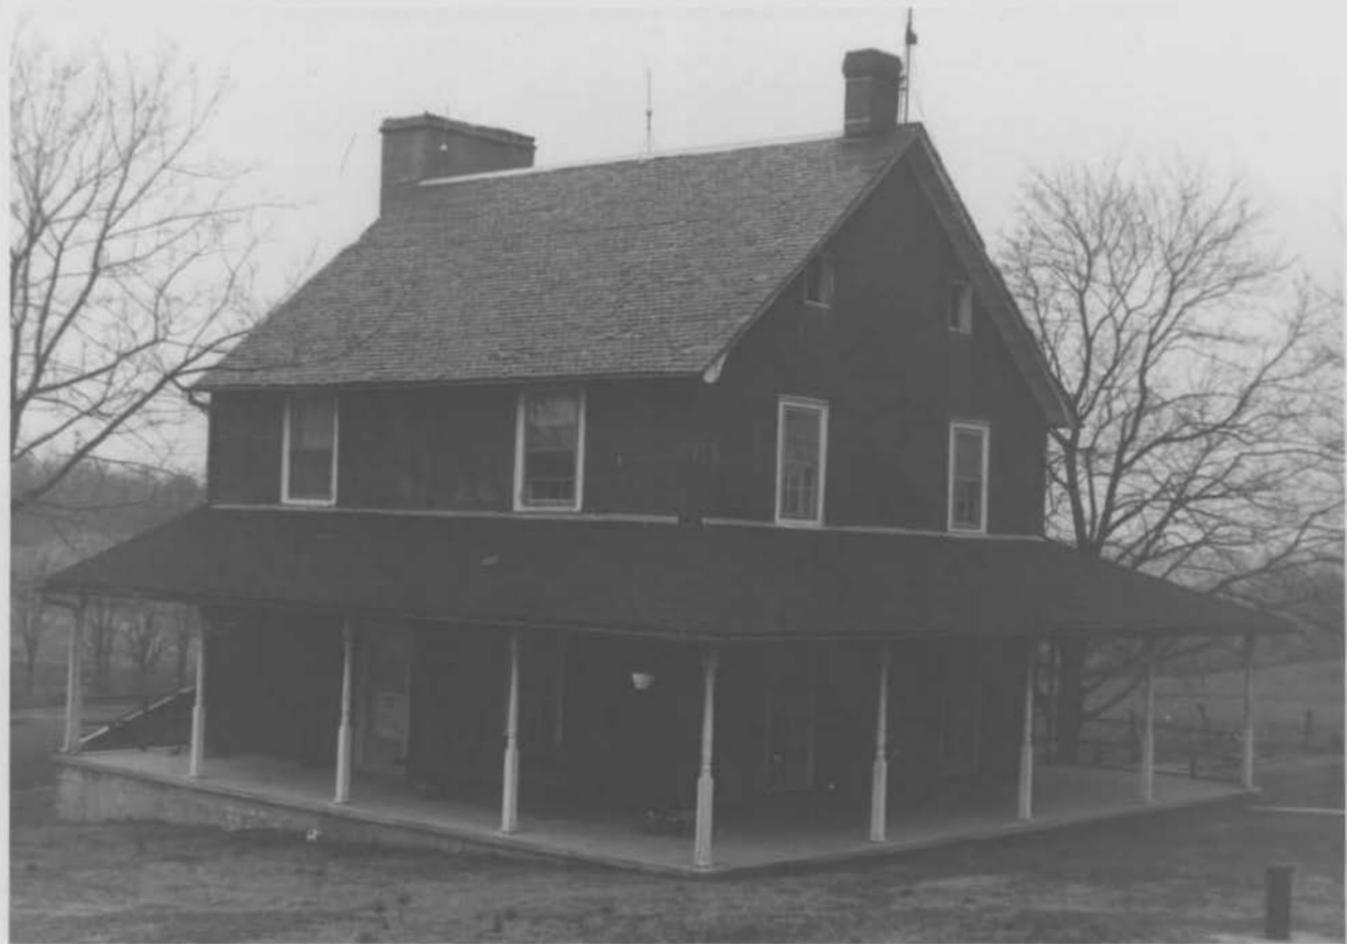
PEMBROKE FORM  
NORTHEAST ELEVATION  
PILOT TOWN, MD.

The east (main facade) is 2 bays across with the main door occupying the southern most bay. The main entrance has a 4 light transom over a six panel door. The other bay has a two over two late 19th century sash. The windows on the second floor are 6/6. There is no boxed cornice and the eaves are extended and open which would substantiate the fact that the roof covering was replaced at a much later date, probably when the slate was added. A late 19th century single story shed roof porch with turned supports extends across this facade along with the north and west.

The north gable end is two bays deep with 2/2 sash on the first floor and 6/6 on the second. Two small 4 pane attic windows flank the stretcher bond brick stack which was probably another late 19th century addition. The barge boards are slightly flared at the ends.

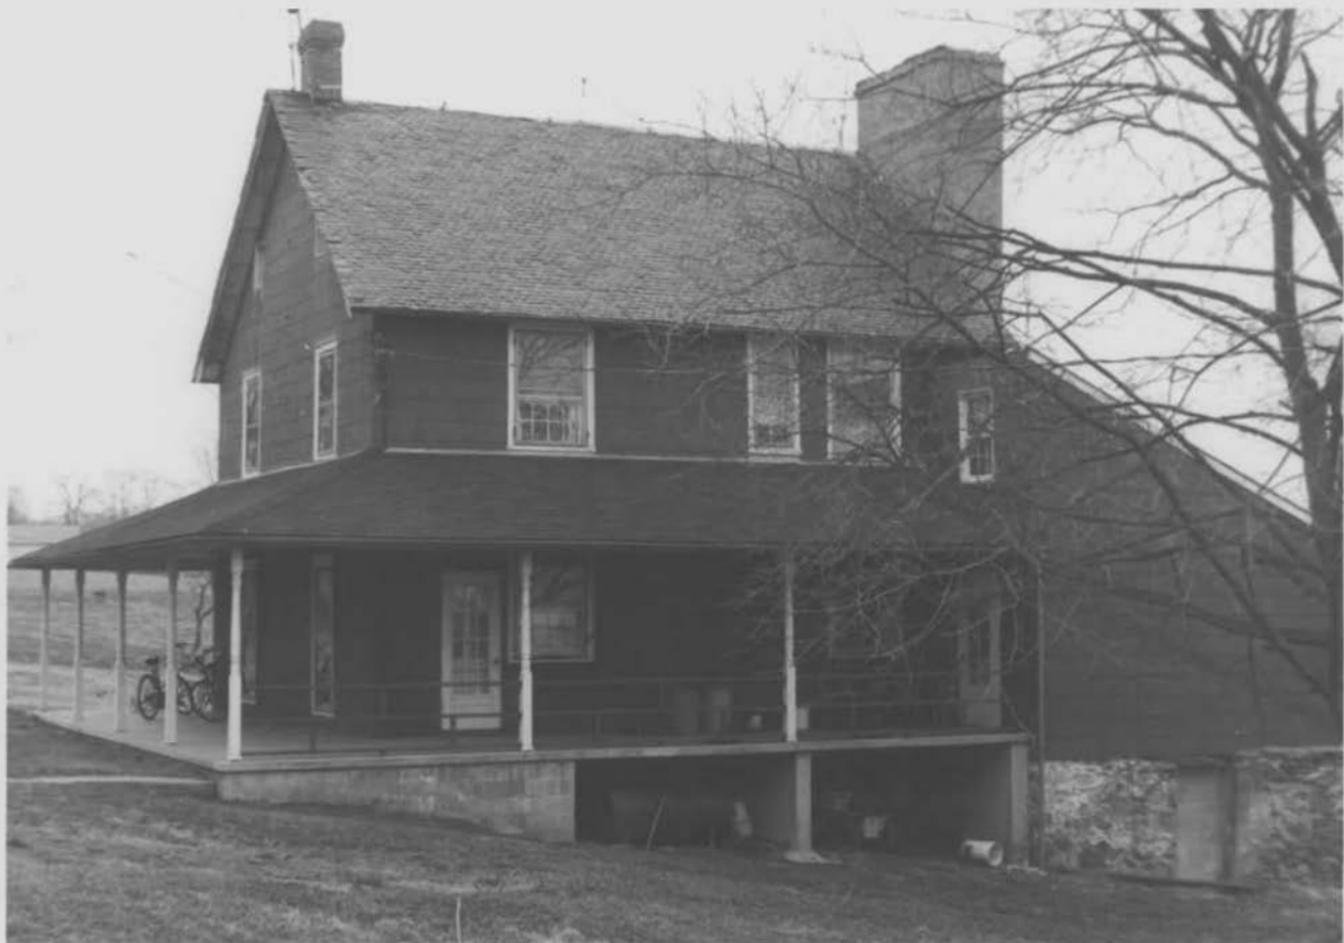
Penikese Island  
West Elevation  
Pilot Town, Md.

The west side is similar to the east except there are 12 over 6 sash windows on the first and second floor. A later door was cut through next to the northernmost bay. Since the house is located on a slope the basement is partially exposed on this side. An eight over eight sash illuminates the basement on this side. Located also on this corner of the house is a late 19th early 20th century story shed addition ~~and an exposed basement~~. There are six over six sash and an entrance on the west side of the house.
