CH-15 Sarum

Constructed
Spring-Summer, 1717
Shed added Fall-
Winter, 1736

NATIONAL REGISTER OF HISTORIC PLACES
INVENTORY - NOMINATION FORM

THE KEY-YEAR DENDROCHRONOLOGICAL
PATTERN FOR THE OAKS OF
MARYLAND'S WESTERN SHORE 1570-1980

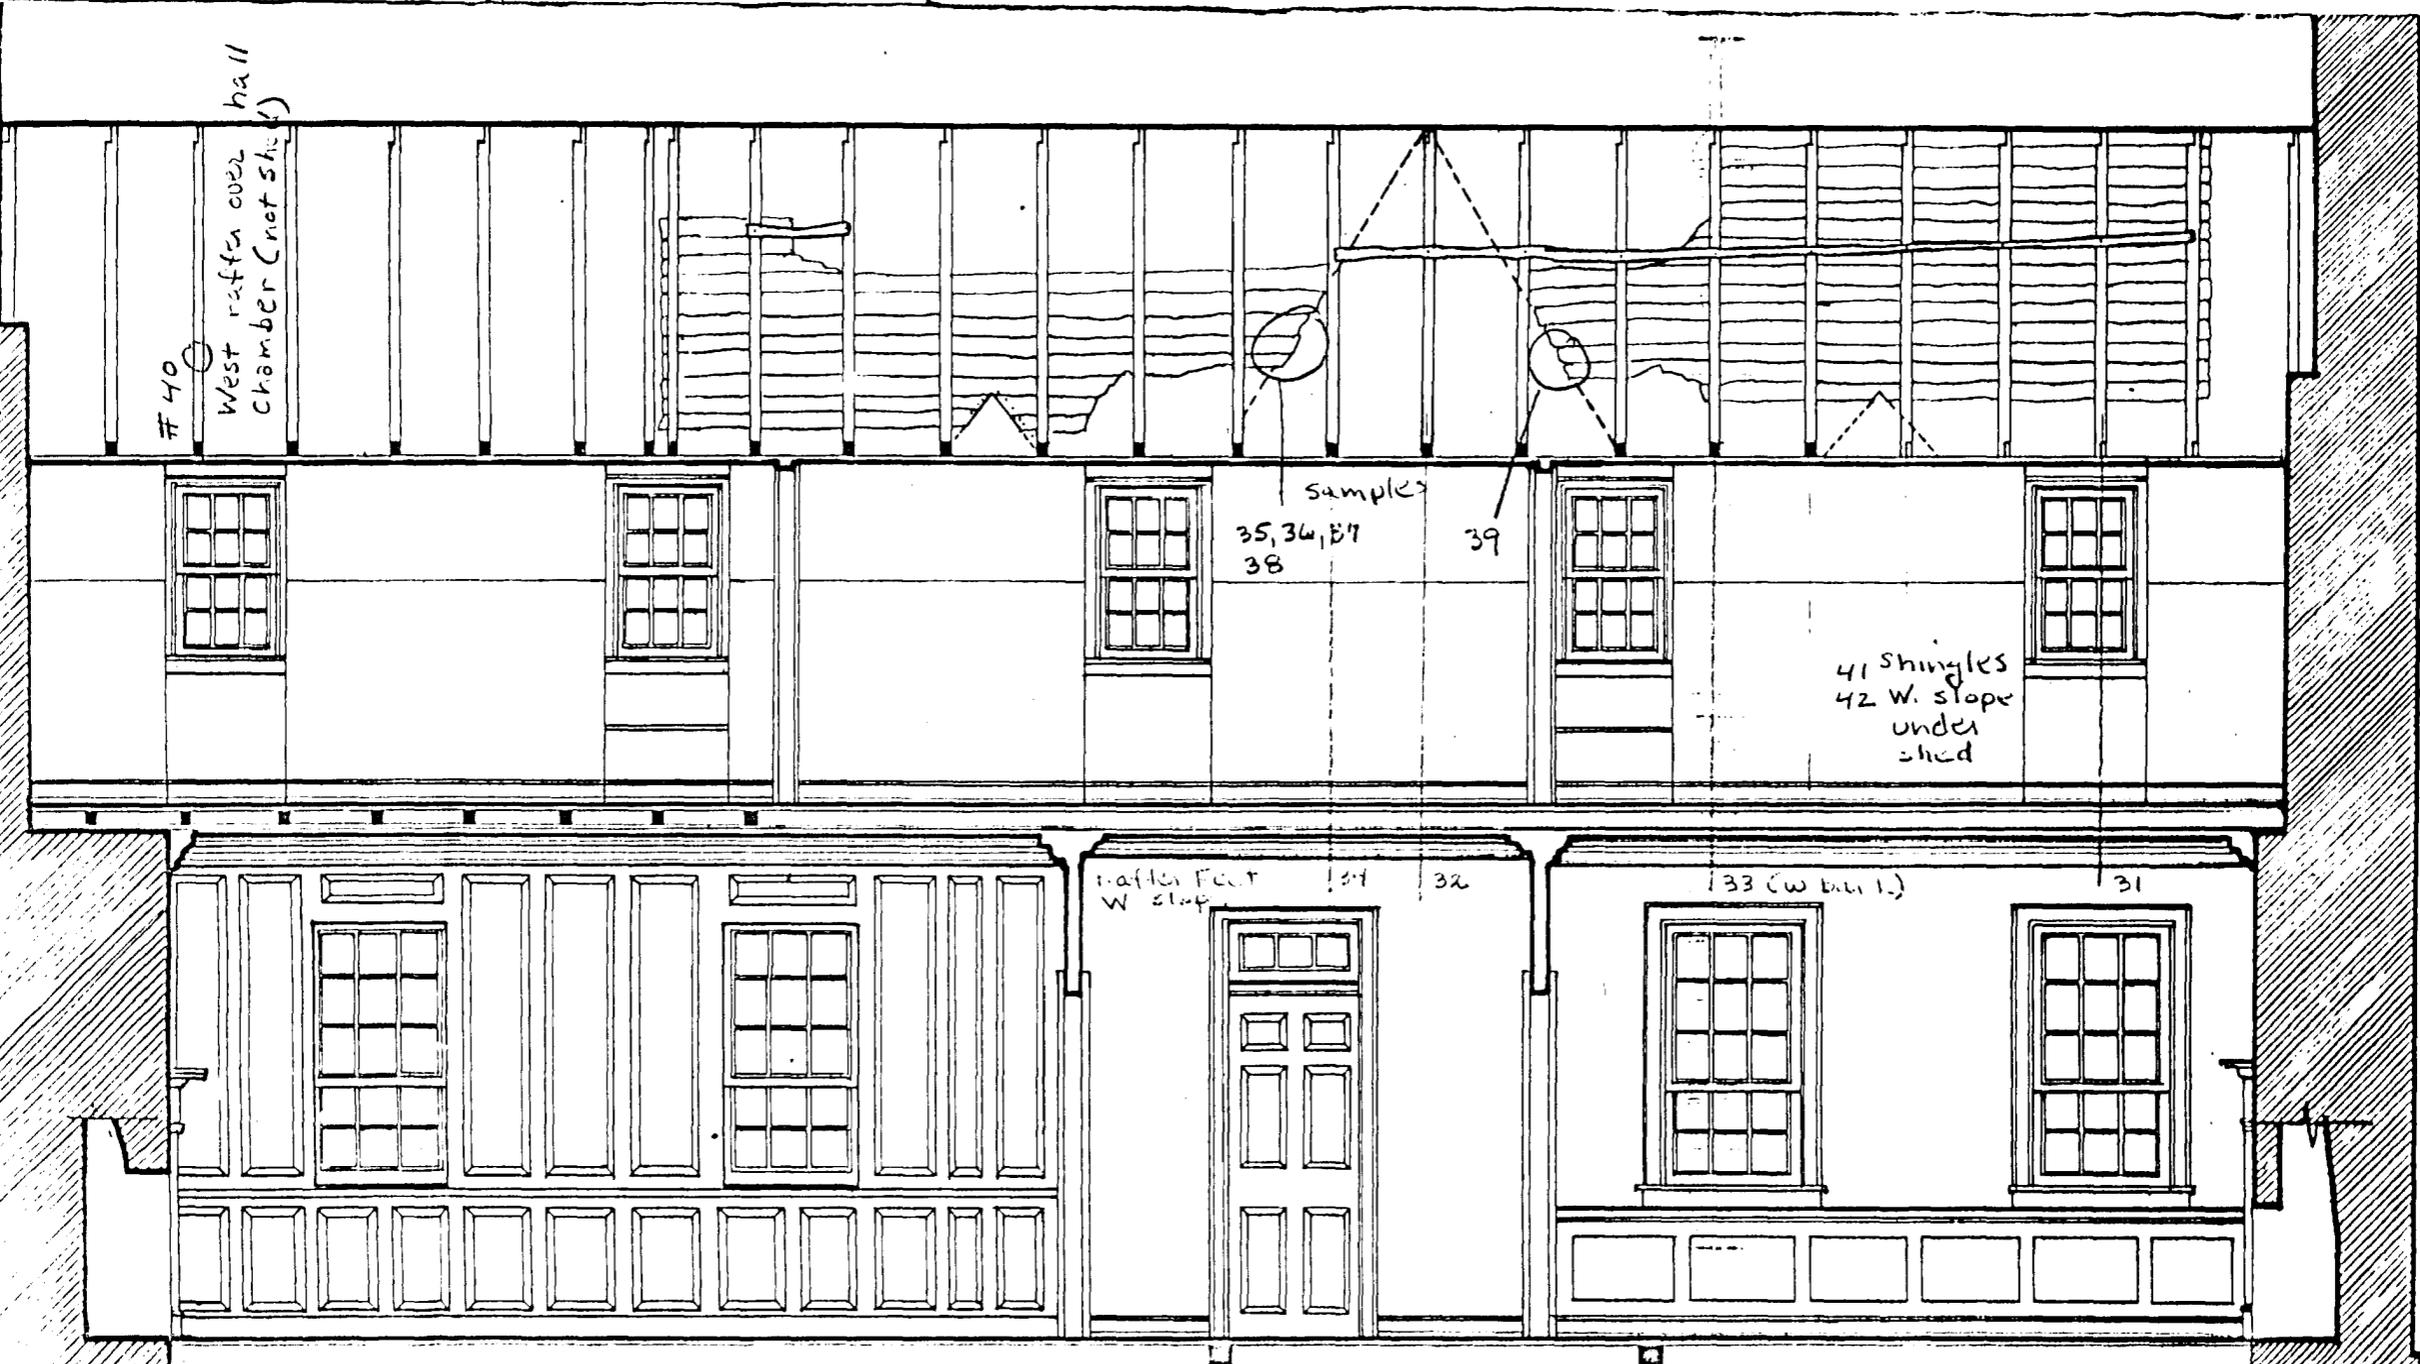
Samples 31-42 collected Dec 1980
 31-34 are feet of W rafters of original structure
 35-39 are clapped samples from E. slope
