NATIONAL REGISTER OF HISTORIC PLACES
INVENTORY - NOMINATION FORM

COMMON:
Maxwell Hall

CITY OR TOWN:
Patuxent City (Benedict vicinity)

FIELD NOTES: MAXWELL HALL, BY ORLANDO RIDOUT II

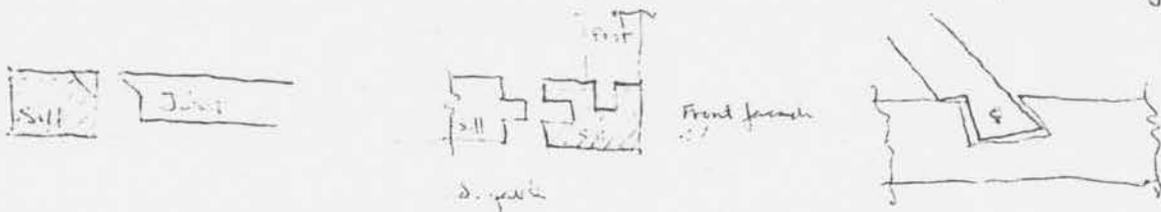
First floor

Framing - by corner posts, stop at 1st floor
top plate, same thickness as stone
w/ brace on gable wall, beam brace on
porch. See joint detail above.

Stones in + top and bottom

Joints deep notched through top plate,
in frame corners.

"Summer" runs down center of first floor,
joints are half-lapped then summer,
but do not run continuous.

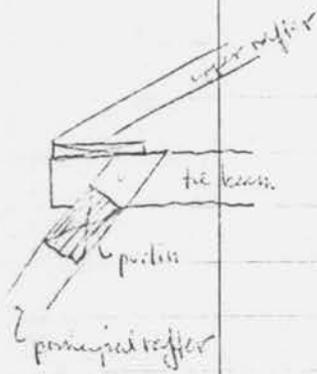
Very unusual roof framing. - Lower half of gabled framed up a series of heavy principal rafters and purlins ~~just below~~ curb saws.

Tie beams center into, joining principal rafters, secondary rafters into bottom edge of purlins, purlins into into principal rafters. Ceiling joists notched over purlins, support flat false plate. Principal rafters come up to bottom of false plate. Upper rafters rest on plate, all are same size, meet at ridge in intp. Collar beams are half lapped and not nailed. Reinforcing wind bracing not nailed to underside of upper rafters, single piece nailed to under side, parallel to ridge. Gable studs nailed and not nailed. 7 principal rafter pairs, on approx 6 foot span.

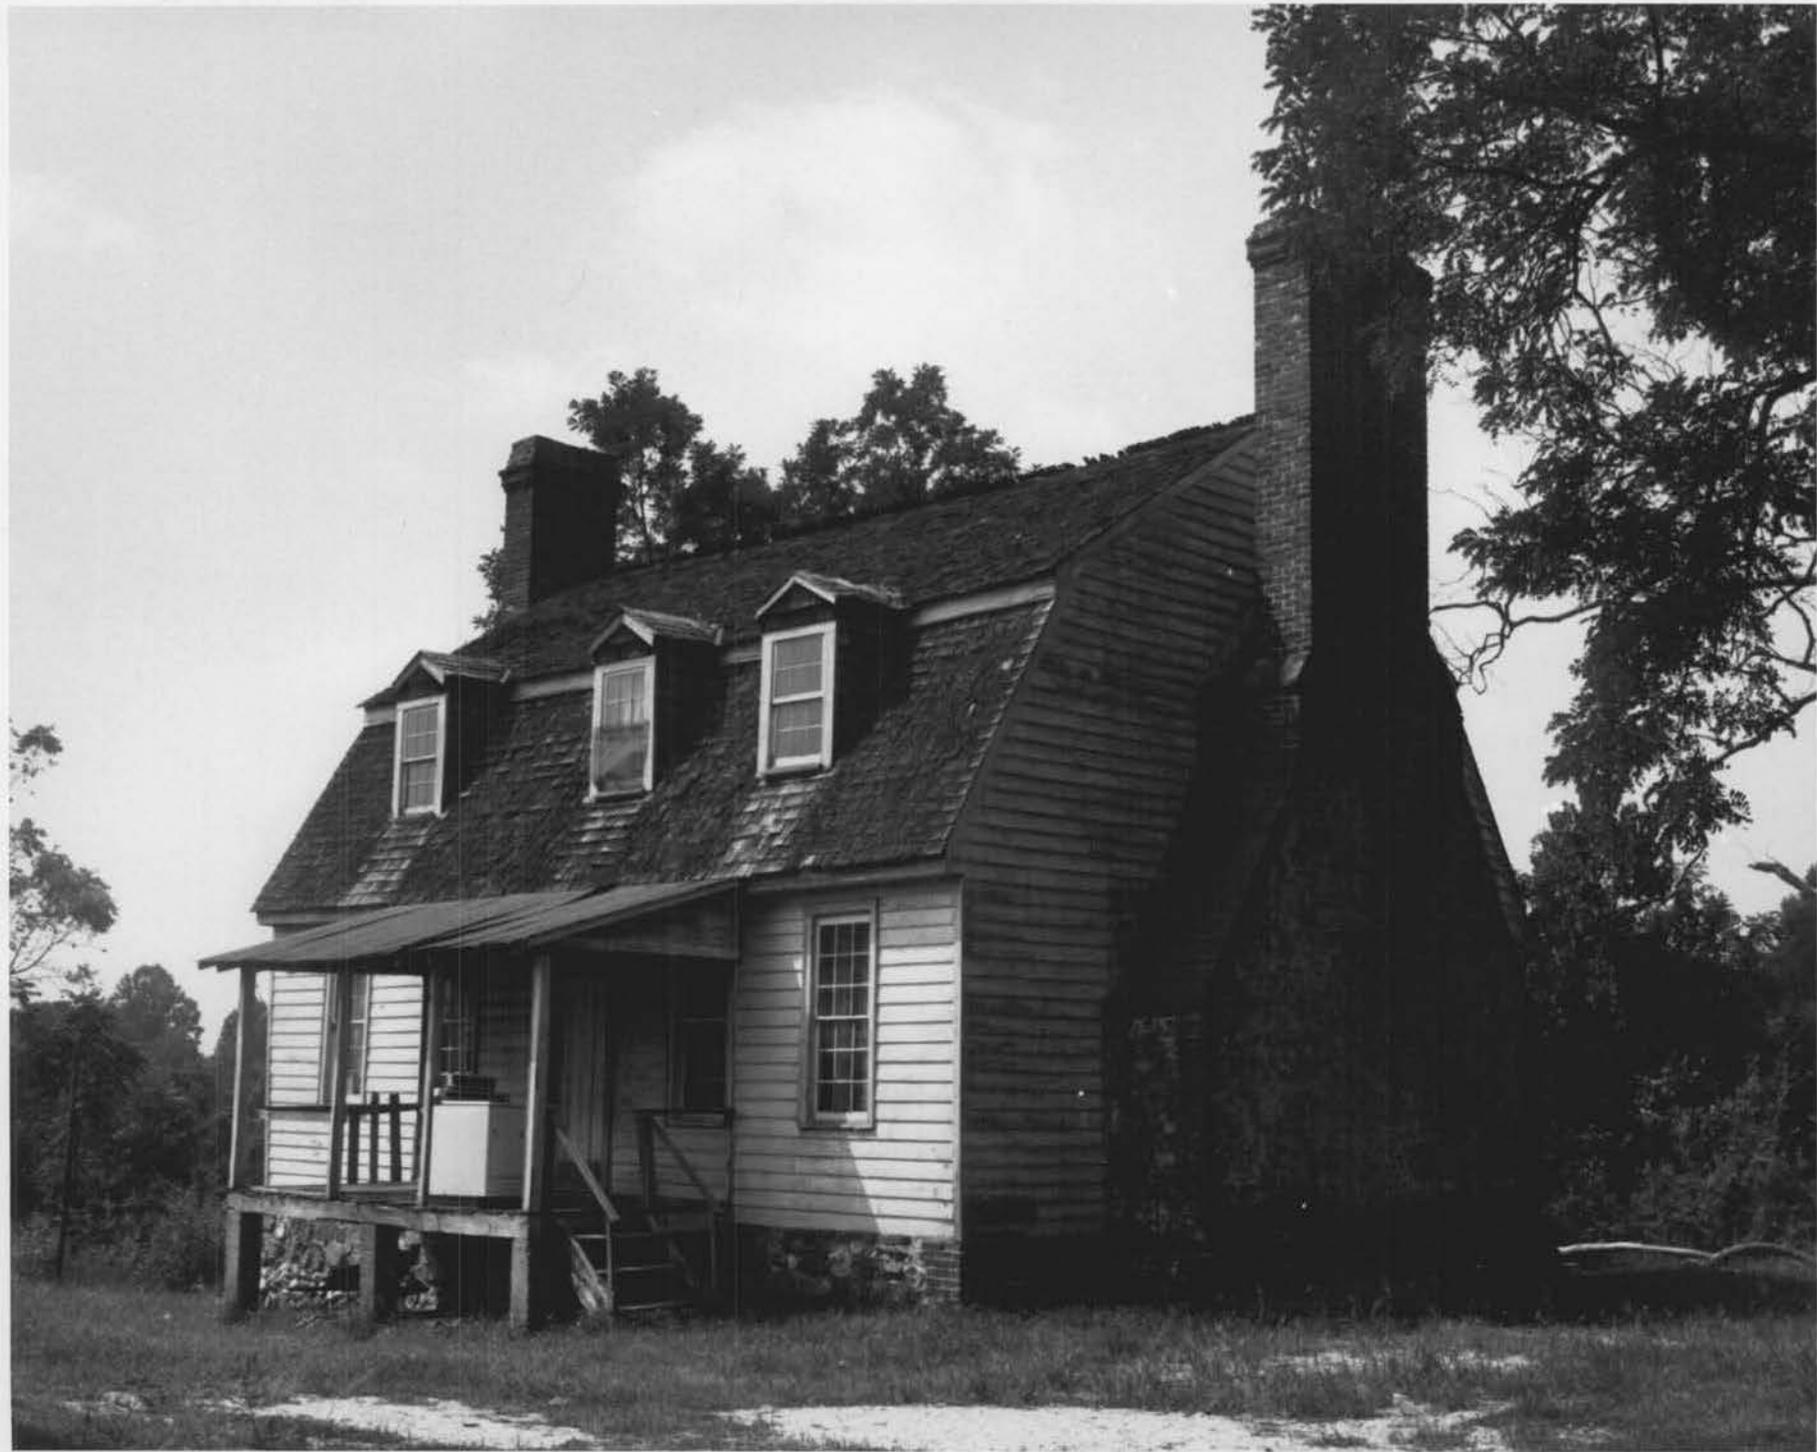
Maxwell Hall, char. Co., Md. / NE Ele. / JRCINORL, 12-72

The N. elevation, facade, is five bays in length. The centered door has panels matching the rear door. Both pair of flanking windows retain their 9/9 pane sash. At roof level are three irregularly spaced peaked dormer windows with 6/6 sash.

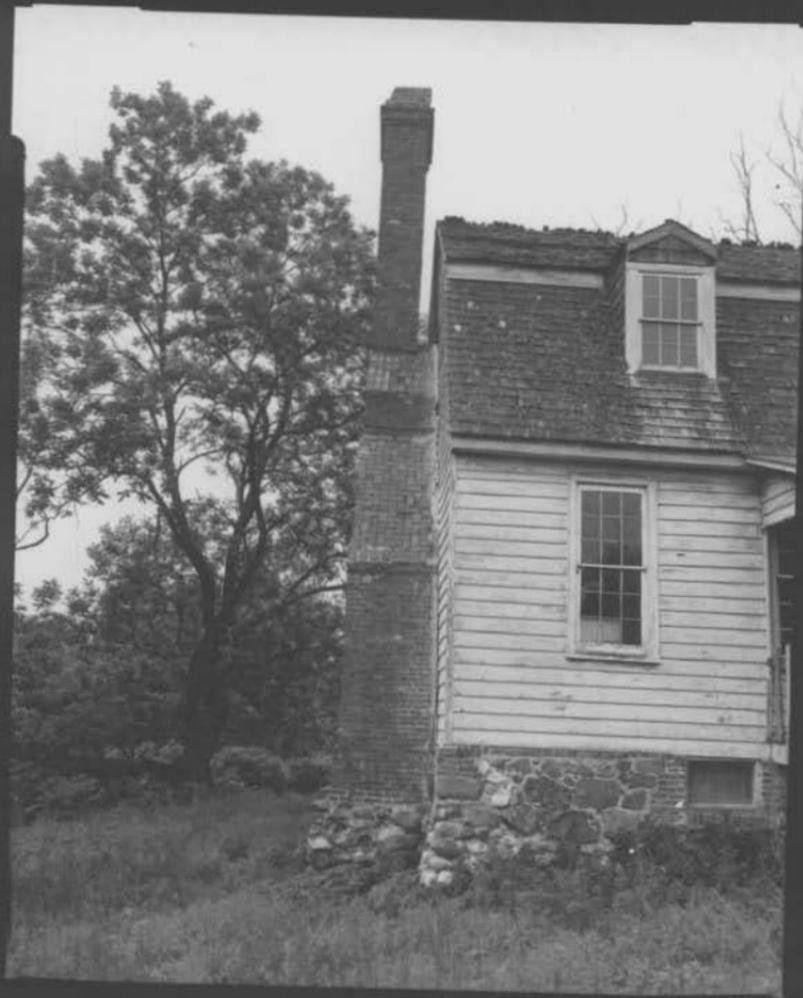
LS1

E. end chimney

At both the E. and W. elevations are single exterior chimneys of massive size. Both are almost exactly alike in design and each measures 18' 3" at the base. Both stacks are exceedingly wide but well balanced visually and stand approx. two feet away from the gables. One interesting feature is visible at the W. stack and that is a small bricked in closer window at the gable level. There is a variation in brick sizes and in the paving of the lower shelves. Both chimneys have a three to six course brick water table with a moulded

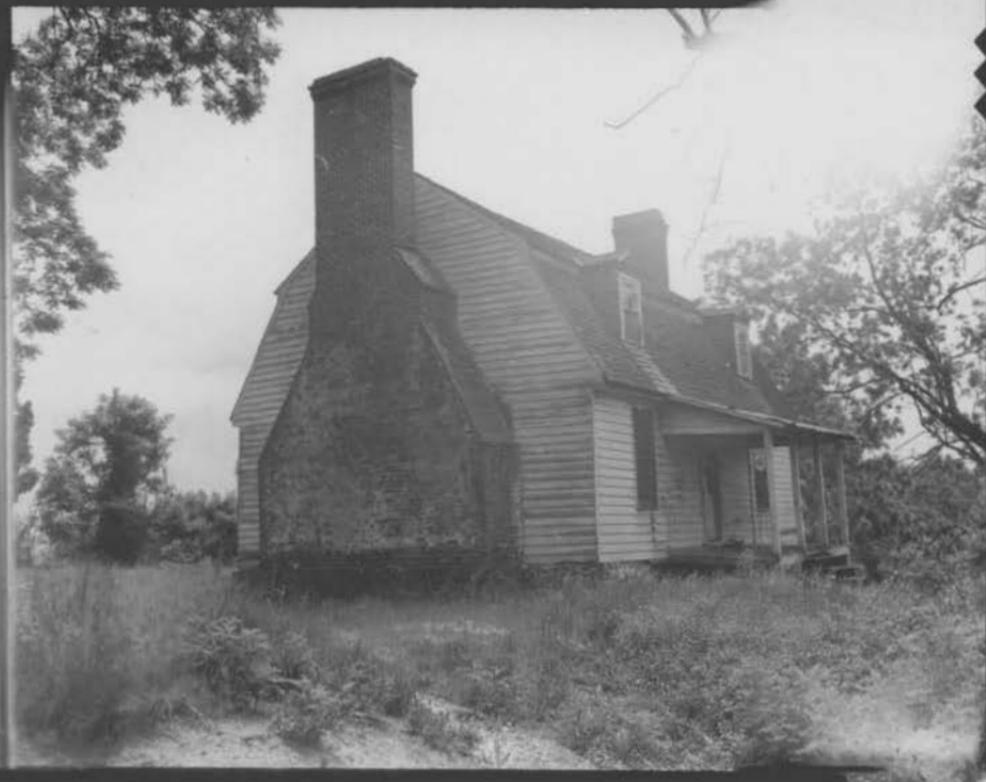
152

S. Ele.

On the approach side (S. Elevation, rear) the dwelling is three bays in length. The centered door is of two vertical flanking panels. To each side of the door is a single window possessing a 9/9 pane sash. Directly above are two peaked dormers spaced slightly toward center line. Each has windows of 6/6 pane sash. Beneath the small shed roofed porch at this elevation the only remaining portion of an early modification cornice is preserved. At the foot of the steps leading to the porch landing is a large flat gravestone of uncertain age since the inscription has been completely obliterated.

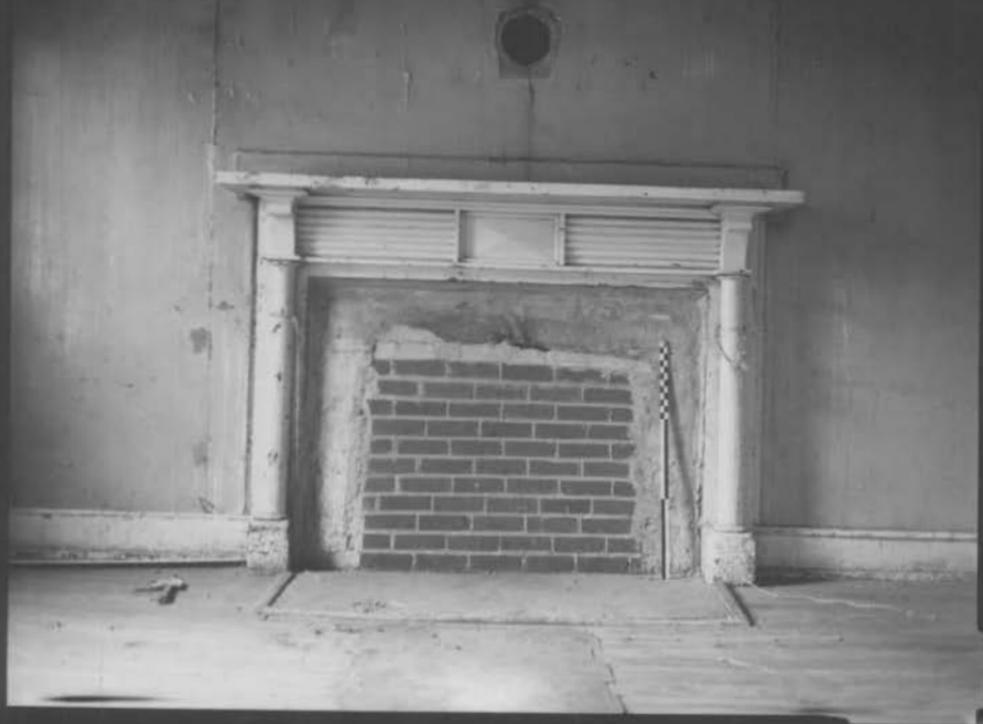
156

NE front room, 1st floor

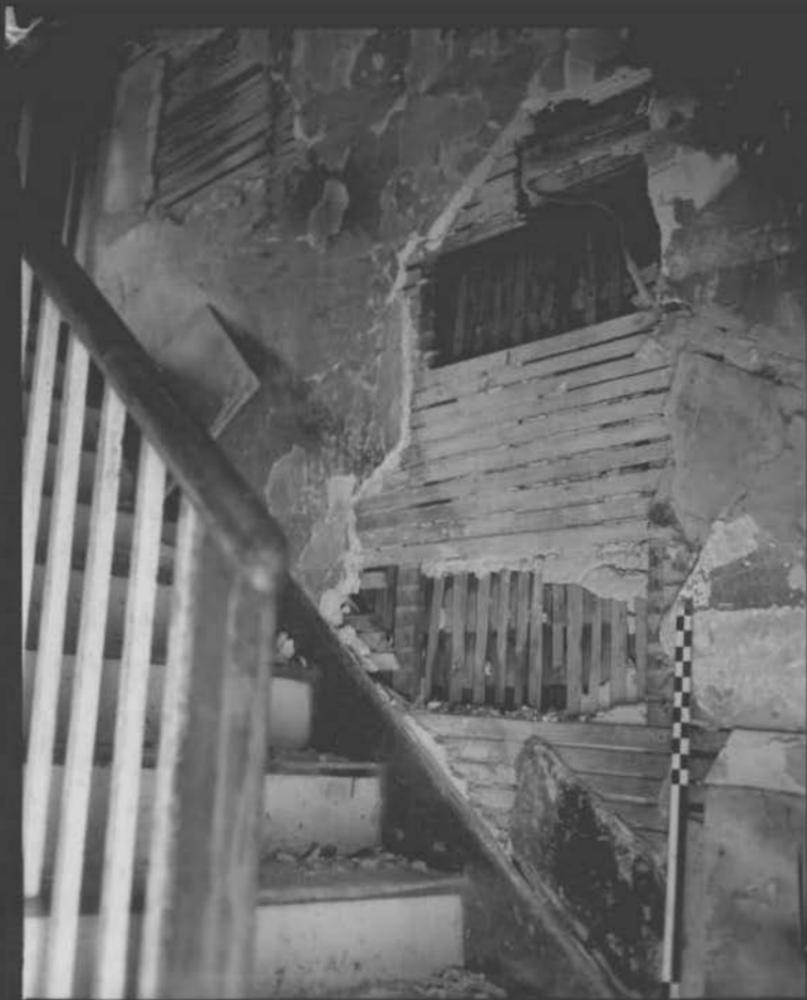
SSI

near stairs showing new
clapboard partition

One unique feature recorded at Maxwell Hall was the evidence of an original use of riven clapboards to sheath an interior partition wall. These clapboards, perfectly preserved under later layers of sawn lath and plaster, extend across the whole of the south wall of the hall. It is not known whether the clapboards extend (or extended) into any of the other rooms up above the first floor ceiling line but their existence alone is rare in houses of this otherwise relatively sophisticated plan. In Maryland, interior wall treatments such as this are more frequently found in more simpler houses and farm dependencies of the seventeenth, eighteenth, and occasionally the nineteenth century.

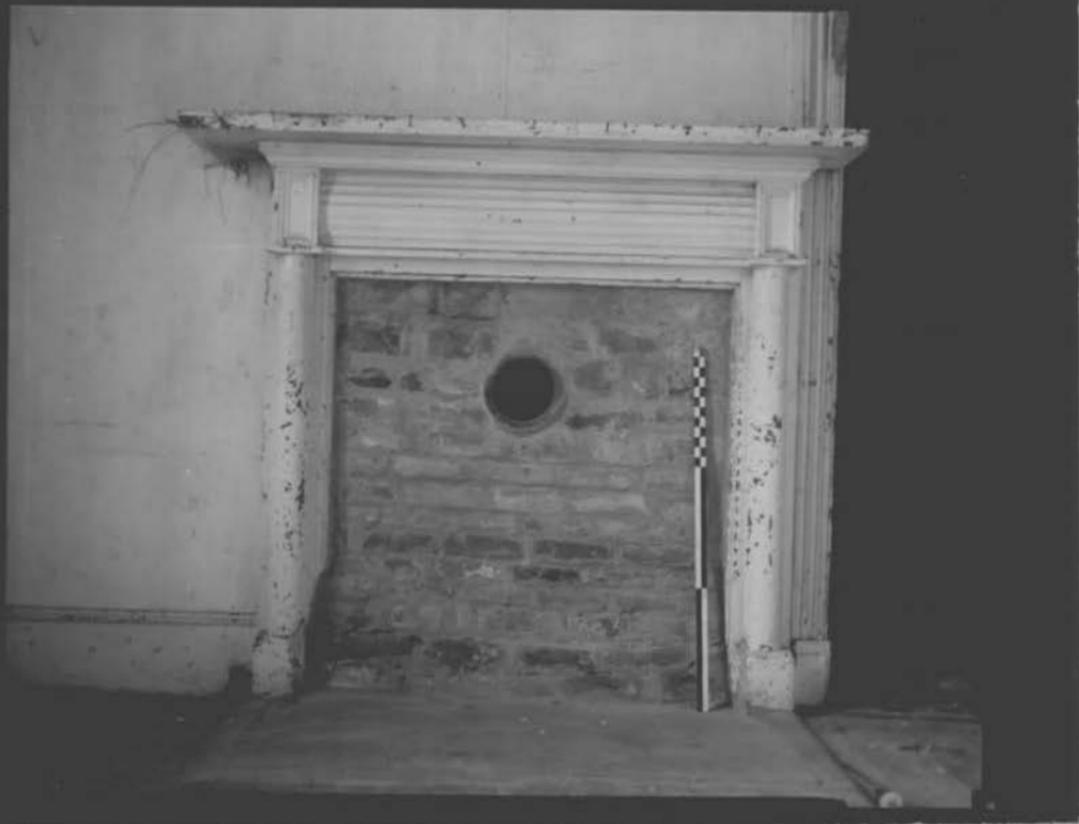
154

SW near roomy, 1st floor

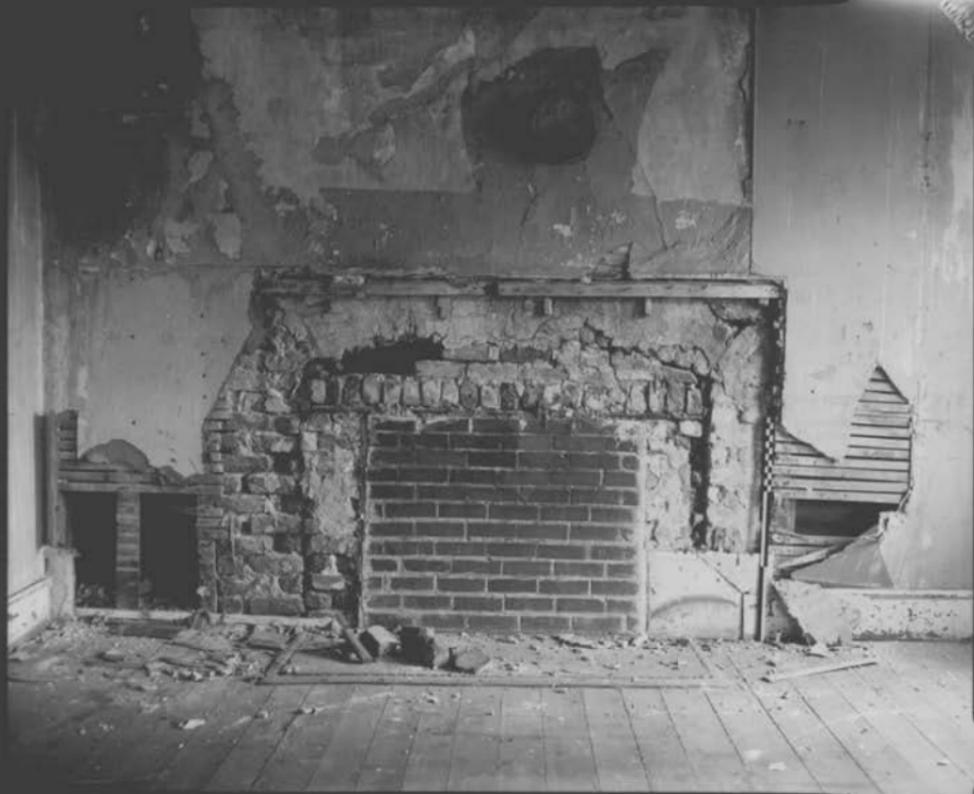
146

NW room, 1st. floor - w. wall

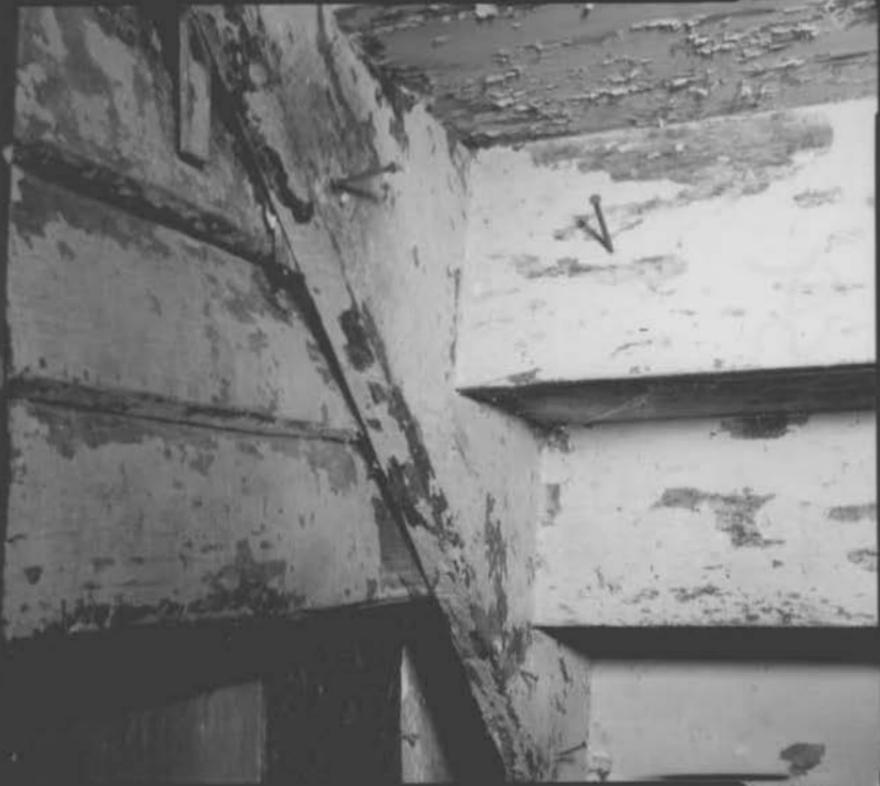
159

clapboard part. wall from stair
closet

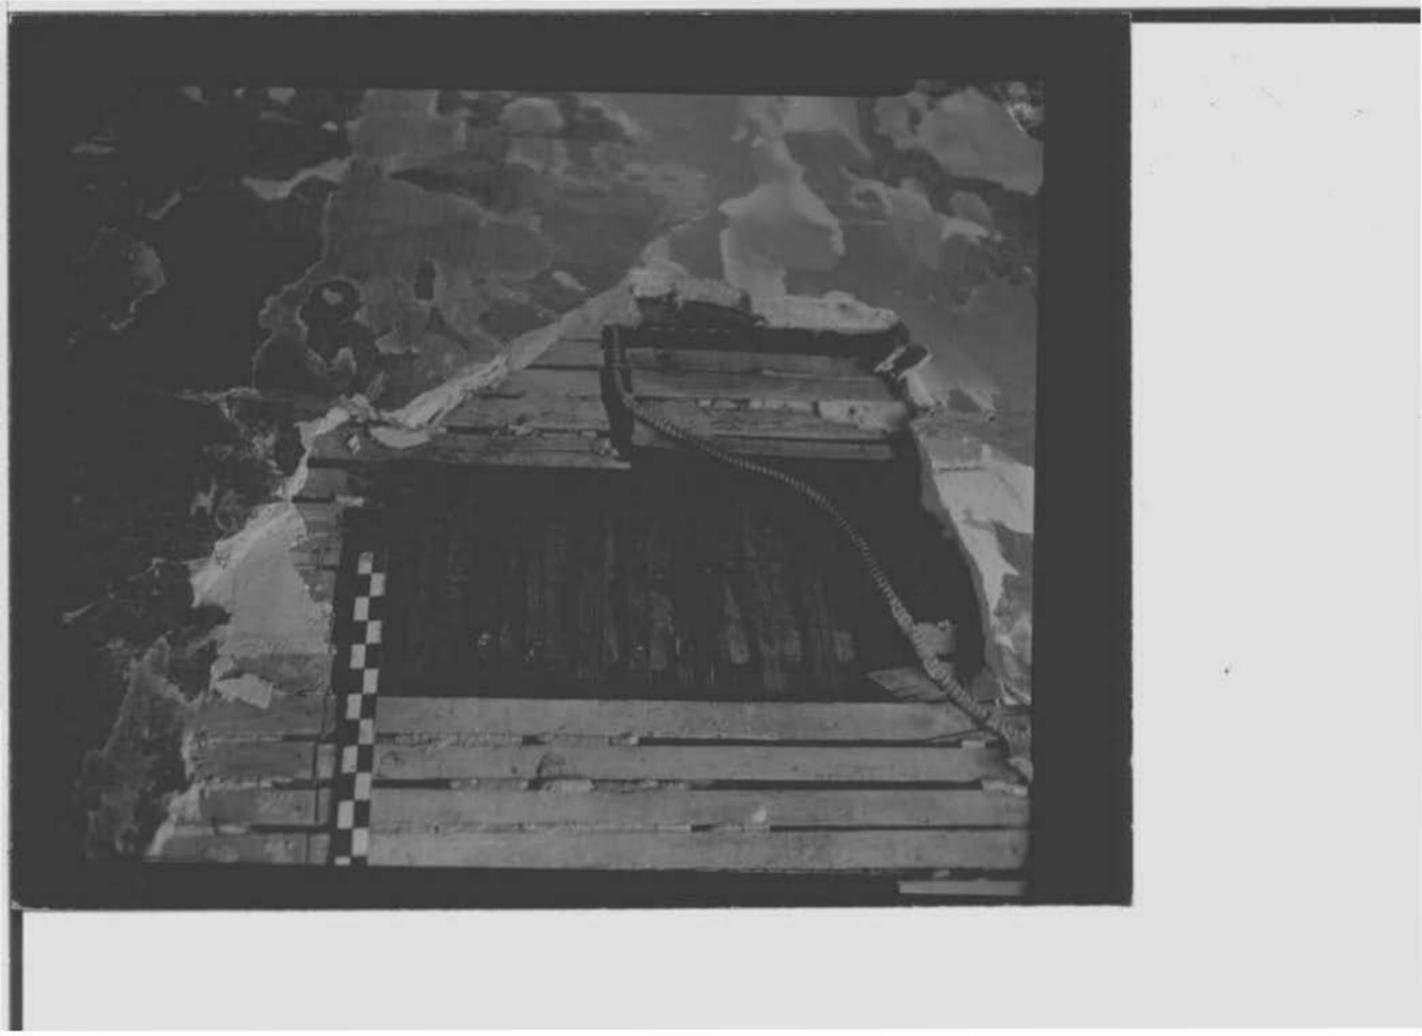
153

detail, seven clapboard part. wall
from 1st floor stairs

S wall of stair hall covered w/
seven clays, w/ wails. Then later (?)
in 18th c, run both sided on
ventrally w/ wails. Then
reworked w/ machine wails.
