## INVENTORY CAPTION : SLAVE HOUSE, CRAIN FARMS

CH-36D  
Mt. Victoria  
Private

INVENTORY FORM FOR STATE HISTORIC SITES SURVEY

**1 NAME**  
 HISTORIC SLAVE HOUSE, CRAIN FARMS  
 AND/OR COMMON "Mt. Victoria" or "Strawberry Vale"

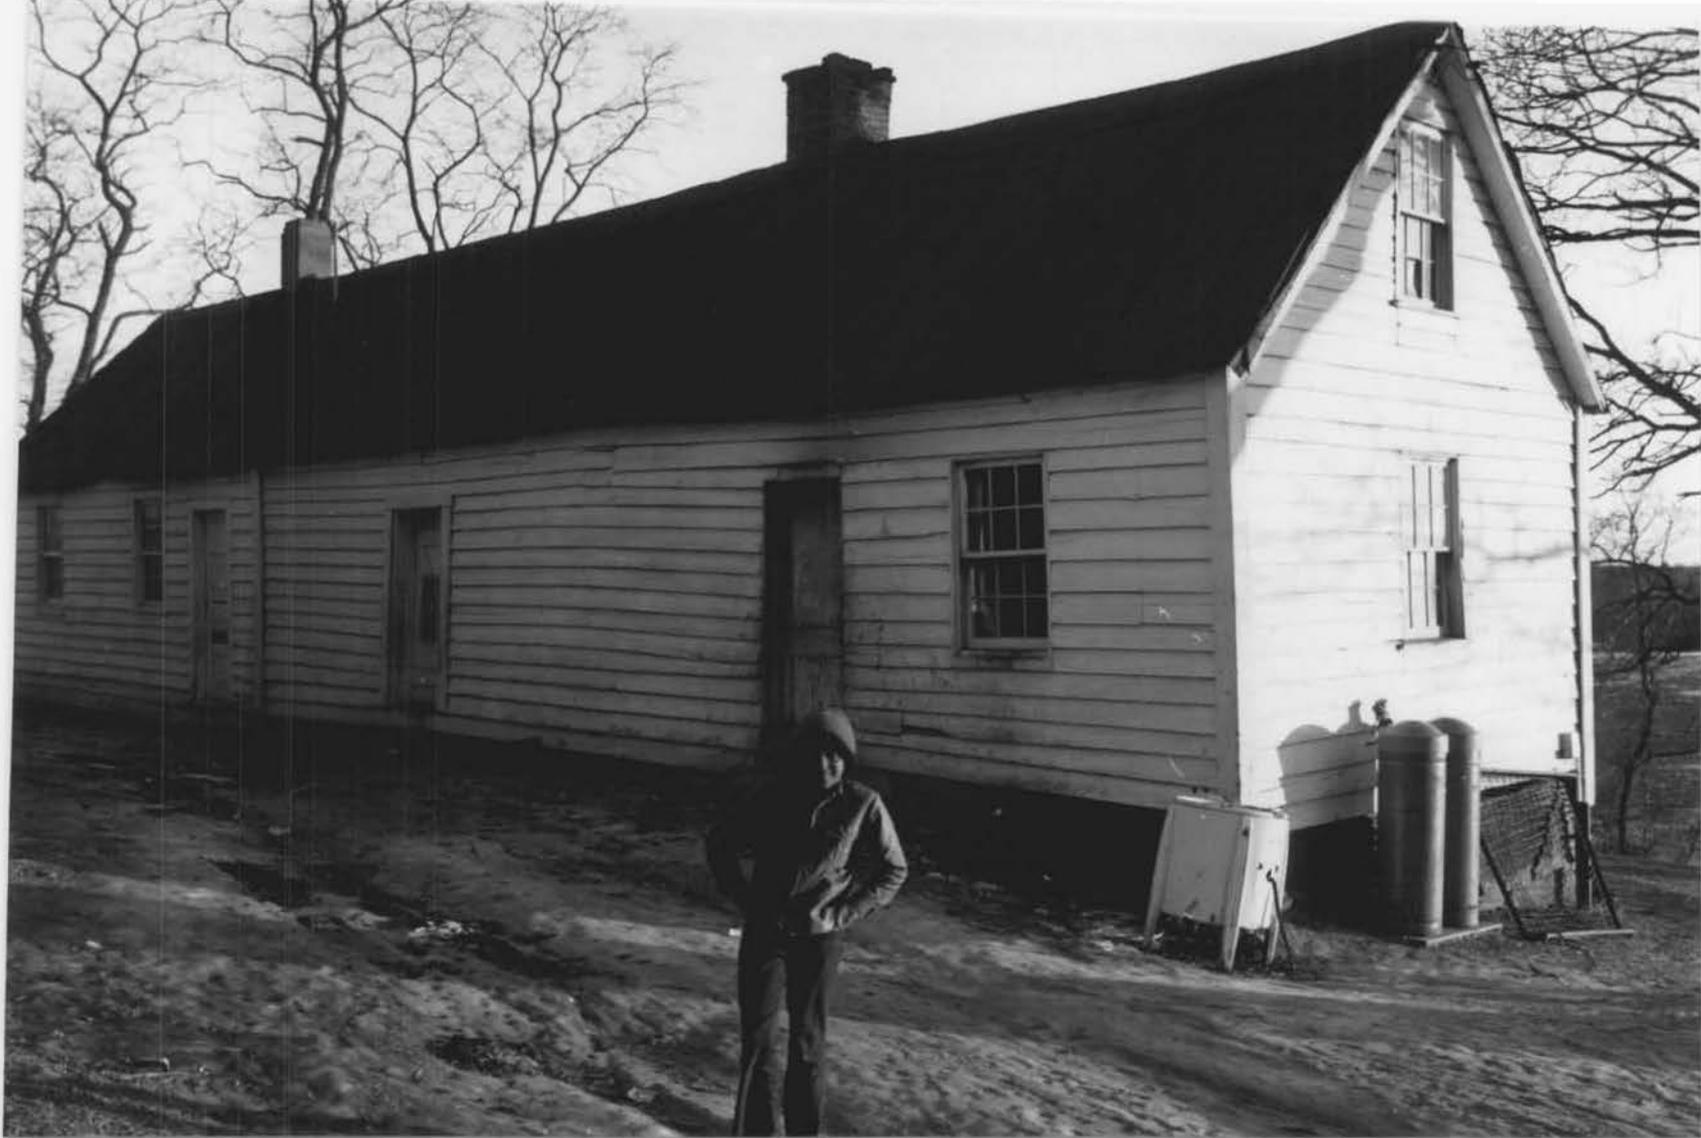
CH 36 D  
Slave house, Crain farms  
Mt. Victoria, Md.  
North elevation  
GWM  
2-77

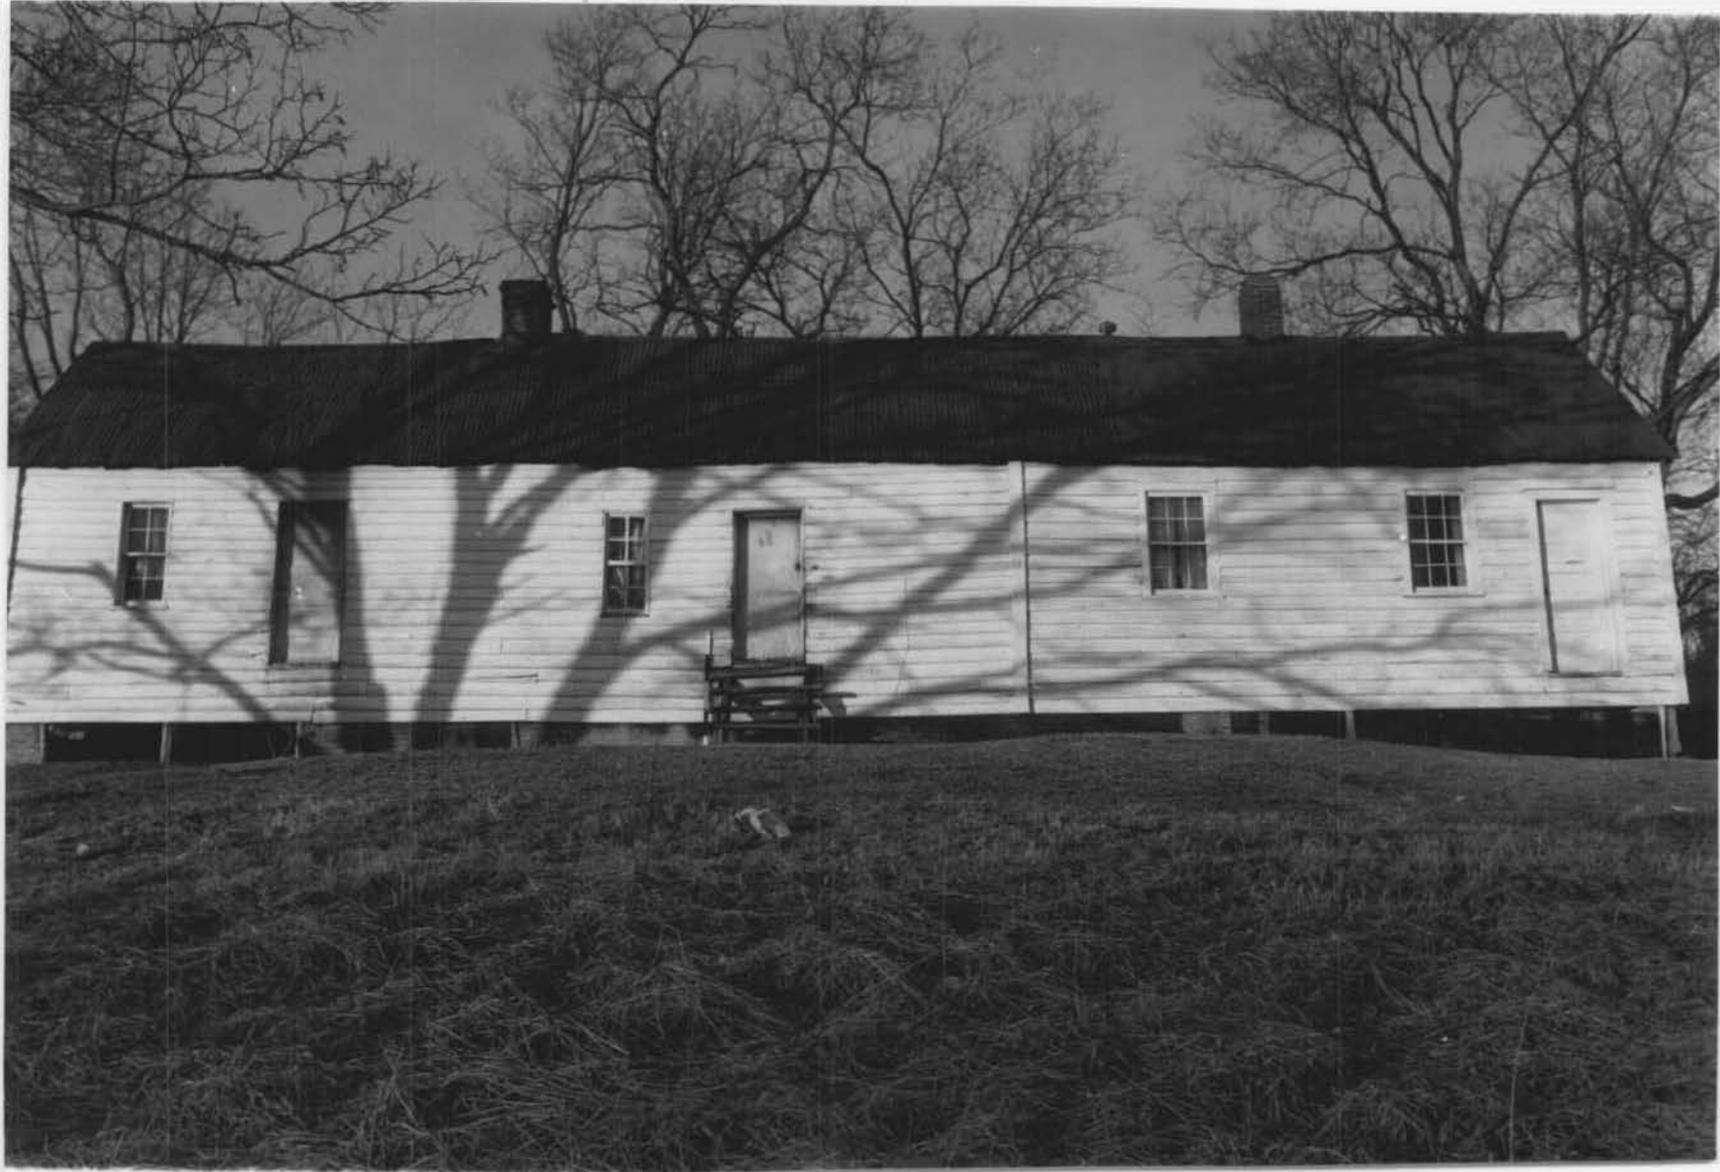
The house consists of three sections, the middle one being the original log house to which two frame additions have been built at different times. The facade of the log block consists of two bays, a door and a small window. It is one bay in depth, and the back length contains only a door, located opposite the front one. The facade has no porch. Steep stairs lead up to the house, for the house is raised rather high above the ground on brick pilings. Corrugated tin insulates the space underneath the house. The log walls are sheathed with white weatherboards that are not original and that cover the corners, so that the notching used in the corners could not be seen. In the window is a double hung sash frame with 2x2 lights. Originally the roof was covered with wood shingles but now with tin, painted red. The eaves are not boxed; the rafters abutt onto a false plate and do not overhang the walls. The gable cornices are enclosed with plain, narrow planks. The structural system of the roof was masked by the ceiling in the upstairs. A large brick chimney supported by a stone foundation ascended the exterior of the west gable end, but has now been enclosed by the frame kitchen.

CH 36 D  
Slave house, Crain farms  
Mt. Victoria, Md.  
Facade, south view  
GWM  
2-77
