SOCIETY HILL (Frailty; Walnut Hill)

INVENTORY FORM FOR STATE HISTORIC SITES SURVEY PAGE # 090375204

Continuation of #7 (Description)--SOCIETY HILL

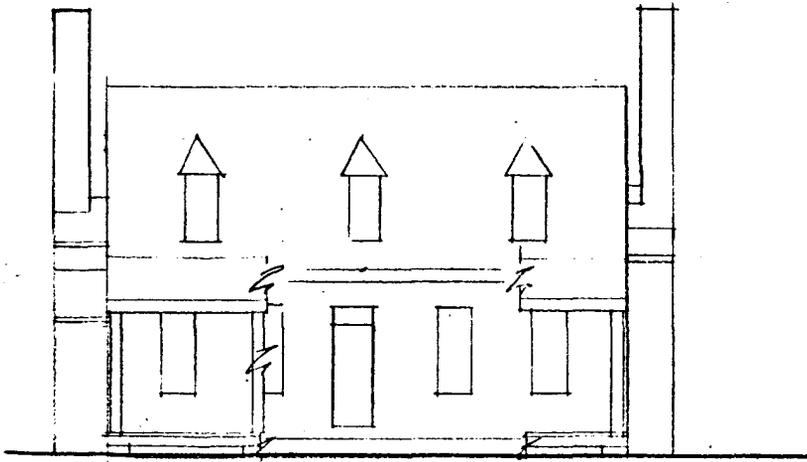
N. EAST FRONT

Believed to have been built circa 1700-1730, the house began as a one and one-half story structure with a steeply pitched dormered roof. The east front was five bays in width, having a centered entrance door with transome flanked by two windows on each side. The west side was evidently four bays wide, having two transomed doors, one occupying the first bay from the northwest end and the other a near central position, a window between them and a second window toward the south end. At each end of the house stood a single exterior chimney, the one at the south end being very broad at the base and rising in two graduated tiers to the attic gable where it continued up in the form of a wide, free-standing stack. A narrow arched doorway in the chimney base presumably led to a detached kitchen dependency.

"SOCIETY HILL"
 SKETCH PLANS OF EXTERIOR
 ELEVATIONS SHOWING
 CONJECTURED APPEARANCE
 OF HOUSE IN THE 18TH CENTURY.
NOT TO SCALE

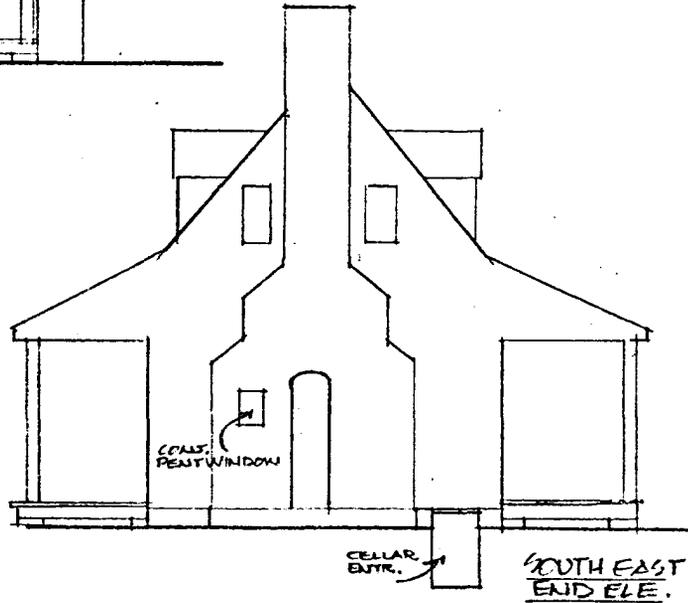
SOUTH EAST
 END ELE.

There is, at the north end, a single exterior chimney with free standing stack. The chimney is positioned off center to the roof ridge. At the south end are two chimneys of rather unique design~~ed~~. Joined at the base the chimneys differ in size, the chimney to the east being double hipped while the one to the west, ^{is} somewhat smaller. There is a vaulted passage the depth of the ^{1st} chimney ~~and the width and height not much larger than a standard door~~. ^{POSITIONED SLIGHTLY OFF CENTER LINE AT THE 1st FLOOR LEVEL} Where the chimneys join is another door with a flat arch. One of these doors leads into what is called the "dining room" (that room which projects onto the west porch) and the other door leads into the southeast front room. It is known that there was an outside (detached) kitchen from the south end of the house which ~~was destroyed~~ ^{WAS DESTROYED} sometime during the early years of this century. A photograph of these chimneys, minus the present wing which hides this unusual feature, can be found in H. C. Forman's "Early Manor and Plantation Houses of Maryland."

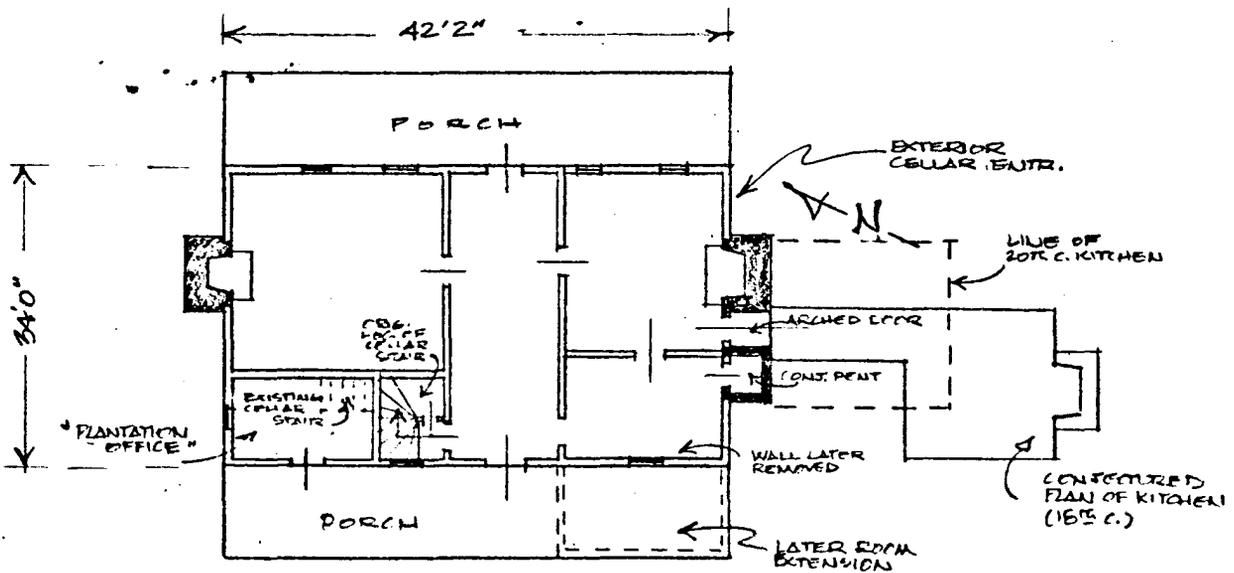
FIRST FLOOR PLAN (18TH C.)
 J. RICHARD RIVCIRE, 1978

It is possible that the existing center hall plan of Society Hill is original. However, the extensive later alterations could have included a change in the initial room configuration. Since center hall plans were not widely used in the region at the time Society Hill is believed to have been built, it is not inconceivable that the original plan followed the then regionally popular arrangement of two large front rooms with two small rear rooms and a centered rear stair hall. This plan, prevalent from the end of the seventeenth century through to the third quarter of the eighteenth century, was often later altered to the center hall plan by installing a partition wall in the largest of the two front rooms. One of the best area examples of this conversion is River View (circa 1730; NR) in St. Mary's County. Of the existing rooms only the large "closet" enclosing the main stair is known to be unaltered. Although the stair itself was rebuilt following an apparent fire its configuration, consisting of broad, steeply winding steps, repeated that of its predecessor. A second stair of similar plan was located beneath the main stair but was later removed and relocated. An unusual and possibly original feature of the existing first floor plan is the small northwest room which is only accessible from the exterior and is believed to have initially served as the plantation office. There is a complete lack of information regarding the original attic plan. Since this area was confined to the interior dimensions of the roof, it probably contained only two or three small bedrooms. The present second floor plan includes four bedrooms as well as a small room at the front of the stair hall that has been converted for use as a bathroom. Two of the bedrooms have fireplaces framed by late eighteenth-early nineteenth century mantels.

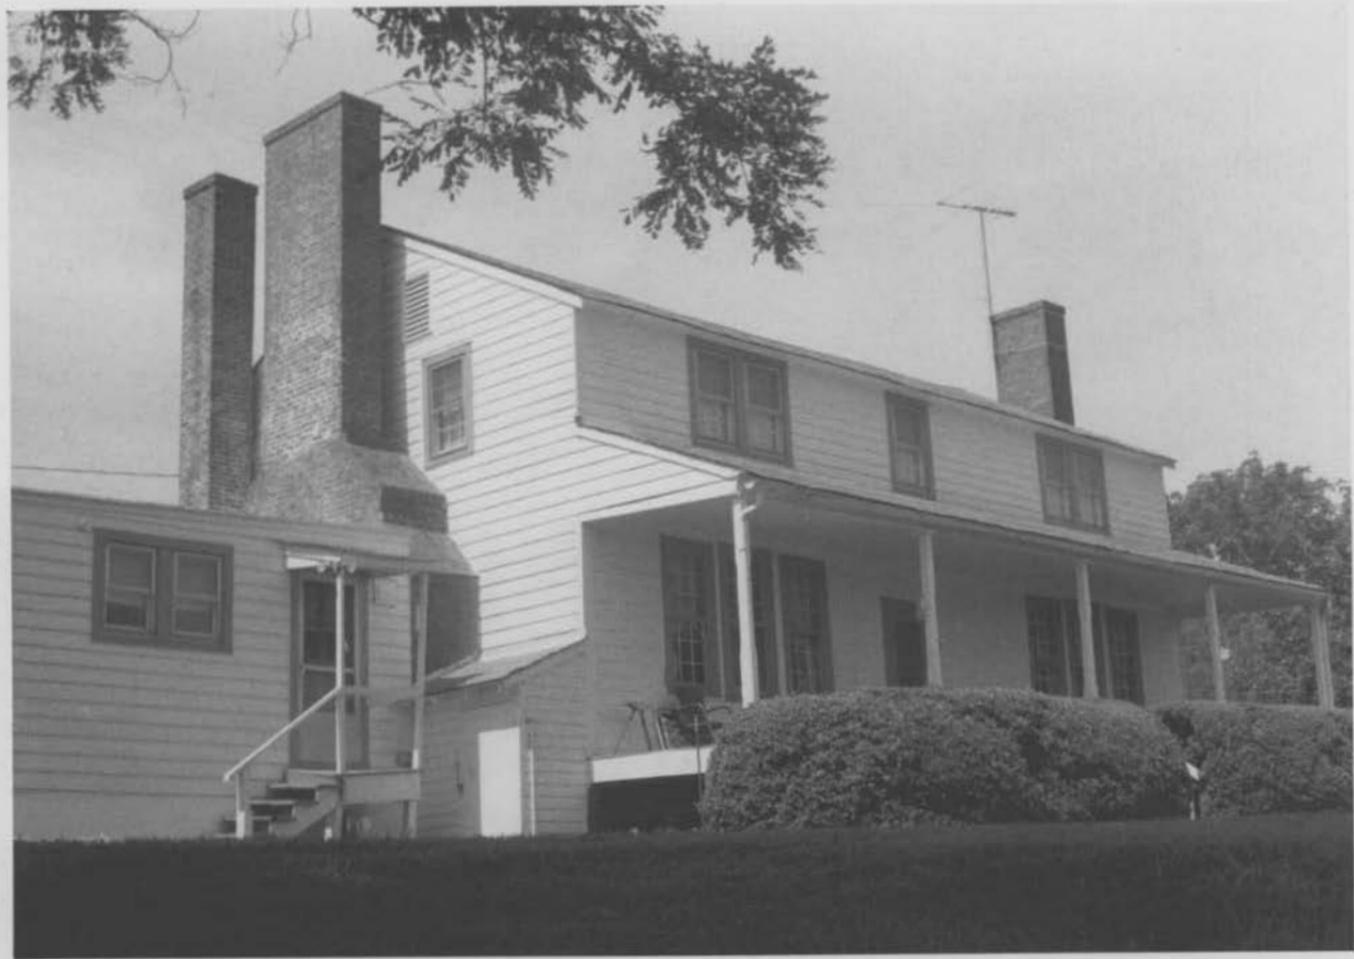
CHAS-37
SOCIETY HILL; East Front.
J.R.Rivoire, 1978

It is believed that Society Hill retained its early nineteenth century appearance until the 1940's when it again experienced several alterations. It was at this time that the two pairs of windows flanking the front (east) door were altered to their present triple unit design by the insertion of a third window between them having the same basic detail and sash. Additional windows were also installed across the second floor of both side elevations, creating three bays of two windows each. The west window of the west porch was also similarly enlarged. It was also about this time that a substantial portion of the interior woodwork was replaced, the main stair rebuilt and the cellar stair relocated. Most of the framing of the two porches was also replaced and a modest shed roofed kitchen built on the site of the former kitchen-service wing.

On the first level front the house has triple windows one set to each side of the center door. All windows at this level are nine over nine sash. At the second floor level are two sets of double windows ~~at~~ one at either end and a single window at the center.
