## Photo Log

CH-425, The Caroline Christ Farm, aka The Herbert Farm-  
7761 Leonardtown Road, Hughesville,  
Charles County, MD, 20637-3011

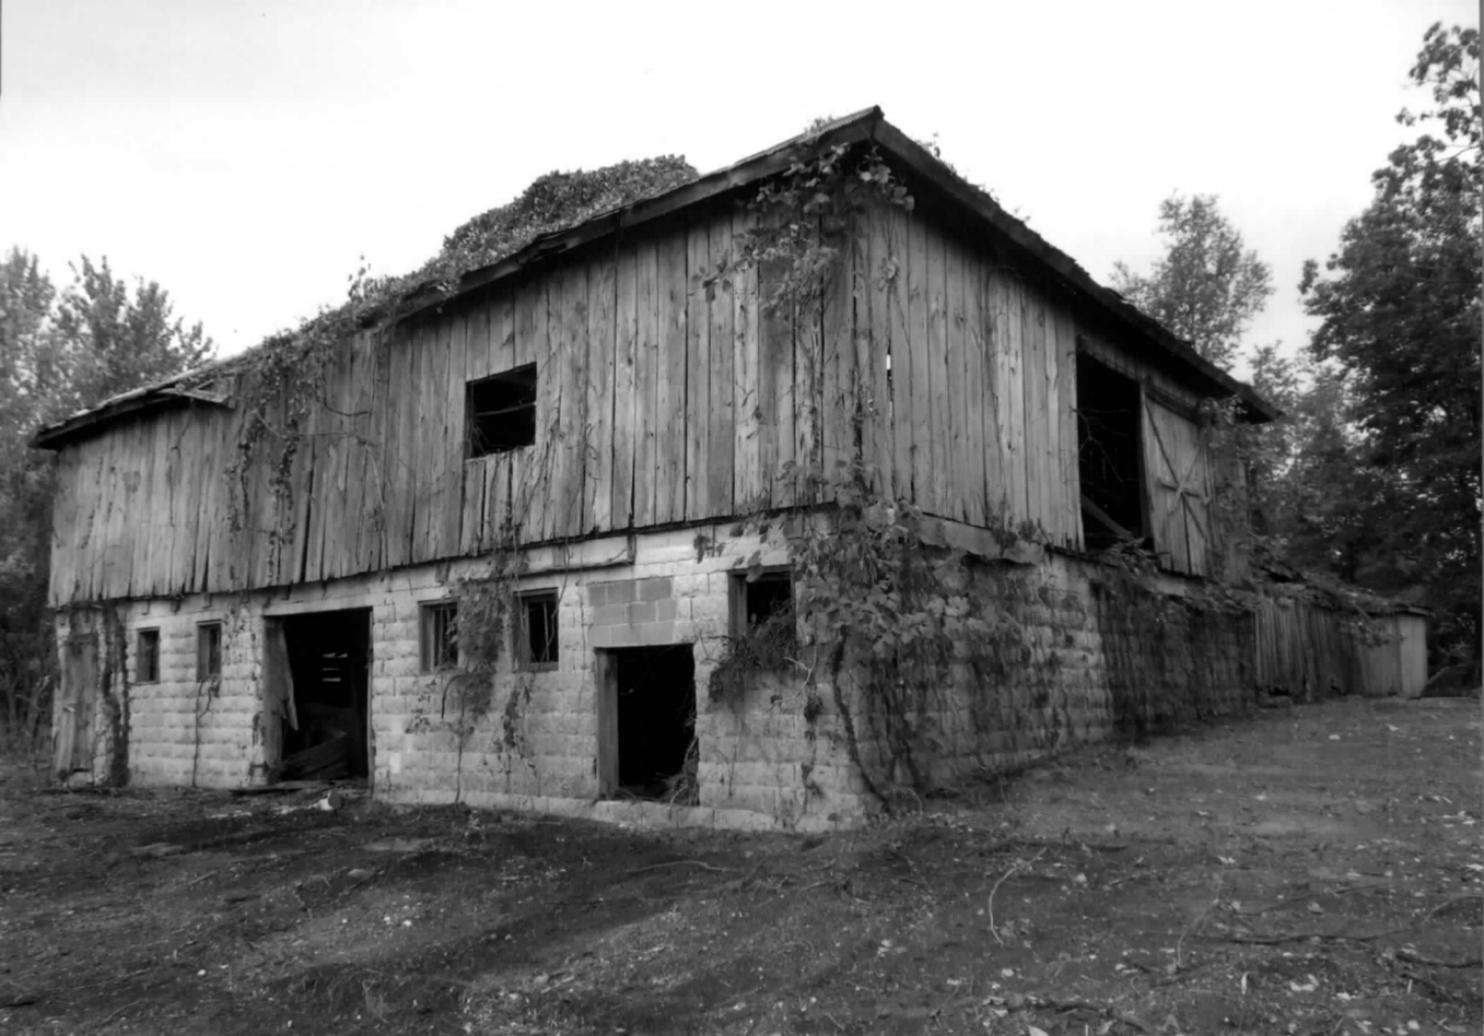
CH-0425\_2012-08-01\_01.tif

Hay Barn View W

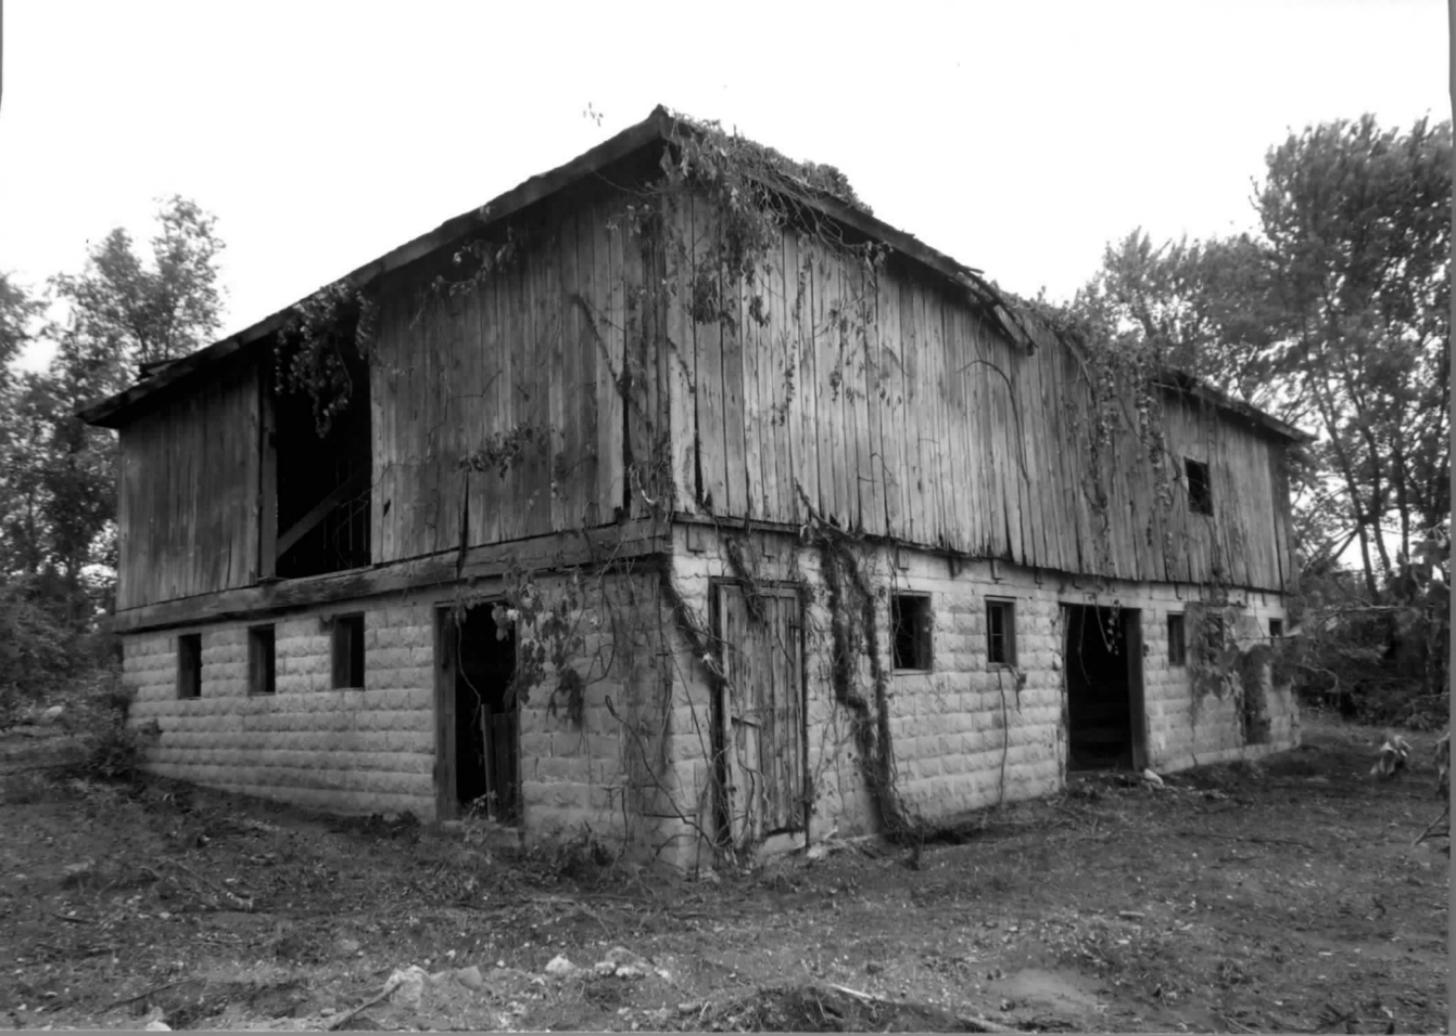
CH-04125\_2012-08-01\_02.tif

Hay Barn, View N

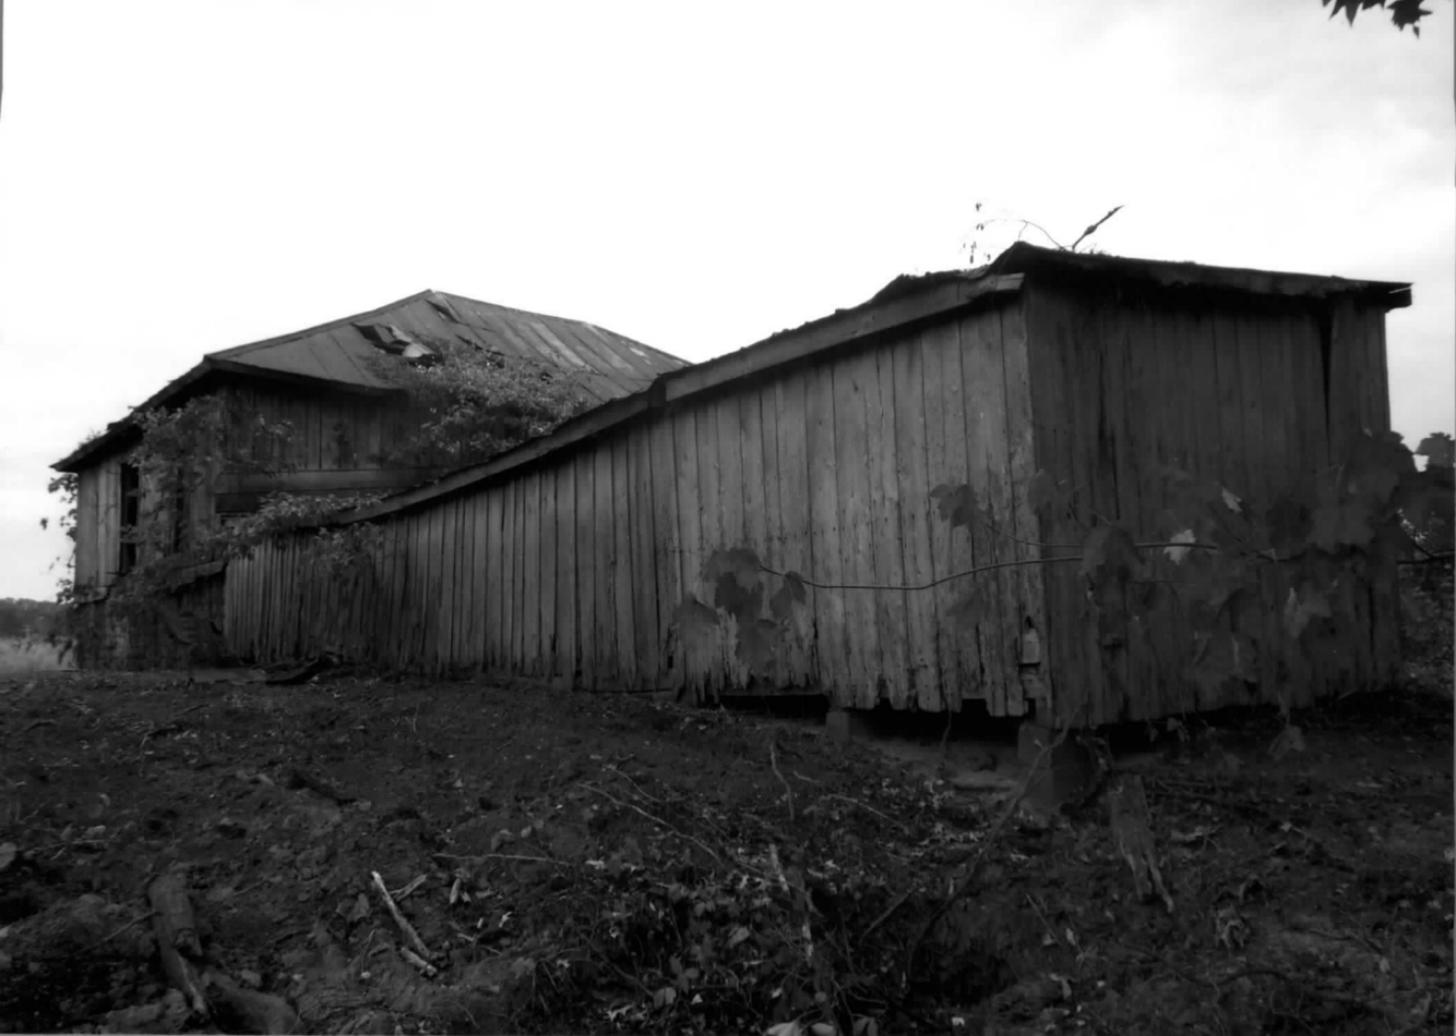
CH-04125\_2012-08-15\_03.tif

Hwy Barn + Shed, view E

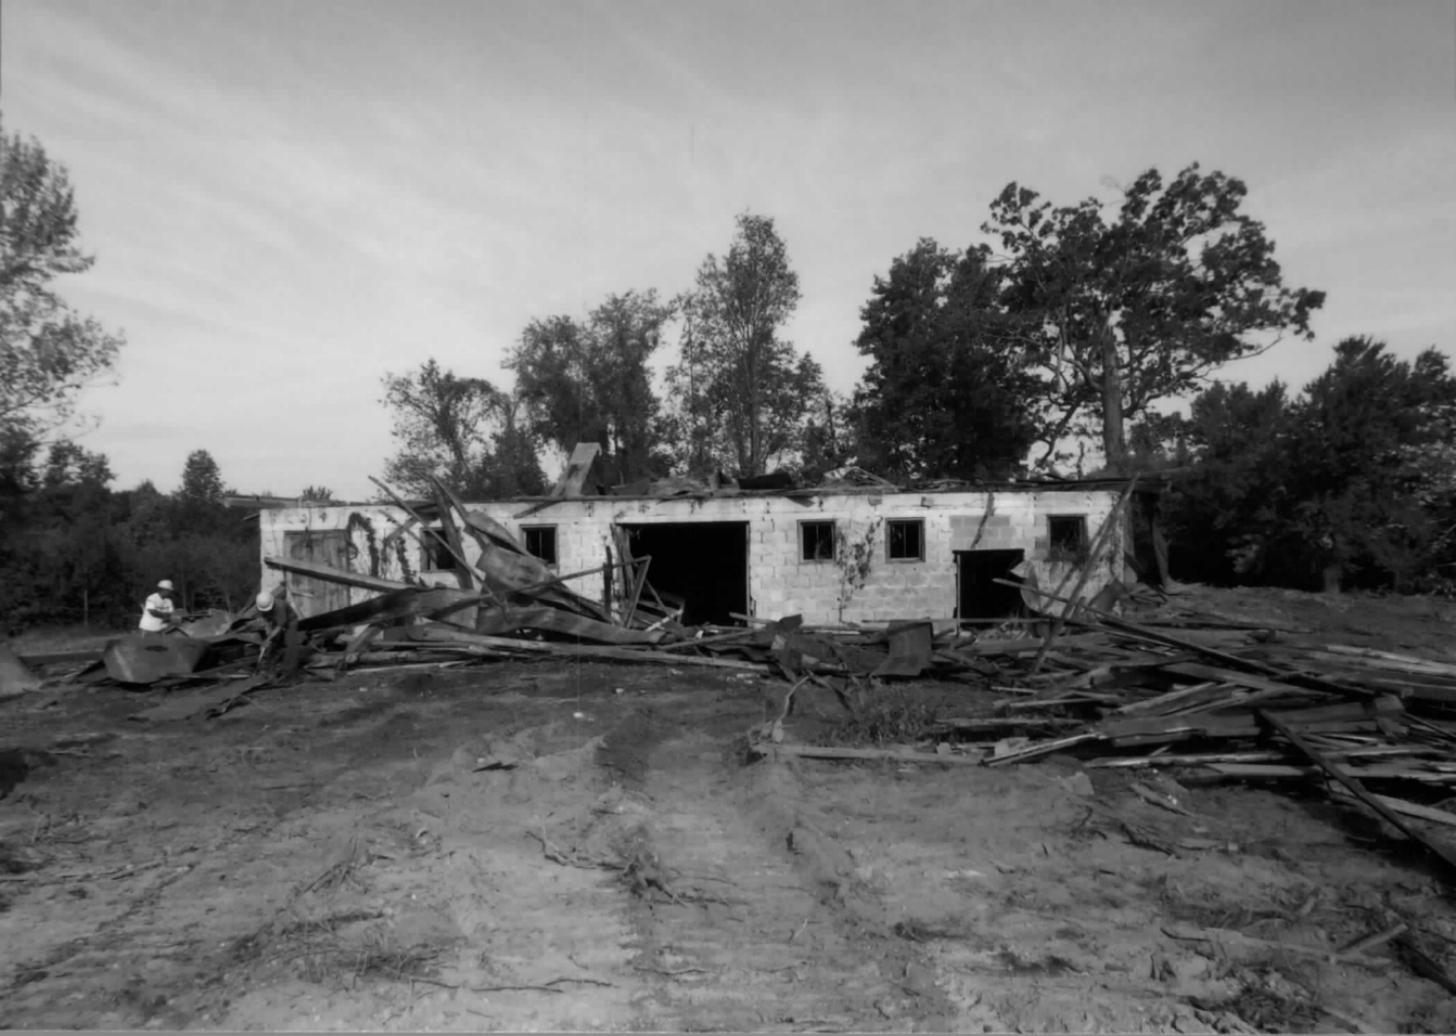
CH-0425\_2012-08-01\_08.tif

Hay Barn Foundation, post demo, view w

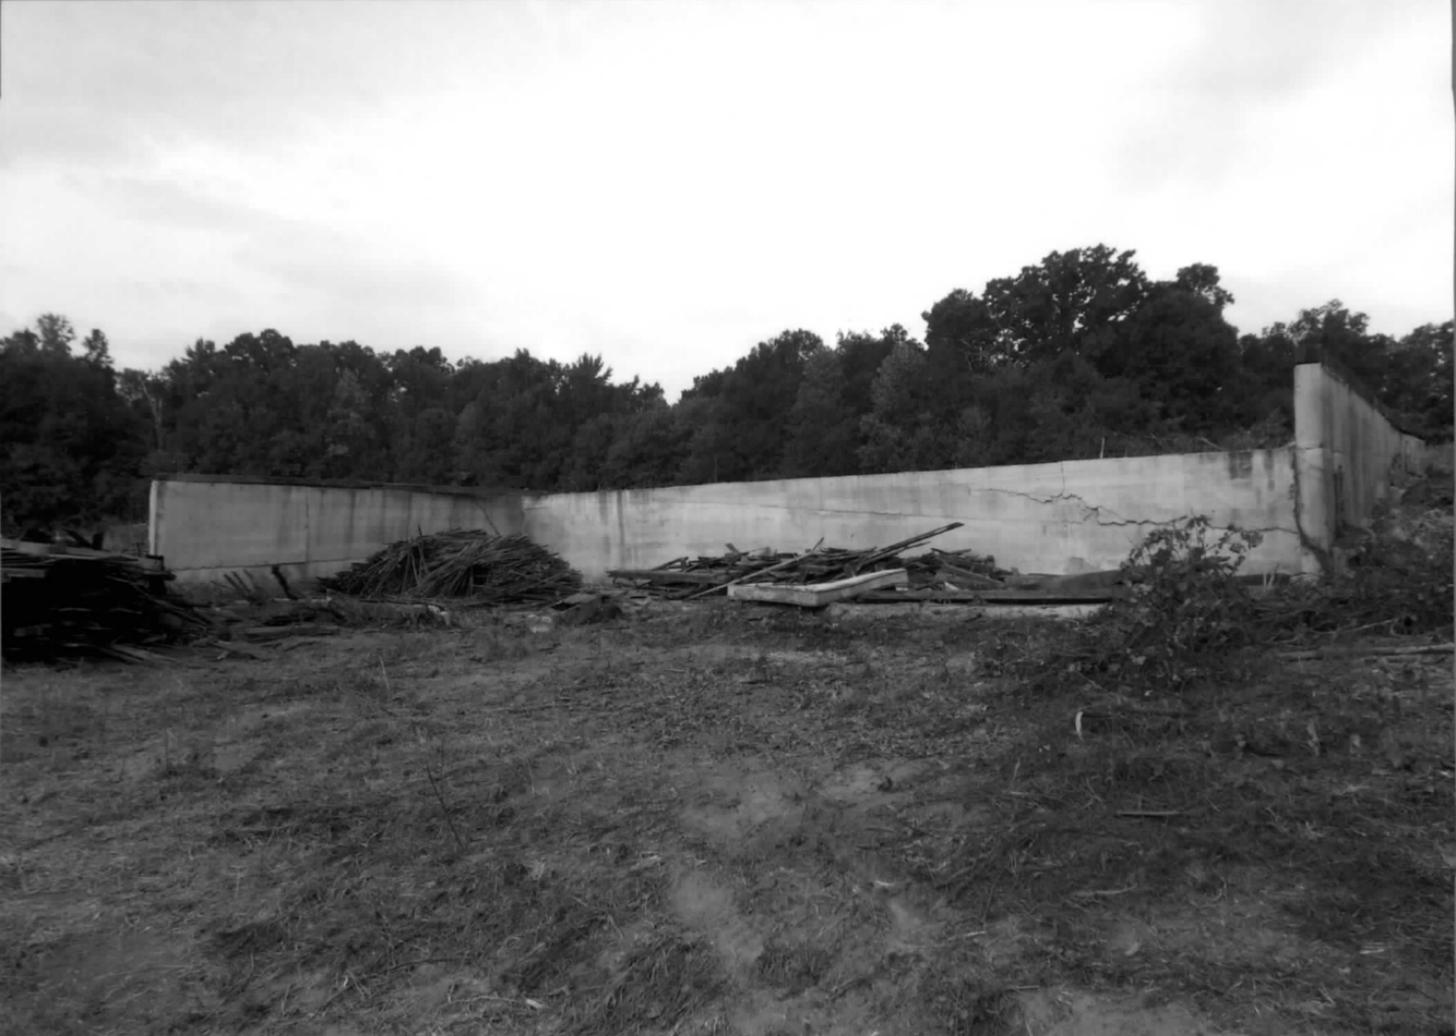
CH-0425\_2012-08-07\_42.tif

Tobacco Barn H foundation, Post Demolition

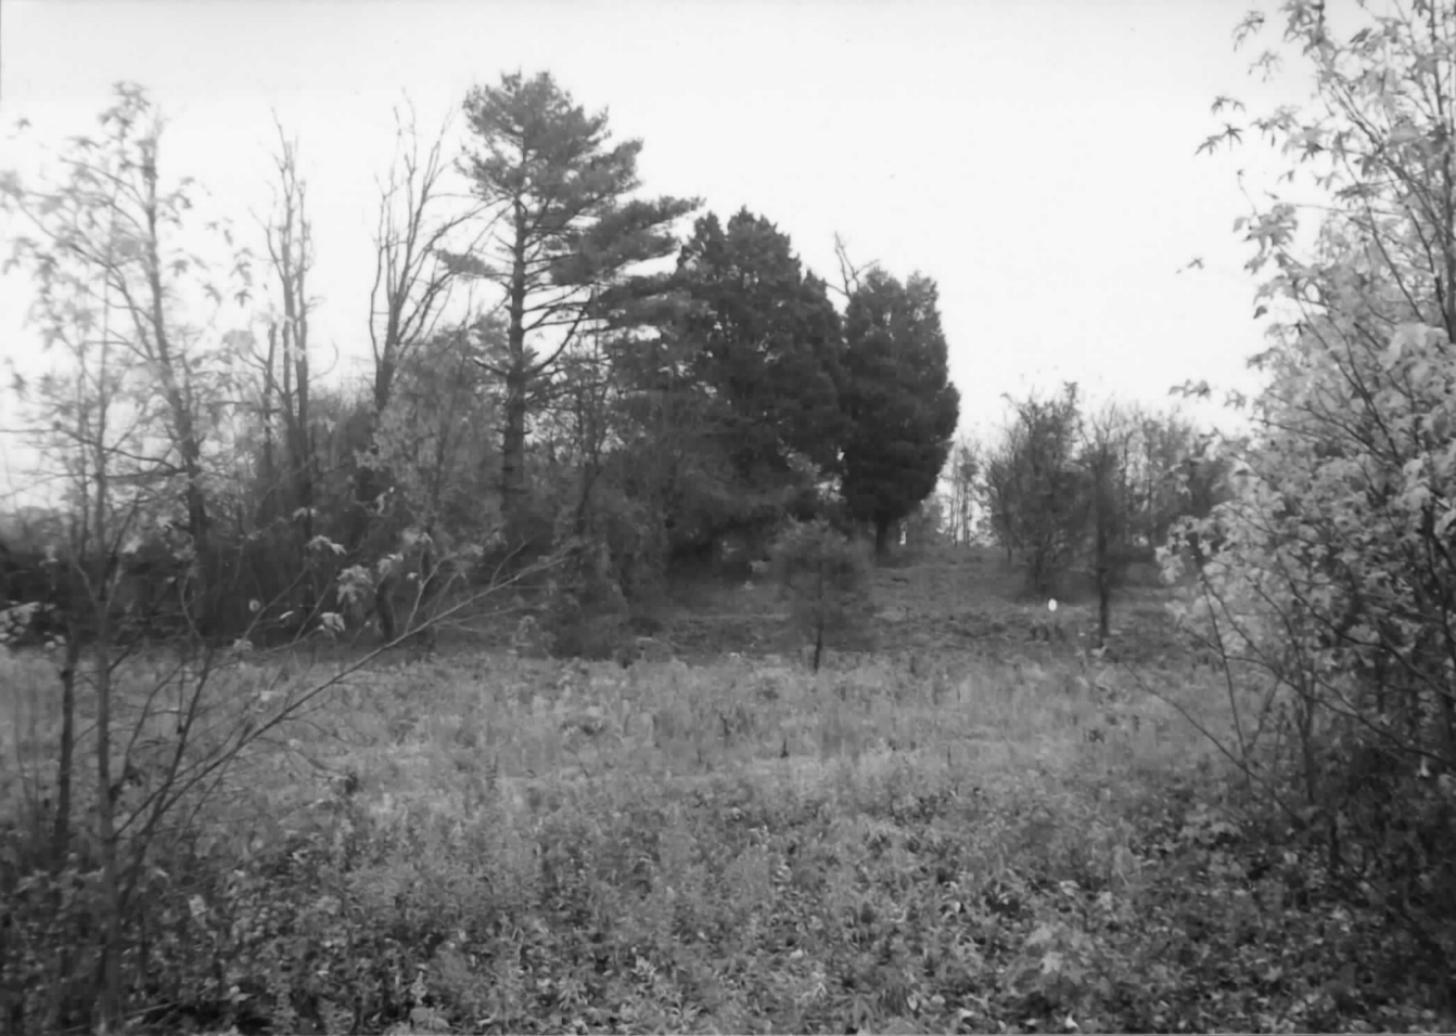
CH-425\_2011-11-14\_01.tif  
Aaron Levinthal

CH-425 Herbar + Farm  
I-House Site  
View West  
Charles County, Maryland  
11/16/11  
1/40

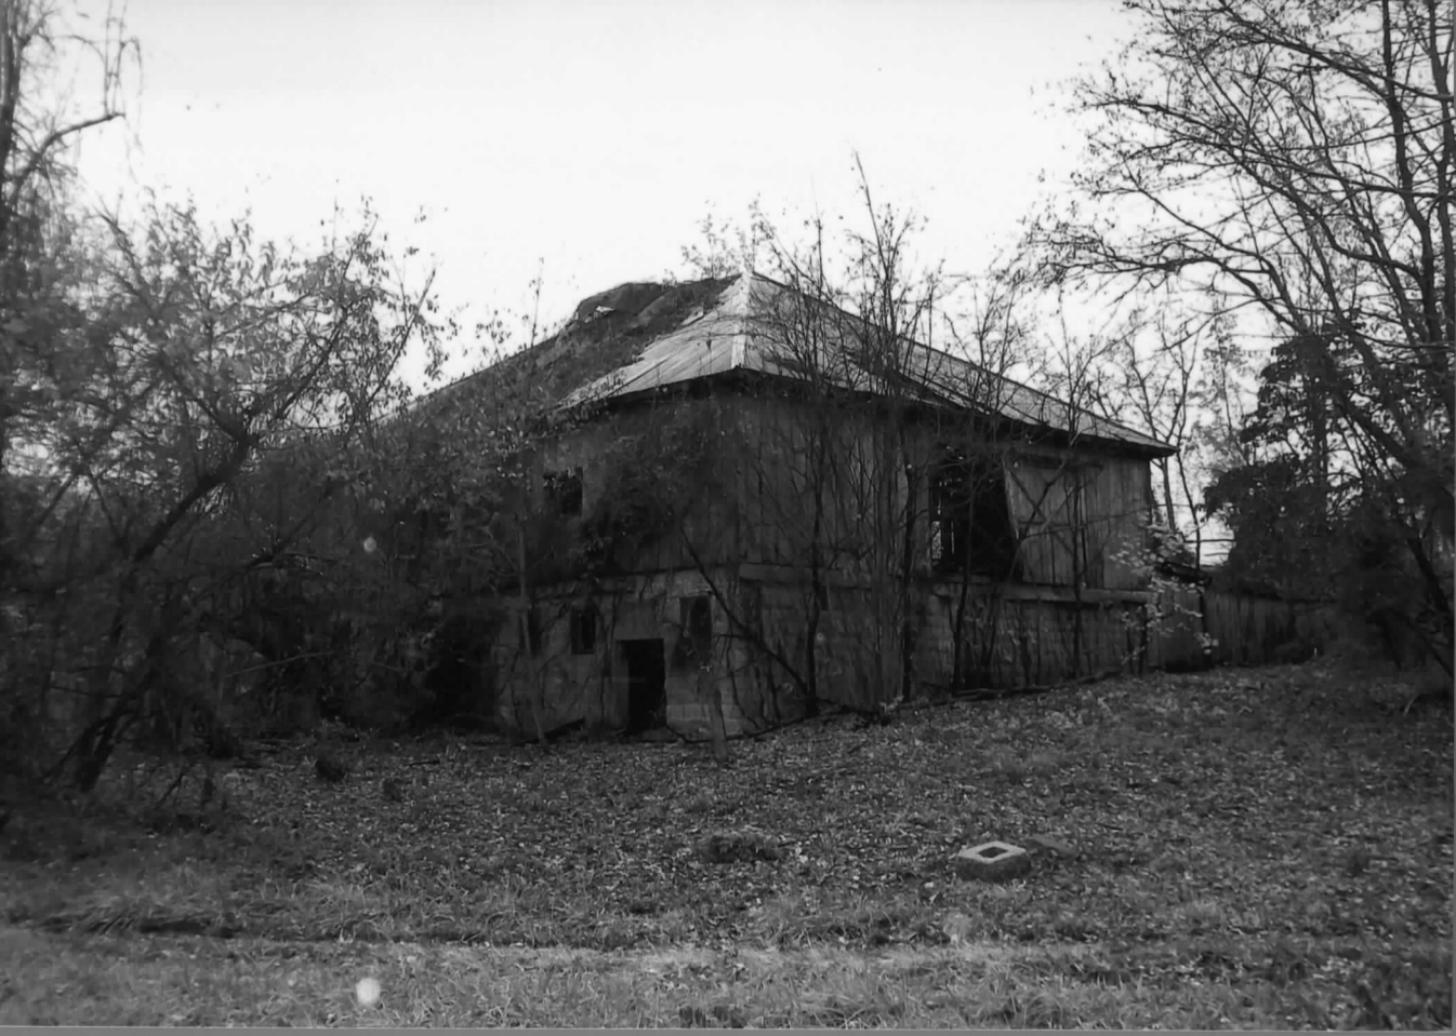
CH-425\_2011-11-16\_03.tif

The Hay Barn is located northwest of the I-house site in a level but overgrown area and it is in moderately poor condition. This very late nineteenth or early twentieth century, 2.50 story barn features a rusticated concrete block first floor filled with animal stalls. Second floor wall exteriors are vertical wood plank and this space probably served as a hay loft. A low pitch hipped roof covered with standing seam metal covers the barn. Barn walls are penetrated by several sizes of empty door frames and several sizes of empty window frames. Areas of metal roofing are missing. A rectangular, wood plank animal shed in poor condition has been fitted to the northwest elevation of the barn. This shed is becoming overgrown with weedy vegetation and vines.

Hay Barn

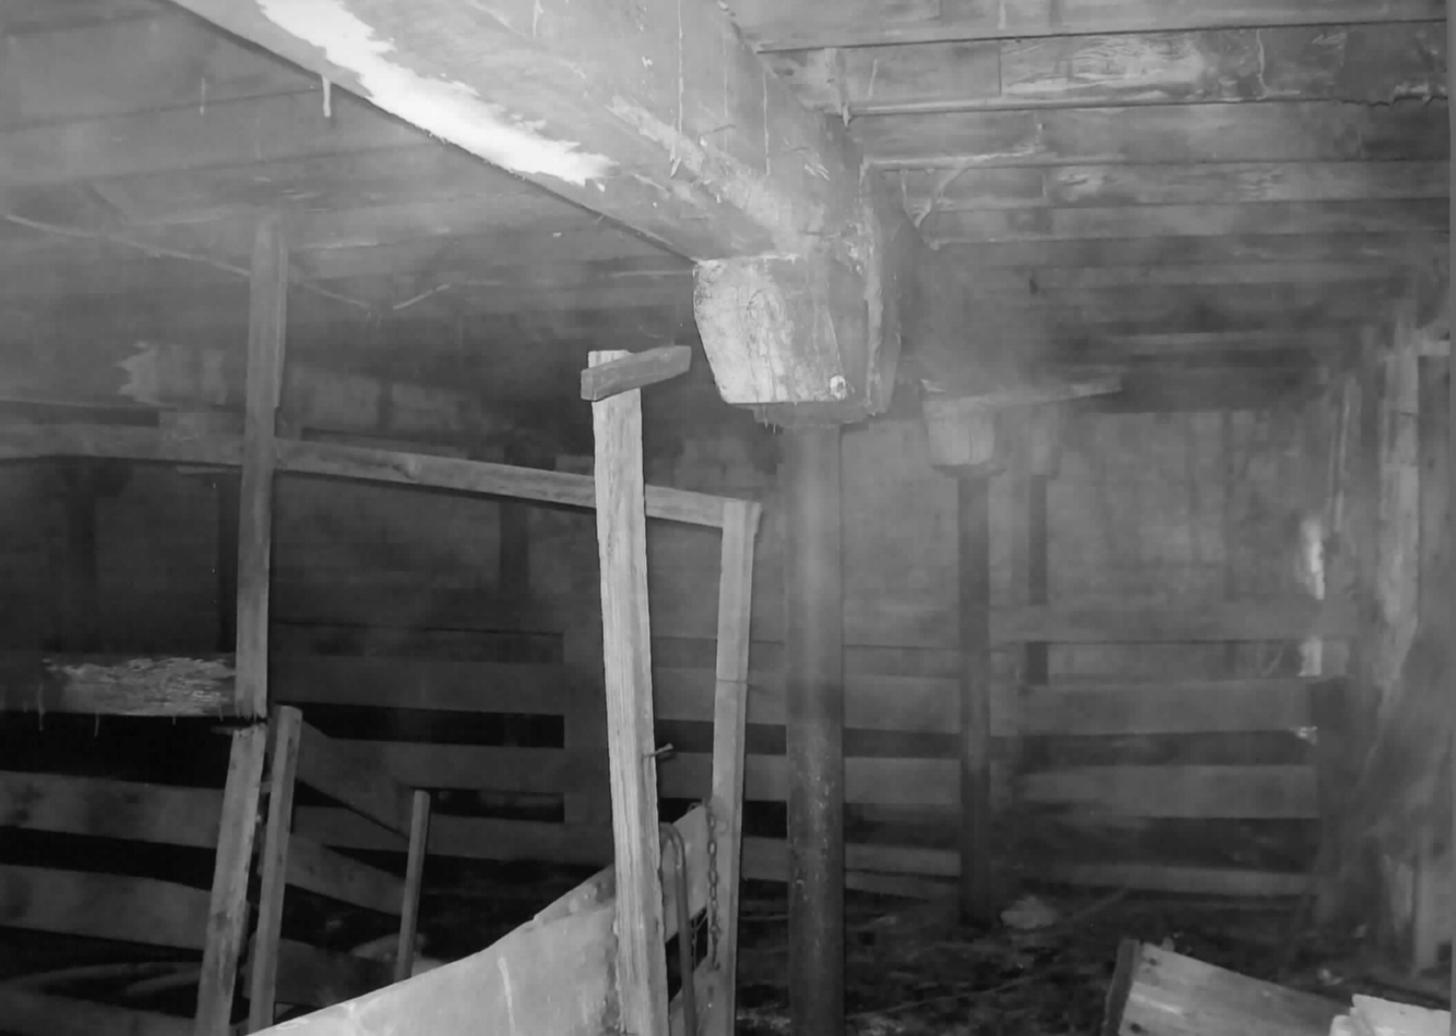
CH-425\_2011-11-16\_05.Tif

Hay Barn Interior

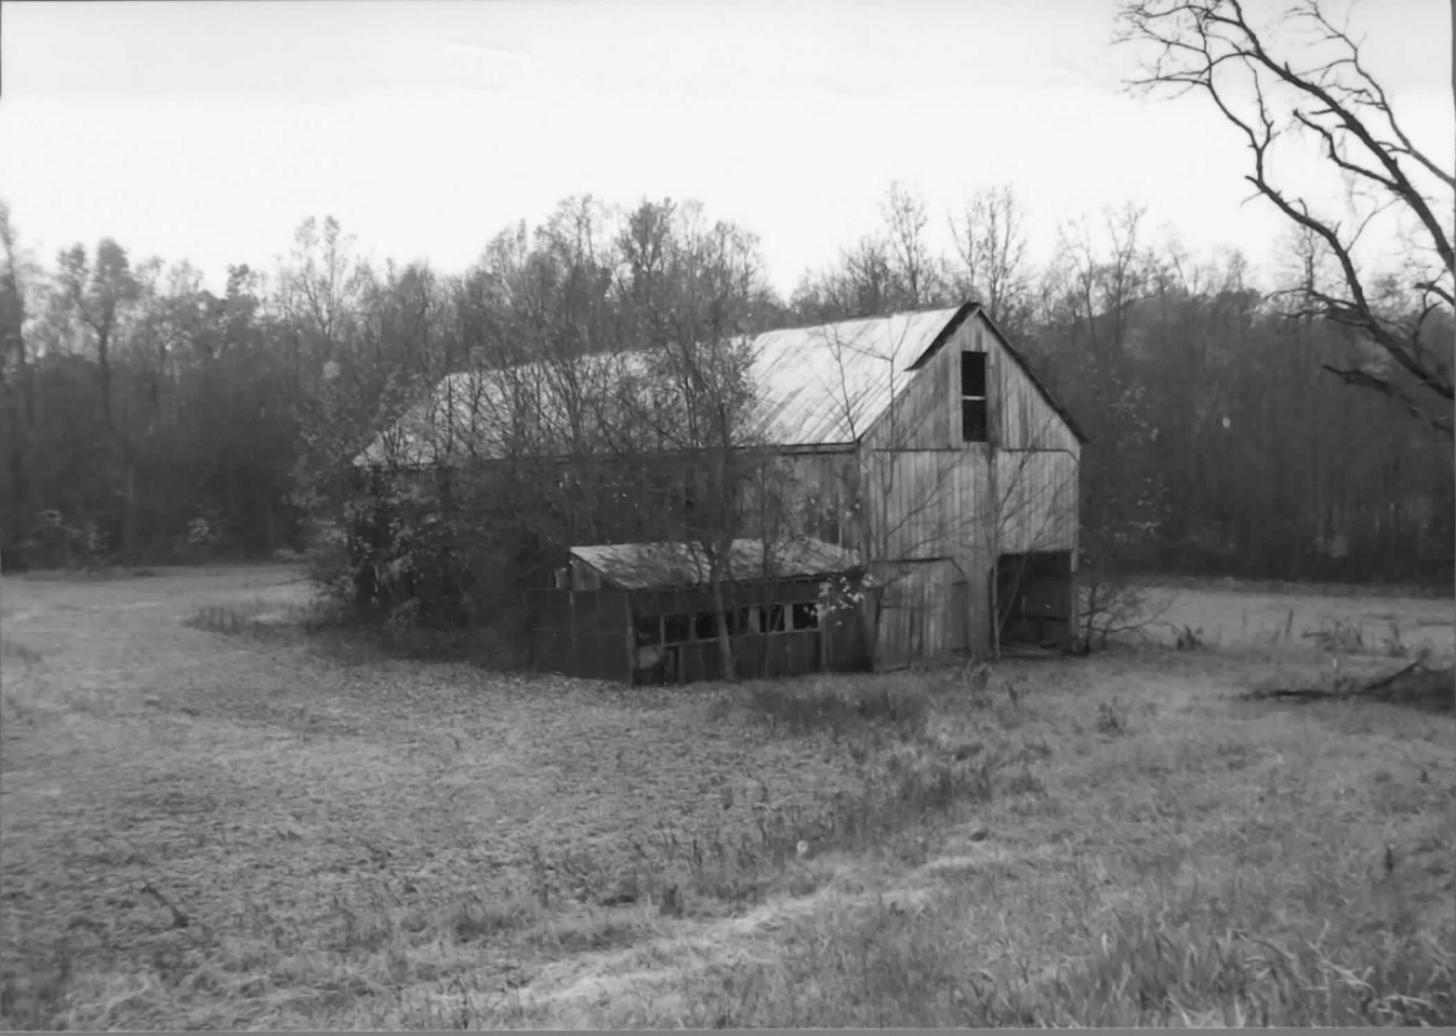
CH-425\_2011-11-16\_06.TIF

The condition of this barn is considered to be good; it is becoming overgrown with weedy vegetation and a barn door has collapsed. The condition of the stripping shed is considered to be moderate to poor; burrowing animals have taken over the interior, window frames are empty, interior insulation is collapsing and the stove has been removed along with most of the electrical elements.

CH-425 Herbert Farm  
Tobacco Barn 1 and Stripping Shed  
View South  
Charles County, Maryland

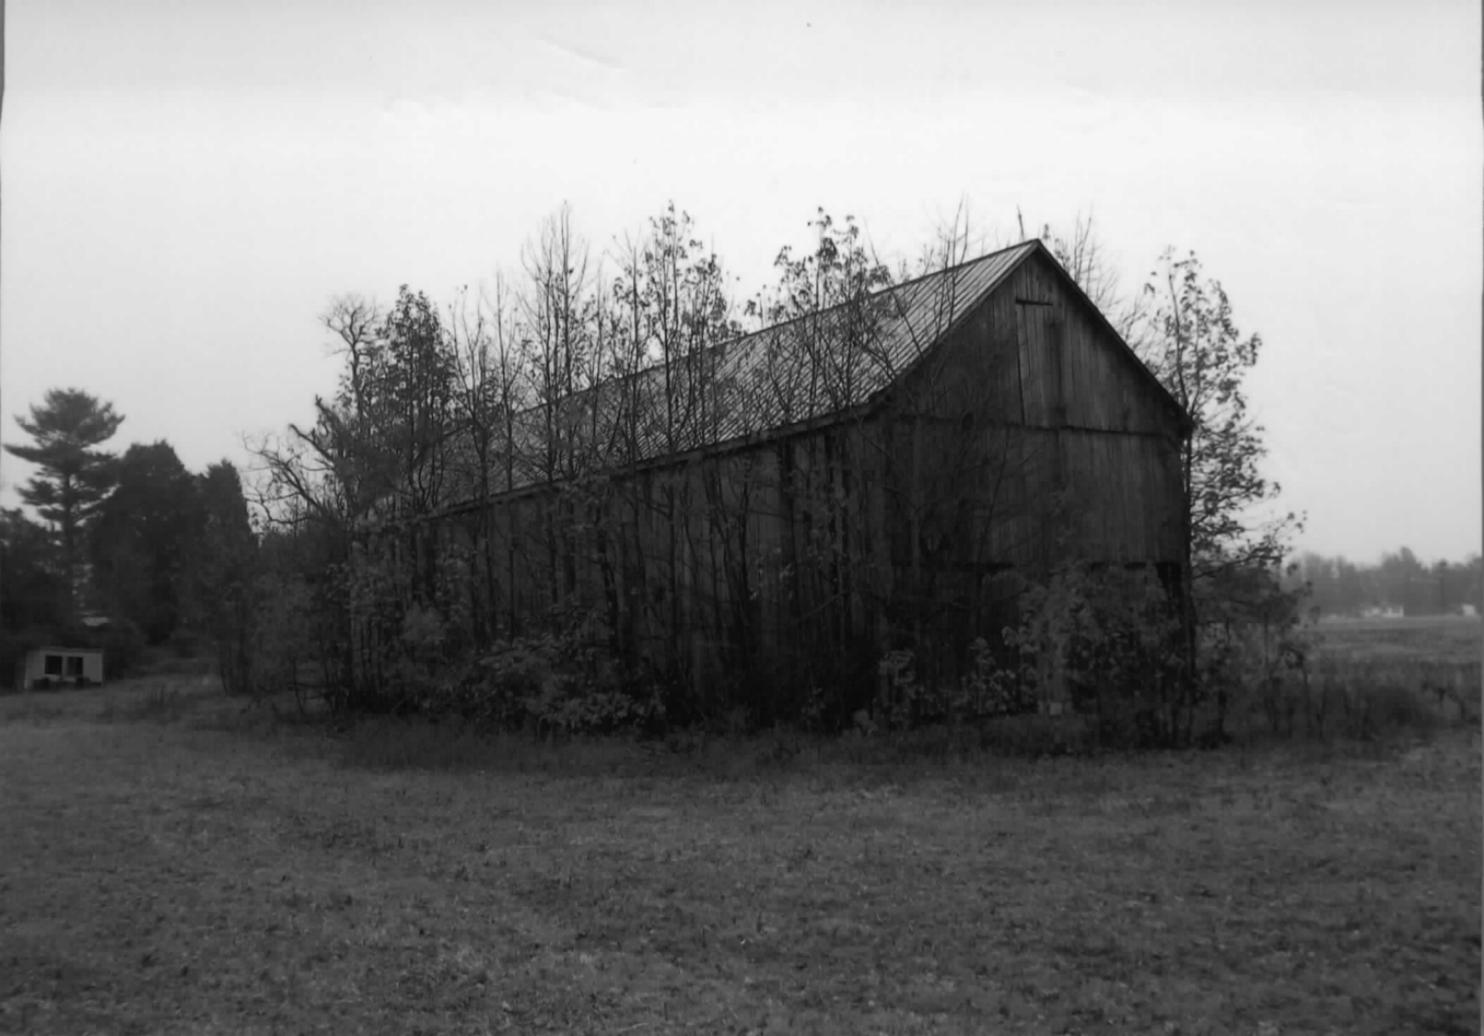
Two tobacco barns on the property are in good condition (Tobacco Barns 1 and 3), one tobacco barn is in fair condition (Tobacco Barn 2) and one tobacco barn is in poor condition (Tobacco Barn 4). Three stripping sheds in various conditions are associated with CH-425; 1 shed is attached to Tobacco Barn 1 (moderate to poor condition), 1 shed is attached to Tobacco Barn 2 (moderate to poor condition) and 1 shed is attached to Tobacco Barn 3 (moderate condition). There is no shed attached to Tobacco Barn 4. Most sheds include at least hints of interior arrangement and design (heating, electricity, etc.). Due to high levels of integrity in regards to barns and sheds combined, increased study focused upon each barn may result in links to periods of ownership. Results of further studies may then provide information related to the sequence of patterns and trends in tobacco agriculture from the late nineteenth century through the mid twentieth century. Due to high levels of integrity coupled with a secure historic record, CH-425 is highly significant in regards to tobacco farming in Southern Maryland.

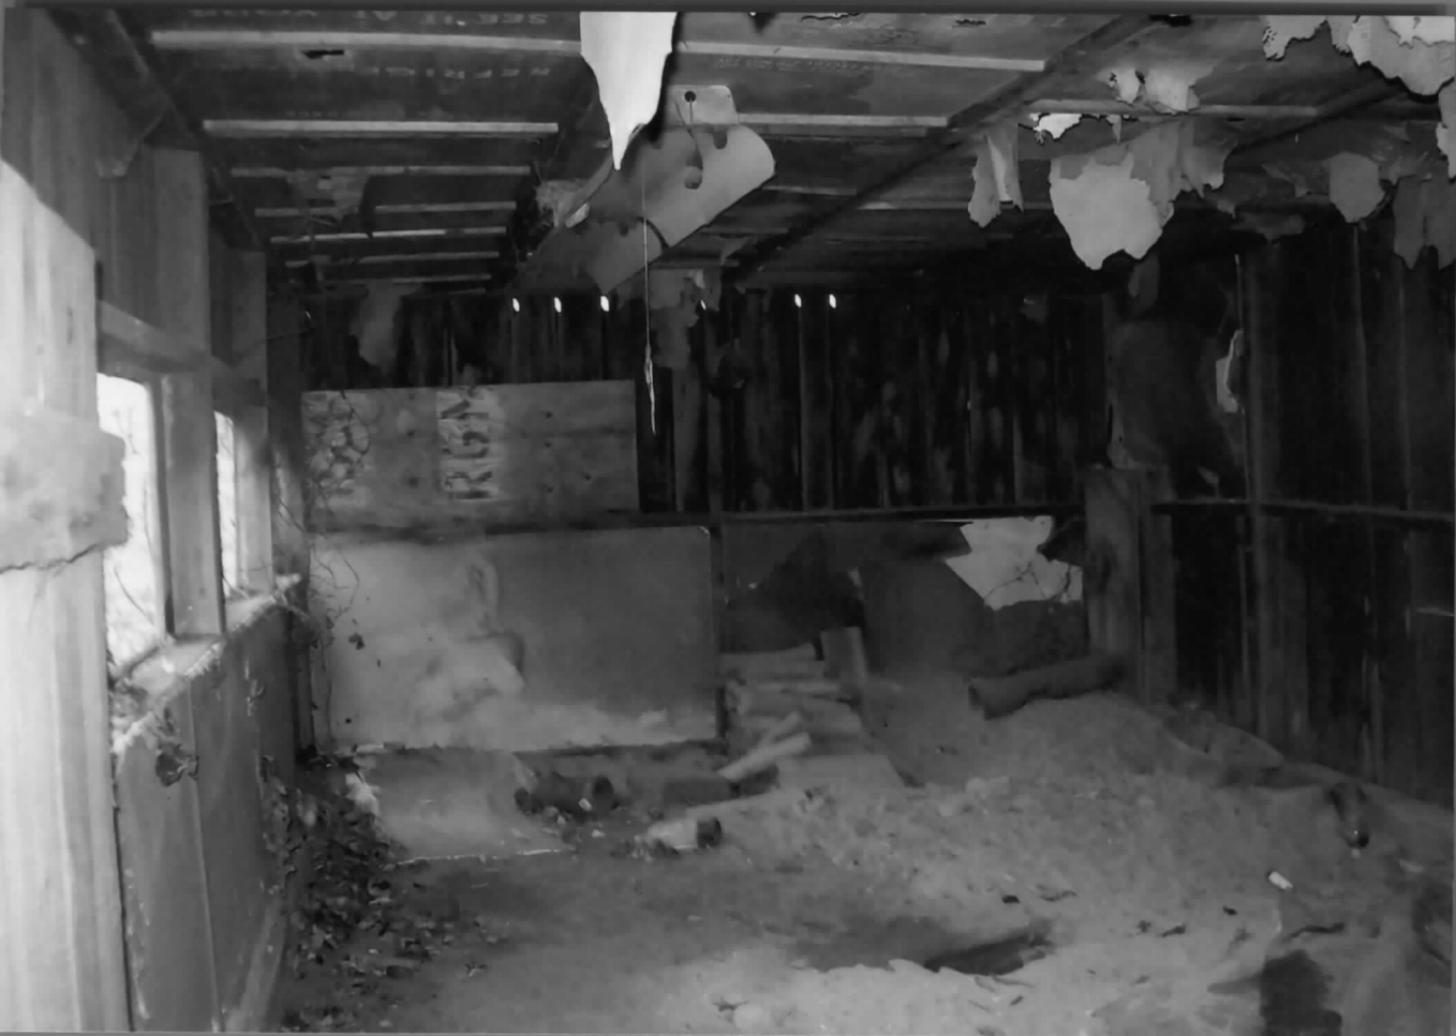
CH-425\_2011\_11-16\_09.Tif  
Aaron Levinthal

Tobacco Barn | Stripping Shed Interior  
View East, 11/16/11, Charles County, MD  
9/40

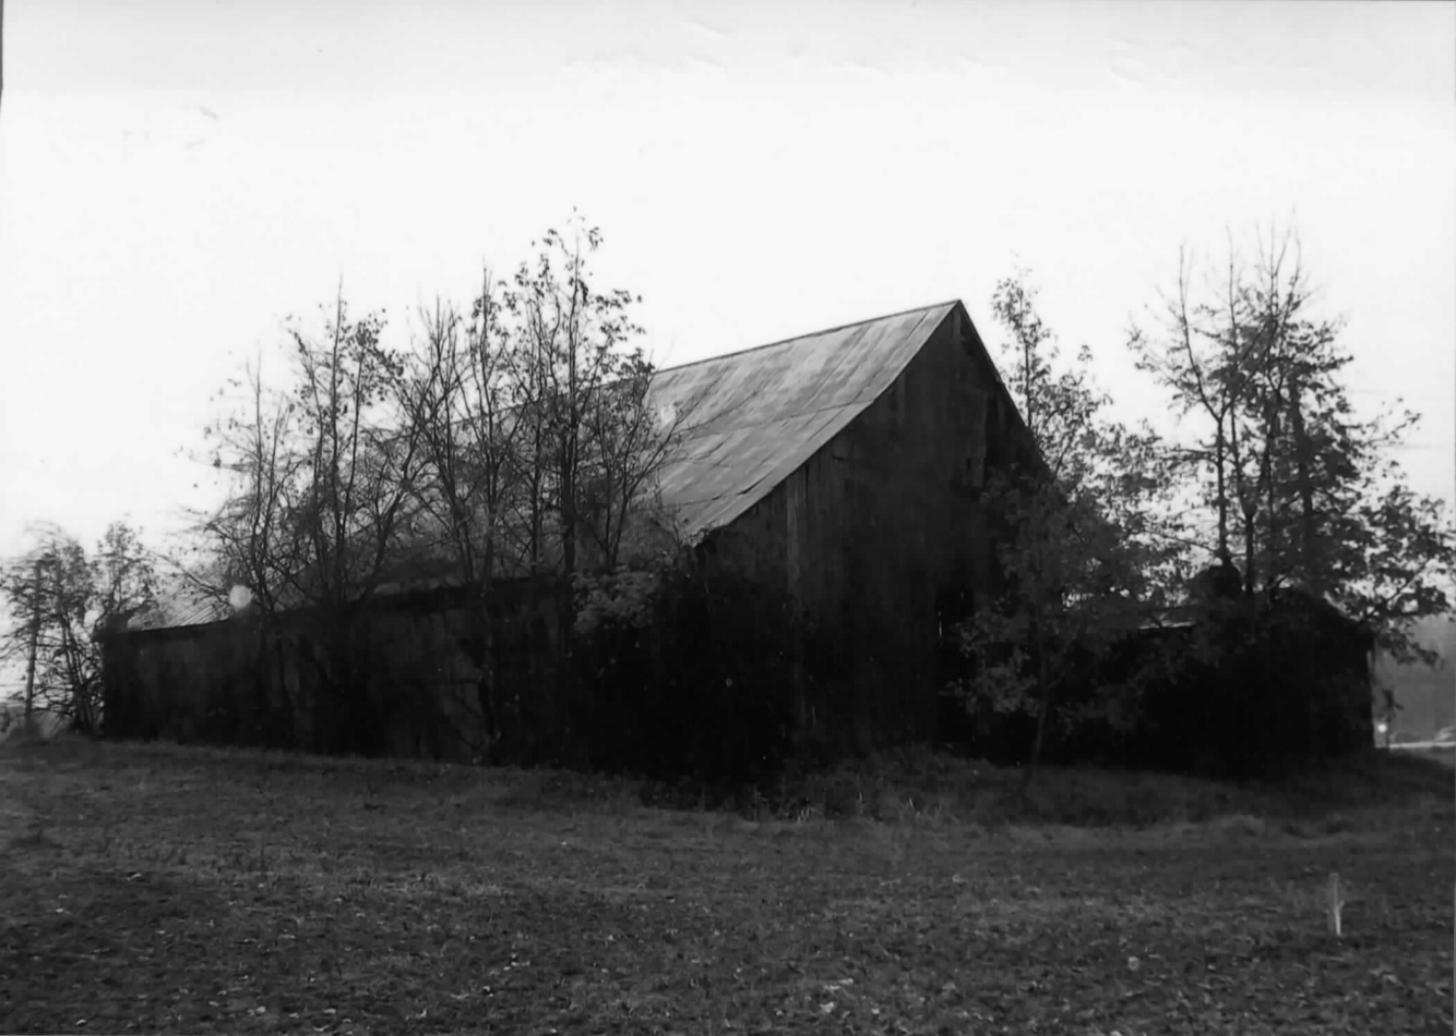
The condition of this barn is considered to be fair; it is becoming overgrown with weedy vegetation and portions of the sill are sagging. The condition of the stripping shed is considered to be moderately poor; burrowing animals have taken over the interior, window frames are empty, interior insulation is collapsing and most of the electrical elements have been removed.

Tobacco Barn 2 and Stripping Shed  
View North, Charles County, MD

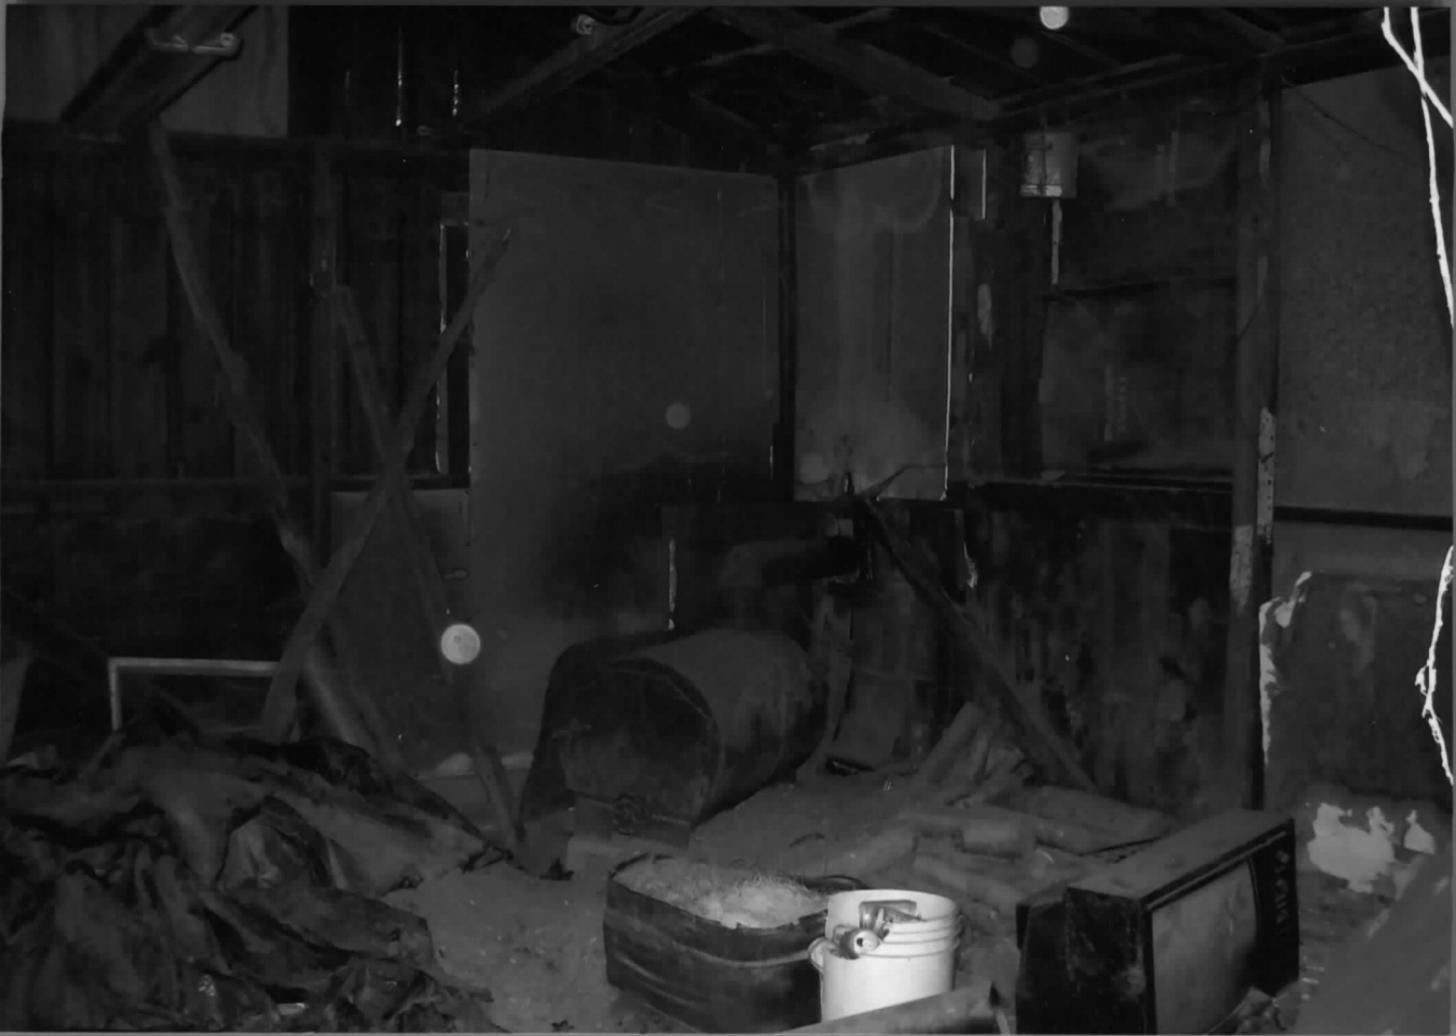
CH-425\_2011-11-16\_13.tif

Tobacco Barn 2 Stripping. Shed Interior  
Charles County, MD

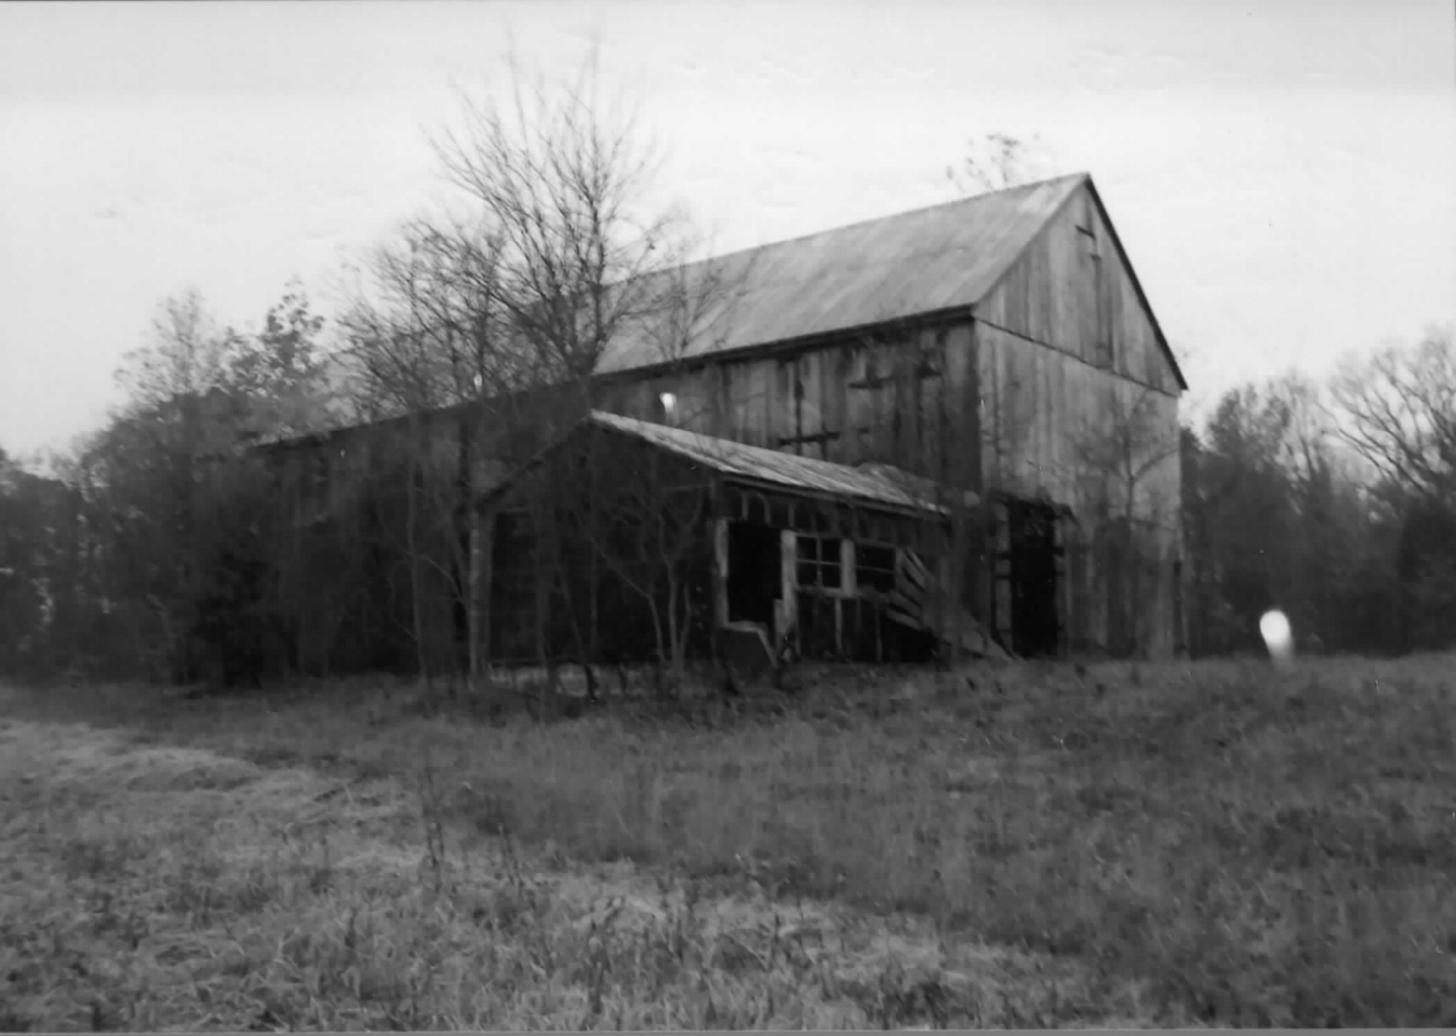
CH-425\_2011-11-16\_14.TIF

The condition of Tobacco barn 3 is considered to be good. The condition of the stripping shed is considered to be moderate, windows are missing, the stove has been removed and insulation is failing.

Tobacco Barn 3 + Stripping Shed  
Charles County, MD  
View South
