## Photo Log

CH-425, The Caroline Christ Farm, aka The Herbert Farm-  
7761 Leonardtown Road, Hughesville,  
Charles County, MD, 20637-3011

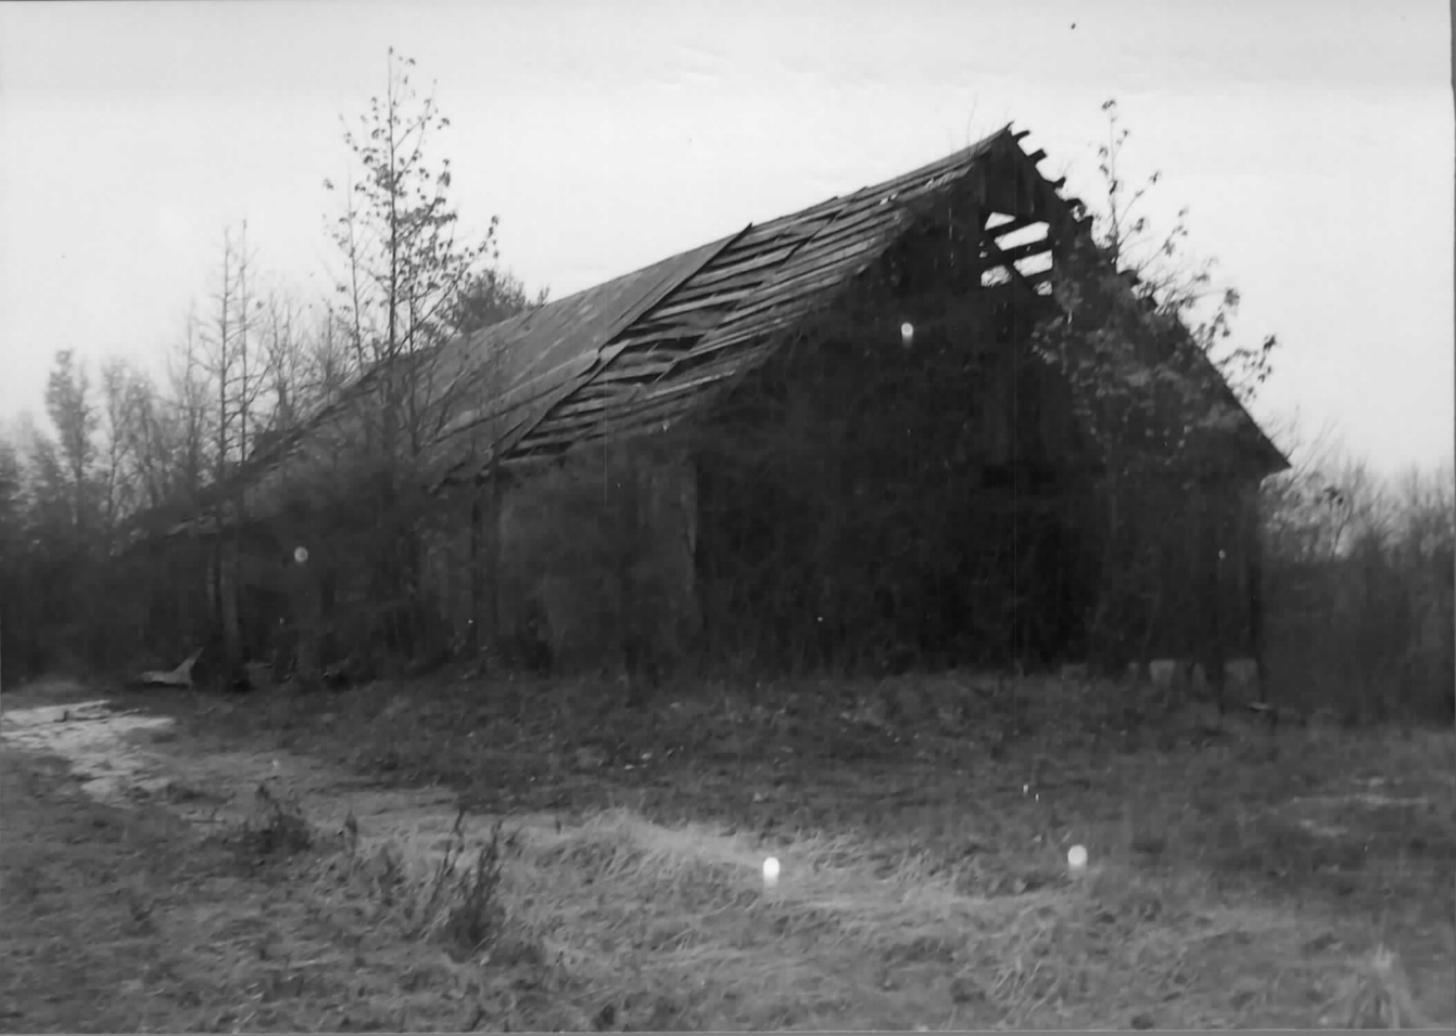
CH-425 Roll 11-11-11 18.tif

The condition of this barn is poor; it is becoming overgrown with weedy vegetation. Much of the siding and roofing materials are missing. The barn is leaning in several directions and collapse is imminent.

Tobacco Barn 4

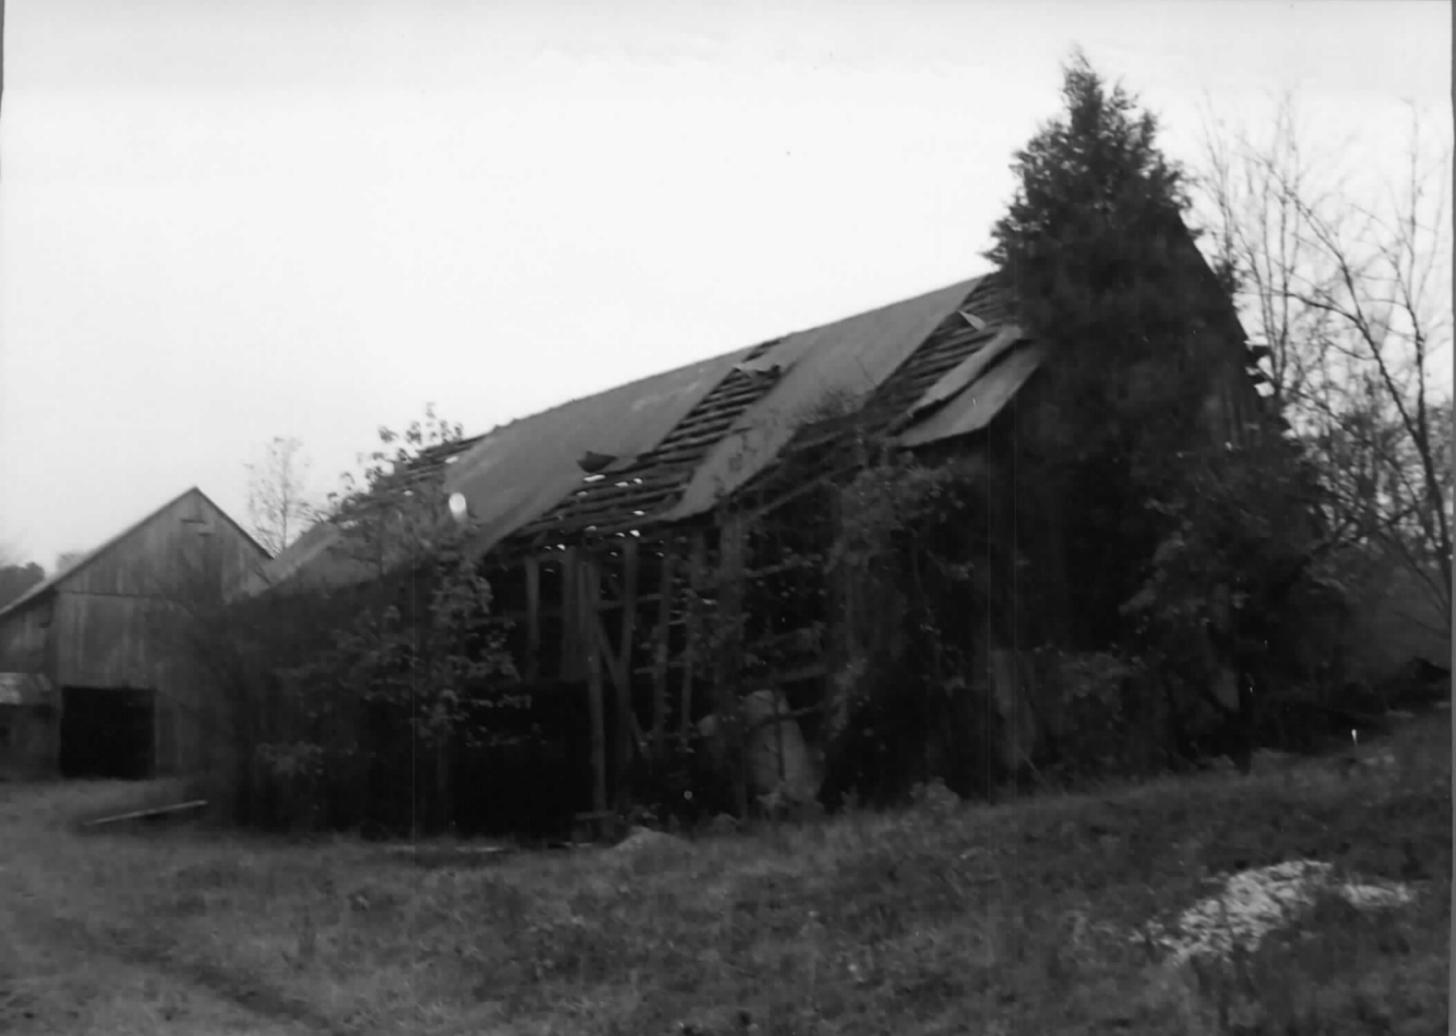
Tabacco Base 4

The barn in the poorest condition is Tobacco Barn 4. Despite a failing state, the mid twentieth century (probably circa 1953) bank barn design of this tobacco barn is intriguing. This survey uncovered no evidence of barn use as anything other than a tobacco barn. The bank form may suggest at least one episode of mid twentieth century agricultural experimentation; the bank barn design applied to tobacco barn function may be rare, the purpose of the tobacco barn is to dry tobacco yet semi-subterranean spaces are notoriously damp.

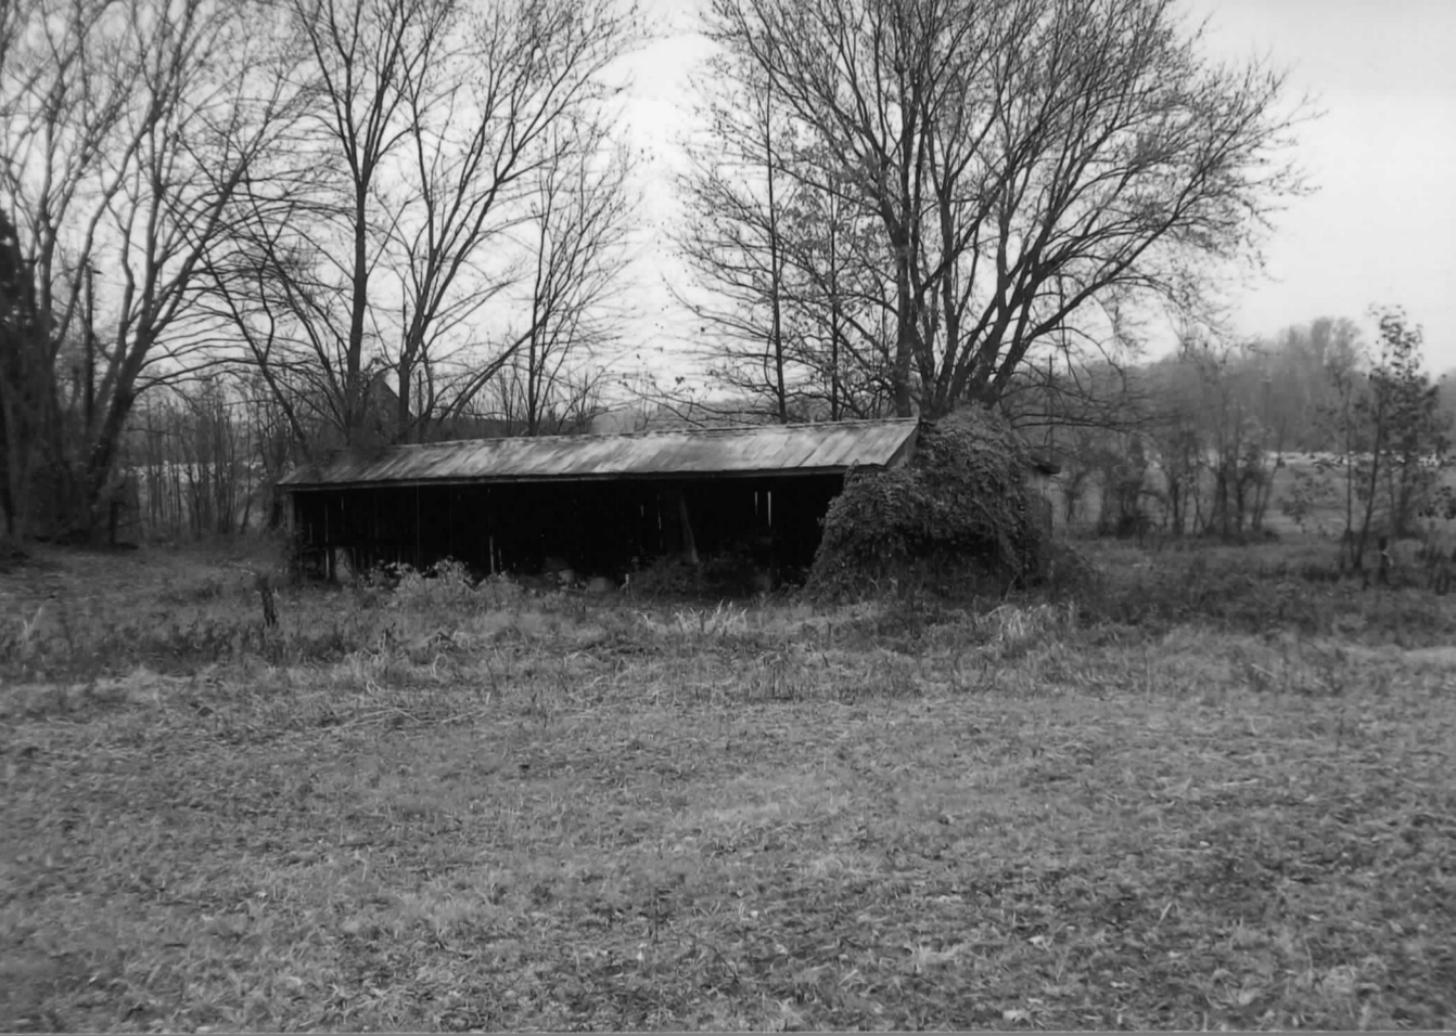
CH-425 2011-11-16\_21.TIF

Tractor Shed 1 is located west of the house site in a level setting adjacent to a farm lane. This outbuilding features several additions. In general this shed appears to date to the mid twentieth century. This shed is more likely an equipment shed rather than a true tractor shed. The main block features three bays and the shed roof is supported by 2 logs posts-in-ground. Other foundations are unknown. Walls are vertical wood planking. A square, chemical shed is attached to the south elevation. This addition features an unknown foundation, vertical wood plank walls and a shed roof. A wood frame, front gable roof corn shed is located west of the tractor shed. This square addition features an unknown foundation, it is clad in vertical wood plank and it is connected to the tractor shed by a breezeway. All roof planes are covered in standing seam metal and the condition of this shed conglomeration is moderate to poor; walls are becoming overgrown with vegetation, roofs are sagging and sections of wall planking are missing.

Tractor Shed 1

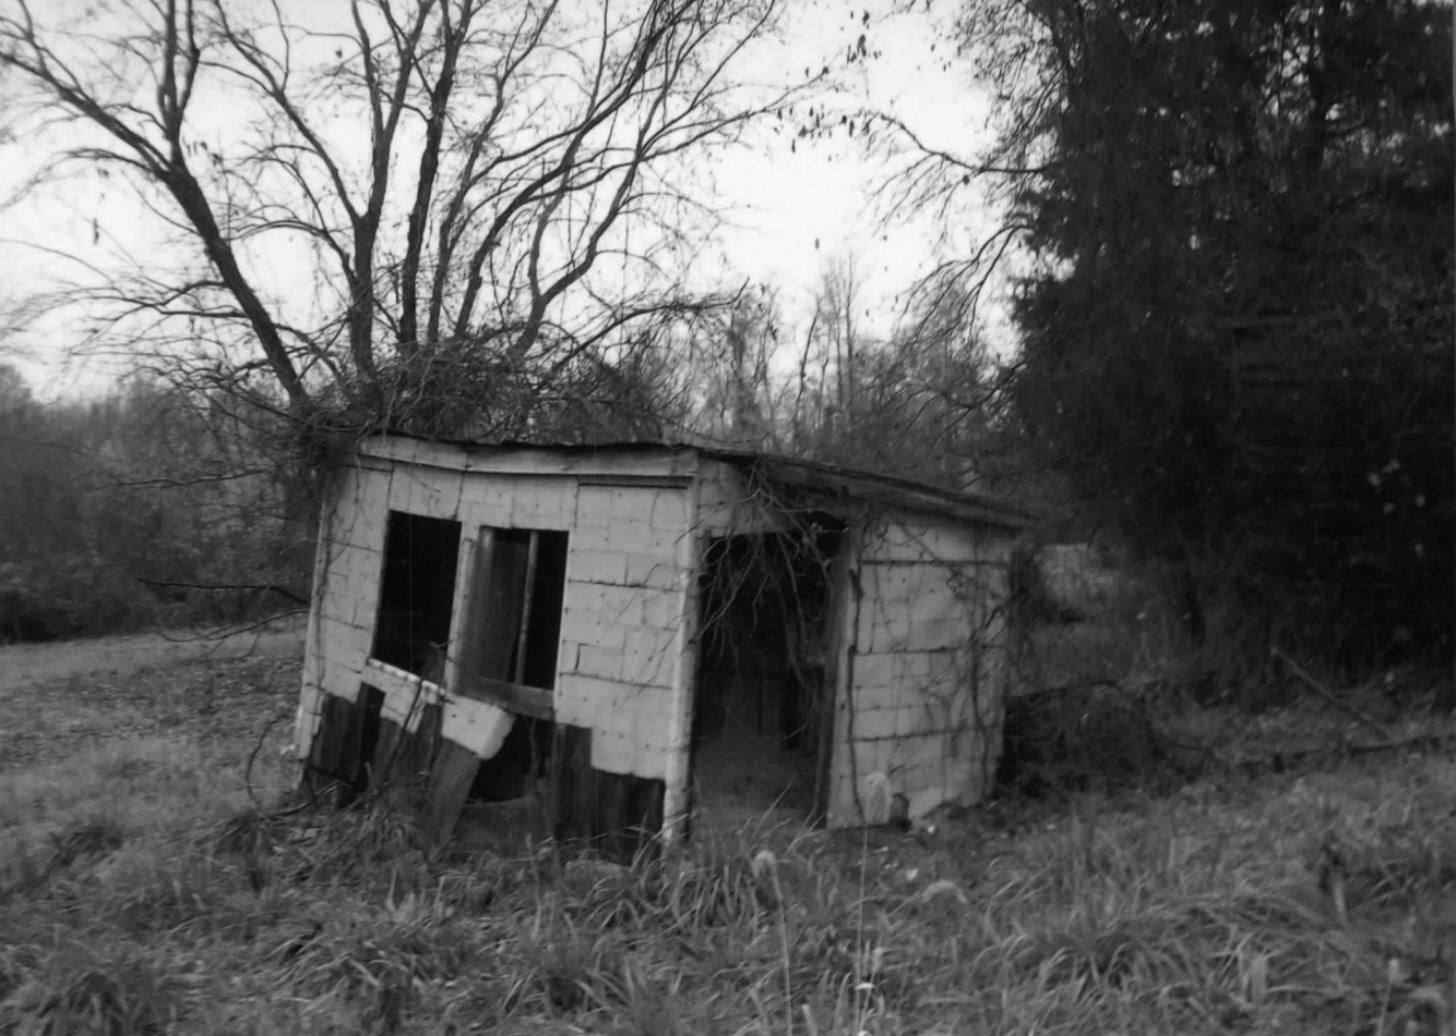
CW-423 - 2011-11-16 - 23-FIF

Shed 1 is located southwest of the I-house site and southwest of Shed 2 in a yard with a slight southwest slope. Shed 1 is a rectangular, probably mid to late twentieth century animal pen or coop. Vertical wood plank walls are covered in asphalt shingles and the shed roof is covered in standing seam metal. This shed is in poor condition, walls are failing and it is collapsing.

Shed 1

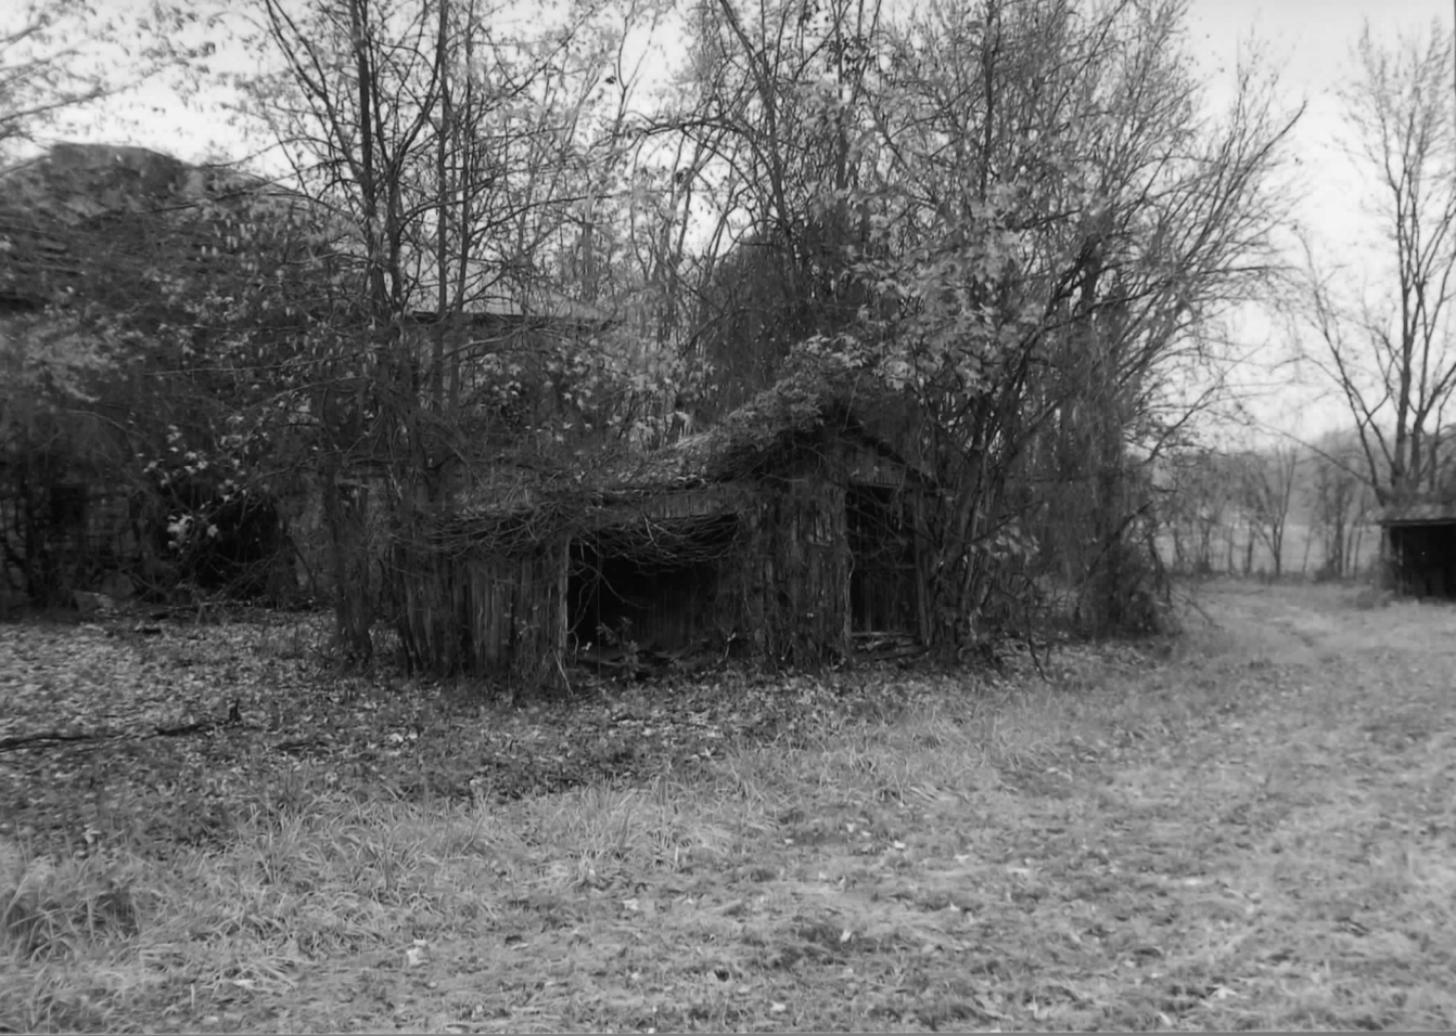
CH-425 Harbort Farm  
Shed 5

Shed 5 is located west of Tractor Shed 2 and north of Tractor Shed 1 in a level yard just west of a farm lane fork. This building is a front gable roof shed with a shed roof addition. It was likely constructed during the early to mid twentieth century. Foundations are unknown and all walls are clad in vertical wood plank siding. Roof planes are covered in standing seam metal. The condition of this shed is poor, it is collapsing due to rot and it is becoming overtaken by vines and weedy vegetation.

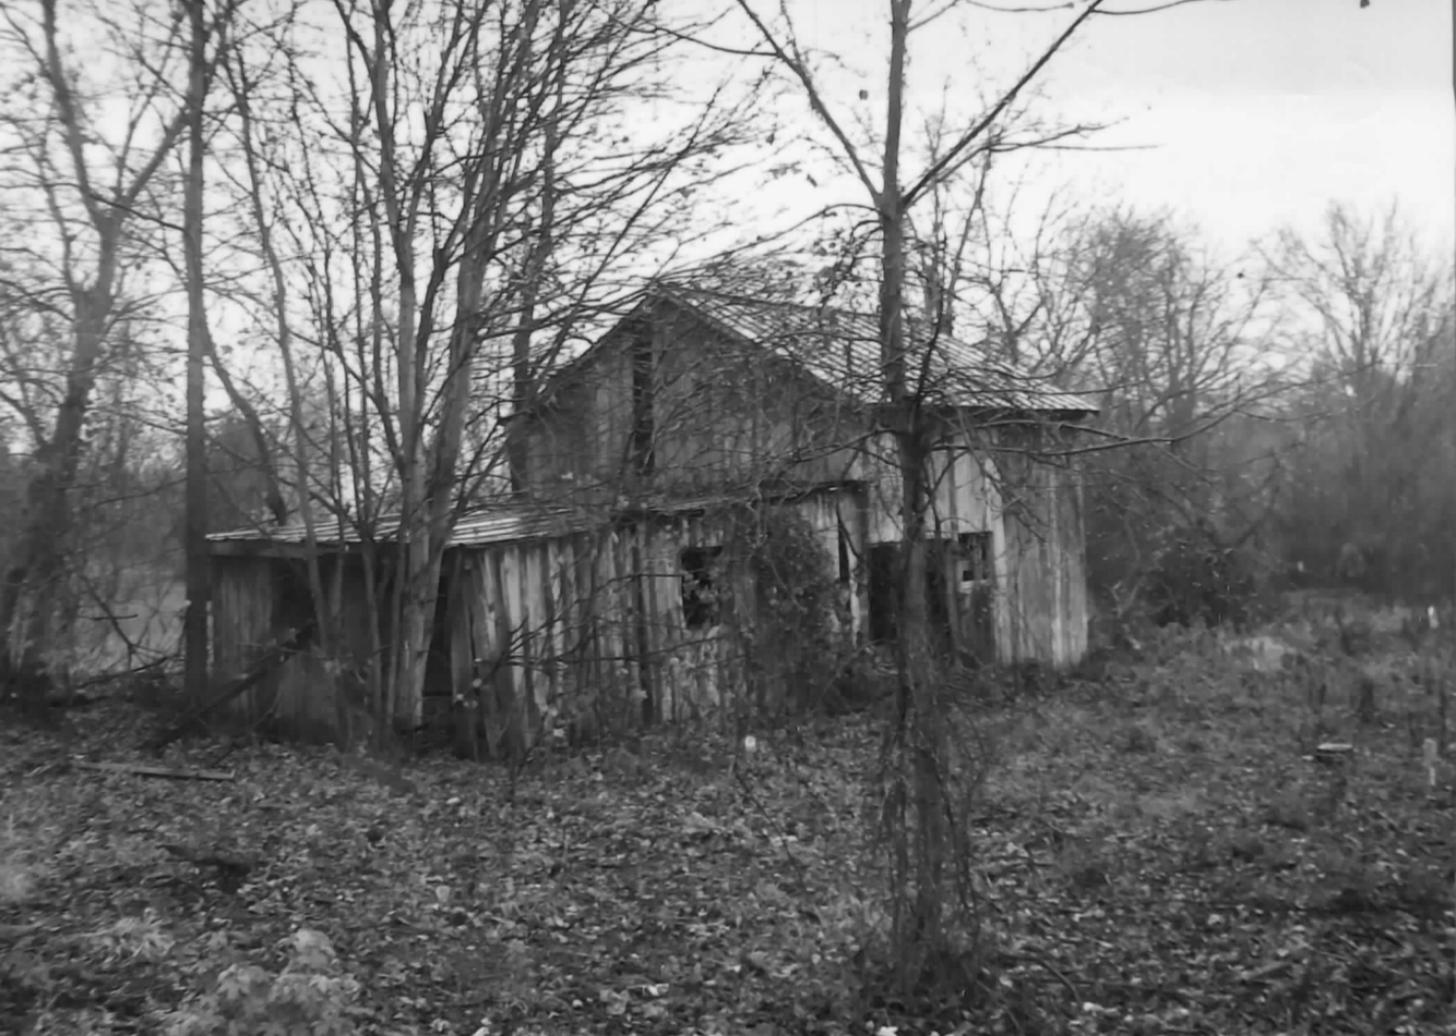
Shed 6 is located east of Tobacco Barn 5 in a low somewhat wooded area suggestive of a former paddock. This shed has likely served as a small, rectangular, side gable barn. The main block features a shed roof addition which may have served as an animal pen within the paddock. The construction date is estimated at the early to mid twentieth century. Walls are covered in vertical wood planking and roof planes are covered in standing seam metal. The foundation is unknown. Wood framed windows were once located on several elevations. The condition of this shed is moderate to poor, doors and windows are missing and vines and weedy vegetation are encroaching.

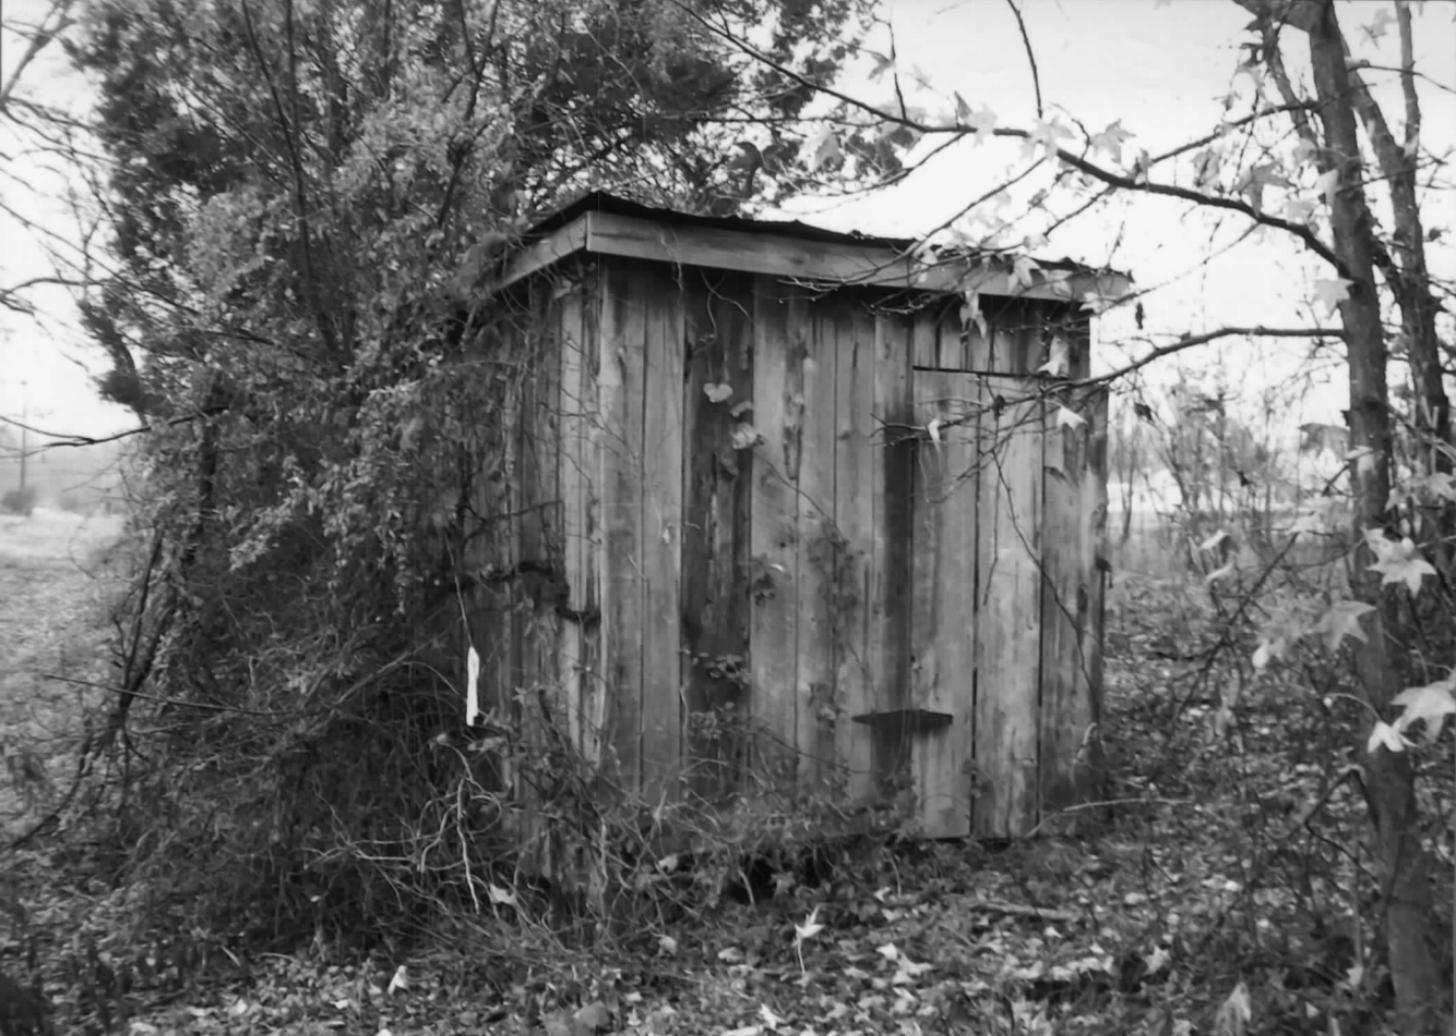
Sheep 8

Shed 8 and 9 are corn cribs located in level yards northwest of Hay Barn 1. These sheds feature vertical wood plank siding and shed roofs covered with standing seam metal. Foundations are unknown. Construction dates are estimated to be mid twentieth century. Interiors are fitted with wire mesh and floors are wood plank. These sheds are considered to remain in moderate condition but will quickly succumb to increasing rot and encroaching vegetation.

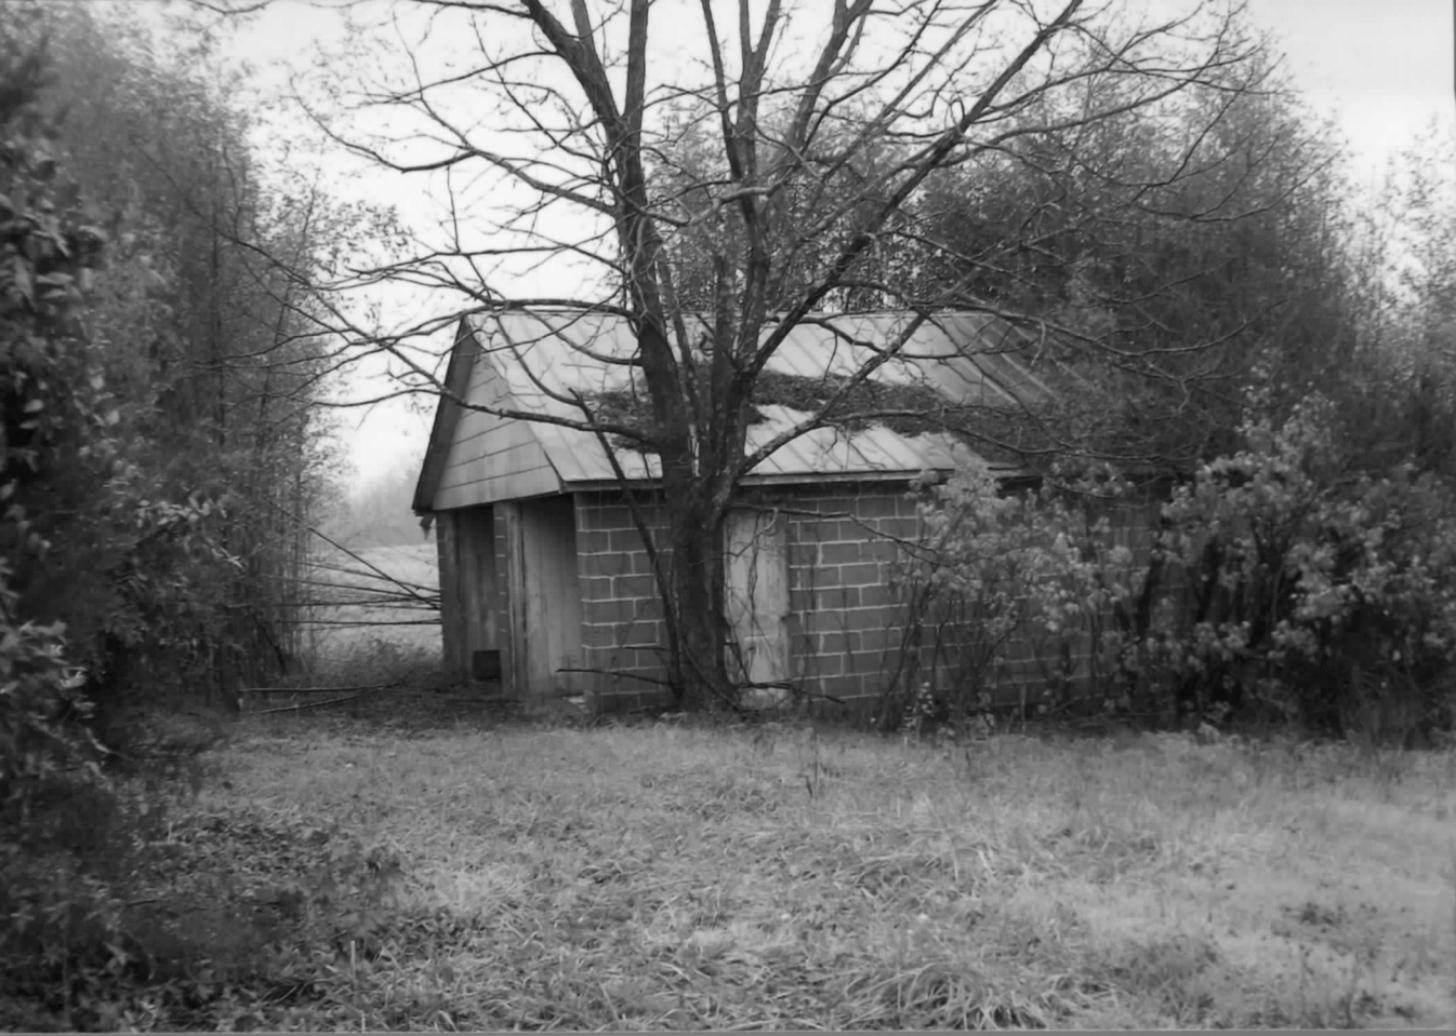
The Garage is located south of the house site on a slope that descends to the south. This square, mid twentieth century, front gable, cinder block garage features two bays. The gables above the garage doors are sheathed with possible asbestos siding while the roof is covered in standing seam metal. A wood, four-panel door provides pedestrian access while wood double doors have been fitted into each garage bay. The condition of this garage is considered to be moderate. The rear of the garage is becoming overgrown by weedy vegetation and vines.

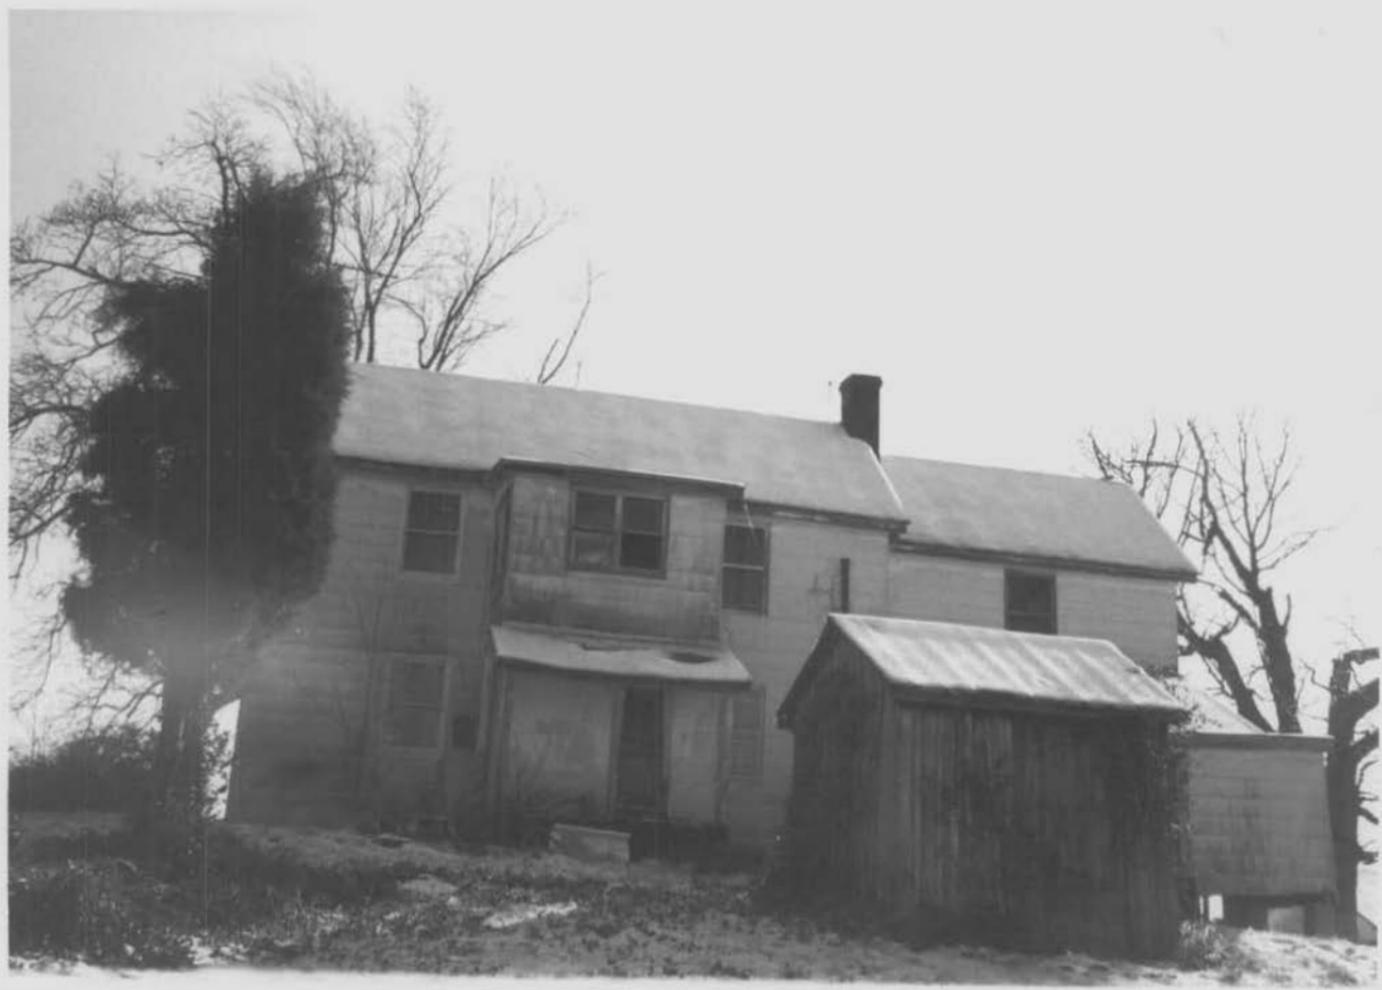
- 1 CH-425
- 2 Caroline Christ Farm
- 3 Charles County, MD
- 4 Caroline Hall
- 5 January 1997
- 6 MD SHPO
- 7 North elevation of shed 3, view SW
- 8 4 of 14

Shed 3 (Site) was once located immediately northwest of the house on the same prominent knoll. This shed was likely burned during the house fire. It is no longer extant. The 1998 survey photos suggest that this shed featured a rectangular footprint, vertical plank walls and was covered by a standing seam metal roof.
