Morgantown Road House
CH-723
Morgantown vic.
Private

Maryland Inventory of Historic Properties Form

Inventory No. CH-723

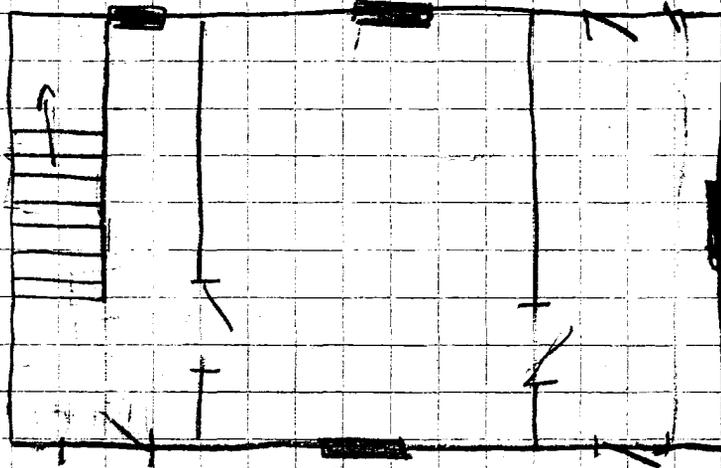
FIRST
FLOOR
PLAN

Due to the building's ruinous condition interior evaluation was limited to the first floor revealing a narrow partitioned stair on the west wall. The stair was enclosed in a narrow stair passage partitioned from the larger room to east. Wide Victorian trim surrounded the windows. Walls were plastered above matchstick wainscoting.

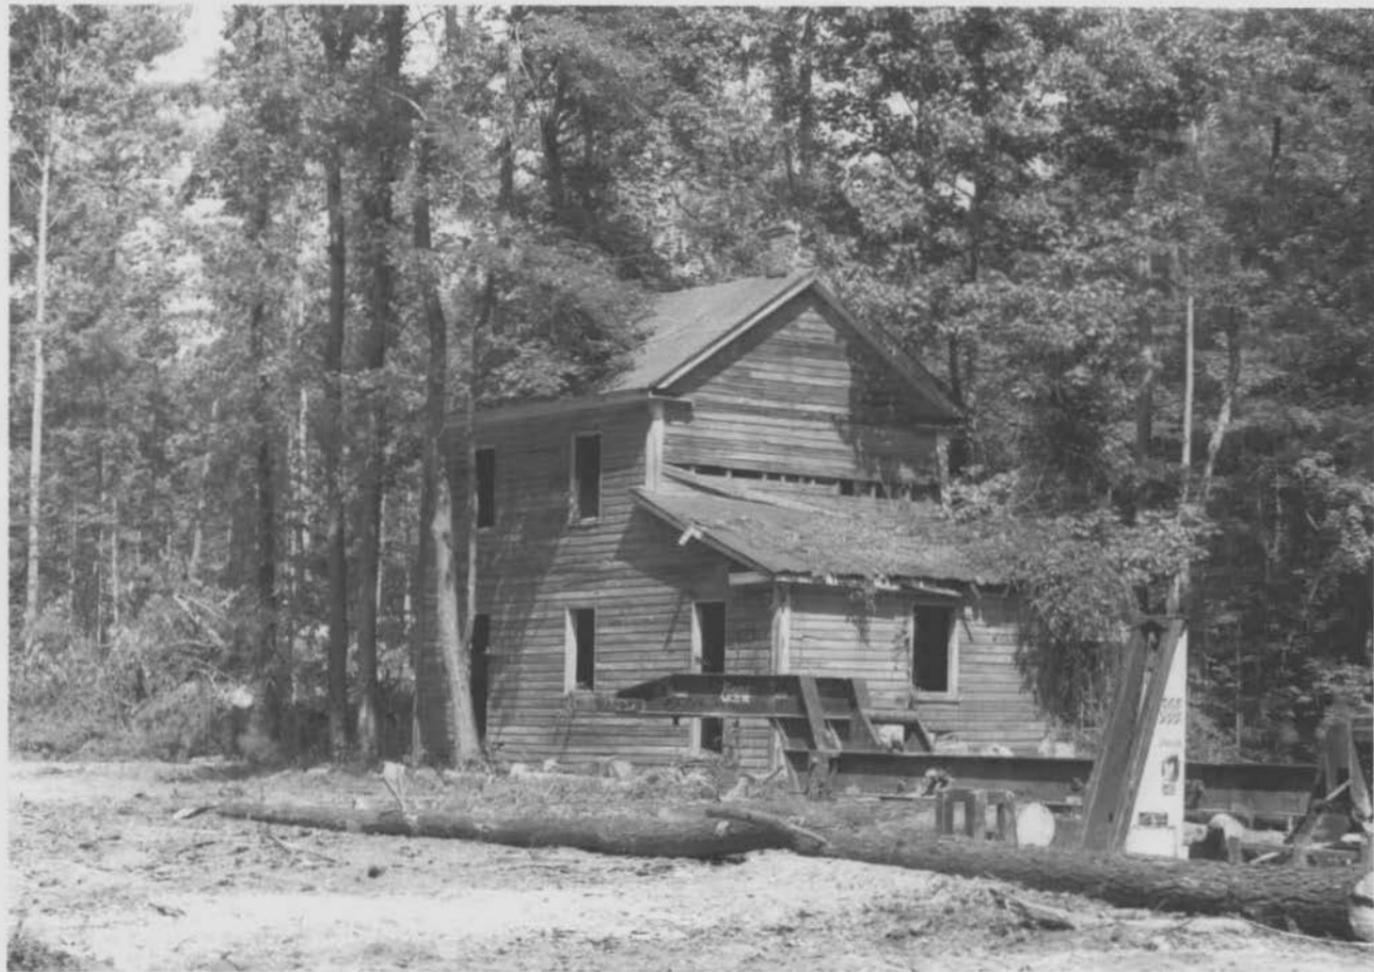
CH-723
MORGANTOWN ROAD HOUSE
CHARLES O. MD
C. CURREY
2/2001
MD SHPO
LOOKING NW
1 OF 2

The Morgantown Road House, demolished soon after being field surveyed, was a two-story, two bay frame dwelling on the north side of Morgantown Road. Abandoned for some time, the house faced south and stood slightly removed from the roadside. An original one story ell extended from the east elevation. Although all windows and doors had been removed long before the property was evaluated, the original exterior finishes including novelty siding remained intact. Although overtly simple in design, the dwelling had some decorative finishes including a boxed cornice, eave returns and corner boards. A single interior end chimney flue was placed in the main block, near the east wall.

The façade was symmetrical with a first floor doorway to the west and a window to the east. Above this were placed two second story windows. The rear elevation included only two first floor windows. The west elevation was without fenestration. The ell included a doorway on the façade, a single centered window on the east wall and a doorway at the rear.
