INVENTORY CAPTION: SLAVE QUARTERS, ST. IGNATIUS CHURCH

INVENTORY FORM FOR STATE HISTORIC SITES SURVEY

HISTORIC SLAVE QUARTERS, ST. IGNATIUS CHURCH

ADDENDUM TO THE FILE
BLACK SERVANT HOUSE AT ST. THOMAS MANOR
CH-7A

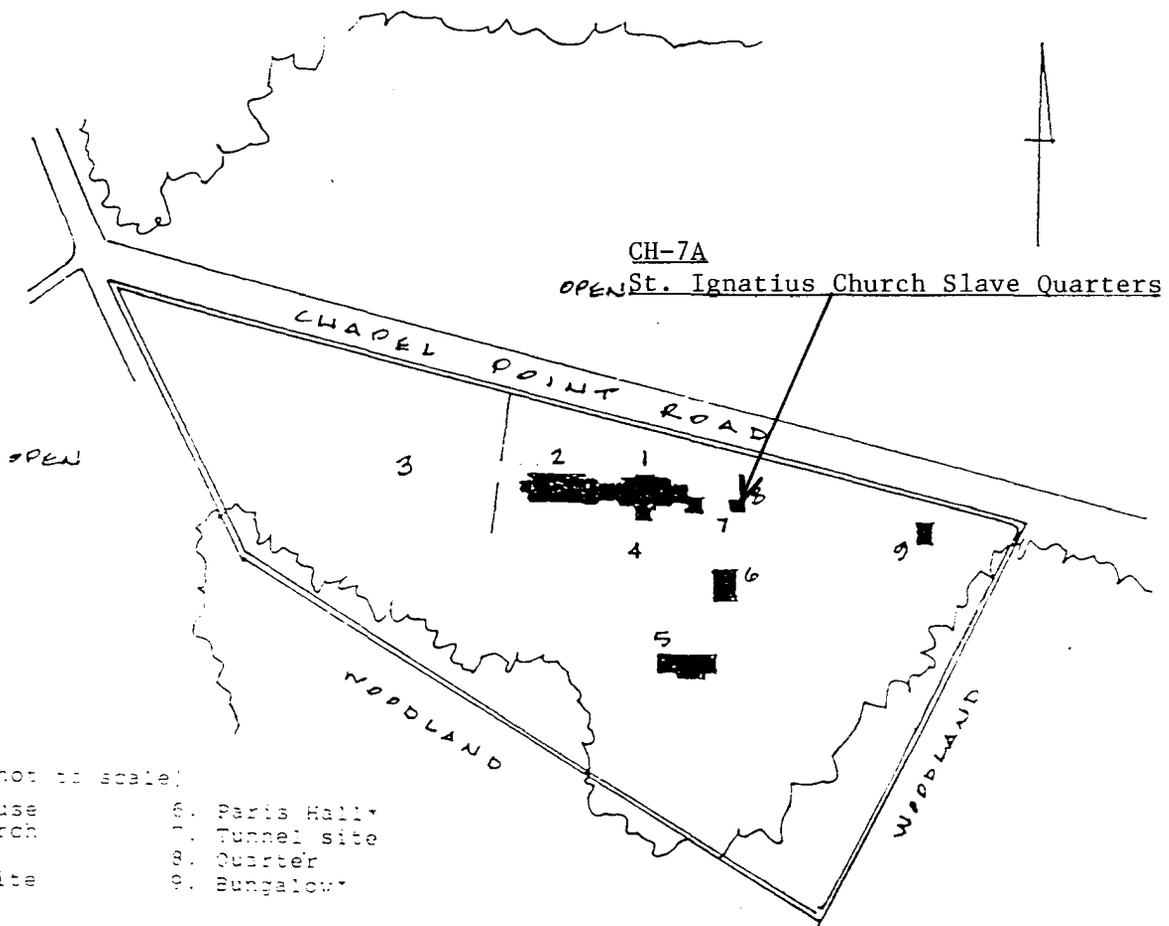
RESOURCE SKETCH MAP, 1988

SITE PLAN

(Buildings not to scale)

| 1. Manor House | 6. Paris Hall* |
| 2. 1798 Church | 7. Tunnel site |
| 3. Cemetery | 8. Quarter |
| 4. Garden Site | 9. Bungalow* |
| 5. Barn | |

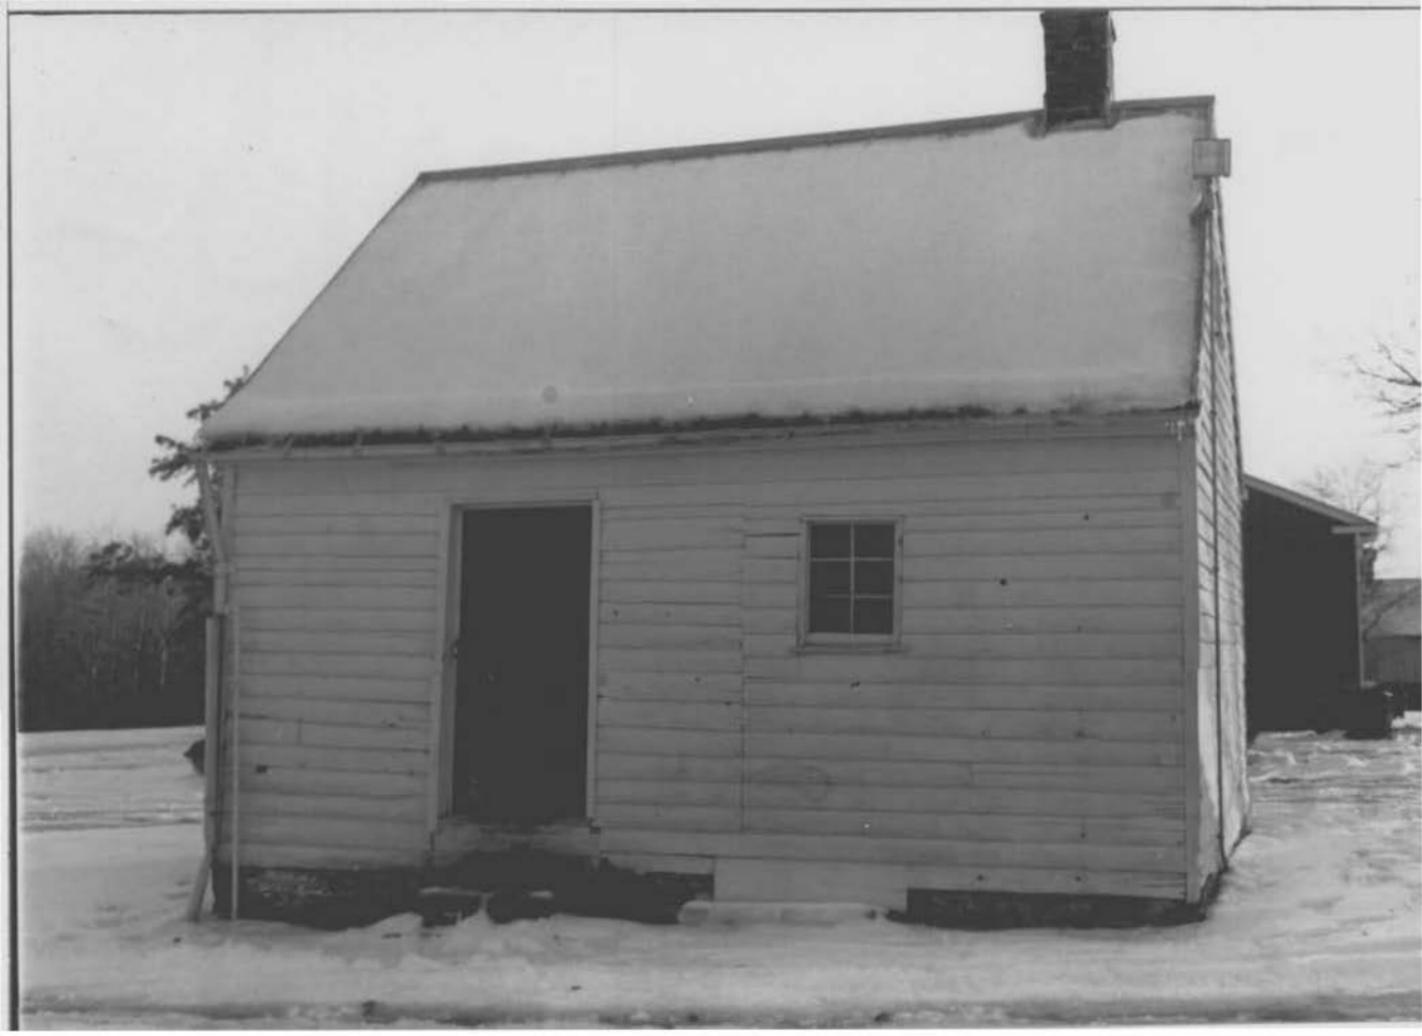
SLAVE QUARTERS, St. Ignatius Church

NORTH facade

The fenestration of the principal north facade consists of a door to the east and a six-light single sash window to the west. A vertical seam in the siding suggests that the door may have originally been centered on the facade. A cellar window is positioned below the first-floor window.

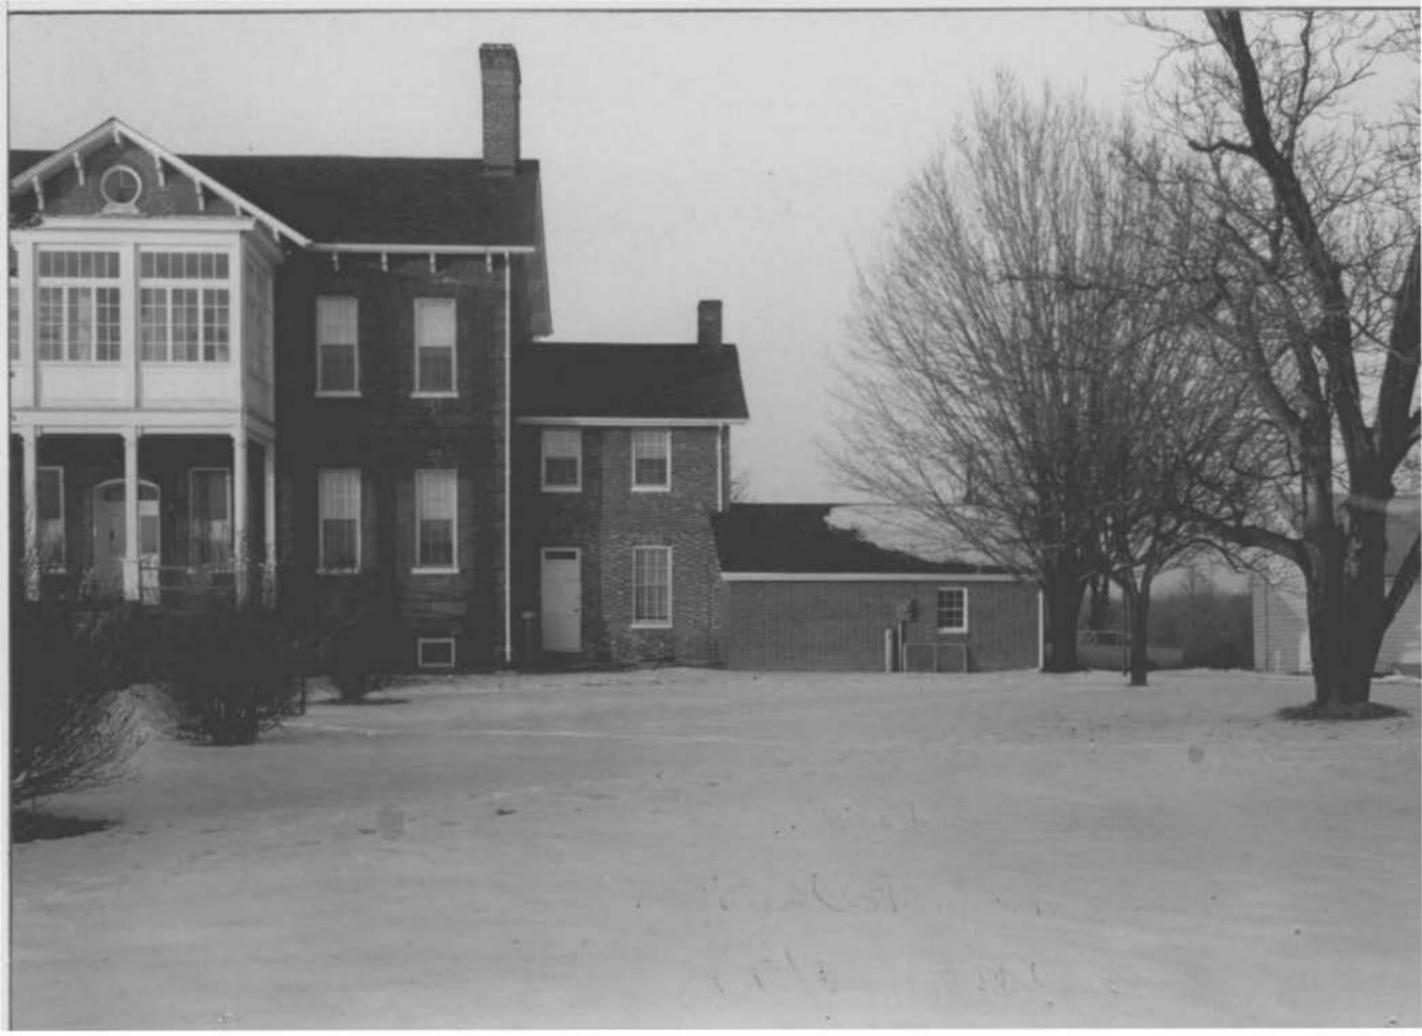
SLAVE QUARTERS, St. Ignatius Church
CH ~~326~~ 7A
BEL Airton, Md.
SOUTH ELEVATION
GWM - 1/77

The south wall has two windows. The west window is identical to that on the north facade; the east window has been replaced with a four-light sash. The two cellar windows are evenly spaced below. A bulkhead with a tin, standing-seam cover is roughly centered and provides access to the fully-excavated cellar.
