House of the Hinges
East New Market
private

Maryland Historical Trust State Historic Sites Inventory Form

Survey No. D-1

historic MANNING HOUSE

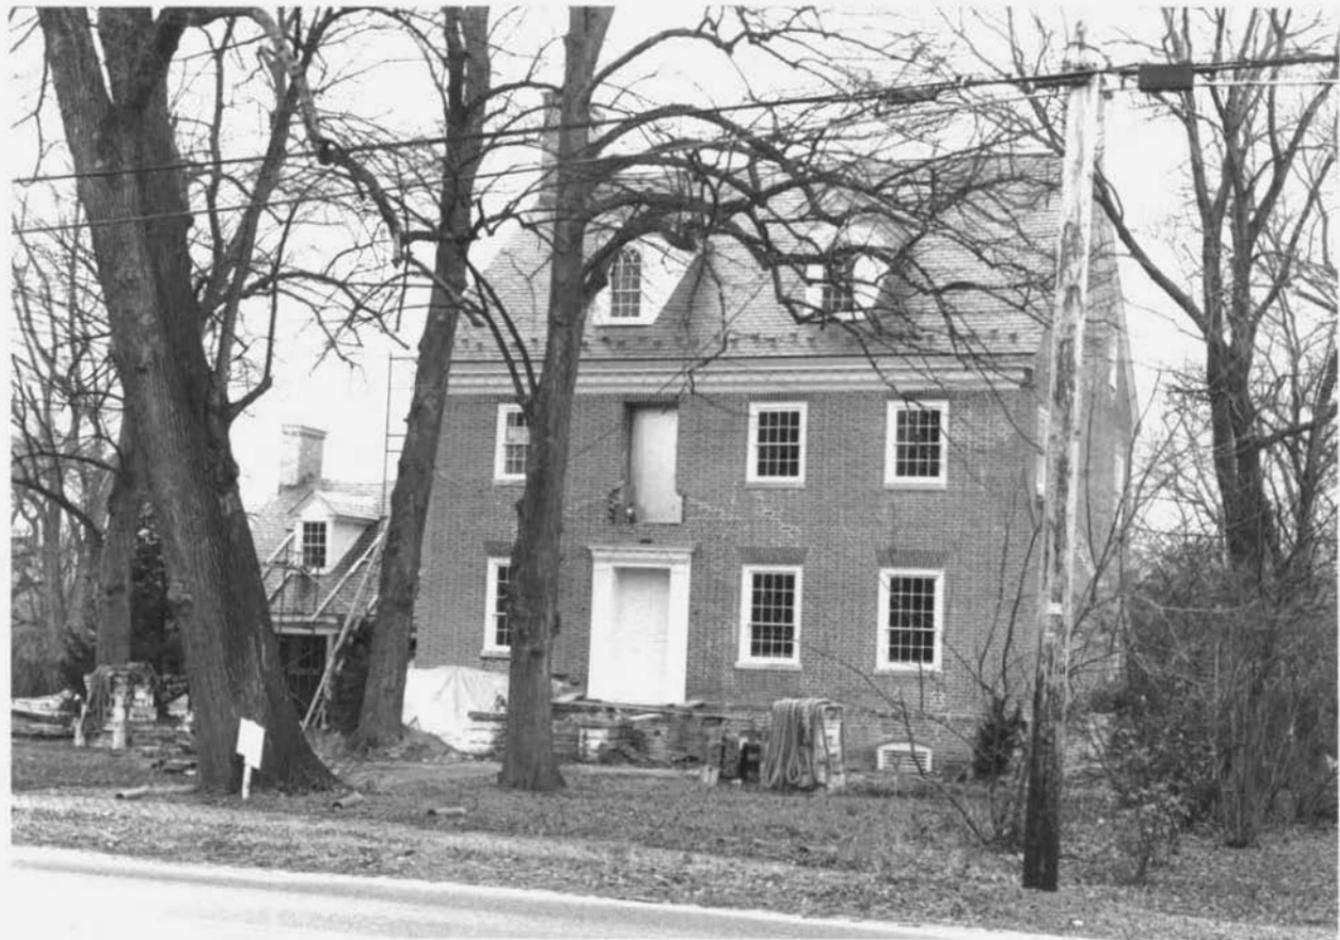
D-1

East elevation

The east (main) facade is an asymmetrical four-bay elevation that has been recently restored with a new double-door entrance and flanking twelve-over-eight sash windows. The raised-panel double doors, located in the second bay from the south, have been interpreted with flanking pilasters and an elaborate modillion block cornice. The cornice profile was taken from the original block cornice surviving on the dormers. Each of the window openings are topped by carefully executed jack arches. The second floor is marked by four window eight-over-eight window openings. The second bay from the south had originally been a window opening, but was changed to a door opening and then back to a window opening. Stretching across the base of the roof is an intricate cornice with an elaborate series of moldings. The modillion blocks have a delicate tapered profile, and a row of candlestick punch and gougework enhance the bed molding. Distinguishing the steeply pitched roof are a pair of gabled dormers that boast modillion cornices and original arched sash windows. The sides to the dormers are covered with diagonal board sheathing. Piercing the foundation are segmental arches cellar window openings with restored horizontal bar grills.

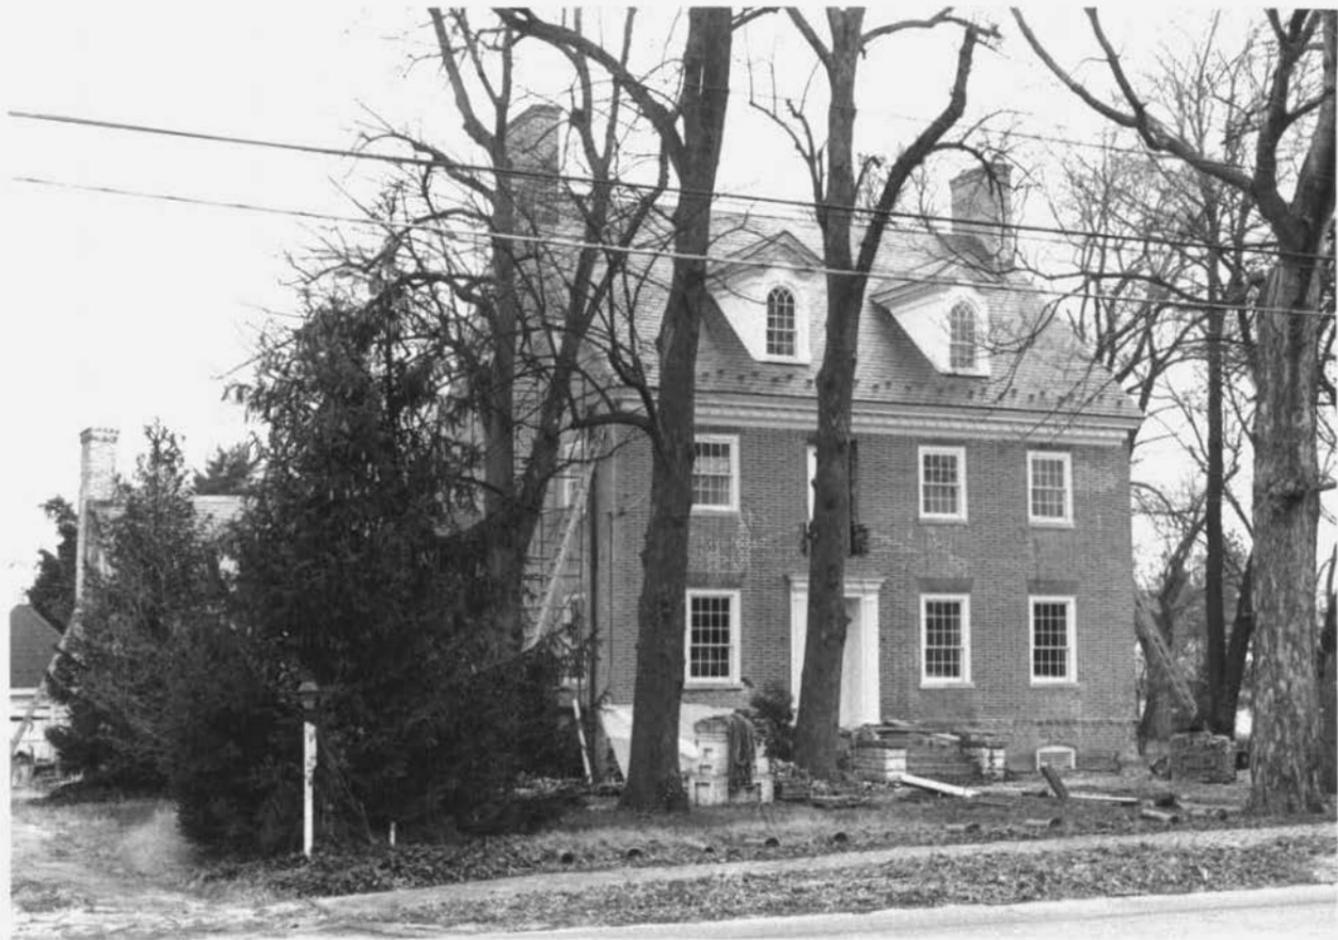
D-1

East elevation

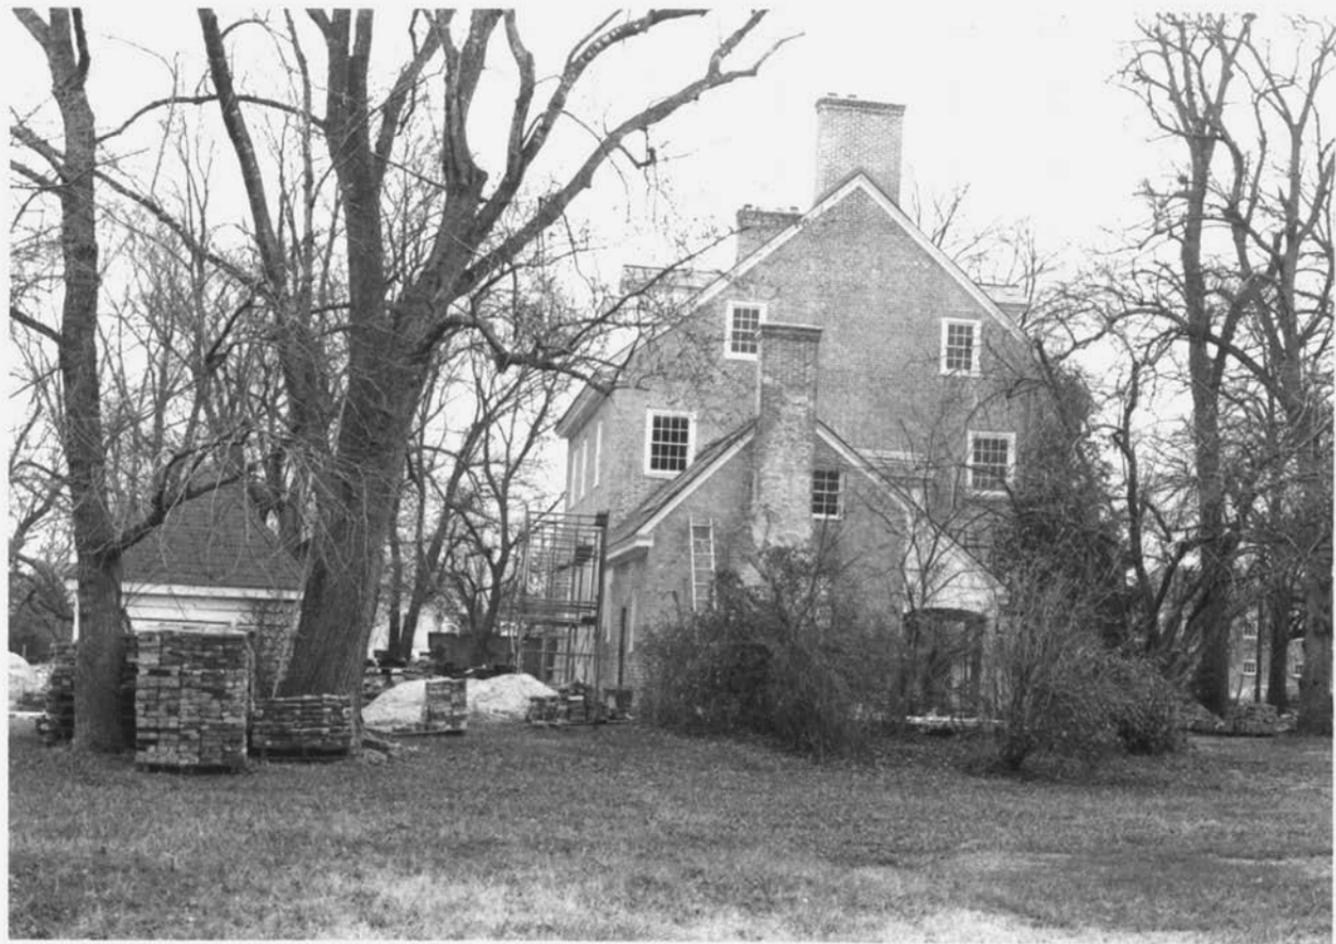
D-1

South elevation

The south side of the main block is partially covered by a story-and-a-half three-course common bond brick kitchen that incorporates the remnants of an earlier brick structure of undetermined date. The balance of the south wall of the main house includes an original eight-over-eight sash window that lights the first stair landing and restored eight-over-eight sash windows that illuminate the south rooms. The attic wall is pierced by a pair of six-over-six sash windows to either side of the large interior end brick chimney. The gable end is finished with a molded bargeboard. An exterior cellar entry is located in the east bay and is sheltered by a gable roof frame entry.

The south end of the kitchen is dominated by a partial exterior brick chimney with corbelled shoulders. The chimney is laid in five-course common bond. Evident in the brickwork is a slight raising of the roof to include the engaged porch in front. A four-over-four sash window pierces the upper gable east of the brick stack, and the end wall of the porch is covered with flush beaded boards.

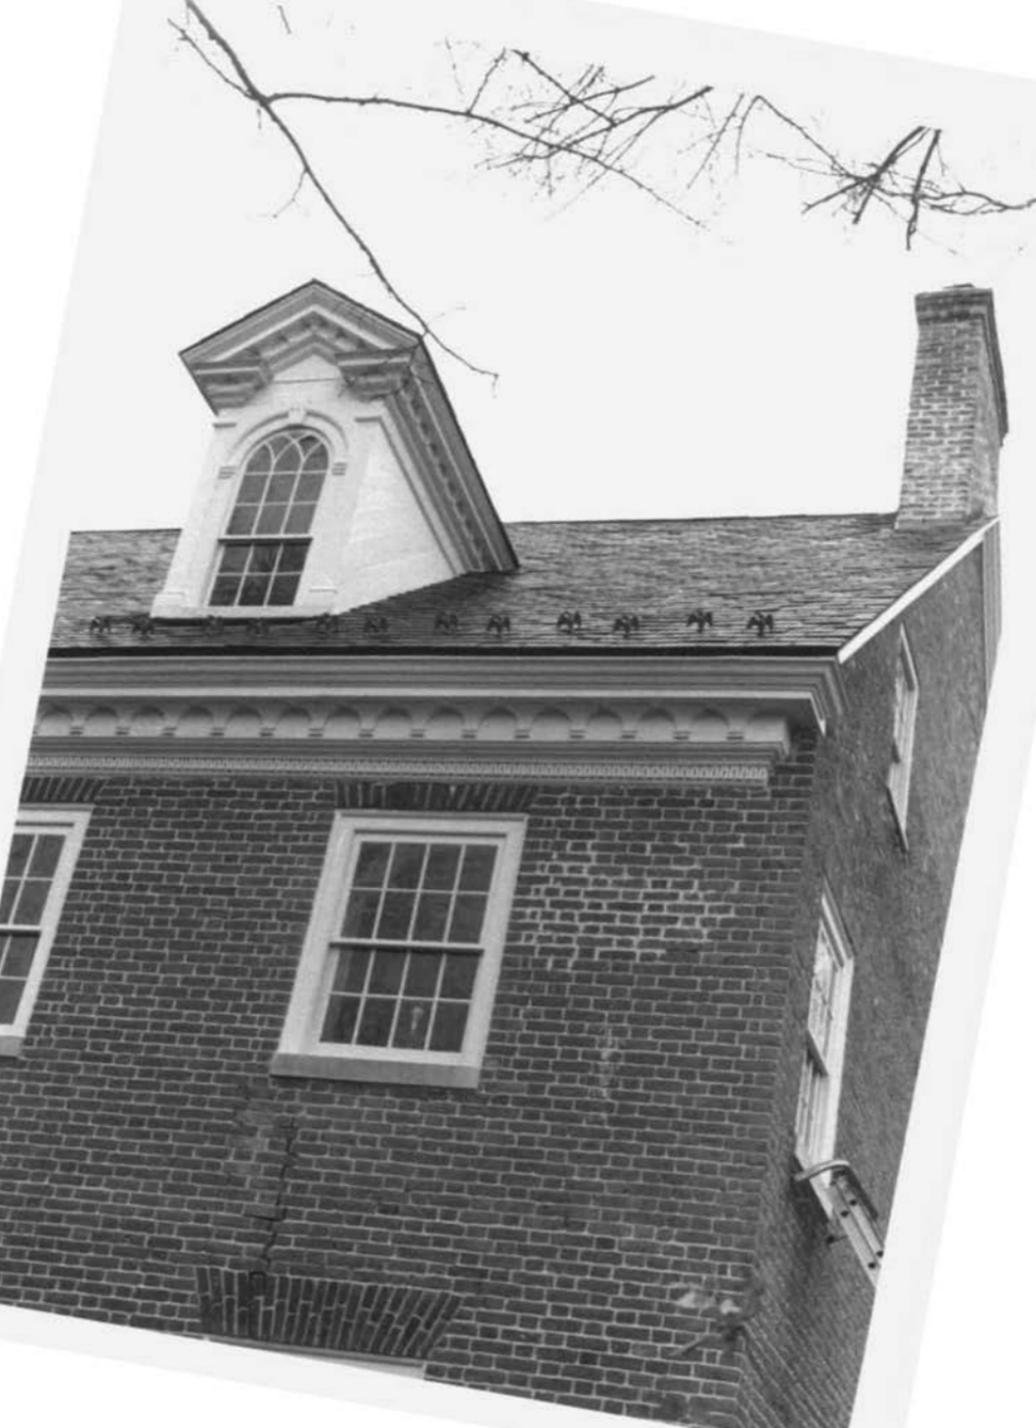
D-1

Northeast corner

The north side of the house is an asymmetrical elevation as well with a single twelve-over-eight sash window marking the west bay, and a pair of eight-over-eight sash windows lighting the second floor. Six-over-six sash windows light the attic to either side of the tall, interior end brick stacks that are finished with corbelled caps. The gable end is flush and trimmed with a molded bargeboard.

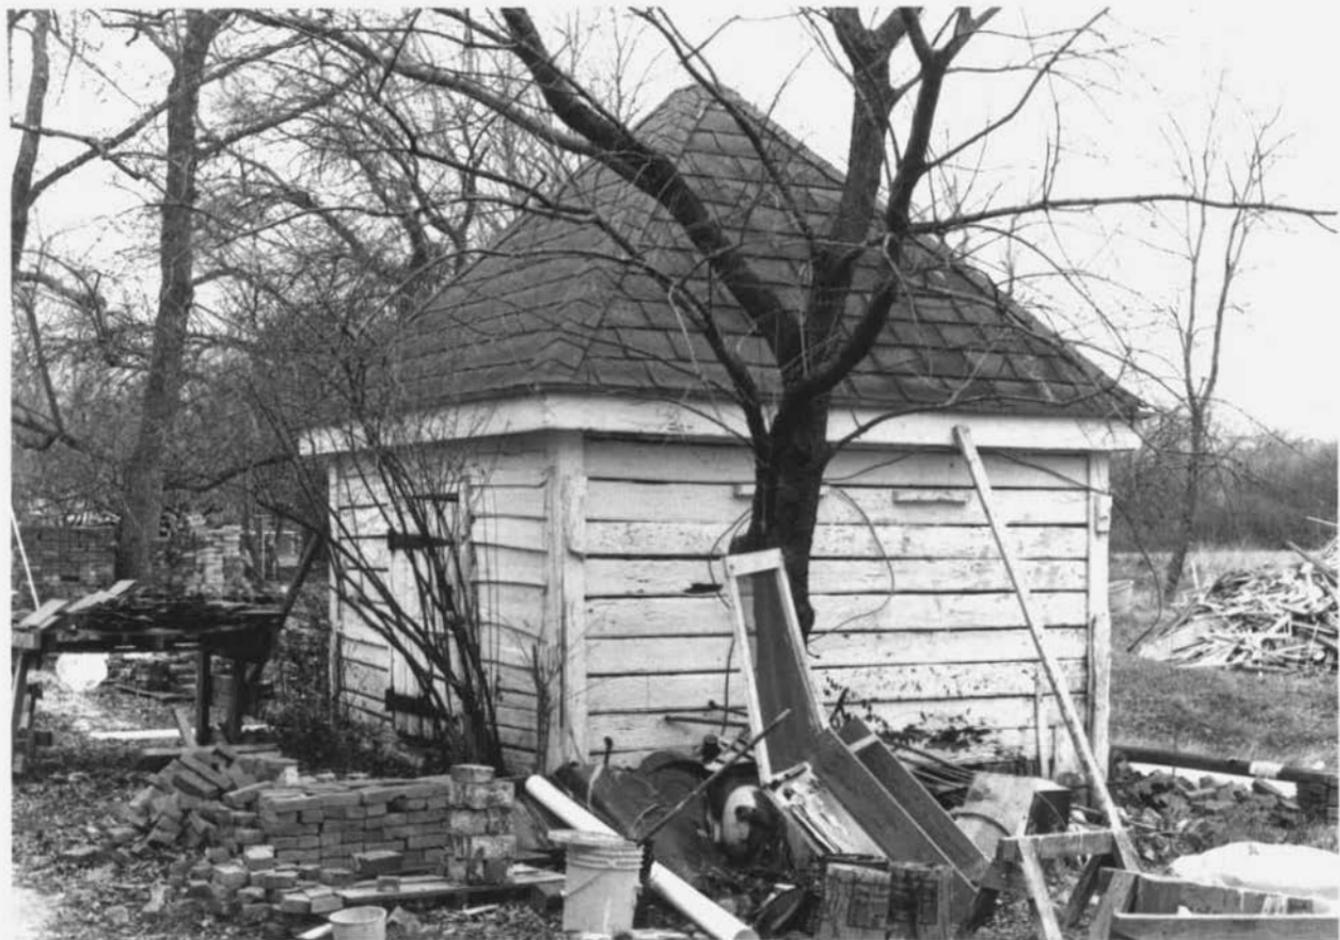
D-1

Northeast elevation of meathouse

Standing directly behind the kitchen is a pyramidal roofed hewn log smokehouse. Supported by the remnants of a continuous brick foundation, the smokehouse is covered by a pyramidal asphalt shingle roof. The exposed logs were finished with a beaded edges, and the corner notching was covered with beaded edge boards. Piercing the east side is a large board door with long spade-tipped strap hinges. Along the inside edge of each strap hinge a tangent section of iron curls out to add further support for the door. The door is framed by a molded surround. The cornice above the door is boxed. The side walls consist of stacked hewn logs with beaded edges, while the west (rear) wall is pierced by a small window opening framed by a molded surround. Two sets of iron bars criss-cross the window opening which is covered by a board shutter hung on long strap hinges. The interior has a loose board floor.

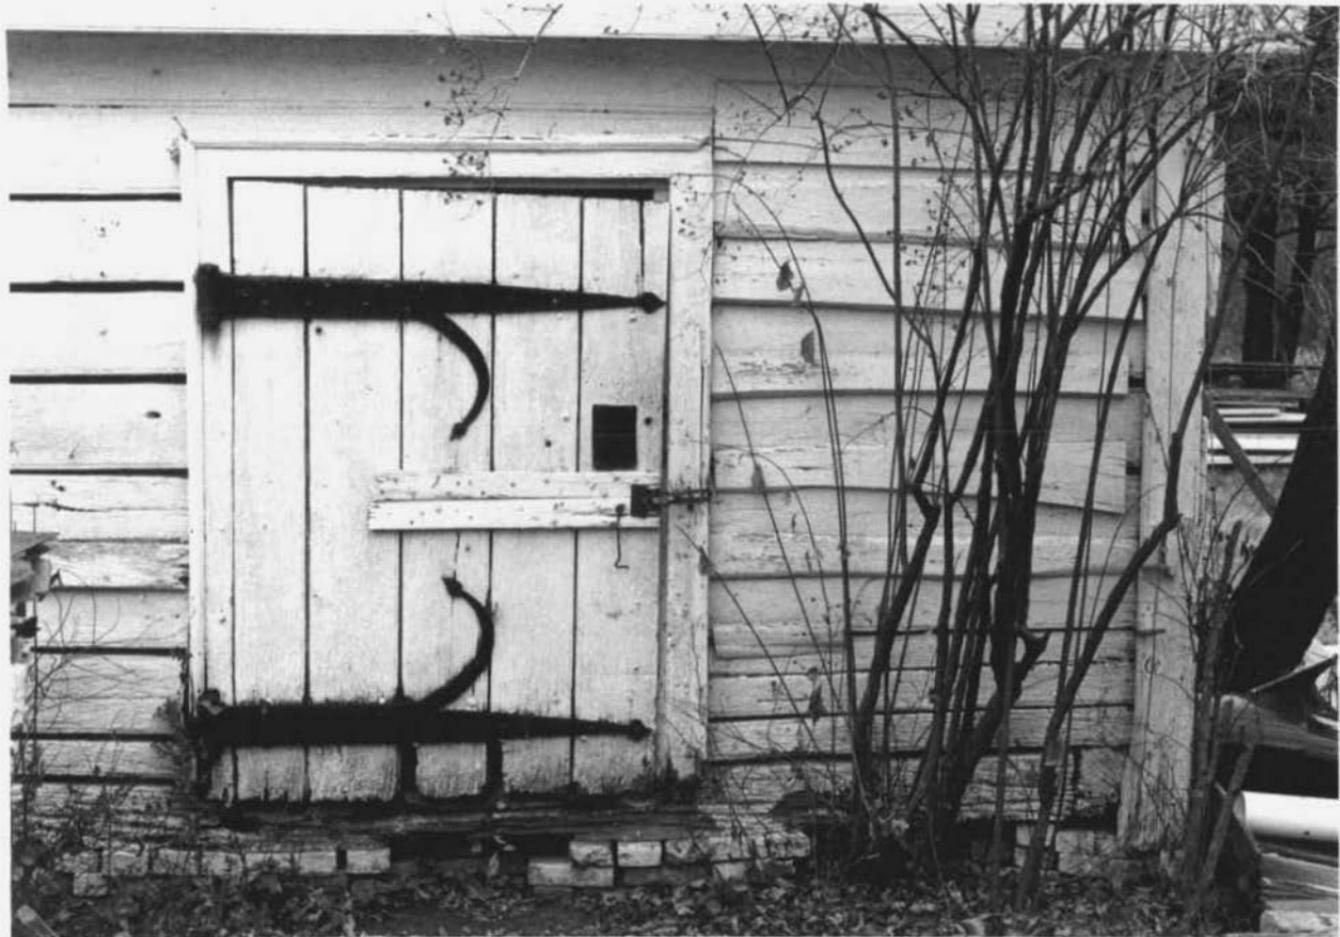
D-1

Meathouse door-east elevation

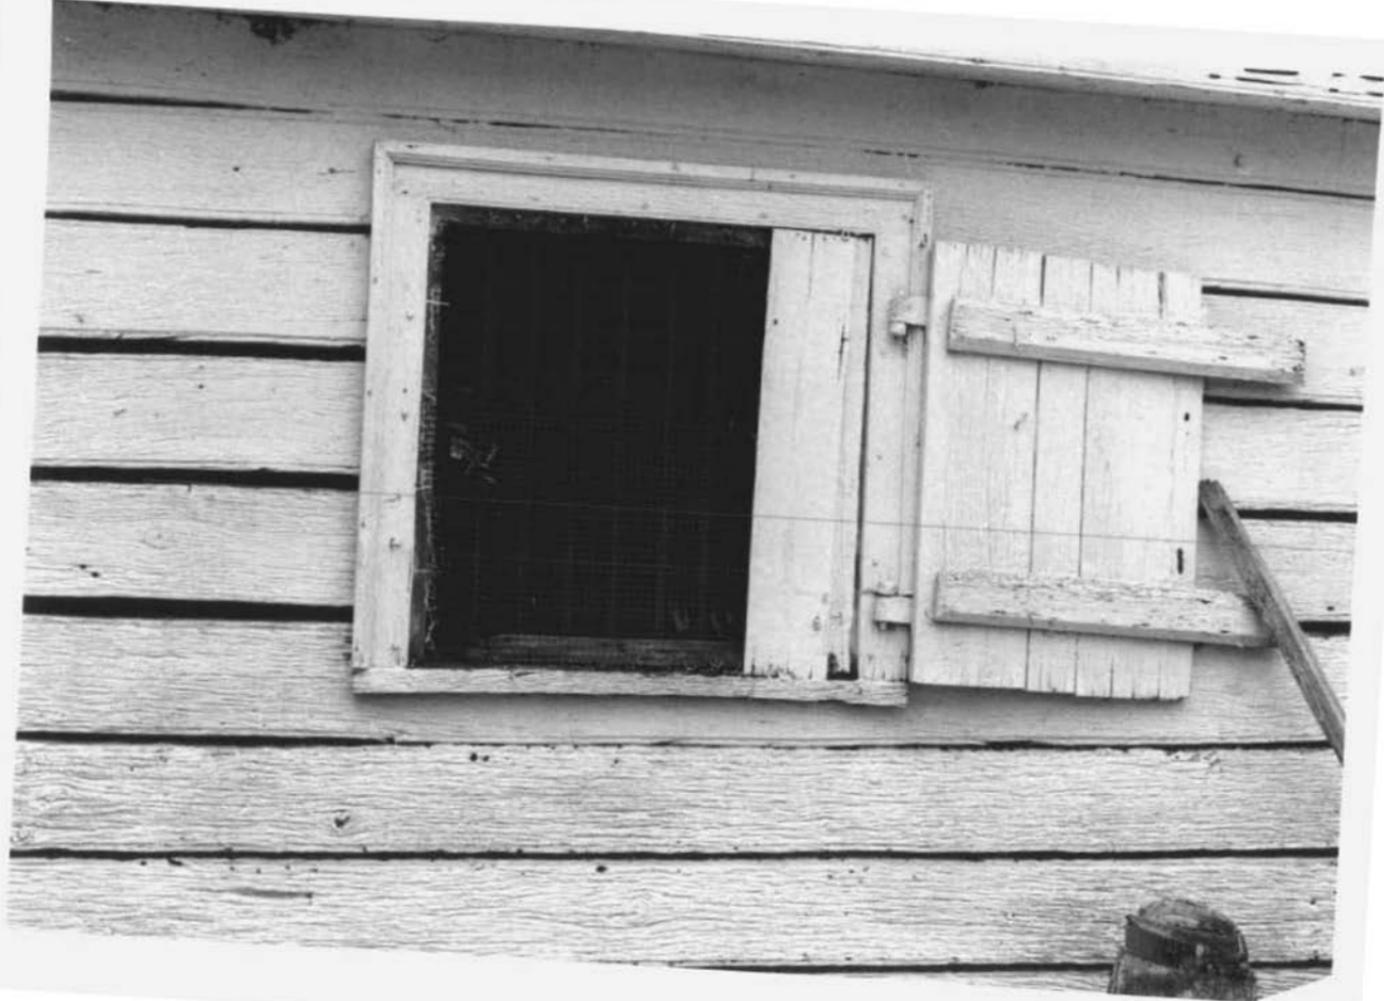
D-1

Meathouse window-west elevation

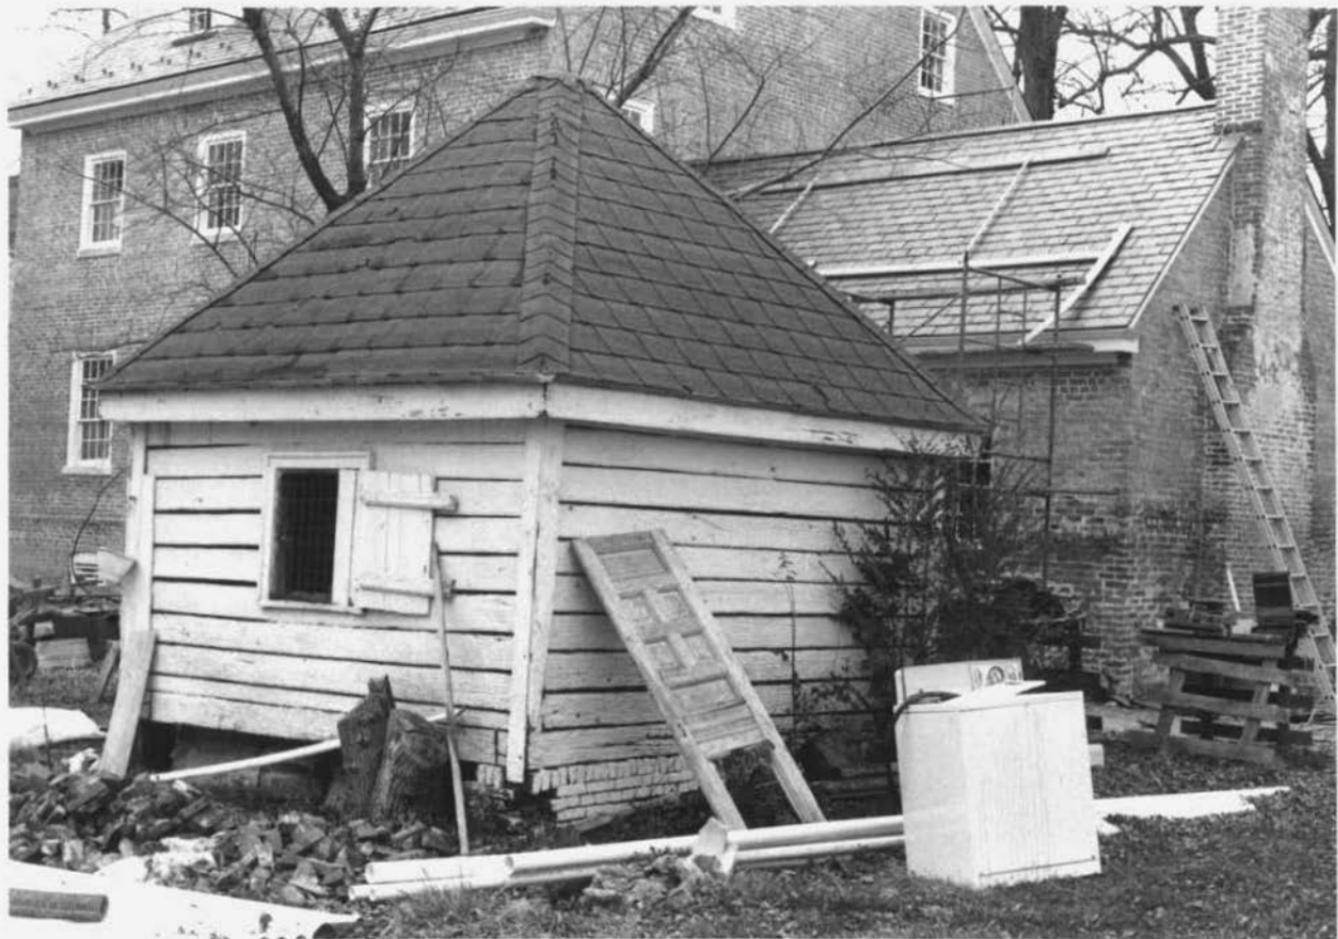
D-1

Southwest elevation of meathouse

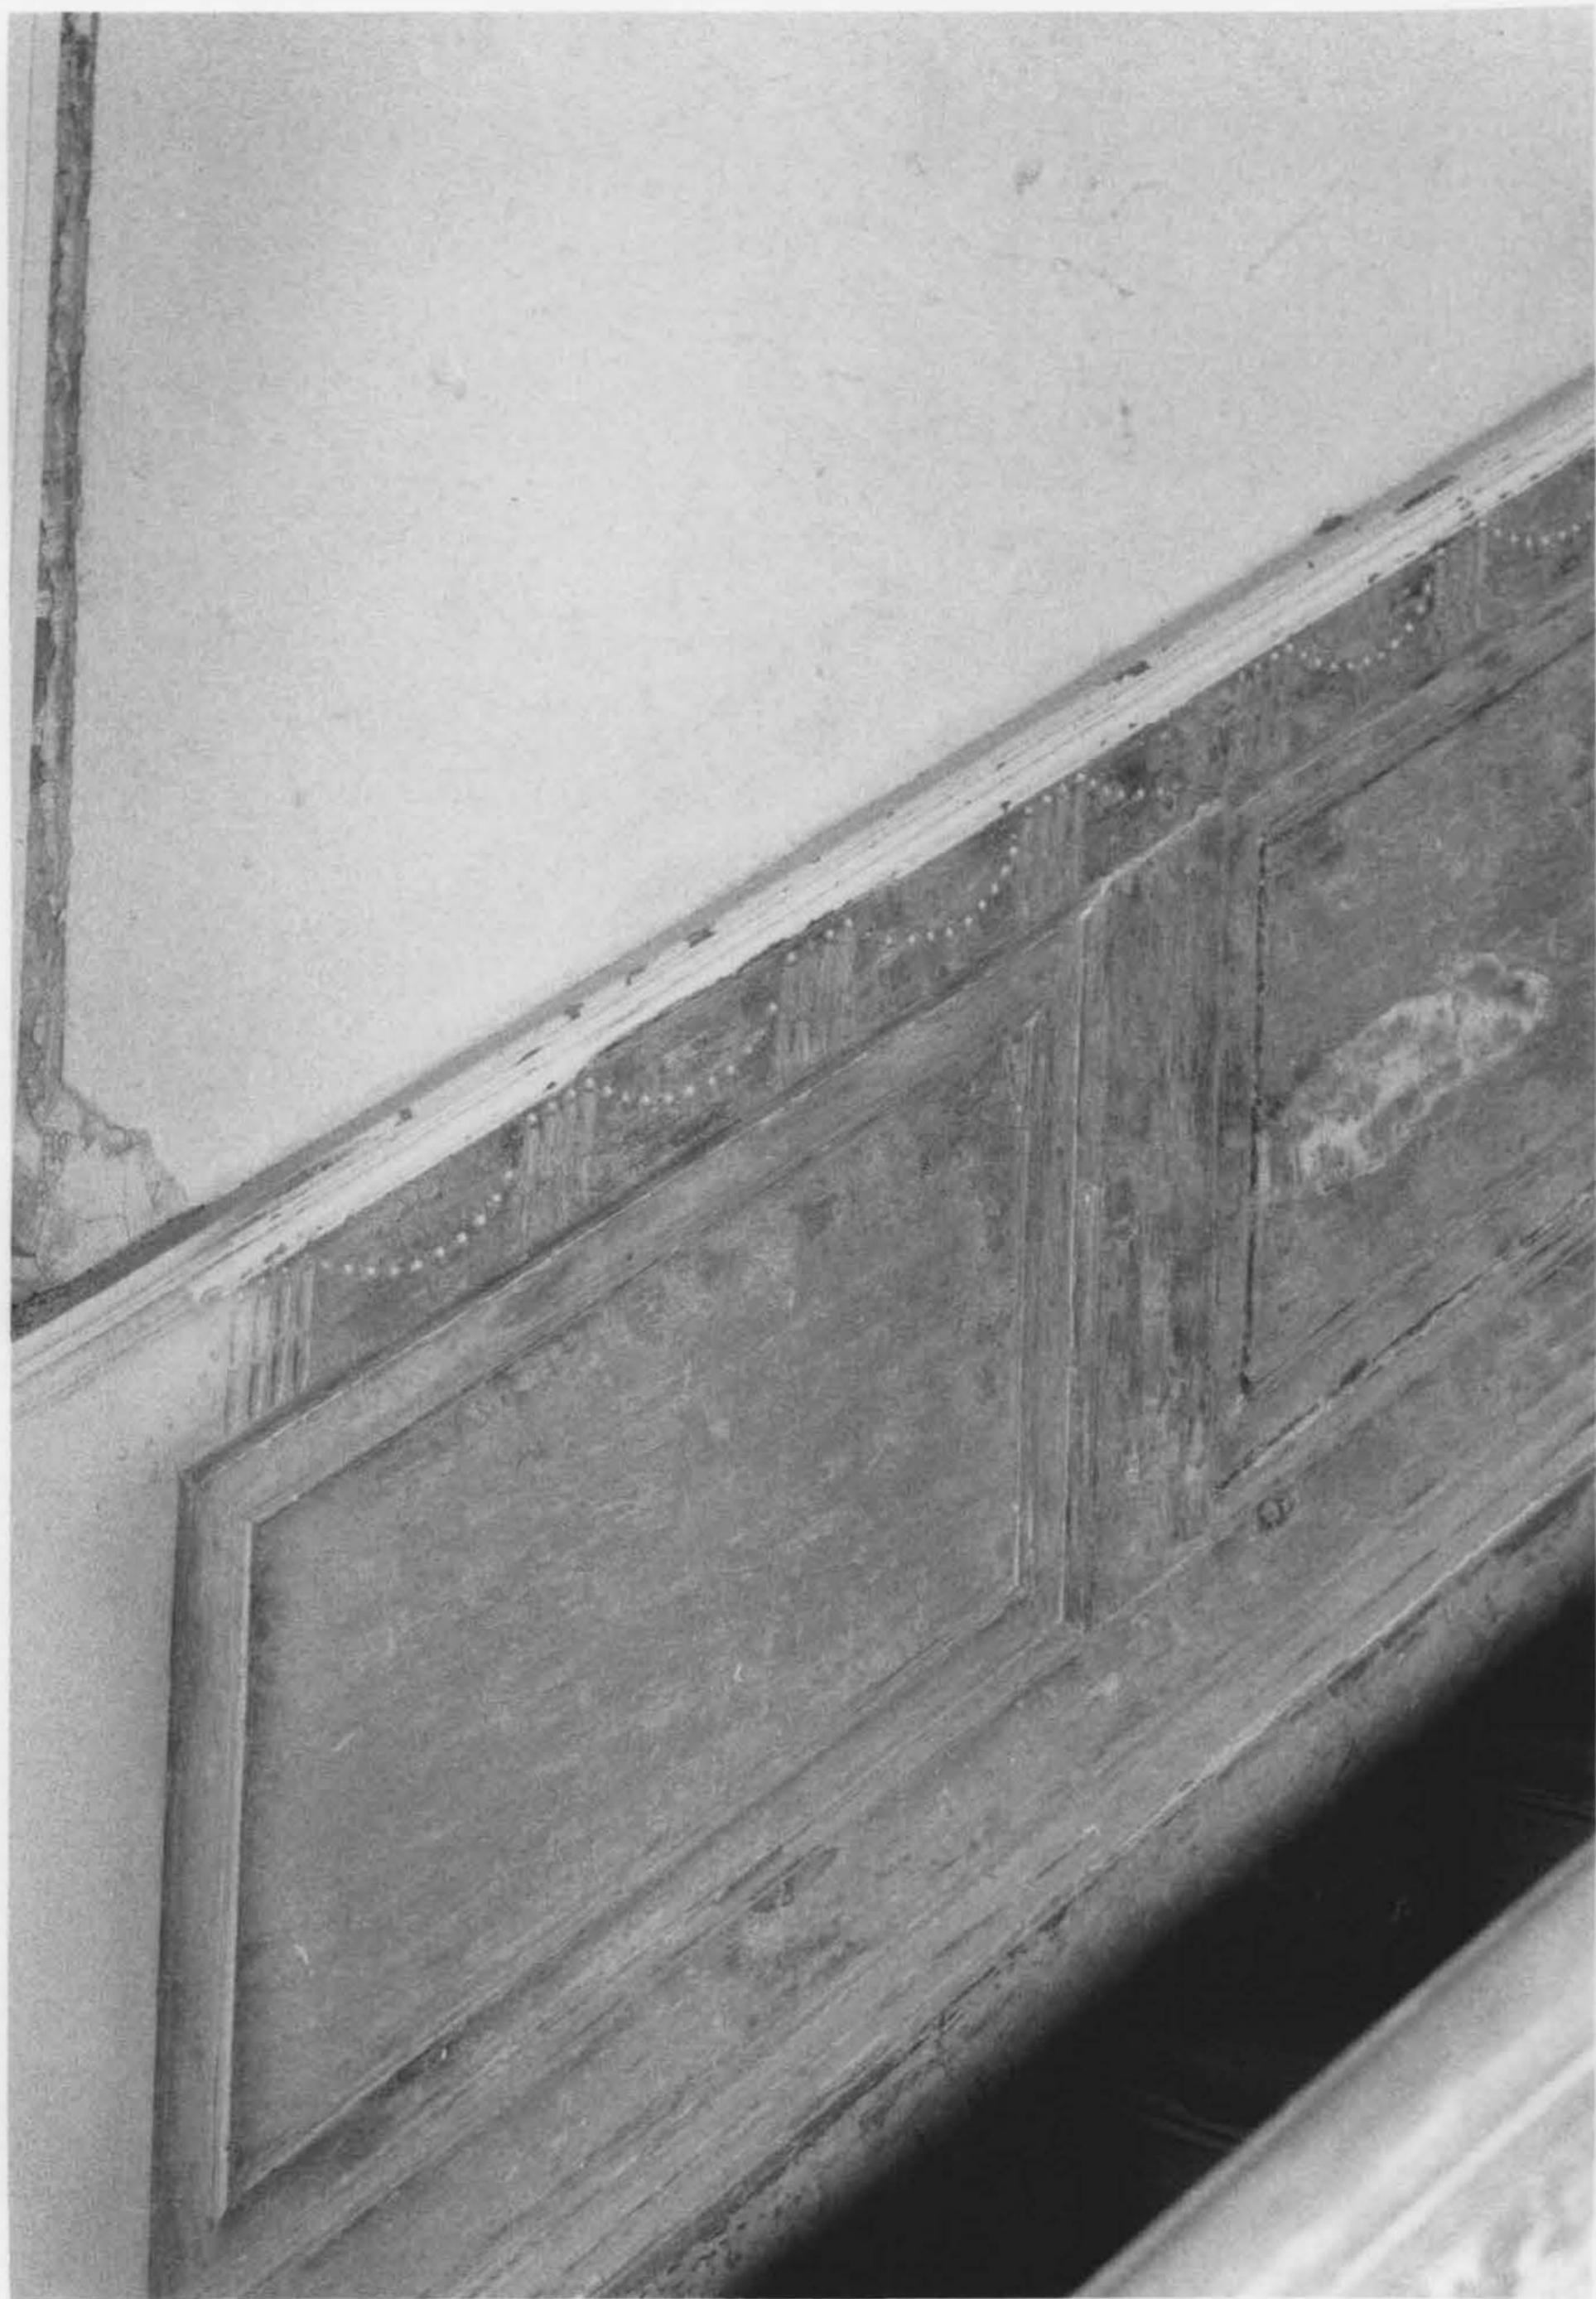
D-1

Wainscoting along staircase

The first floor is divided into four unequal sized rooms. The squarish entrance hall, comprising the southeast quarter of the first floor, is dominated by the decorated quarter-turn stair that rises in the southeast corner of the entrance hall. The slender turned newel post and the series of turned balusters support a molded handrail. The stringer below is decorated with a delicate scroll design with the end of the S-shaped curve embellished with a gougework star. Below the stringer the large triangular space is divided by a series of flat panels. The stair soffit is finished with the same flat panels. The soffits of the second floor run of steps were fitted with reproduction flat paneling as well. The entrance hall walls were originally fitted with flat-panel wainscoting as well, a section of which survives against the south wall rising with the stair. The wainscoting is embellished with a punch and gougework row imitating classical swags. The entrance hall has been refitted with restored six-panel doors framed by crossetted surrounds with ovolo molded backbands.

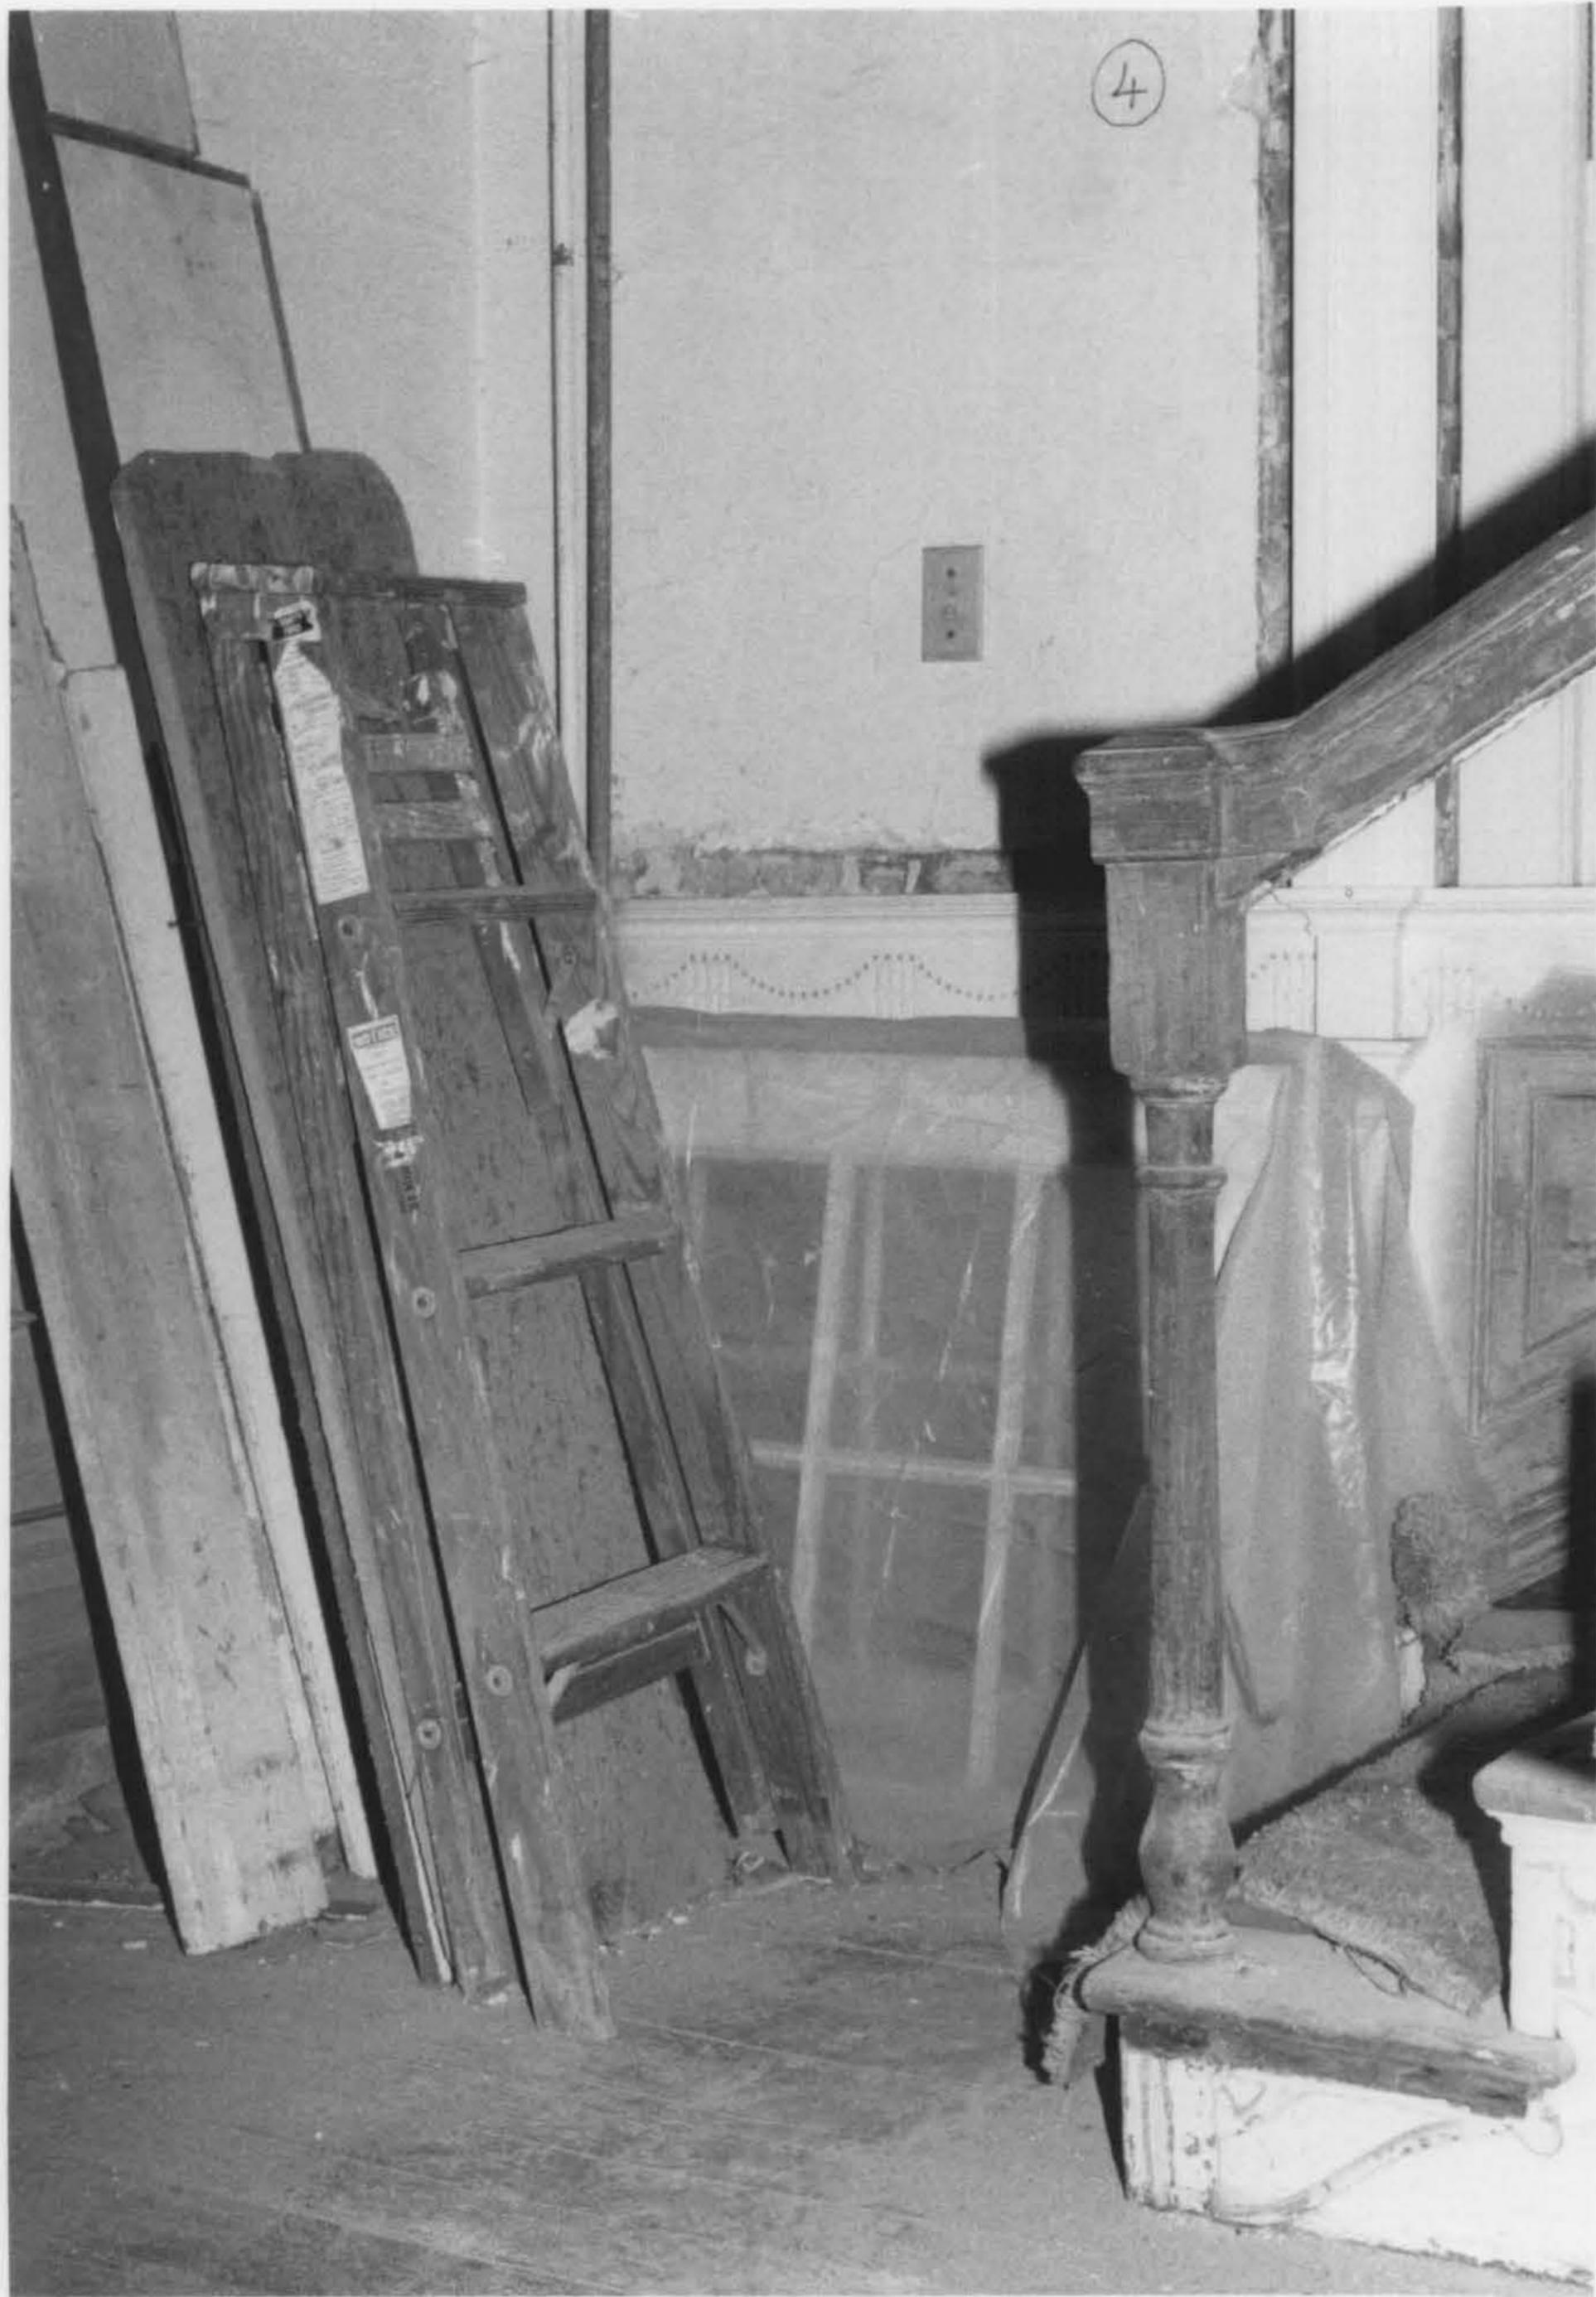
D-1

Newel post
