House of the Hinges
East New Market
private

Maryland Historical Trust State Historic Sites Inventory Form

Survey No. D-1

historic MANNING HOUSE

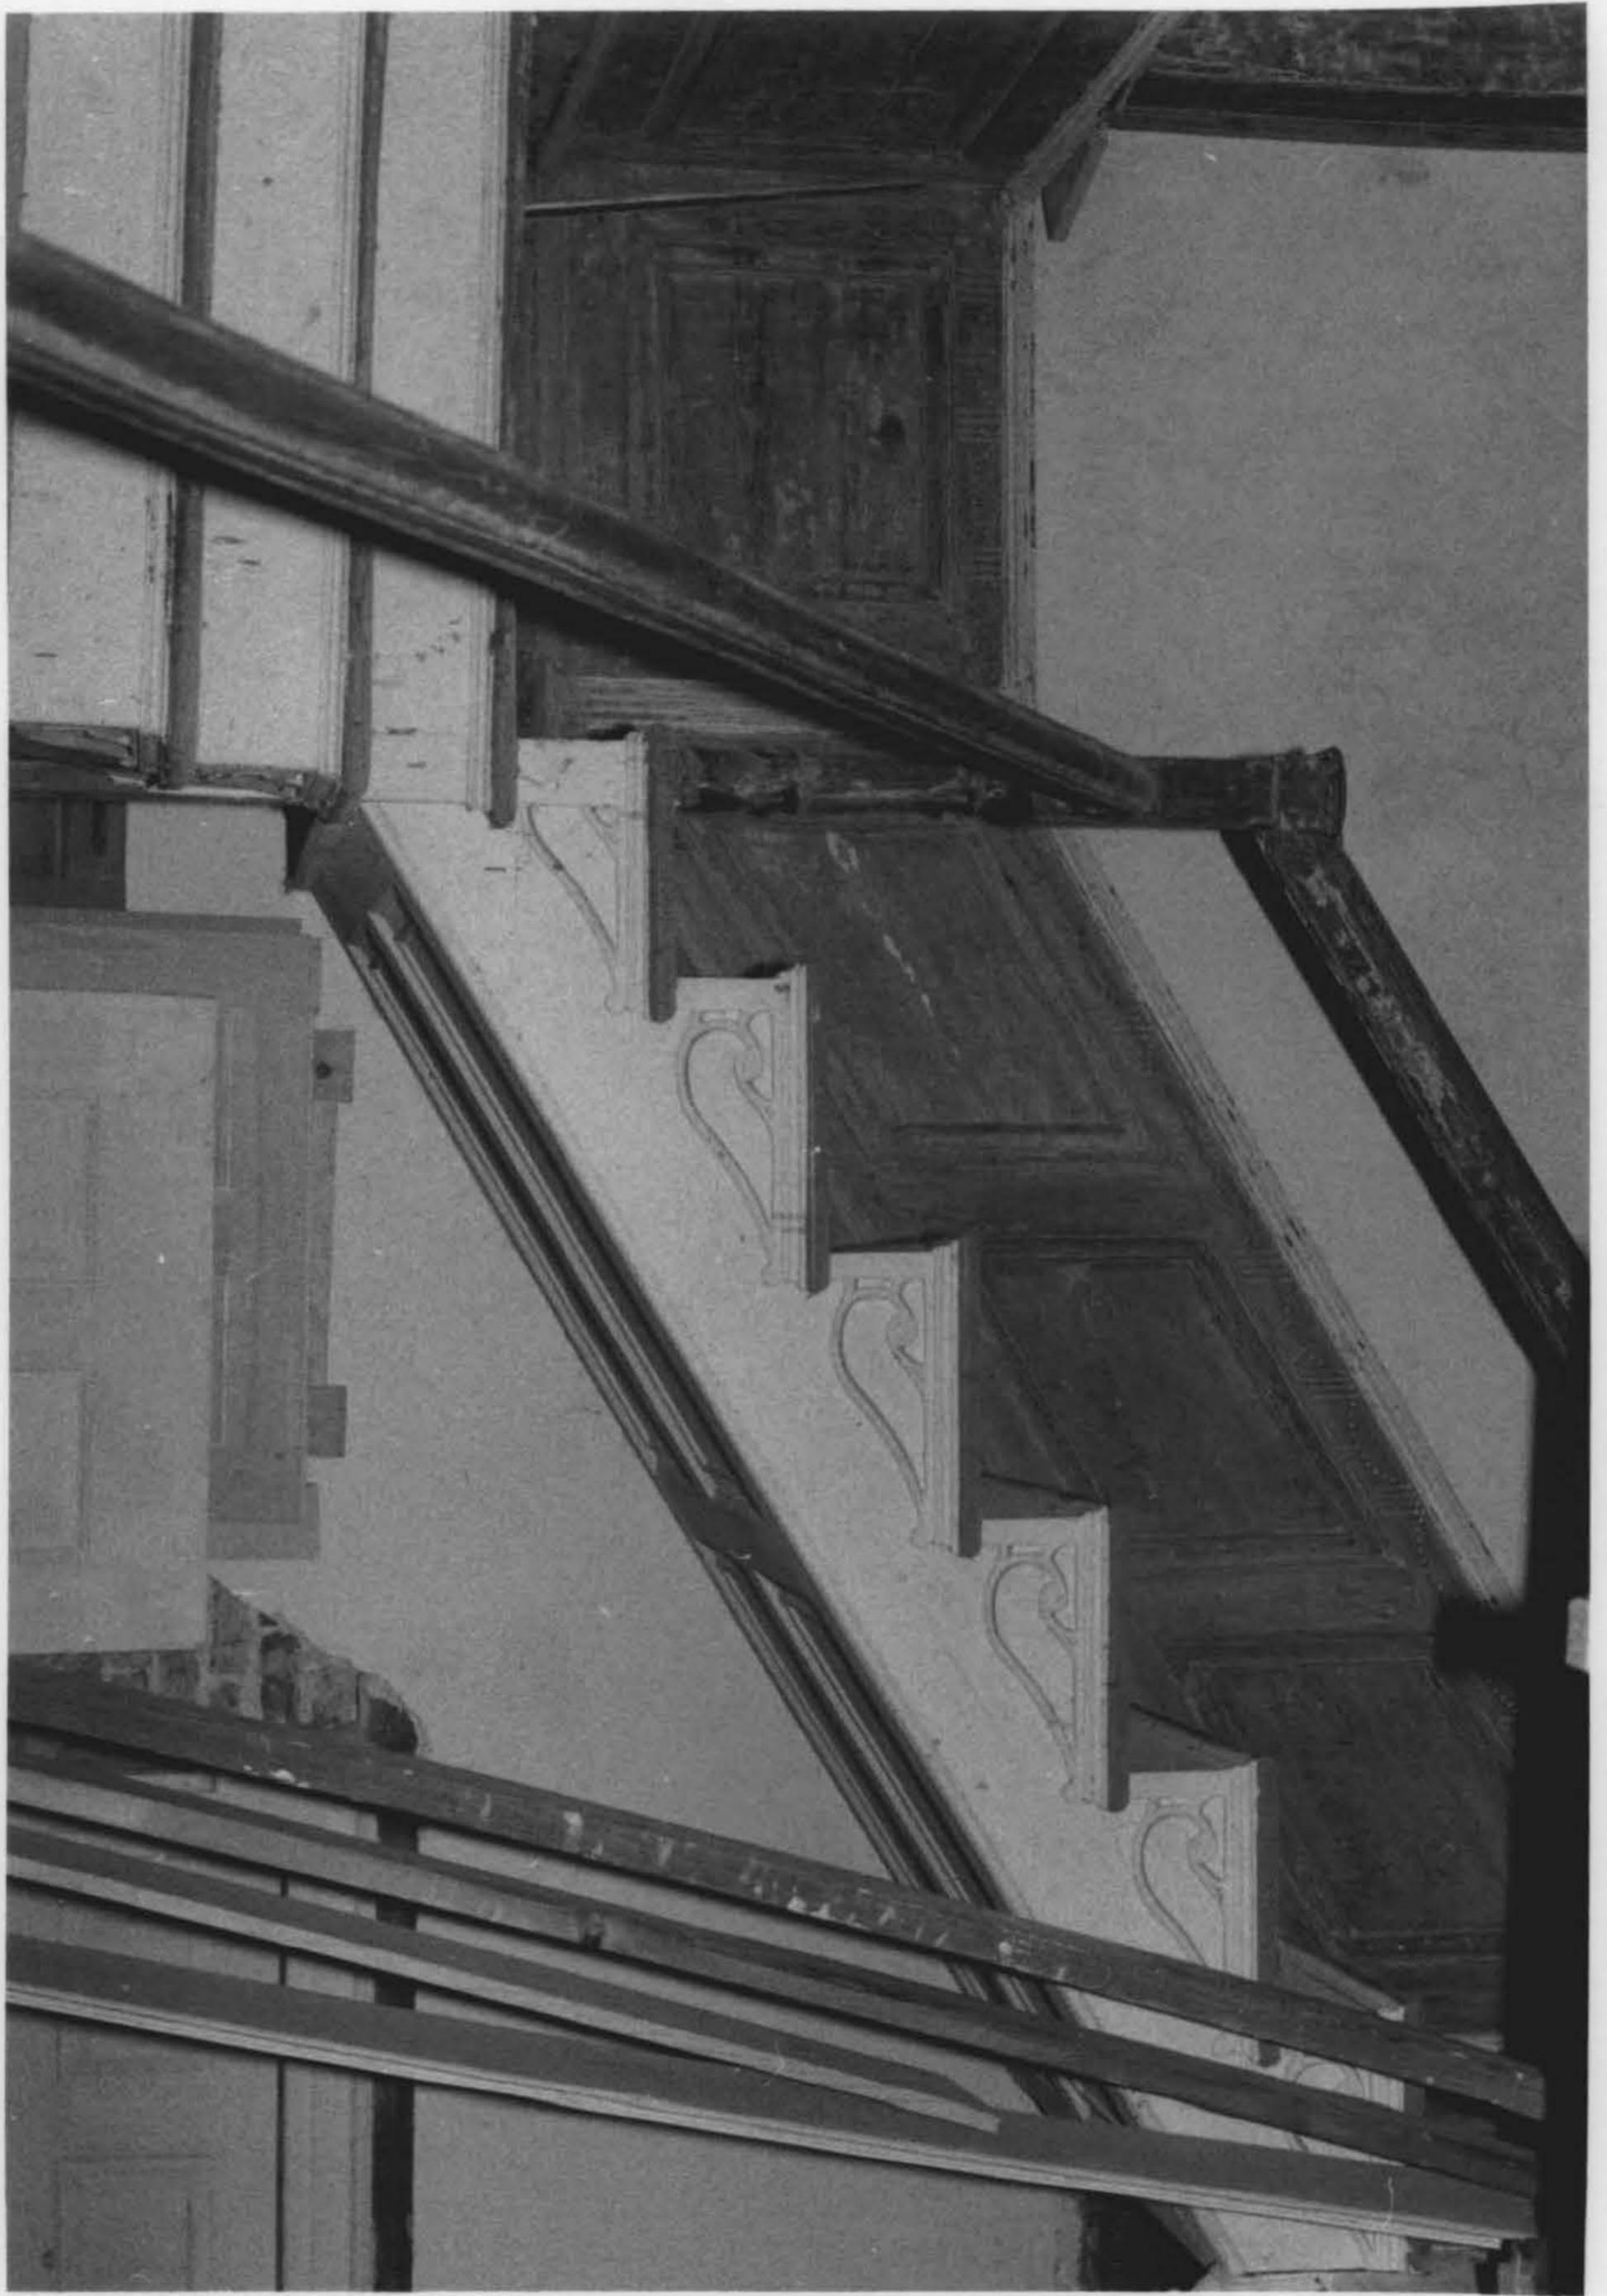
D-1

Stair

The first floor is divided into four unequal sized rooms. The squarish entrance hall, comprising the southeast quarter of the first floor, is dominated by the decorated quarter-turn stair that rises in the southeast corner of the entrance hall. The slender turned newel post and the series of turned balusters support a molded handrail. The stringer below is decorated with a delicate scroll design with the end of the S-shaped curve embellished with a gougework star. Below the stringer the large triangular space is divided by a series of flat panels. The stair soffit is finished with the same flat panels. The soffits of the second floor run of steps were fitted with reproduction flat paneling as well. The entrance hall walls were originally fitted with flat-panel wainscoting as well, a section of which survives against the south wall rising with the stair. The wainscoting is embellished with a punch and gougework row imitating classical swags. The entrance hall has been refitted with restored six-panel doors framed by crossetted surrounds with ovolo molded backbands.

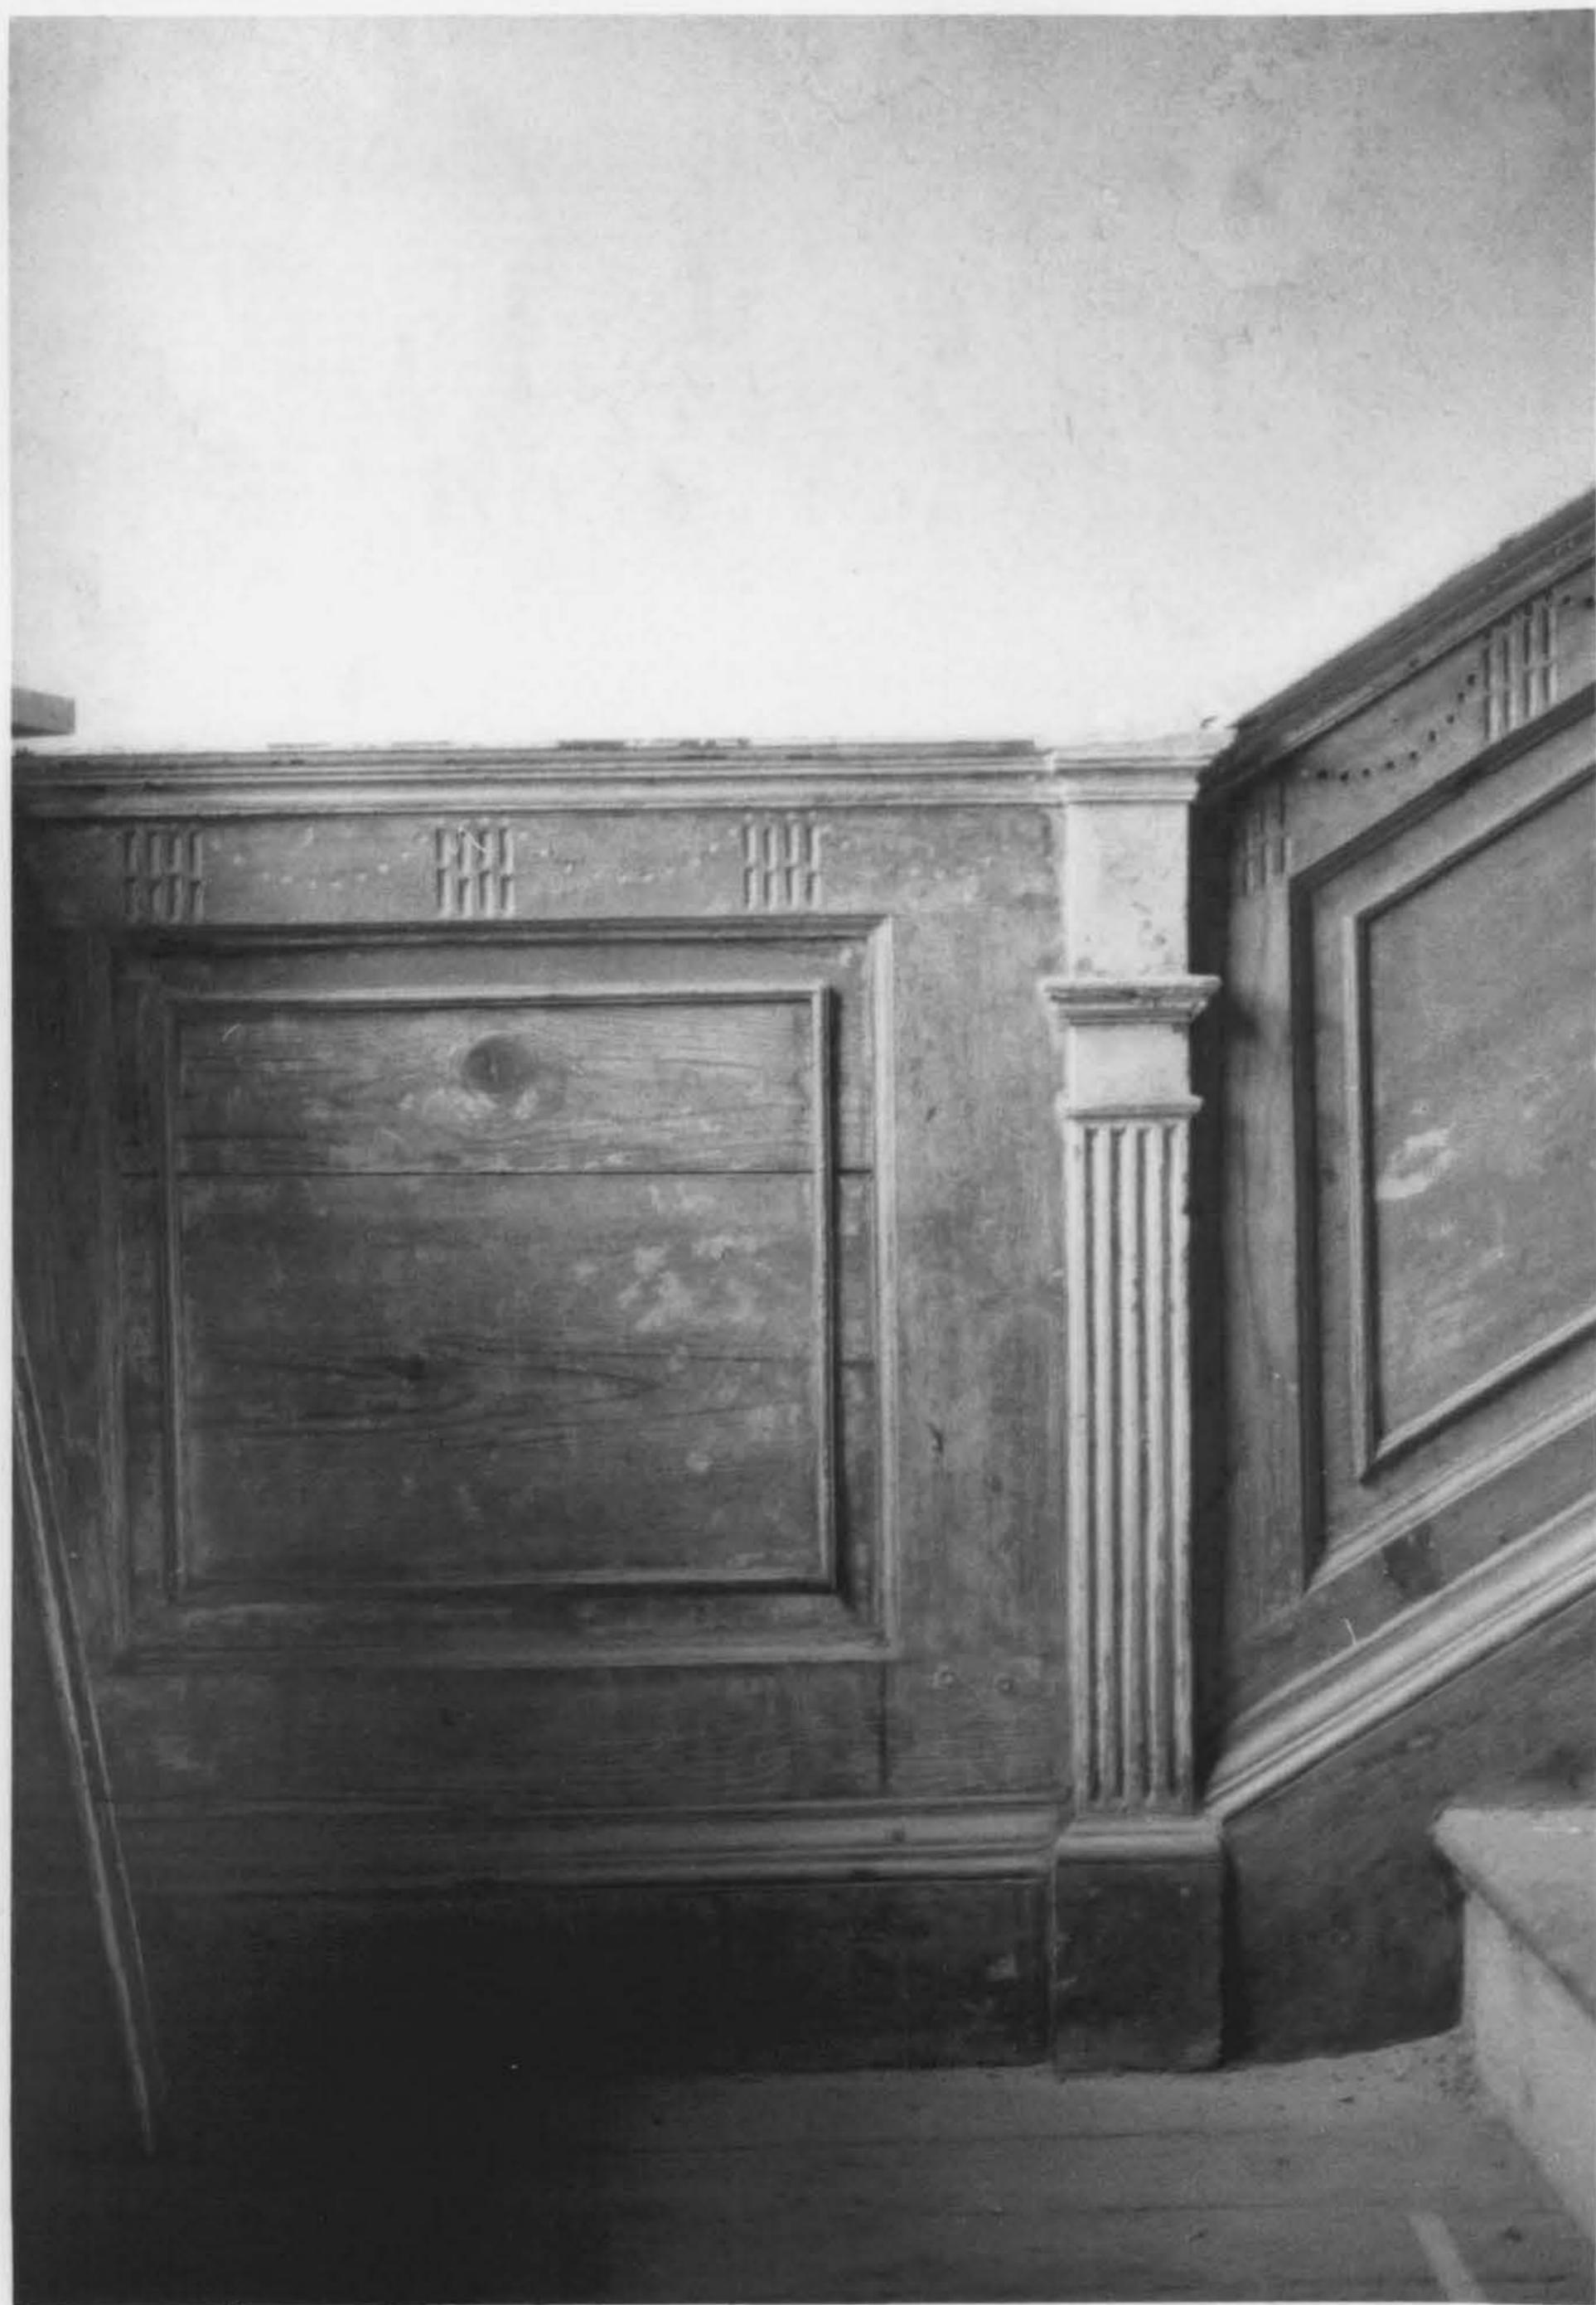
D-1

Wainscoting at stair

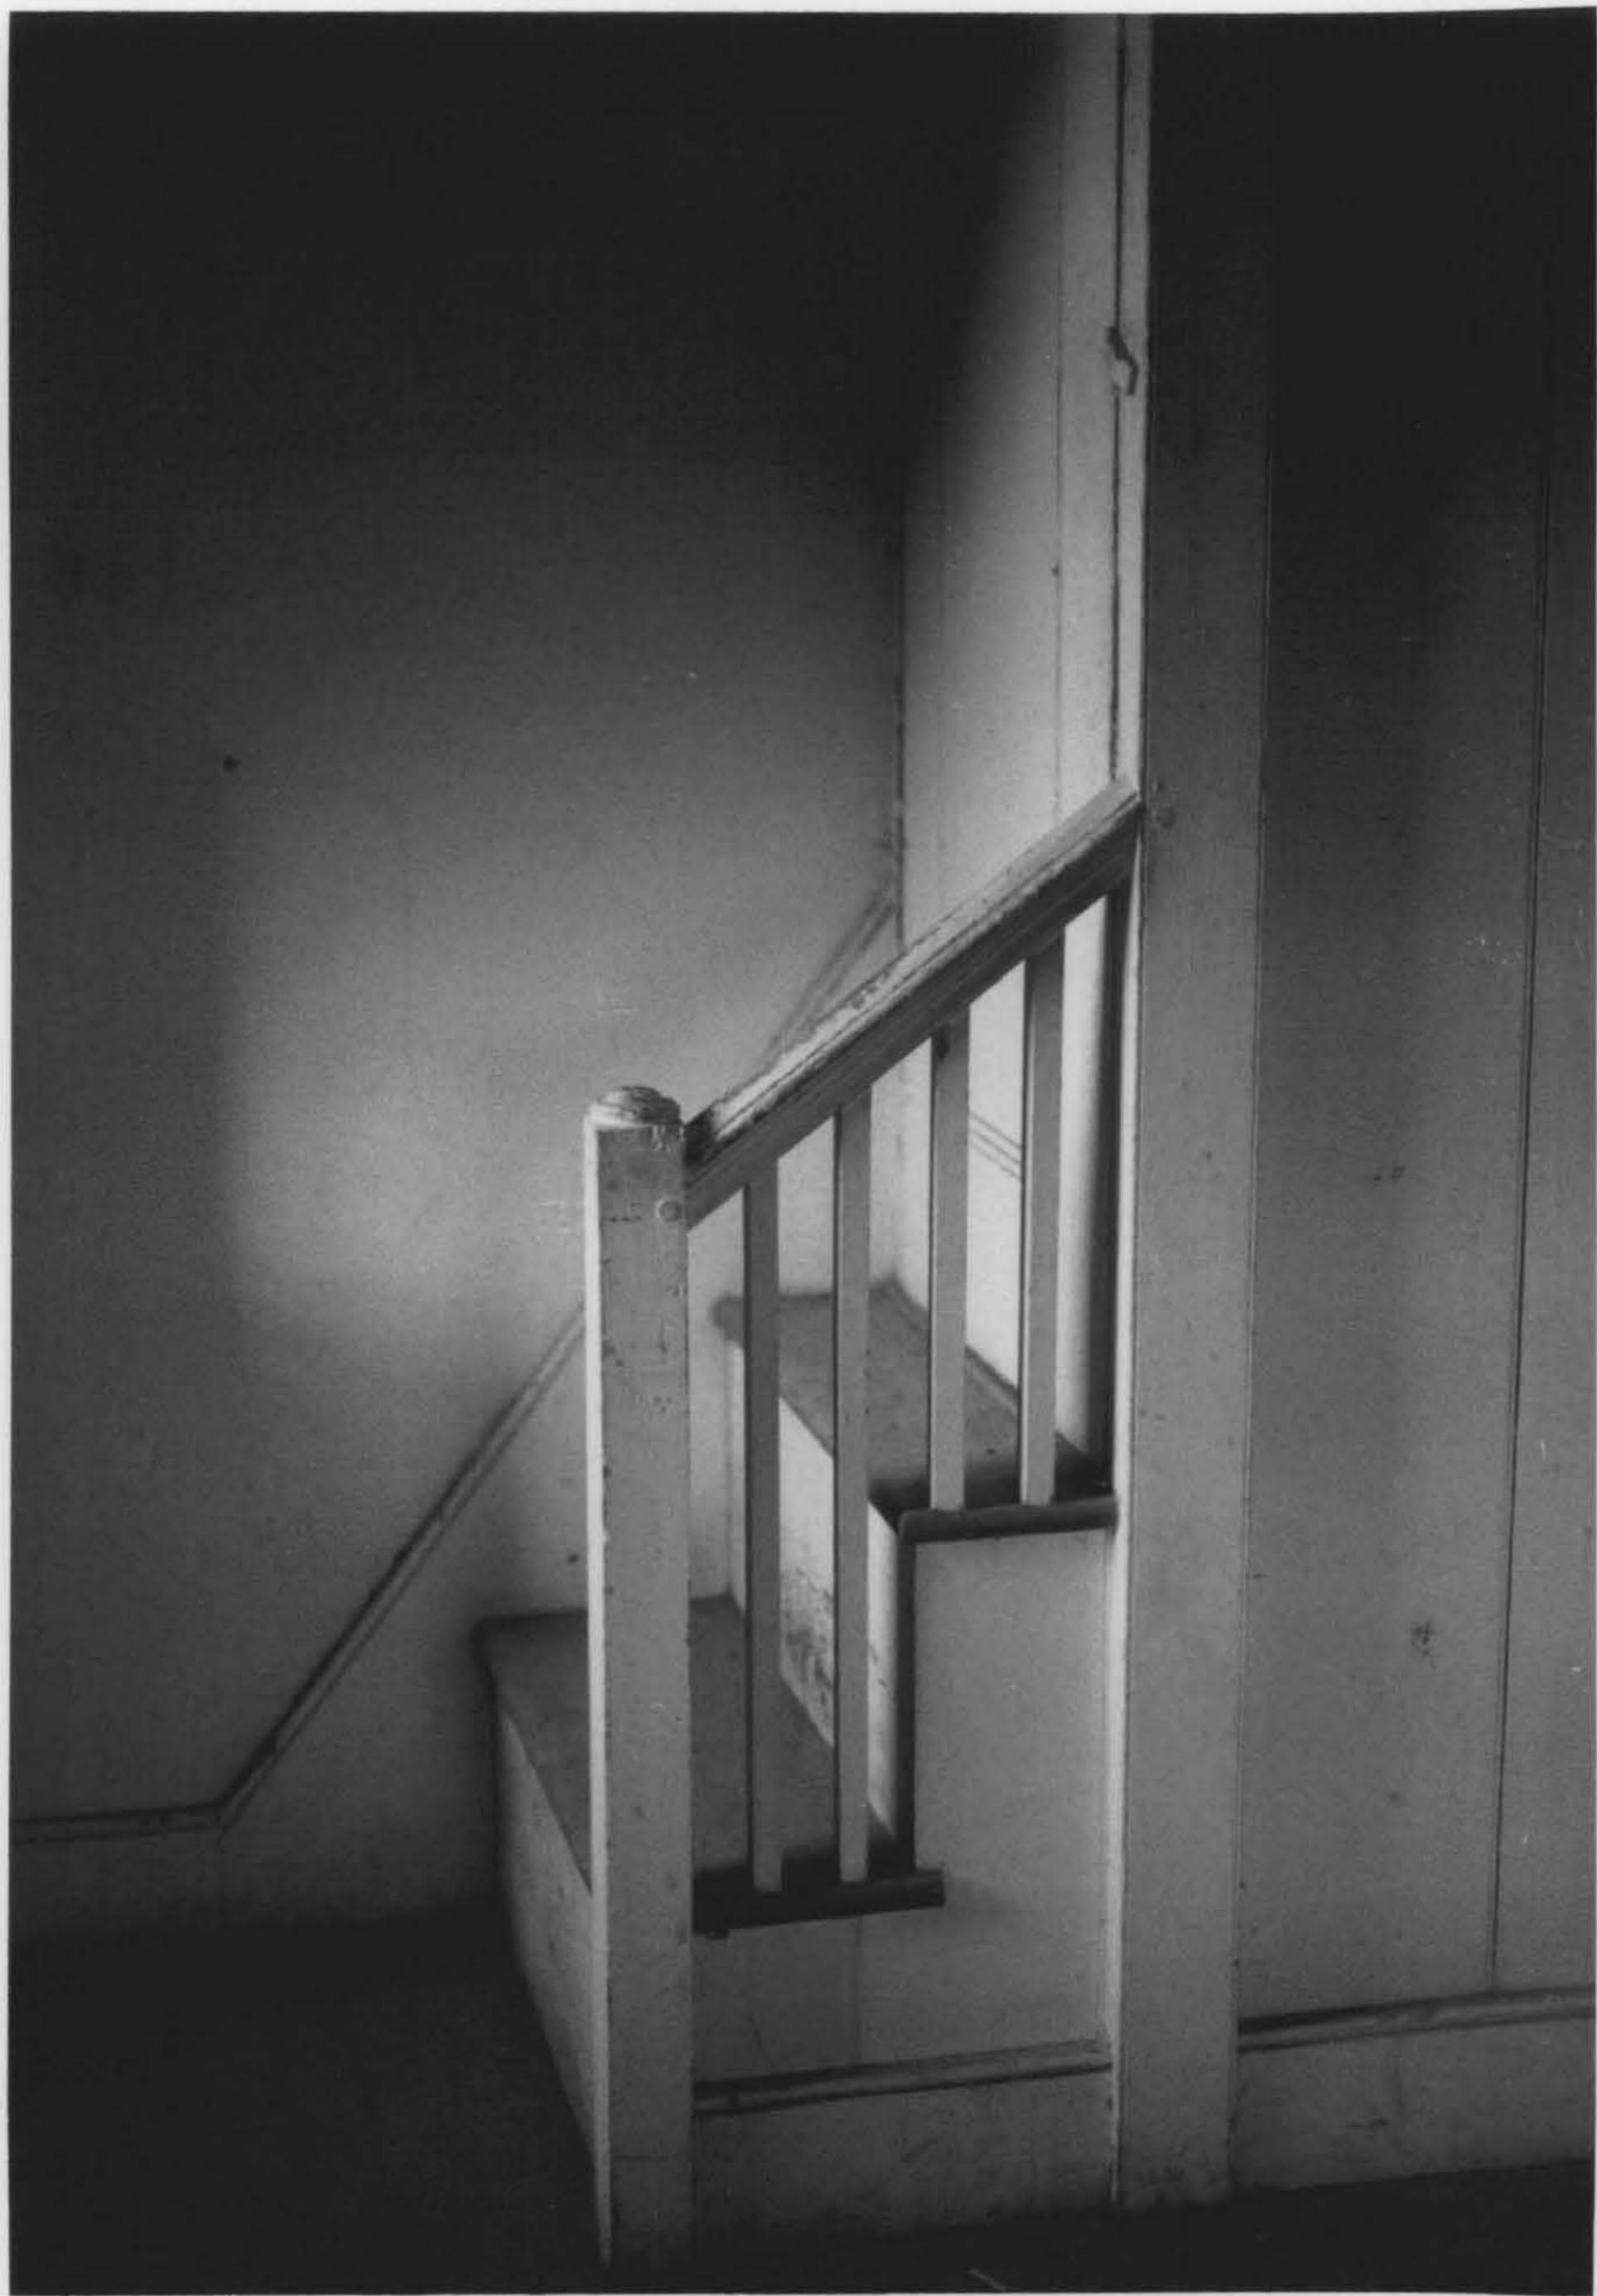
D-1

Attic stair

The attic was finished evidently around 1840 with the space partitioned into five rooms. Sawn lath and plaster walls with beaded baseboards were the principal finish. Located in the southwest room is the enclosed attic stair which carries an early square newel post and square balusters that support a molded handrail. A beaded board partition encloses the ladder stair. The upper attic is unfinished.
