D-691
Tubman House
East New Market
private

Maryland Historical Trust State Historic Sites Inventory Form

Survey No. D-691

The Tubman house, also known as the Howard Simmons house, stands at 10 Railroad Avenue in the center of East New Market, Dorchester County, Maryland. The two-story, three-bay frame house faces south with the principal gable oriented on an east/west axis.

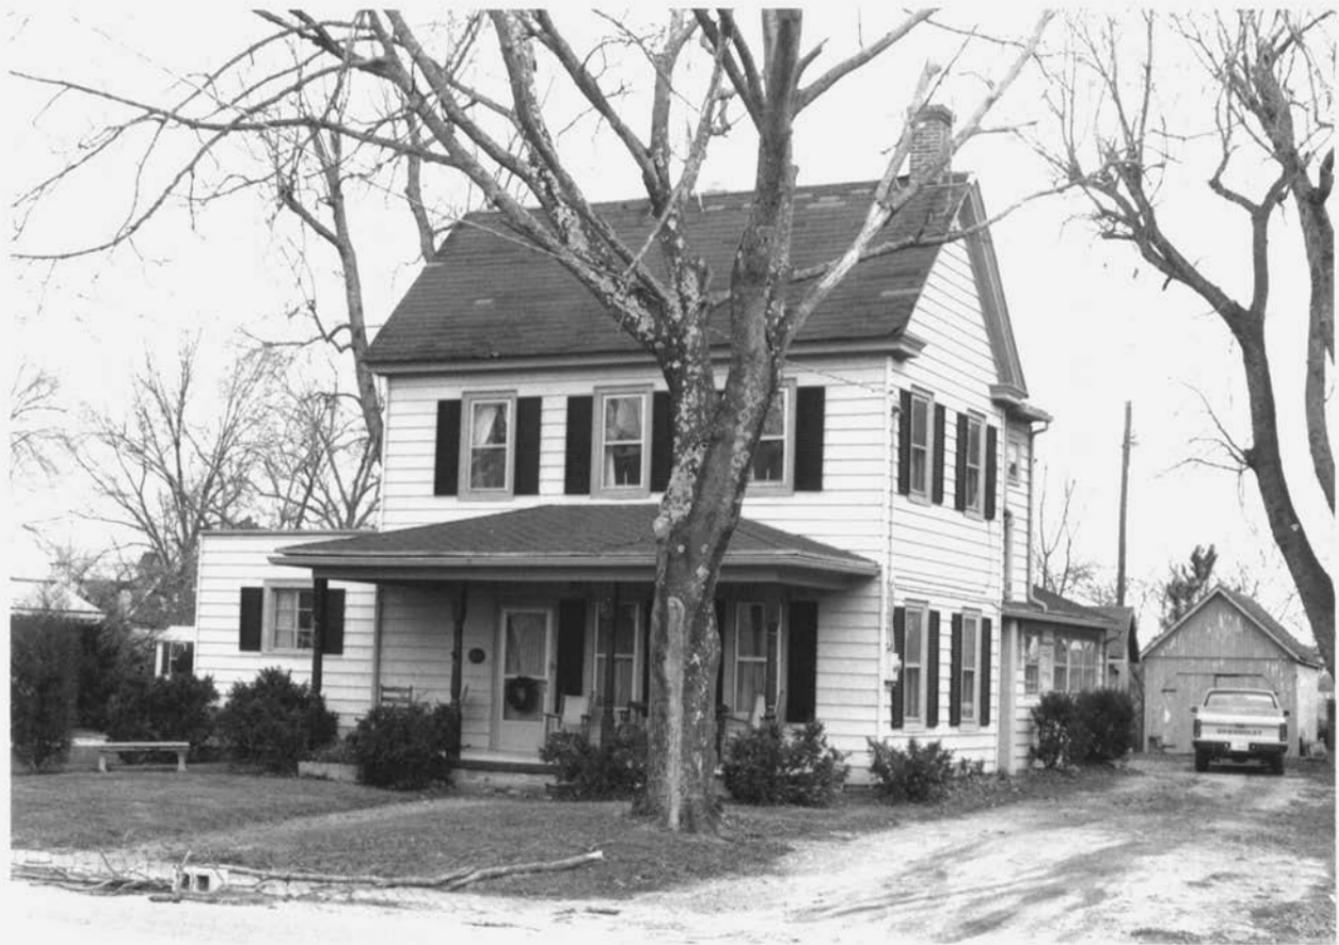
South elevation

The south (main) facade is an asymmetrical three-bay elevation with a side entrance and flanking single-pane sash windows. The front door is distinguished by an oval glass, and the windows are flanked by aluminum shutters. Stretching across the entire first floor is a turned post, hip roof porch. The second floor is lighted by three unevenly spaced single-pane sash windows. The cornice is boxed and trimmed with period molding.
