D-795
Bay Shore Road House
Taylor's Island
c. 1840-50
Private

Maryland Historical Trust Maryland Inventory of Historic Properties Form

Inventory No. D-795

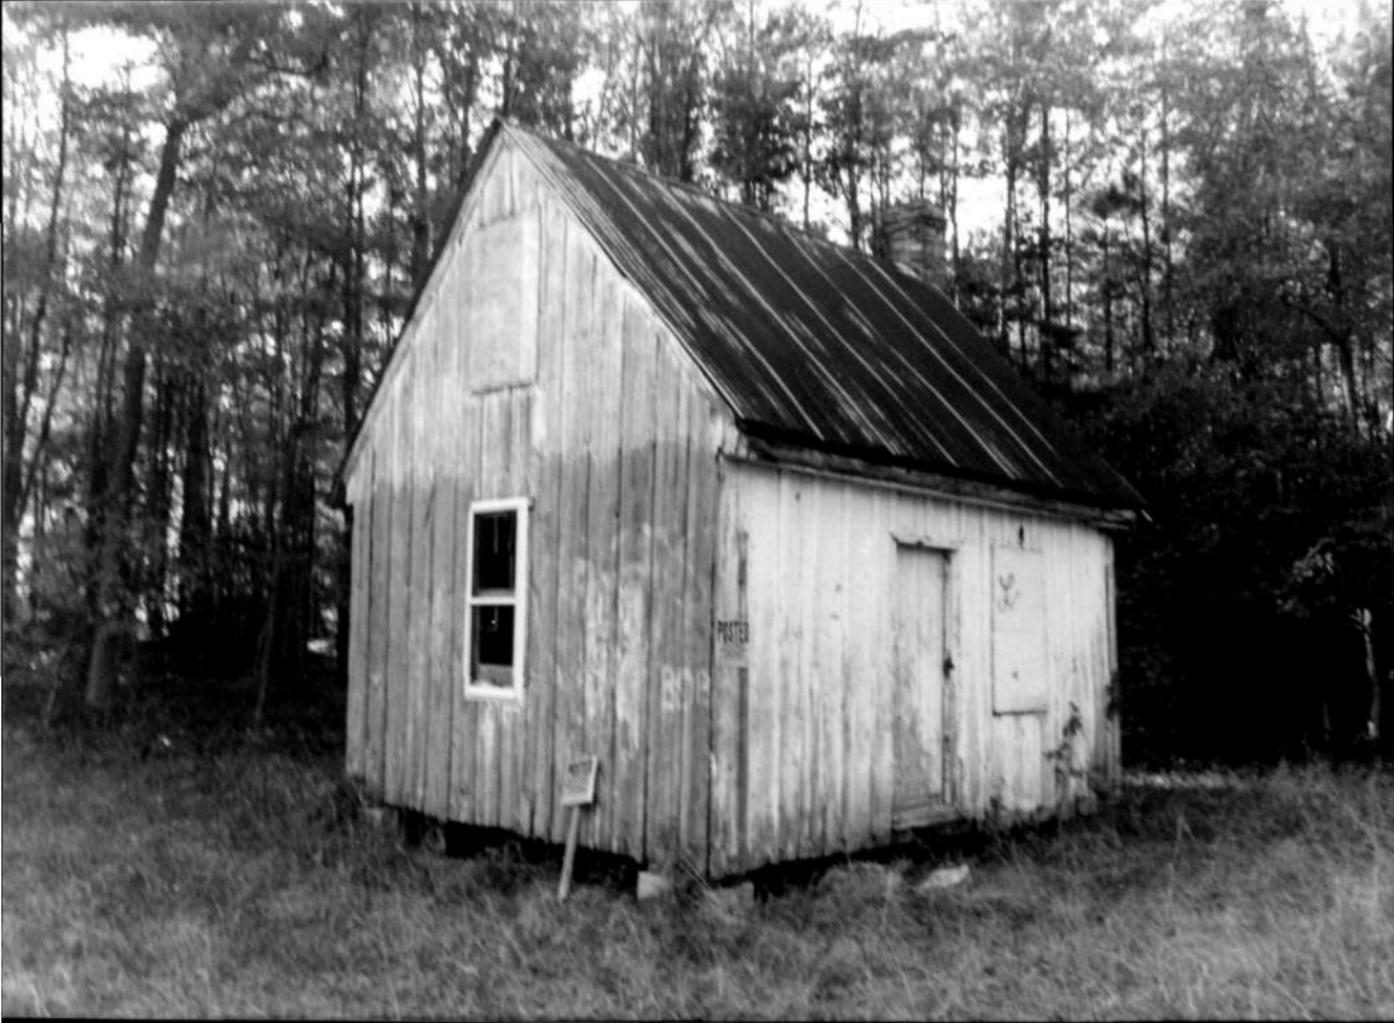
1 of 3

The southwest (rear) wall is pierced by a center door opening that is flanked on its left side by a six-over-six sash window opening. The door opening features a board-and-batten door. The base of the gable roof is finished with a plain boxed cornice.

Southeast ELEVATION

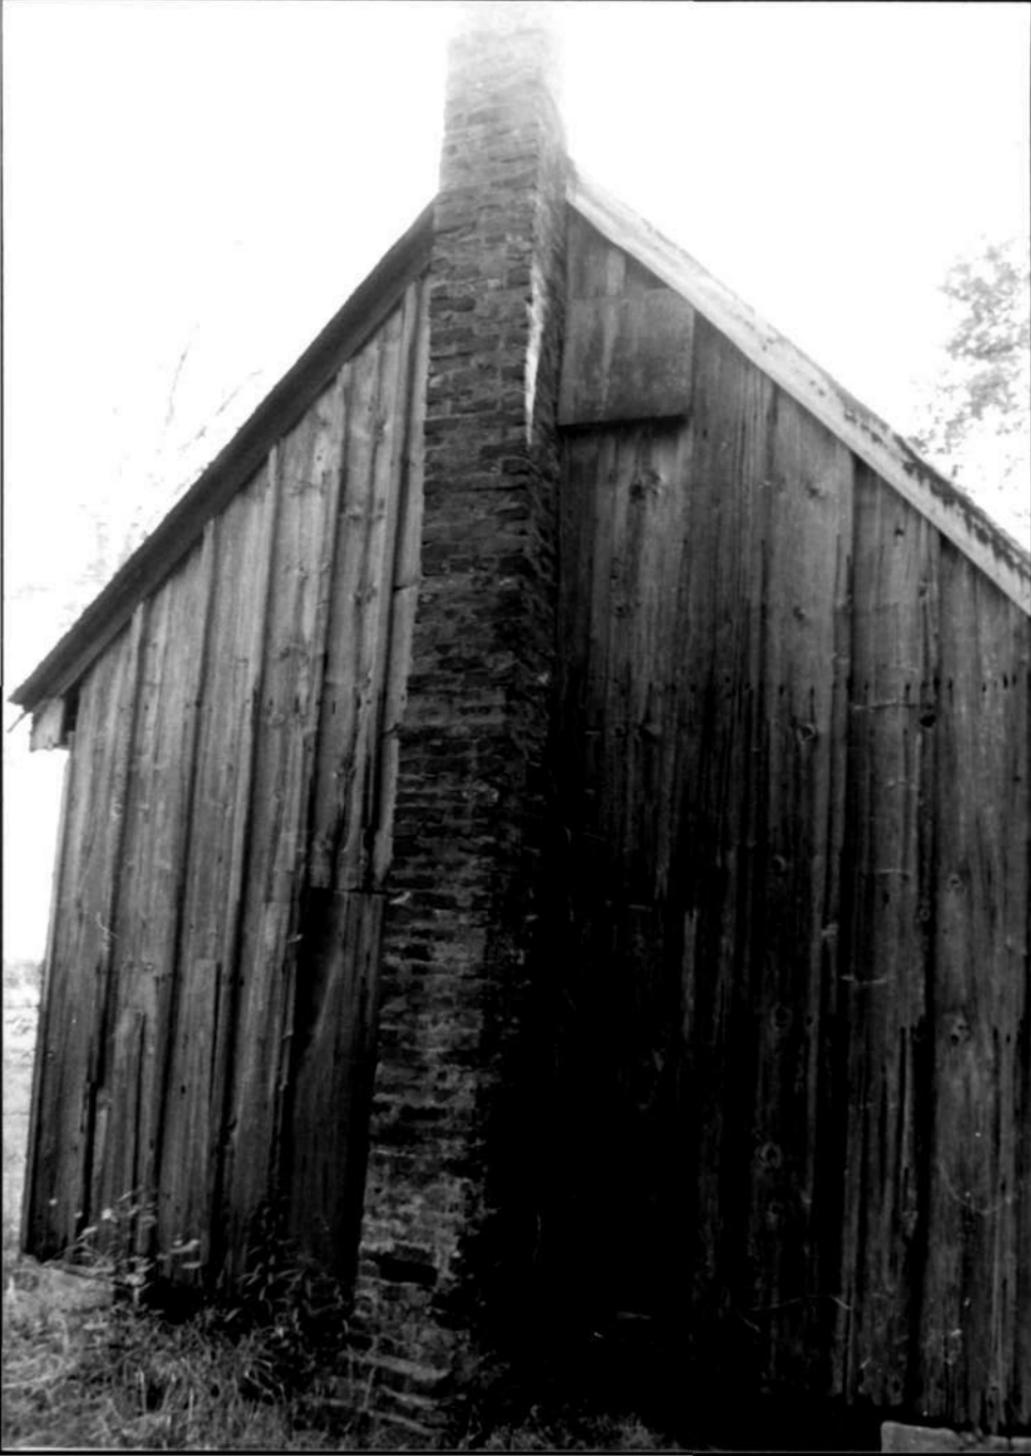
2 of 3

The northwest gable end is a board-and-batten elevation with a roughly built brick stove chimney rising against the exterior. Behind the chimney stack on the first floor is a boarded over wall section that indicates the former size of the original base of the former exterior brick stack. Piercing the right side of the wall surface in the gable end is a boarded over four-pane window that formerly lighted the loft. The gable end is flush and finished with a simple bargeboard. The opposite southeast gable end is marked by a single six-over-six sash window opening on each floor, and the edge of the roof above the board-and-batten siding is finished flush with a plain bargeboard.

NOVA ELEVATION

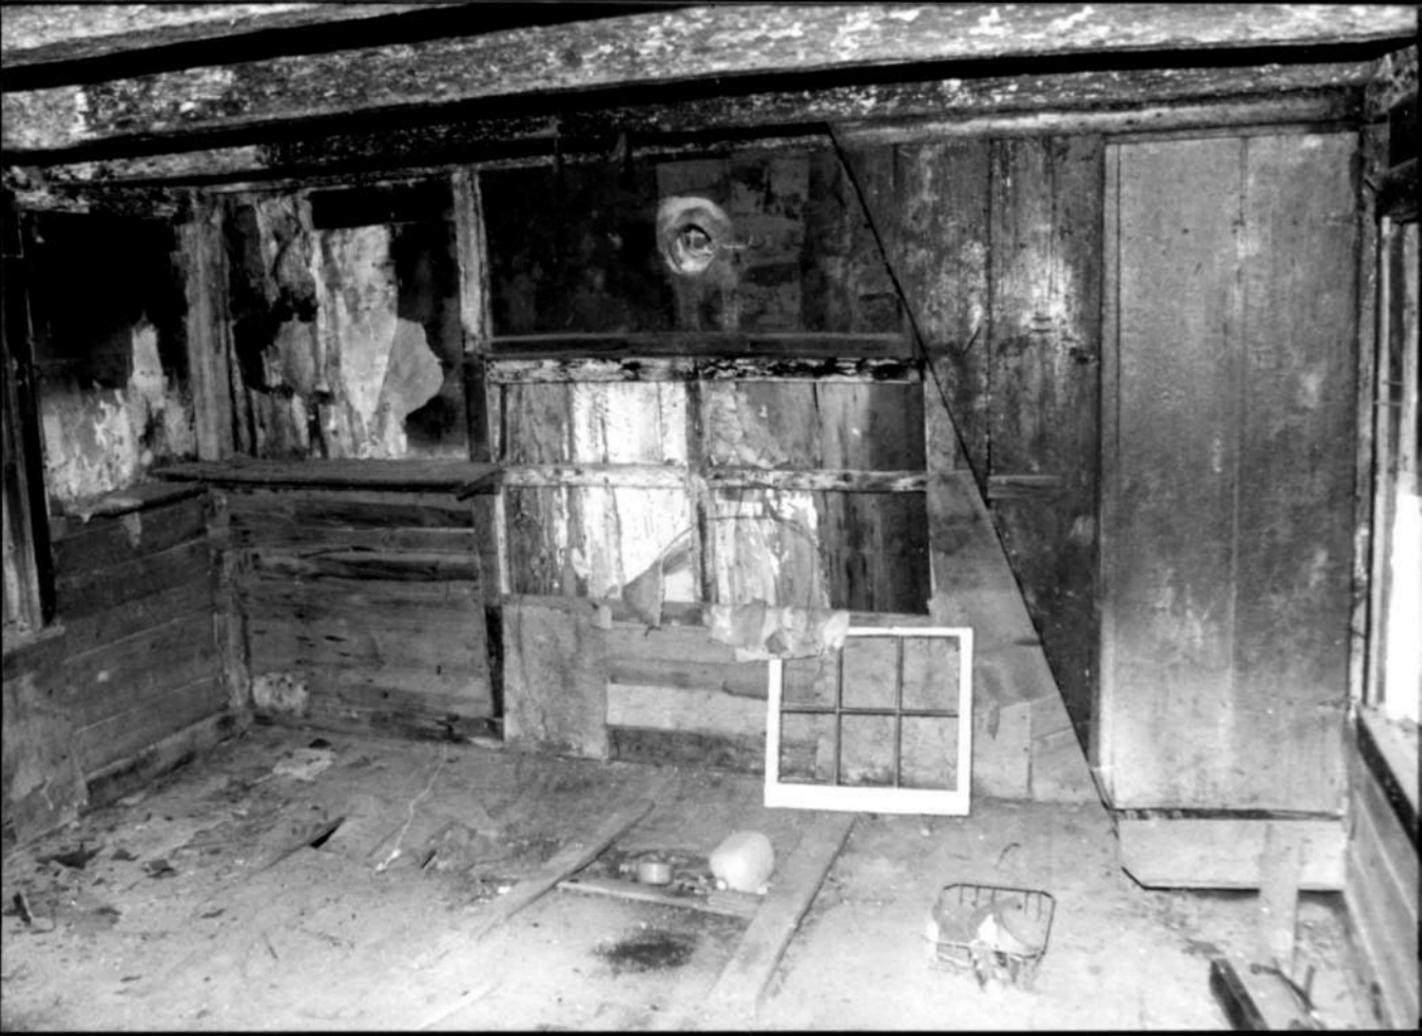
3 of 3

The interior has an exposed frame with an open joist ceiling. Fixed in the northeast corner is an enclosed staircase with a ladder access to the loft. The framing is assembled with mature cut nails.

interior - north wall
