F-1-120
Charles Millard House
ca. 1880
Buckeystown Vicinity
Private

MARYLAND INVENTORY OF HISTORIC PROPERTIES
Maryland Historical Trust
State Historic Sites Inventory Form

Survey No. F-1-120

historic Charles Millard House

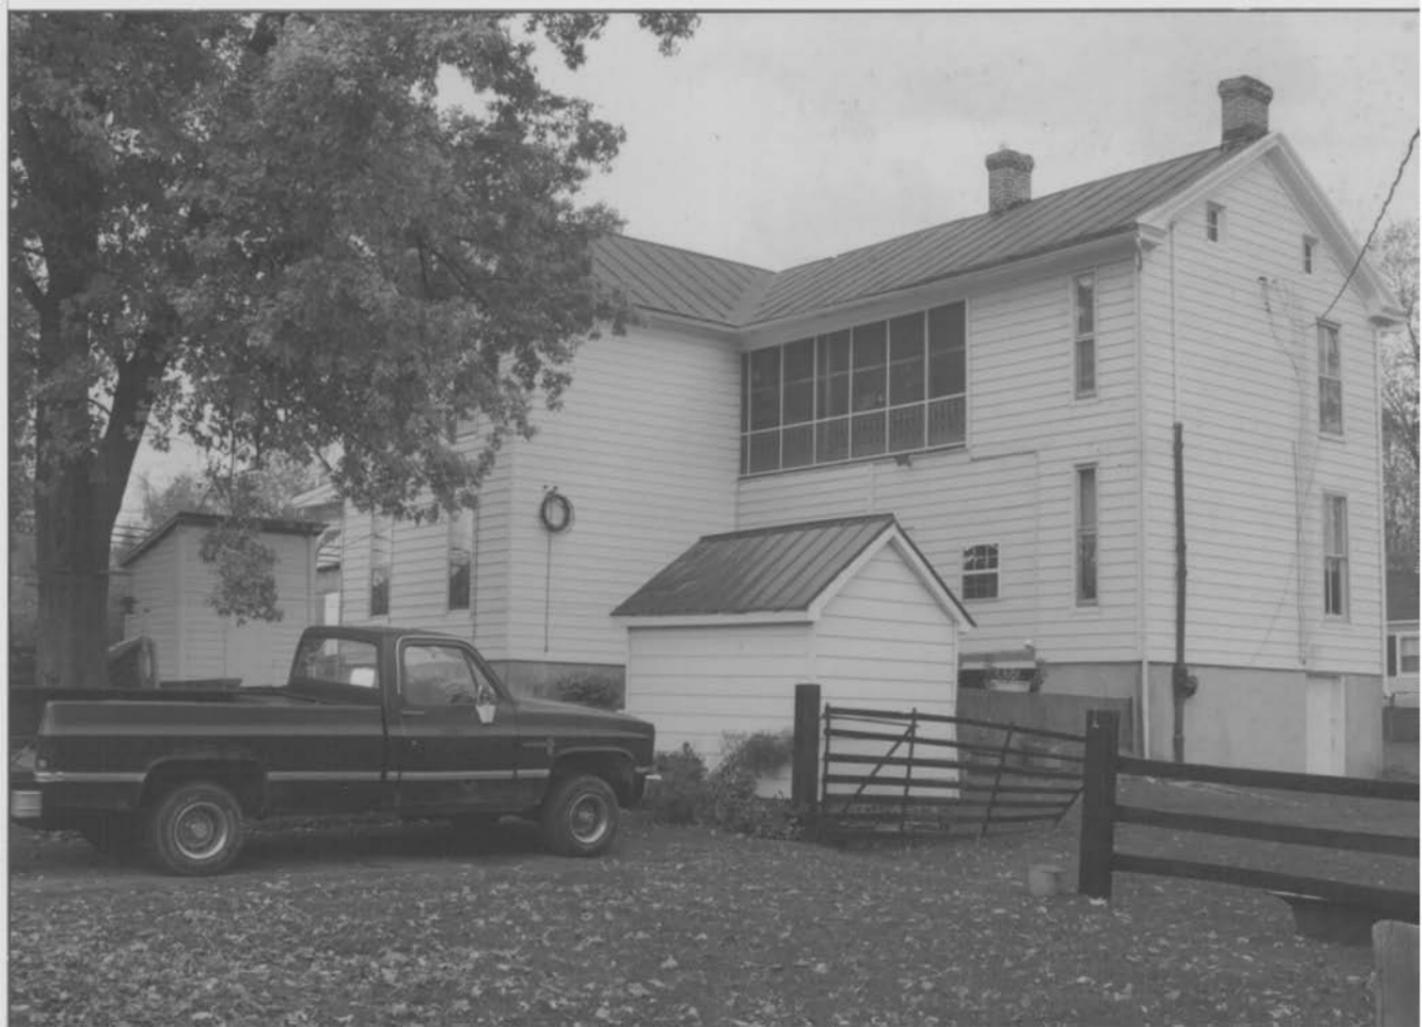
2 of 13

Principal Dwelling, view southwest depicting meat house and well house

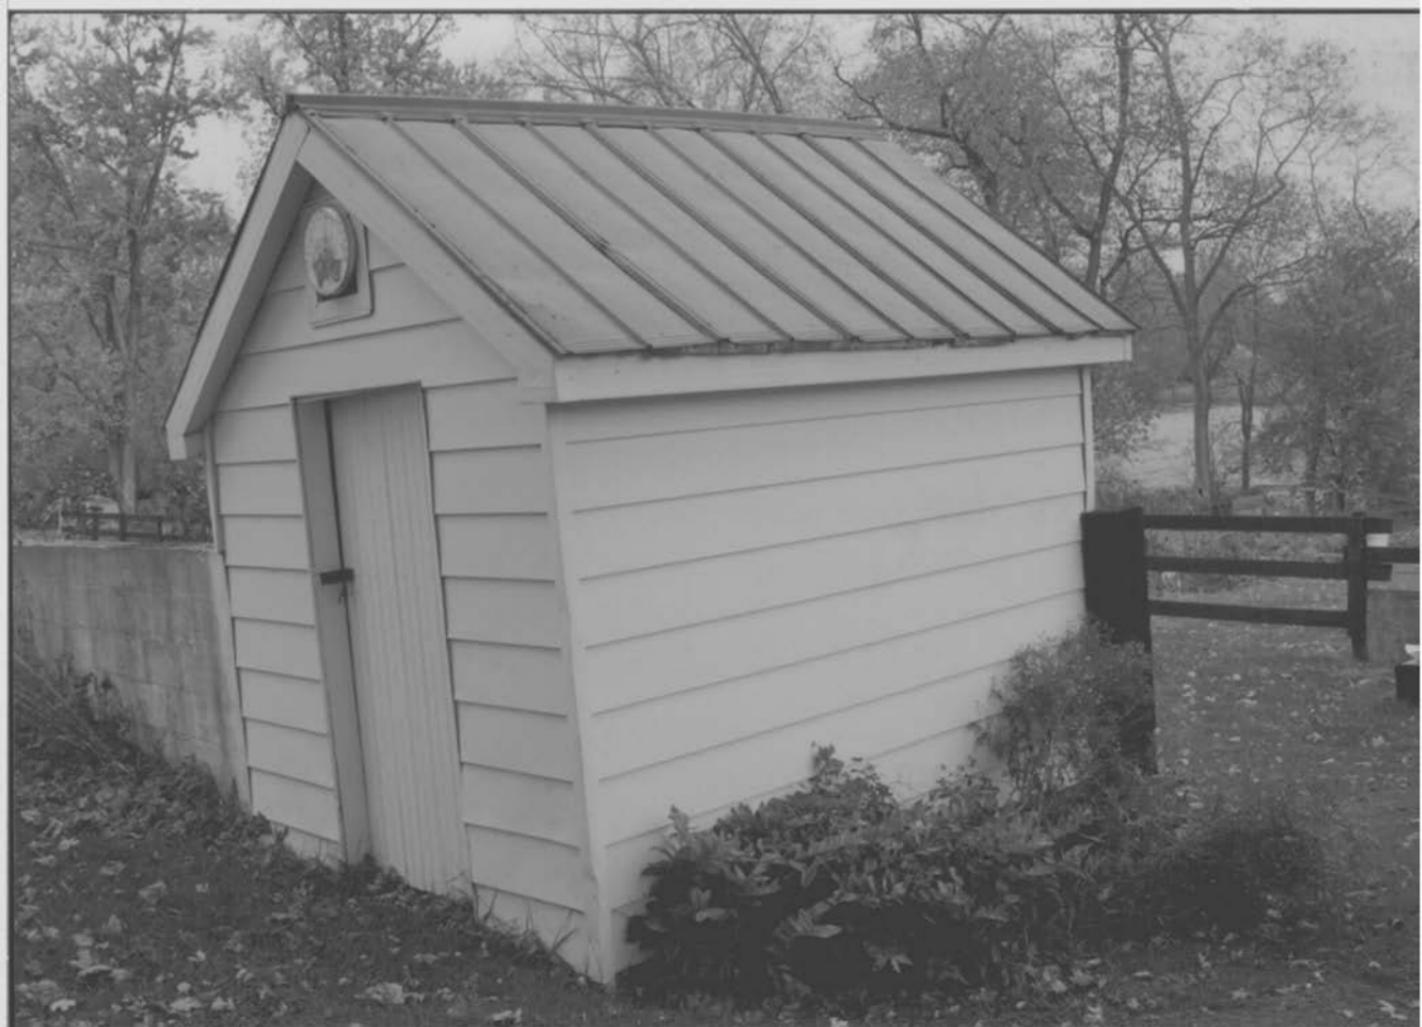
4 of 13

A meat house (ca. 1880) is located northeast of the principal dwelling. The one-story, one-bay, rectangular wood-frame structure is clad with aluminum siding that covers the original German siding. The structure rests on a fieldstone foundation. The structure terminates in a standing seam metal, front gable roof. The primary (south) elevation of the building features a wood door constructed of vertical boards.

Meat house, view ~~NW~~ GO TOP 36-02 111111-05AU 038

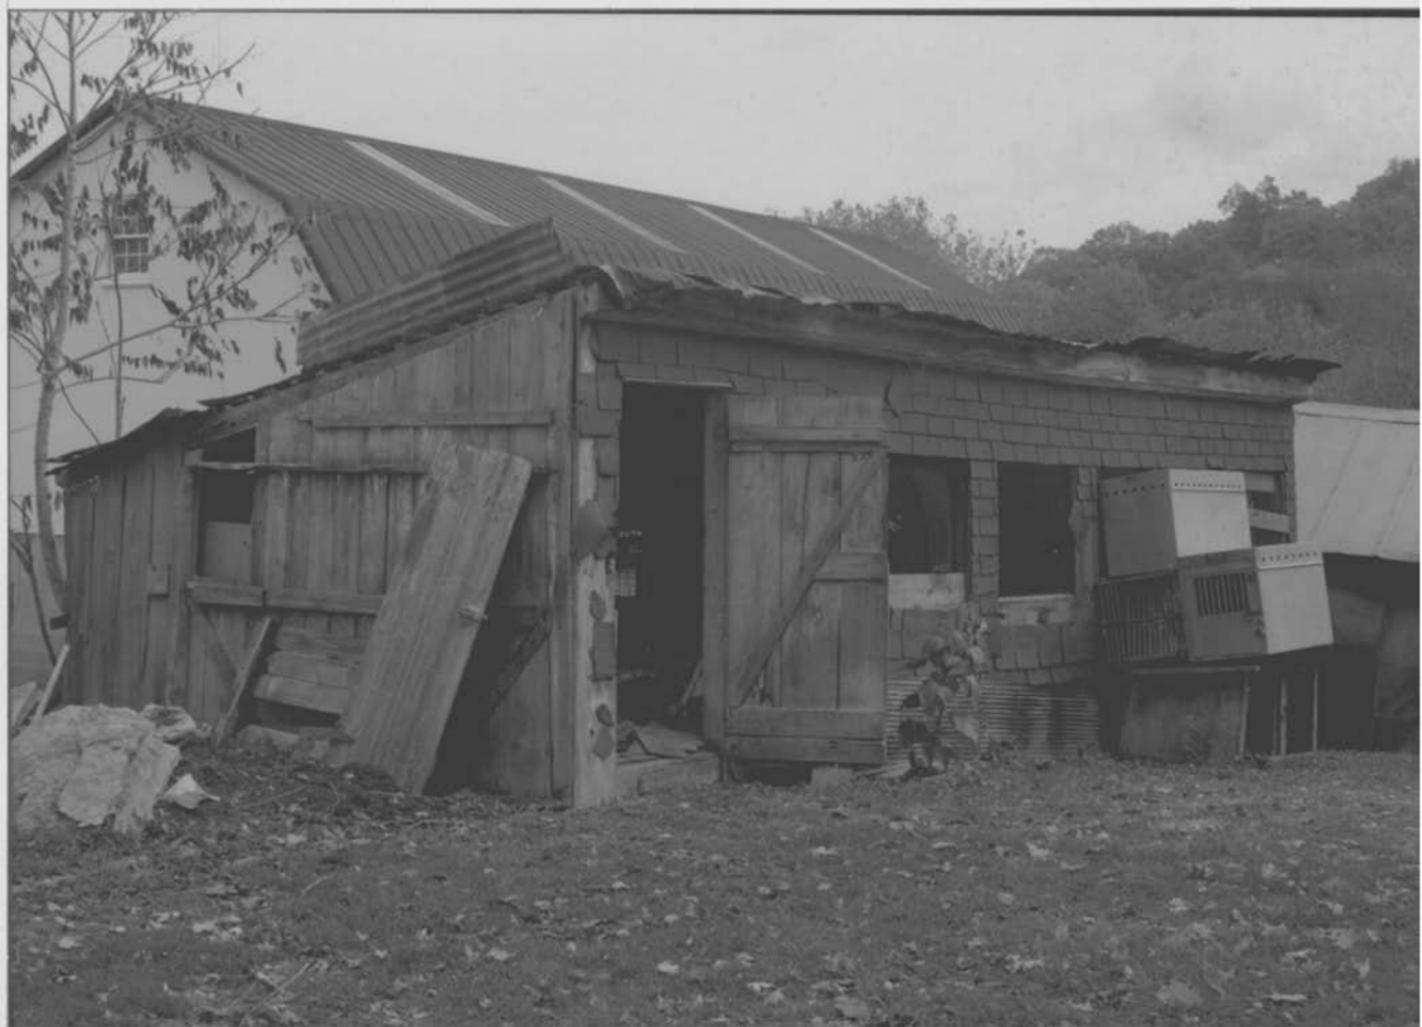
8 of 13

A chicken coop (ca. 1930) is located northwest of the concrete-block barn. The one-story, five-bay, rectangular, wood-frame structure is clad with rough vertical board siding and asphalt shingles. The structure rests on a wood sill. The structure terminates in a shed roof sheathed with corrugated metal panels. The front (south) elevation features a wooden door constructed of vertical boards flanked by four wooden window openings covered with wire mesh. The structure is in deteriorated condition.

Chicken Coop, view NE

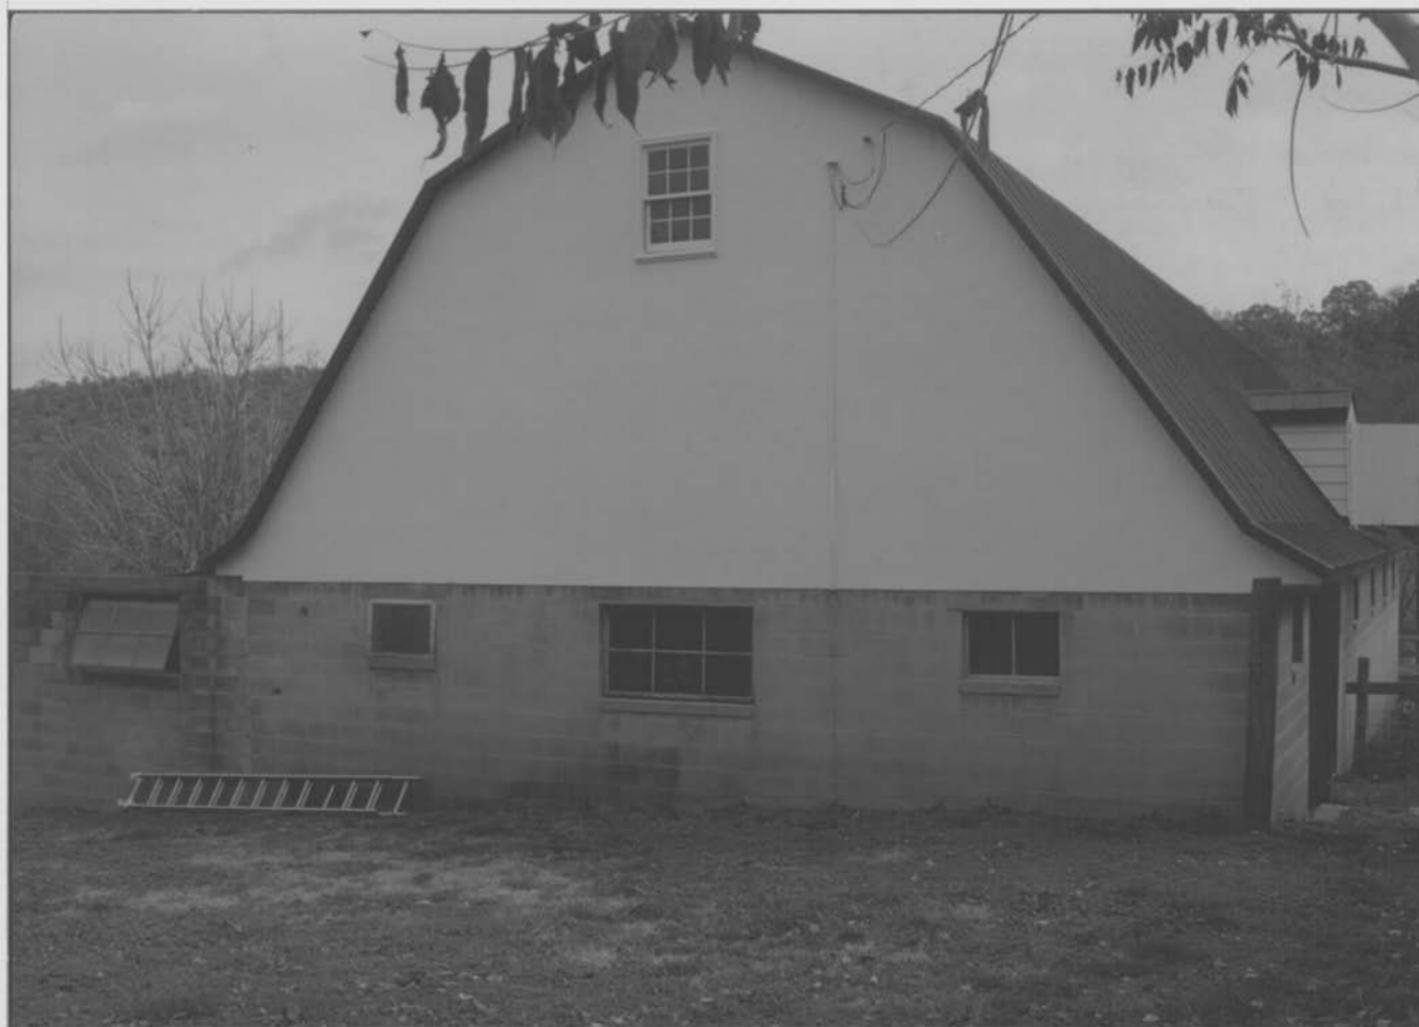
11 of 13

The concrete-block barn is located northeast of the principal dwelling. The barn is a rectangular plan, one-and-one-half story, six-by-three-bay building constructed ca. 1940. The concrete-block barn rests on a poured concrete slab. The barn terminates in a gambrel roof clad with metal standing seam. The hayloft is accessed from east gable end by sliding track doors located on the second floor level. The front (east) elevation on the first floor level features a central wood sliding track door constructed of vertical wood boards flanked by two-light, metal-frame hopper windows. The rear elevation (west) elevation on the first floor level feature two, two-light, metal-frame hopper windows and one, six-light fixed metal sash window. The south elevation features a single wood door and five, two-light, metal-frame hopper windows. The north elevation features a one-story, wood-frame shed roof addition sheathed in plywood siding with multiple door openings.

Concrete-block, view **E**

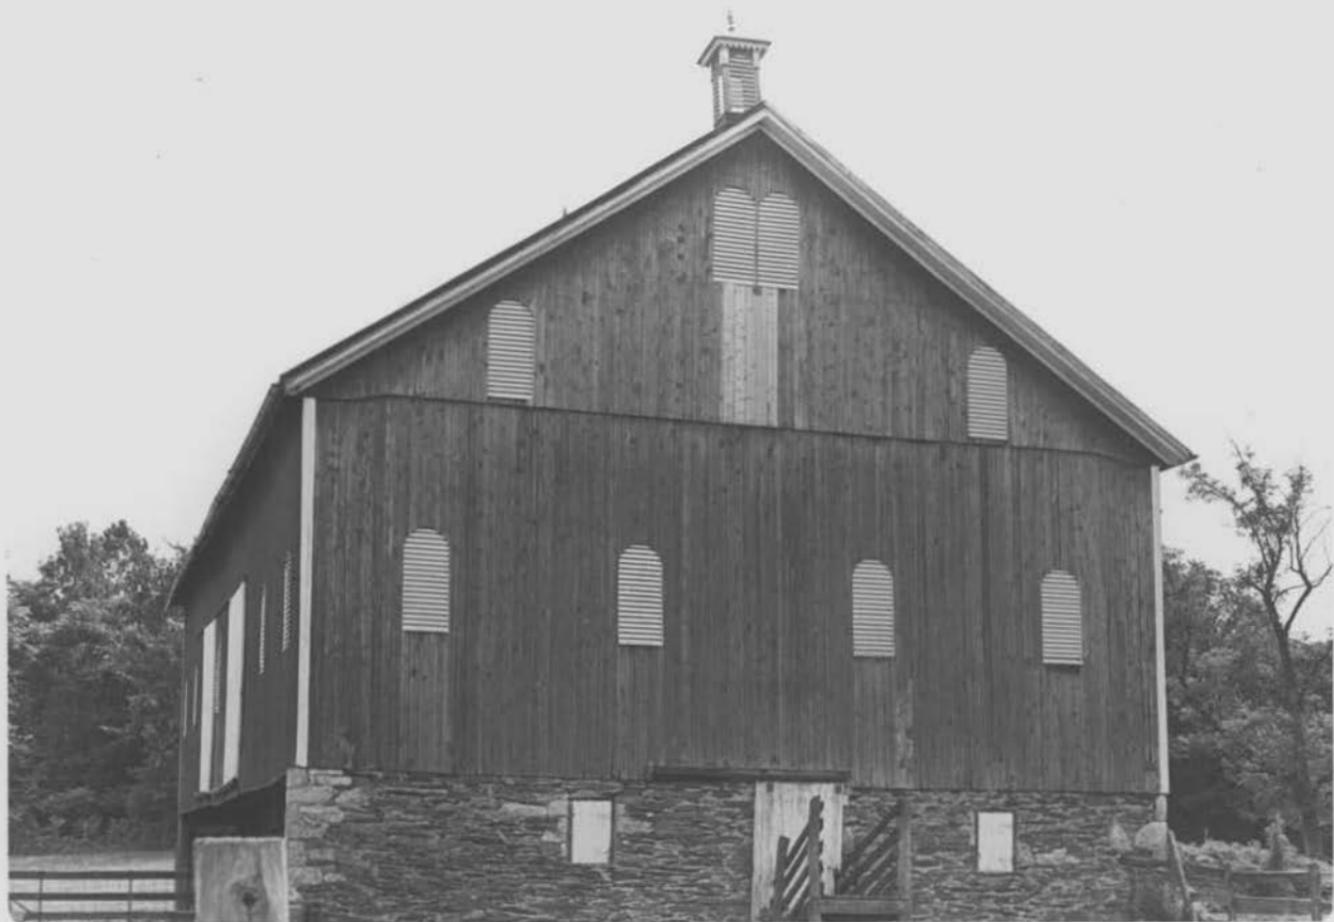
A two story frame bank barn built on a high coursed stone foundation with louvered air vents, standing seam tin roof and three louvered cupolas with finials and scalloped decoration is located immediately adjacent to the house south of Michaels Mill Road.

BARN

NORTH ELEVATION

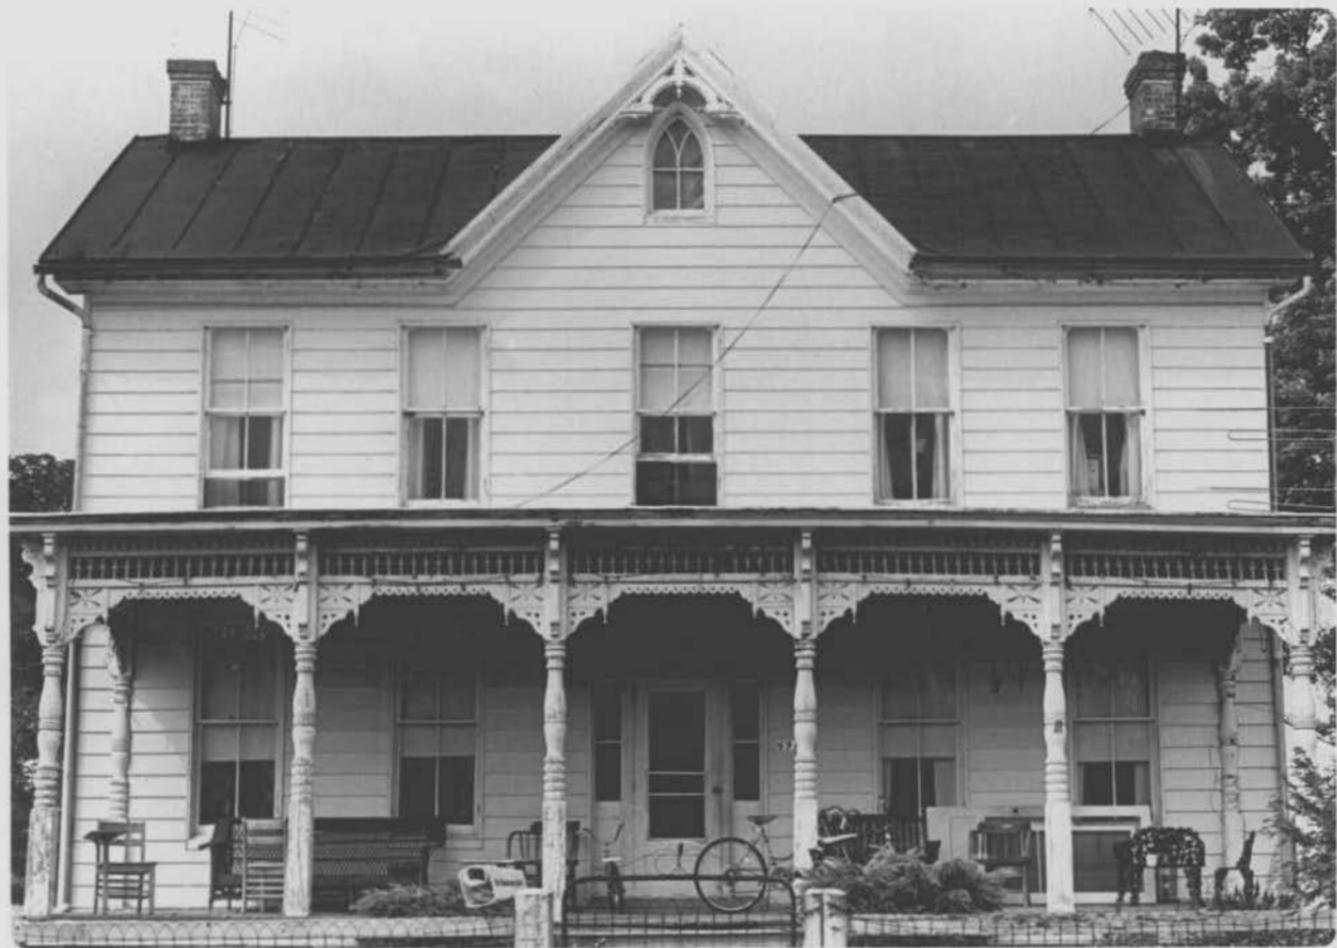
SOUTH ELEVATION

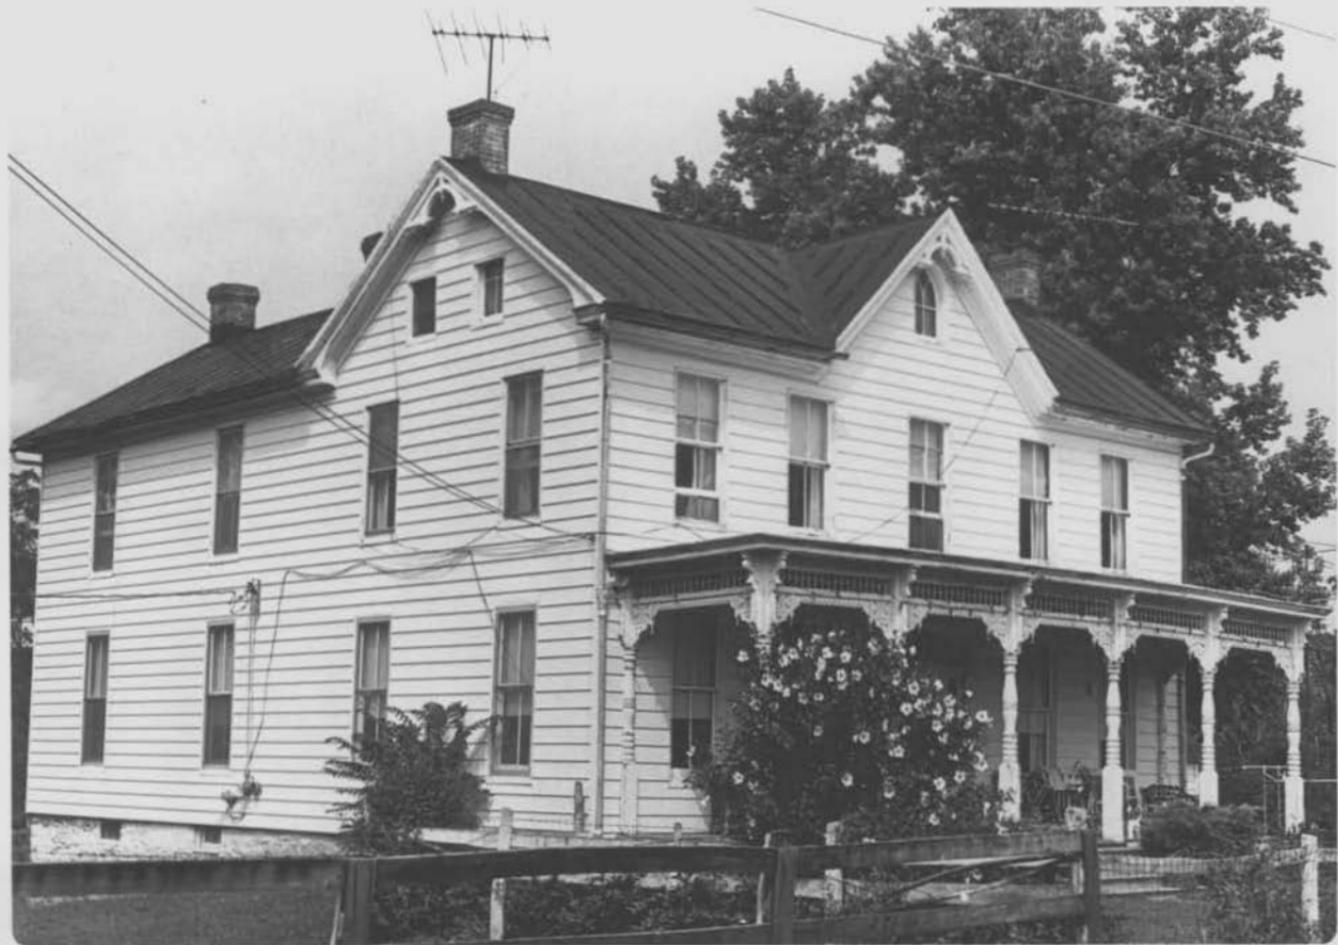
F-120 Charles Milland HSE
N/3 MICHAELS MILL RD
CEW 6/79
SOUTHWEST ELEVATION
