**MARYLAND HISTORICAL TRUST  
NR-ELIGIBILITY REVIEW FORM**

Property Name: Samuel Thomas Farmstead Inventory Number: F-1-137

# Maryland Historical Trust State Historic Sites Inventory Form

historic Samuel Thomas Farmstead (preferred); "Thomas' Profit"

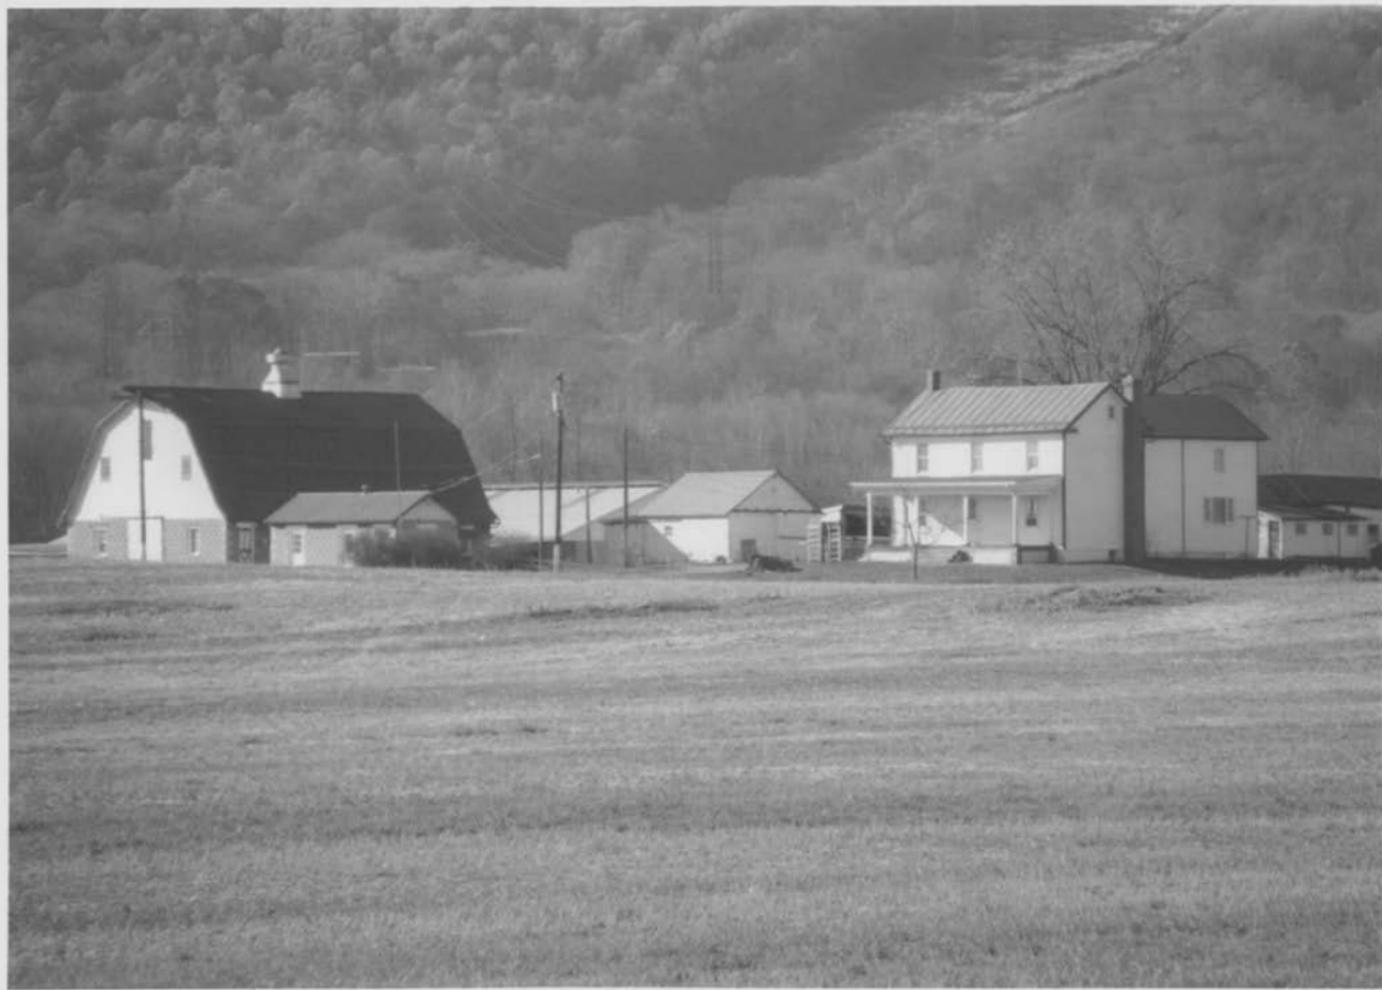
1/1

Overall, view W.

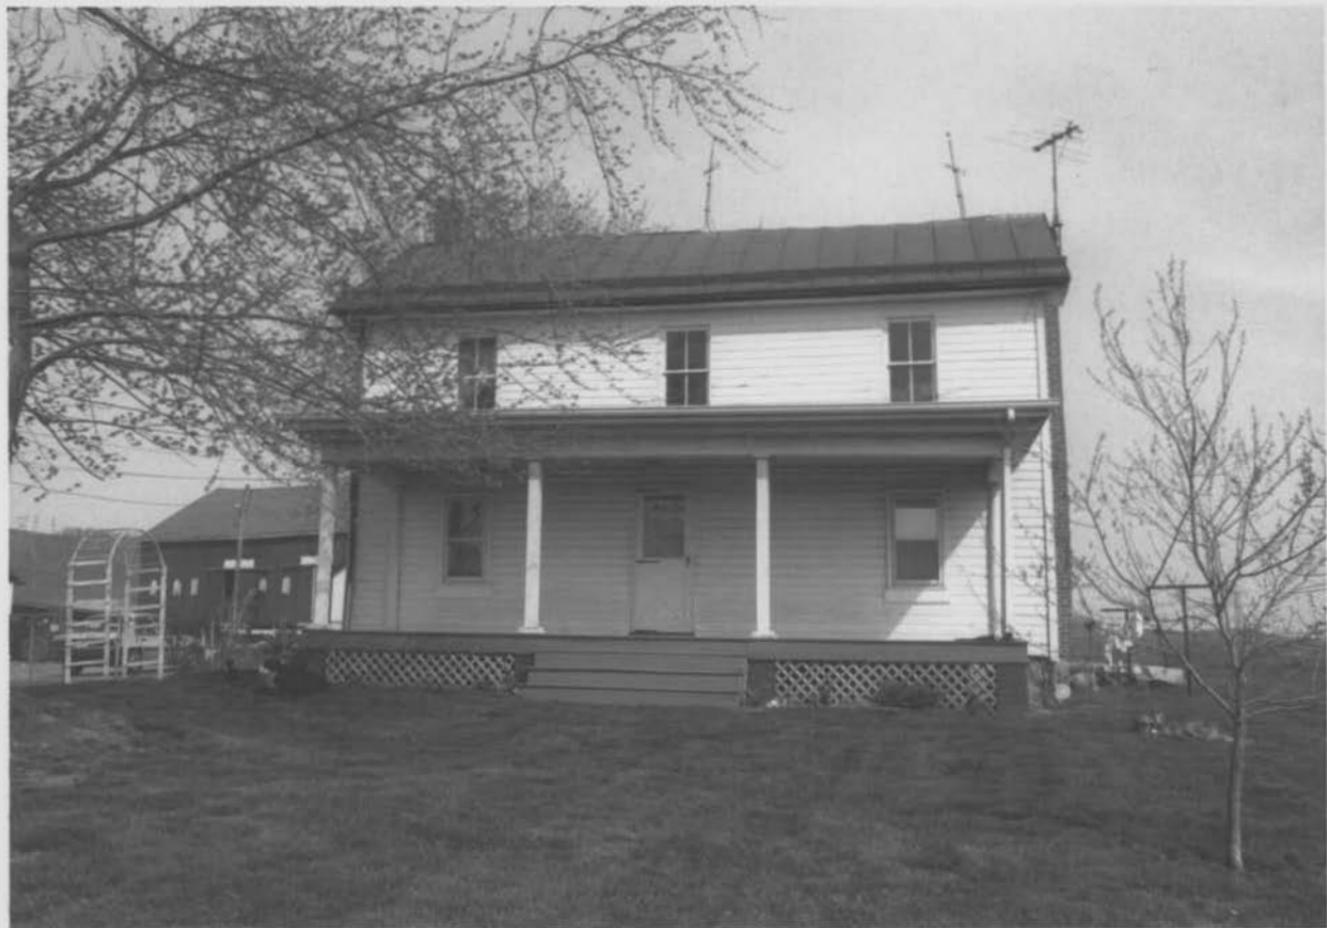
1/7

The dwelling has a three-bay main section with a two-story rear wing extending from the northwest corner built in two sections, the one adjoining the main section being log and the northwestern end being frame. The sections are demarcated by a vertical board over the joint in the exterior siding. The exterior is covered with german siding and the roof is standing seam metal, probably covering or replacing original wood shingles. An interior end chimney rises at the southwest gable end and the corresponding northeast chimney has been rebuilt on the exterior. A one-story porch extends across the entire southeast elevation, with square columns. The windows on the first story are 1/1 replacements and those on the second story are 2/2. The cornice is boxed with returns on the gable ends. The central entrance has a replacement paneled door and has no sidelights or transom. The rear wing has a one-story shed porch on the southwestern side, with square posts and an enclosed pantry at the northwest end. Each of the two sections has two bays, the log section having a boarded doorway. The sash is 1/1 on the first story and 2/2 on the second story as in the rest of the house. The door in the frame section is a glass-paneled modern replacement. On the northwest end of the wing, asbestos shingle siding over the german siding reveals the location of an exterior chimney which has been removed. The northeast side of the wing, which also is covered with asbestos shingles, has a modern picture window and the same 1/1 and 2/2 sash as on the rest of the building. A single 6/6 window on the second story of the main section may be an example of the original sash in the house. The interior of the house has been much altered with modern paneling, later partitions, and carpeting. A surviving mantelpiece in the first floor living room has columns and bull's-eye rosettes and appears to date from about 1835.

Southeast elevation

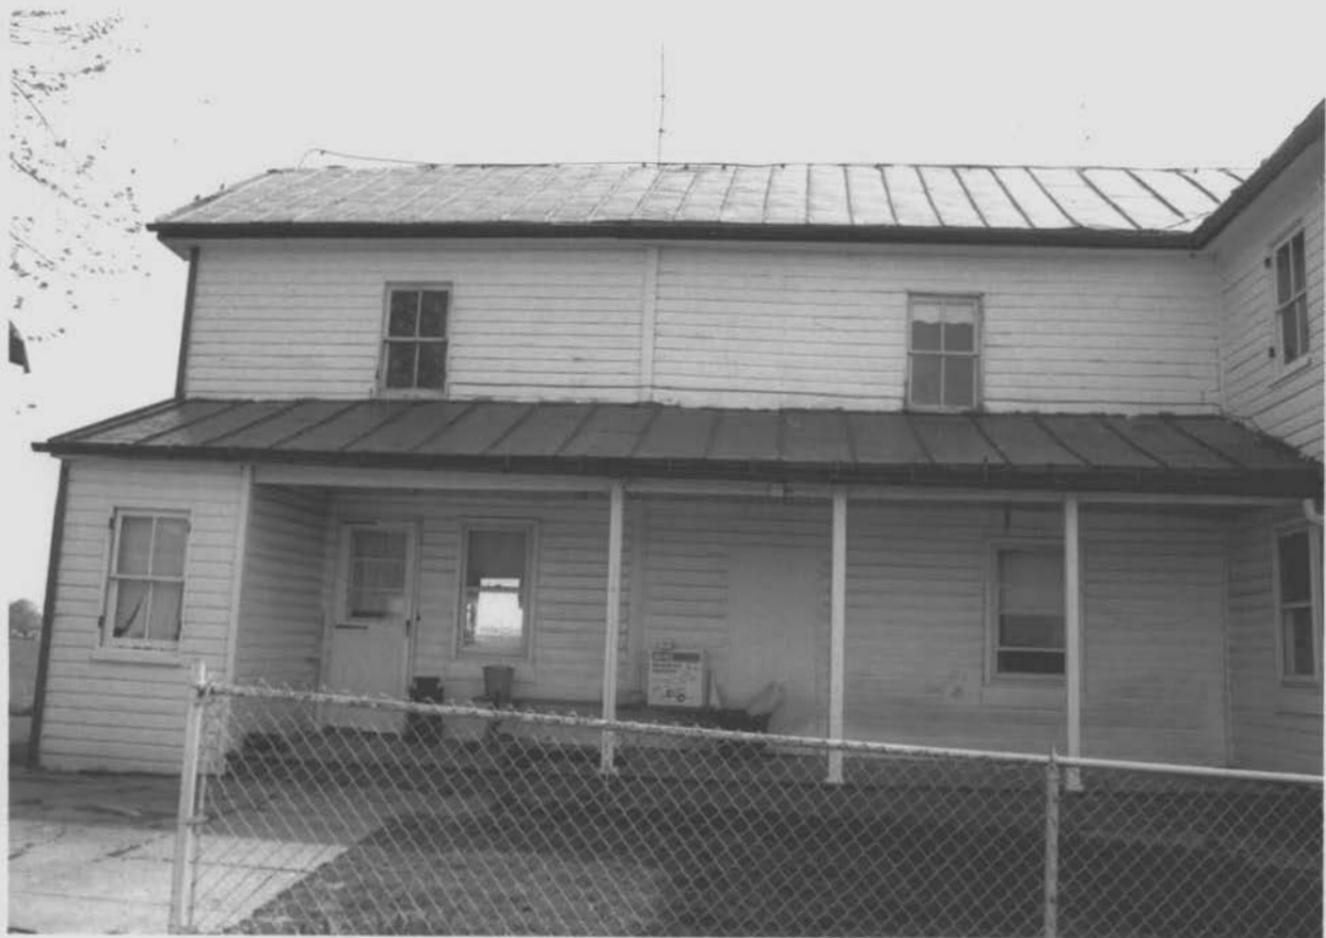
2/7

Southwest elevation of wing

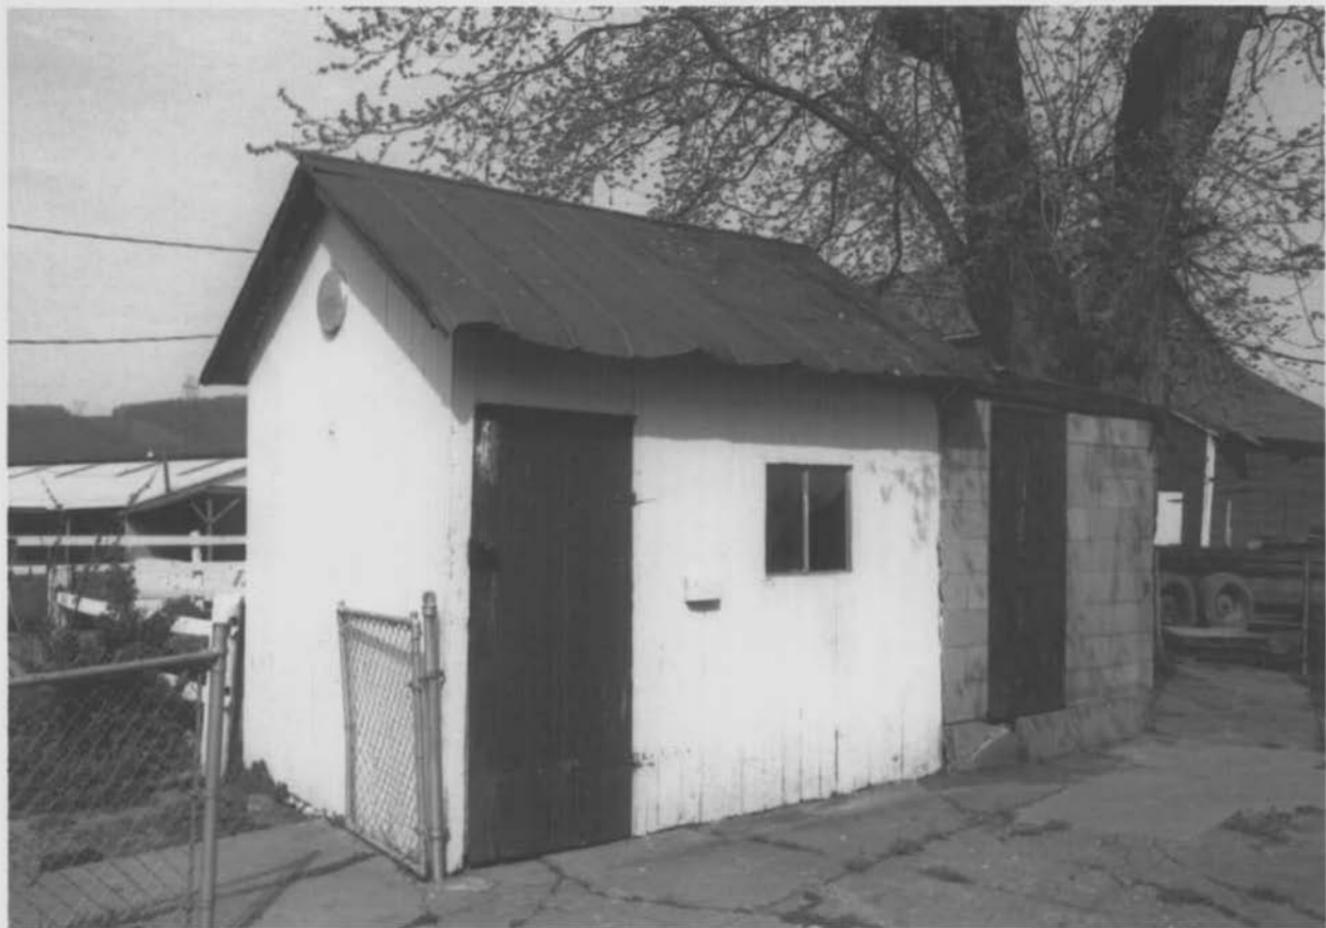
3/7

Dairy: The small frame building located southwest of the rear wing is identified by Mr. Melvin Beachley, the current owner, as a dairy. It has tongue-and-groove siding, a standing seam metal gable roof and a single tongue-and-groove door near

the southeast corner. A small window with a vertical muntin is located next to the door. A concrete block addition adjoins the dairy on the north, with a second vertical board door. The dairy was probably built about 1910-1920, based on its materials. The dairy is located next to the raised concreted well and was used for milk can sterilization and storage.

Dairy, southeast corner view

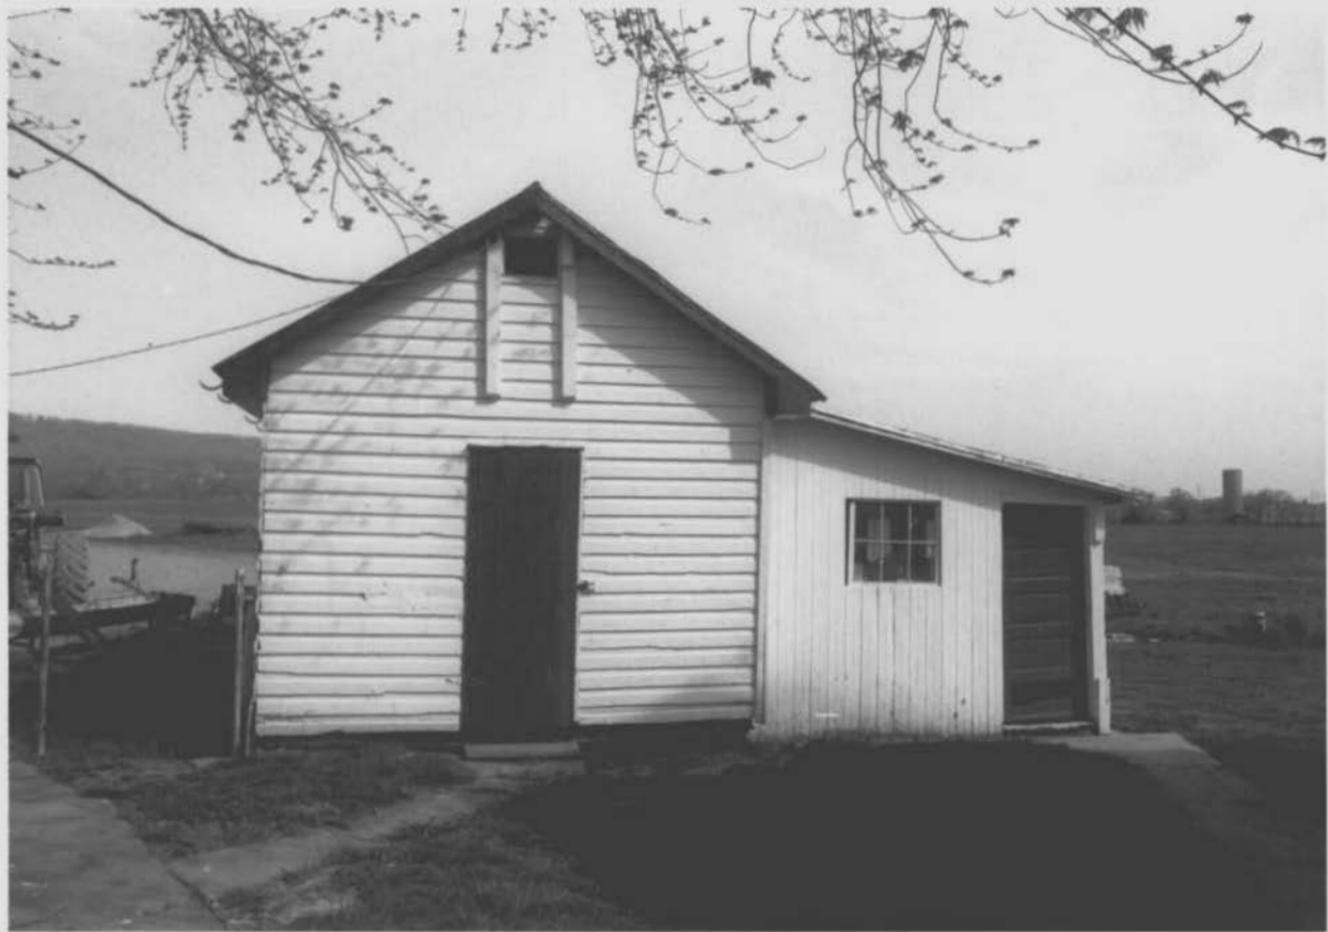
4/7

**Meathouse/summer kitchen:** The frame meathouse is located northwest of the rear wing of the house. It is a rectangular structure with german siding and a standing seam metal roof. A single vertical board door is located in the center of the southeast elevation and a "jib" window opening, a covered opening in the same german siding, is located in the southwest elevation. On the south elevation above the door is a small screened opening at the gable peak. A shed-roofed frame addition on the northeast side of the meathouse was identified by Mr. Beachley as the summer kitchen. It has tongue-and-groove siding, a paneled door and a 3/3 window in the southeast elevation, and three 3/3 windows on the north side. Adjoining the meathouse on the northwest gable end is a frame shed of vertical tongue-and-groove siding with sliding doors and a swing door on the southwest elevation. This was apparently built for equipment storage, possibly in the 1920's. The meathouse appears to date from about 1890 and the summer kitchen addition about 1920.

Meat house and summer kitchen addition  
view from southeast

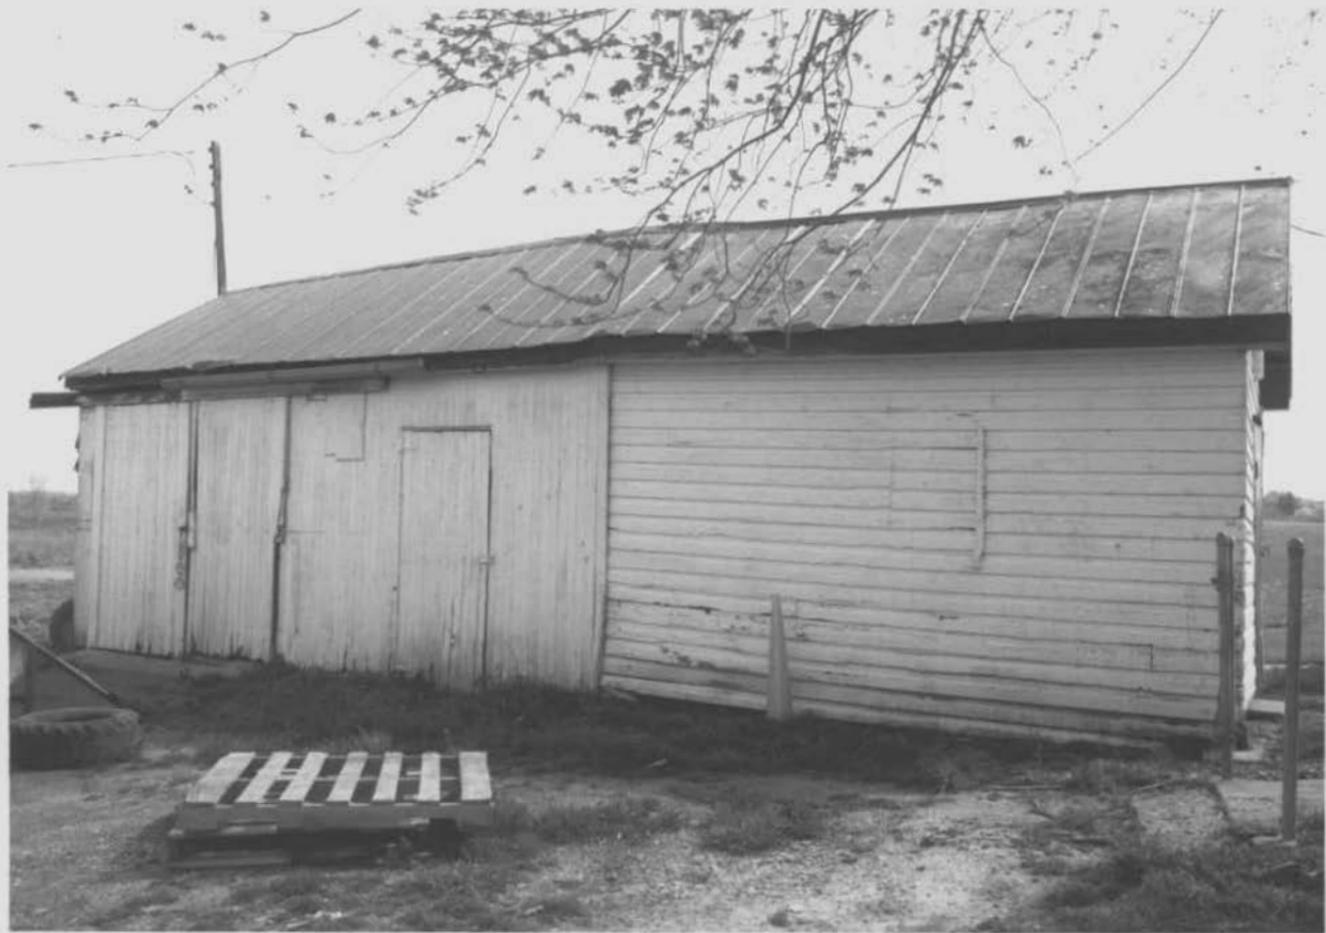
5/7

Meat house and addition, south elevation

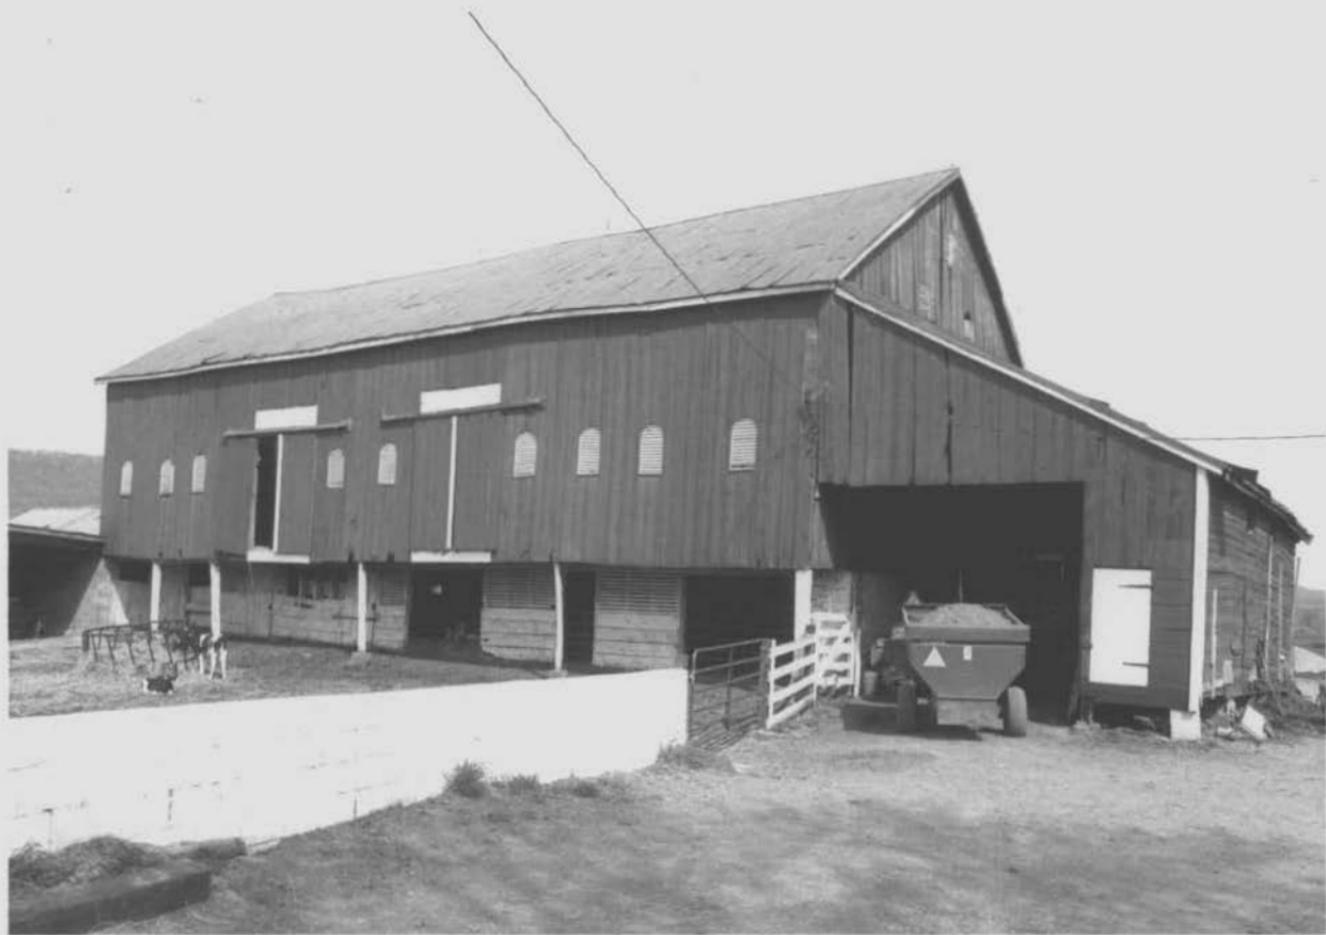
6/7

**Bank barn:** The frame bank barn has a stone foundation with the ramp to the barn floor on the northwest elevation. The exterior is covered with board and batten siding on the southeast elevation and northeast gable end. The rest of the building has vertical siding. The roof is covered with corrugated metal, over the original wood shingles. Louvred arched vents are located on all elevations. A shed addition on the northeast elevation is a wagon shed with corn crib on the outside wall. This appears to have been added about 1900. The barn itself may date from about 1875, having circular saw marks on the barn floor exposed beams. A non-contributing concrete block loafing shed adjoins the barn on the south.

Bank barr., southeast elevation

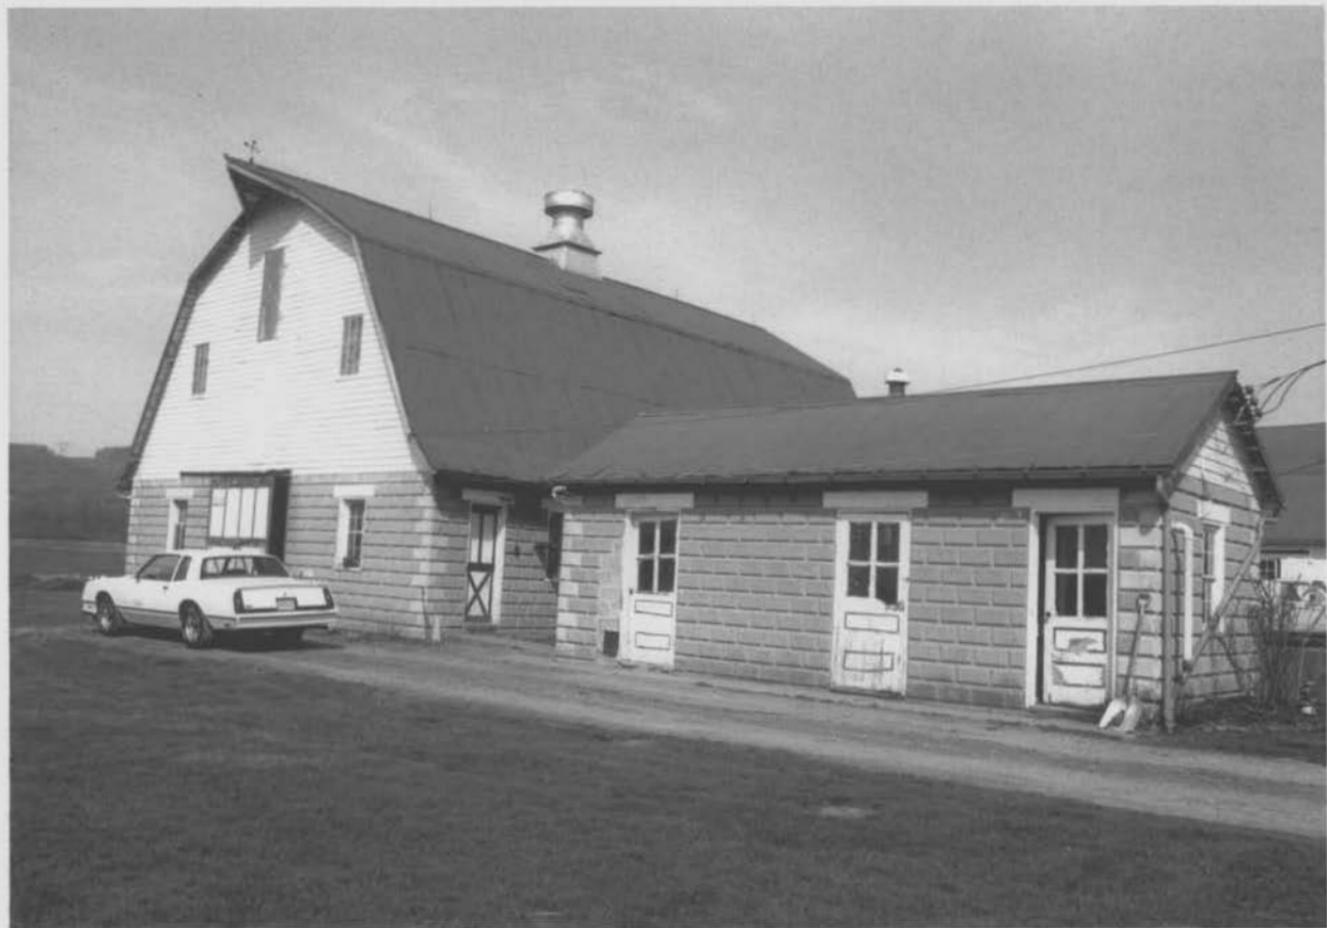
7/7

**Dairy barn and milk house:** The rusticated concrete block dairy barn was possibly built during the period 1935-1940 and has lighter colored quoins, a gambrel roof covered with corrugated metal, and german siding in the end gables. The windows are 6/6 with plain lintels. The milk house is a rectangular building with three doors with glazed upper panels in the southeast elevation and 6/6 sash in the gable ends.

Dairy barn and milk house, view from  
southeast

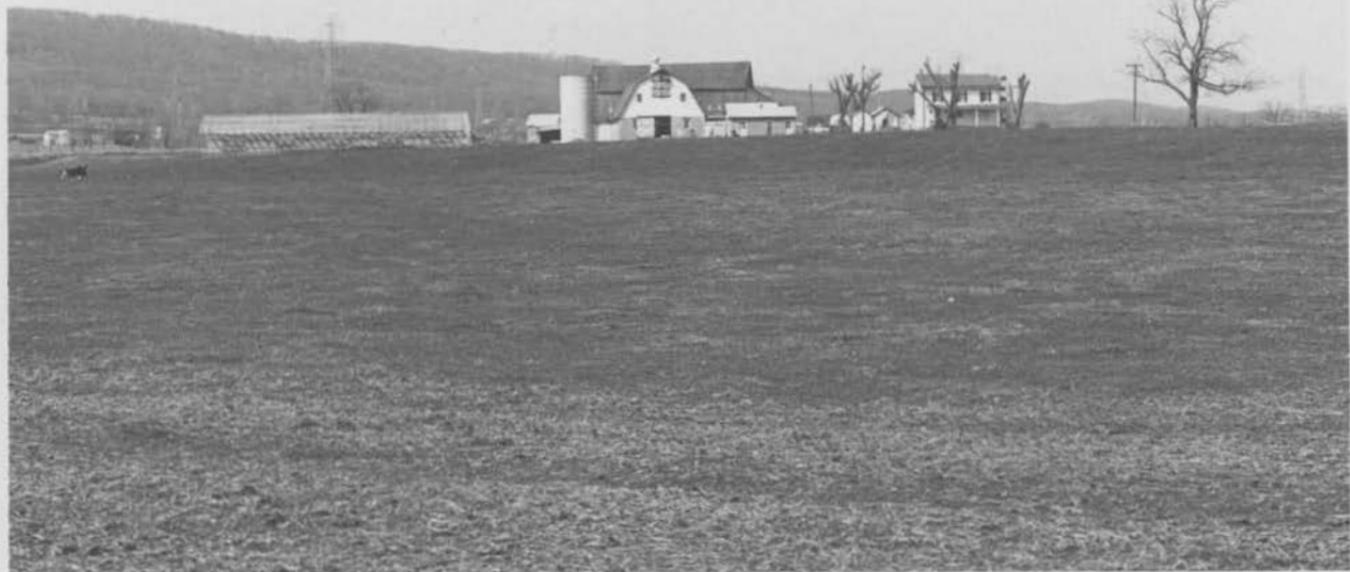
South elevation

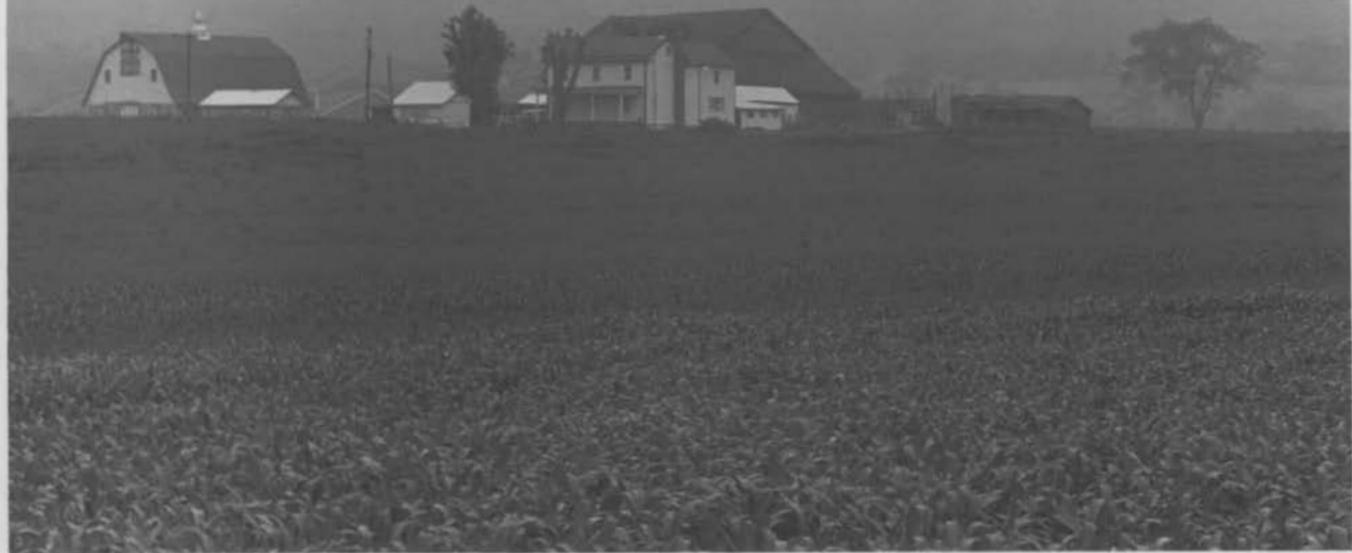
Southeast elevation
