F-1-164

Moreland; Lamar-White Farmstead
Adamstown vicinity
Private

F-1-164
Moreland (preferred)
Adamstown vicinity
Frederick County

Maryland Historical Trust State Historic Sites Inventory Form

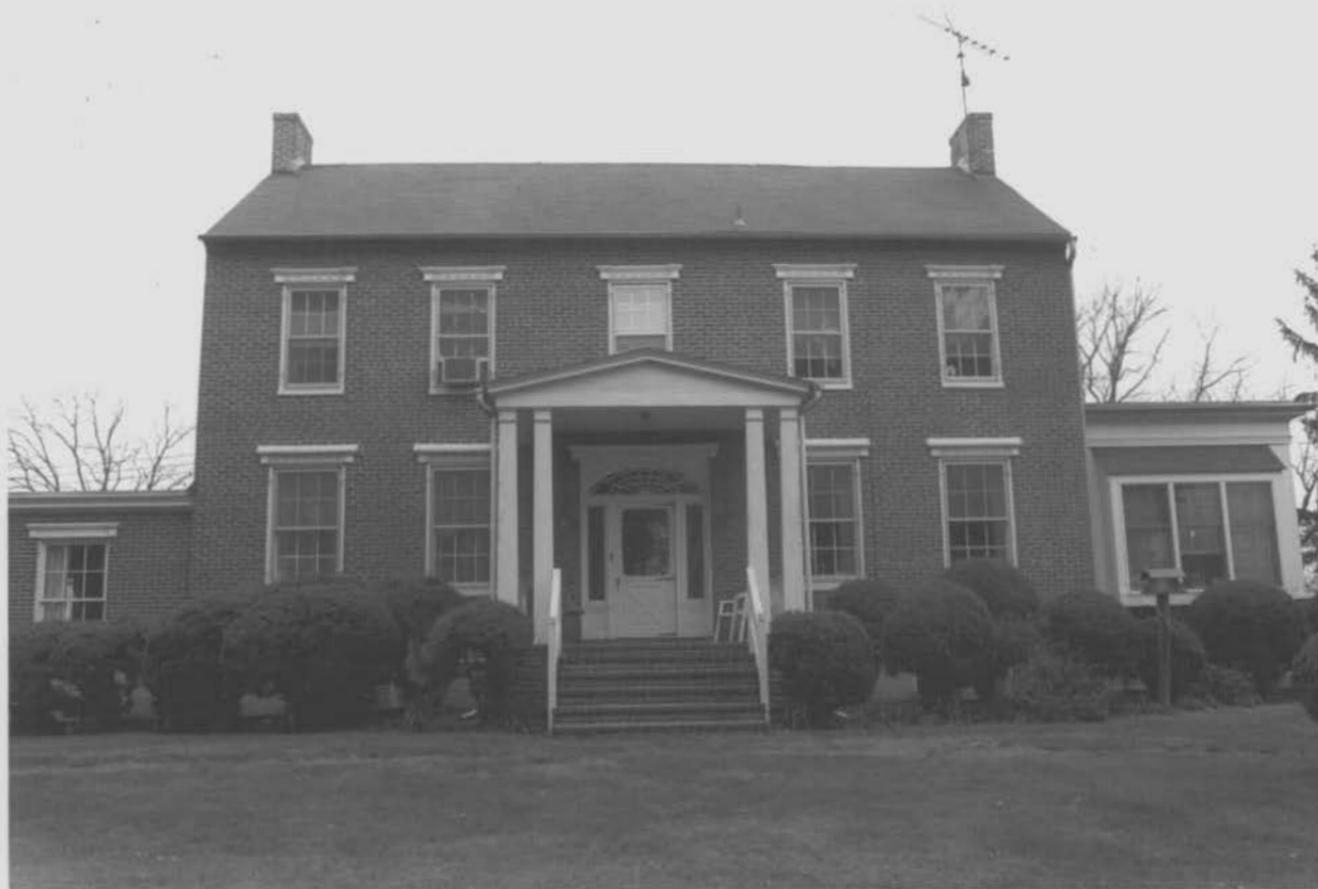
1/9

East elevation

The dwelling has 8:1 American bond walls which have been sandblasted. The east elevation has five bays with a center entrance and a modern entry porch. The gable roof is covered with composition material, replacing the original slate roofing, and interior chimneys rise at the north and south gable ends. The cornice is corbeled brick with a dog tooth course. The window bays have 6/6 replacement sash with molded hoods with an interlaced design. The center entrance also has this molding but the fanlighted door surround appears to be an early to mid-20th century Colonial Revival replacement of the original doorway. The usual Renaissance Revival treatment, the style suggested by the window hoods, would have more likely had a large rectangular transom. The sidelights contain clear glass with zinc comes, which also appear to be of the same date as the Colonial Revival doorway. The entry porch has a brick base, a 1980's replacement, and the roof supports are grouped square posts. The gable roof has a plain flush board pediment. The entry porch is also a later replacement; evidence on the brick of an earlier porch may have been removed with the sandblasting done in about 1983. The north elevation has the one-story sun porch which was enclosed in the early 1990's. A projecting door hood is located over the exterior door from this porch. According to Mrs. Elwood Hipkins, one of the current owners, the porch also had a roof deck accessed through a door on the second floor. The door, converted from a window in the early 1950's, has been returned to a window. The rear wing of the house is considerably longer than is usually seen in the familiar L-shaped plan. A group of three windows, also a 1950's alteration, is located in the section nearest the main part of the house. The south elevation of the wing has an enclosure of the original integral two-story porch. The enclosure took place in the 1950's alteration, while the siding is a recent addition. The exterior is covered with vinyl siding and two similar entry porches are located on the south and on the west end of the wing. The south elevation of the main part of the house is abutted by the one-story brick garage added about 1950.

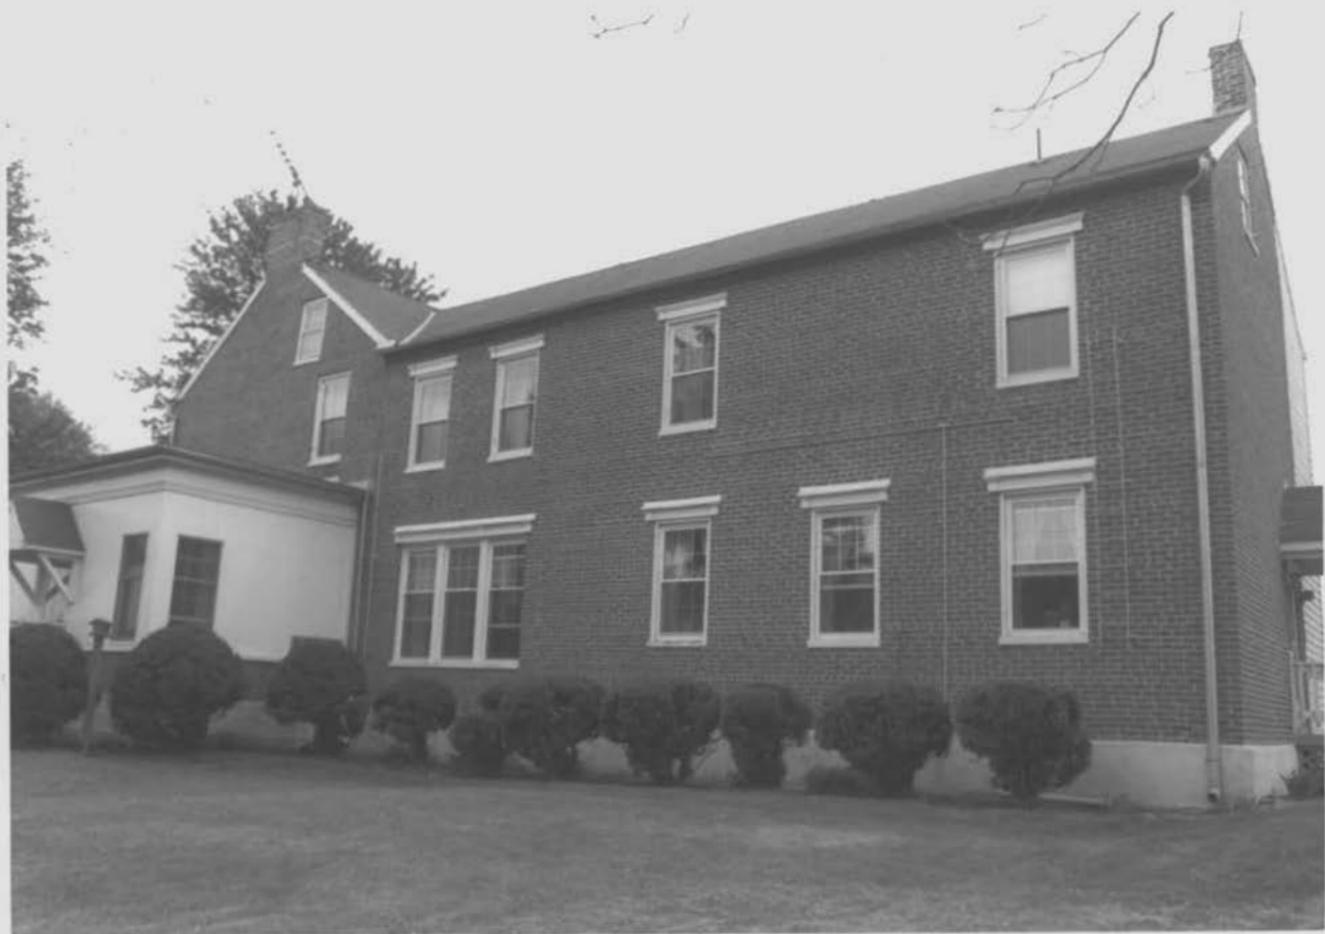
2/9

North elevation

On the north wall of the ell, a wide window consisting of three sash windows may also possibly be a later alteration; it, too, would be unusual for a mid-19th century (or earlier) house in this area. On the east side of the ell, a former two-story gallery has been partially enclosed with large windows. The house is well maintained and part of an active agricultural complex; the grounds around the house are well landscaped. The interior of the house still retains much of its 19th century woodwork, including door trim and mantels.

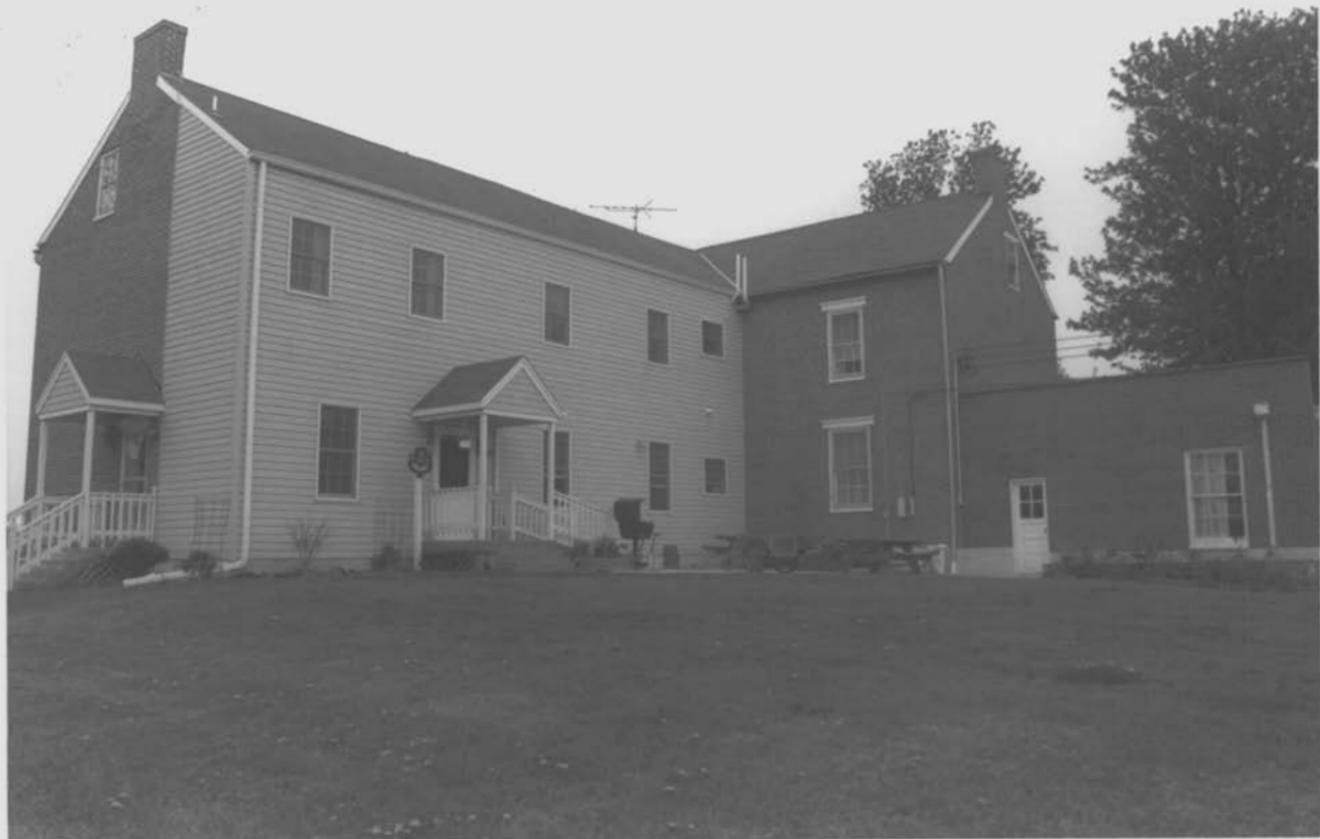
3/9

Southwest corner view

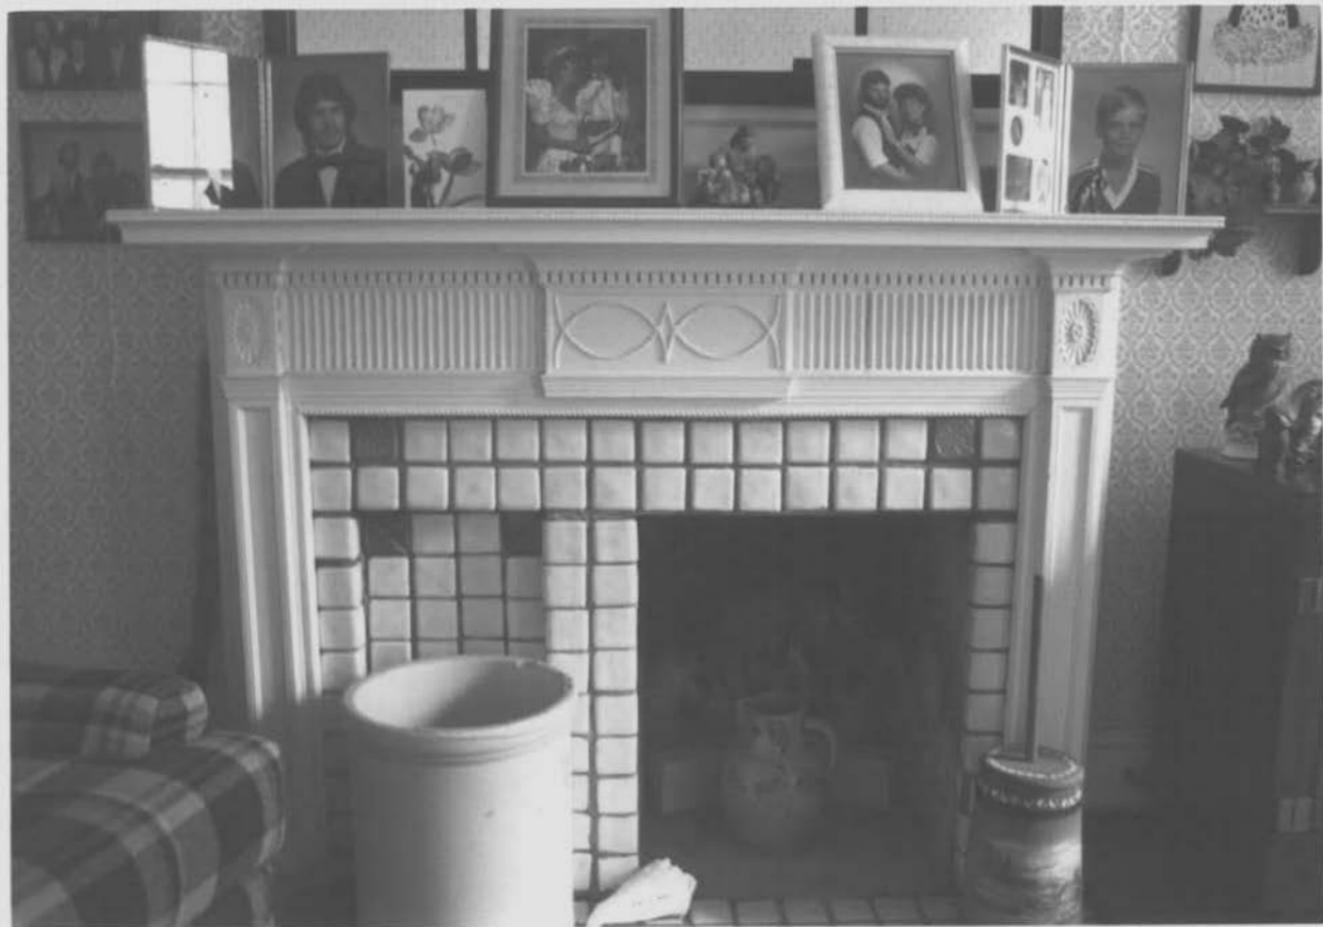
5/9

Colonial Revival, mantelcase, street front

wing. The main section has a doorway with paneled soffits opening from the central hall to the south parlor. The mantel is a modern brick replacement. The north parlor has a simple fluted door surround with corner blocks. The original floors are covered by mid-20th century hardwood floors. The mantel in this room is a Colonial Revival reproduction of the 1950's, with Adam style fluted lozenges and frieze. The walls are covered in wallpaper. A wide arch leads from the north parlor to the dining room in the rear wing. This room has the triple window noted in the exterior description and built-in corner cupboards. Part of the plan changes in the wing made in the 1950's included the addition of a butler's pantry off the dining room and a side hall with a rear staircase, which may have been relocated from a corner during the remodeling. The westernmost room in the wing is the modern kitchen. A modern bathroom was added on the east end of the formerly open porch near the back of the stair hall.

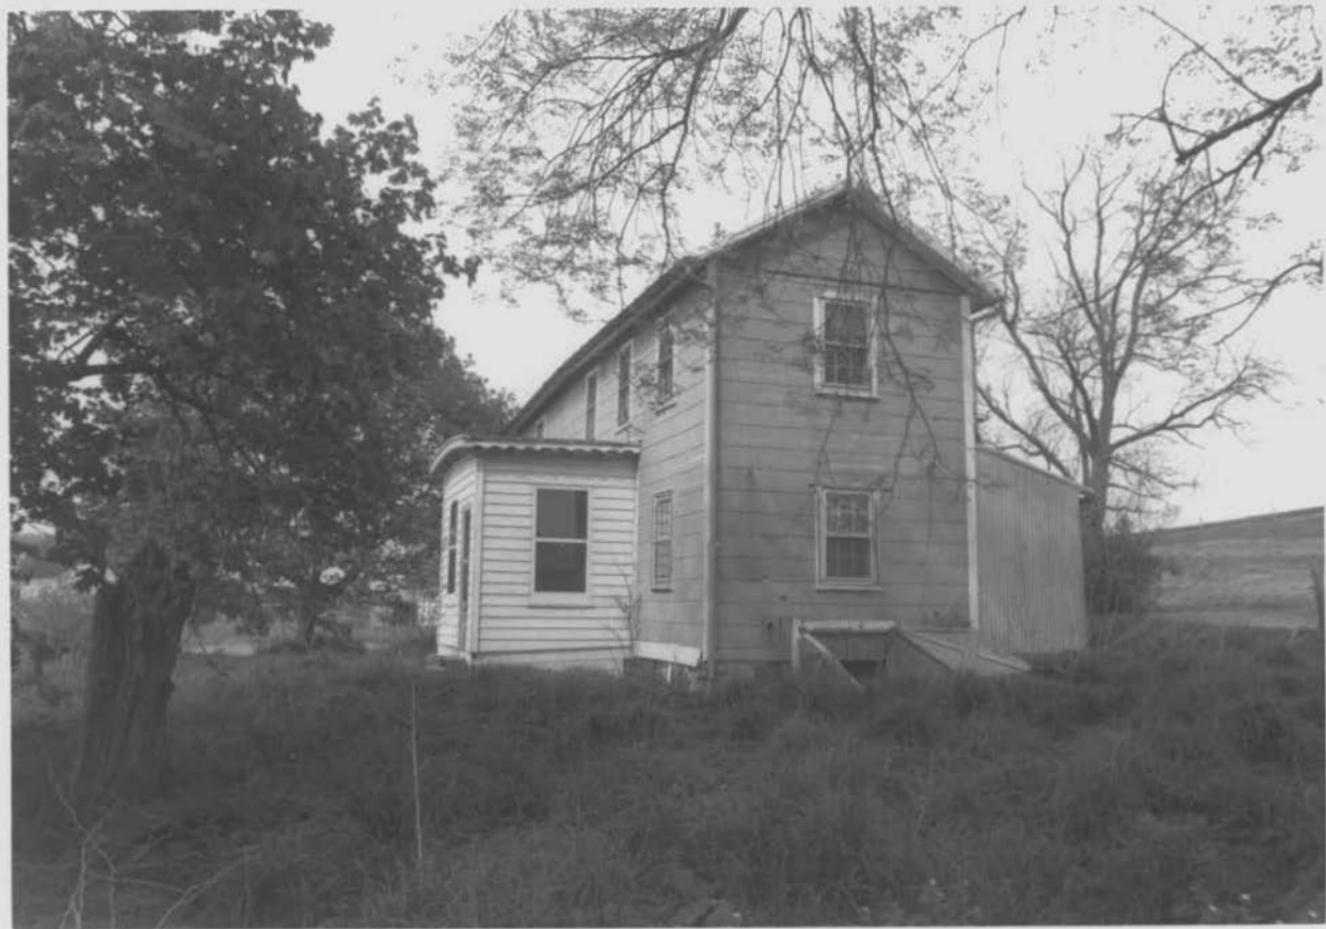
8/9

Tenant house, view from south

Tenant house: The two-story, two-section tenant house is a frame structure possibly built about 1875-1880 in its original three-bay form and later extended with a second section on the north gable end. The exterior is covered with vertical siding under asbestos shingles and a one-story enclosed entry porch is located on the west elevation. It has an unusual curved cornice line and a serpentine bargeboard decoration. On the east elevation, the house has a shed addition in approximation of a rear wing, but it has been much altered. Both sections have 6/6 sash and the gable roof is covered with standing seam metal. The house is currently unoccupied.

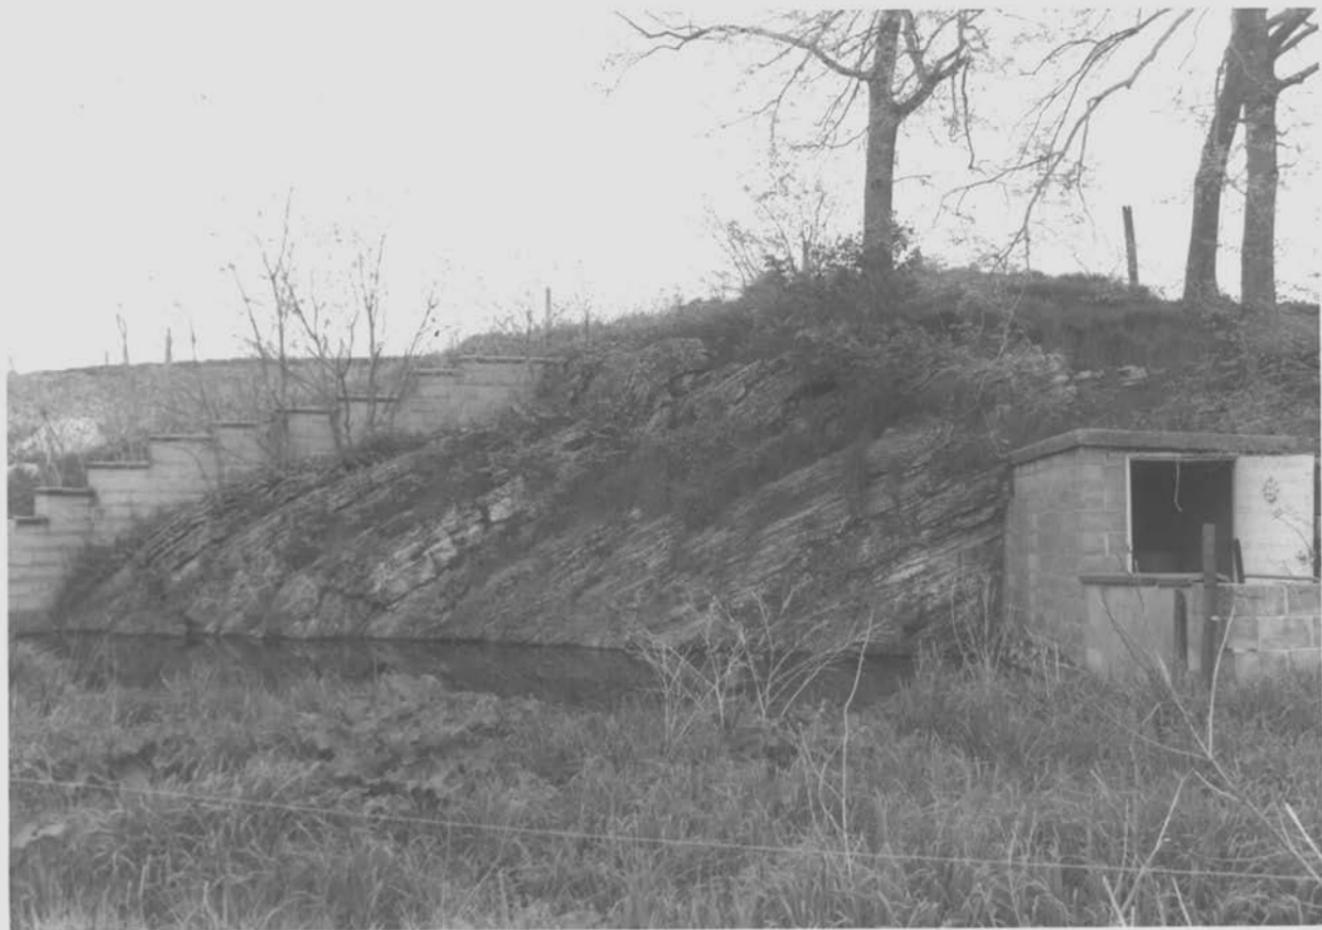
7/9

"Big Spring" view from west

Big Spring: The natural spring is located near the present milking barn and the tenant house. It is at the base of an exposed uplifted rock face, where concrete block retaining walls and a pump house have been built around its. The spring keeps a large pool constantly level and supplies the dairy barn, while the dwelling currently has a separate well, although the spring was historically the source of all water on the farmstead.

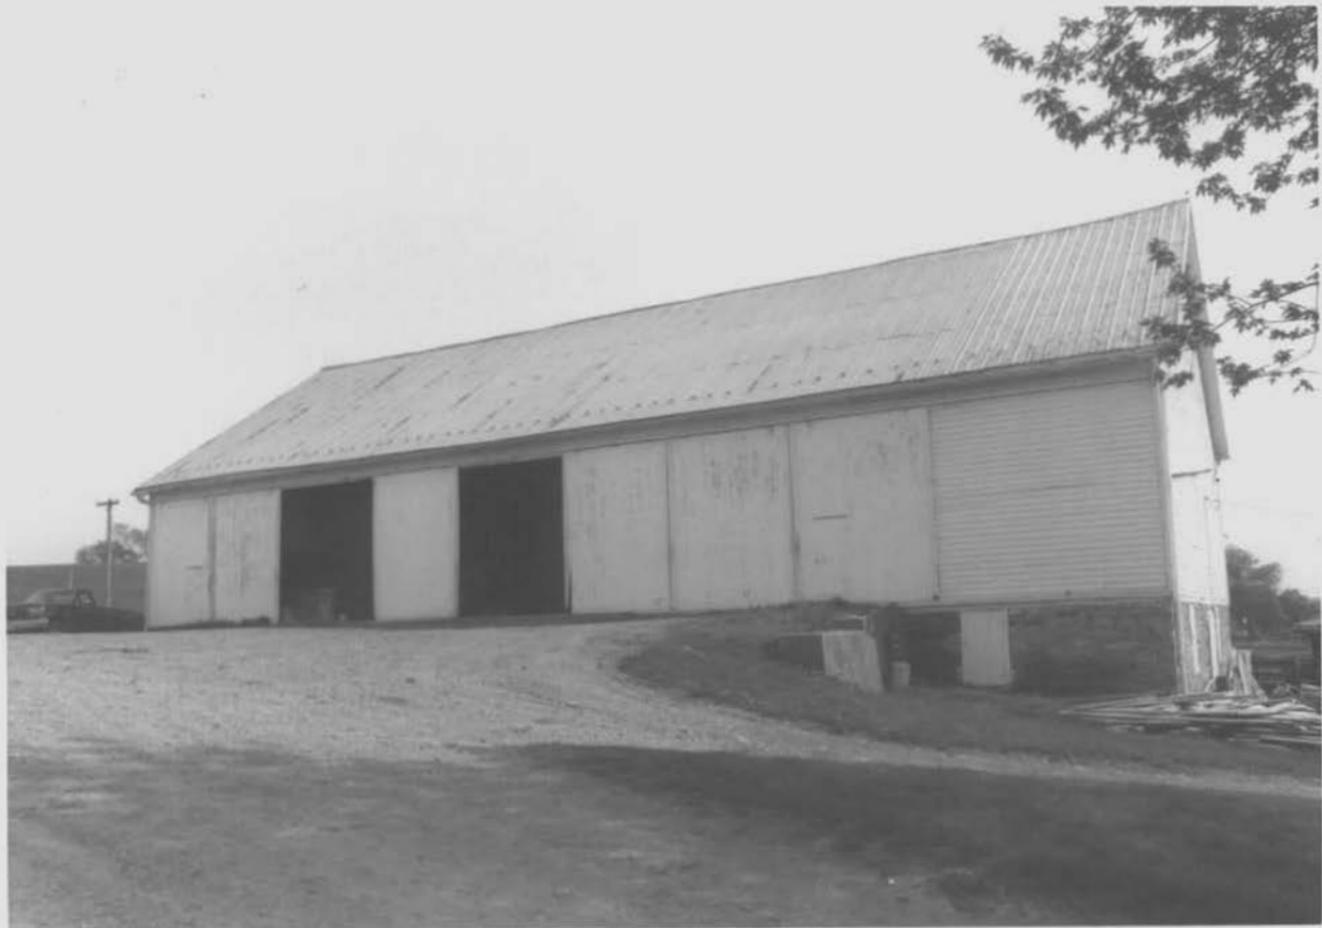
6/9

Bank Corn, north elevation

Bank barn: The bank barn also appears to have been built about 1900 and has german siding and a corrugated metal roof. Three sets of sliding doors are located on the north elevation and the east and west elevations have twin louvred vents.

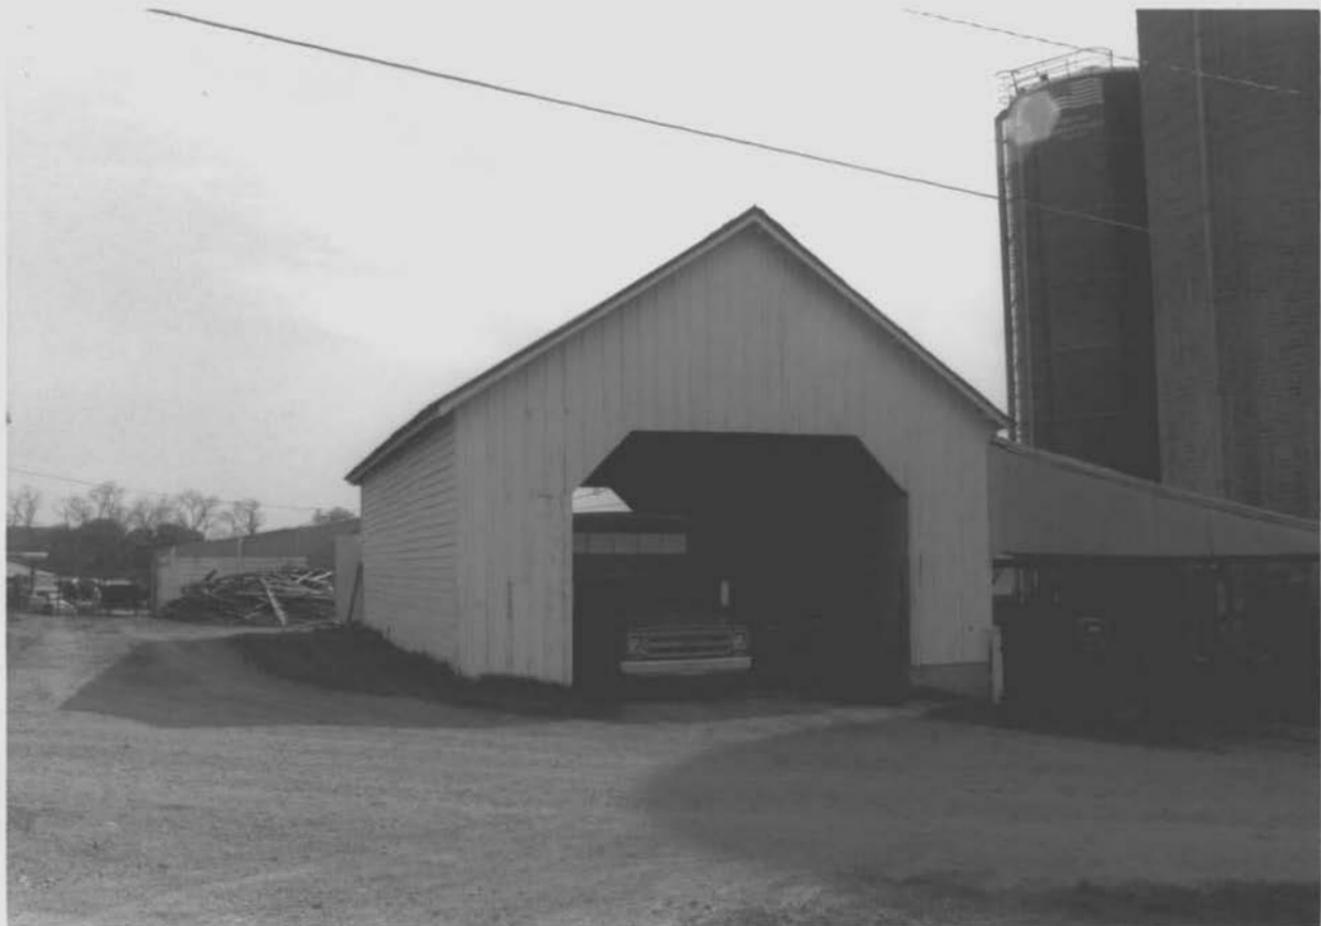
Neq. loc.: Rd. 5470, Brownsville, Md
Wagon shed porch end north elevation
7/9

Wagon shed/corn crib: The frame wagon shed with flanking corn cribs was built about 1890-1900, based on its materials and construction. It is located near the center of the outbuilding group and its drive-through is oriented north-south. The north elevation has board and batten siding and the side elevations are horizontal vented boards. The roof is covered with corrugated metal.
