F-1-197

Samuel C. Thomas Farm Outbuildings
Adamstown vicinity
Private

Ca. 1875-1920

Maryland Historical Trust State Historic Sites Inventory Form

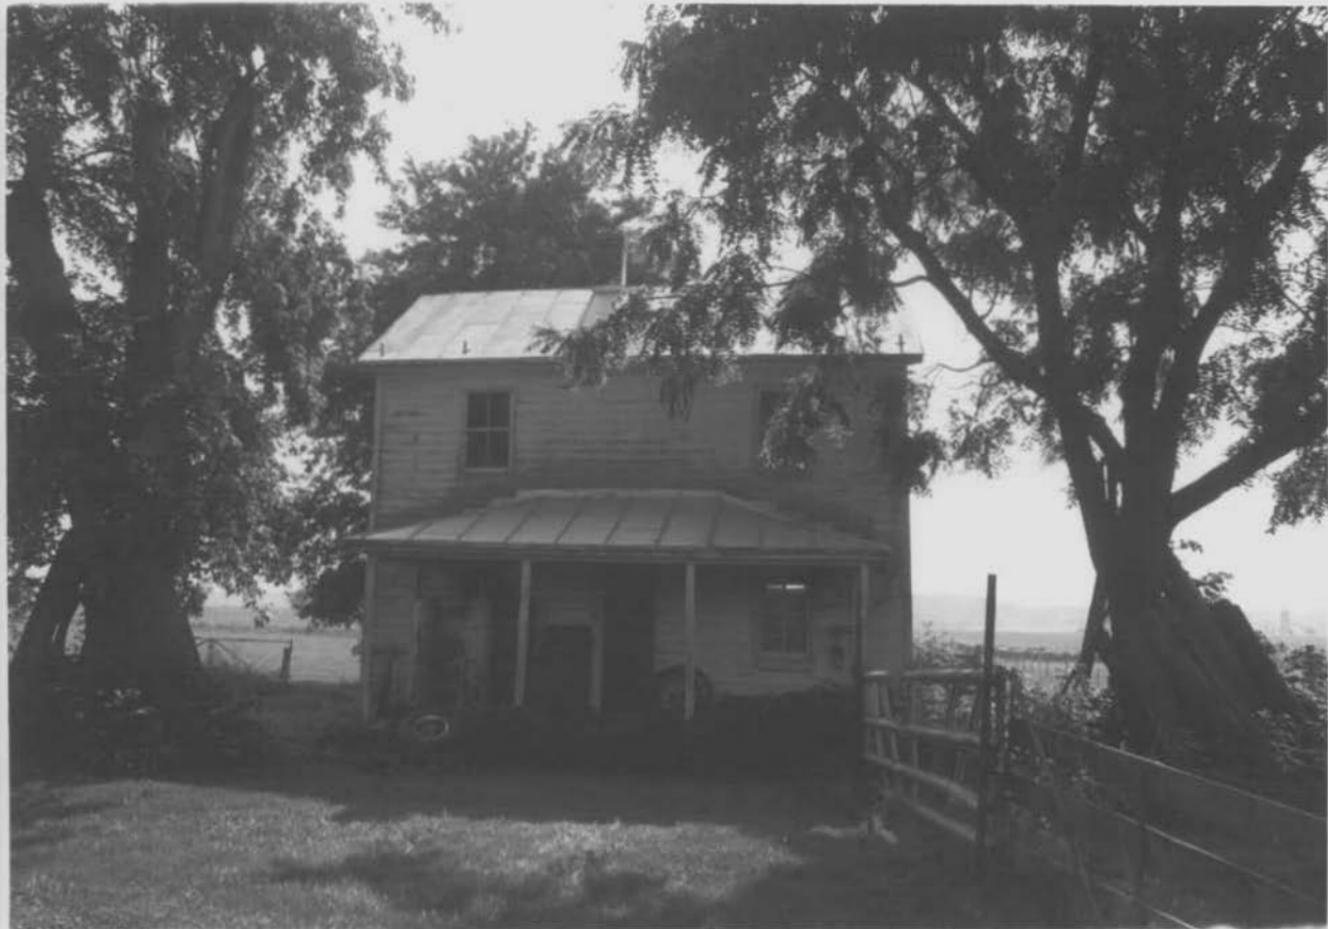
1/5

Tenant house, west elevation

The tenant house was also built about 1900, based on its materials. According to information supplied by Ms. Sarah Hoffman, whose aunt lived in the house in the 1950's, the house was originally a chicken house that was later converted to a tenant dwelling. The two-story german sided building has all the features of a simple vernacular house of the period about 1890-1910, pointing to the possibility that the chicken house may have been a temporary use in the early 20th century. The west elevation had three bays on the first story and two on the second. A one-story shed porch covers the lower part of the elevation. The sash is 2/2 and the roof is covered with standing seam metal. The chimney is off-center at the ridge. The east elevation has two bays, one with a glazed panel door. The interior has plaster walls over lath and a two-room plan. No fireplace or mantelpiece is present, and it appears that a wood stove provided heat as well as the cooking fire. The house is

in generally deteriorated condition and is also a storage building in the farmstead.

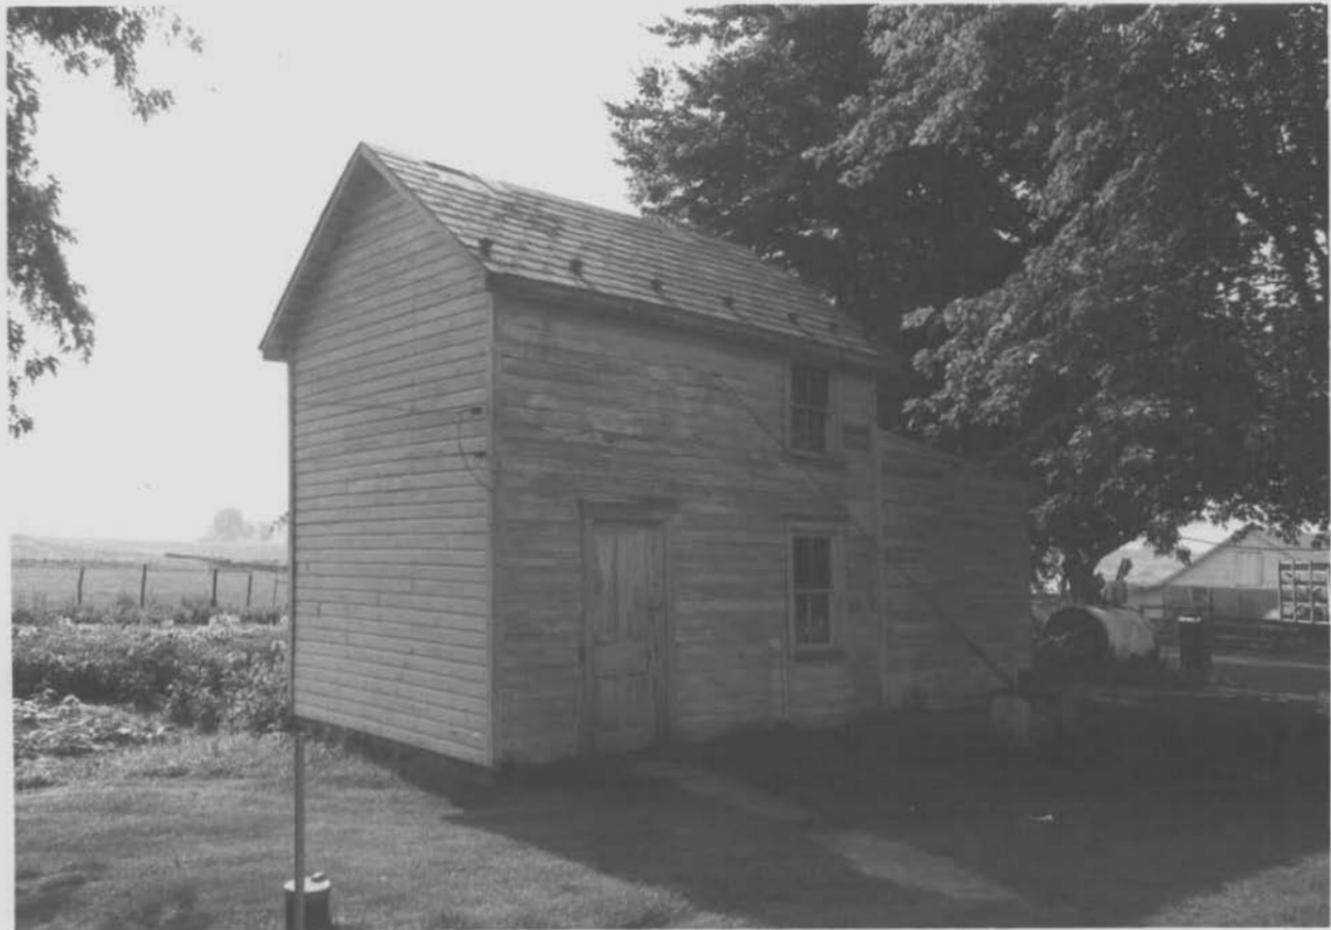
2/5

Summer kitchen, northwest corner view

The summer kitchen is a frame building with two stories and a gable roof with its principal elevation facing west. The exterior is covered with german siding and the roof is slate. The west elevation has an irregular bay arrangement, with a single doorway in the north bay and a two-story bay on the south with 2/2 windows on each level. The door itself is a 4-panel type. The north elevation has no openings and the east elevation has a single off-center bay with 2/2 windows. The south elevation originally had an exterior chimney which has been removed. The outline of the chimney is visible on the south gable end and the slate roof has a break in the eave where the stack rose above the roof. The chimney was apparently removed at an unknown date prior to the 1950's and a one-story windowless shed addition added to the structure. On the interior, the south wall was completely removed inside this shed. The outline of the original hearth is still evident in the floor. The building was probably built about 1875-1878 in its original form and is now in fair condition and used for storage.

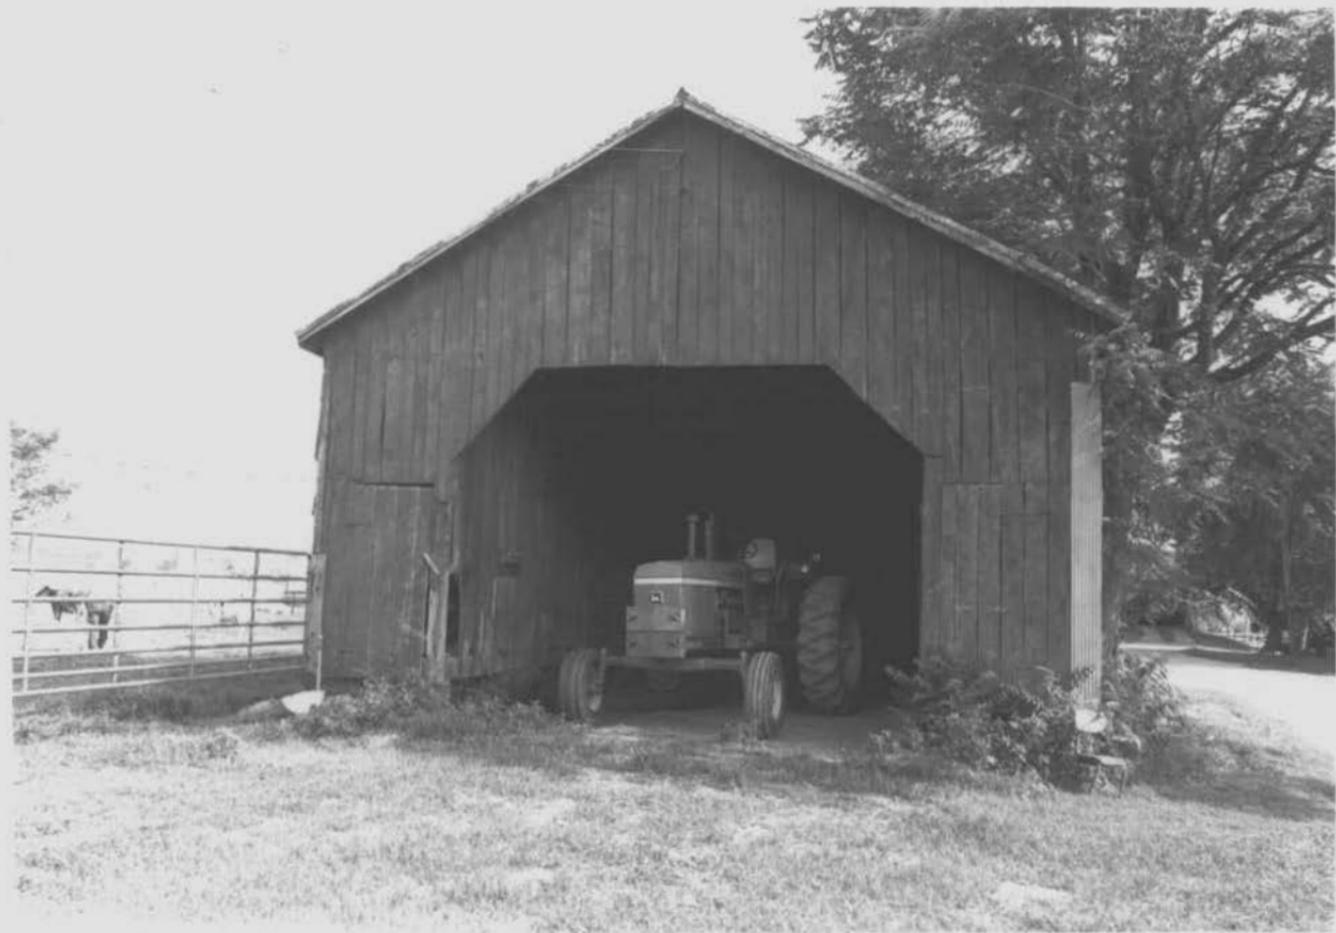
3/5

Wagon shed/corn crib, south elevation

The wagon shed/corn crib has vertical siding on the south elevation, while the east and west elevations are covered with various types of metal siding. The roof is corrugated metal. On the north end of the shed is a non-contributing, open-sided equipment shed added after 1964. The wagon shed was probably built about 1900.

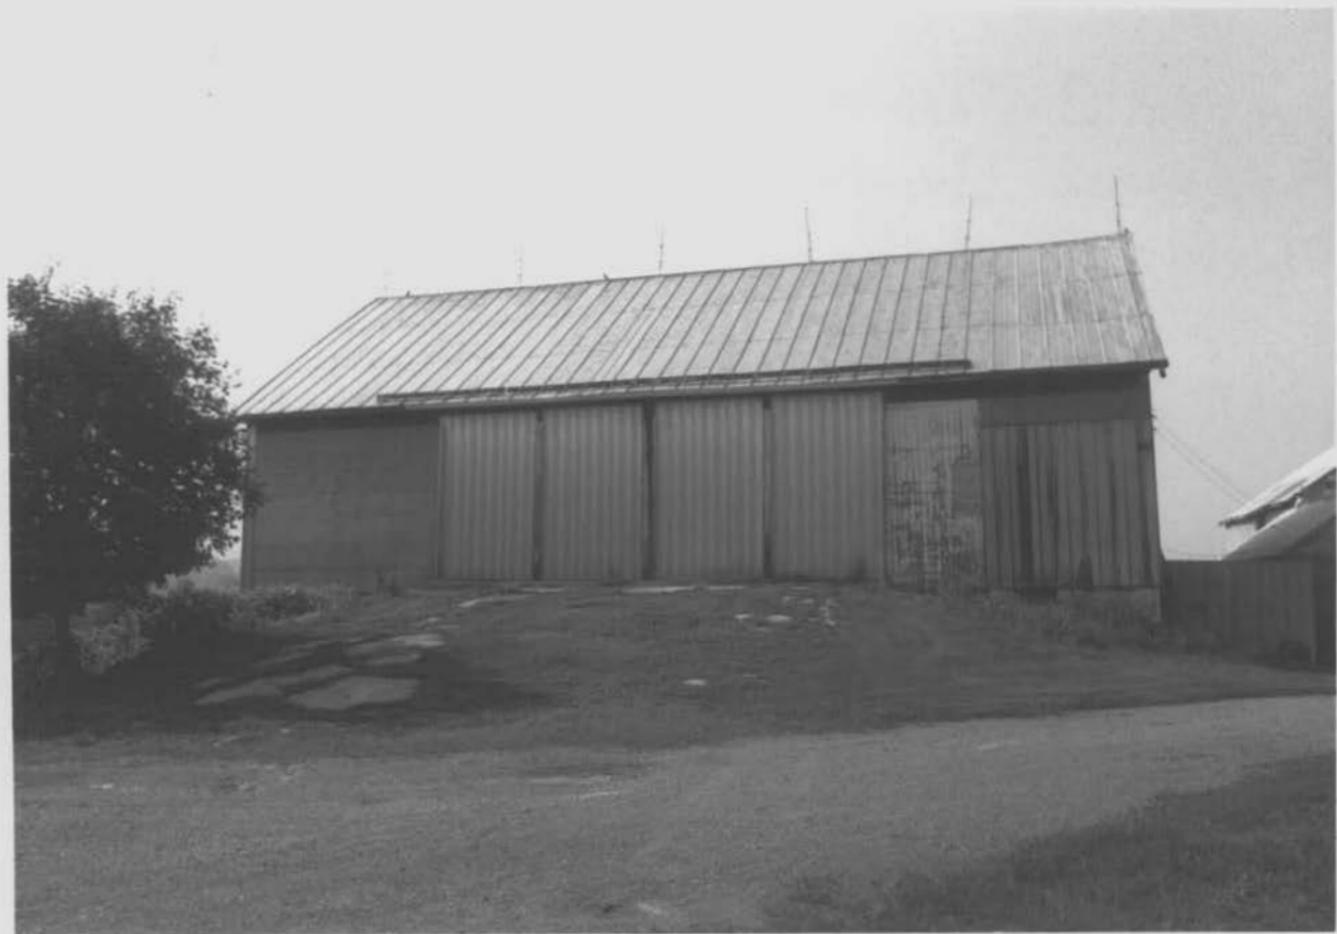
4/5

Bank barn, north elevation

The bank barn is located south of the domestic buildings and the wagon shed. It has been almost completely covered with various types of metal siding on the north, west, and east elevations. Large sliding metal doors are on the north elevation. A small section of the vertical siding is exposed to the right of the doors, showing a louvred arched vent as well. The roof is also standing seam metal. The barn was probably built about 1875-1890, based on its general form and details. The rusticated concrete block milk house with corrugated metal roof and german sided gables is located east of the barn. It appears to have been built about 1920.

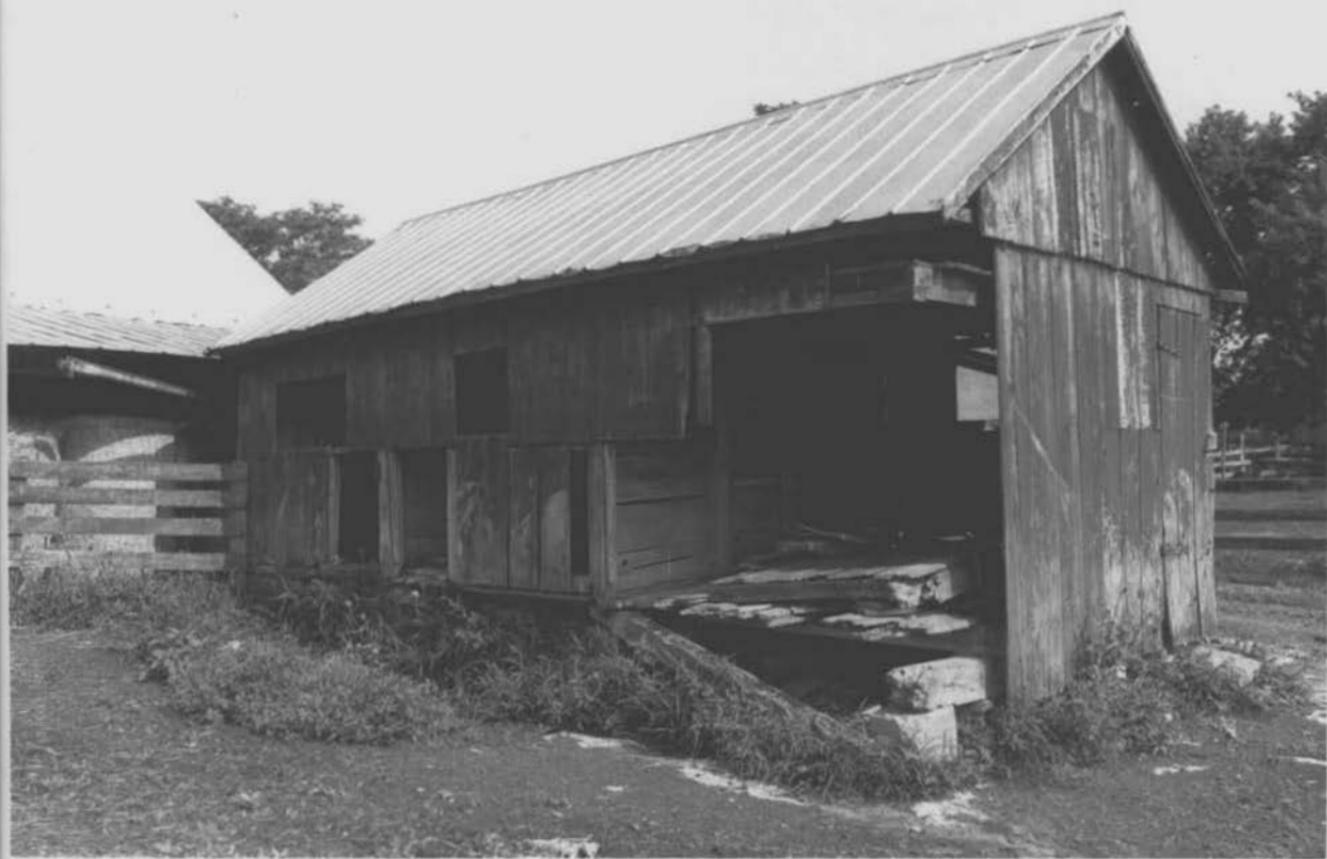
5/5

Hog barn, southeast corner view

The hog barn is located east of the bank barn. It is in deteriorated condition and part of its south wall has been removed. The rest of the vertical siding and standing seam metal roof remain fairly intact, however. The barn was probably built about 1910-1920.
