F-1-201
Eli Nicodemus Farmstead
Buckeystown vicinity
Private

F-1-201
Eli Nicodemus Farmstead
Buckeystown
Frederick County

Maryland Historical Trust
State Historic Sites Inventory Form

historic Eli Nicodemus Farmstead

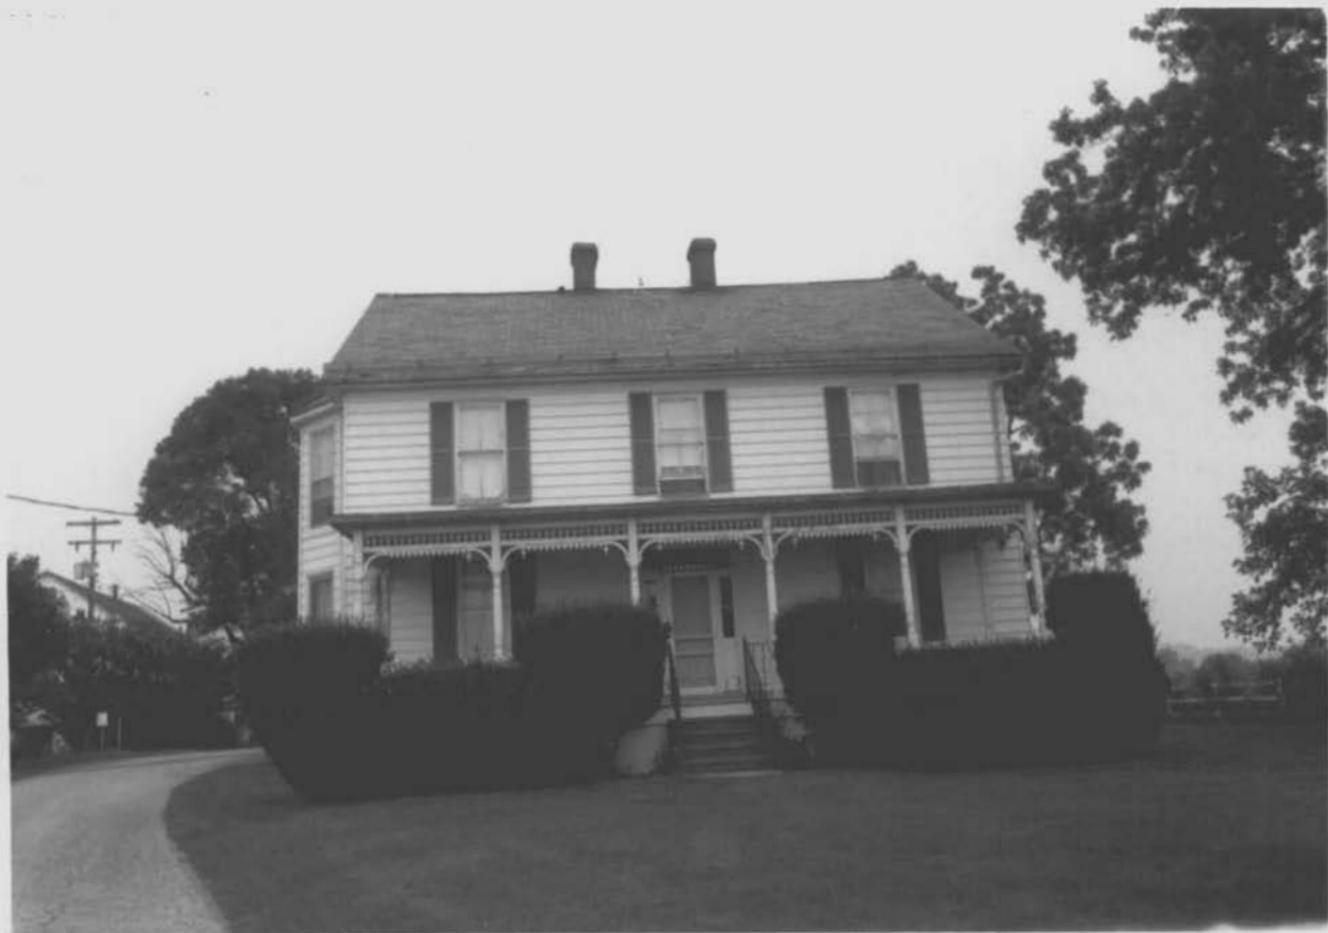
1/6

The dwelling is a two-story frame structure with vinyl siding and a slate roof. The east elevation has three bays with a one-story porch with elaborate turned columns, a spindle frieze, and pendants. The doorway has a rectangular transom and sidelights and the windows are 2/2 with replacement metal shutters. Two brick chimneys rise from the center of the house. The south elevation has a shingled gable above two bays. The eastern bay has a polygonal two-story projection. In the center of the elevation is a doorway with an entry porch. The north elevation also has a shingled gable and two bays. An additional small modern window has been added near the northwest corner. The west elevation is dominated by a large rear win. which is almost the width of the main section. Part of the stone foundation at the northwest corner has been replaced by concrete block. Two additional interior chimneys rise from the roof. The western gable is also shingled and two bays with 6/6 windows are on the two floors. The west wall extends to enclose the two-story porch on the south side of the wing. The lower level of the porch has been enclosed with screened windows and a frame, german-sided storage projection is located at the southwest corner of the enclosed porch. The upper level has a plain balustrade. The interior of the house was not accessible for this survey.

East elevation

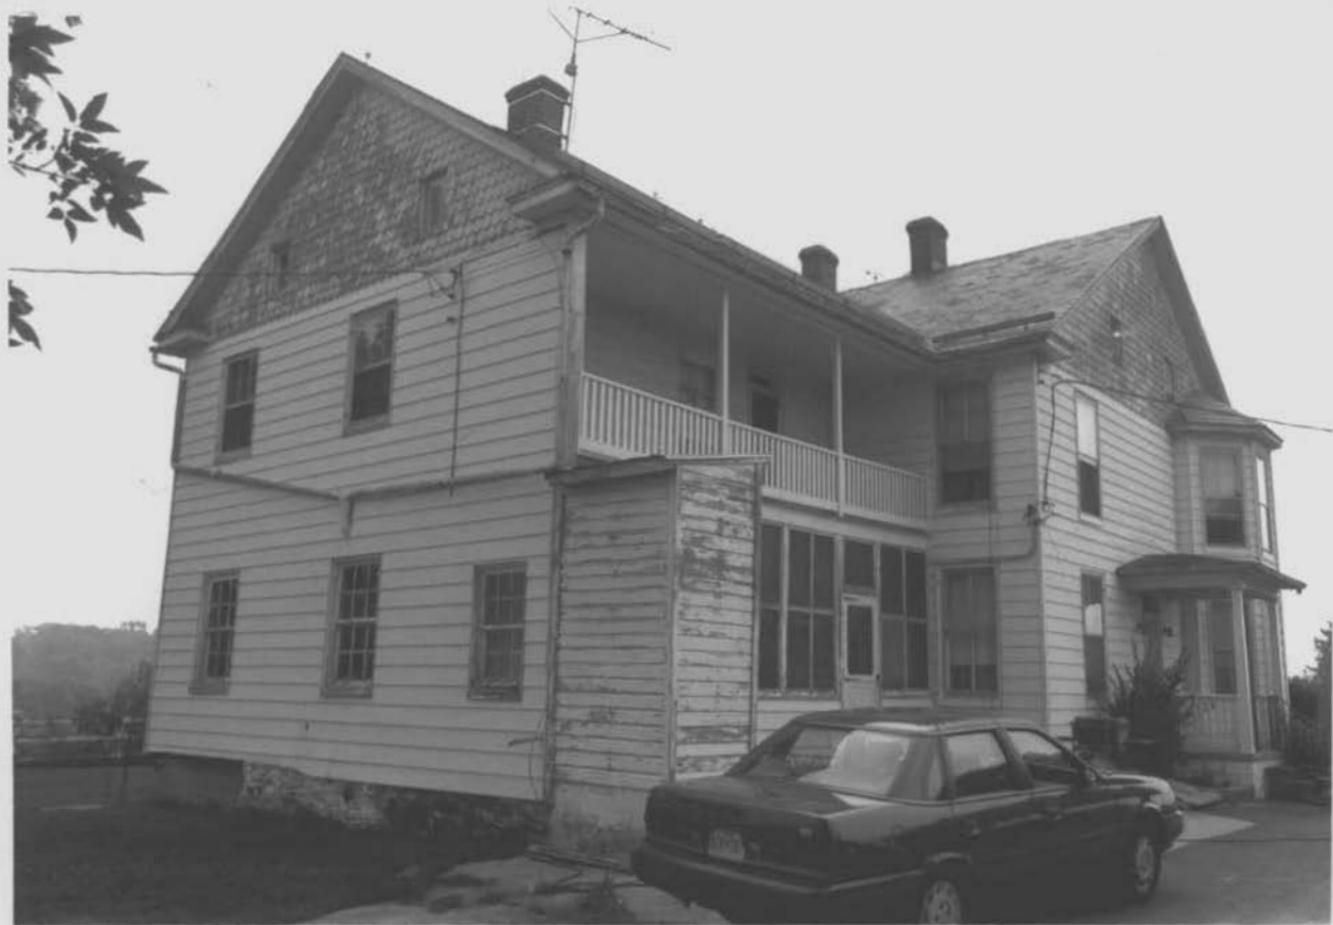
2/6

Southwest corner view

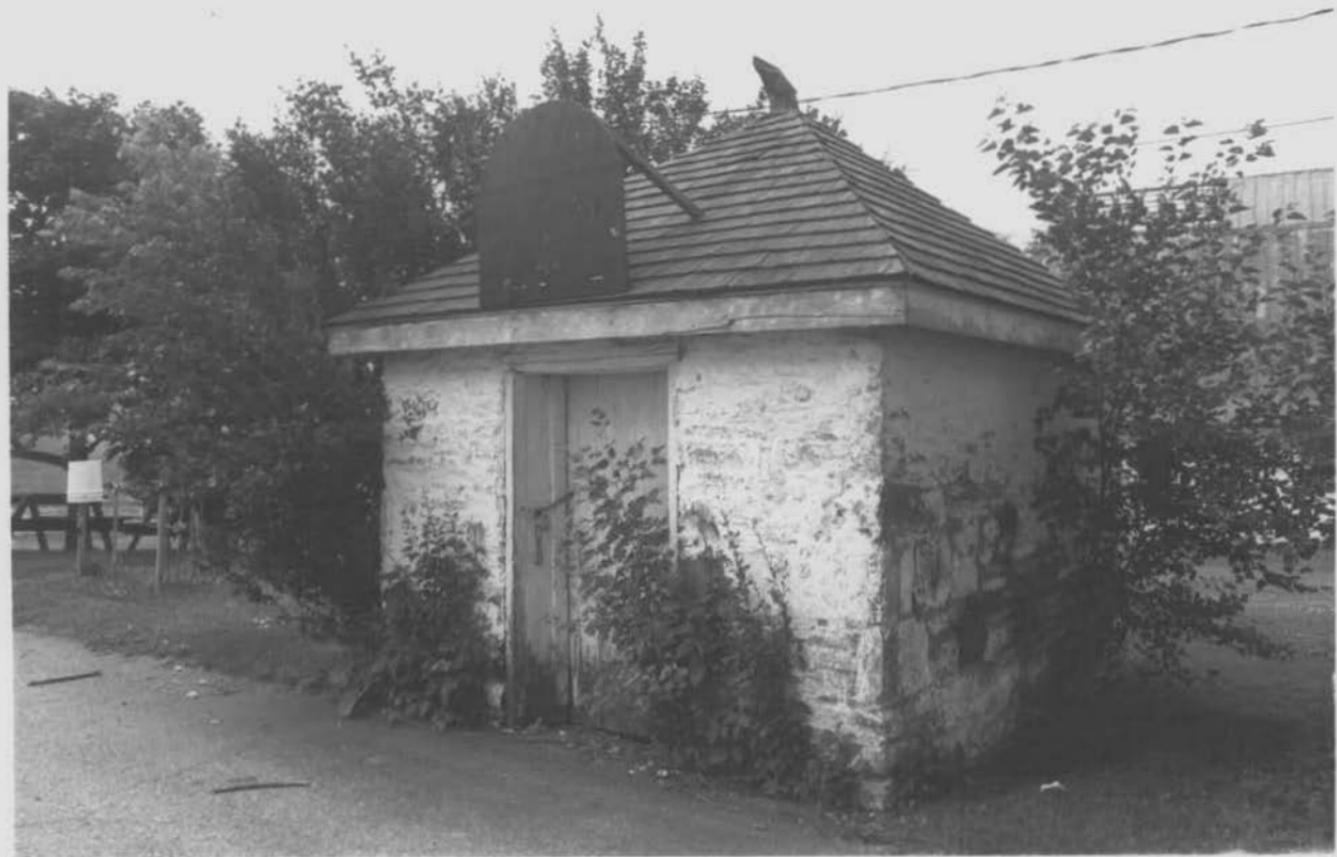
3/6

Smokehouse: The stone smokehouse is located south of the rear wing at the edge of the present paved driveway. It is a square plan building with whitewashed walls and a wood shingle hipped roof, which appears to be a replacement. At the peak of the roof is a ventilation pipe. A basketball backboard is attached to the roof above the doorway on the north elevation. The door is a vertical board type. The smokehouse was probably built about 1870.

Neg. loc.: Md. SHPO, Crownsville, Md
Smokehouse, north elevation

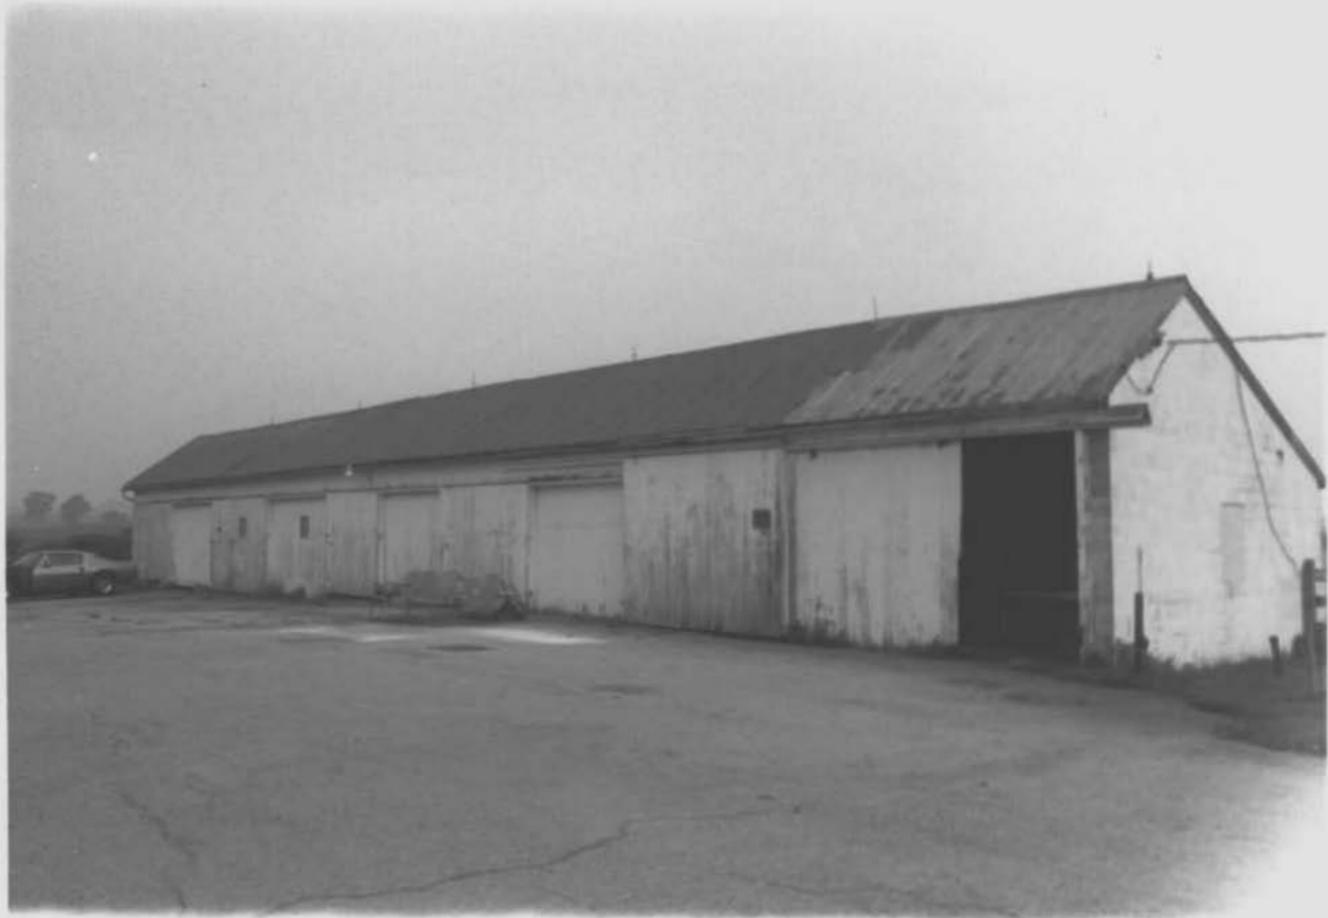
4/6

Equipment shed: The long, rectangular equipment shed is located along the north side of the paved apron between the barn and the domestic group. It consists of five doorways with sliding tongue-and-groove doorways across the south elevation and concrete block walls on the east, west, and north sides. The roof is standing seam metal. The date of this building is probably about 1940.

Equipment sheds, southeast corner view

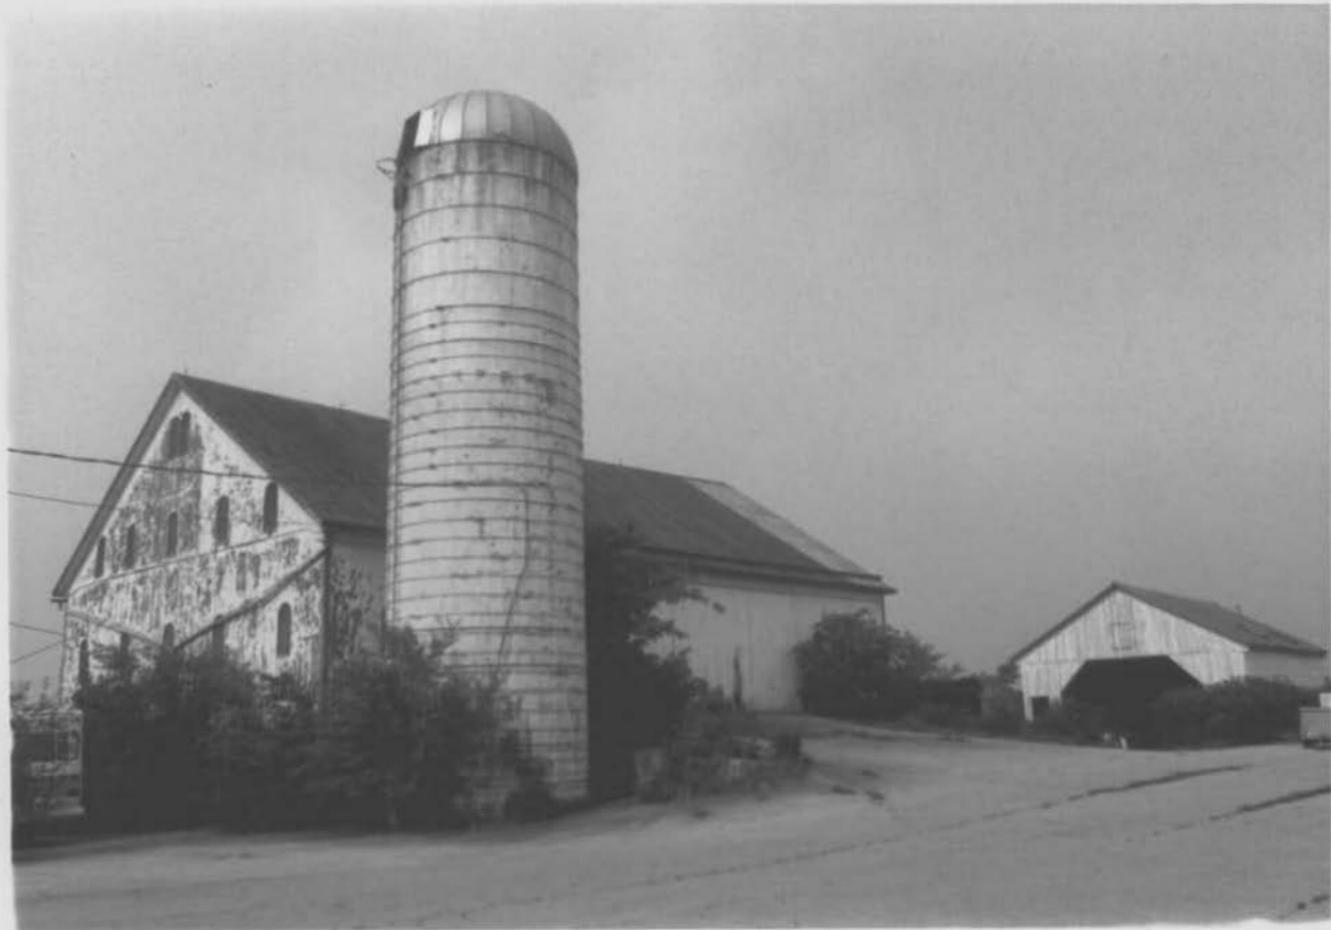
5/6

Bank barn: The bank barn is a frame and stone structure in fair condition locate south of the domestic buildings at the south edge of a large paved area between the

barn and the equipment shed on the north edge of the agricultural group. The barn has vertical board siding which has been whitewashed, but is weathering. Arched louvred vents are in the gable ends and the south elevation and a non-contributing concrete silo is located next to the ramp on the north elevation. The gable roof is covered with both standing seam and corrugated metal. The barn's form and materials indicate that it is contemporary with the house, about 1870.

Wagon shed/corn crib: The wagon shed is located west of the bank barn and faces east. The drive-through passage is wider than is usually seen in late 19th century buildings, suggesting that it was built in the early 20th century to accommodate larger farm equipment. The siding is vertical tongue-and-groove and the siding on the north and south sides is horizontal. The roof is corrugated metal.

Bank barn & wagon shed/corn cribs, view
from north

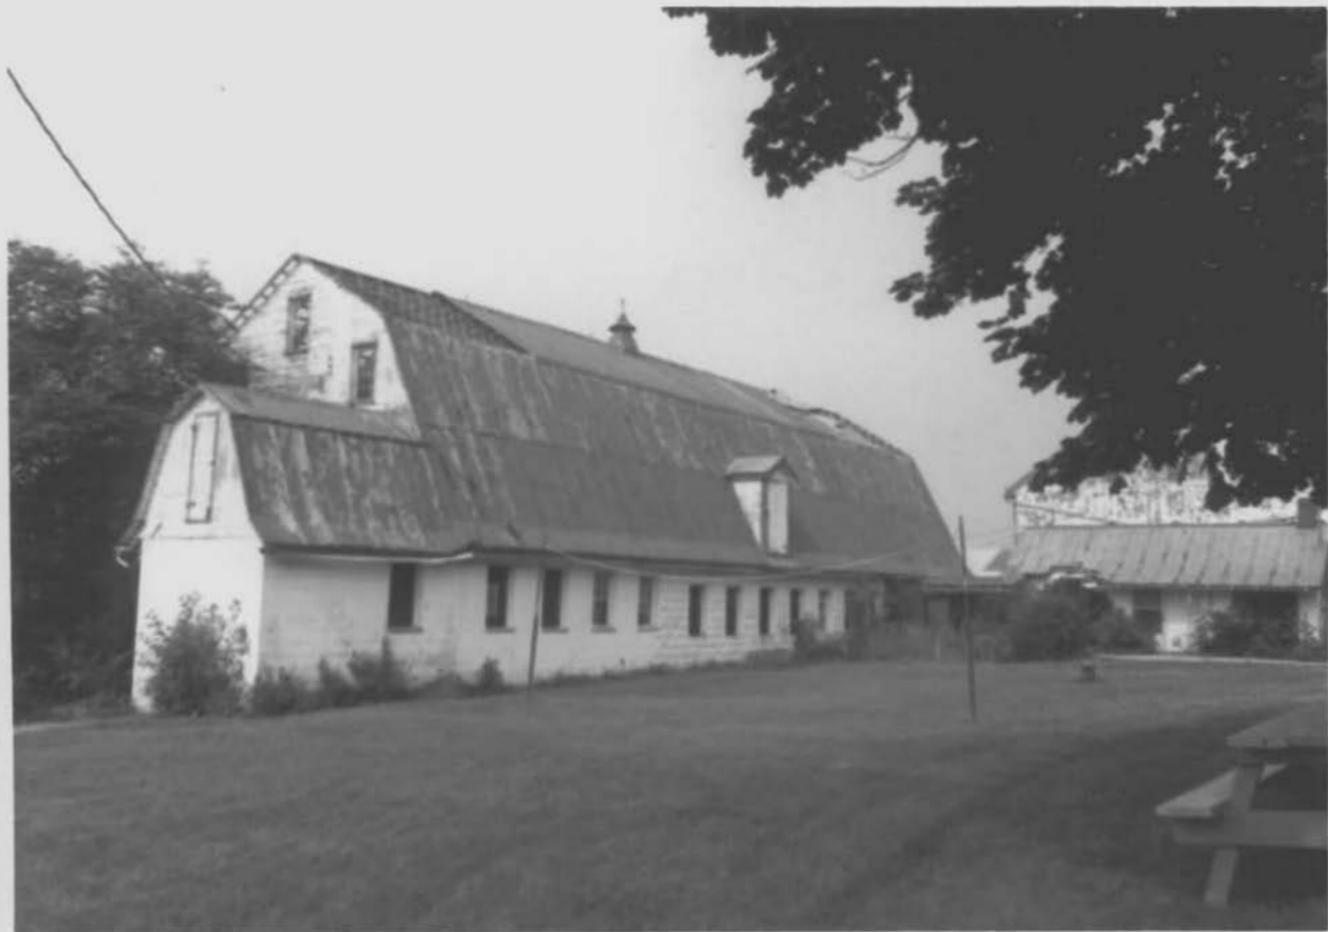
6/6

Dairy barn and milk house: The dairy barn and milk house are located east of the bank barn. The barn has rusticated concrete block walls with a gambrel roof which is deteriorated at the east and west gable ends. The barn was extended with plain concrete block on the east end, probably during the 1950's. The milk house stands perpendicularly to the west end of the barn and is a one-story structure with plain concrete block walls and a standing seam metal gable roof. The original section of the barn was probably built prior to 1935 and the extension built in the 1950's. The milk house may date from the 1950's as well, based on its similar materials.

Dairy barn, view from northeast
