CAPSULE SUMMARY

F-1-211

John H. Hargett House

**Maryland Historical Trust
State Historic Sites Inventory Form****1. Name** (indicate preferred name)

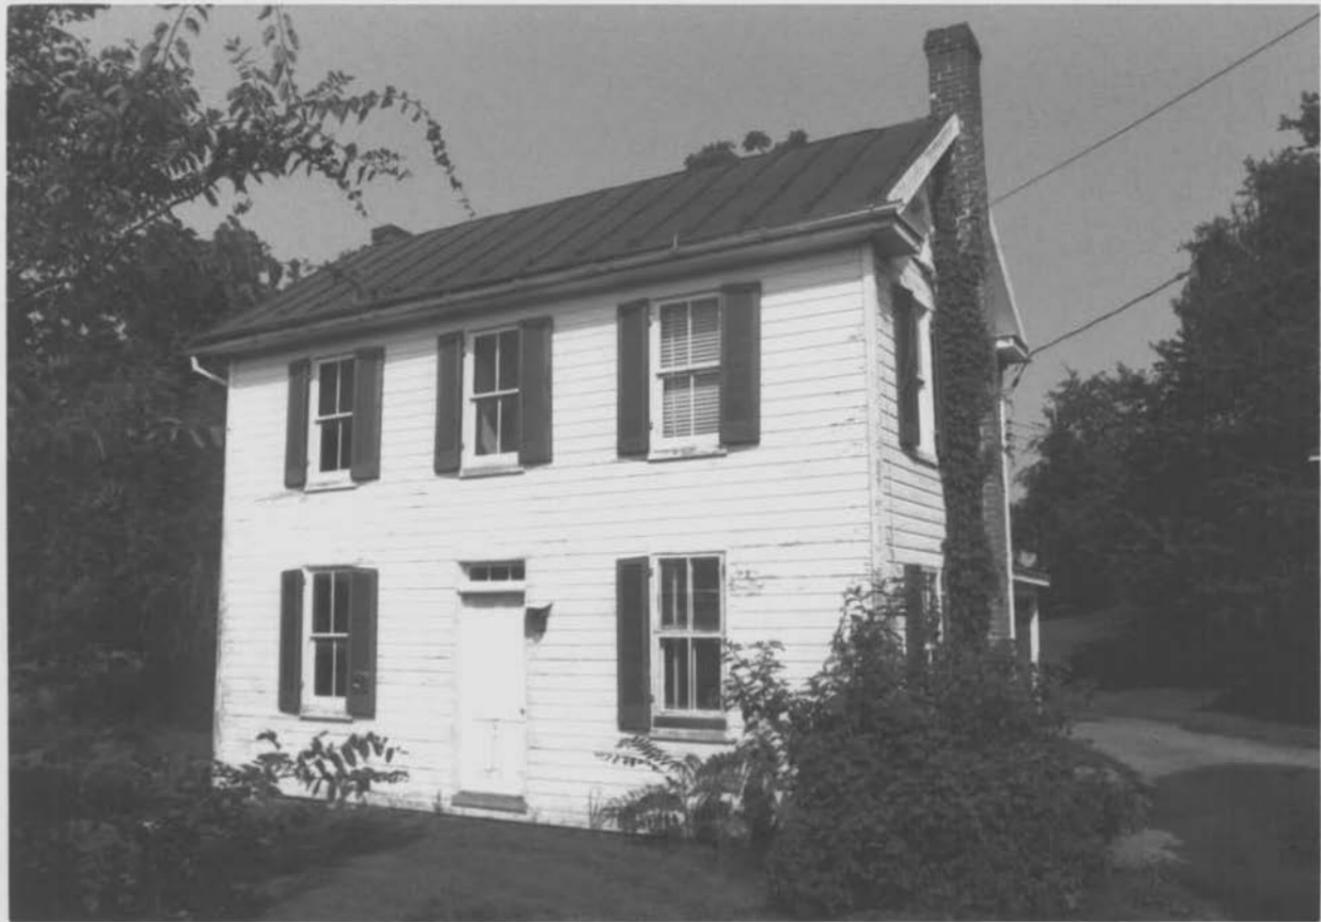
1/3

The dwelling has a three-bay east elevation with a center entrance. The facade has no porch or stoop in front of the doorway and the german siding reveals no evidence that a porch was removed. The door is a 4-panel design with a narrow three-light transom above it. The windows are 2/2 with louvred shutters. The cornice is boxes and returns on the north and south gable ends. The roof is covered with standing seam metal. Interior end chimneys were originally at each gable end, but the north chimney has been replaced by an exterior brick chimney. The south gable end has one bay near the front of the house and two 2/2 attic windows flanking the interior chimney stack. A small 2/2 casement window is located on the second story near the rear of the house, possibly an early 20th century addition to light a bathroom. The north elevation also has a single bay at the front of the house. A two-story wing extends from the center of the west elevation, with one-story shed porches on both the north and south sides. Each side has an entrance with glazed panel doors. A third interior chimney is at the west end of the wing. The interior was not accessible for this survey.

Southeast elevation

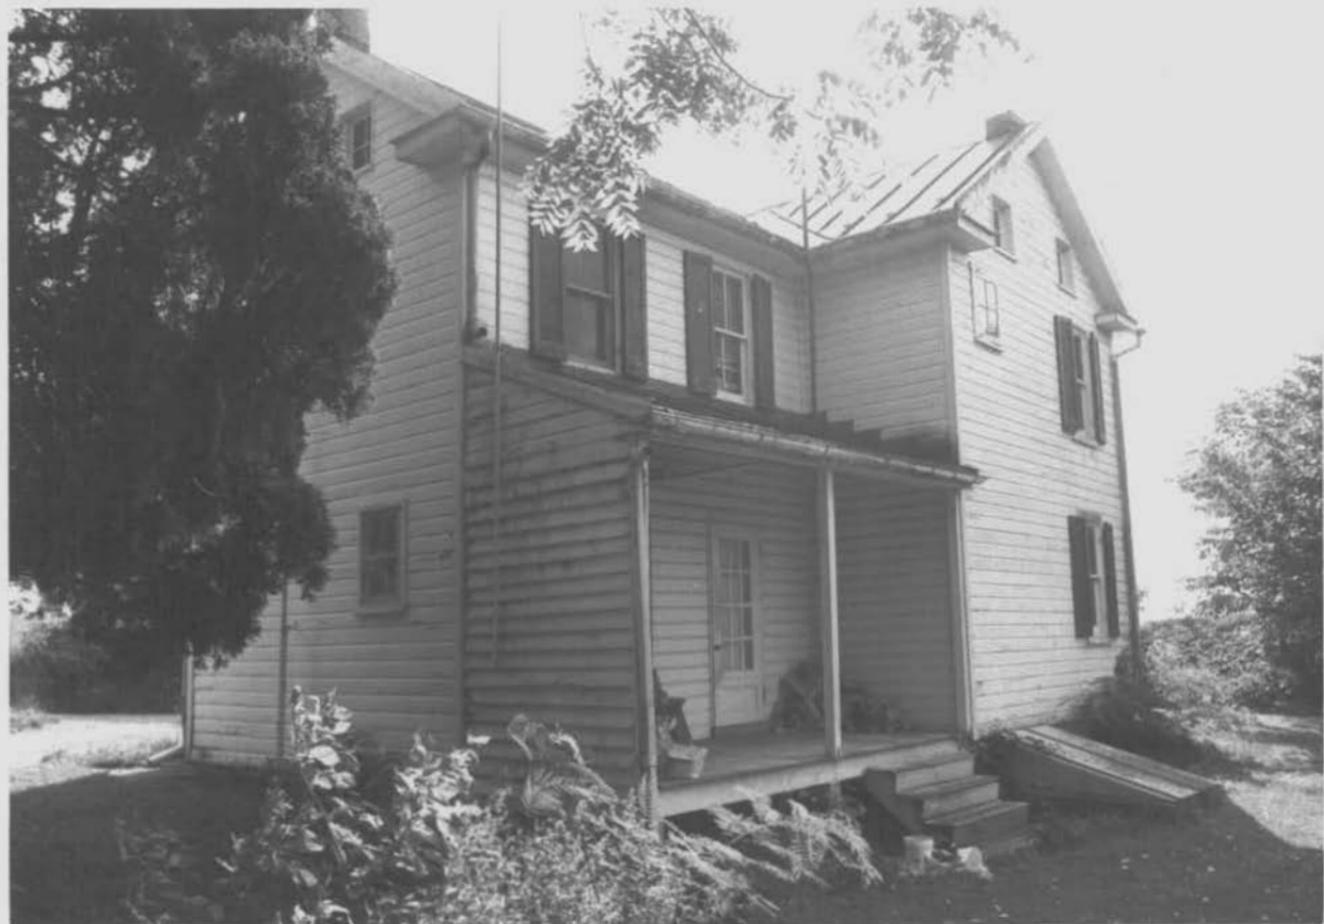
2/3

Southwest corner view

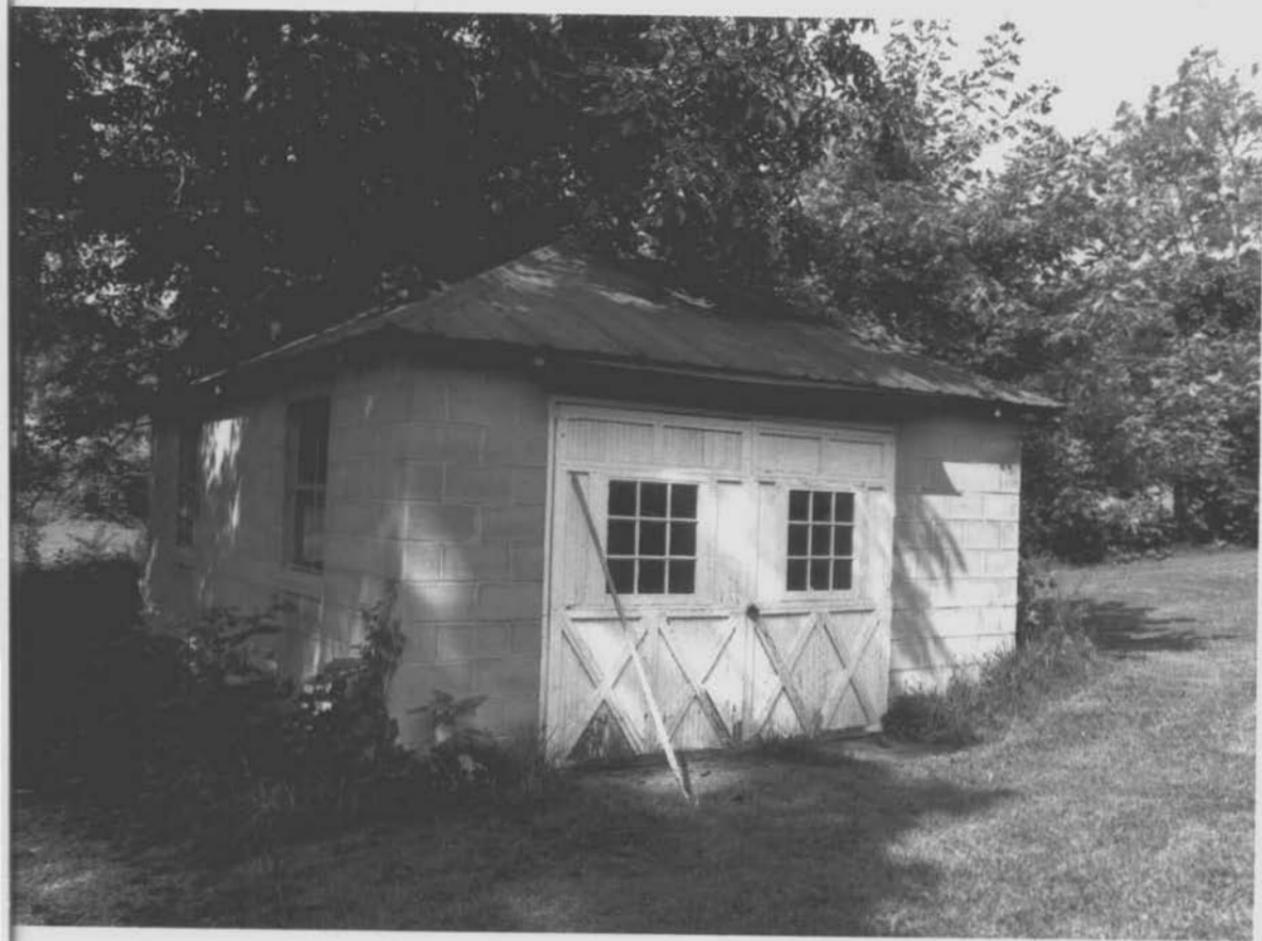
3/3

Garages: The two garages built in the early 1920's are of plain concrete block. One of the garages has a hipped corrugated metal roof and 2/2 metal sash windows. The double swing doors on the north elevation have cross braced tongue-and-groove panels with centered 9-light windows. The second garage was also once a one-story building, but was altered later with a second story. The hipped corrugated metal roof and swing doors are similar to those on the other building. Both levels have metal 2/2 windows. Parts of the upper structure have wood siding.

Garage, north elevation
