**MARYLAND HISTORICAL TRUST  
NR-ELIGIBILITY REVIEW FORM**

Property Name: Charity Ellen Frazier Farmstead Inventory Number: F-2-104

# Maryland Historical Trust Maryland Inventory of Historic Properties Form

historic Charity Ellen Frazier Farmstead  
other Biser Farm

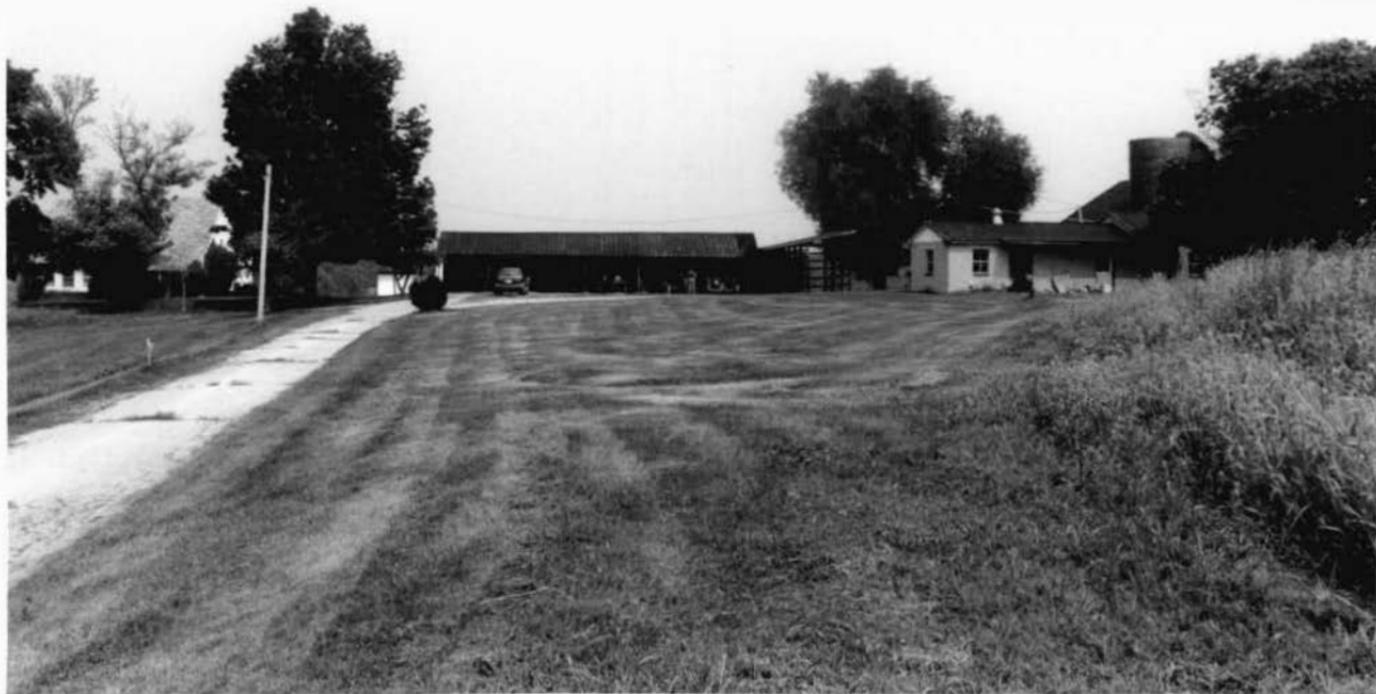
1 of 16

Overview of farm, view NW

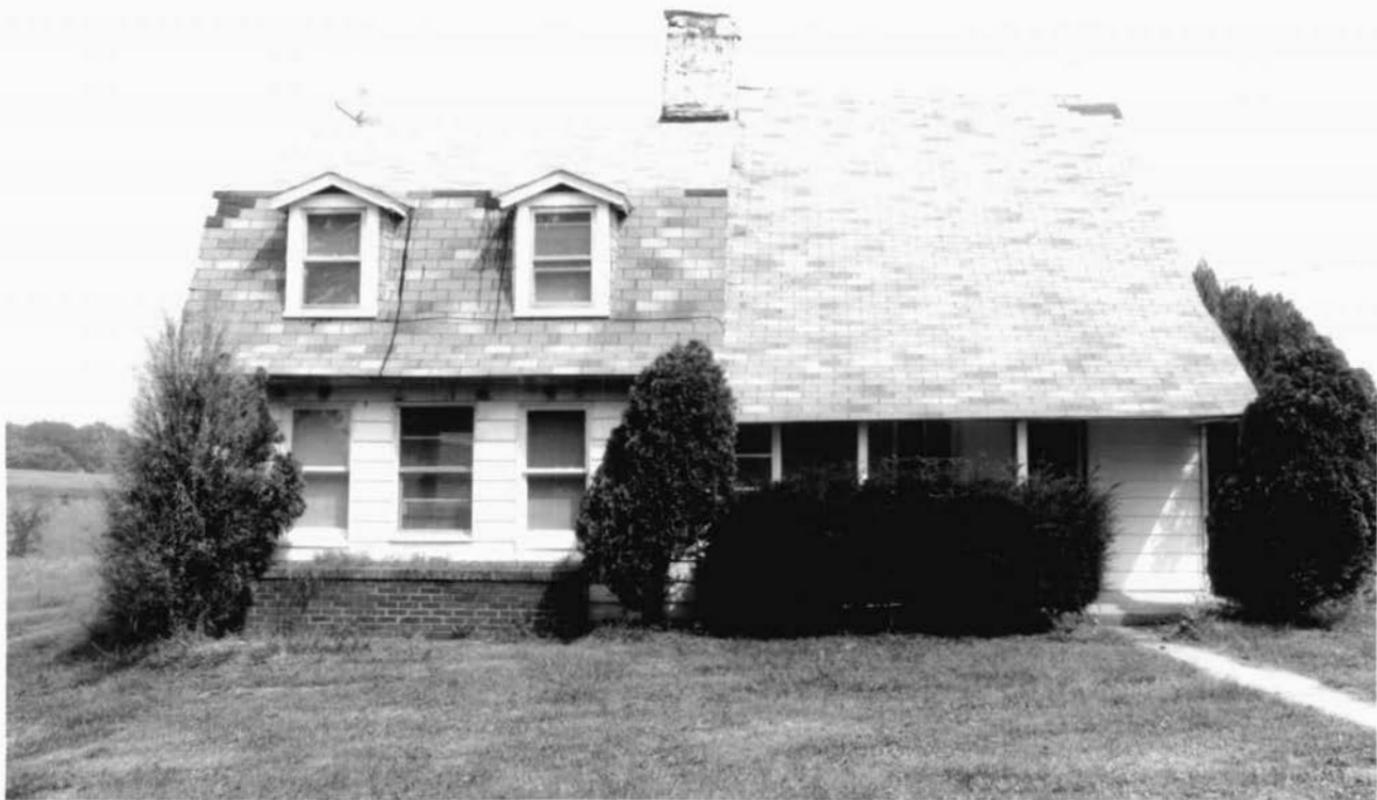
2 of 16

The house is characterized by a three-bay, two-story, main block with a three-bay, two-story, wood-frame wing on the left (west) side, and a one-bay, two-story, shed roof addition on the rear of the main portion that connects with a four-bay deep, two-story, wood-frame, ell. The house is sheathed with aluminum siding over wood clapboard. The windows are two-over-two-light, double-hung, wood sash units. The roof is clad with asphalt shingles.

Front (south) elevation

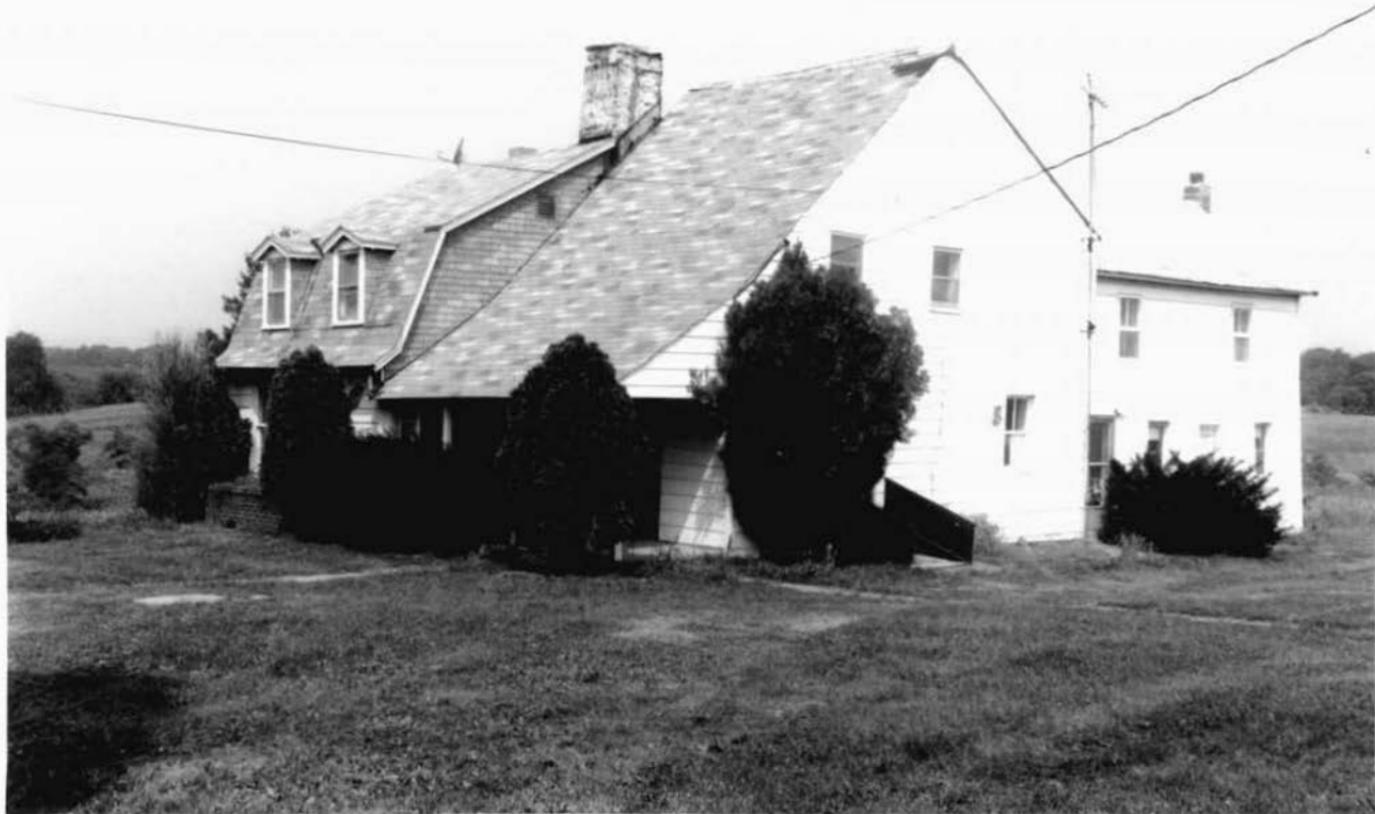
3 of 16

The oldest portion of the house, dating from ca. 1851, is the eastern end. This portion rests on a stone foundation with a cellar. The first floor features log joists. The attic has no ridgepole and the common rafters feature pegged joints. The section terminates in a side gable roof. The principal façade is sheltered by a three-bay, shed-roof porch. The porch roof is supported by chamfered 4"x4"s. The principal entrance is located in the right bay and features a plain wood surround door with single light over two wood panels. The west wall of this section featured an exterior, random-laid stone fireplace. The fireplace features a simple wood mantel and surround. The fireplace has been infilled. The windows in this section feature plain wood surrounds.

South and East elevations

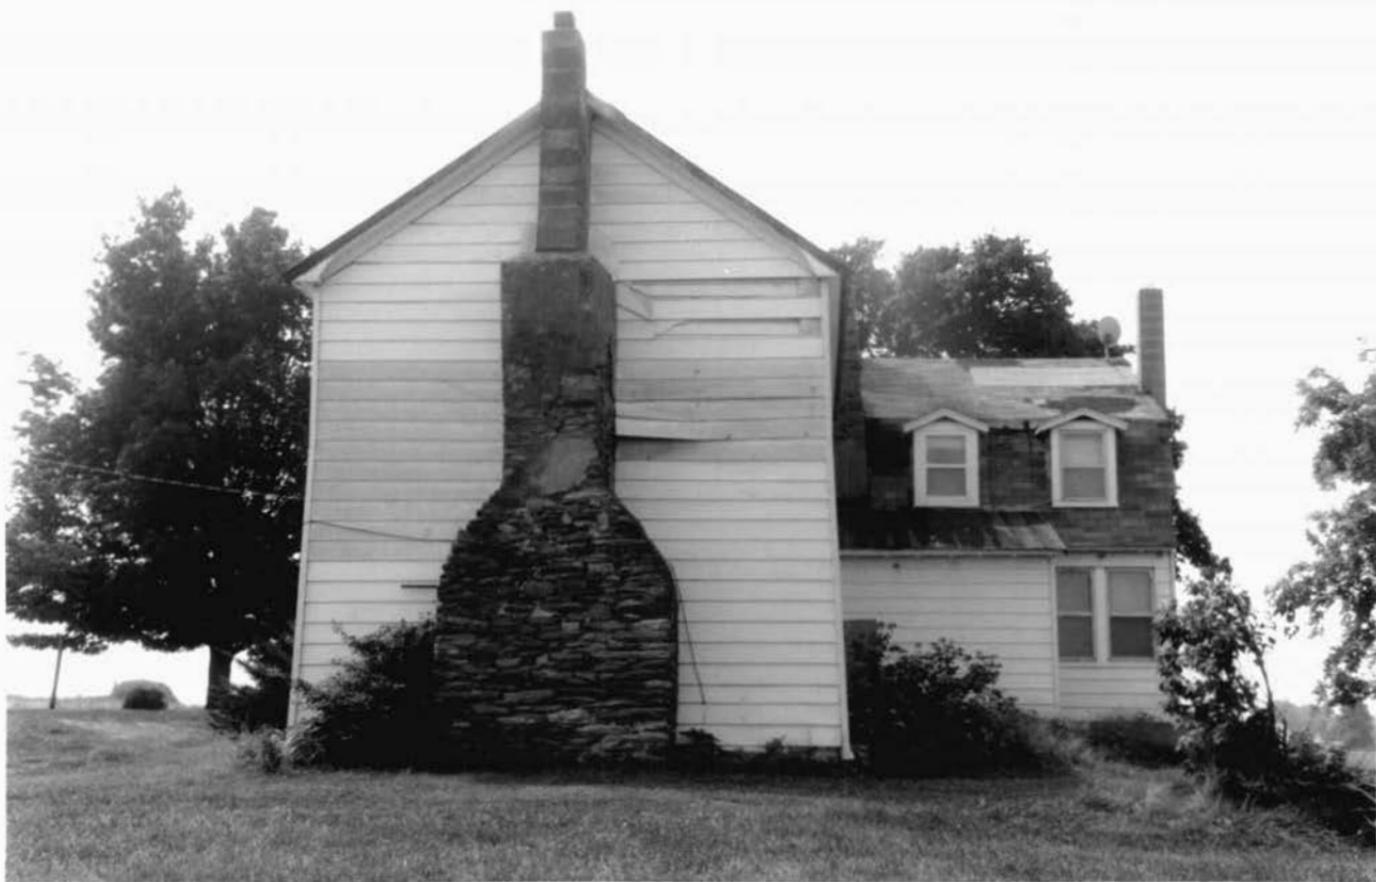
4 of 16

A detached kitchen was located to the rear of the original house. A wood-frame, rear addition was built ca. 1920 to connect the kitchen to the main house. The east wall rests on a short concrete wall. The section terminates in a shed roof.

North elevation

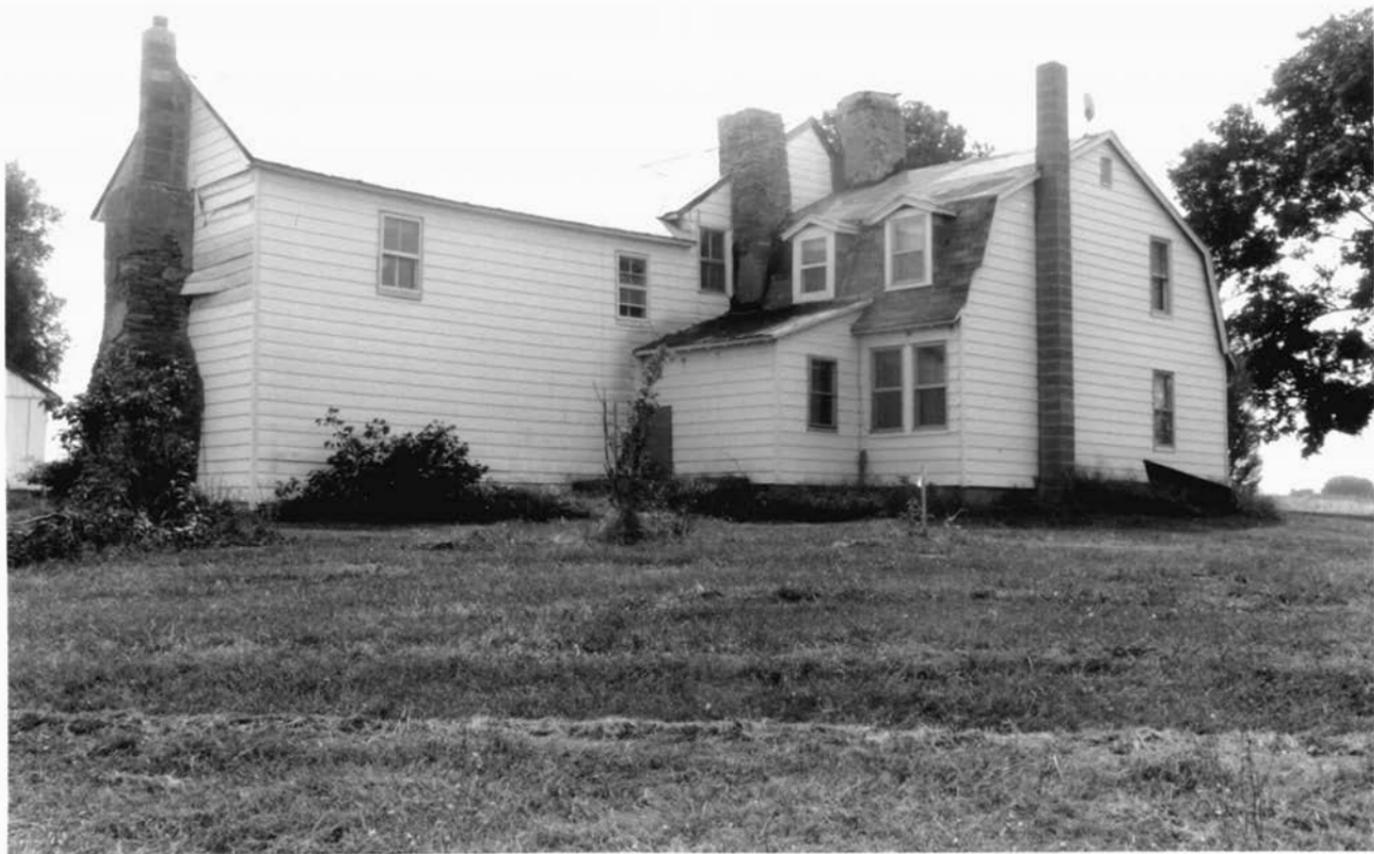
5 of 16

The three-bay wide, two-story, west addition was added ca. 1950. The wood-frame, west addition terminates in a gambrel roof. The gambrel roof features two gable roof dormers on the front and rear elevations. A side entrance on the east elevation opens onto the shed roof porch of the main portion. A shed-roof, rear entrance has been converted into a full bathroom. A concrete basement was added under the rear of the west addition.

West and North elevations

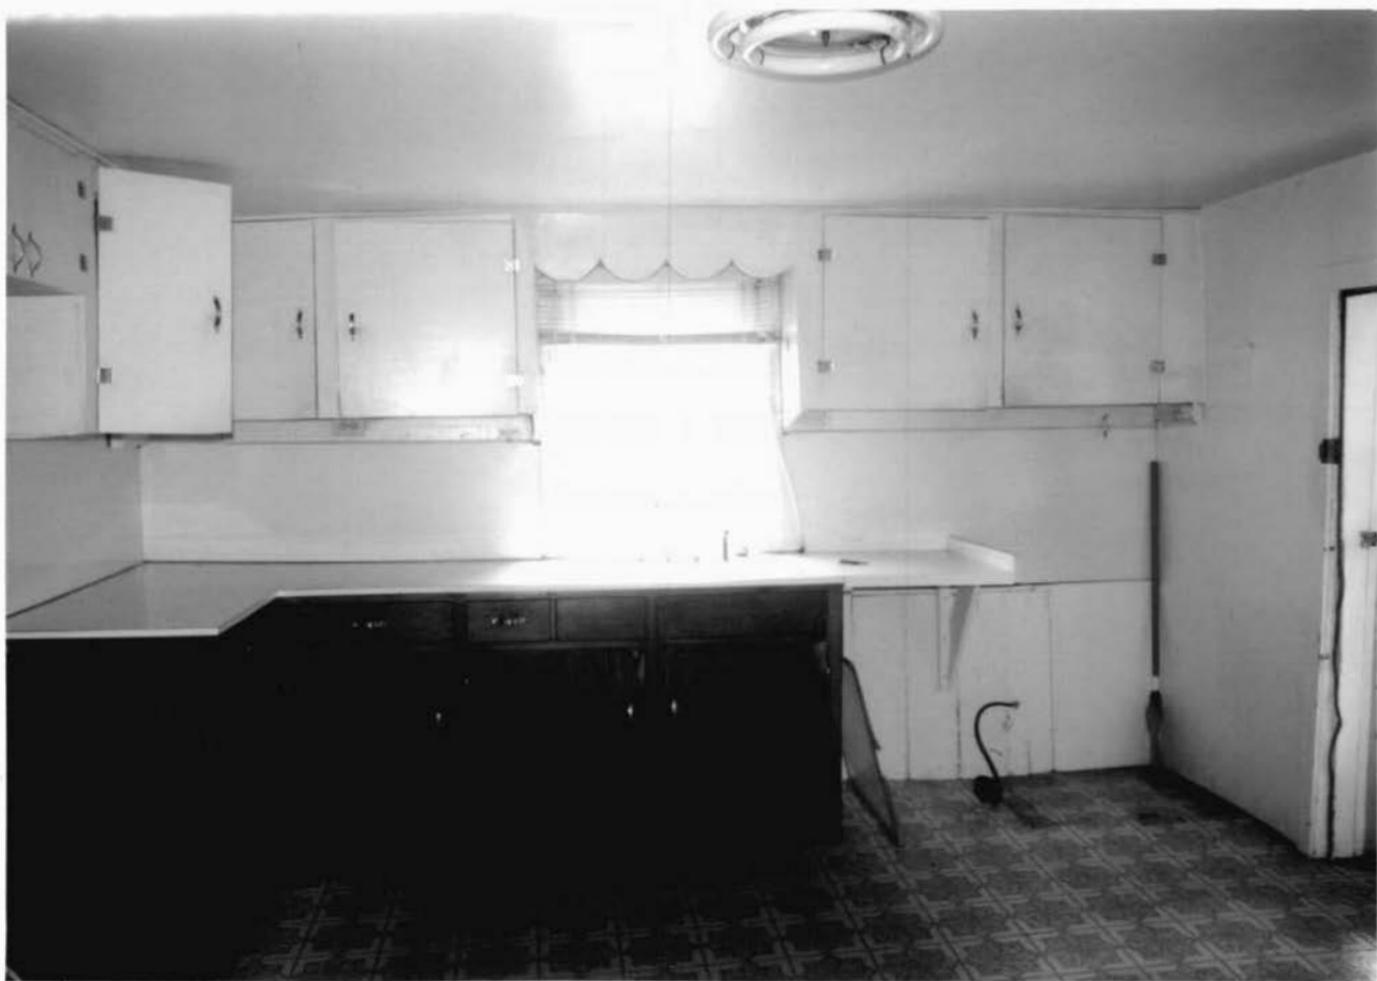
6 of 16

Kitchen, Main Portion, view E

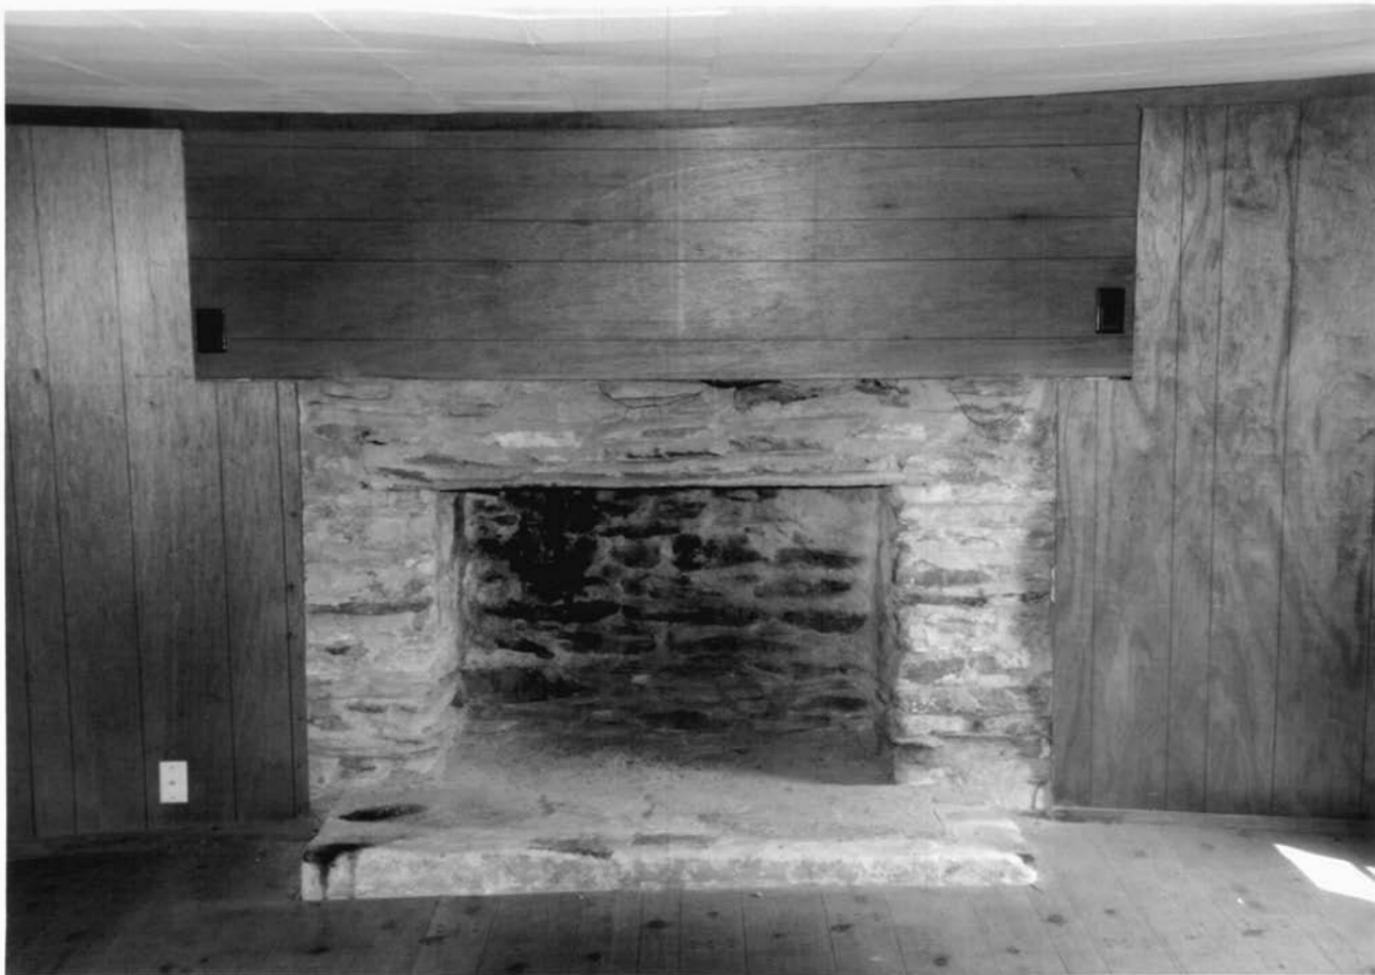
7 of 16

The four-bay deep, rear ell originally consisted of a ca. 1851, one-story detached kitchen. A second story was added ca. 1920. The ell rests on a random-laid stone foundation. A stone fireplace is centered on the north wall. The stack was extended with cinder block when the second story was added. The first floor was paneled ca. 1970 consistent with use as a family room. The room features very low ceilings. An enclosed staircase runs along the west wall. An entrance is located on the east wall in the first bay closest to the main portion. The door has two wood panels. A second entrance located in the third bay has been converted into a window.

Original detached kitchen, view N

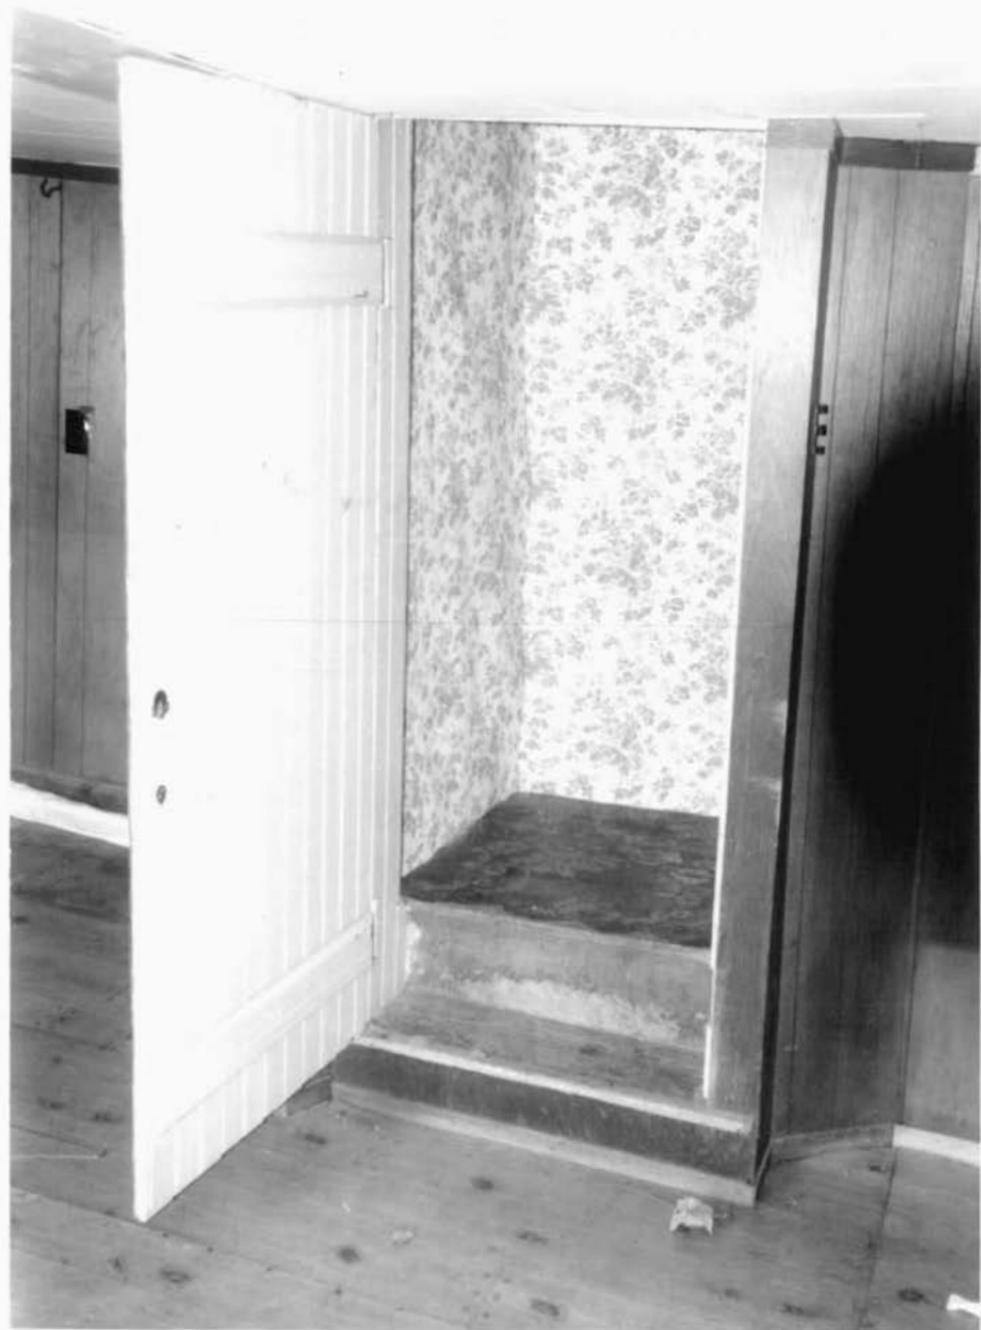
8 of 16

Stair in original detached kitchen, view W

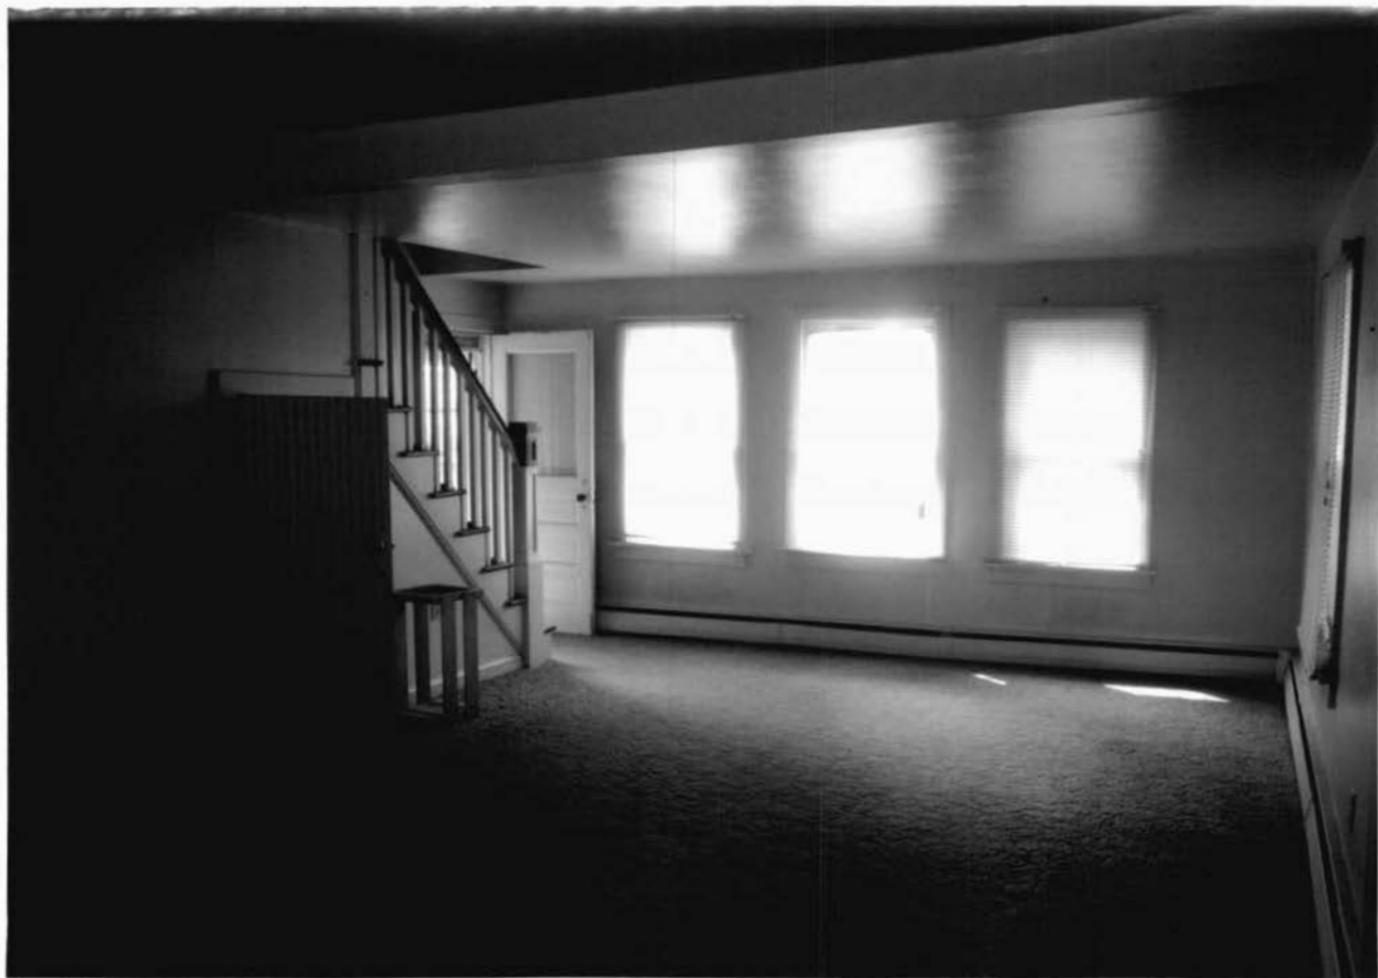
9 of 16

The floors throughout the house have been replaced and moldings have been removed. At least three entrances located on the west, north, and east sides of the house have been infilled or converted into window openings.

Living room in ca. 1950 west addition, v.w. SE

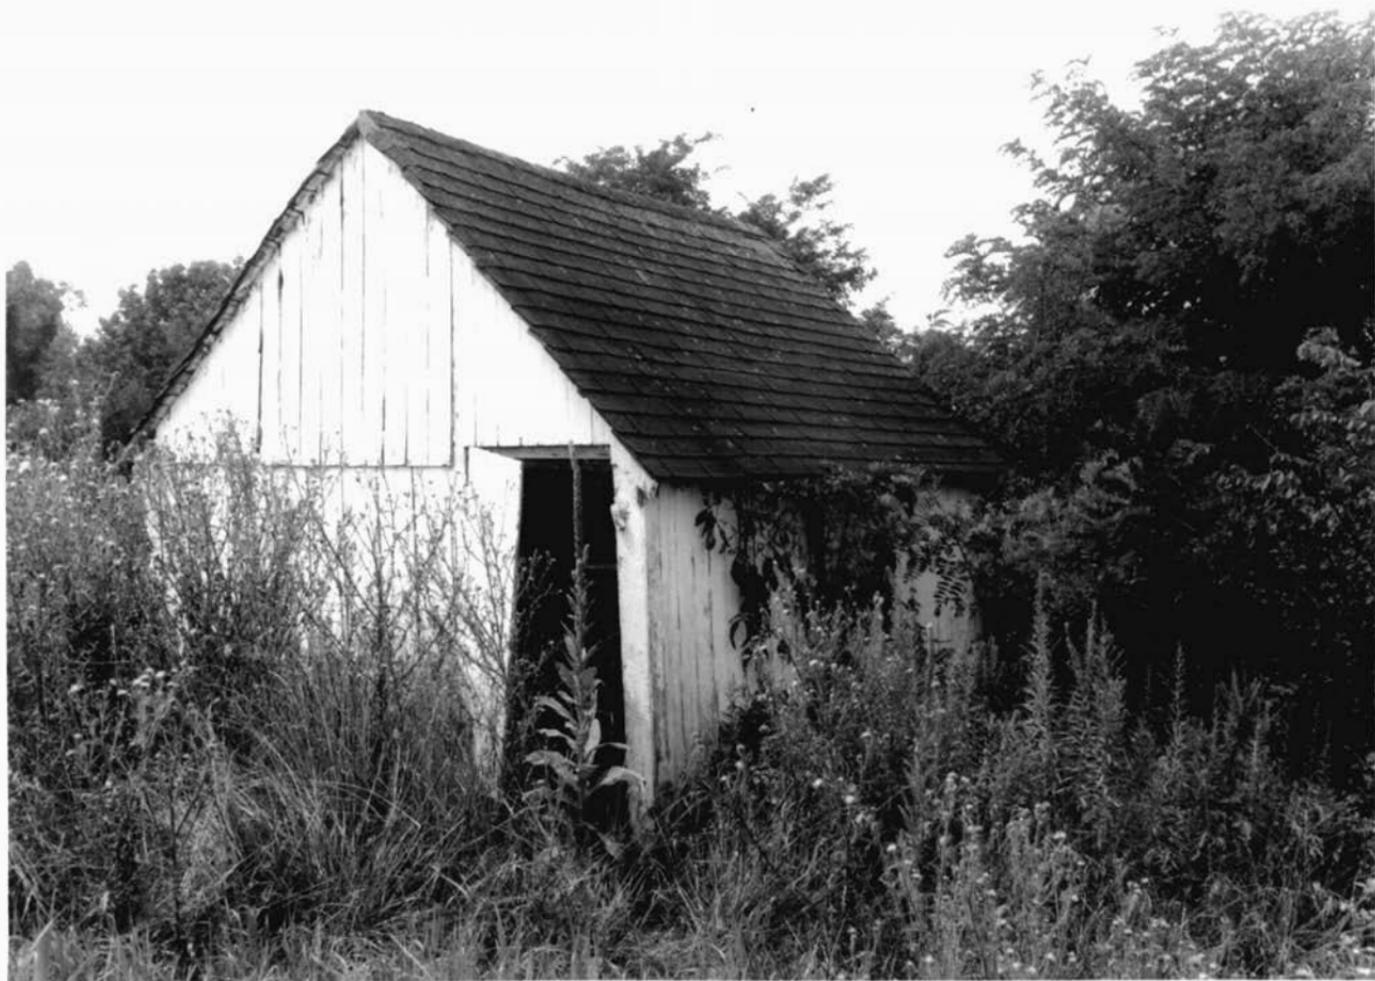
10 of 16

The farm complex contains seven buildings. A single ca. 1920 wood-frame shed is located west of the house. The other six buildings are located east of the house and include a ca. 1920 shed, a ca. 1980 equipment shed/corn crib, a ca. 1950 dairy, a ca. 1980 equipment shed, a ca. 1851 Pennsylvania bank barn, and a ca. 1925 silo. Both ca. 1920 sheds are rectangular, wood-frame sheds resting on a concrete wall foundation. The buildings are clad with vertical board siding. The gable roofs are sheathed with asphalt shingles. The principal entrances feature an offset, vertical board door. The buildings are clad with vertical board-and-batten siding. The buildings terminate in front gable roofs sheathed with metal.

Ca. 1920 shed west of house, view SW

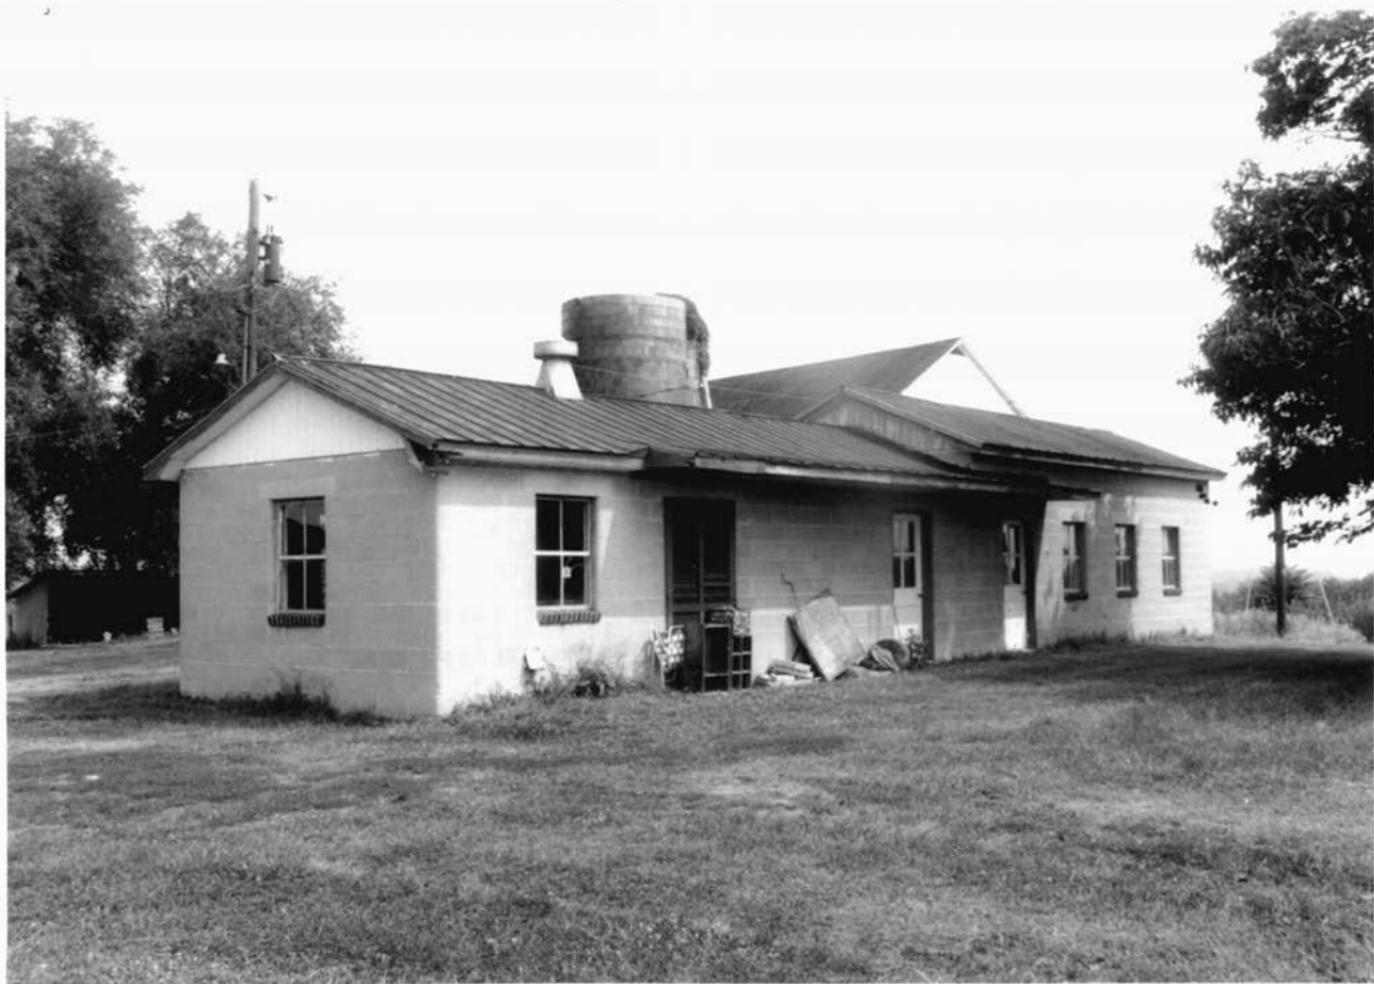
12 of 16

The concrete block dairy rests on a concrete slab. The building terminates in a double side gable roof sheathed with metal. The eastern half of the roof over the milking parlor is higher than the western end. The western end features a metal ventilator. The building features three entrances on the front (south) elevation. The eastern two entrances feature a four-light window over beaded board, wood panel doors. The western entrance features a screen door. Entrances on the east and north elevations feature concrete ramps for cows to enter and exit the milking parlor, respectively. The building features two-over-two-light, metal sash windows except for the eastern half of the rear elevation, which has three-light, metal sash units.

Ca. 1950 dairy, view N

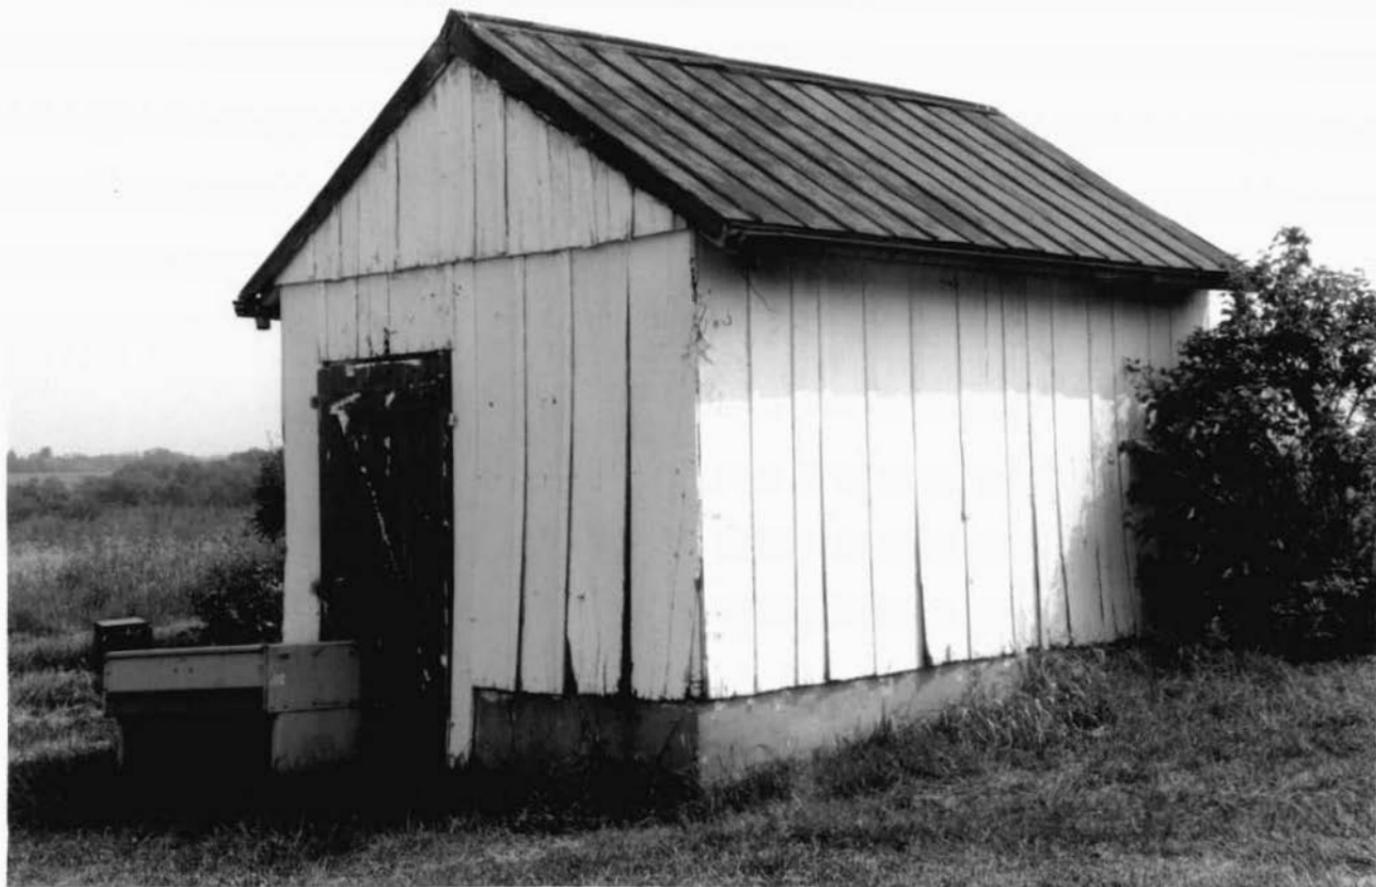
11 of 16

Ca. 1920 shed east of house, view N

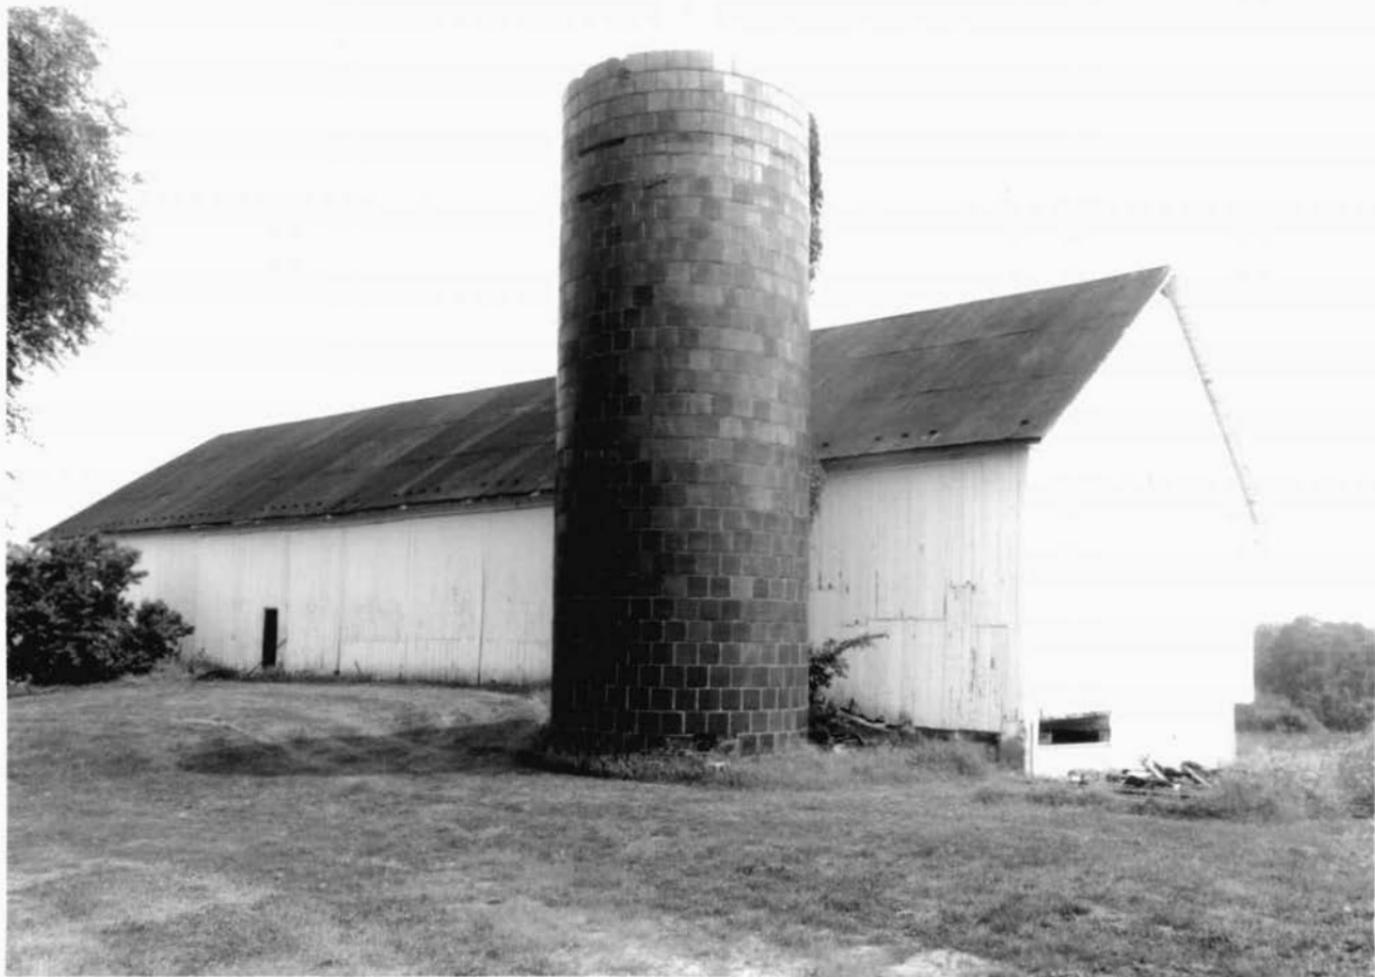
13 of 16

The large Pennsylvania bank barn faces west. The barn features an open forebay and has an attached tractor shed on the north elevation. The rectangular building rests on a concrete wall foundation. The ground floor was used for pigs on the north end and cows on the south end. A concrete floor has been added on the south end. The upper walls are clad with vertical board siding. The gable roof is sheathed with metal. The inner posts of the post and beam frame extend to the roof and the tie beams reaching from end post to end post has been eliminated. The framing system is primarily supported by upright posts that directly support the roof purlins. Cross beams support the upright posts just below the roof purlins. Secondary cross beams tie the upright posts to the outer walls just below the eave line. This form of construction first appeared in the mid-nineteenth century.

A tile block silo was added adjacent to the barn ca. 1925. The silo roof is no longer extant.

Silo and Pennsylvania Bank Barn, view N

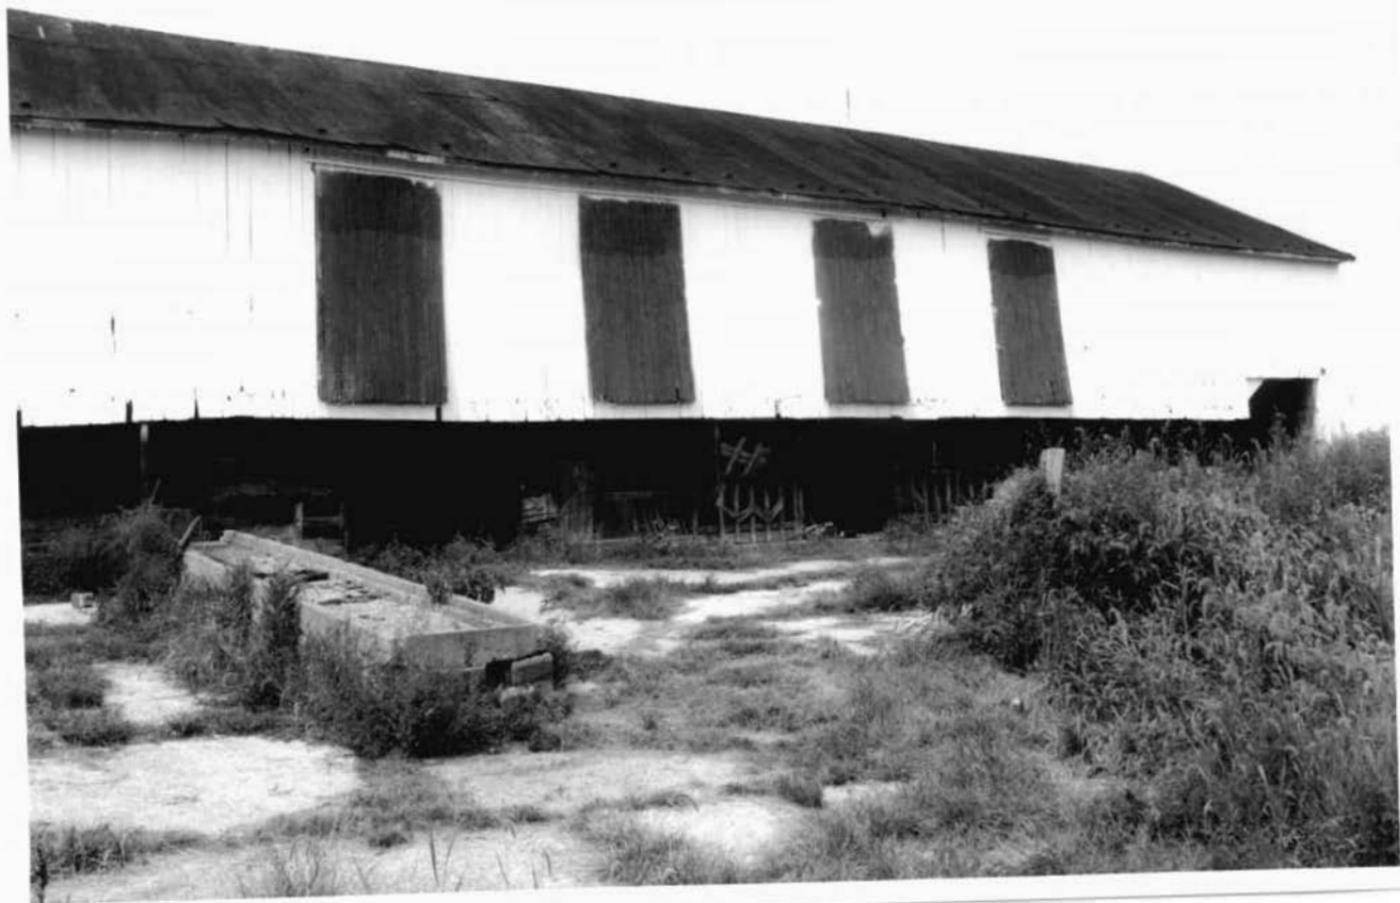
14 of 16

The nineteenth-century bank barn also exhibits alterations. These include replacement of its foundation, remodeling of the ground floor, and renewing of exterior siding on the upper portion. The rebuilding of the barn's foundations has negatively impacted its integrity of materials.

The nineteenth-century bank barn also exhibits alterations. These include replacement of its foundation, remodeling of the ground floor, and renewing of exterior siding on the upper levels. The arrangement of the bays on ground floor and addition of concrete stalls reflect changes made to meet the requirements of dairy production. The main floor features an open floor plan, traditional elements associated with a nineteenth century bank barn, such as mows and haylofts are no longer extant. Although the building appears as a traditional bank barn, the introduction of modern materials, reorganization of spatial division, and change in utilization to meet twentieth century requirements have compromised the barn's integrity of design, workmanship, materials, and feeling.

Pennsylvania Bank Barn, view W

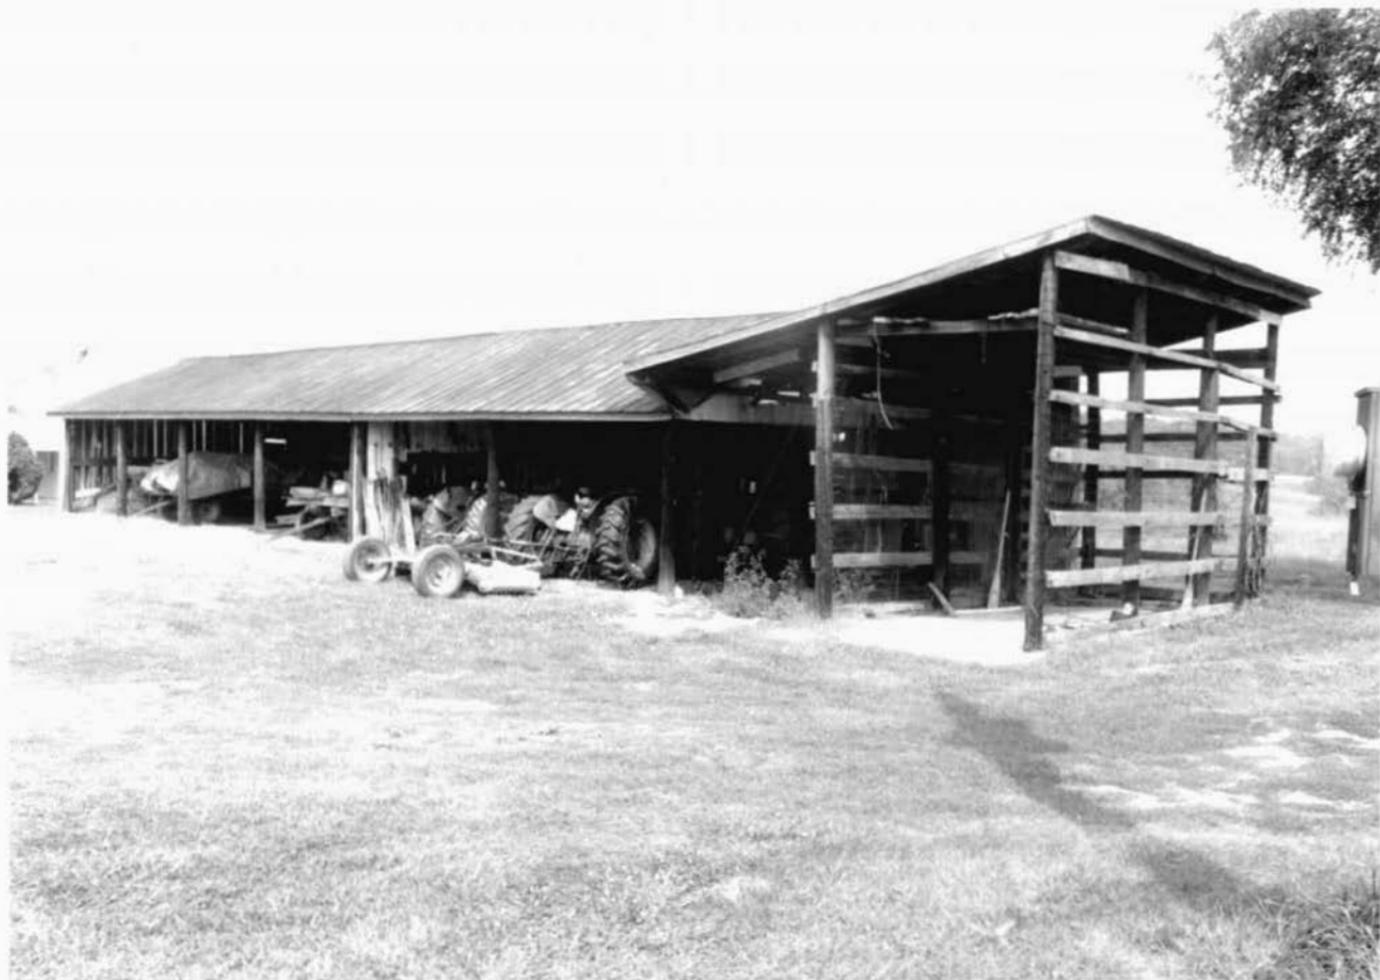
15 of 16

The equipment shed/corn crib is constructed of creosoted, round wood posts. The equipment shed is five bays wide and features an open front. The equipment shed is clad with metal siding on the north elevation and vertical boards on the west elevation. The equipment shed features a side gable roof. The corncrib is two bays wide. It is clad on the west north and east sides with metal fencing. The fencing on the south side has been removed to allow access for equipment. The corncrib terminates in a shed roof. All roof planes are sheathed with metal.

Ca. 1980 Equipment shed / corn crib

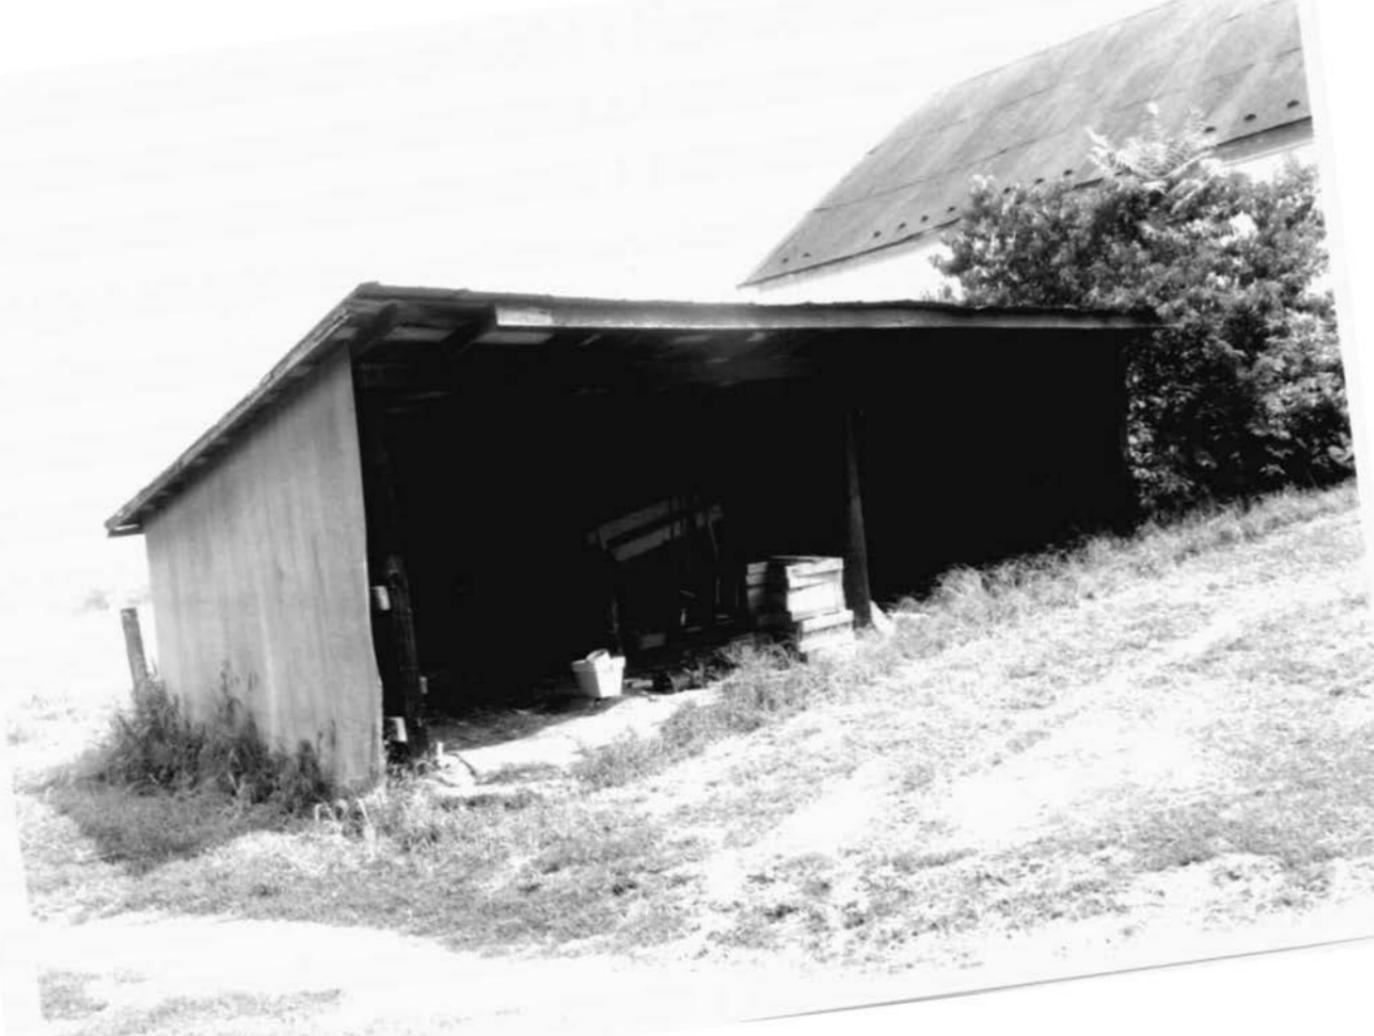
16 of 16

The small equipment shed is constructed of creosoted, round wood posts and has two open bays. The east, north, and west elevations are clad with metal. The shed roof is sheathed with metal.

Ca. 1980 Equipment Shed
