**MARYLAND HISTORICAL TRUST
DETERMINATION OF ELIGIBILITY FORM**

Property Name: Horine Farm Inventory Number: F-2-129
 Address: 3419 and 3421 Jefferson Pike (MD 180) Historic district: yes no
 City: Jefferson Zip Code: 21755 County: Frederick
 USGS Quadrangle(s): Point of Rocks
 Property Owner: John and Joanna Lovell Tax Account ID Number: 327916
 Tax Map Parcel Number(s): 203 Tax Map Number: 84
 Project: MD 180, US 340 to Old Holter Road, Frederick County, MD Agency: SHA
 Agency Prepared By: EHT Traceries
 Preparer's Name: Eric Griffitts Date Prepared: 4/8/2015

Project Name: MD 180 from US 340 to Old Holter Road

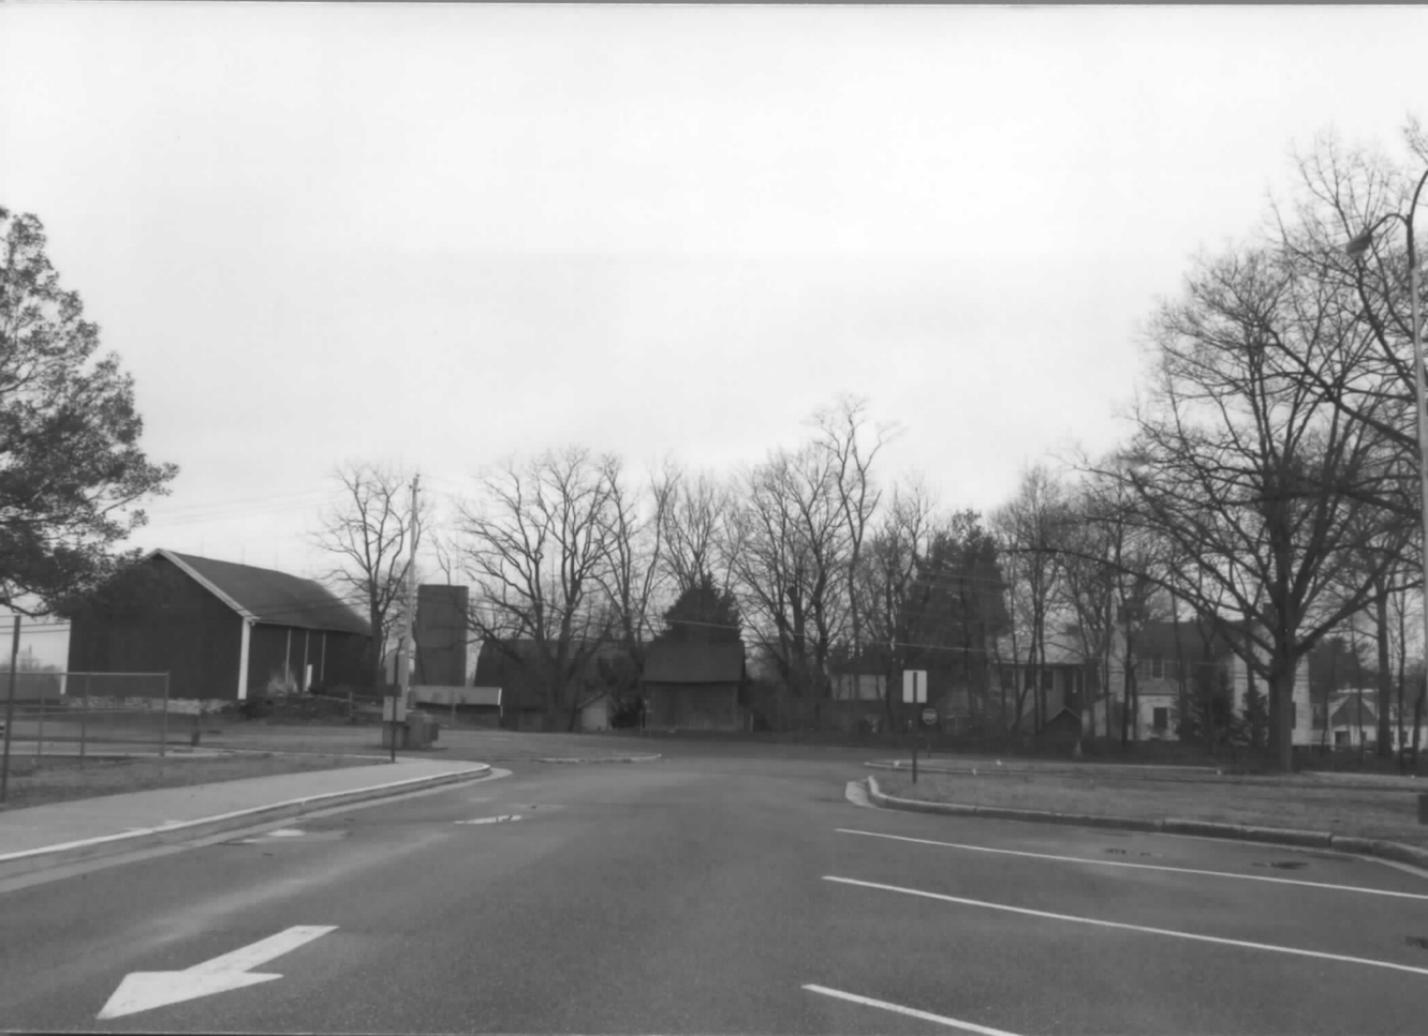
The Horine Farm is located on a nine-acre property west of the intersection of Jefferson Pike (MD Route 180) and Horine Road. The farm consists of a primary residence, a secondary residence, wash house, smokehouse, ice house, carriage house, bank barn, shed, dairy barn with milk house, and a wagon shed. All of the buildings with the exception of the wagon shed are clustered together near the northeast end of the property near the intersection of Horine Road and Jefferson Pike. The area around these buildings contains multiple mature trees. An unpaved access road leads into the farm from Horine Road. Fallow fields are located both south and west of the buildings on the property. The equipment shed is located in the field west of the other farm buildings. A modern residential subdivision is located on the north side of Jefferson Pike opposite the property. The Valley Elementary School is located east of Horine Road, opposite the farm.

F-2-129
Horine Farm
Frederick County, Maryland
Eric Griffiths
4-3-2015
MD SHPO
Horine Farm, Looking West
1 of 17

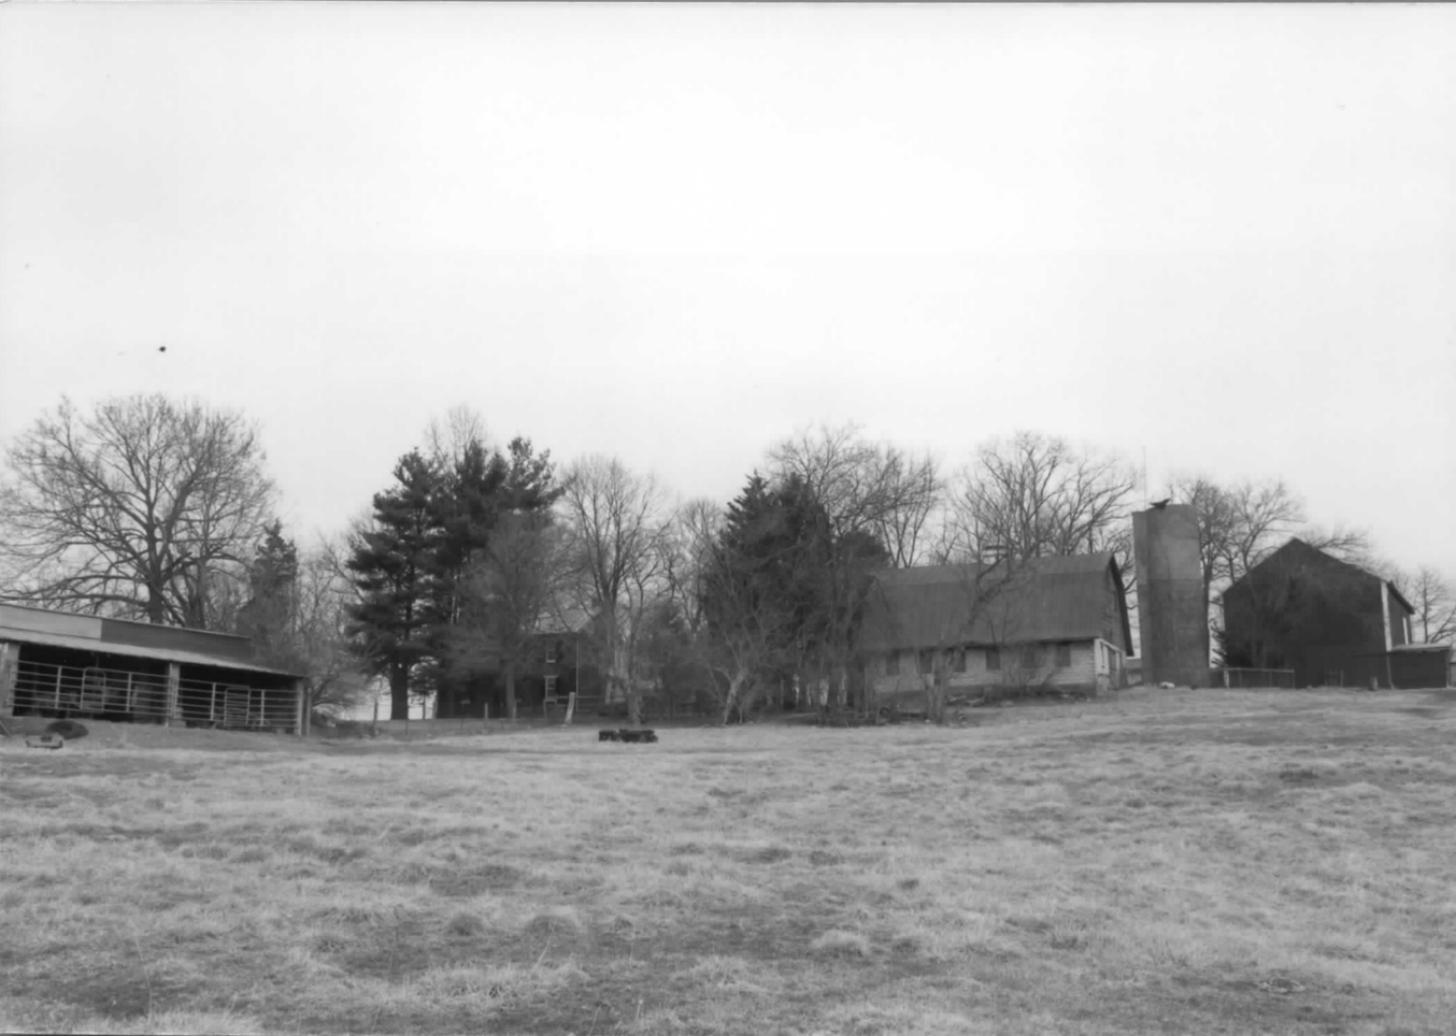
F-2-129
Horine Farm
Frederick County, Maryland
Eric Griffiths
3-24-2015
MD SHPO
Horine Farm, Looking East
2 of 17

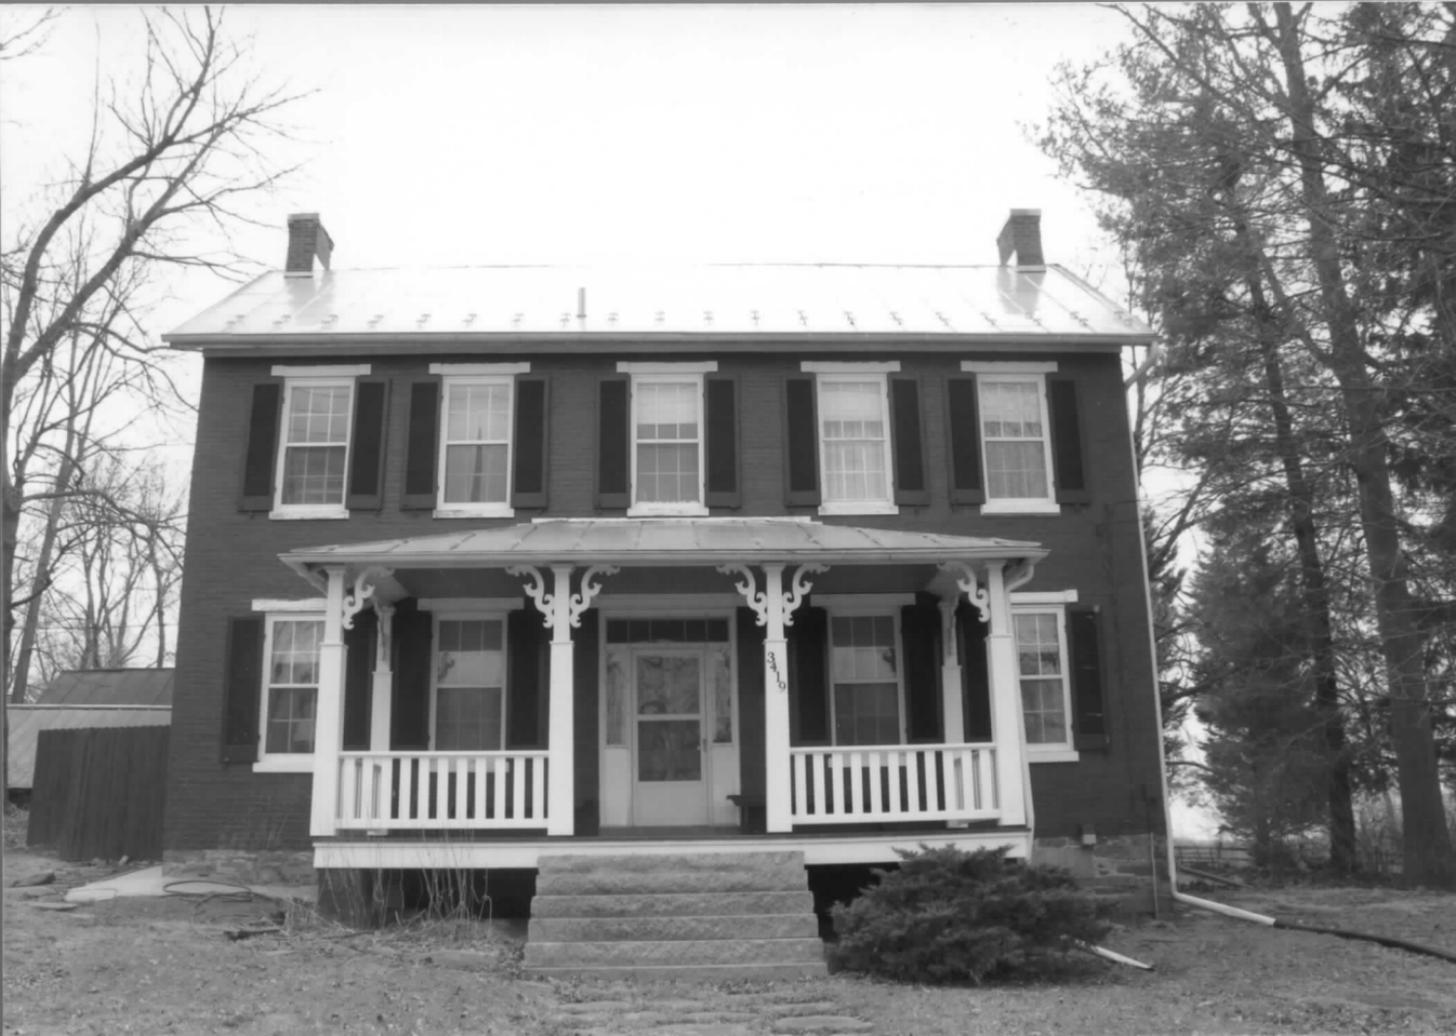
The primary residence of the farm is a two-and-one-half-story vernacular farmhouse with Georgian Revival details constructed circa 1880. The dwelling is located at 3419 Horine Road and is approximately 50 feet south of Jefferson Pike. The farmhouse is set on a rubble stone foundation and has brick walls laid in running bond and is capped by a standing-seam-metal-clad, side-gabled roof. Two exterior end chimneys pierce the east and west ends of the roof.

The north (front) elevation contains five symmetrical bays. The first story contains two, six-over-six double-hung wood windows located on both sides of a centrally located single-leaf, wood paneled door containing three-light wood sidelights and a five-light wood transom. The entrance is located inside a hipped roof porch extending from the center of the elevation. The porch contains a wood floor and has four, tapered-square wood-column supports adorned with decorative wood scrollwork. Two engaged wood pilasters are located at both ends where the porch meets the main block of the dwelling. The second story contains five, six-over-six double-hung wood windows. All of the windows have wood sills, wood lintels with corner blocks containing rosettes, and wood louvered shutters.

F-2-129
Horine Farm
Frederick County, Maryland
Eric Griff, HS
3-24-2015
MD SH PO
Primary Farm House (3419 Jefferson
Pike) North Elevation, Looking
South
3 of 17

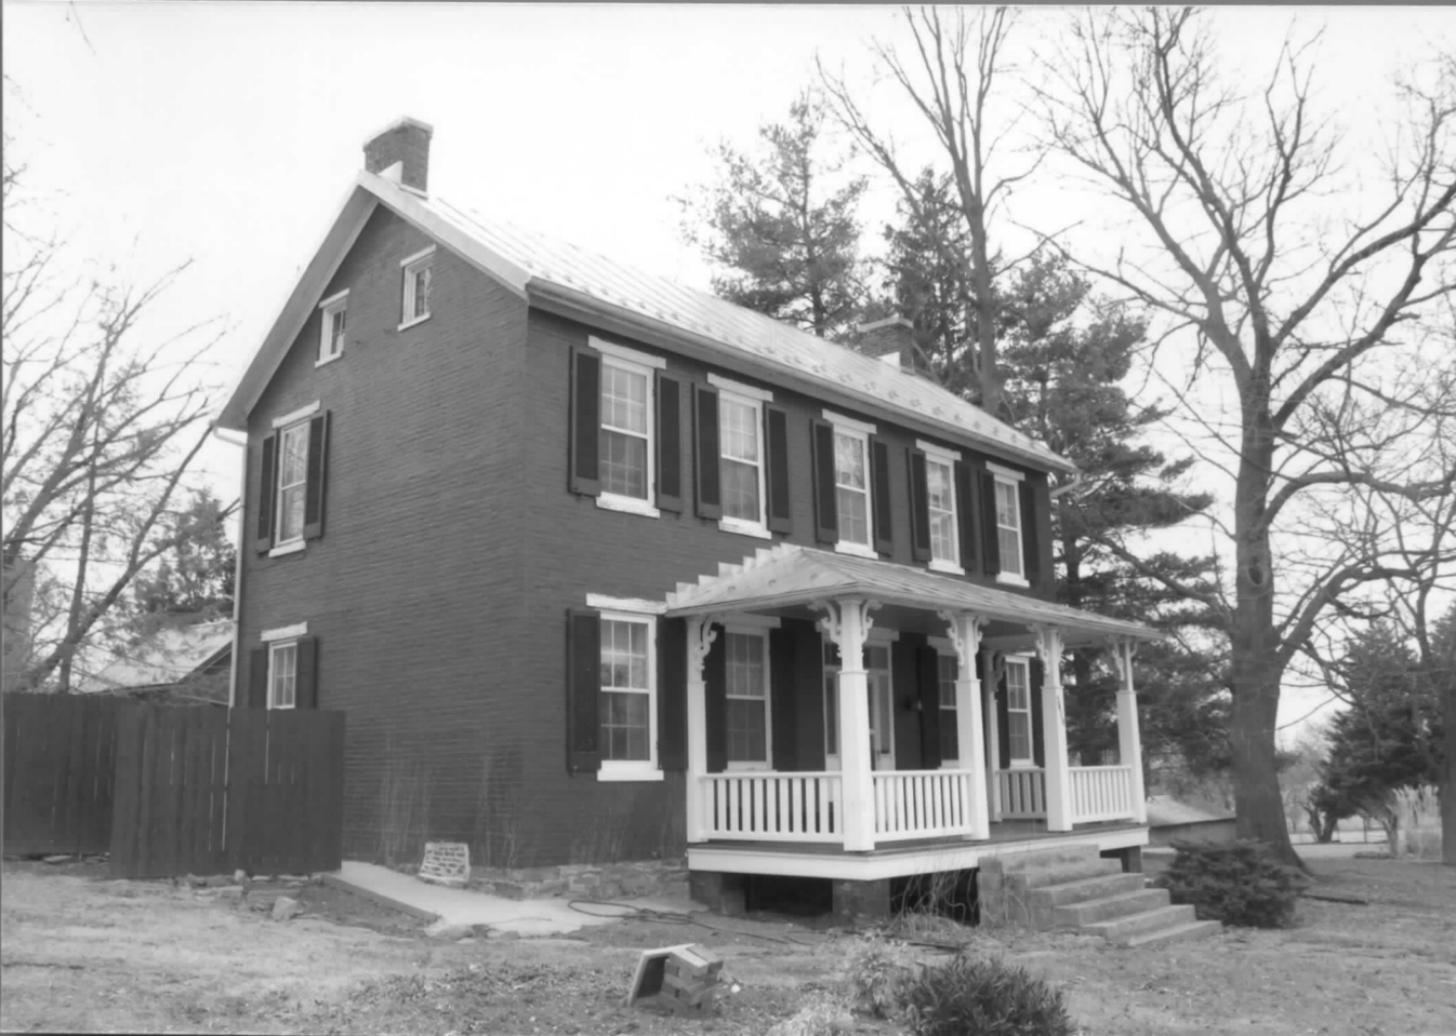
4 of 17

The east and west elevations of the main block of the dwelling are identical. Both elevations contain two asymmetrical bays. One of the bays contain aligned, six-over-six double-hung wood windows located on the first and second stories and a four-light wood window in the gabled end. The double-hung windows have wood sills, wood lintels with corner block containing rosettes, and wood louvered shutters. The second bay contains only a four-light wood window in the gabled end.

Primary Farm House (3419 Jefferson
Pike) North and East Elevations
Looking SW

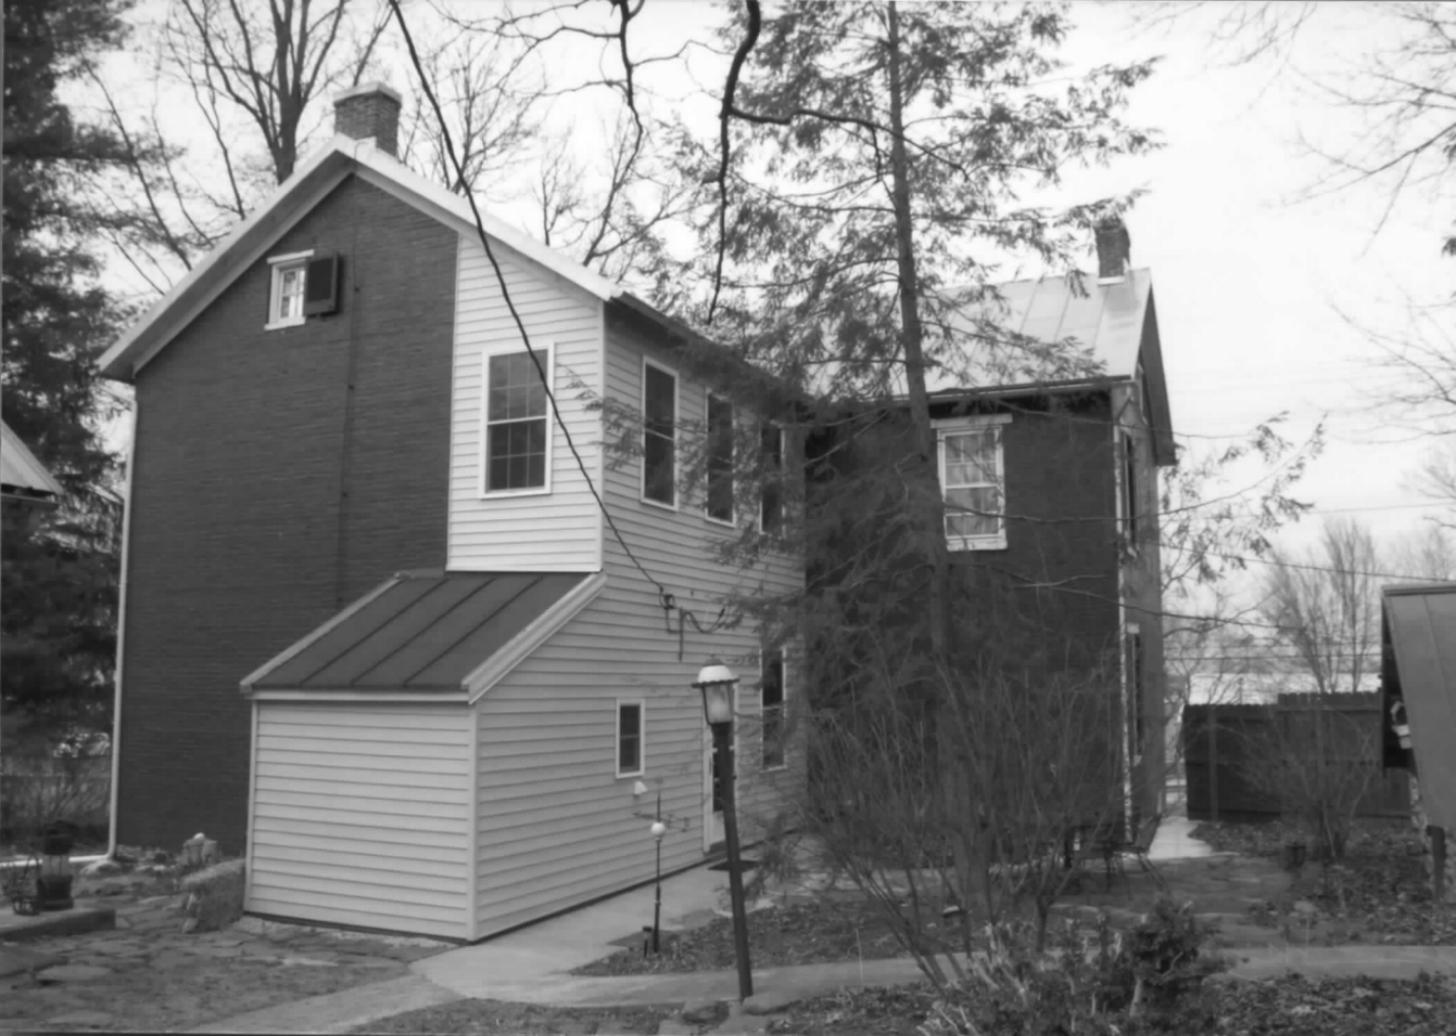
The south (rear) elevation of the main block of the dwelling contains one bay with a six-over-six, double-hung wood window located in the second story at the east end of the elevation. A two-and-a-half-story rear ell extends from the west end of the elevation. The rear ell has brick walls and a standing-seam metal-clad gabled roof with an interior end brick chimney. A two-story wood-frame addition has been constructed onto the east side of the ell. The east elevation of the addition contains three asymmetrical bays containing two, one-over-one double-hung vinyl windows of different sizes on the first story flanking a single-leaf, two-light metal door. The second story contains three, double-hung one-over-one vinyl windows with false muntins. The south elevation of the rear ell includes two asymmetrical bays consisting of portions of the original structure and the addition. The addition at the east end of the elevation contains a one-story shed-roof projecting bay extending from its first story. The projecting bay contains a one-over-one double-hung vinyl window with false muntin on its west side. The second story on the south elevation of the addition contains a single, one-over-one double-hung vinyl window.

The south elevation of the original ell contains one bay with a single, four-light wood window in the gabled end with a wood louvered shutter. The west elevation of the ell contains two bays with aligned six-over-six double-hung wood windows on the first and second stories. The windows contain wood sills, wood lintels with corner blocks containing rosettes, and wood louvered shutters.

F-2-129
Horine Farm
Frederick County, Maryland
Eric Griffiths
3-24-2015
MDSHPO
Primary Farm House (3419 Jefferson
Pike) South and East Elevations
Looking NW
S of 17

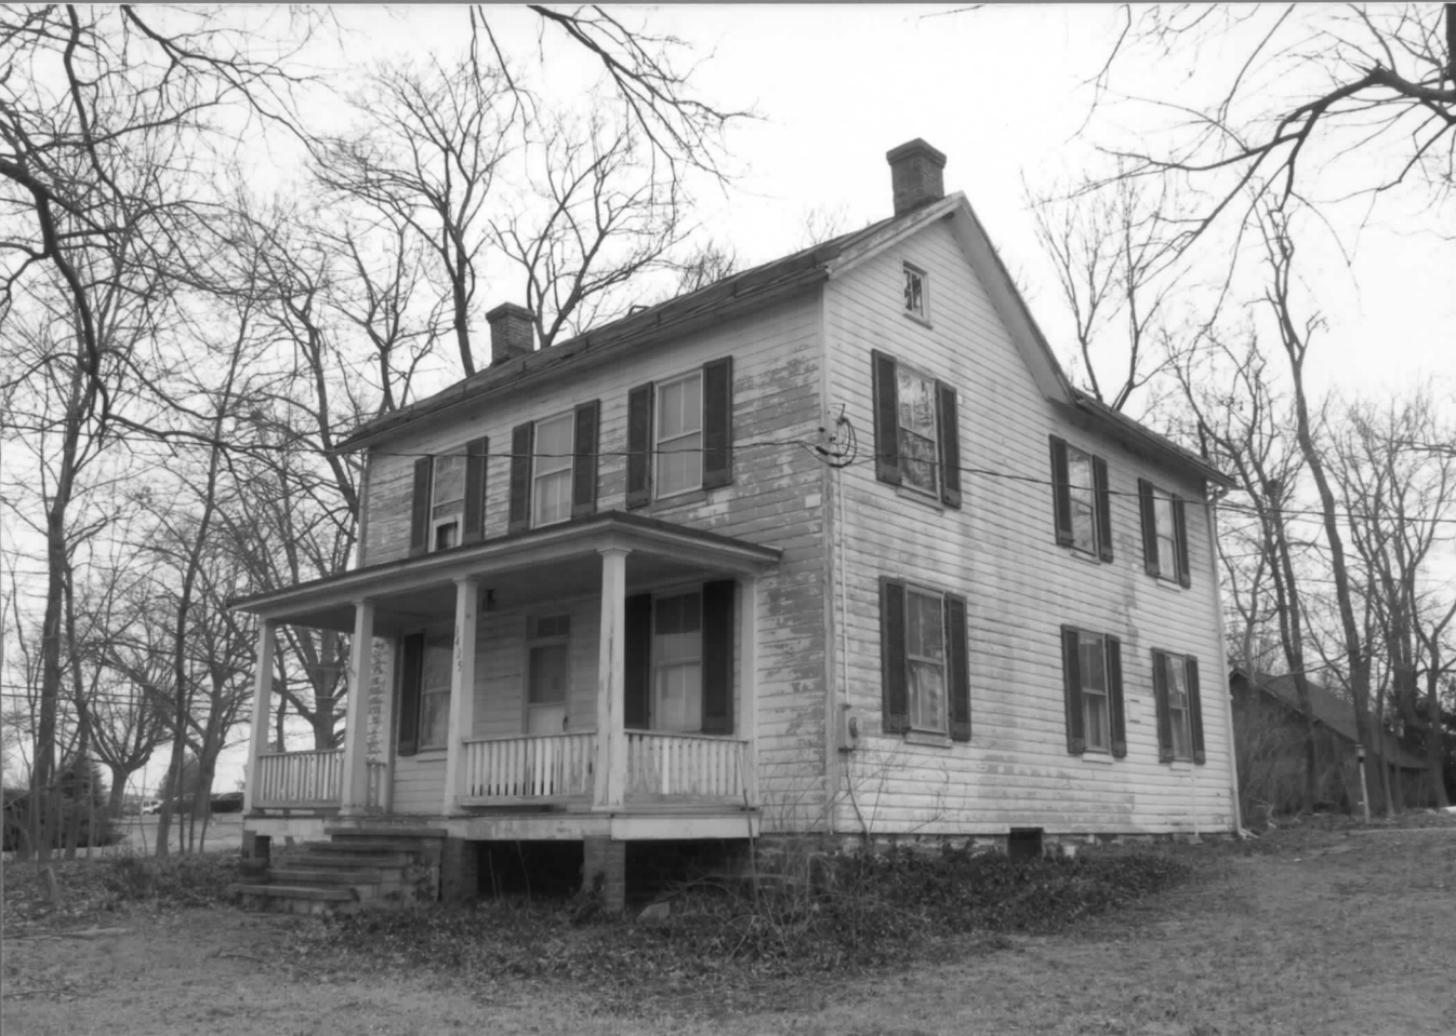
A secondary residence on the property, constructed circa 1880, is located approximately forty feet west of the primary residence at 3421 Horine Road. This two-and-a-half-story, wood-frame, I-House is set on a rubble stone foundation and has wood clapboard walls and is capped by a standing-seam-metal-clad, side-gabled roof. Two interior end chimneys pierce the roof at the east and west ends of the dwelling.

The north (front) elevation of the dwelling contains three symmetrical bays. A single-leaf wood paneled door with a two-light metal transom is located in the center of the first story. The entrance is flanked by two-over-two double-hung wood windows. The entrance and windows are located inside a hipped-roof porch set on brick piers. The porch has a wood floor, four square wood column supports, and a wood railing. Two engaged wood pilasters are located at both ends where the porch meets the main block of the dwelling. The second story contains three, two-over-two double-hung wood windows. All of the windows on the elevation contain wood sills and have wood louvered shutters.

The east and west elevations of the dwelling's main block are identical. Both contain one bay with aligned one-over-one, double-hung wood windows on the first and second stories and a four-light wood window in the gabled end. The foundation also contains a two-light wood basement window.

F-2-129
Horine Farm
Frederick County, Maryland
Eric Griffiths
3-24-2015
MD SHPO
~~Prima~~ Secondary Farmhouse
(3421 Jefferson Pike)
North and West elevations
Looking SE
6 of 17

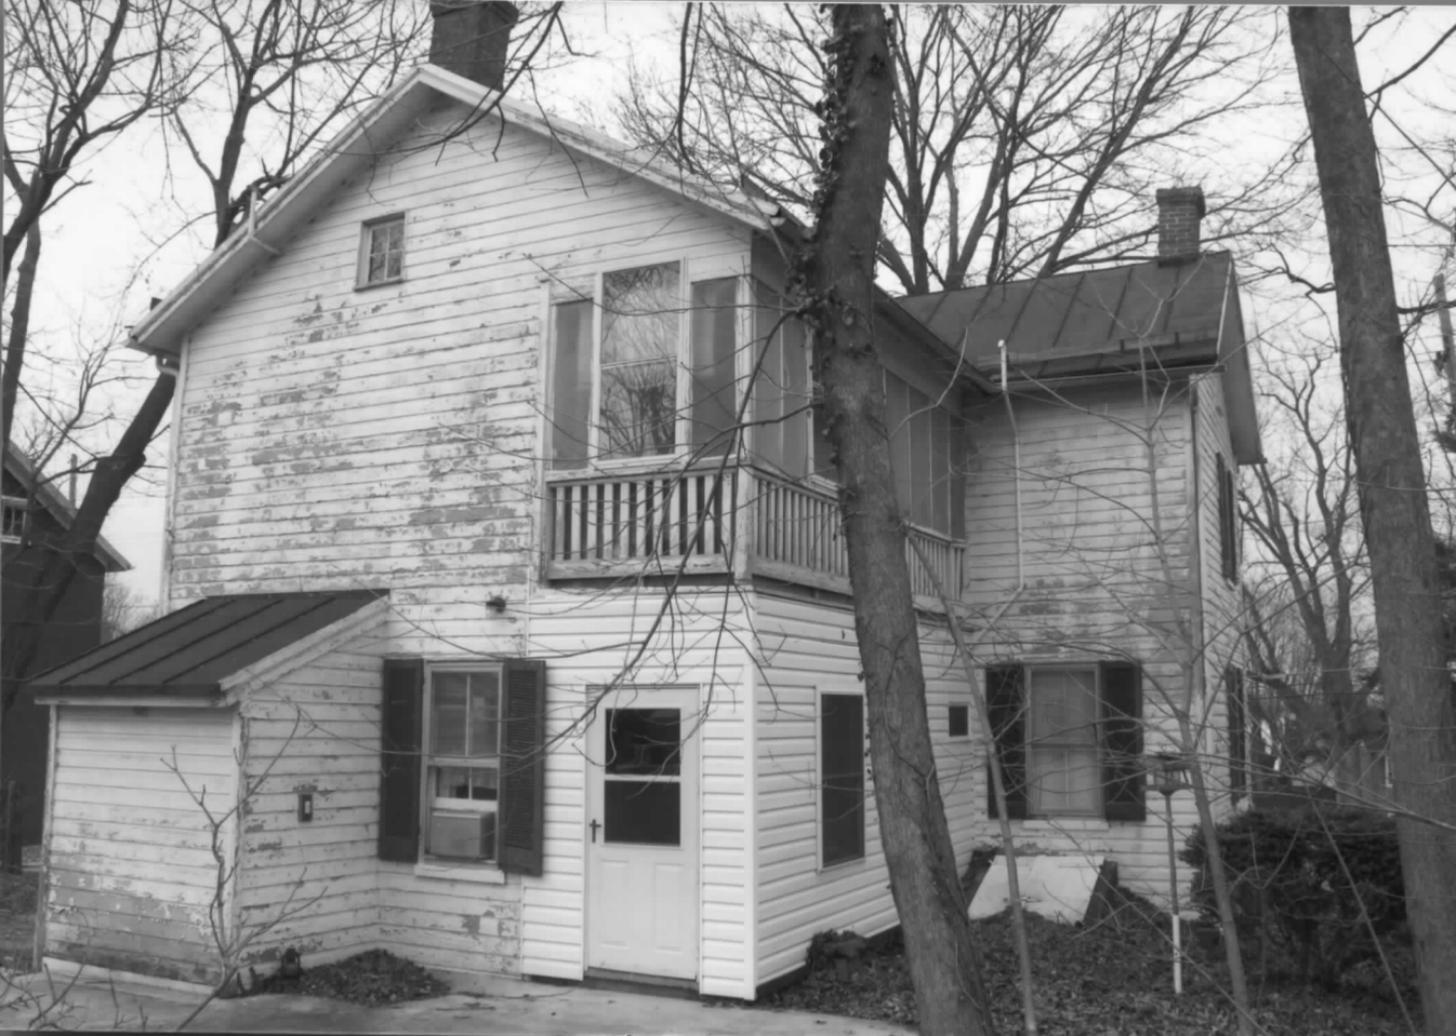
The south elevation of the main block contains one bay with a two-over-two double-hung wood window with wood louvered shutters only on the first story. A two-and-a-half-story rear ell extends from the west half of the main block. The ell is a frame structure clad with wood clapboard and capped by a standing-seam-metal-clad gabled roof with an interior end brick chimney.

The east elevation of the ell contains a one-story addition clad with vinyl siding. The addition is likely an enclosure of the two-story porches that are reflected in the typical design of this property type. The east elevation of the addition contains two bays with a one-over-one double-hung vinyl window and a fixed one-light vinyl window. A balcony with a wood railing, part of the original building, is located above the addition. The east elevation of the balcony contains a ribbon window of eight, wood-frame screened window openings. The south elevation of the rear ell contains three asymmetrical bays. A single-leaf two-light metal door is located on the first story of the addition at the east end of the elevation. Above this entrance is a portion of the balcony containing two, screened openings flanking a one-over-one metal window. The center bay contains a single, two-over-two double-hung wood window with wood louvered shutters on the first story and a four-light wood window in the gabled end. The bay at the western end of the elevation has a one-story shed-roof projecting bay with a standing-seam-metal-clad roof and a one-over-one double-hung wood window with a wood louvered shutter on its west side. The west elevation of the rear ell contains two symmetrical bays containing aligned two-over-two double-hung wood windows with louvered wood shutters.

F-2-129
Horine Farm
Frederick County, Maryland
Eric Griffiths
3-24-2015
MOSHPO
Secondary Farmhouse
(342) Jefferson Pike)
South and East elevations
Looking NW
7 of 17

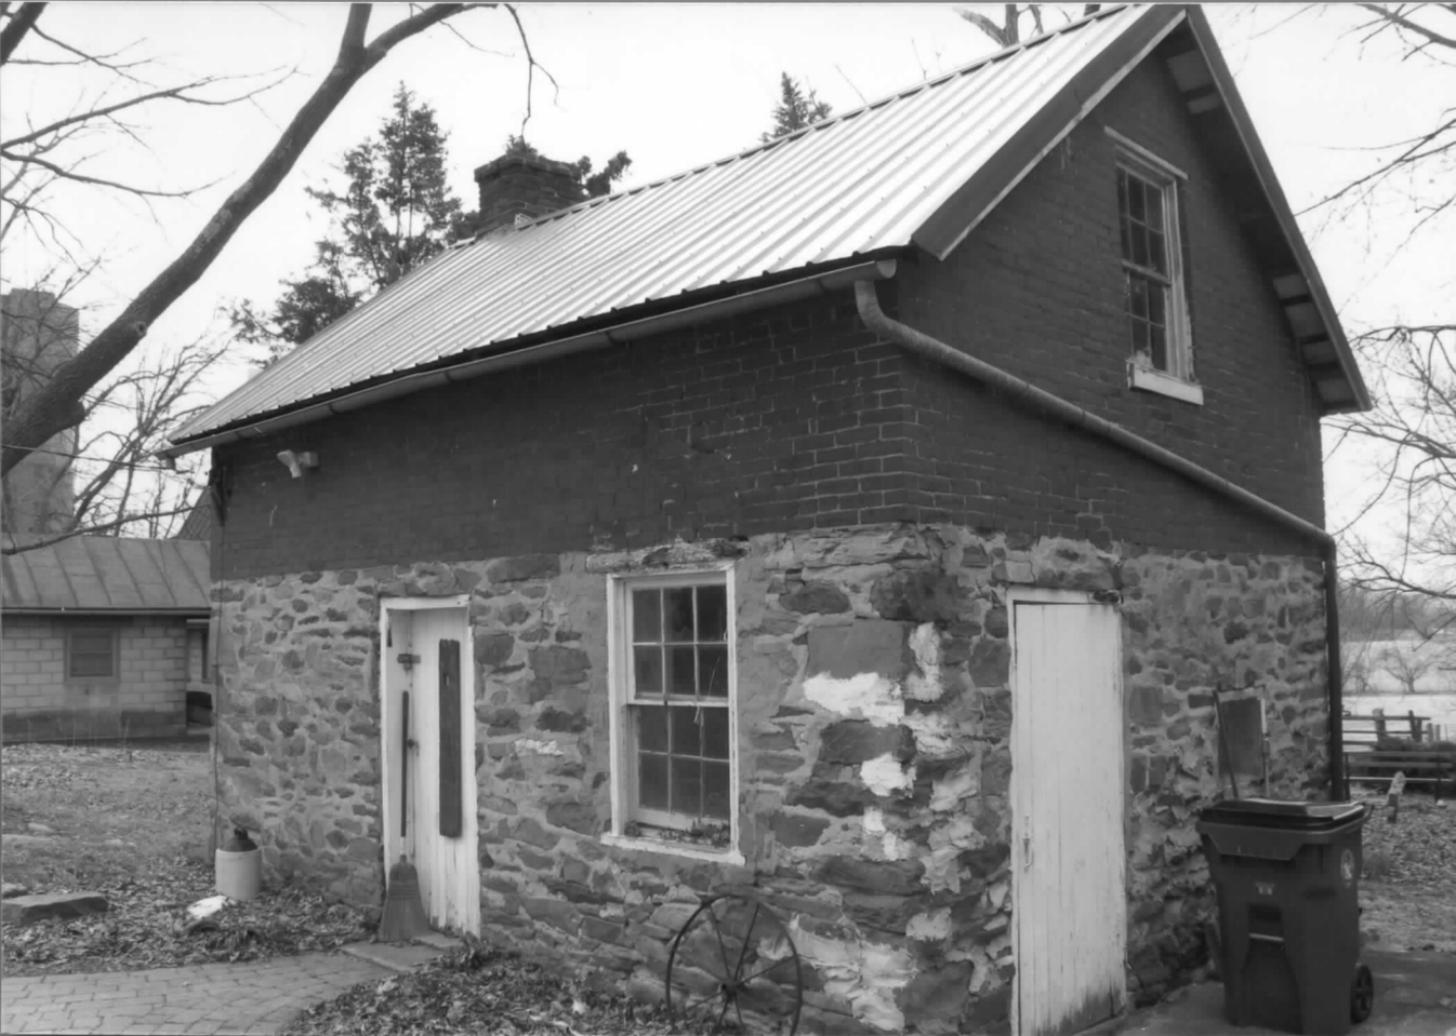
The wash house is a one-and-a-half-story masonry building. The first story is constructed of rubble stone and the upper story is built of brick laid in running bond. The building is capped by a standing-seam-metal-clad gabled roof and has an interior end brick chimney. The east elevation of the building contains two asymmetrical bays featuring a single-leaf wood door and a six-over-six, double-hung wood window on the first story and no window openings on the second story. The north elevation contains three asymmetrical bays. The first story has a single-leaf wood door and a four-light wood window. The gabled end between these two bays contains a six-over-six double-hung wood window. The west elevation contains one bay with a single, six-over-six double-hung wood window on the first story. The south elevation also features one bay with a single, six-over-six double-hung wood window on the upper story in the gabled end.

F-2-129
Horing Farm
Frederick County, Maryland
Eric Griffiths
3-24-2015
MD SHPO
Wash House
North and East elevations
Looking SW
8 of 17

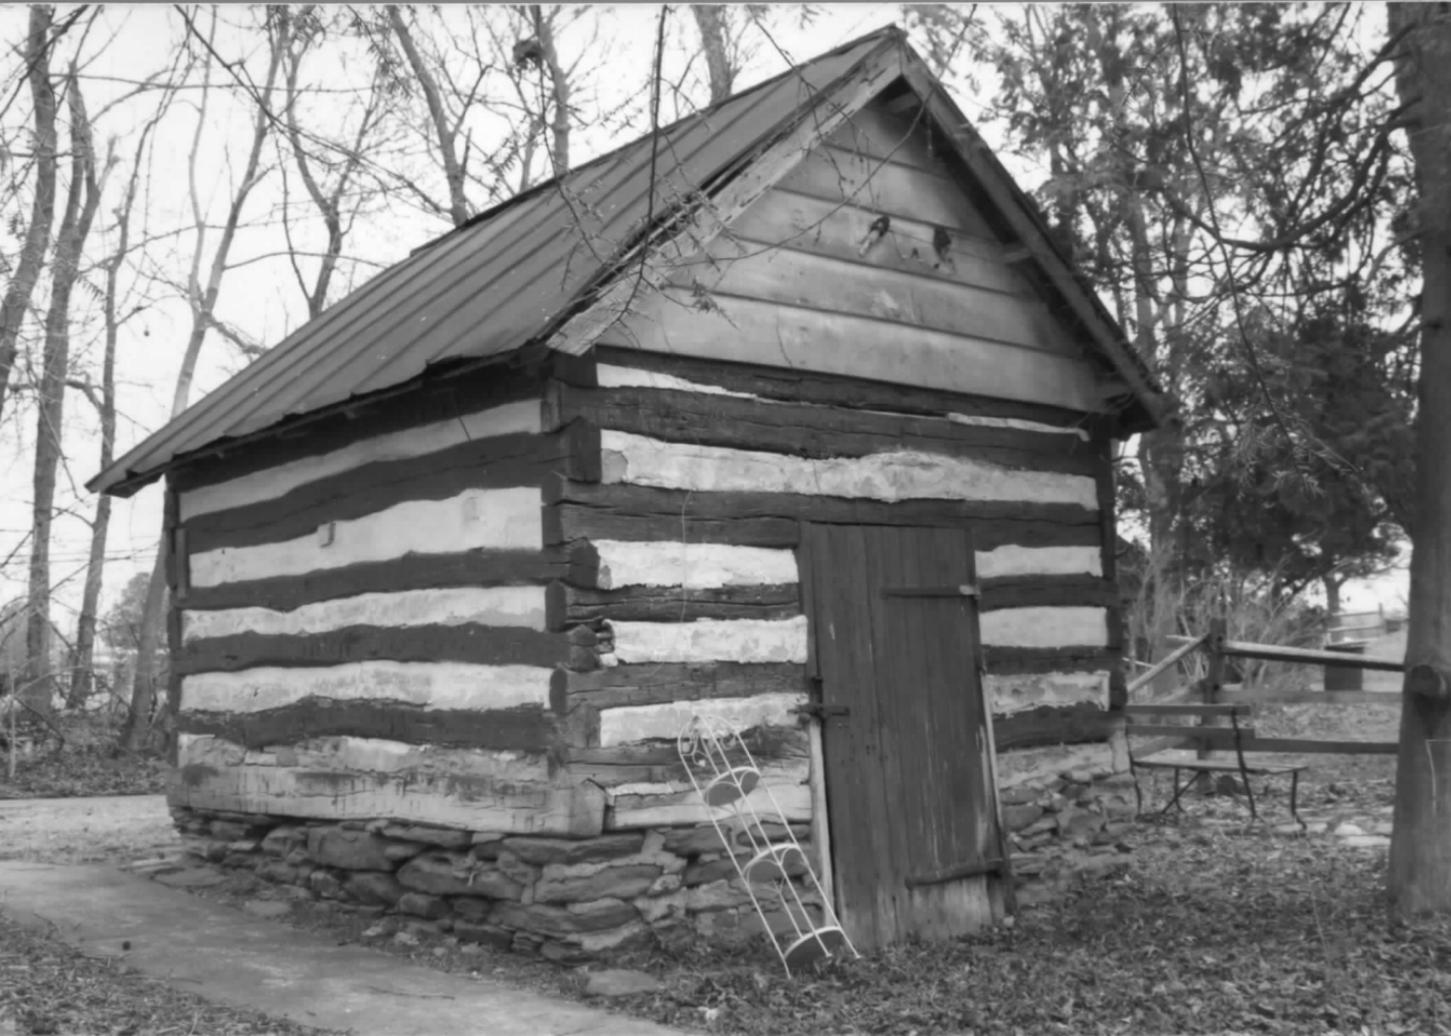
The smokehouse is a one-story log building located east of the ice house. The building sits on a rubble stone foundation and is capped by a standing-seam-metal-clad front-gabled roof. The gabled ends are clad with wood planking. The smokehouse contains only one opening, a single-leaf wood door on its west elevation.

F-2-129
Horne Farm
Frederick County, Maryland
Eric Griffiths
3-24-2015
MD SHPO
Smoke House
~~South~~ North and West elevations
Looking SE
9 of 17

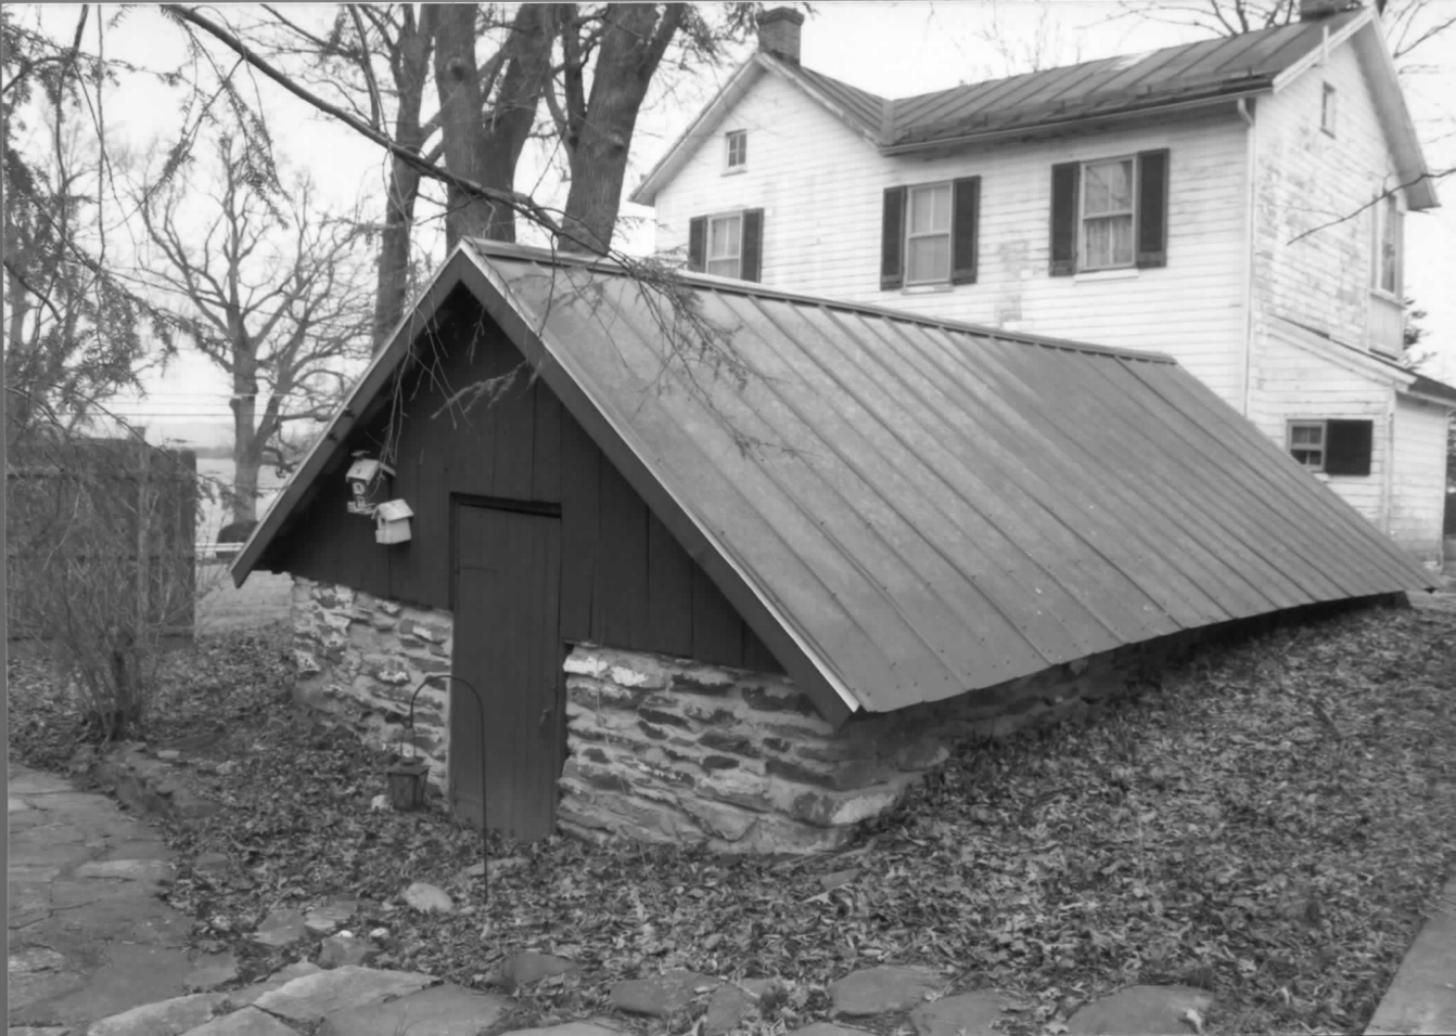
The ice house is located east of the wash house. The one-story building is built into a small embankment and has rubble stone walls capped by a standing-seam-metal-clad front gabled roof. The gabled ends are clad with vertical wood planks. The west and east elevations each contain one bay with a single-leaf wood door.

F-2-129
Horine Farm
Frederick County, Maryland
Eric Griffiths
3-24-2015
MD SHPO
ICE House, Looking NE
10 of 17

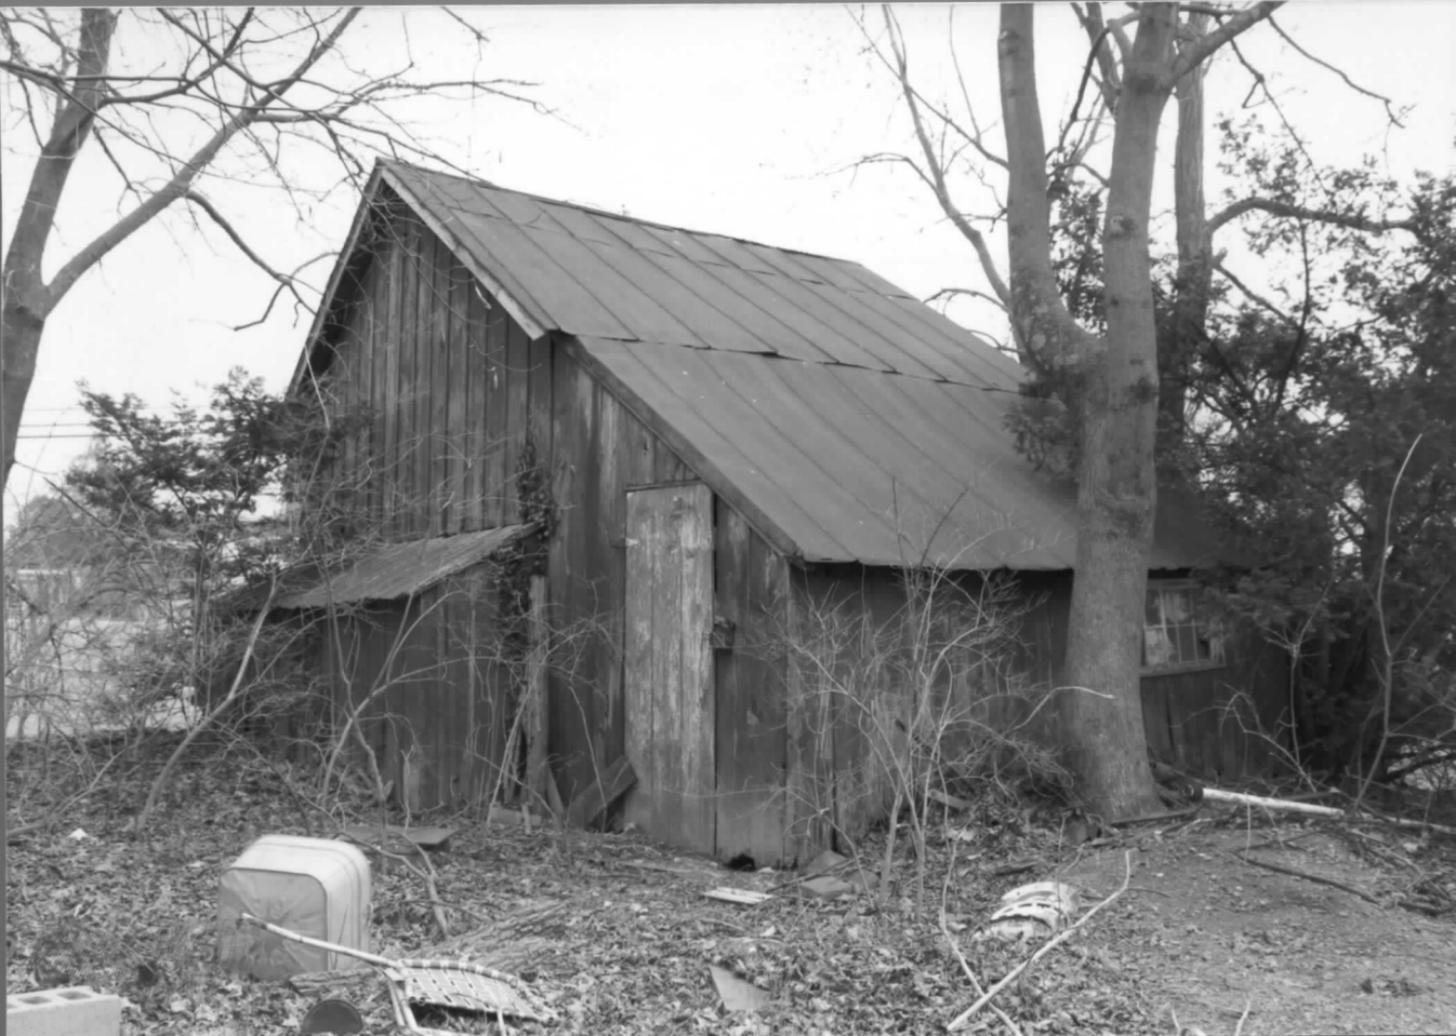
A wood-frame carriage house, constructed circa 1900, is located just west of Horine Road and north of the driveway leading into the farm from the road. This one-story wood-frame building has board-and-batten wood siding and is capped by a standing-seam-metal-clad gabled roof. A one-story lean-to bay extends from the west elevation of the building. The north elevation contains two bays with a single-leaf wood door located within the lean-to bay and a small shed-roof projecting bay extending from the north end of the building's main block. The west elevation of the lean-to bay contains one bay with a six-light wood window. None of the other elevations contain openings.

F-2-129
Honne Farm
Frederick County, Maryland
Eric Griffiths
3-24-2015
MD SHPO
Carriage House
North and West elevations
Looking SE
11 of 17

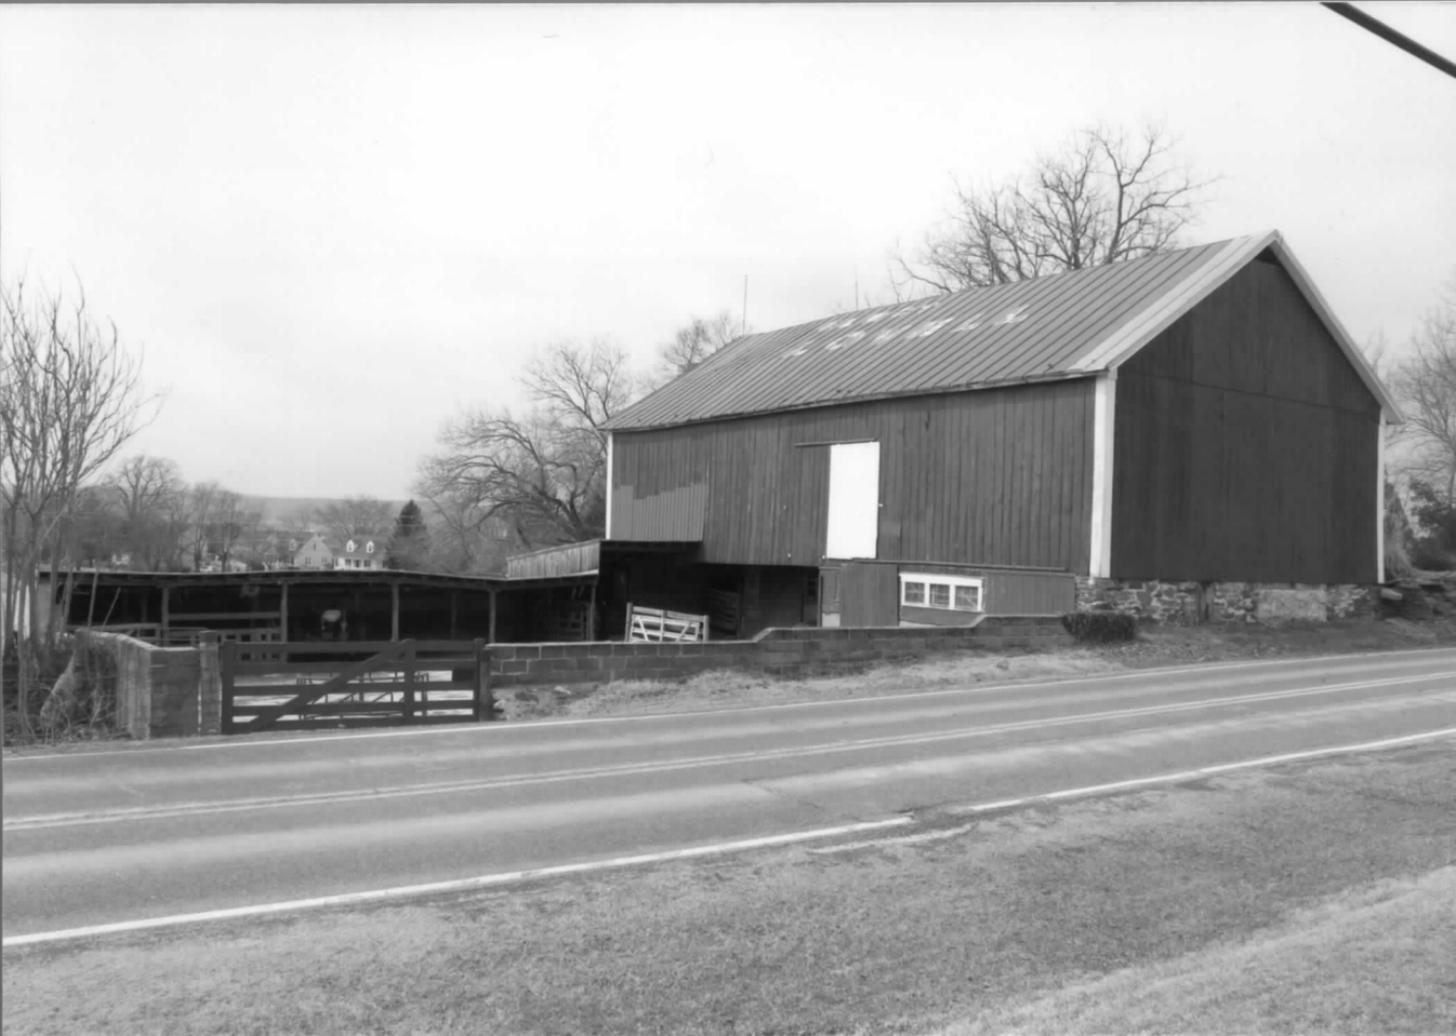
A bank barn, constructed circa 1880, is located south of the driveway leading into the farm. The barn is a large, one-story building

constructed into the side of an embankment. The barn is set on a rubble stone foundation and has vertical wood plank walls and a standing-seam-metal-clad gabled roof. The north elevation of the barn contains three asymmetrical bays. The west end of the elevation contains double-leaf wood doors. Near the center of the elevation atop the embankment is a single-leaf wood door. Between these bays is a center bay containing a projecting bay with a single-leaf wood door and a window opening in the rubble foundation with a wood cover. The east and west elevations of the barn have no openings. The south elevation has four asymmetrical bays. The east half of the elevation contains triple, six-light wood windows located between two sliding wood doors. A second sliding wood door is located in a center bay above a recessed bay in the west half of the barn. The portion of the elevation under the recessed bay contains double-leaf sliding wood doors. A one-story six-bay wood-frame tractor shed extends from the west end of the elevation. The tractor shed has concrete block walls and a standing-seam-metal-clad-shed roof. The east elevation contains an open façade with only wood posts dividing the individual bays.

F-2-129
Horine Farm
Frederick County, Maryland
Eric Griffiths
3-24-2015
MD SHPO
Bank Barn
South and East Elevations
Looking NW
12 of 17
