**MARYLAND HISTORICAL TRUST
DETERMINATION OF ELIGIBILITY FORM**

Property Name: Horine Farm Inventory Number: F-2-129
 Address: 3419 and 3421 Jefferson Pike (MD 180) Historic district: yes no
 City: Jefferson Zip Code: 21755 County: Frederick
 USGS Quadrangle(s): Point of Rocks
 Property Owner: John and Joanna Lovell Tax Account ID Number: 327916
 Tax Map Parcel Number(s): 203 Tax Map Number: 84
 Project: MD 180, US 340 to Old Holter Road, Frederick County, MD Agency: SHA
 Agency Prepared By: EHT Traceries
 Preparer's Name: Eric Griffitts Date Prepared: 4/8/2015

Project Name: MD 180 from US 340 to Old Holter Road

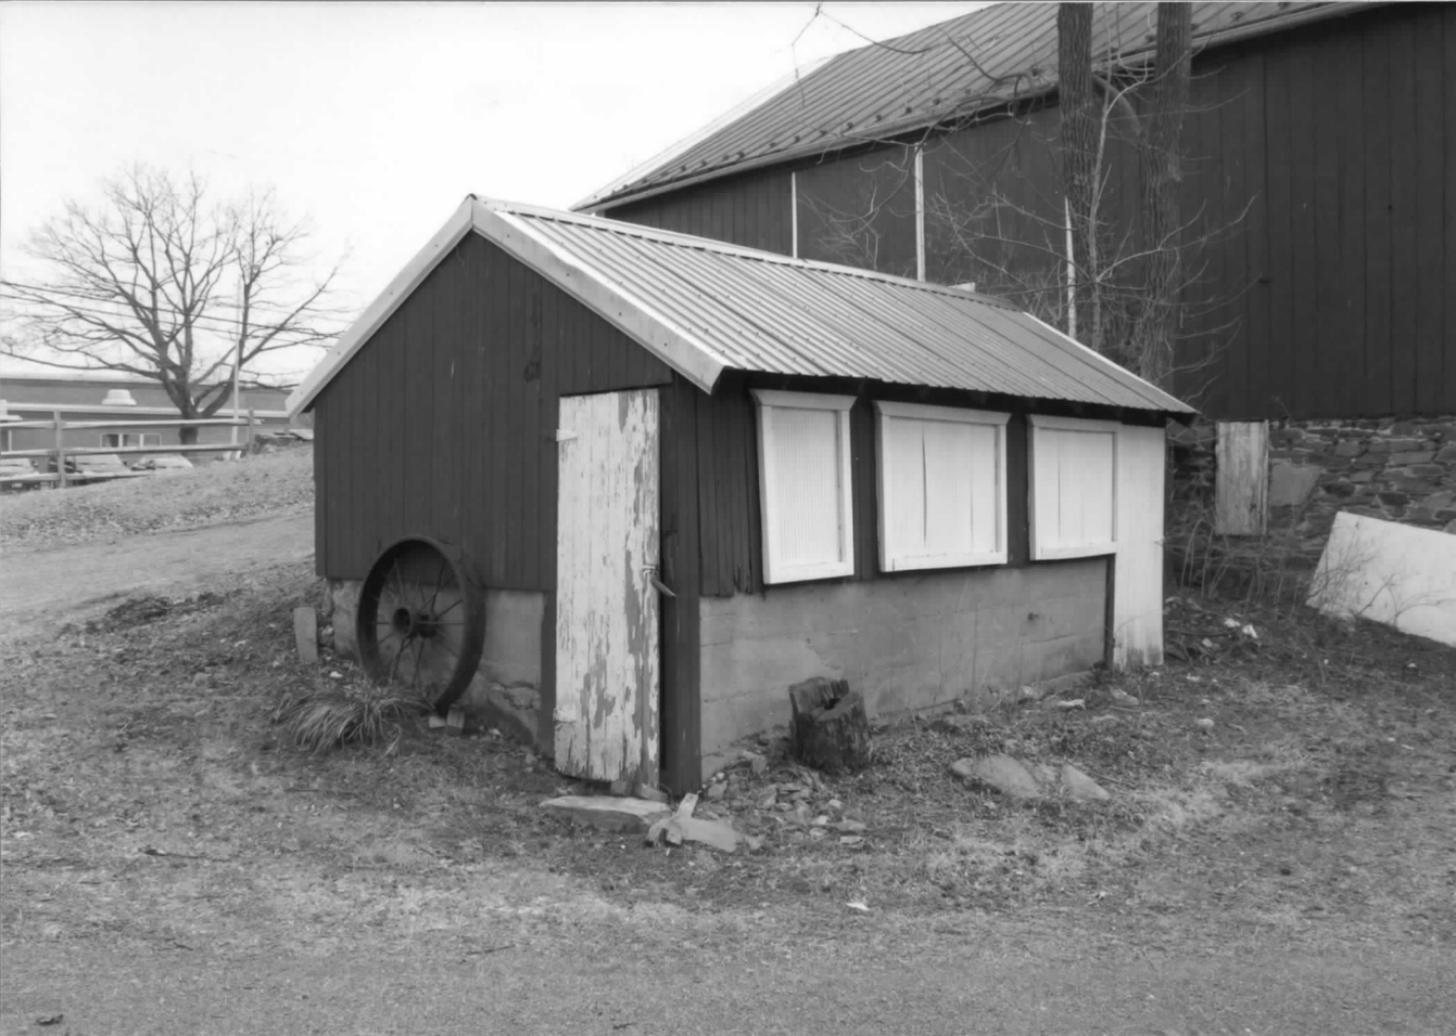
A one-story wood-frame shed, constructed circa 1930, is located about ten feet north of the barn. The building is set on a concrete block foundation and has vertical wood plank walls and a standing-seam-metal-clad gabled roof. The west elevation of the building contains four asymmetrical bays featuring three windows sealed with metal and a single-leaf wood door. The north elevation of the building has one bay containing a single-leaf wood door. The south and east elevations have no openings.

F-2-129
Horine Farm
Frederick County, Maryland
Eric Griffiths
3-24-2015
MD SHPO North
SHed, ~~South~~ West Elevations
Looking SE
13 of 17

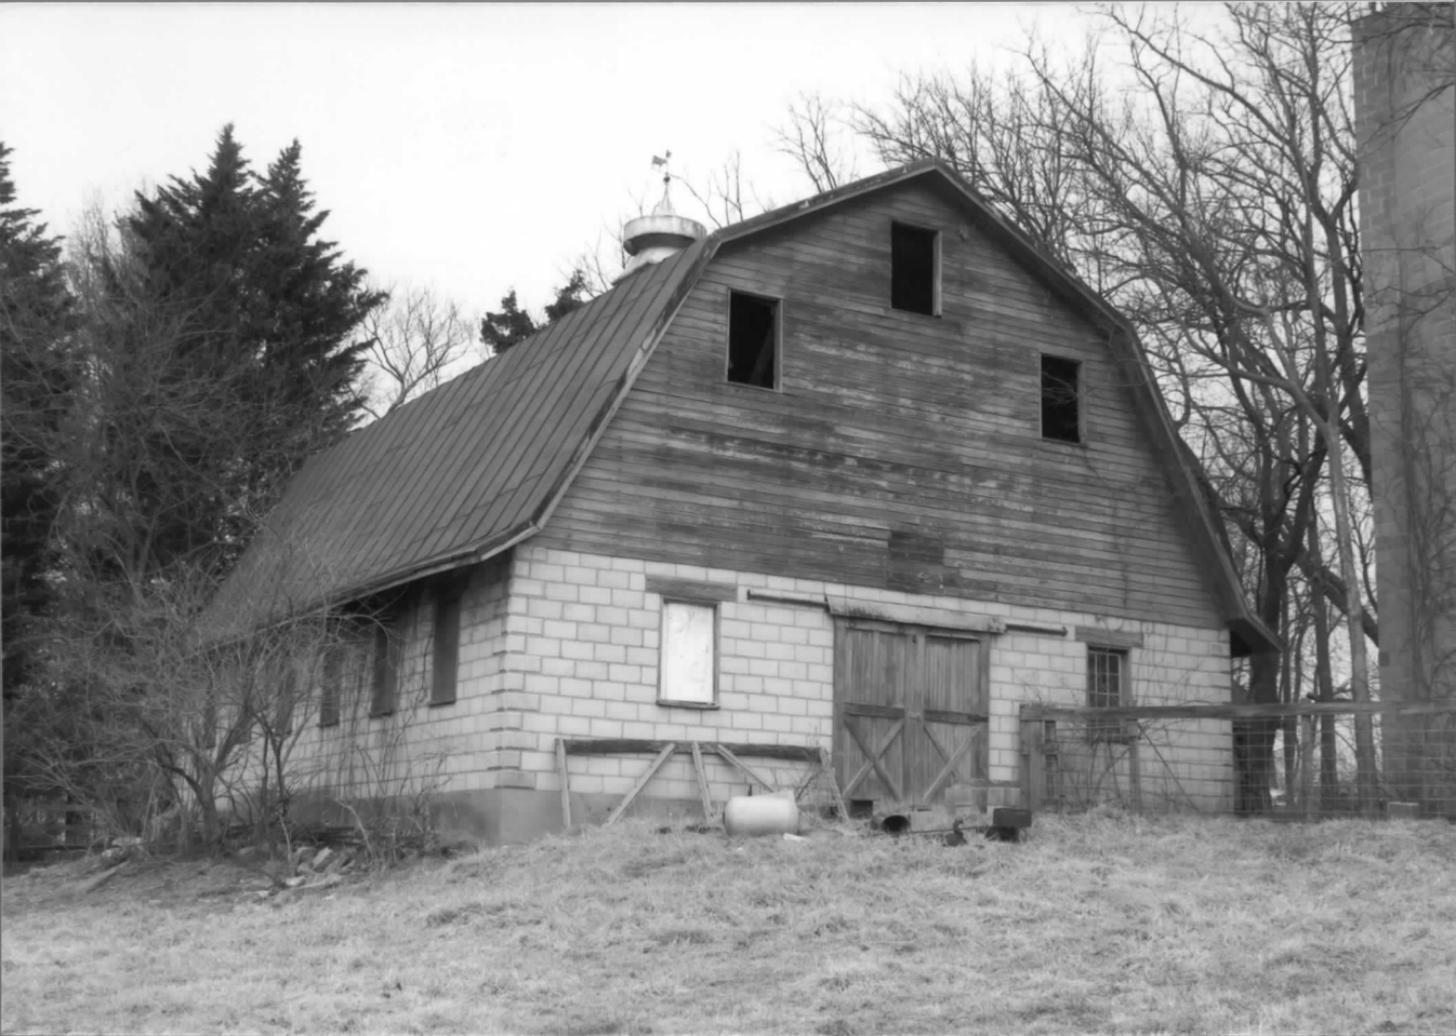
A dairy barn, constructed circa 1940 and located approximately fifty feet northwest of the bank barn, is a one-and-a-half-story barn with a standing-seam-metal-clad gambrel roof containing a metal cupola. The building was constructed as part of the development of dairy operations during the twentieth century. The first story of the barn is constructed of concrete block and the gambrel roof ends in the upper story are clad with wood planks. The south elevation of the barn contains three symmetrical bays. The first story contains a centrally located double-leaf wood door flanked by single windows. A twelve-light wood window is located east of the door and the window opening west of the door is sealed with wood. Three window openings located on the upper story have no glazing. The west elevation of the barn contains six symmetrical bays with window openings sealed with wood.

F-2-129
Horne Farm
Frederick County, Maryland
Eric Griffiths
3-24-2015
MD SHPO
Barr Barn, South and West elevations
Looking NE
14 of 17

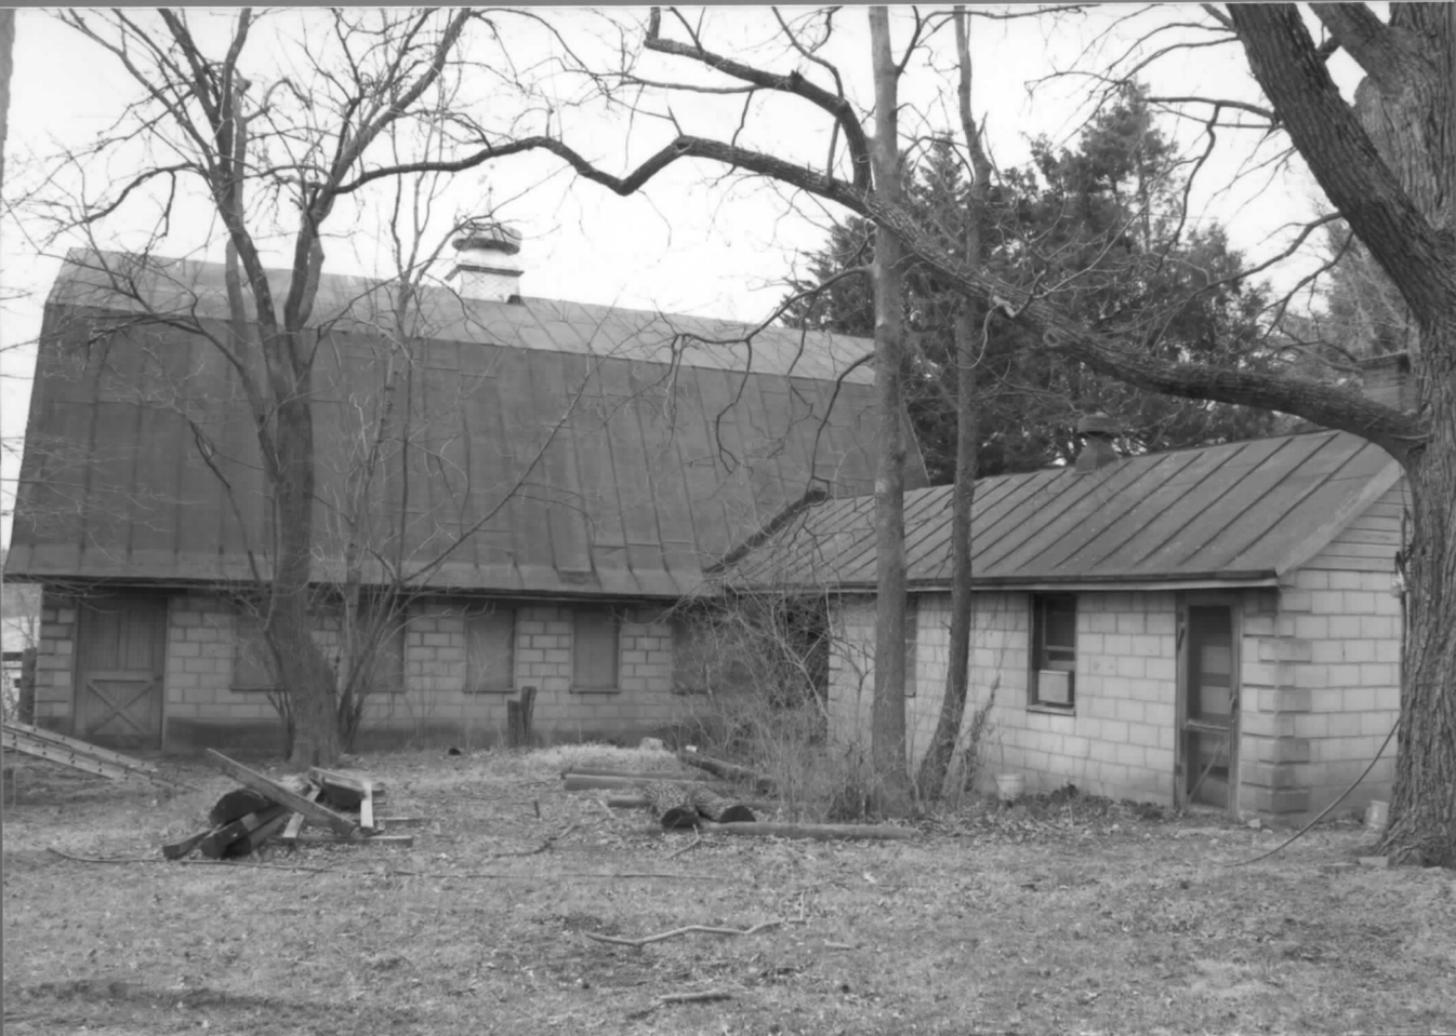
The north elevation of the barn has four symmetrical bays featuring four window openings on the first story sealed with wood. The upper story contains single and double-leaf wood doors flanked by six-over-six double-hung wood windows. The east elevation of the barn contains eight symmetrical bays. Single-leaf wood doors are located at both ends of the elevation. Six window openings sealed with wood are located between these two doors.

An attached one-story milk house, constructed circa 1940, is connected to the east elevation of the barn. The milk house is a rectangular building that has concrete block walls and is capped by a standing-seam-metal-clad gabled roof containing a metal cupola and interior brick chimney. The south elevation of the building contains three asymmetrical bays containing a single-leaf wood paneled door and two one-over-one double-hung wood windows. The north elevation of the milk house contains three asymmetrical bays containing a single-leaf wood paneled door, a single-leaf wood slab door, and a one-over-one double-hung wood window. The east elevation has no window openings. The west elevation has no opening but is sheltered by the overhang of the roof that is connected to the dairy barn.

F-2-129
Honne Farm
Frederick County, Maryland
Eric Griffiths
3-24-2015
MD SHPO
Dairy Barn (East Elevation)
and Milk House South Elevation)
Looking NW
15 of 17

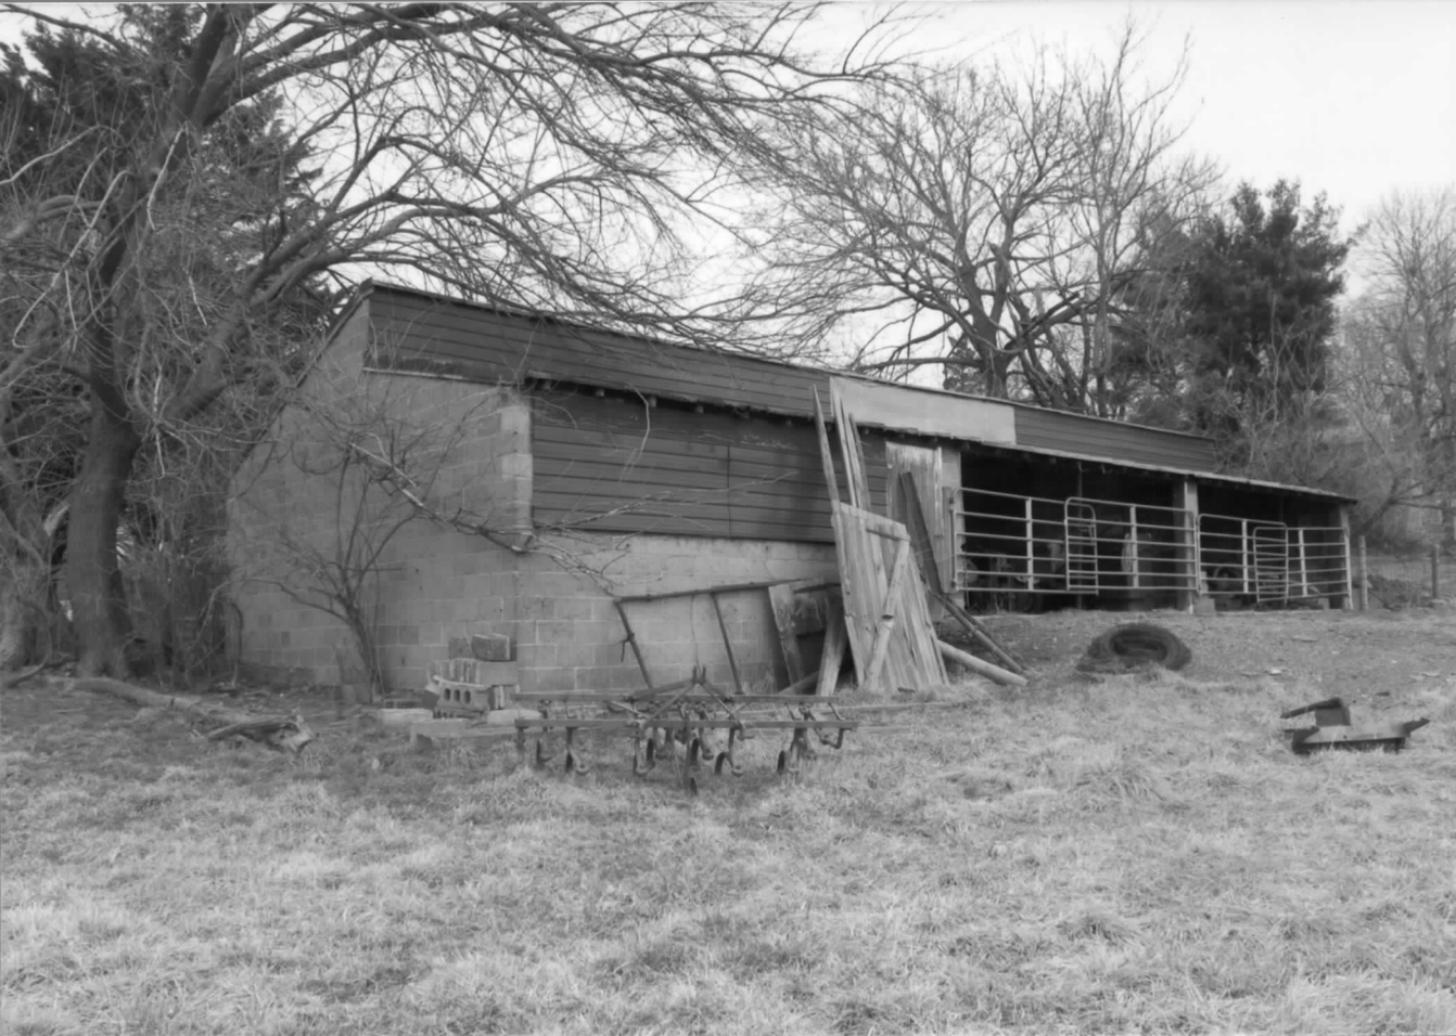
The wagon shed, constructed circa 1960, is located approximately 130 feet west of the farm complex in the middle of a fallow agricultural field. The shed is a one-story concrete block building capped by a standing-seam-metal-clad gabled roof containing what appears to be a clerestory bank of windows now clad with metal siding. The south elevation of the shed contains four open bays and a single-leaf wood door. The north, east, and west elevations have no window openings.

F-2-129
Horne Farm
Frederick County, Maryland
Eric Griffiths
3-24-2015
MD SHPO
Wagon Shed
South and west elevations
Looking NE
16 of 17

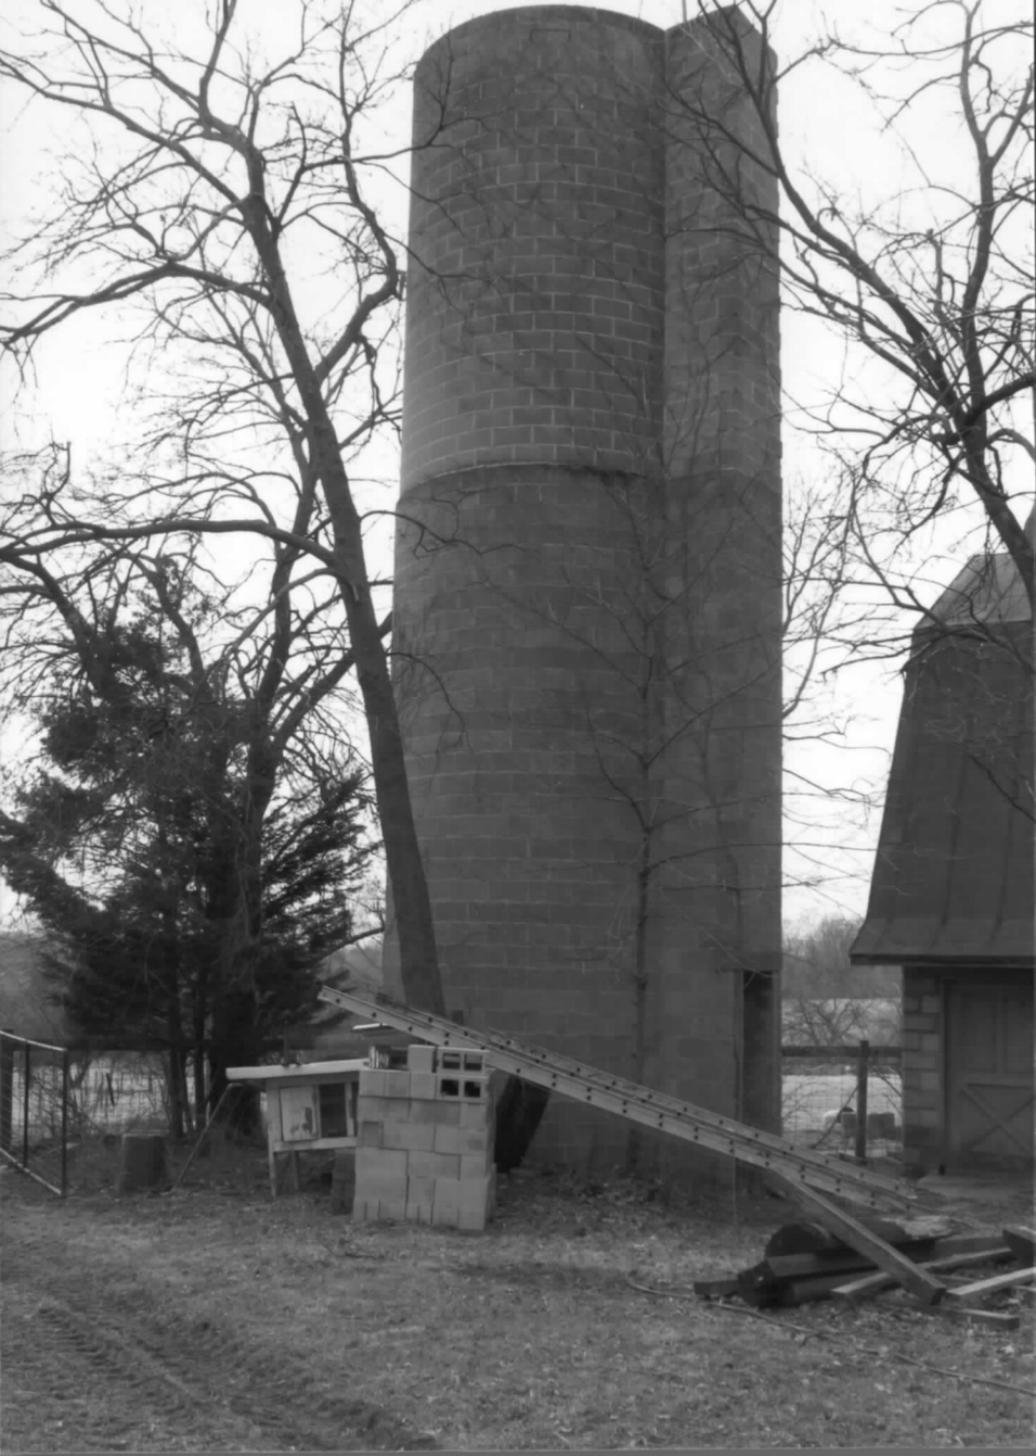
A silo, constructed circa 1940, is located approximately fifteen to twenty feet southeast of the dairy barn. The cylindrical tower is constructed of clay tiles and contains a rectangular shaft with an opening on its northwest side.

F-2-129
Horne Farm
Frederick County, Maryland
Eric Griffiths
3-24-2015
MD SHPO
Silo, Looking SW
17 of 17
